Building and Timber Pest Inspection Report

Inspection Date: Fri, 30 Jan 2026

Property Address: 3 Brockamin Dr, South Penrith NSW 2750, Australia

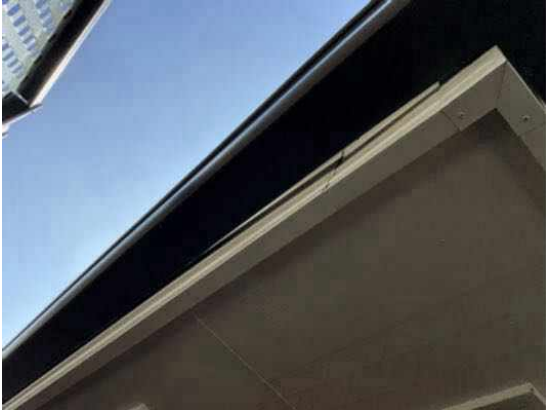
Finding 3.03

Building: Main Building
Location: Rear Elevation
Finding: Poor workmanship
Information: The structure exhibits signs of poor workmanship, evident in various aspects of construction and finishing.

Risk: Poor workmanship poses a range of risks, including compromised structural integrity, potential safety hazards, and a decreased lifespan of the structure. It may

also lead to aesthetic and functional issues.

Resolution: A qualified contractor or construction professional should be consulted to assess and address the poor workmanship. They can implement corrective measures to ensure structural soundness, safety, and overall quality of the construction.

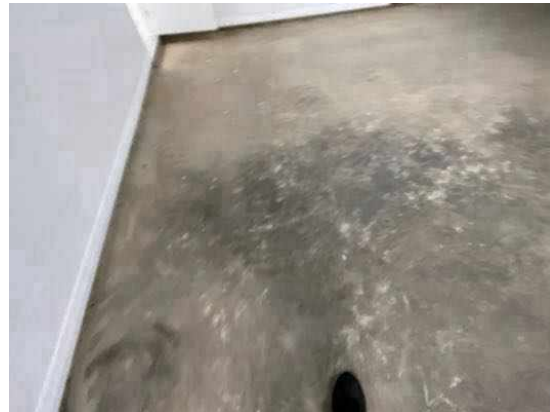
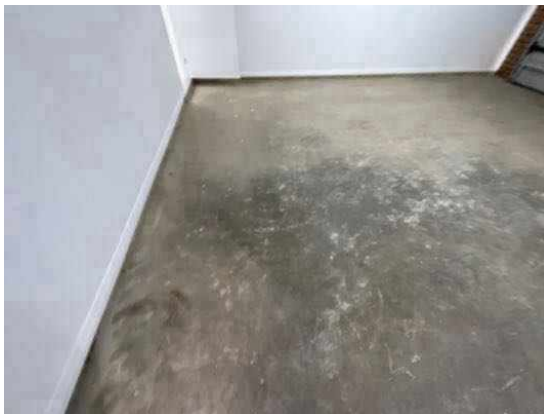
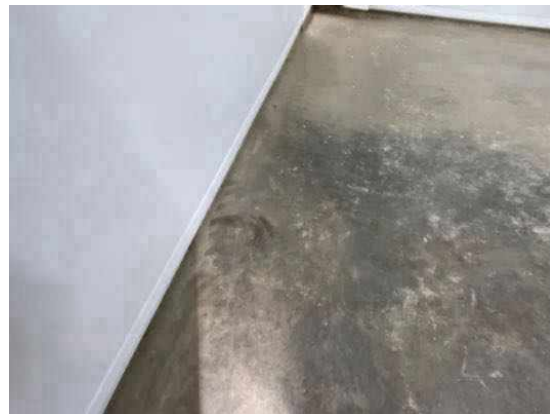
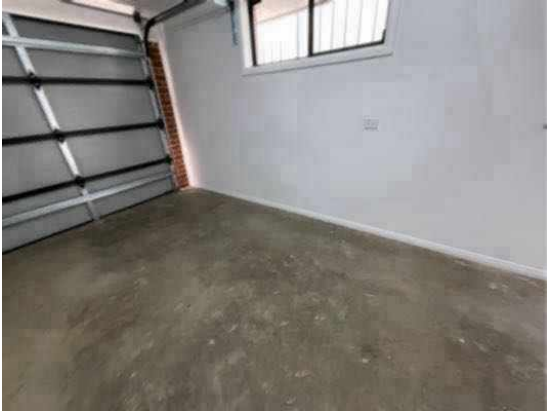
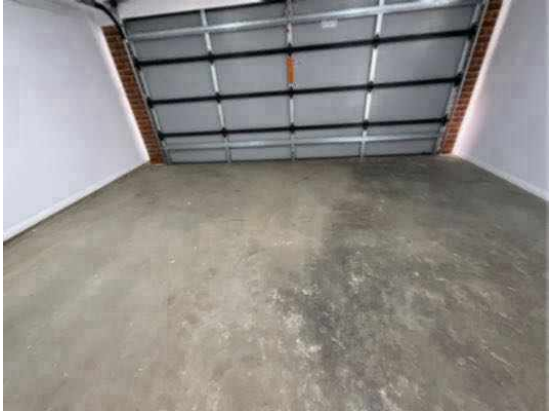
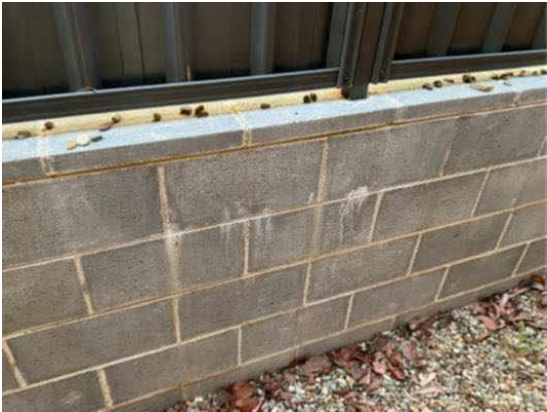
Finding 3.04

Building: Main Building
Location: All Areas
Finding: Cleaning required
Information: It was observed that the house requires cleaning.

Works are defective where windows are not clean, floors are not swept, mopped or vacuumed as appropriate, tiles, sinks, basins, baths, windows or any other area throughout the property are not cleaned, and shelving, drawers and cupboards are not ready for use not cleaned and ready for use at handover.

Building sites are defective if they are not clear of building debris.

This is to be addressed prior to handover.

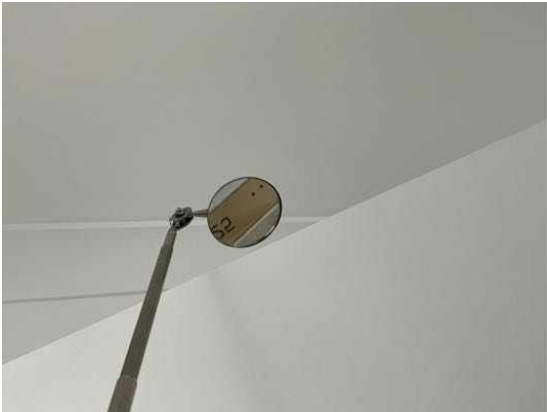
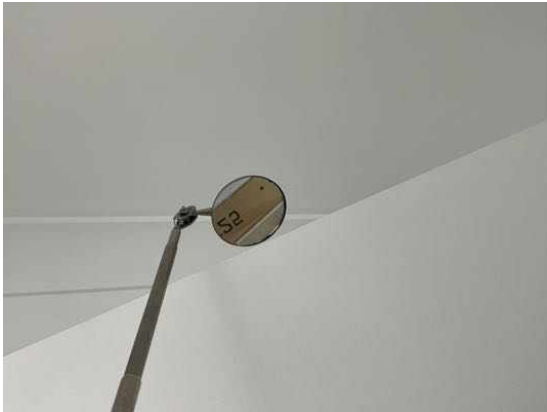
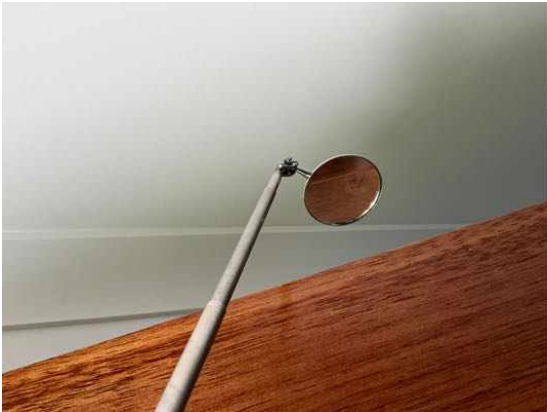
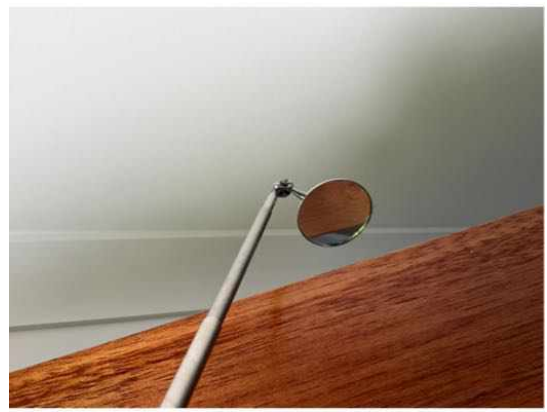
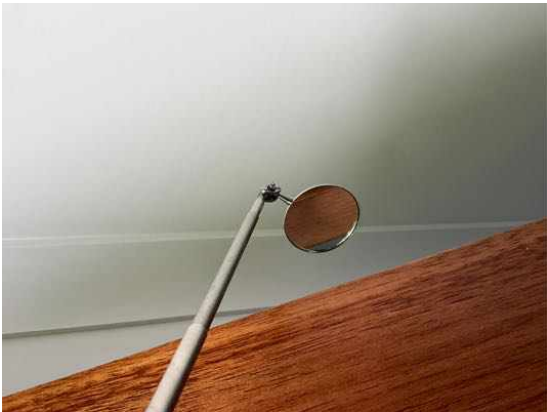
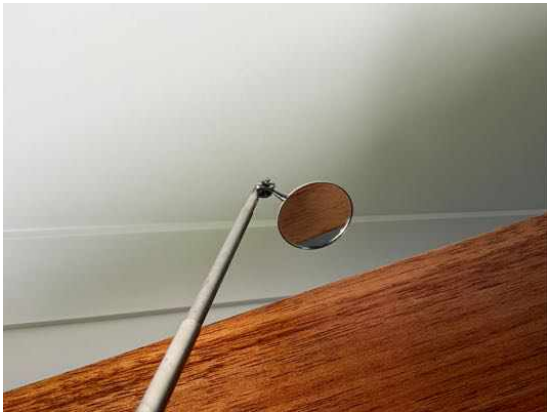
Finding 3.05

Building:	Main Building
Location:	All Areas
Finding:	Incomplete Painting of Doors
Information:	The paintwork on the doors throughout the building is incomplete, failing to meet the requirements specified by Australian Guides and Tolerances.

- ****Coverage:**** Incomplete paint coverage on the doors, with visible areas left unpainted or thinly coated.
- ****Edges and Corners:**** Edges and corners of the doors are inadequately painted, showing bare or poorly covered areas.

- Reduced durability and protection of the door surfaces against wear and environmental factors.
- Compromised aesthetic quality and overall visual appeal of the building.
- Increased maintenance costs due to the need for early repainting or repairs.

- Ensuring complete and consistent paint coverage on all surfaces of the doors.
- Achieving a smooth and even finish without visible defects such as brush marks, drips, or streaks.
- Proper surface preparation to ensure good paint adhesion and prevent peeling or flaking.
- Thoroughly painting edges and corners to achieve a uniform appearance.

A detailed inspection should be conducted post-repainting to confirm compliance with the required standards.

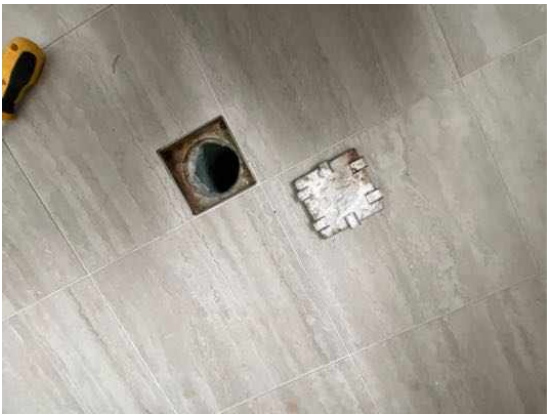
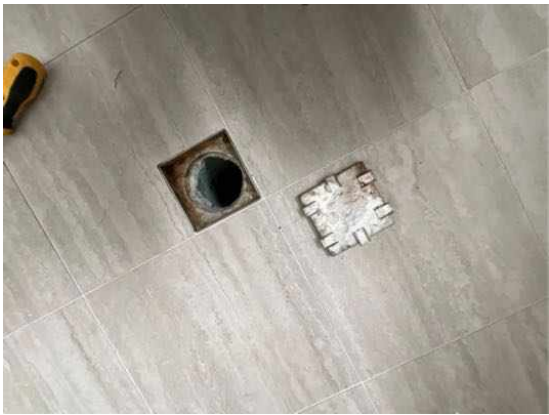
Finding 3.06

Building: Main Building
Location: All Areas
Finding: Floor waste- missing internal grill component (strainer or insert)
Information: The drain cover in the tiled floor area is missing its internal grill component (strainer or insert), exposing a direct opening into the drain pipe. This is considered a non-compliant installation as the drain cover is incomplete.

- AS/NZS 3500.2:2021 – Plumbing and Drainage – Sanitary plumbing and drainage requires that all plumbing fittings and fixtures must be installed in a manner that prevents debris from entering the drainage system and ensures the safe operation of the drain.
- The Guide to Standards and Tolerances 2017, Section 13 (Plumbing and Drainage), notes that drainage systems should be installed in accordance with relevant standards, including correct fitting of drain covers and grates to ensure hygiene, safety, and protection from blockages.

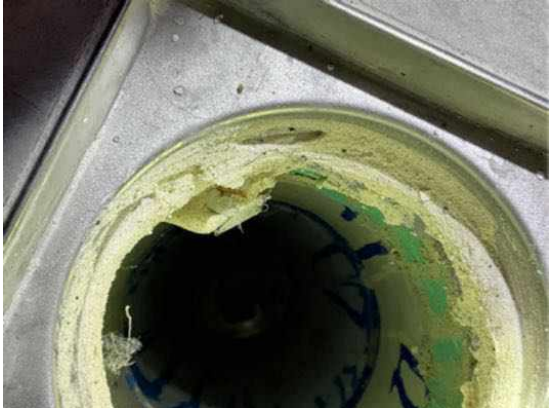
Finding 3.07

Building: Main Building
Location: All Areas
Finding: Floor waste Debris
Information: It was noted that there is builder debris in the floor waste drainage. Debris in the plumbing system may lead to blockages in the future.

This is referenced against the Australian Standards and Tolerances clause 19.8 Cleaning - Owners are entitled to expect that the building site and works are clean and tidy on completion.

Building sites are defective if they are not clear of building debris. All floor wastes need to be checked and cleared prior to handover.

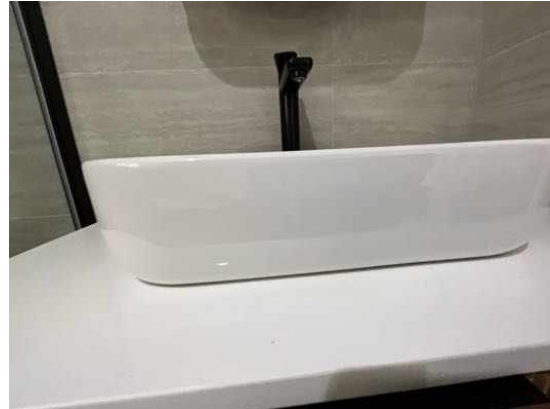
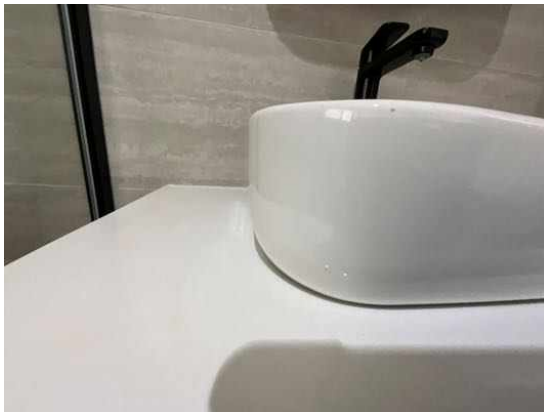
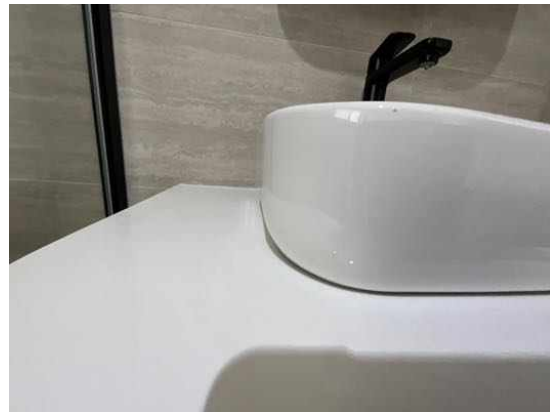
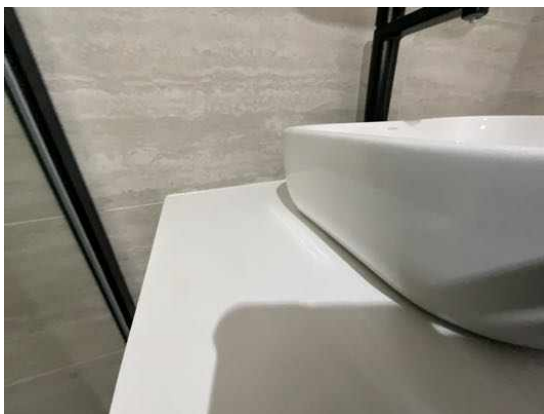
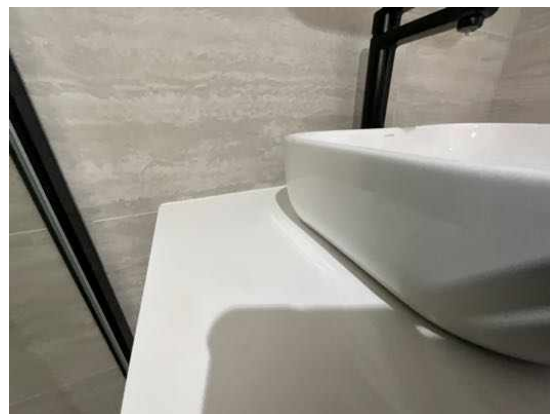
Finding 3.08

Building: Main Building
Location: All Areas
Finding: Silicone- Missing Sealant Around Basin
Information: No silicone sealant was observed around the perimeter of the vessel basin where it meets the benchtop surface. This is considered non-compliant with good building practice and may allow moisture ingress, leading to potential swelling, mould growth, and damage to cabinetry and surrounding finishes.

In accordance with the NCC and the Guide to Standards and Tolerances 2017, joints between sanitary fixtures (such as basins) and adjoining surfaces must be properly sealed with a flexible waterproof sealant to ensure water resistance and durability.

It is recommended that a qualified tradesperson apply a continuous bead of mould-resistant, sanitary-grade silicone sealant to all exposed joints to prevent future water damage and ensure compliance with standards.

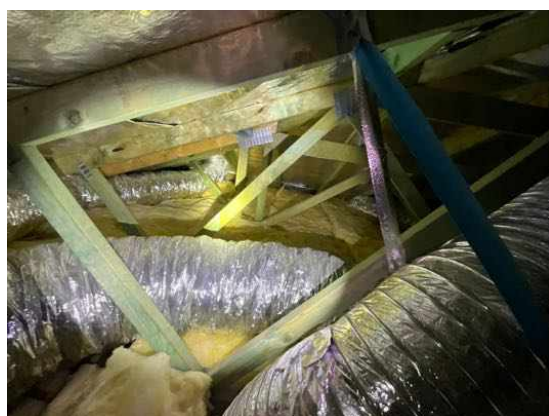
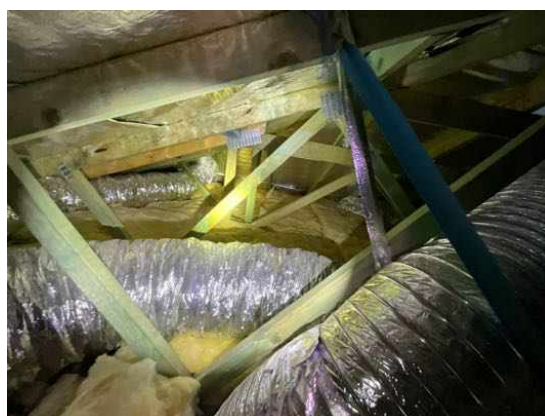
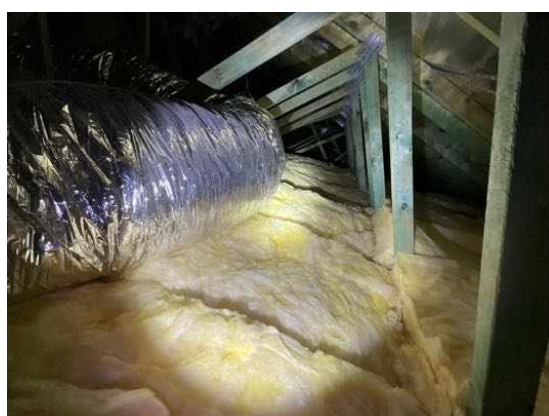
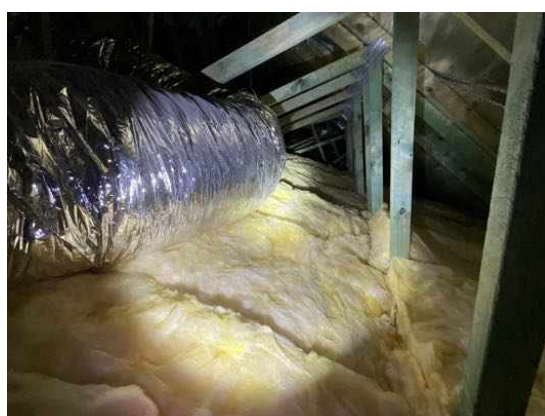
Finding 3.09

Building:	Main Building
Location:	Roof Void
Finding:	Insulation - Covering downlights
Information:	Sections of insulation in the roof void have been poorly installed or moved from their original position and are covering down light fittings. While the down lights have been

fitted with appropriate protective covers, the presence of this insulation creates a potential fire hazard.

Any insulation within the vicinity of down light fixtures should be moved and re-applied to more appropriate sections of the roof void, thus ensuring the area is fire-safe. An insulation contractor should be appointed as soon as possible to perform any necessary works as required.

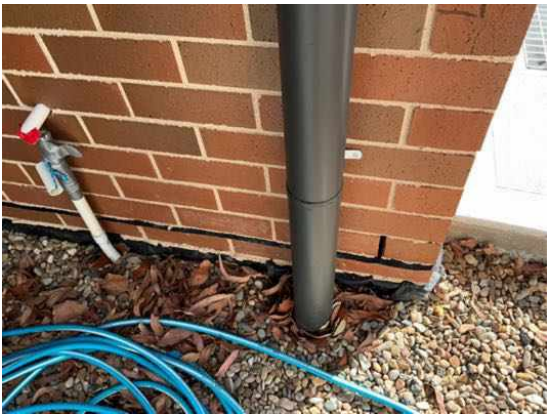
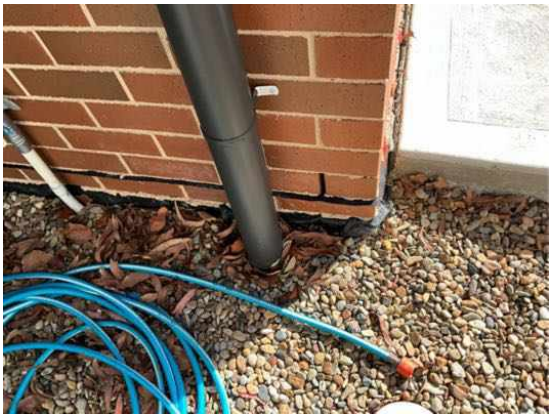
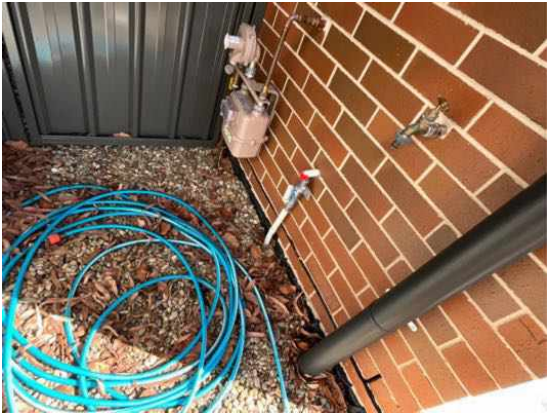
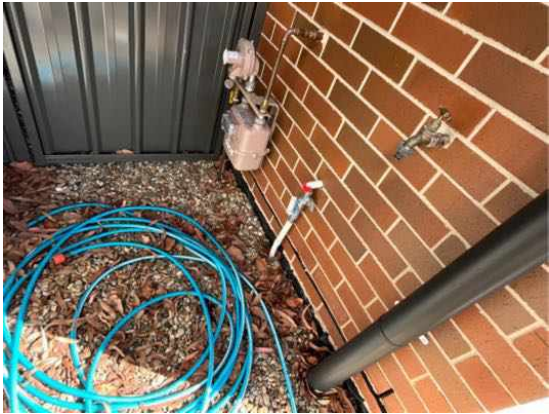
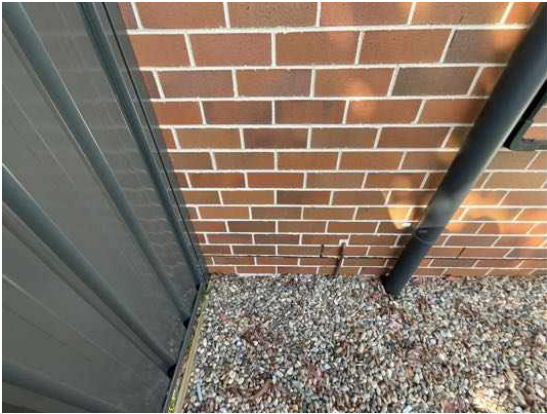
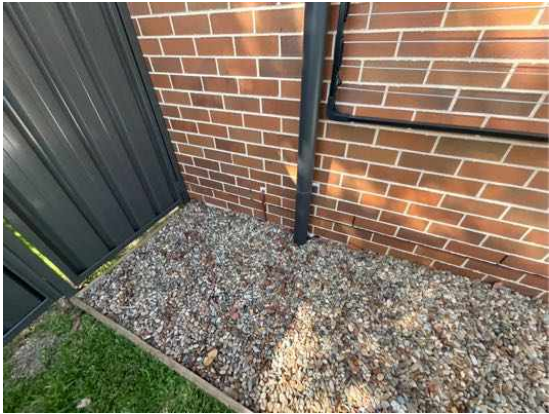
Where the slab edge cannot be properly inspected, it is highly recommended that termite or timber pest inspections be carried out every 6-12 months to aid protection of the property against infestation.
