# Building and Timber Pest Inspection Report

Inspection Date: Fri, 06 Mar 2026

Property Address: 28A Vale Rd, Thornleigh NSW 2120,  
Australia

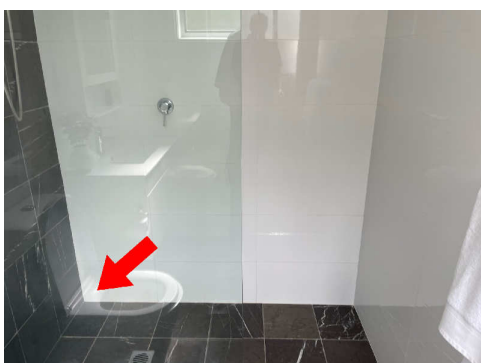
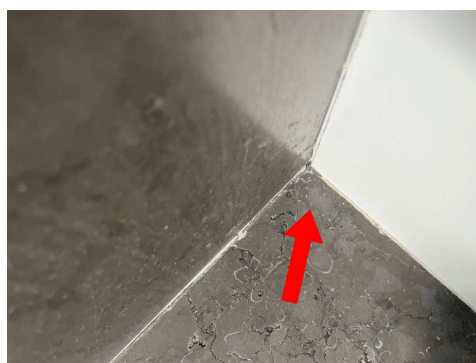
Finding: Tiles - Missing Sealants and/or Grouts

Information: During the inspection, sections of the existing tiled surfaces were observed with missing, cracked, or deteriorated grout and/or sealant. These gaps were visible along tile joints and at junctions where tiles meet adjoining walls, skirtings, or fixtures.

The deterioration has likely occurred over time due to general wear, building movement, or ongoing moisture exposure. Missing or damaged grout and sealant allow water to penetrate behind tiles, which can lead to staining, mould growth, or damage to the substrate and surrounding finishes.

It is recommended that the affected areas be re-grouted and re-sealed by a qualified tiler or trade as a short-term priority to maintain a watertight finish and prevent further deterioration.

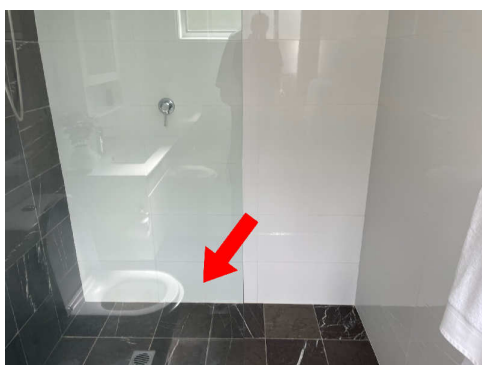
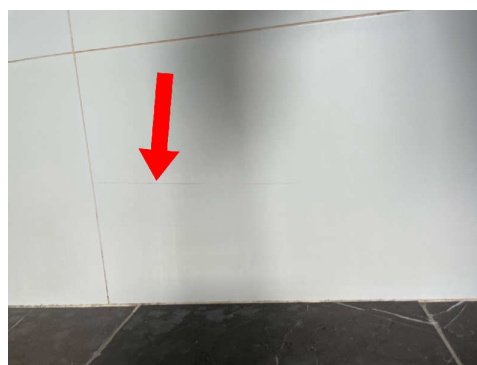
#### Finding 3.02

Building:	Main Building
Location:	Ensuite - Master
Finding:	Tiles - Cracked or damaged
Information:	Cracking was evident to the tiling in this area at the time of inspection. While the cracking appears to be minor, this area is frequently exposed to water, allowing potential for water penetration into adjoining sections of walls or flooring.

If left unmanaged, water penetration to these areas may lead to subsequent water damage, which is likely necessitate repair work to affected building elements.

A tiling contractor should be appointed to ensure that no further water damage occurs. The re-application of silicone and grouting throughout remaining tile work is also advised, to further protect the area against water penetration.

Where water penetration has led to water damage, appointment of a relevant tradesperson may be required to repair damaged building elements.

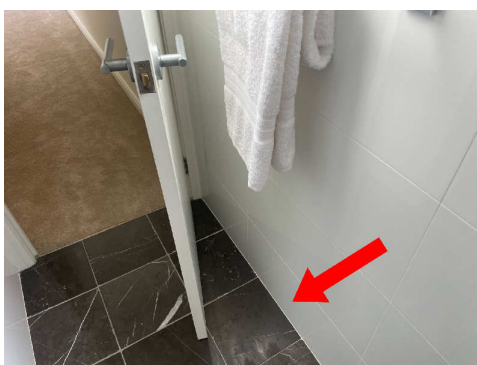
### Finding 3.03

Building:	Main Building
Location:	Ensuite - Master
Finding:	Door stop - Missing

Information: The door stop is missing or is inadequate to stop the door handle from damaging the wall. Although some building elements may seem irrelevant or unnecessary, all building elements play a key role in the operation and function of the overall structure and its performance.

Re-installation or replacement of the door stop is advised as soon as possible to prevent any subsequent damage to the door or associated structures. A general handyman may be appointed to perform these works at client discretion.

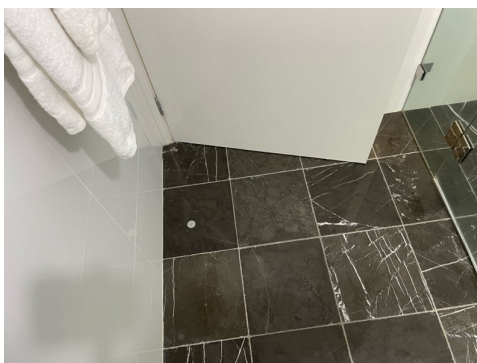
### Finding 3.04

Finding: Door stop - Missing

Information: The door stop is missing or is inadequate to stop the door handle from damaging the wall. Although some building elements may seem irrelevant or unnecessary, all building elements play a key role in the operation and function of the overall structure and its performance.

Re-installation or replacement of the door stop is advised as soon as possible to prevent any subsequent damage to the door or associated structures. A general handyman may be appointed to perform these works at client discretion.

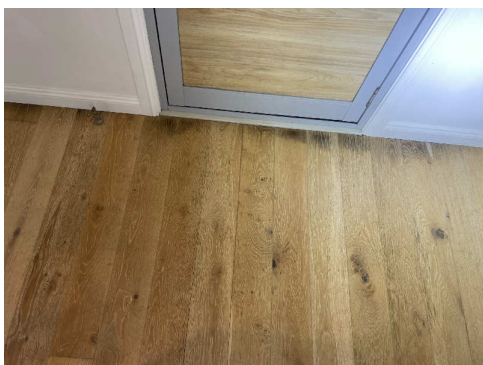
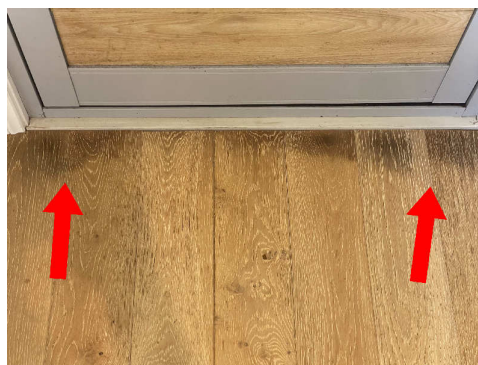
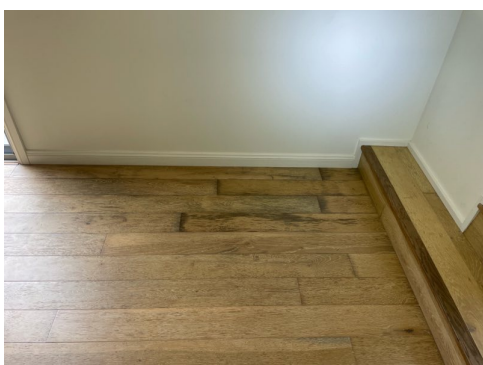
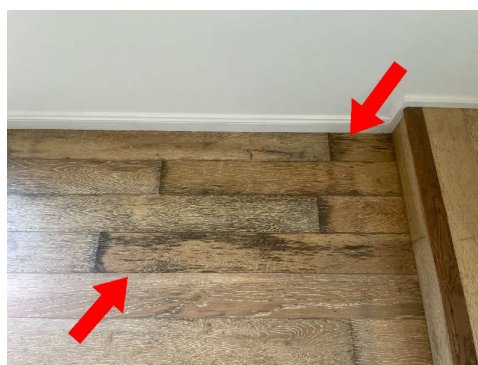
### Finding 3.05

Finding: Timber Flooring – Dark Staining / Suspected Moisture Ingress

Information: Darkened and discoloured areas were noted to sections of the timber flooring at the time of inspection. The appearance is suspicious of past or ongoing moisture ingress, although the exact source and extent could not be confirmed during the visual inspection.

Moisture-affected timber flooring may deteriorate over time and can indicate a concealed leak, water penetration, or previous water damage. Continued exposure to moisture may lead to further staining, distortion, swelling, or deterioration of the flooring material.

A qualified building contractor and/or plumber should be engaged to investigate the cause of the staining, confirm whether moisture ingress is active, and carry out repairs as required.

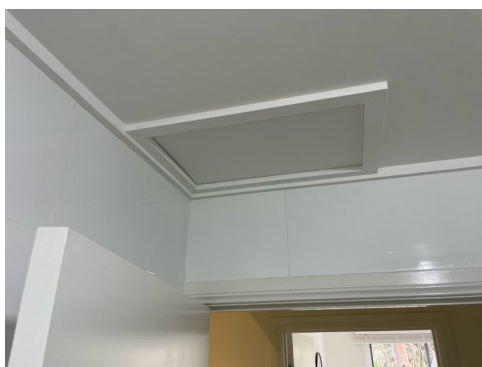
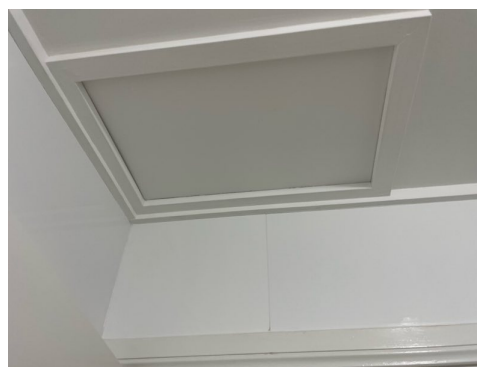
**Finding 3.06**

**Information:** The roof access manhole was observed to be undersized, measuring less than 400 × 500 mm. In accordance with AS 4349 (Inspection of Buildings), roof space access openings are required to be of sufficient size to allow reasonable and safe access for inspection.

Due to the inadequate size of the manhole, the roof cavity could not be safely accessed or inspected at the time of inspection. As a result, no comment can be made regarding the condition of roof framing, insulation, services, or concealed building elements within the roof space.

This condition is considered substandard. Enlargement of the roof access opening by a suitably qualified contractor is recommended to enable proper inspection and ongoing maintenance.

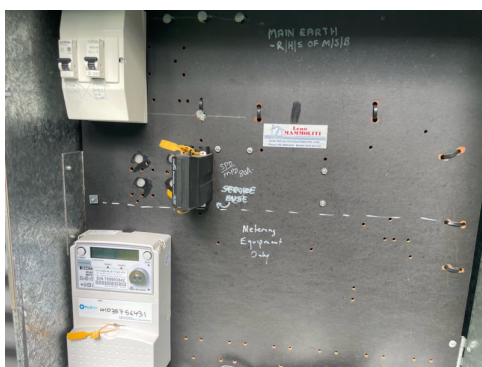
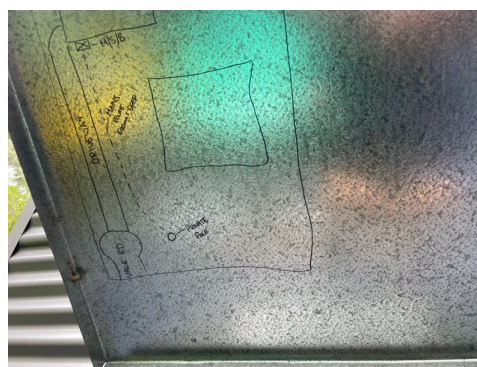
**Building:** Main Building  
**Location:** Electrical Switchboard  
**Finding:** Termite Management – Durable Notice Missing

A post-construction chemical termite barrier is strongly recommended, particularly given the history of termite activity, to help protect timber building elements and reduce the risk of concealed termite damage.

It is recommended that a licensed pest controller confirm whether any termite protection exists and its condition, and if not, arrange installation as a short-term priority. Annual timber pest inspections are recommended in accordance with AS 4349.3 and ongoing termite management practices consistent with AS 3660.2.

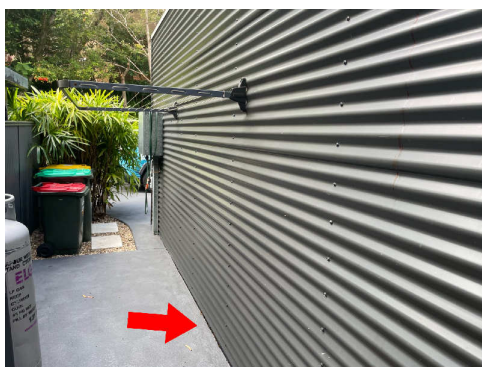
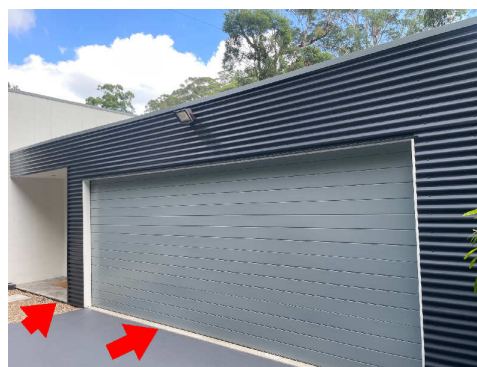
### Finding 6.02

Building: Main Building  
 Location: All Areas - Slab Edge  
 Finding: Slab Edge - Exposure

If the slab edge is not properly exposed there is a high risk of termite attack. Sometimes, in order to determine the type of slab, a suitably qualified person such as an architect or builder may be required to consult the construction plans.

Where the slab edge cannot be properly inspected, it is highly recommended that termite or timber pest inspections be carried out every 6-12 months to aid protection of the property against infestation.

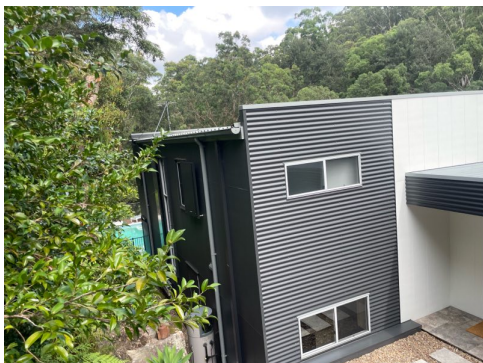
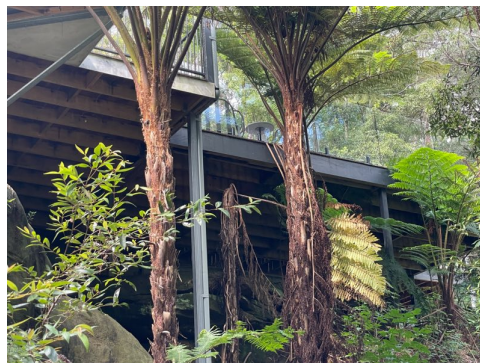
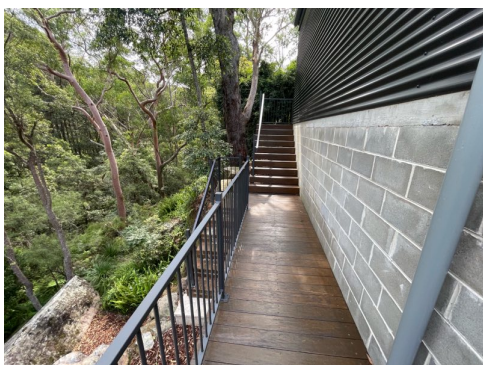
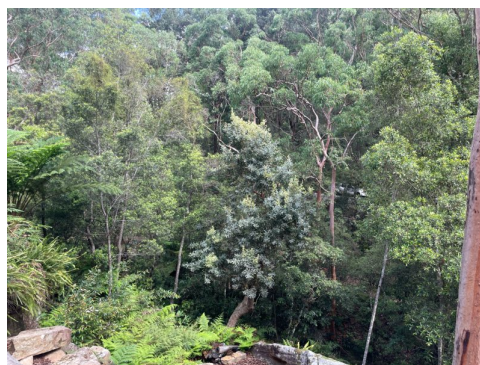
Finding: Large trees/stumps within 30m of house

Information: There are a number of large trees/stumps within 30m of the house which may contain natural termite activity. It is important to monitor these areas to ensure no natural activity is allowed to progress into the main house. Regular inspections are recommended. Consider test drilling any large trees. A pest controller can be contacted to carry out such testing at the owners discretion.
