Building and Timber Pest Inspection Report

Inspection Date: Fri, 6 Feb 2026

Property Address: 25 Leith Rd, Pennant Hills NSW 2120, Australia

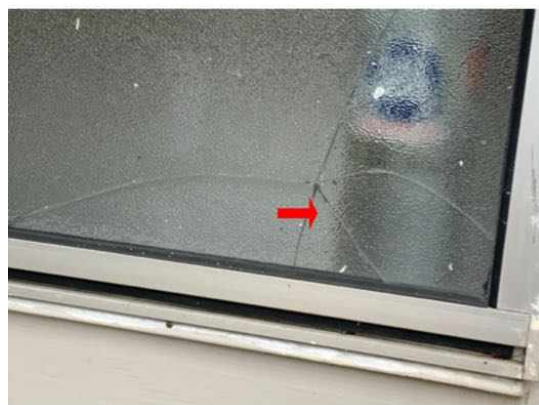
Building:	Main Building
Location:	Exterior walls - rear
Finding:	Window - Cracked
Information:	Cracks were identified in the window in this area. Cracking in windows is generally the result of impact damage, and is likely to develop further when left unmanaged.

The likelihood of this windowpane further cracking and shattering is increased exponentially, providing a safety hazard in the area. The cracked window also impairs the weather tightness of the building, creating potential for minor water leaks.

A qualified glazier is required to repair the window as soon as possible. Depending on the extent of the cracking, replacement of the window may be required. Please be advised that any persons coming into contact with the cracked window should do so with due caution to avoid any personal injury that may ensue.

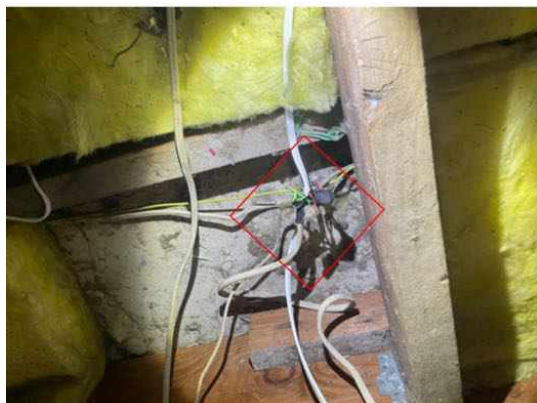
Finding 1.02

Building:	Main Building
Location:	Roof Void
Finding:	Electrical junction box - Missing
Information:	Several wiring joins in the roof space are not adequately protected by a junction box. Junction boxes provide a second insulation barrier to adequately seal off and protect the wires, increasing the safety of the immediate environment and ensuring that the wiring is not damaged.

The absence of junction boxes in the roof space poses as an electrical safety hazard, providing risk of electrocution. It appears as though wiring in this area has been completed to a substandard level of workmanship, evidenced by the lack of adequate

wiring protection.

Appointment of a licensed electrician is highly advised to provide additional information on the risks of unprotected wiring and to install junction boxes and any other elements as required. Such works should be carried out as a matter of urgency; until this time, any persons within the roof space should exercise a high level of caution.

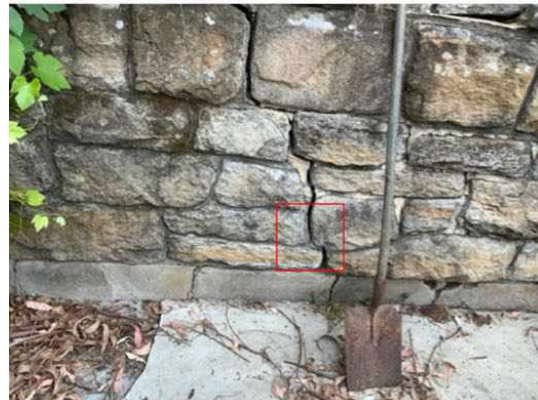
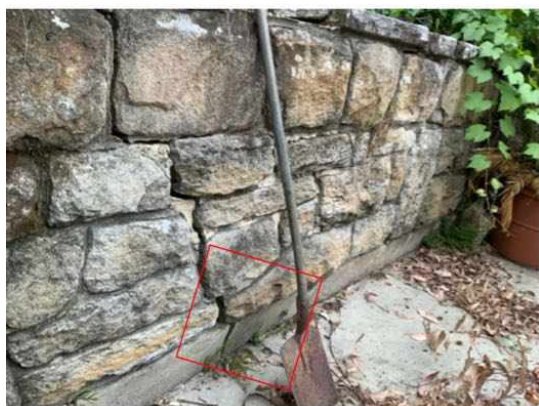
Building: Main Building
 Location: Exterior walls - rear
 Finding: Retaining wall - Defective
 Information:

The retaining wall in this area was found to be defective at the time of inspection. Generally, defective retaining walls are caused by poor original design or material use. However, deteriorated retaining walls may also be a result of substandard construction, poor site drainage or unmanaged stormwater flows.

If left unmanaged, the retaining wall may become a safety hazard if it continues to destabilise.

Significant repair and replacement should be expected. Where retaining walls are considered structural walls, a structural engineer / surveyor should be consulted regarding required remedial works. Otherwise, a landscaper or retaining wall installer may be appointed to repair or replace the wall, at the discretion of the client.

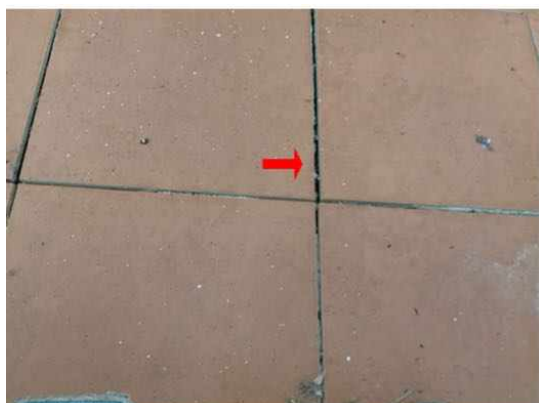
Finding 2.03

Building:	Main Building
Location:	Toilet (WC)
Finding:	Tiles - loose and grout missing
Information:	Loose tiled areas were identified at the time of inspection. The term loose refers to tiles that have become detached from their fixing, despite otherwise being in relatively good condition. Such defects are generally caused by physical or moisture damage to the area. Loose tiled areas may also be a direct result of poor workmanship during the construction process.

Tiled areas may swell and shrink with changes in air humidity if the area has sustained moisture damage. Any exposure to moisture is capable of causing tiled areas to become drummy and/or cracked over a prolonged period of time. Drummy tiled areas generally require removal and replacement of affected tiles, with adequate sealant and grouting.

Specialist trades are available for these types of services. A registered builder may be required to undertake works if damage is extensive or if secondary building defects have resulted. Otherwise, it is advised that a tiling contractor be appointed to perform works as necessary. Immediate action is recommended to ensure that no further damage is sustained in the affected area.

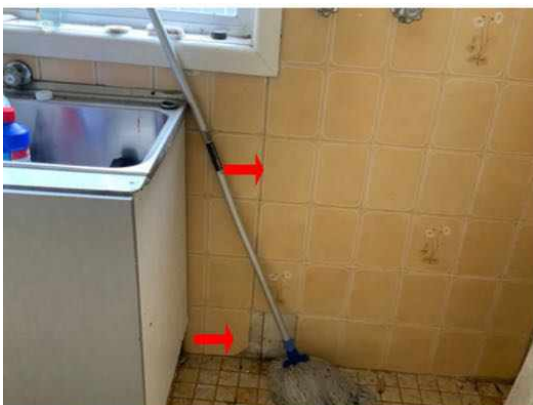
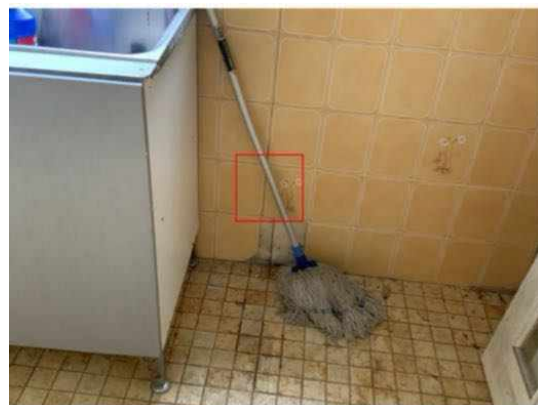
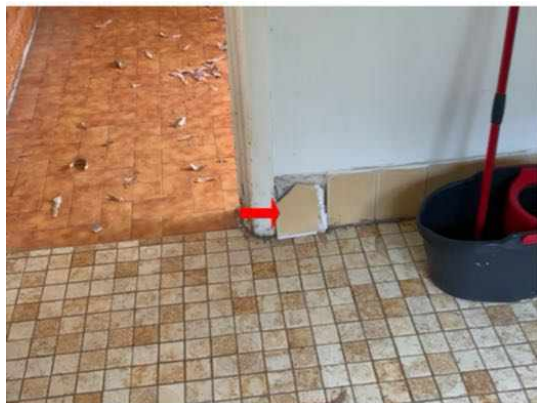
Finding 2.04

Finding: Tiles - Cracked or damaged

Information: Cracking was evident to the tiling in this area at the time of inspection. While the cracking appears to be minor, this area is frequently exposed to water, allowing potential for water penetration into adjoining sections of walls or flooring.

If left unmanaged, water penetration to these areas may lead to subsequent water damage, which is likely necessitate repair work to affected building elements.

A tiling contractor should be appointed to ensure that no further water damage occurs. The re-application of silicone and grouting throughout remaining tile work is also advised, to further protect the area against water penetration.

Where water penetration has led to water damage, appointment of a relevant tradesperson may be required to repair damaged building elements.

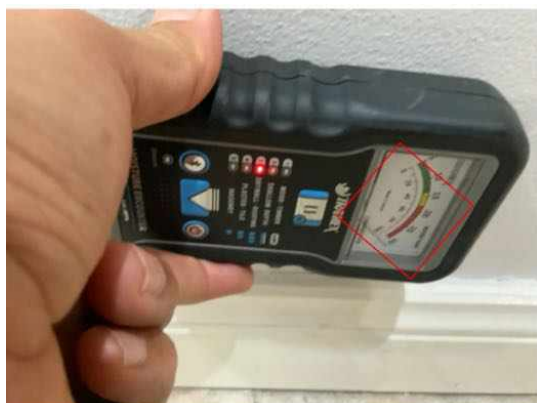
Finding 2.05

Building:	Main Building
Location:	Bathroom
Finding:	Shower - Leaking
Information:	High Moisture was evident to the shower base at the time of inspection. It is suspected that the leaking has occurred as a result of general ageing of the building elements.

Leaking from the shower base, where left unattended, is likely to lead to water damage to adjoining flooring and walls. Such damage can lead to water damage and necessitate extensive remedial works being required. Active water leaks may also create an environment that is susceptible to the formation and development of mould.

Appointment of a tiling contractor is required to repair or replace the shower base. Such works should be performed as soon as possible to ensure that no further damage occurs.

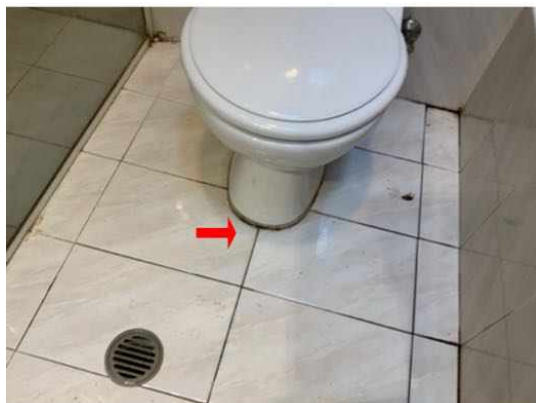
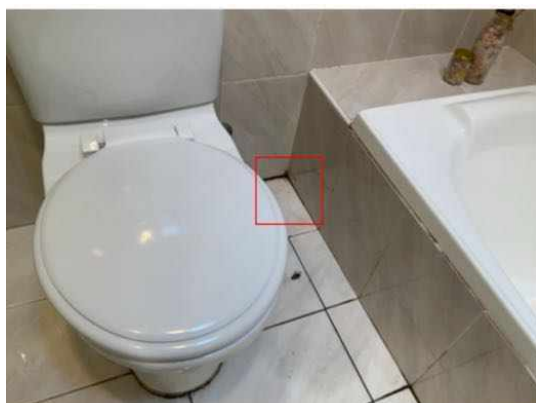
Finding 2.06

Building:	Main Building
Location:	Bathroom
Finding:	Toilet - Leaking

Information: At the time of inspection, the toilet showed evidence of leaking during operation.

Although common, internal water leaks can be detrimental to surrounding building elements. Rust, corrosion, decay and water damage are all potential outcomes of a water leak that is left unattended, which are then likely to develop into more serious defects and may necessitate major repair works. Additionally, internal water leaks may significantly increase the water usage within the property.

It is highly advised that internal water leak be addressed by a licensed plumber as soon as possible. Use of the leaking toilet should be minimised until such time.

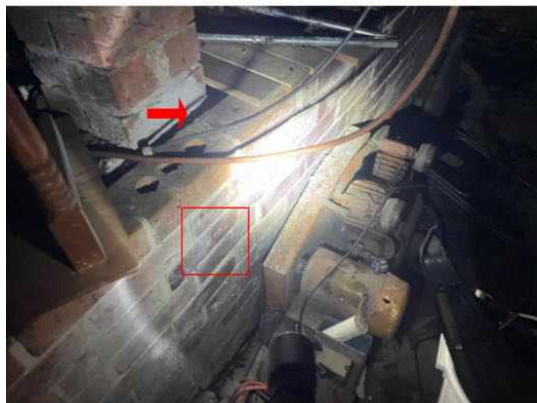
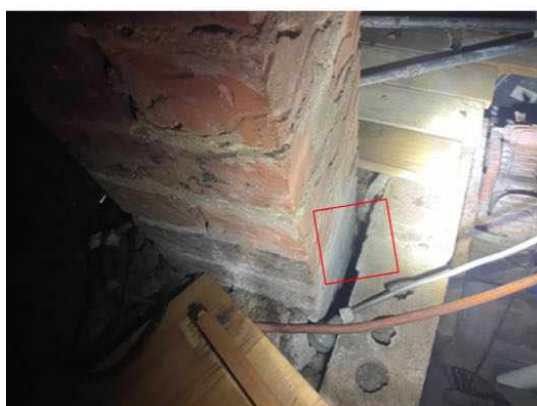
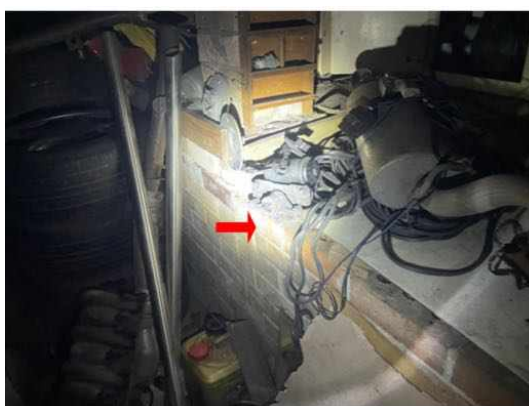
Finding 2.07

Finding: Retaining wall - Defective

Information: The retaining wall in this area was found to be defective at the time of inspection. Generally, defective retaining walls are caused by poor original design or material use. However, deteriorated retaining walls may also be a result of substandard construction, poor site drainage or unmanaged stormwater flows.

If left unmanaged, the retaining wall may become a safety hazard if it continues to destabilise.

Significant repair and replacement should be expected. Where retaining walls are considered structural walls, a structural engineer / surveyor should be consulted regarding required remedial works. Otherwise, a landscaper or retaining wall installer may be appointed to repair or replace the wall, at the discretion of the client.

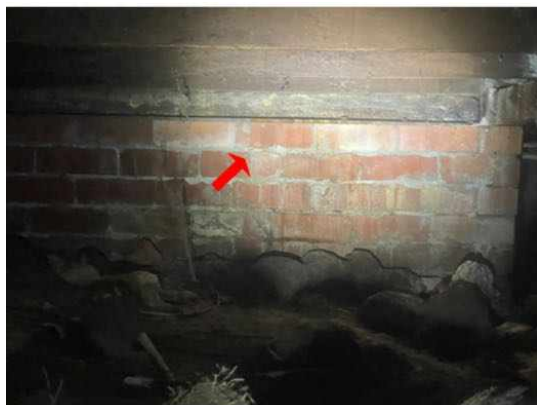
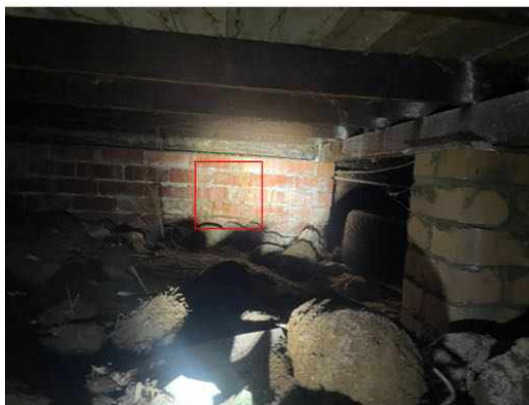
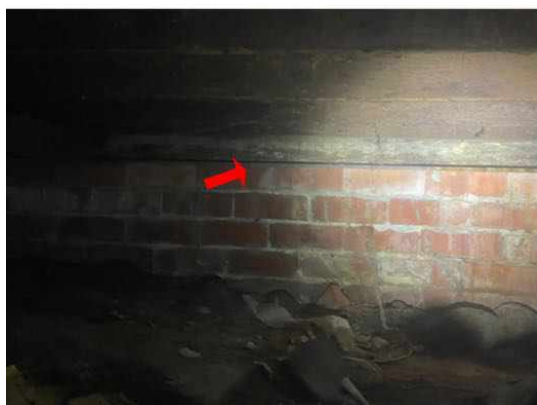
Finding 2.08

Building:	Main Building
Location:	Subfloor
Finding:	Damp - Rising
Information:	Rising damp describes the upward movement of water in low sections of building elements (e.g. walls) by capillary action - the movement of water through porous materials such as bricks, sandstone or mortar.

Rising damp is generally managed by the installation of a damp proof course during construction. A Damp Proof Course (DPC) is an impermeable barrier at the base of the wall above ground level. However, many 19th Century buildings have no damp course installed, or the materials have failed. The DPC may have been omitted as a consequence of poor workmanship, or it may have been bridged where materials built up against the side of the house allow moisture ingress above the DPC level.

The first step in addressing rising damp is to diagnose the cause. The identified cause should be addressed first before addressing the appearance and other defects which have resulted from the rising damp. If the original cause is not resolved, further cases of damp are likely to ensue, resulting in secondary defects.

Consultation with a qualified plumber is advised immediately to identify the cause of the damp and perform remedial works as required.

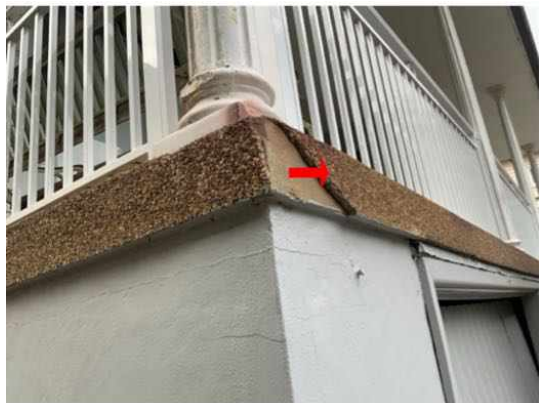
Finding 3.01

Building:	Main Building
Location:	Exterior walls - front
Finding:	Render - Drummy
Information:	Drummy rendered areas were identified at the time of inspection. The term 'drummy' refers to render that has become detached from its fixing, despite it still being solid. Such defects are generally caused by physical or moisture damage to the area. Drummy render may also be a direct result of poor workmanship during the construction process.

Render may swell and shrink with changes in air humidity if the area has sustained moisture damage. Any exposure to moisture is capable of causing rendered areas to become drummy and/or cracked over a prolonged period of time. Drummy render generally requires chipping off and re-rendering or painting.

Specialist trades are available for these types of services. A registered builder may be required to undertake works if damage is extensive, or if secondary building defects have resulted. Immediate action is recommended to ensure that no further damage is sustained in the affected area.

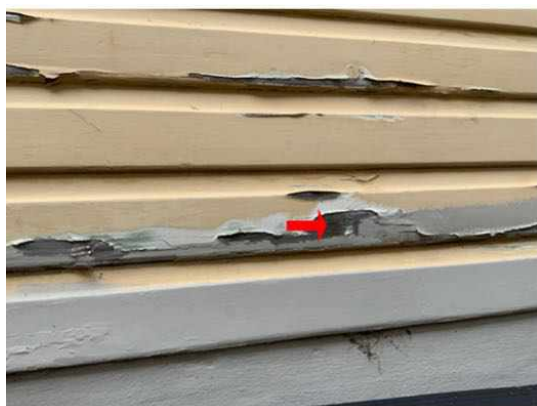
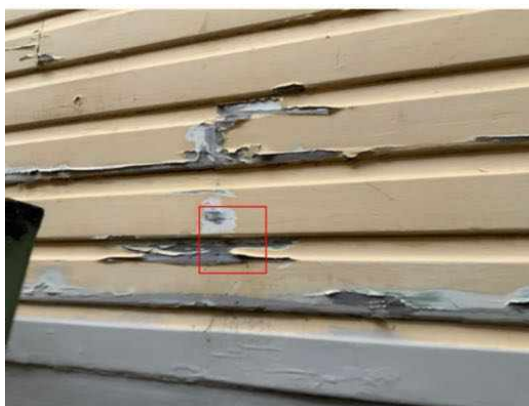
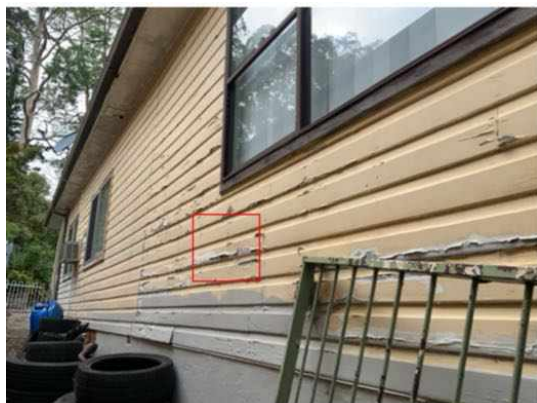
Finding 3.02

Building:	Main Building
Location:	All Areas
Finding:	External painting deteriorated
Information:	Much of the external paintwork including but not limited to windows, fascias, guttering, veranda and other external fitments have been neglected and require attention to prepare and re-paint.

Whilst incomplete or missing paint finish is generally an appearance defect, it can also lead to the development of secondary building defects over time. Incomplete areas of paint finish expose the area to moisture, potentially accelerating the deterioration of underlying building materials.

Degraded paint finishes should be sanded back, filled, leveled and painted, as applicable. Where inadequate or missing paint protection has led to the deterioration of the associated building element, repair and/or replacement of this building element may be required.

A painting contractor should be appointed as soon as possible to perform necessary works to aid the appearance of the affected area and to ensure the area is protected against further deterioration. Alternatively, the homeowner following manufacturer instructions may perform these works.

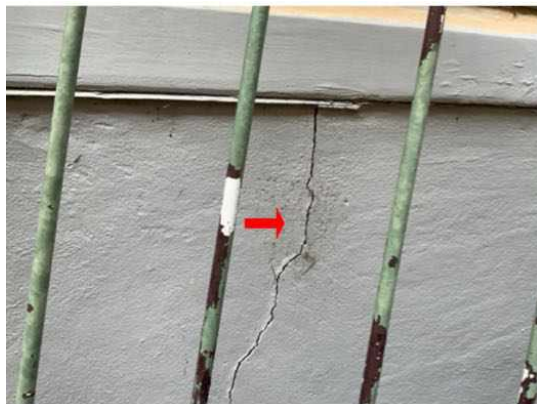
Finding 3.03

Building:	Main Building
Location:	Exterior walls - left side
Finding:	Subsidence Monitor
Information:	It appears that the wall structure has been affected by movement of the foundations, often referred to as sinking or subsidence. A degree of movement is expected in subfloors over time, especially as environmental conditions change and buildings settle after construction.

The apparent subsidence is evidenced by some gaps and cracks to brickwork, usually adjacent to windows or openings, excessive footpath movement and undulation of floors.

General subsidence is usually initiated by changes in soil moisture content. The most critical factor is identifying the specific causes, and identifying if this is a recurring or ongoing problem, or one that has been resolved by previous works in the past.

Subsidence can have complex and varying causes, which will influence the required remedial works. If movement continues It is advised to consult a structural engineer to determine if repair works are warranted. Works may include some form of underpinning, as well as addressing the underlying cause. Consultation with a geotechnical engineer may also be necessary where changes to soil moisture content is apparent.

A Registered Builder would then generally carry out works as advised by an Engineer.

At this point it is recommended to contain storm water flows, ensure pavements flow away from the building to lessen any excessive wetting and drying effects.

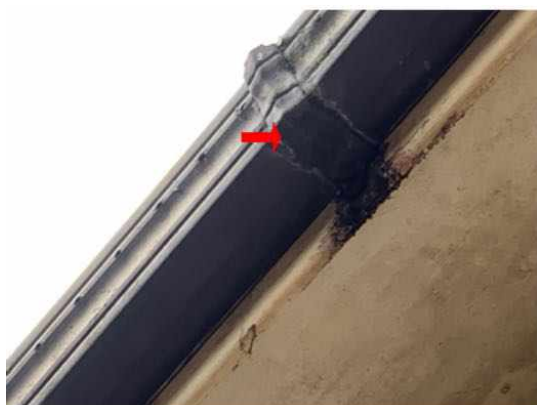
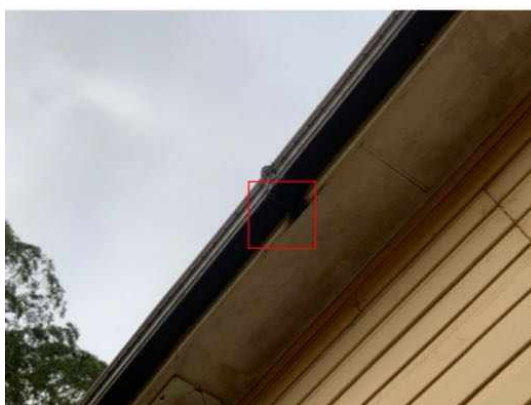
Finding 3.04

Building:	Main Building
Location:	Exterior walls - left side
Finding:	Gutter miters leaking
Information:	Gutters are showing signs of deterioration and leaks where identified from mitre joints.

This style of the gutter is designed to hold a small amount of water but mitres must be sealed to prevent any leaks.

Leaking gutters will create excessively damp conditions around the base perimeter of the building and will also lead to termite conducive conditions.

A roofing plumber can provide further advice in cost for repairs.

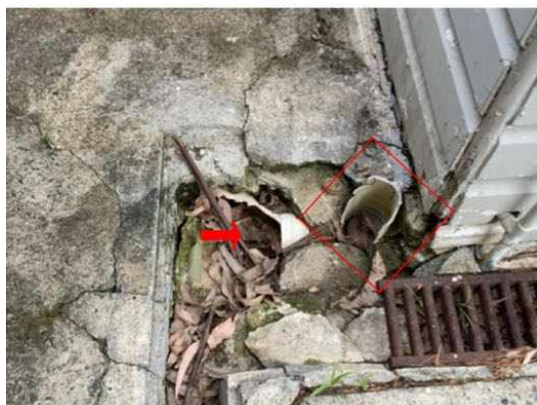
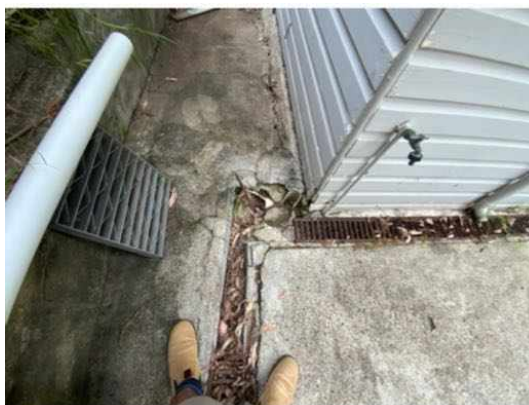
Finding 3.05

Location:	Exterior walls - right side
Finding:	Storm water pipe - Damaged
Information:	Breakage occurs generally when the building materials have either aged and decayed, or as a result of damage (accidental or deliberate).

Repair or replacement of broken elements is advised to ensure that additional secondary defects do not arise as a consequence. Such works are necessary, as all building elements play a key role in the operation and function of the overall structure and its performance.

A qualified plumber should be appointed to repair or replace the affected building element prior to any subsequent damage being caused.

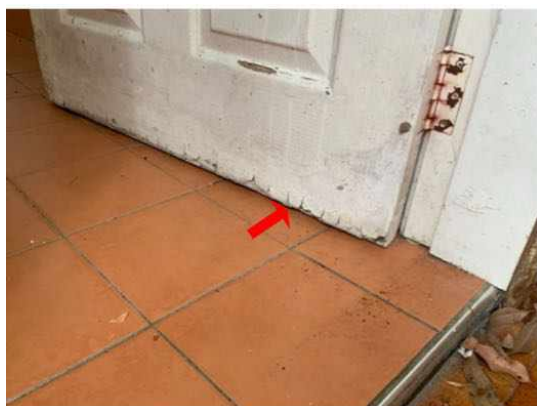
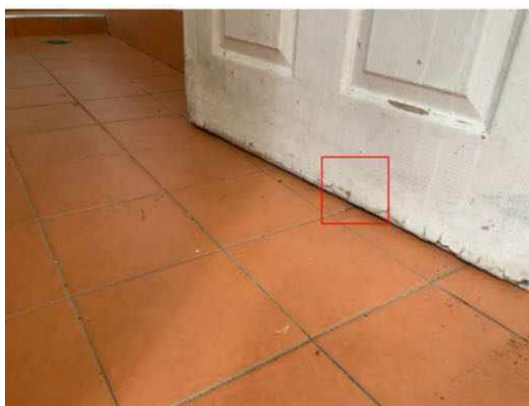
Finding 3.06

Building:	Main Building
Location:	Toilet (WC)
Finding:	Door/weathered
Information:	External doors that are frequently exposed to harsh weather conditions require adequate protection in order to maintain their condition. Where doors are not painted or treated in any way general deterioration is likely to occur at an accelerated rate.

If left unattended replacement of this door is likely to be necessary in the short-term future.

Adequate treatment of the door is required as soon as possible or painting contractor or general handyman.

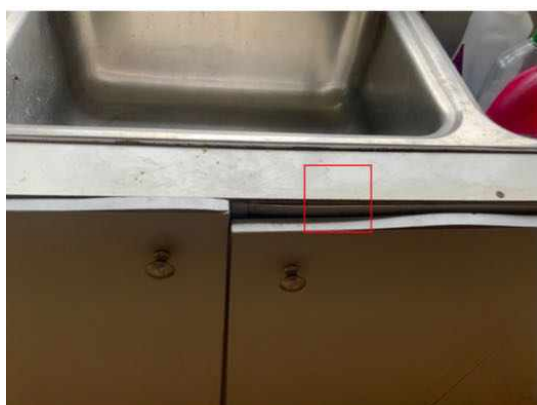
Finding 3.07

Building: Main Building
 Location: Laundry
 Finding: Laundry cupboard/deteriorated
 Information: At the time of inspection it was noted that the laundry cupboard were delaminating due to age and exposure to water or moisture ,also could be due to low quality doors or the misuse by the occupants or the lack of ventilation.

A qualified cabinets maker should be contacted to make good at the client discretion.

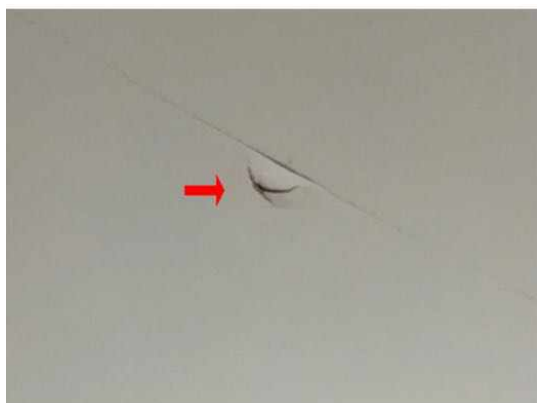
Finding 3.08

Building: Main Building
 Location: Bedroom
 Finding: Ceiling - Water damaged
 Information: Water damage to the ceiling lining is generally an indication of excessive moisture being present in the roof void, usually via a leak to the roof covering.

Where water damage is evident to the ceiling, the primary requirement is to identify and rectify the source of the leak. A roofing plumber should be appointed as soon as possible to identify the leak and perform rectification works as necessary, ensuring the water damage is restricted.

Once the leak is repaired, consultation with relevant tradespeople, including plasterers and painters, is advised. Rectification works may include replacement of ceiling lining or minor repainting, depending on the extent of the damage.

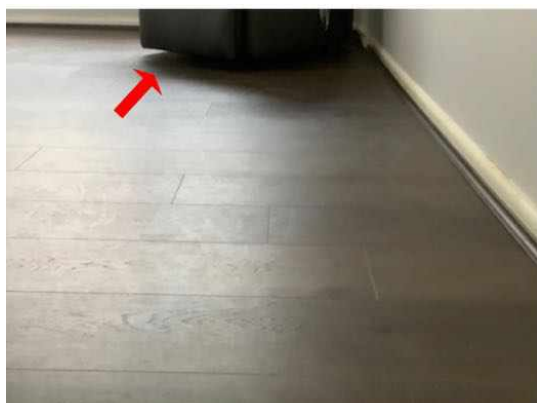
Finding 3.09

Information: The internal flooring in this area is out of level and uneven. Uneven flooring is likely to indicate minor defects such as expected movement of the foundations of the property, but may also indicate subsidence of the associated subfloor stumps.

It is advised that the flooring be closely monitored to identify any further movement. Where flooring remains relatively unchanged for an extended period of time (i.e. several months), it is likely that this defect has been caused by expected movement of the foundations of the property.

However, where flooring is uneven further, potentially invasive inspection of the subfloor structures and stumps in this area is required. In this case, works to repair are likely to be required, and would be carried out by a registered builder specialising in re-stumping.

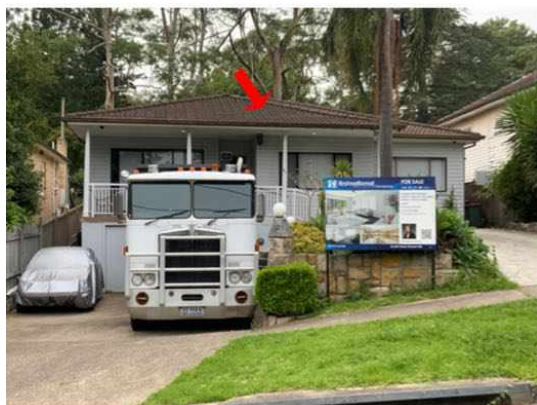
While it would appear that this defect has been present for a long period of time repair is recommended in the short term to ensure the longevity and structural integrity of the dwelling.

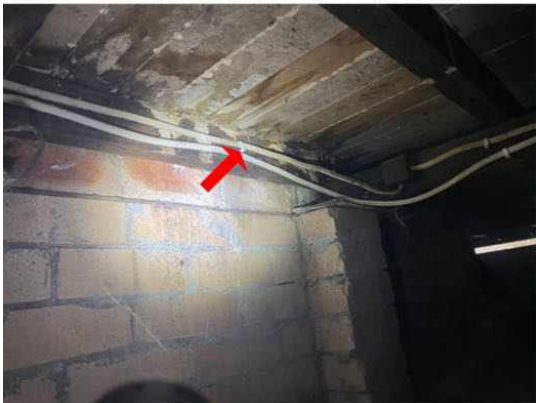
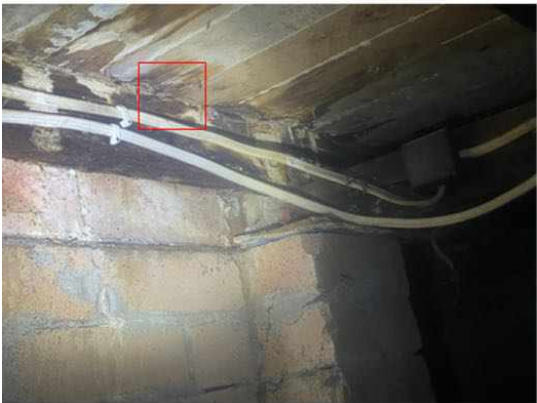
Finding 3.12

Building:	Main Building
Location:	Subfloor
Finding:	Flooring- Water stained
Information:	Water staining to floor linings in this area was evident at the time of inspection. Water staining indicates that surfaces have been exposed to excessive moisture over time. The minerals and other elements in the water lead to staining, which may graduate to corrosion and deterioration if left unmanaged.

While mostly an appearance defect, water staining can be indicative of more serious defects, which may be currently concealed .

Conversely, where water staining is old and inactive, affected building materials may be repaired or replaced at client discretion.

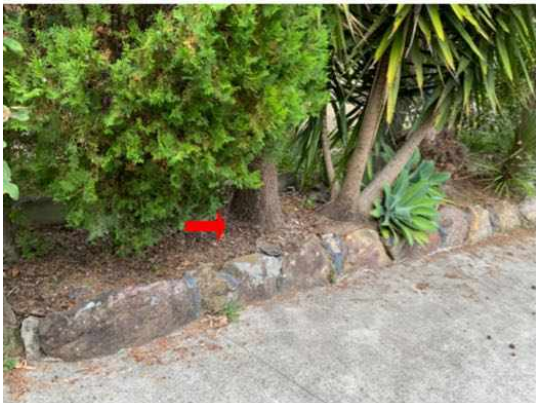
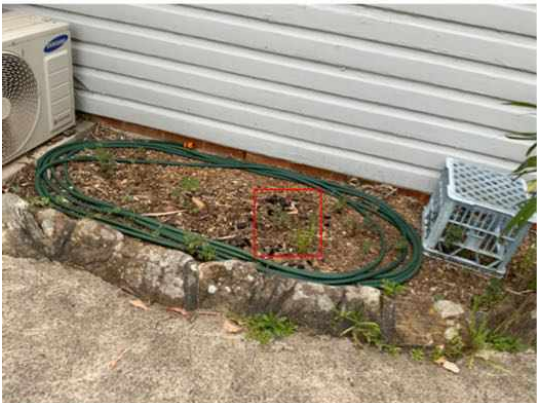
Finding 6.01

Building: Main Building
 Location: Exterior walls - front
 Finding: Garden Beds - Conditions Conducive to Termites
 Information: Garden beds were found to be evident in the garden area. These garden beds can include untreated timber, and with a combination of moisture from watering hosing can make conditions conducive to termite activity and termite ingress.

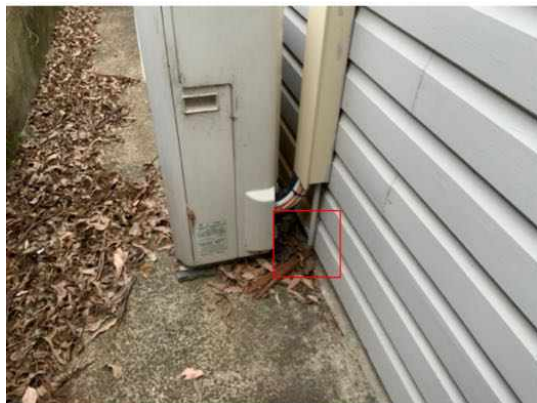
Finding 6.03

Building: Main Building
 Location: Exterior walls - right side
 Finding: Air conditioner - Disconnected overflow
 Information: The Air Conditioner (A/C) overflow was found to be disconnected from storm water drainage and is creating excessive moisture in the surrounding area.

It is highly recommended that a licensed plumber be appointed to connect the A/C overflow in order to prevent such an environment from being created. These minor works should be carried out as soon as possible.

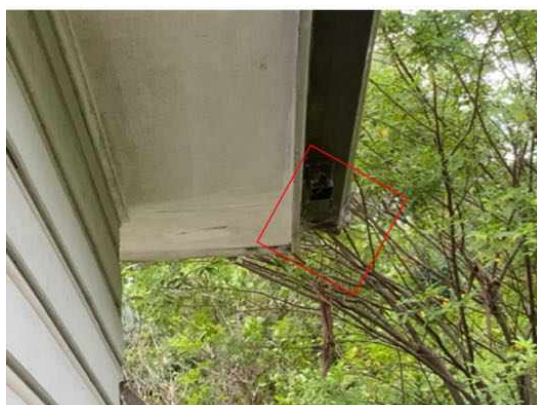
Finding 6.04

Building:	Main Building
Location:	Exterior walls - right side
Finding:	Stormwater drain - Not connected
Information:	The roof plumbing is not adequately connected to stormwater drainage on the site. This disconnection negatively impacts the functional capacity of the roof plumbing.

It is highly recommended that a plumber be appointed to further inspect the area and to install adequate drainage equipment where necessary.

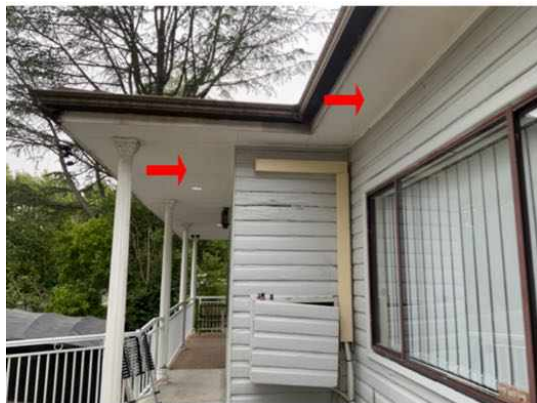
Building:	Main Building
Location:	All Areas
Finding:	Asbestos - Suspected ACM Identified on Site
Information:	Reporting on Asbestos is outside the Scope of this Report. This suspected defect is highlighted as a caution only. We suspect, based on our experience in the building industry, that there is a higher risk of the identified building element containing asbestos.

In the interim, the client is advised to act with caution, especially when considering any damage to building materials general wear and tear renovations extensions demolition and general maintenance activities due to the suspected presence of Asbestos.

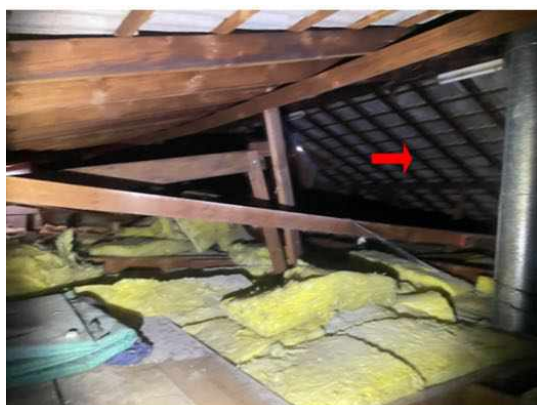
Building: Main Building
 Location: Roof Void
 Finding: Sarking - Missing
 Information: Sarking is missing under the roof sheeting. Sarking acts as an insulator that helps with noise reduction and protects against water penetration. Sarking plays a key role in the operation and function of the overall roofing structure and its performance.

Sarking may be retrospectively fitted by a registered builder at the discretion of the client.
