Building and Timber Pest Inspection Report

Inspection Date: Thu, 26 Mar 2026

Property Address: 44 La Fontaine Ave, Lavington NSW 2641,
Australia

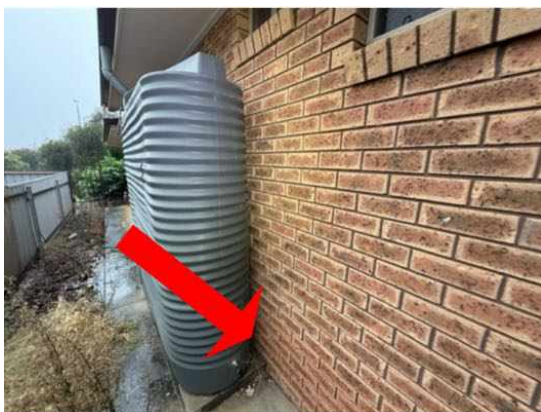
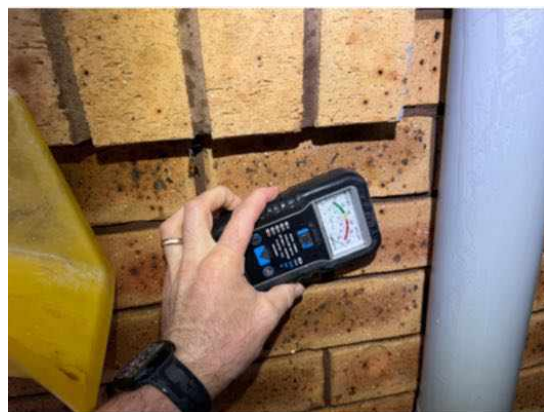
Finding 3.01

Building: Main Building
Location: Right Side Building, Garage
Finding: Rising Damp
Information: It appears that damp conditions were evident above the damp proof course, at but not limited to the right side of the building near the water tank and to the garage wall. Rising damp is managed by a damp proof course (DPC - an impermeable barrier at the base of the wall)

Causes of this defect include but aren't limited to, deterioration of the DPC and water pooling against the brickwork.

For water pooling issues, a licensed plumber should be engaged in the short term, to provide further advice & remedial works. Consultation with a damp proofing specialist is also advised to provide further advice.

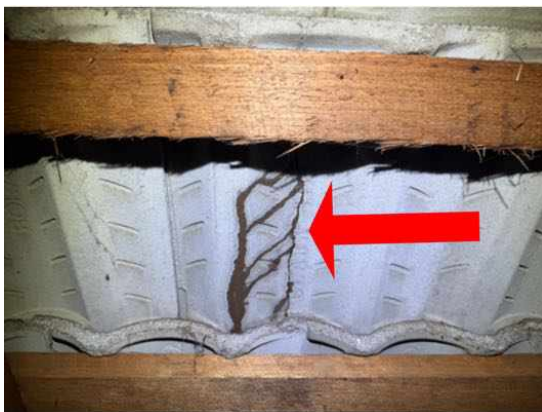
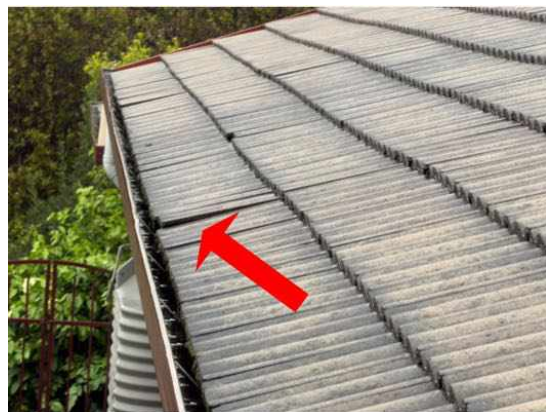
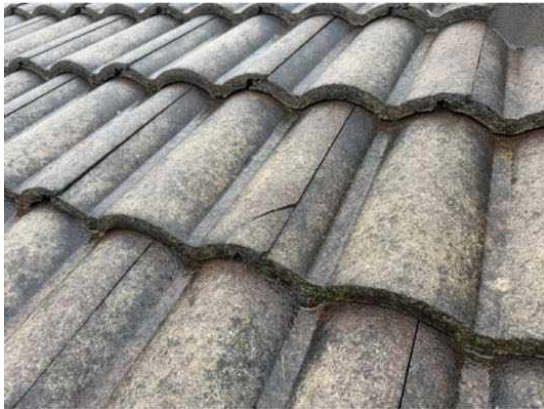
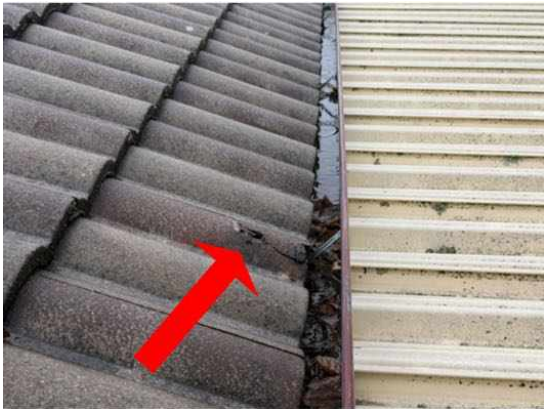
Finding 3.02

Finding: Roof Exterior - Weathered, Cracking

Information: Areas of weathered & cracked roof tiles were noted. It appears a tile in the roof void was cracked and leaking. While weathering of the tiles is consistent with the age of the property, maintenance works are required. Where left unmanaged, deteriorating and damaged roof tiles are likely to lead to secondary defects, including water leaks.

Recommend consulting with a licensed roofing contractor in the short term, to provide further advice on maintenance works required and to replace the leaking/cracked roof tile.

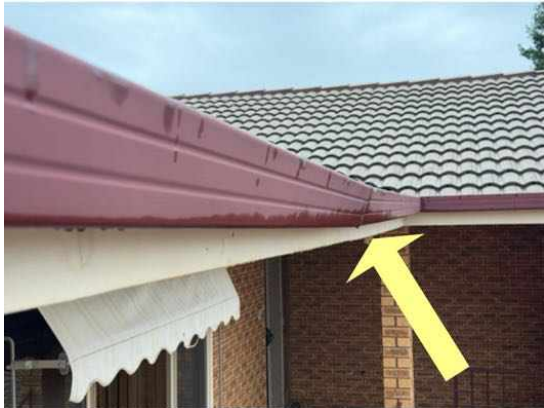
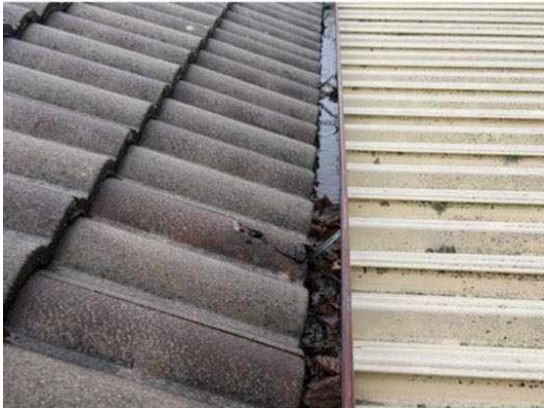
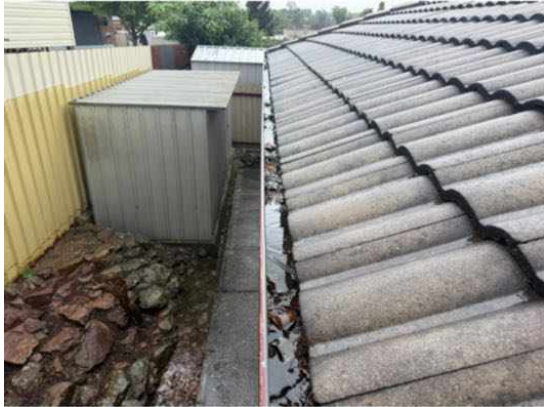
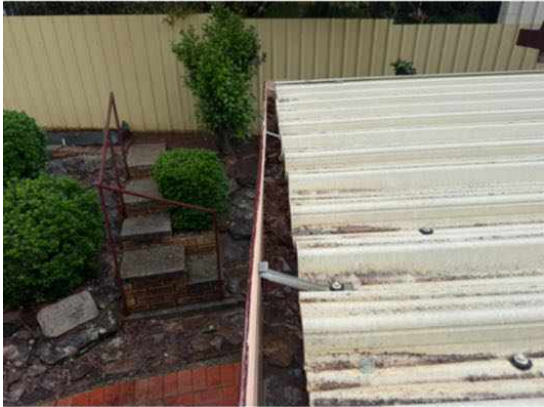
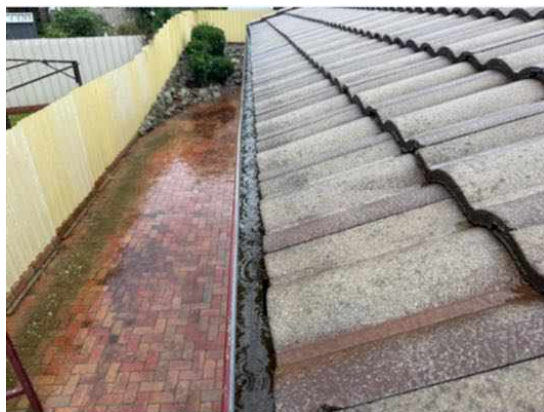
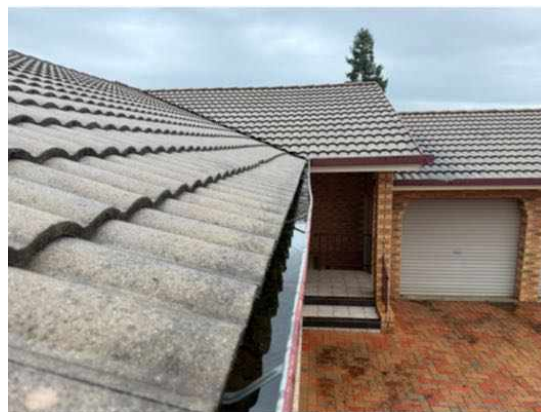
Finding 3.03

Building: Main Building
 Location: Gutters
 Finding: Gutters - Debris & Water pooling
 Information: Water pooling and debris were noted in sections of the guttering at the time of inspection, likely due to sagging or blockages. Water pooling can lead to deterioration of the roof plumbing over time, if neglected.

A licensed roof plumber should be engaged in the short term, to provide further advice & maintenance works to ensure adequate roof drainage is achieved. All debris should be cleared promptly to ensure proper drainage and prevent overflows.

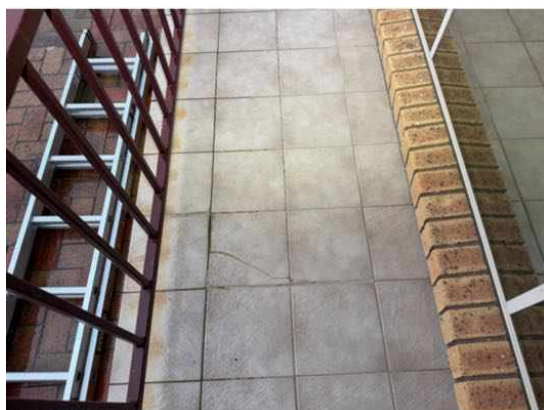
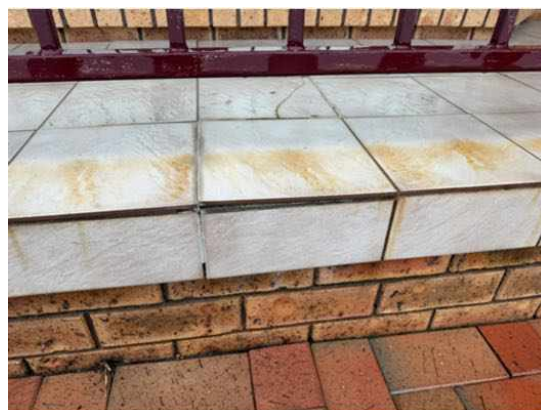
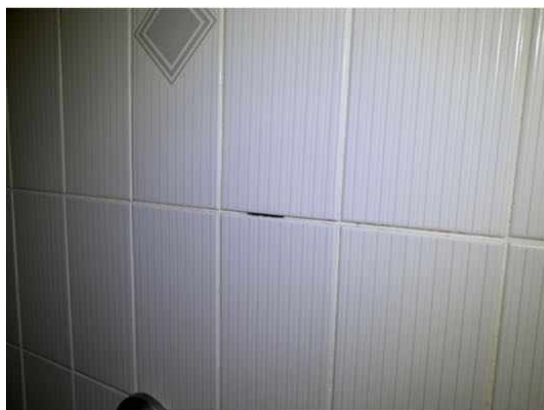
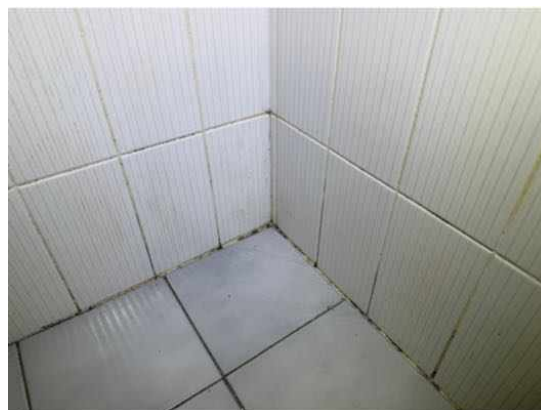
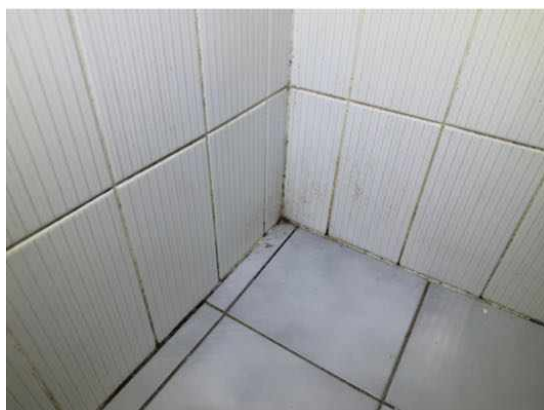
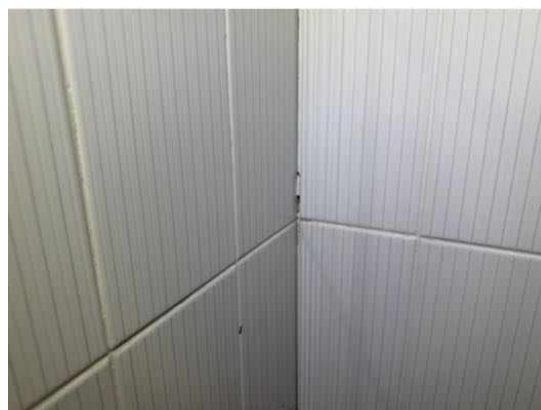
Finding 3.04

Building:	Main Building
Location:	Tiled Areas
Finding:	Sealant / grouting - deteriorated or missing & Cracked Tiles
Information:	It appears that the sealant and grout has deteriorated in some tiled areas, a common defect in buildings of a similar age. Areas of cracked tiles were also noted. Sealant and grouting in areas that come into regular contact with water should be maintained for the long term care of your property.

Recommend engaging a licensed tiling contractor in the short term, to provide maintenance works where necessary.

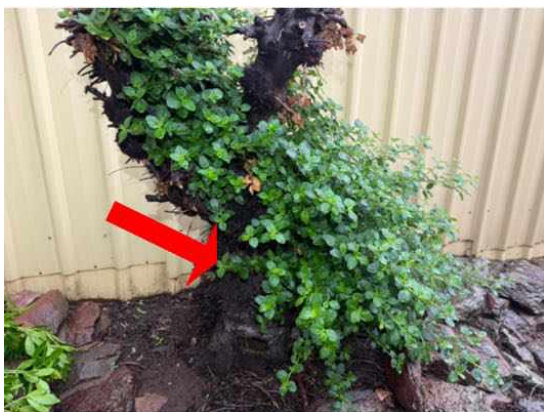
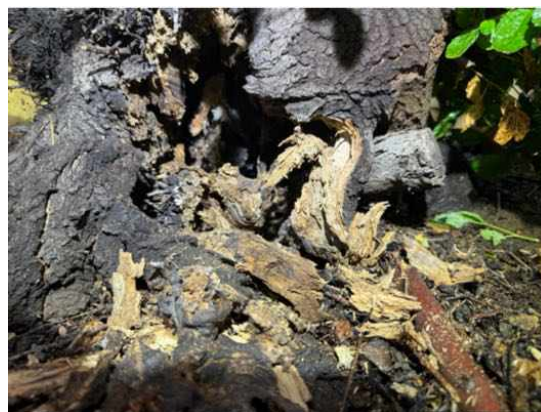
Finding 5.01

Building:	Main Building
Location:	Rear tree stump
Finding:	Evidence of termite workings & damage
Information:	It appears previous termite damage & workings were identified at, but not limited to, a rear tree stump. The client should engage a licensed pest controller at their earliest convenience to provide further advice regarding installation of a termite treatment. 12 monthly ongoing termite inspections, conducted by a qualified termite inspector, are also recommended

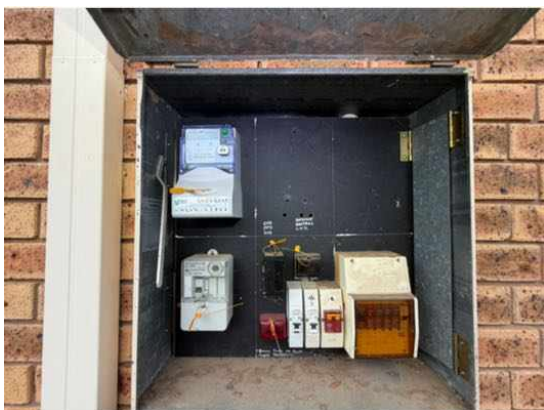
Finding 6.01

Building:	Main Building
Location:	Switchboard
Finding:	Termite Management System - no evidence of a chemical installation
Information:	The application of a termite barrier is strongly recommended, as it appears no termite management system has been installed, with no evidence or durable notice to suggest works taking place. Generally, a durable notice is placed in the meter box to indicate current termite barriers.

Such barriers are highly effective in preventing termite attack on the building and therefore should be installed.

Recommend seeking further advice from a licensed pest controller.

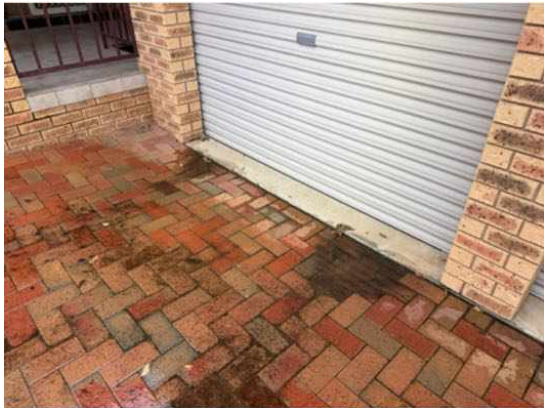
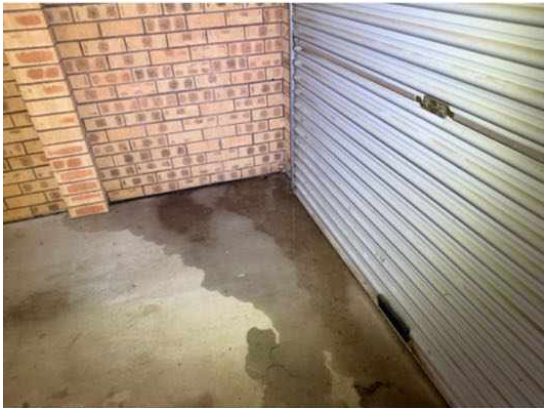
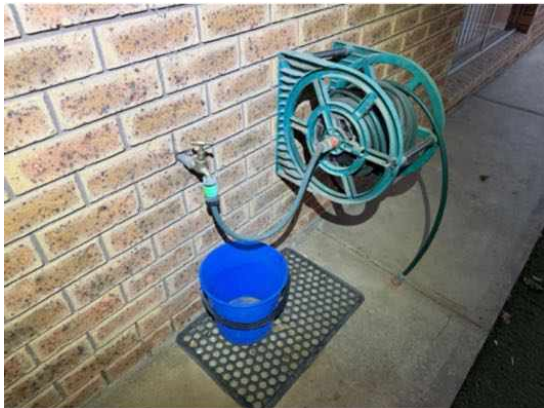
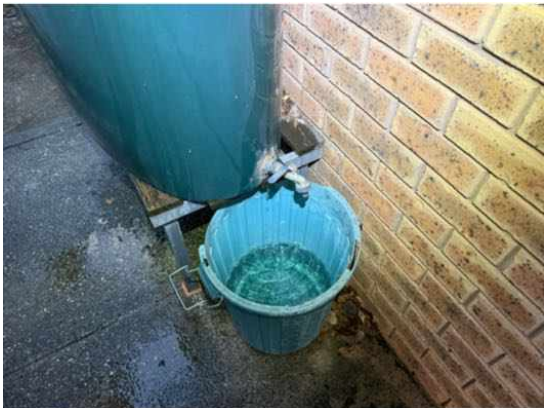
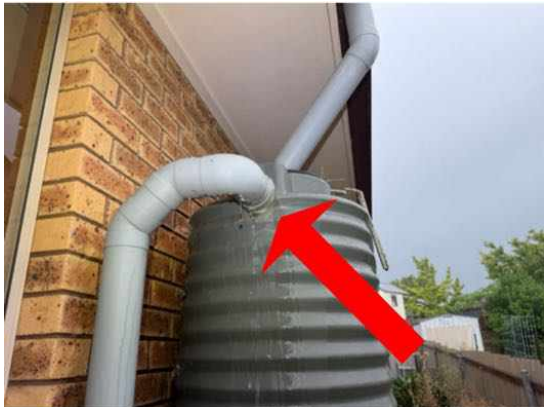
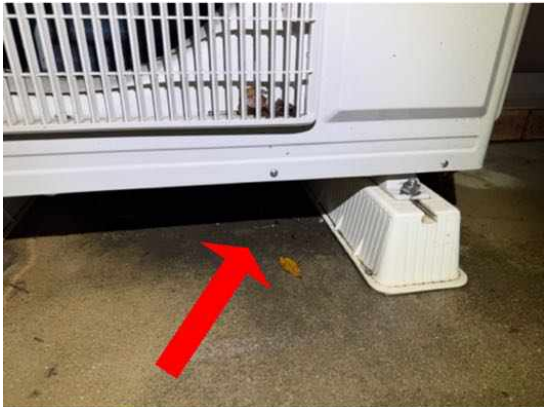
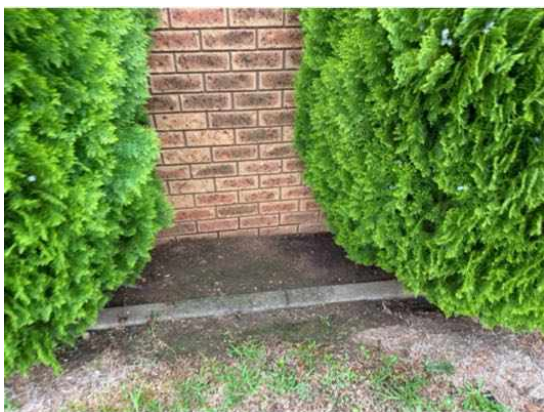
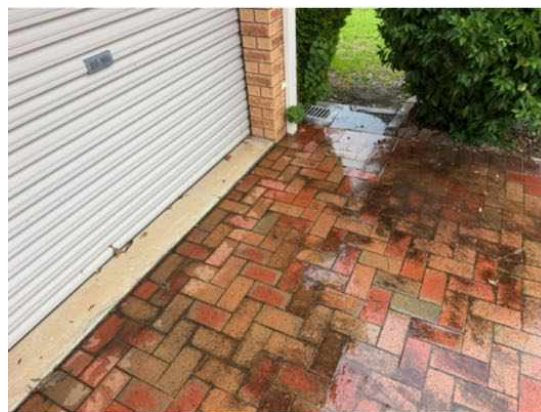
Finding 6.02

Building:	Main Building
Location:	All external areas, garage, water tank
Finding:	Potential Water pooling - against property

Information: Potential areas of water pooling around the perimeter of the property were identified. Water pooling was noted in the garage area and it appears areas of the water tanks were leaking.

Where insufficient site drainage and poor drainage of taps, aircon overflows, and garden beds against the house are present, water pooling is likely to occur, and can create areas conducive to timber pests. Recommend consulting with a licensed plumber to provide further advice.

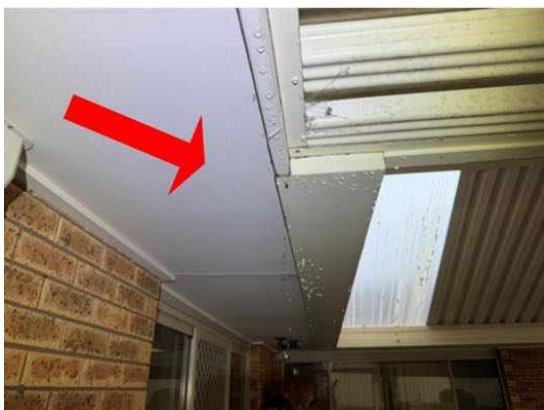
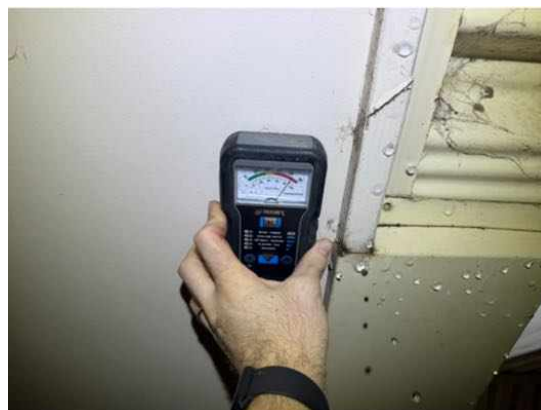
Finding 6.03

Building:	Main Building
Location:	Rear Patio Eave
Finding:	Eaves - High Moisture
Information:	It appears that high moisture was present at, but not limited to the rear patio eaves. This has likely been caused by leaking of the associated roof plumbing. Recommend engaging a licensed roof plumber promptly, to provide further advice and remedial works where necessary.

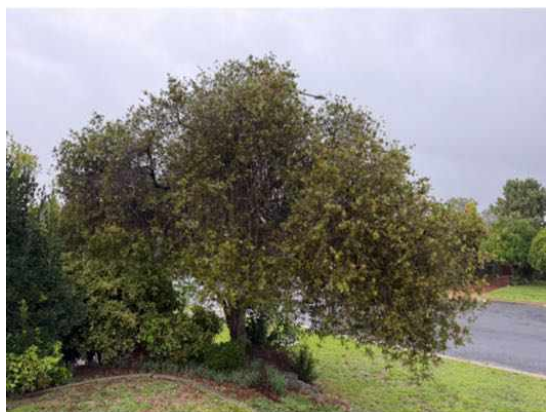
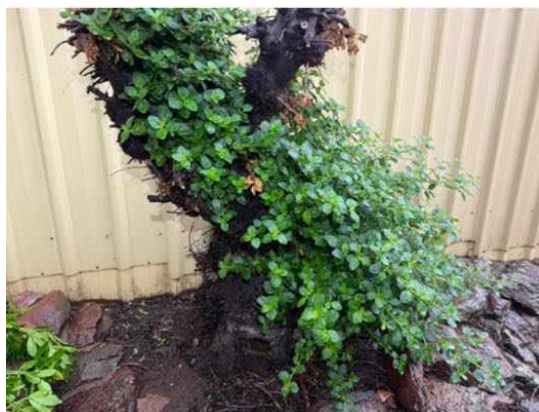
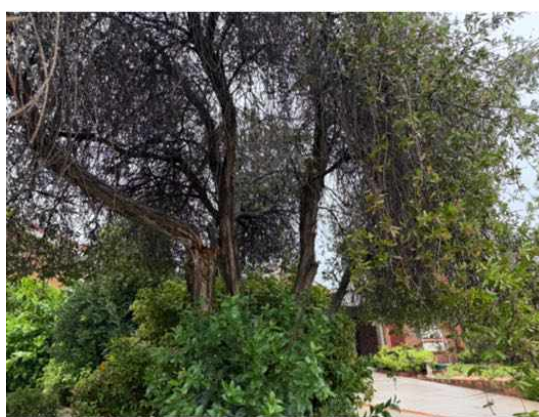
Finding 6.04

Building:	Main Building
Location:	All External Areas
Finding:	Timber in direct ground contact & trees - conducive to termites
Information:	Where timber materials are in direct contact with the ground and consequently moisture, they become conducive to termite activity. The tree stumps, landscaping timbers and trees surrounding the building create an environment conducive to termite activity.

Where feasible, any timbers in direct contact with the ground should be removed and any trees in close proximity to the building should be removed or test drilled

(inspected) at least annually to reduce the risk of termite infestation & detect any early signs of termite activity.

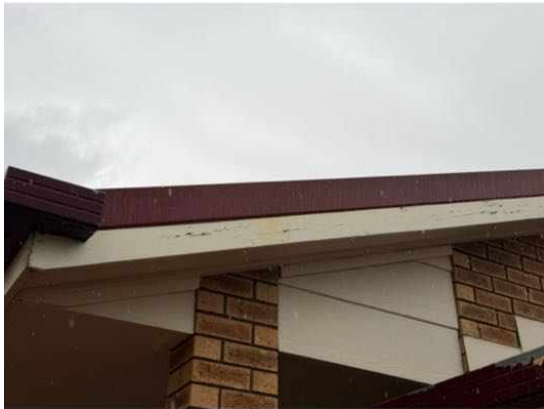
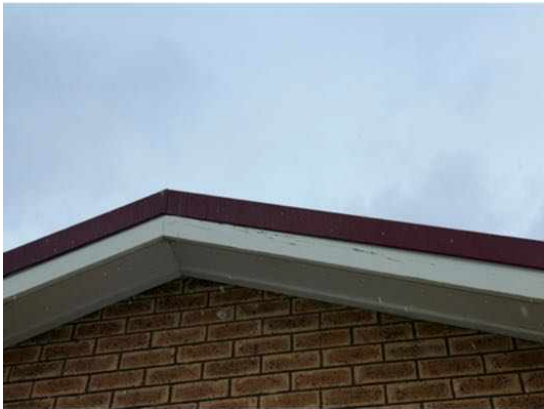
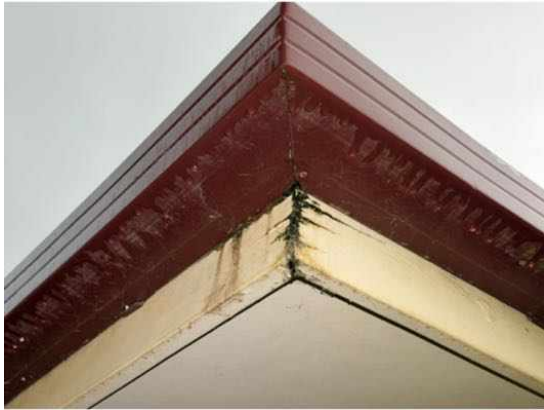
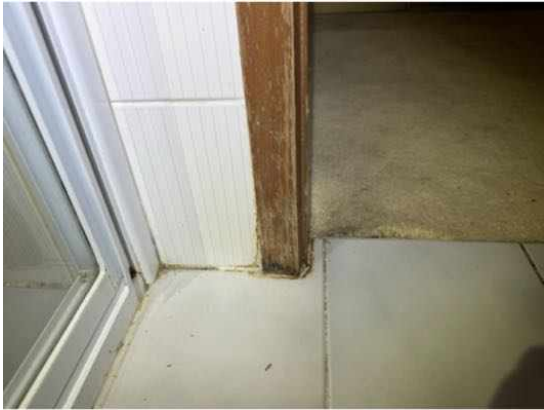
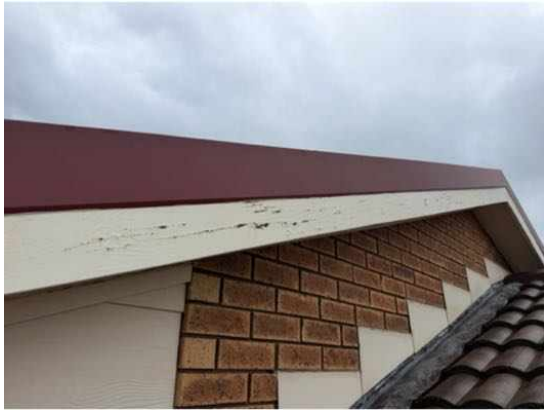
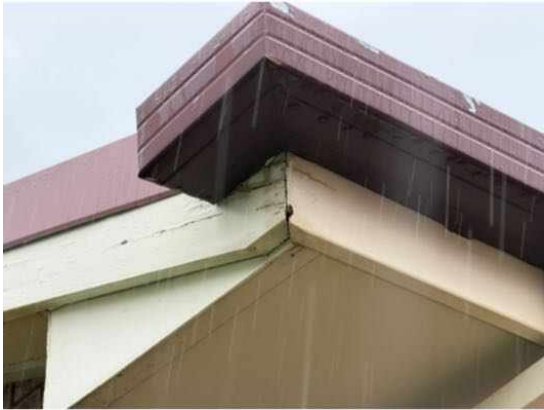
Finding 7.01

Building:	Main Building
Location:	Fascias, Bathroom Architraves
Finding:	Fungal decay & weathering
Information:	Areas of fungal decay (wood rot) were identified at but not limited to some fascias, and bathroom architraves. For areas of fungal decay / leaking gutters, the client can engage a licensed carpenter and/or licensed roof plumber, to provide maintenance works.

For areas of general weathering, it is advised the client engage a licensed painter to apply protective sealant or coating to areas of weathered external timbers.

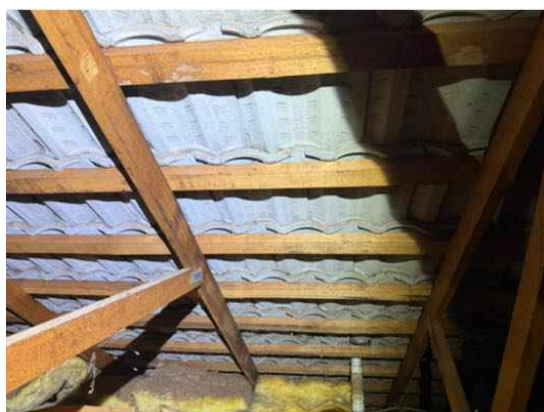
Building: Main Building
 Location: Roof Void
 Finding: Sarking - Not Present
 Information: It is noted for your information that sarking has not been installed on the roof. Sarking is a laminated aluminium foil applied to the interior of the roof covering, assists in insulating the property and acting as a vapour-barrier to the roof void.

The client can consult with a licensed roofing contractor at their discretion, to provide further advice.

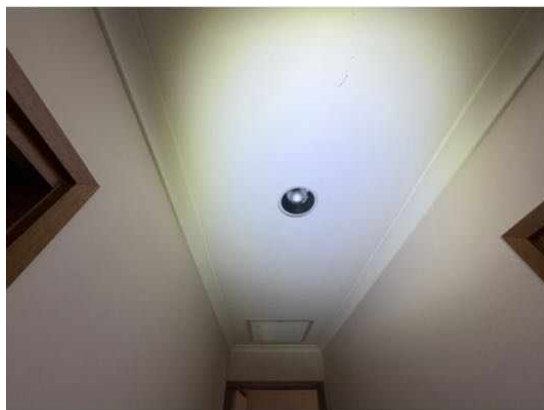
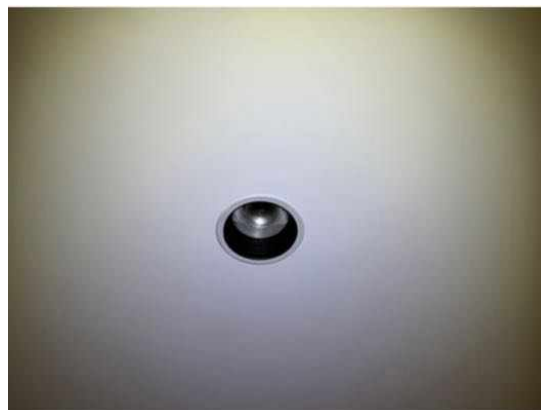
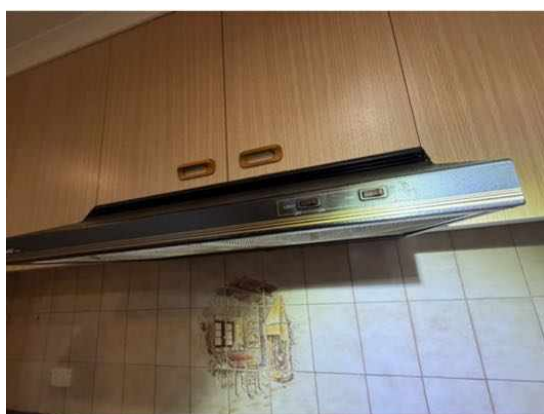
Building: Main Building
 Location: Hallway, Bedroom, Rangehood

Finding: Lights & Rangehood - Not Operating
 Information: It appears that some lights and the stove rangehood were not operating at the time of inspection. Recommend engaging a licensed electrician, to provide remedial works at clients discretion.

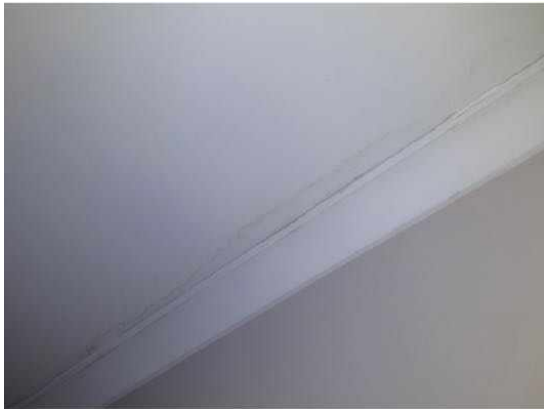
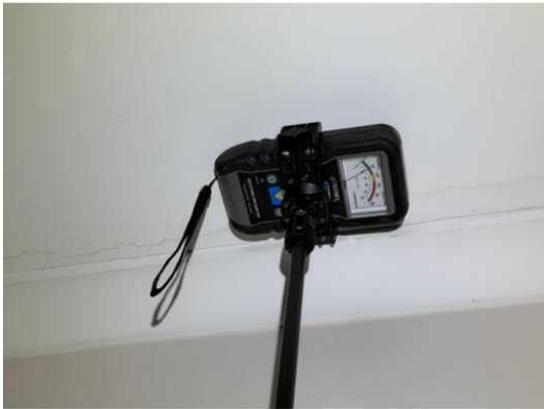
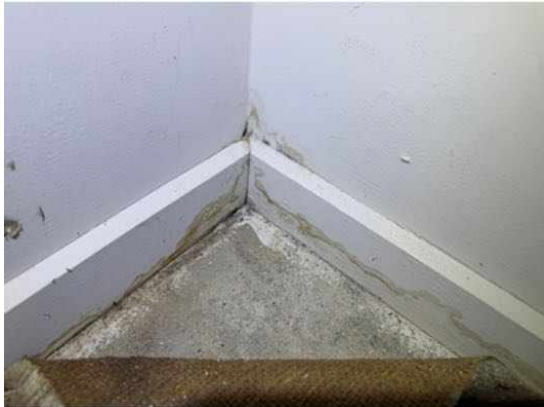
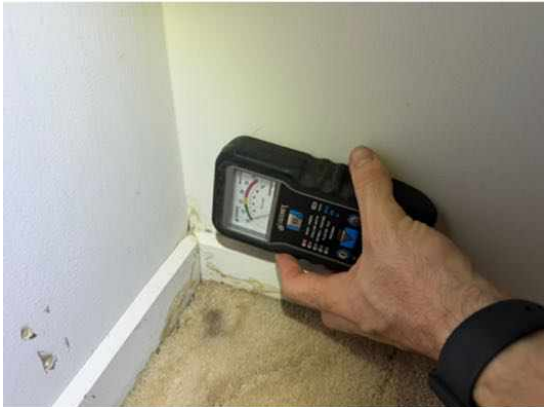
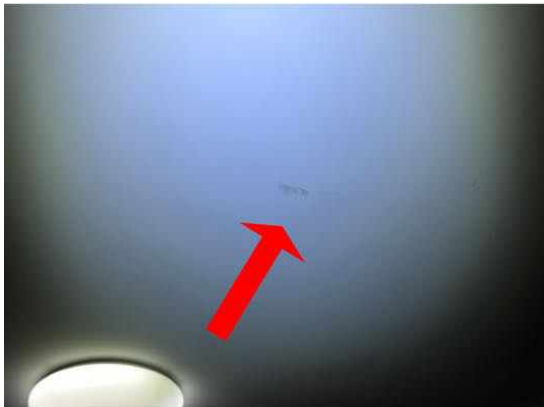
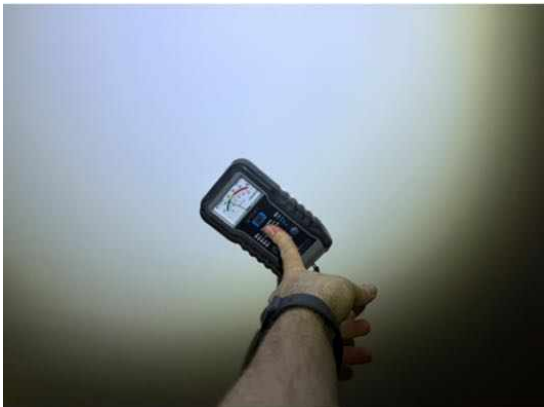
Building: Main Building
 Location: Lounge room ceiling, wardrobe, dining room ceiling
 Finding: Water Staining Present
 Information: It appears that water staining was present at but not limited to, the lounge room ceiling, wardrobe and dining room ceiling. Potential causes of leaking include deteriorated roof cladding or damaged plumbing fittings and fixtures. No excessive moisture was evident in these areas at the time of inspection.

It is recommended that the client closely monitor these areas and engage a licensed roof plumber promptly, should the leak persist or return.
