Building Inspection Report

Inspection Date: Tue, 17 Mar 2026

Property Address: 119 Richmond Rd,CAMBRIDGE
PARK,NSW,2747,Australia

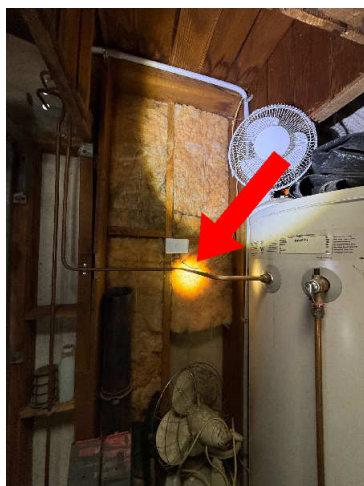
Defects 1.01

Finding: Exposed wiring

Information: During the inspection, exposed electrical wires were noted. This condition poses a significant safety hazard, as it increases the risk of electrical shock, short circuits, and potential fire. It is imperative that a qualified electrician addresses this issue immediately by properly insulating the exposed wires and ensuring all electrical connections comply with safety standards. Prompt action will mitigate the risks associated with exposed wiring and maintain the safety and integrity of the property's electrical system.

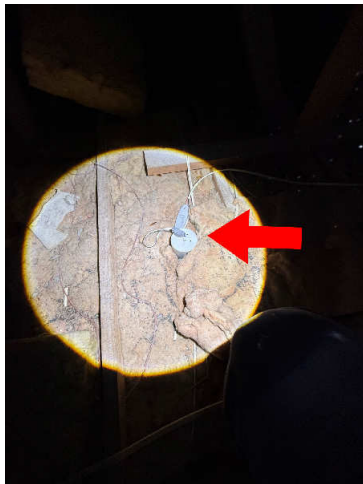
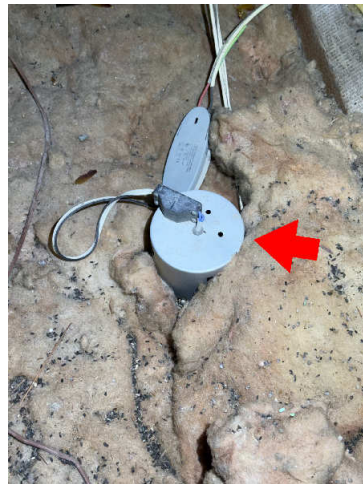
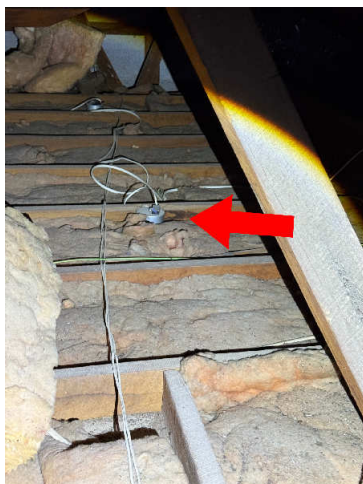
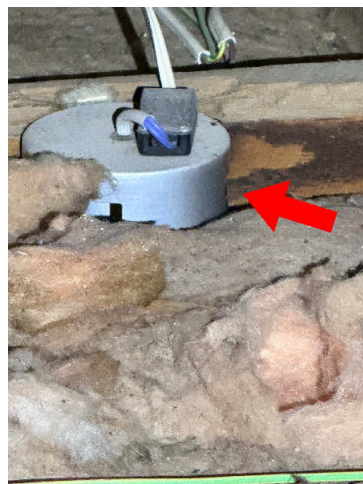
Defects 1.02

Information: Sections of insulation in the roof void have been poorly installed or moved from their original position and are covering down light fittings. While the down lights have been fitted with appropriate protective covers, the presence of this insulation creates a potential fire hazard.

Any insulation within the vicinity of down light fixtures should be moved and re-applied to more appropriate sections of the roof void, thus ensuring the area is fire-safe.

An insulation contractor should be appointed as soon as possible to perform any necessary works as required.

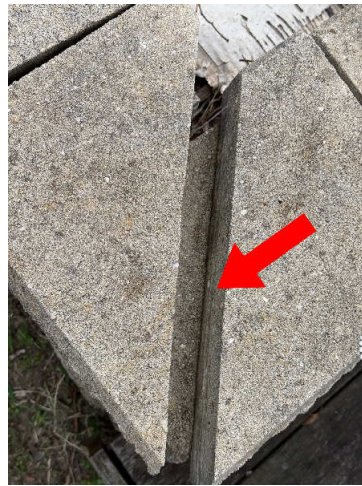
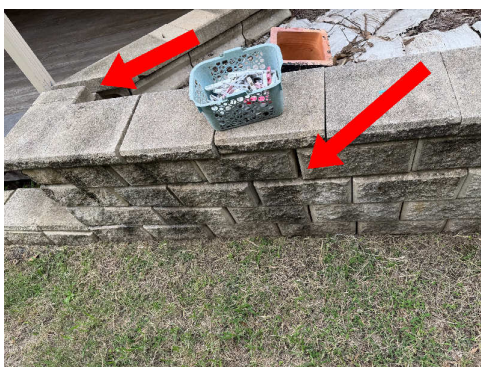
Defects 2.01

Information: The external planter box constructed of brick and concrete masonry blocks is observed to be leaning outward, with evidence of structural movement and separation between masonry units. Several capping units are displaced, misaligned, and uneven, with visible gaps and cracking in mortar joints. These conditions indicate loss of structural integrity, likely due to ground movement, inadequate footing support, soil pressure from retained fill, and/or ineffective drainage behind the planter wall.

The observed displacement and leaning represent a structural defect and pose a risk of progressive movement, collapse, and potential injury.

The condition may also allow water ingress, accelerate deterioration of masonry, and cause further instability over time.

This condition is considered a major defect as the planter box is no longer performing its intended structural function and may present a safety hazard

It is strongly recommended that a licensed builder, structural engineer, or qualified landscaper experienced in retaining structures be engaged to further assess the planter box and too rectify as needed

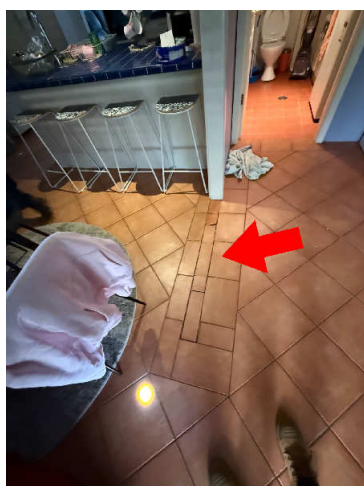
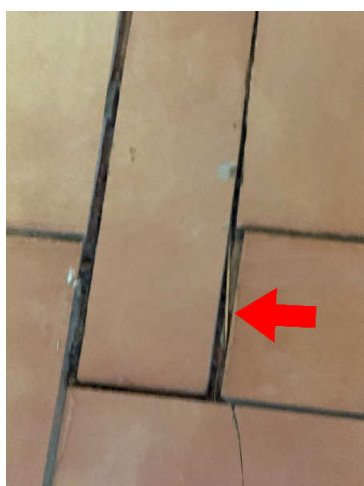
Defects 2.02

Finding: Loose floor tiles

Information: At the time of the inspection, it was observed that several ceramic floor tiles within the dining area were found to be loose, debonded, and uneven, with missing or degraded adhesive and open grout joints visible. Some tiles exhibit vertical and lateral movement when walked on, indicating inadequate bonding to the substrate. Localised cracking and separation between tiles were also observed.

Loose tiles present a trip hazard and may worsen with continued use.

The condition suggests adhesive failure, substrate movement, moisture ingress, or age-related deterioration. If left unrectified, further tile loosening and damage to surrounding tiles can be expected.

Putting this as a major defect because it is causing safety hazard also.

It is recommended that a qualified tiler or builder be engaged as soon as possible to further investigate the cause of tile failure. Rectification may involve lifting and re-laying affected tiles, repairing the substrate, and re-grouting, or replacing sections of flooring where necessary.

Any repairs should be carried out in accordance with current standards and good building practice.

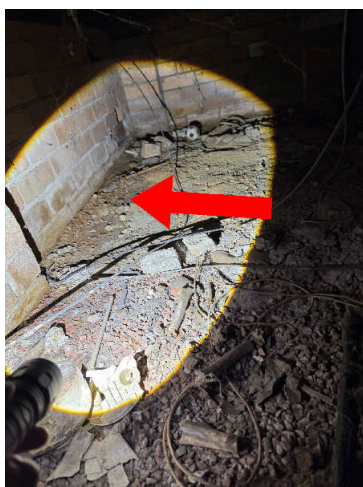
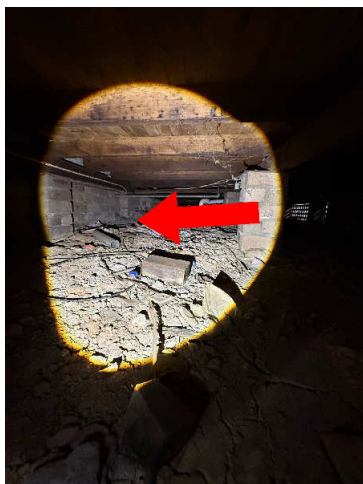
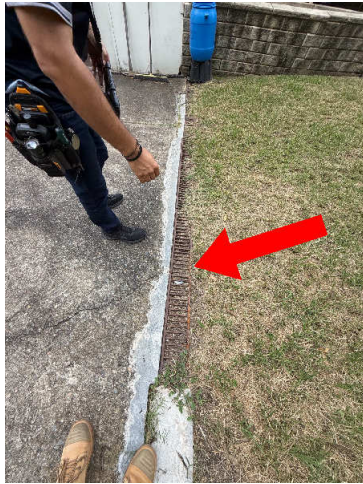
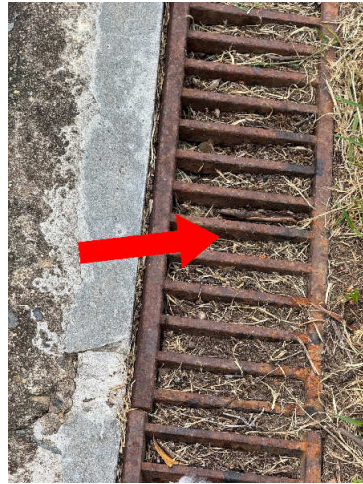
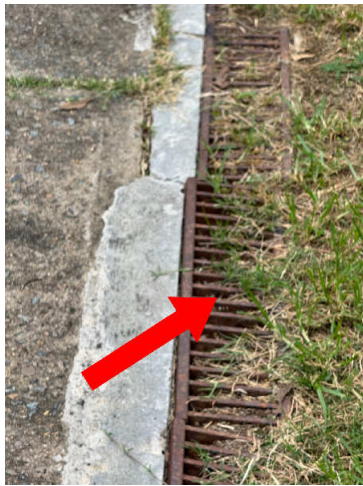
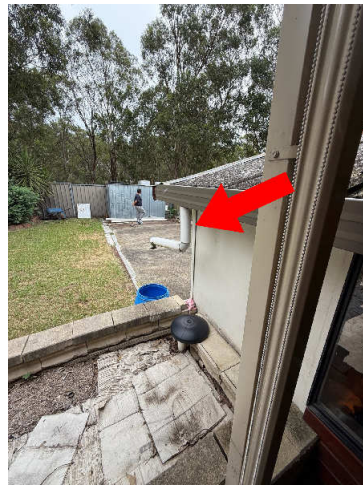
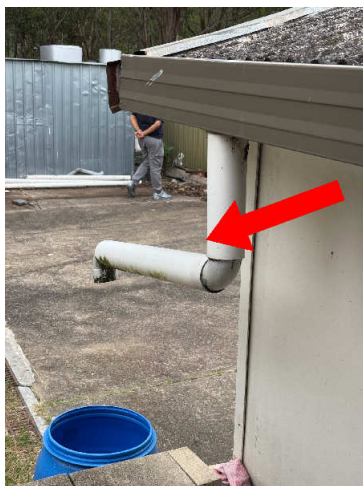
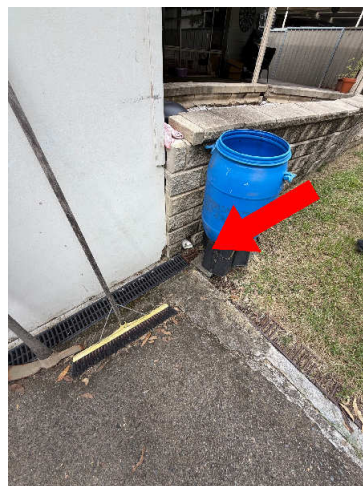
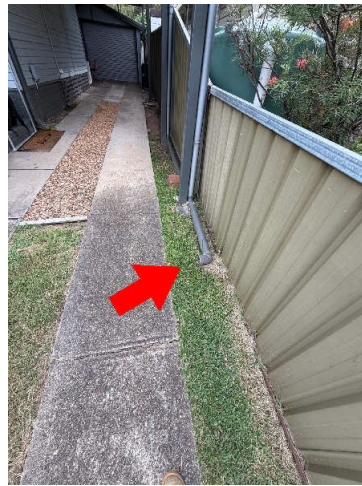
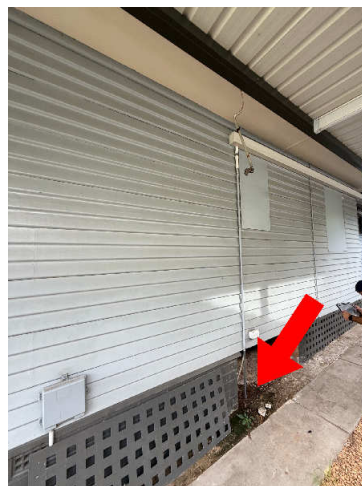
Defects 2.03

Building:	Main Building
Location:	The Site
Finding:	Site drainage - Inadequate

The site drainage in this area was found to be inadequate at the time of inspection, creating potential for subsequent water damage to associated building elements.

It is important that water does not lie against the base of walls; surrounding paths and ground levels should be sloped to drain water away from walls. Downpipes should not disgorge stormwater onto lower walls or plinths. Stormwater should be carried away by large, regularly cleaned drains. Ground levels may need to be lowered to expose a buried DPC.

Where site drainage is inadequate, installation of an Agricultural (Aggie) Drain may be required. A qualified plumber should be appointed to further inspect the property and perform any remedial works as necessary. Water damage and secondary defects are likely to occur if left unmanaged.

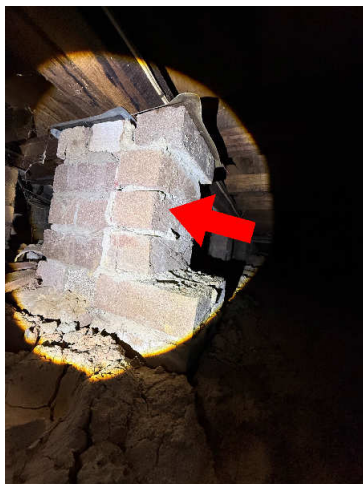
Defects 2.04

Finding: Subfloor brick piers - Unstable or deteriorated

At the time of the inspection, it was observed that the brick pier supporting the subfloor structure is observed to be splitting and cracked, with displaced bricks and deteriorated mortar joints. Cracking appears to extend through multiple courses, and there is evidence of separation along the vertical mortar joints.

This condition indicates a loss of structural integrity of the pier and may be associated with foundation movement, overloading, or inadequate original construction.

The condition of the brick pier may compromise its ability to adequately support the loads above. Continued movement or deterioration could result in further cracking, uneven floors, or localised structural instability.

This defect is considered structural in nature
It is strongly recommended that this brick pier be urgently assessed by a qualified structural engineer to determine the cause of the cracking and confirm the adequacy of support. Repairs may involve rebuilding, underpinning, or replacement of the pier in accordance with the engineer's recommendations. All rectification work should be carried out by a suitably licensed contractor.

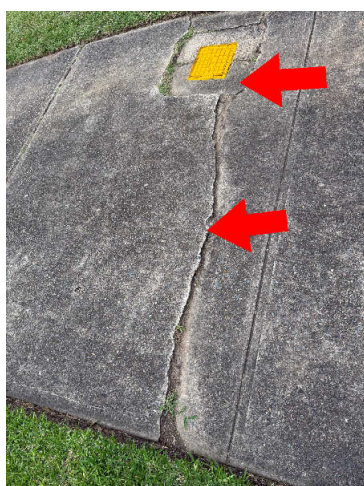
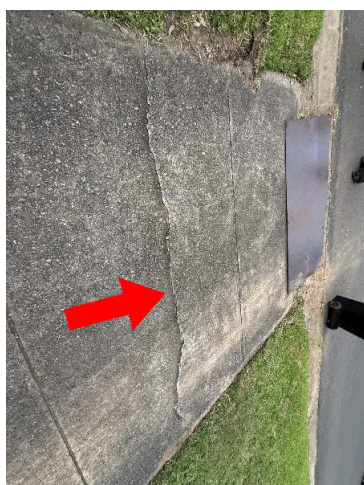
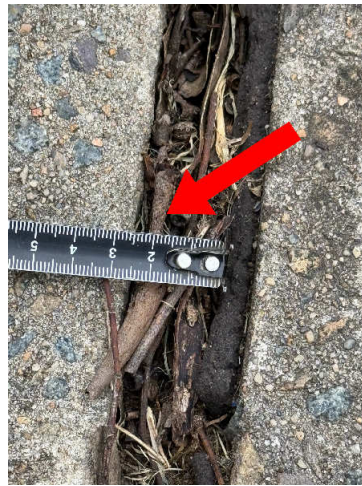
Defects 3.01

Building:	Main Building
Location:	Driveway
Finding:	Crack in concrete slab - Category 3
Information:	A crack coded as Category 3 was identified in the slab.

A Category 3 crack is described as a wide crack with obvious curvature or change in level, affecting the slab.

The approximate width of the crack to be considered Category 3 is greater than 2.0mm, or a change in offset of 15-25mm when a 3m straight edge is placed over the defect.

Category 3 cracks to slabs exceed allowable Standards and Tolerances, and are considered defects requiring rectification.

Inadequate control joints or joint failure

Age-related deterioration

Moisture variation in subgrade soils

If not rectified, the open gaps may continue to widen, create trip hazards, allow water ingress and vegetation growth, and contribute to further deterioration of the concrete and supporting subgrade.

It is highly recommended that suitable contractor is engaged as soon as possible to assess the concrete slab condition and carry out rectification

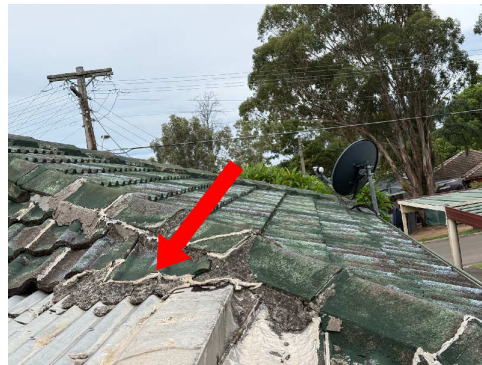
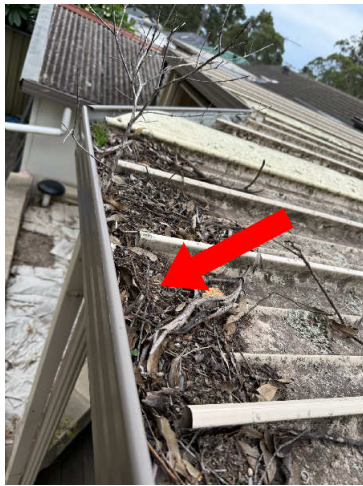
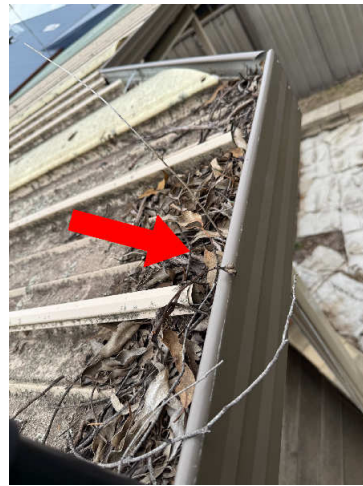
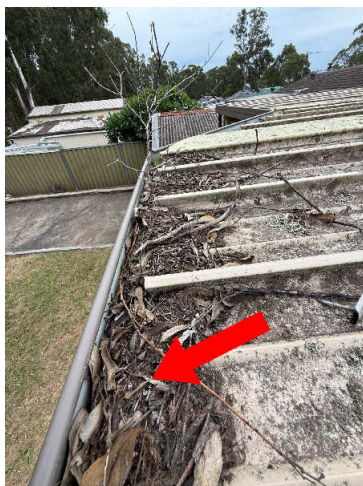
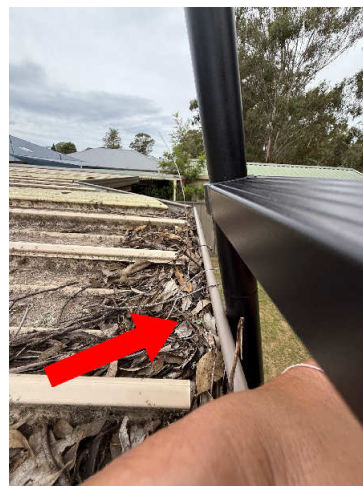
Defects 3.02

Information: At the time of inspection, it was observed that the roof gutters are blocked and were full of leaves and debris.

Blocked gutters are likely to lead to high levels of moisture in the affected areas.

Such moisture will not only cause rust and decay of the associated building materials, but can also provide conditions that are conducive to termite and timber pest activity. Blockages in gutters should therefore be removed immediately to ensure dry conditions are maintained.

Consult a Licensed Plumber for further specific advice on remedial works that may be required.

In the interim, it is highly advised that blocked gutters be cleaned by the homeowner or a general handyperson as a matter of urgency.

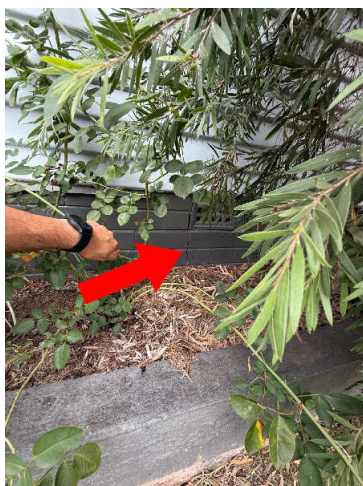
Defects 3.03

Finding: Brickwork - Cracking [Repair required]

Information: Significant vertical and stepped cracking was observed to the external masonry wall, extending through multiple courses of brickwork and mortar joints. The cracks show clear separation between masonry units and are of a width and nature greater than typical shrinkage or thermal cracking. This type of cracking is indicative of structural movement and exceeds what would be considered a minor or maintenance-related defect. In accordance with AS 4349.1 – Inspection of Buildings, cracks of this extent and pattern are assessed as a major defect due to their potential to affect the structural performance, serviceability, and durability of the building.

Foundation or footing movement

Ground subsidence or reactive soil conditions

Implications: If left unaddressed, further movement may occur, resulting in widening of cracks, loss of structural integrity, increased moisture ingress, and potential deterioration of the masonry wall.

Recommendation: It is strongly recommended that a qualified structural engineer be engaged to carry out a detailed assessment of the affected areas.

The engineer should determine the cause, extent, and significance of the movement and provide appropriate rectification and monitoring recommendations. Structural repairs may be required.

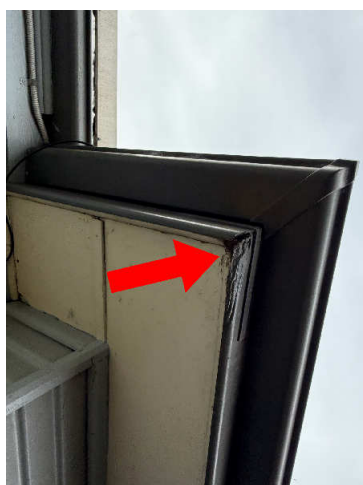
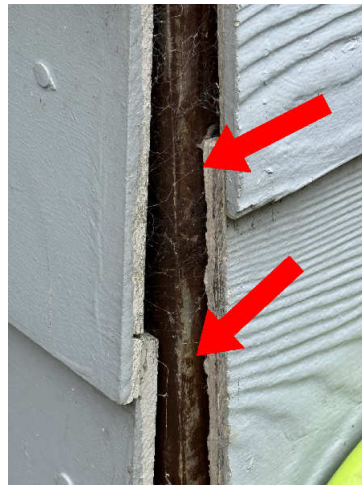
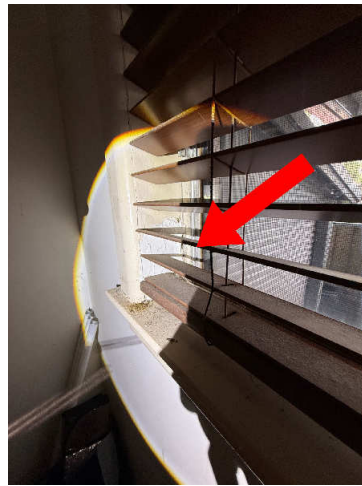
Defects 3.04

Finding: Wood rot (fascia, decking, timber in ground, window)

Information: This building element shows evidence of wood rot. Wood rot, also known as Fungal Decay, occurs when timbers and other cellulose building materials are exposed to damp conditions on an ongoing basis. This could be the result of exposure to weathering over a prolonged period of time, or the attraction of excessive moisture from other abutting building materials. Contributing factors also include poor air ventilation in the area.

Wood rot is often associated with general damp problems and is evidenced by a 'musty' smell or mould and mildew occurring on surfaces. If left unmanaged, damp conditions can lead to further health problems and the decay of timbers will continue.

Prior to any works being performed, the cause of the moisture that has created the visible wood rot should be identified and addressed in a suitable manner. Replacement of affected timbers may then be a necessary step in protecting surrounding building elements from such deterioration.

A qualified plumber may be appointed to assess the cause of excessive moisture and to provide advice on any remedial works as required.

A qualified carpenter or registered builder may also be required to replace affected building materials.

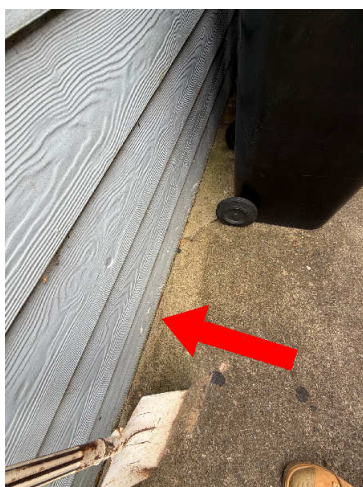
Defects 3.05

Evidence of moisture staining and deterioration at the lower edge of the cladding was observed.

Cladding installed in direct contact with concrete paving is susceptible to moisture wicking, premature deterioration, and concealed decay of wall components. This condition also restricts drainage and drying, increasing the risk of water ingress, mould growth, and pest activity.

The lack of clearance is not consistent with good building practice.

It is recommended that a licensed builder be engaged to assess this condition. Rectification may involve lowering the pavement level, introducing an appropriate clearance gap, installing a termination flashing or trim, or replacing affected cladding where deterioration has occurred. Any repairs should be carried out in accordance with current standards, manufacturer requirements, and good building practice.

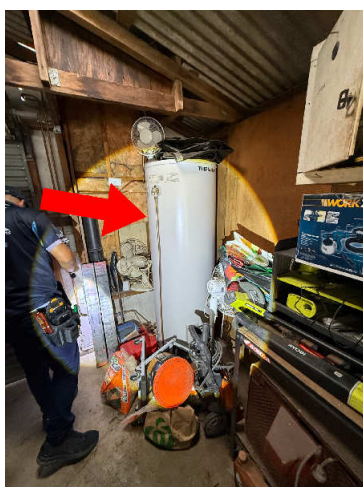
Defects 3.06

Information: The Hot Water System (HWS) overflow and AC drain were found to be disconnected from storm water drainage and is creating excessive moisture in the surrounding area.

These damp conditions can lead to secondary defects such as rot, rust or corrosion of associated building elements, the formation of fungal decay, or even the creation of potential slip hazards.

When coupled with poor site drainage, pooling of water may also attract termite activity to this area.

It is highly recommended that a licensed plumber be appointed to connect the HWS overflow in order to prevent such an environment from being created. These minor works should be carried out as soon as possible.

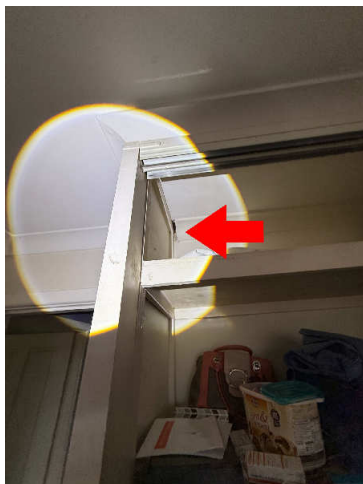
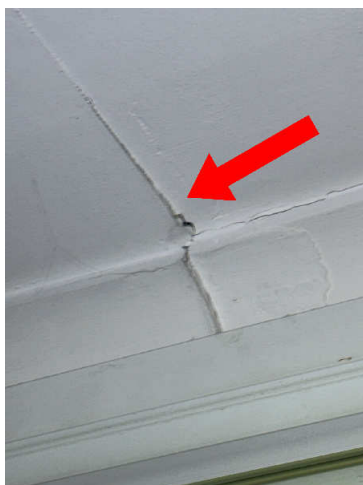
Defects 3.08

Finding: Damaged ceilings

Information: The ceiling lining shows visible damage, including cracking, separation at joints, impact damage, and localized holes/penetrations. Sections of the ceiling appear delaminated and poorly supported, with cracks extending along joint lines and edges. The condition is inconsistent with acceptable standards of finish and serviceability. In some areas, damage suggests either previous moisture exposure, structural movement, impact damage, or inadequate fixing.

The extent of deterioration could not be fully determined without invasive inspection.

It is recommended that a licensed builder or qualified tradesperson be engaged to further investigate the cause of the ceiling damage and carry out appropriate repairs or replacement. Where moisture damage is suspected, the source should be identified and rectified before cosmetic repairs are undertaken.

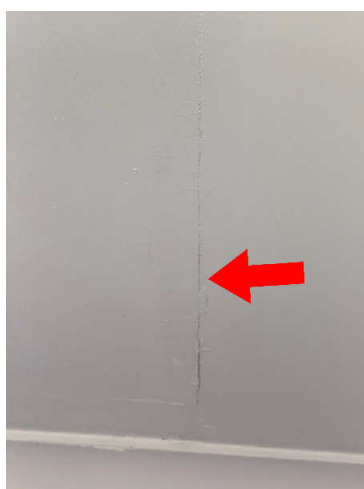
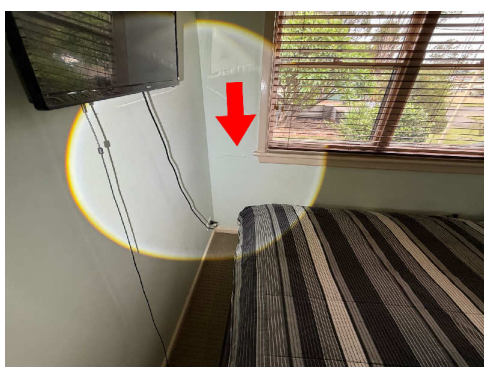
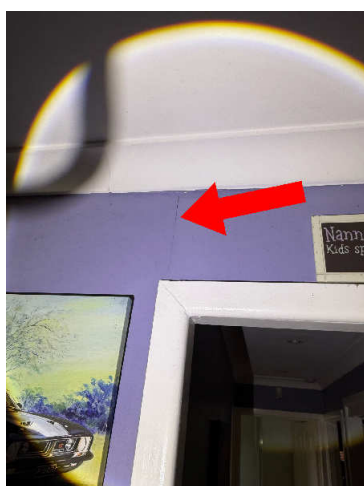
Defects 3.09

Finding: Settlement Cracks in Gyprock

Information: There are fine cracks and gaps visible through out the house. Over time, settlement cracks have appeared in the gyprock walls. These defects are typically caused by natural building movement, foundation settlement, or thermal expansion and contraction.

While common in new constructions during the settling period, they affect the aesthetic finish and may require repair to prevent further deterioration.

- Natural foundation settlement over time.
- Thermal expansion and contraction of building materials.
- Inadequate joint treatment or sealing during construction.

The severity is primarily aesthetic, but requires monitoring for structural concerns.

It is recommended to hire a professional painter to seal cracks and gaps and paint the surfaces at the client's discretion.

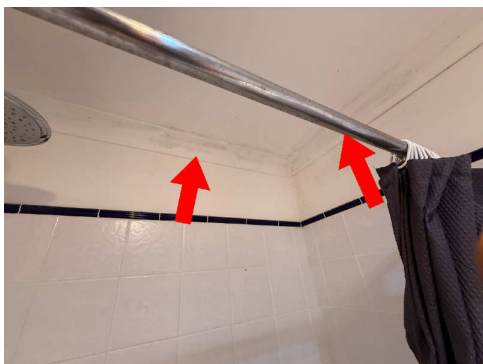
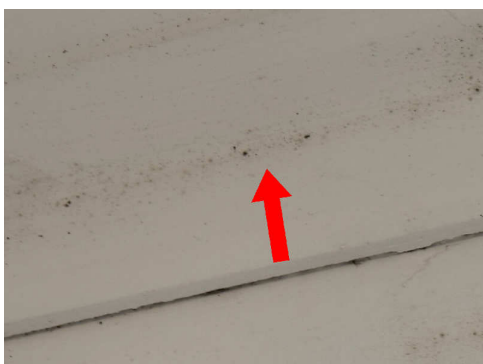
Defects 3.10

Information: Visible mould growth was observed on the bathroom ceiling and wall surfaces, particularly along junctions, corners, and high-moisture zones. The mould appears as dark spotting and staining, consistent with prolonged moisture and inadequate ventilation. Associated cracking and deteriorated paint finishes were also noted in affected areas.

Mould growth indicates persistent elevated moisture levels and may be associated with poor ventilation, ineffective exhaust systems, excessive condensation, or possible water leaks.

If left unaddressed, mould may continue to spread and can contribute to deterioration of finishes and potential health concerns, particularly for occupants with respiratory sensitivities.

The presence of mould may indicate underlying moisture issues that were not fully identifiable at the time of inspection.

It is recommended that a qualified tradesperson be engaged on urgent basis to clean and treat the affected surfaces using appropriate mould remediation methods. In addition, the source of excess moisture should be identified and rectified, which may include improving ventilation (e.g. exhaust fan performance), repairing waterproofing or leaks if present, and reinstating damaged finishes.

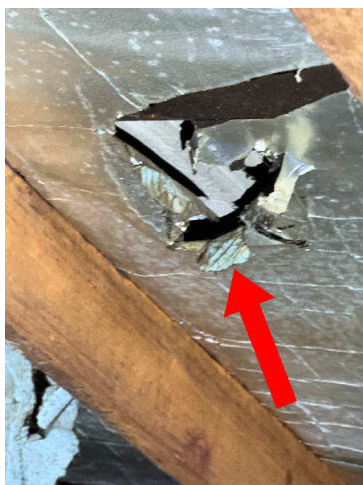
Defects 3.11

Building:	Main Building
Location:	Roof Void
Finding:	Sarking - Damaged

During inspection, it was observed that roof sarking was damaged (Deteriorated) at many places in the roof void.

Where sarking is damaged, both insulation and moisture protection of the property are inhibited.

This creates a loss of energy and thus negatively impacts the energy efficiency of the property, allowing potential for moisture ingress from condensation or leaking roof tiles.

It is important to repair any holes or damaged sections of sarking to ensure that the building material is fully functional. A registered builder or qualified carpenter, roof installer should be consulted as soon as possible to provide further advice on this defect and to perform rectification works

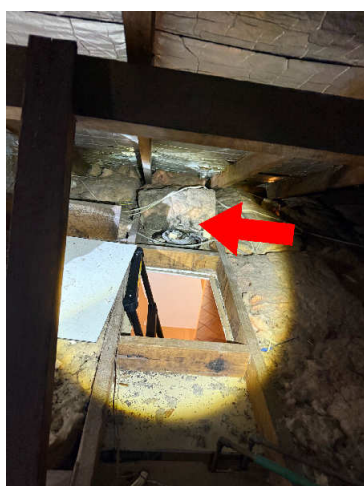
Defects 3.12

Information: At the time of inspection, the bathroom exhaust fan was found to be venting directly into the roof space, rather than being ducted to discharge to the external atmosphere.

Where exhaust fans discharge into the roof space, there is an increased risk of moisture accumulation, particularly if roof sarking is installed, as this can restrict natural ventilation through roof tile gaps.

Prolonged moisture buildup within the roof cavity may contribute to condensation issues, mould growth and deterioration of roof timbers, insulation, and other building elements

It is recommended that the client engage a licensed electrician as soon as possible to upgrade the bathroom exhaust fan system so that it vents directly to the external atmosphere, in order to reduce the risk of moisture buildup and associated damage

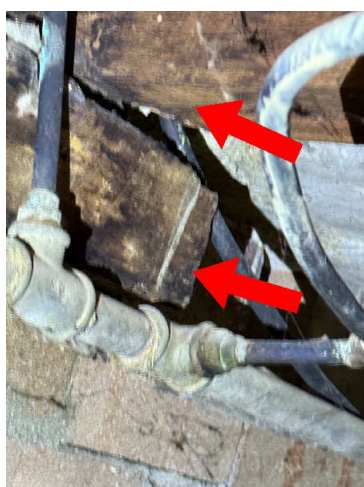
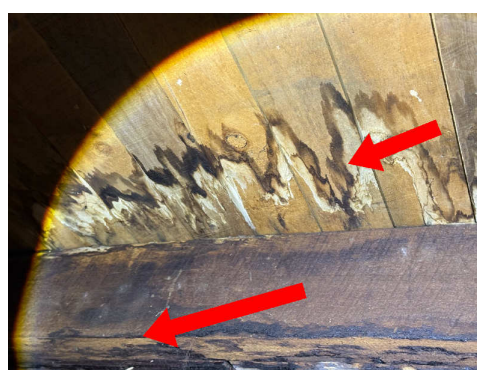
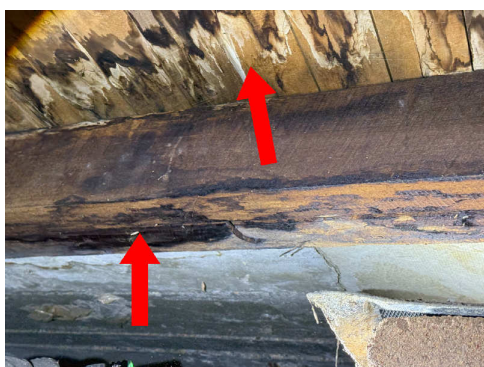
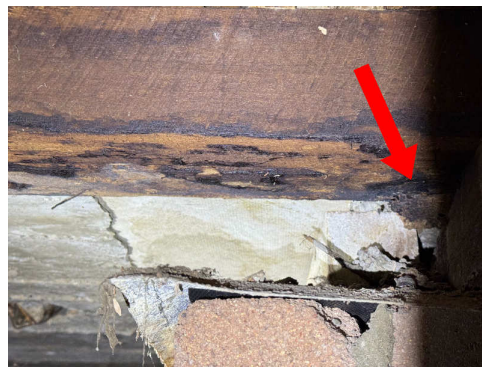
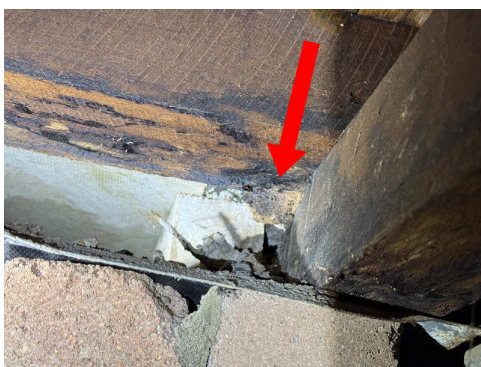
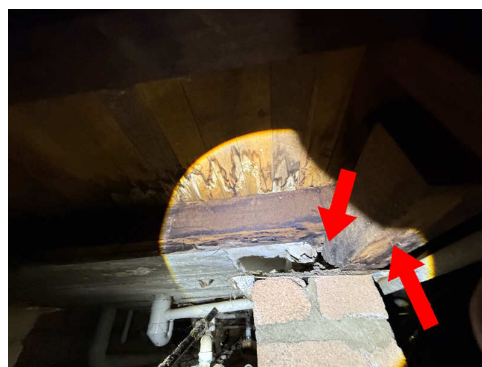
Defects 3.13

Finding: Water staining to timber joist, bearers and floor boards

Information: Evidence of water staining and moisture damage was observed on timber floorboards, joists, and bearers within the subfloor. The affected timbers display dark staining and discoloration consistent with past or ongoing moisture exposure. These conditions may be associated with inadequate subfloor drainage, plumbing leaks, poor ventilation, or external water ingress.

Prolonged or repeated moisture exposure can lead to timber deterioration, fungal decay, reduced structural capacity, and may create conditions conducive to termite or pest activity.

While active decay or excessive moisture was not confirmed at the time of inspection, the presence of water staining indicates an elevated risk that warrants further assessment.

The source of moisture be identified and rectified (e.g. plumbing leaks, drainage issues, or inadequate subfloor ventilation).

A licensed plumber or qualified contractor be engaged to investigate potential leaks or water ingress.

A licensed pest controller assess the area, as damp conditions may attract timber pests.

Ongoing monitoring of the affected timbers is undertaken, and repairs or replacement carried out where deterioration is confirmed.

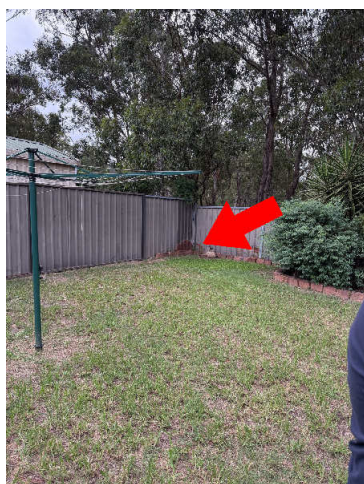
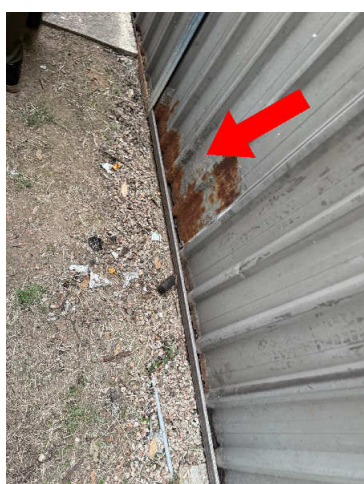
Defects 3.14

Finding: Rusted Metal fence

Information: The metal boundary fence panels exhibit significant corrosion, particularly along the lower sections where the metal is in close contact with soil and moisture. Visible rusting and surface deterioration are evident, indicating breakdown of the protective coating and ongoing metal degradation. Continued corrosion may lead to loss of structural integrity, reduced service life, and eventual failure of fence panels. Corroded metal can also result in sharp edges, presenting a safety hazard. The condition suggests prolonged moisture exposure and inadequate corrosion protection at ground level. It is recommended that:
A qualified contractor assess the extent of corrosion.
Affected fence sections be treated, repaired, or replaced as necessary.
Protective coatings be restored or upgraded, and ground contact reduced where possible to limit further deterioration.
Ongoing monitoring and maintenance be undertaken to prevent recurrence.

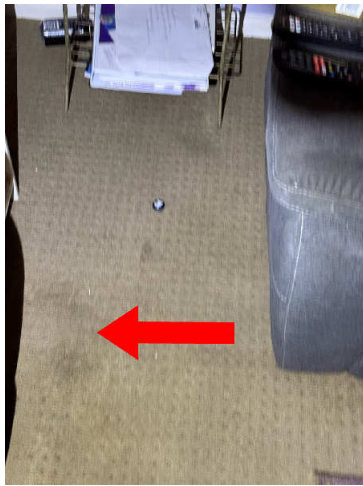
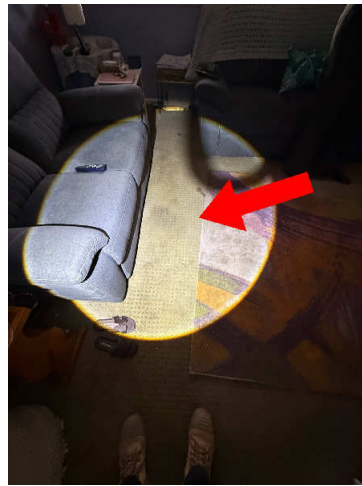
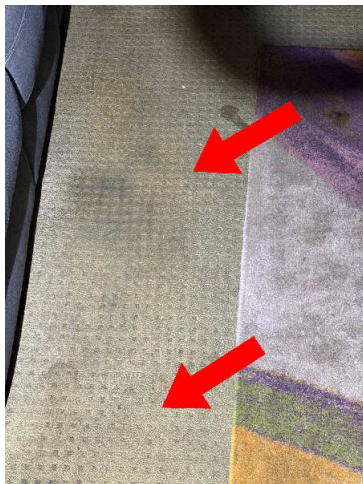
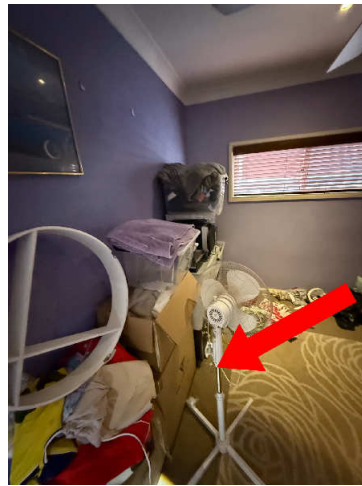
Information: Given the age of the dwelling, the existing carpets are significantly worn, dated, and not suitable for continued use. The carpets show signs consistent with long-term wear and ageing and are considered beyond their practical service life. While not a structural defect, the condition of the carpets may affect comfort, hygiene, and presentation of the home.

Prospective purchasers should allow for removal and replacement of all carpets as part of post-purchase refurbishment, particularly if intending to occupy the property immediately.
