# Building and Timber Pest Inspection Report

Inspection Date: Wed, 4 Feb 2026

Property Address: 8 Devlin Rd, North Epping NSW 2121,  
Australia

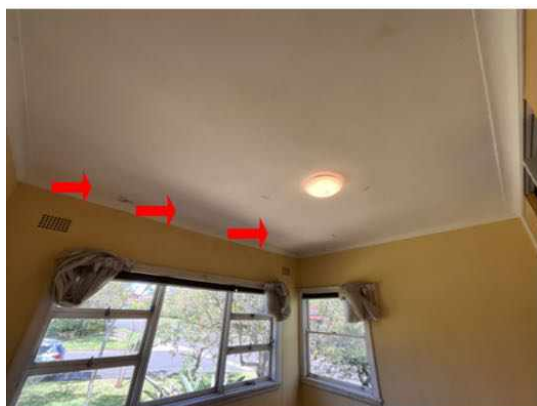
Building:	Main Building
Location:	Multiple areas
Finding:	Mould - Present
Information:	Where evidence of mould growth was noted, there may be environmental, biological or health issues associated with the report. A specialist inspection by a suitably qualified environmental health inspector is warranted, where mould is extensive or where any queries regarding air quality spores or other related issues apply.

Generally, the client is advised to ensure that the general environment is free of moisture and humidity to aid in the prevention of mould formation and development. Any mould found during the inspection should be cleaned immediately by a cleaning contractor or the homeowner as applicable.

Please note that severely affected building elements may require replacement by a registered builder or qualified carpenter.

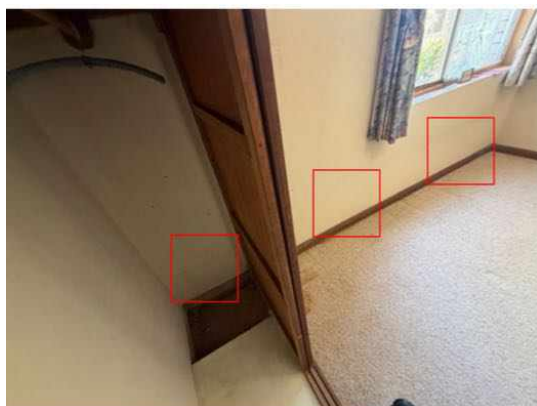
### Finding 2.01

Building:	Main Building
Location:	Extension downstairs
Finding:	Exterior walls - Lateral damp
Information:	Lateral penetrating damp refers to the sideways movement of moisture, predominantly from the surrounding ground, which tends to affect basement walls and other earth-retaining walls. The implications of unmanaged damp range from mould fungi growth, wood rot and decaying building materials, to finishes including lifting, bubbling, peeling and staining of paint, plaster and wallpaper.

It is important to address damp conditions as the World Health Organisation notes that excess moisture leads - on almost all indoor materials - to the growth of microbes such as moulds, fungi and bacteria, which subsequently emit spores and other matter into the indoor air. Exposure to these contaminants is associated with a wide range of respiratory and other health-related problems. Additionally, the development of damp in timber building elements also provides an environment that is conducive to termite / timber pest attack.

Immediate consultation with a licensed builder and plumber is advised to address the cause of the damp and to perform remedial works as necessary.

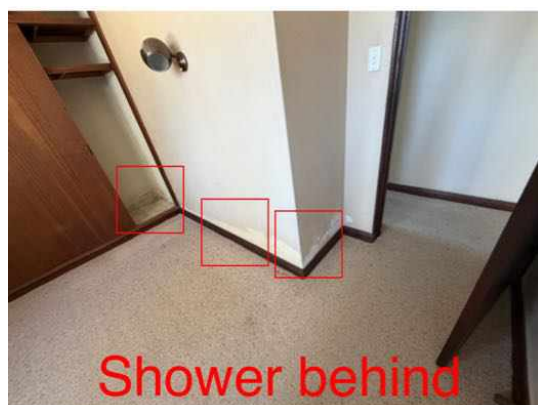
### Finding 2.02

Building:	Main Building
Location:	Extension bathroom
Finding:	Water leak - Internal
Information:	A water leak was found in this area at the time of inspection. Internal water leaks can be detrimental to surrounding building elements; their potential causes include damage to plumbing fittings and fixtures, through to water damage and deterioration of associated building elements.

Rust, corrosion, decay and water damage are potential outcomes where a minor water leak is left unattended. More serious defects may also result, such as electrical hazards, or water damage to structural building elements.

In extreme cases, structural damage may develop due to a prolonged water leak. It is highly advised that internal water leaks be addressed by a licensed plumber as a matter of relative urgency.

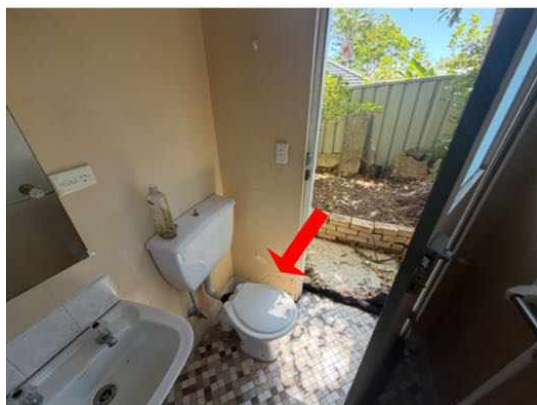
### Finding 2.03

Building:	Main Building
Location:	Extension bathroom
Finding:	Evidence of excessive moisture was present at the time of inspection
Information:	Excessive moisture can attract termites and produce conditions that promote termite attack, fungal growth and wood decay. Excessive moisture is generally caused by deteriorated, inadequate or missing roof drainage, leaking plumbing pipes or fixtures, poorly plumbed HWS overflows or condenser units and poor site drainage. It is highly recommended that all plumbing and drainage fixtures and fittings be maintained regularly in order to prevent excessive moisture being present in the external / internal property.

A licensed plumber must be appointed urgently for assessment and repairs.

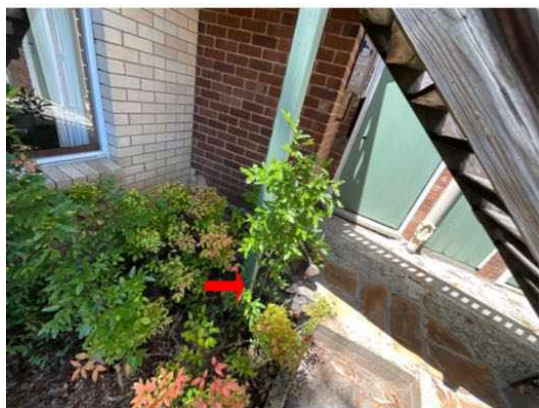
### Finding 2.04

Building:	Main Building
Location:	Rear staircase
Finding:	Wood rot/decay
Information:	This building element shows evidence of severe wood rot. Wood rot, also known as Fungal Decay, occurs when timbers and other cellulose building materials are exposed to damp conditions on an ongoing basis. If left unmanaged, damp conditions can lead

to further health problems and the decay of timbers will continue, causing the complete failure of the staircase.

Replacement of affected timbers is a necessary step in protecting surrounding building elements from such deterioration.

A licensed carpenter is required to replace affected building materials.

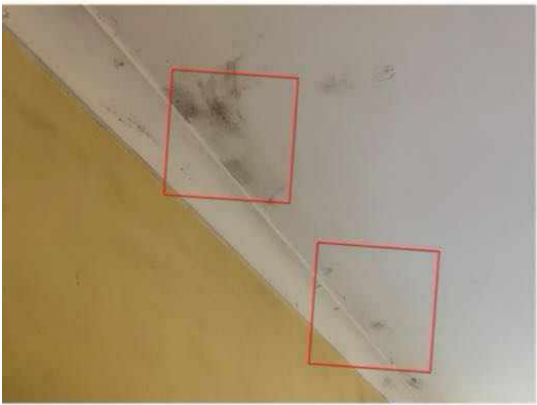
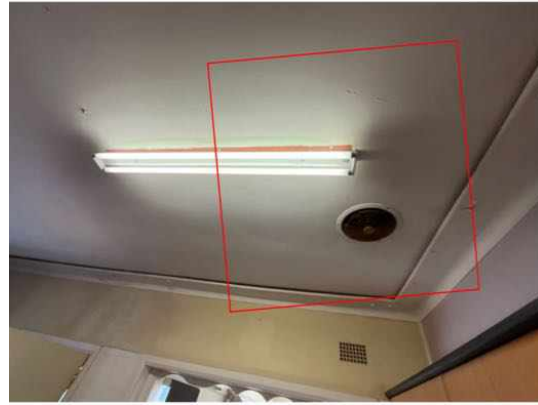
## Finding 2.05

Building:	Main Building
Location:	Multiple areas
Finding:	Ceiling - Water damaged
Information:	Water damage to the ceiling lining is generally an indication of excessive moisture being present in the roof void, usually via a leak to the roof covering.

Where water damage is evident to the ceiling, the primary requirement is to identify and rectify the source of the leak. A roofing plumber should be appointed as soon as possible to identify the leak and perform rectification works as necessary, ensuring the water damage is restricted.

Once the leak is repaired, consultation with relevant tradespeople, including plasterers and painters, is advised. Rectification works may include replacement of ceiling lining or minor repainting, depending on the extent of the damage.

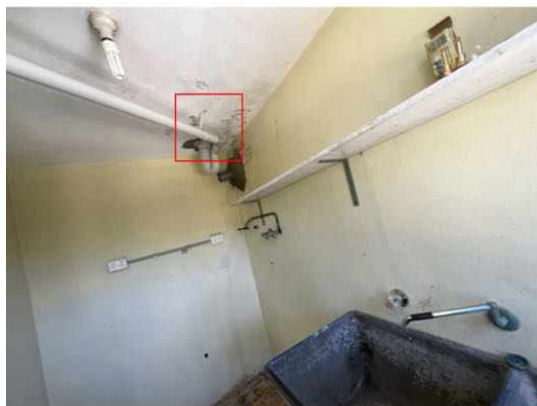
Building: Main Building  
Location: Laundry  
Finding: Water Damage  
Information: Water damage is generally an indication of excessive moisture being present, usually via a leak.

Where water damage is evident, the primary requirement is to identify and rectify the source of the leak. A roofing plumber should be appointed as soon as possible to identify the leak and perform rectification works as necessary, ensuring the water damage is restricted.

Once the leak is repaired, consultation with relevant tradespeople, including carpenters, plasterers and painters, is advised.

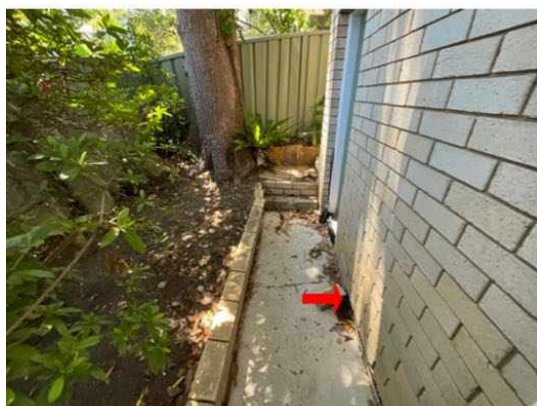
### Finding 3.03

Building:	Main Building
Location:	Rear Elevation
Finding:	Unconventional handyman work
Information:	This handyman work appears to have been completed to a substandard level and does not comply with regular building practices. Where handyman work is not completed satisfactorily, accelerated deterioration of the associated building elements is likely to occur and secondary defects to surrounding structures may develop.

It is highly recommended that the substandard work be rectified by professional services. Works to improve this area are likely to increase the safety and the operation of the associated building elements.

The client should exercise care when coming into the immediate vicinity of the substandard works. Rectification works are advised as soon as possible by the appropriate trades.

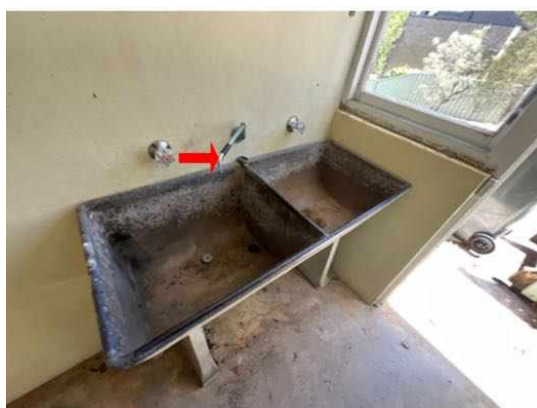
### Finding 3.04

Building: Main Building  
 Location: Laundry  
 Finding: Washers - Degraded  
 Information: The washers on the taps in this area appear to have degraded as a result of general ageing. Degraded washers generally result in slow, persistent leakage from taps and plumbing hardware.

Replacement of washers will ensure that water wastage does not occur and that the persistent water leak does not result in secondary damage to surrounding structures. Such damage may range from rust and corrosion to damage of surfaces, e.g. bench tops, etc.

A qualified plumber should be appointed to replace degraded washers and to further inspect associated plumbing fixtures and fittings. Where water damage has occurred, a carpenter or cabinet maker may be appointed to replace affected building elements.

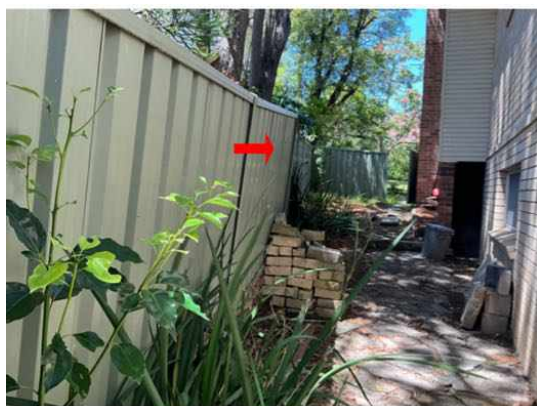
### Finding 3.05

Building: Main Building  
 Location: Fencing  
 Finding: Fencing - Deteriorated  
 Information: It was noted at the time of inspection that sections of the fencing in this area has deteriorated. Typically fencing deteriorates due to age and or wear, rot and or rust which is generally expected for a structure of this age, due to prolonged exposure to weather conditions. Sometimes inadequate installation or maintenance can be to blame.

If left unattended, it is likely that further damage will occur. It is suspected that repair of several elements of the fencing may be required however replacement may be a consideration of the client also.

A licensed fencing contractor should be appointed to provide further advice and perform rectification works as necessary.

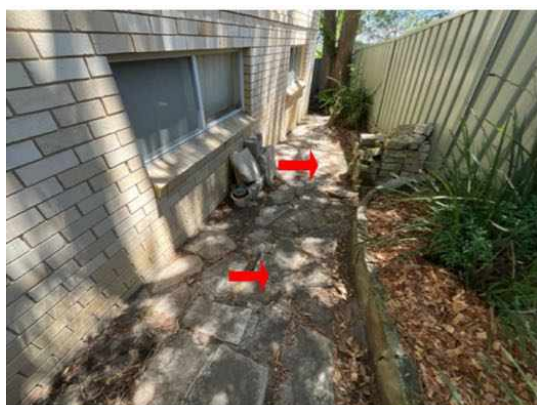
### Finding 3.06

Building: Main Building  
 Location: Multiple areas  
 Finding: Paving — Uneven  
 Information:

Sections of the external paved area are uneven, which may develop into a trip hazard. It appears as though the area has been subject to rough installation, or that paving sections have lifted due to movements in the foundation.

Left unmanaged, the May develop into a safety hazard due to trip and fall.

Re-paving of the area is required to remedy this situation. Further consultation with a specialist concreter is advised.

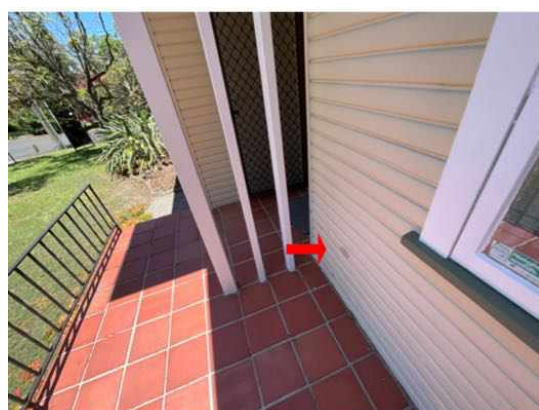
### Finding 3.07

Building: Main Building  
 Location: Porch  
 Finding: Paint cracking and peeling  
 Information:

Cracking and ultimately flaking of paint can occur for a variety of reasons. Often these failures are due to the fact that the paint has inadequate adhesion and flexibility, both common problems with lower quality exterior flat paints.

A qualified painter should be appointed to rectify the problem.

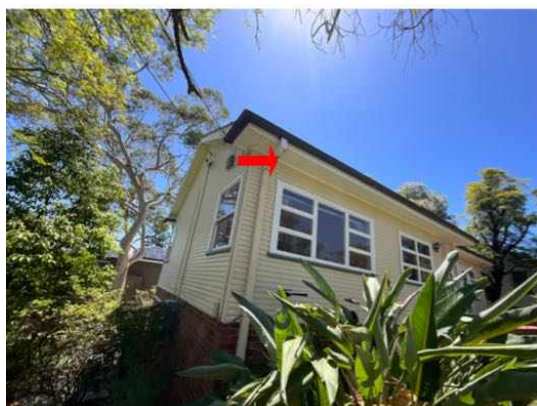
### Finding 3.08

Building:	Main Building
Location:	Yard
Finding:	Untreated or non-durable timbers in a hazardous environment
Information:	To reduce the risk of timber pest attack it is essential that timber used in a hazardous environment (e.g. in direct contact with the ground or frequently exposed to damp conditions) is of sufficient durability and/or is adequately preservative treated.

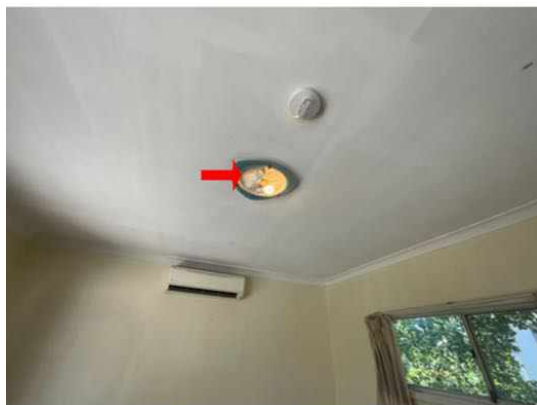
**Finding 3.16**

Building:	Main Building
Location:	Lounge Room
Finding:	Light cover - Missing (Cosmetic)
Information:	The light cover in this area was found to be missing at the time of inspection. Breakage occurs generally when the building materials have aged and decayed, but may also be indicative of impact damage to the building element (accidental or deliberate). This is mainly a cosmetic defect which can be replaced by the home owner.

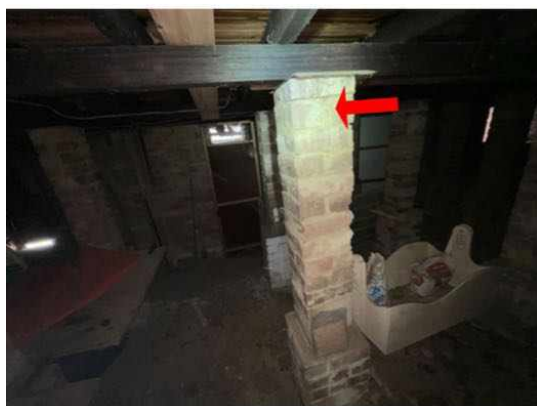
### Finding 3.17

Building:	Main Building
Location:	Subfloor
Finding:	Piers - Leaning
Information:	Pier to the subfloor structure is leaning, indicating that its structural integrity may have been affected. The cause of this instability is likely to be caused by movement / minor subsidence of the pier due to moisture.

If further movement is evident appointment of a structural engineer is advised to assess the condition of the piers and provide advice on remedial works that may be required.

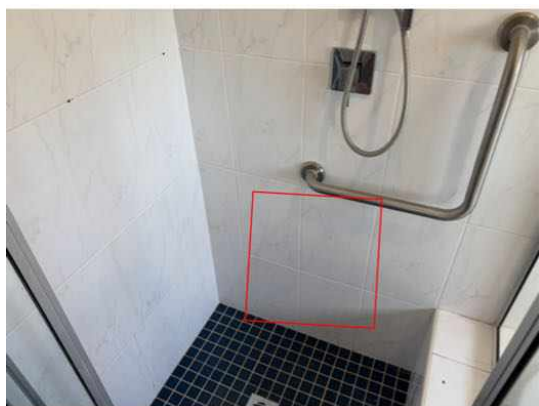
### Finding 3.18

Building:	Main Building
Location:	Bathroom
Finding:	Shower damp - Sealant and grout
Information:	Damp is evident to the lower 400mm of wall to the shower alcove. This defect is quite common, and is suspected to have been caused by moisture permeating or leaching through the grouting and sealant in this area, which shows evidence of deterioration. Leaking pipes within the wall is also a possible cause however this seems unlikely in this instance as there is no moisture build up around the taps or transferring to the other side of the wall. There appears to be no sealant around the tap spindles which may be a small contributing factor.

Always ensure that sealant and grout is in good condition to prevent any moisture issues occurring in the future.

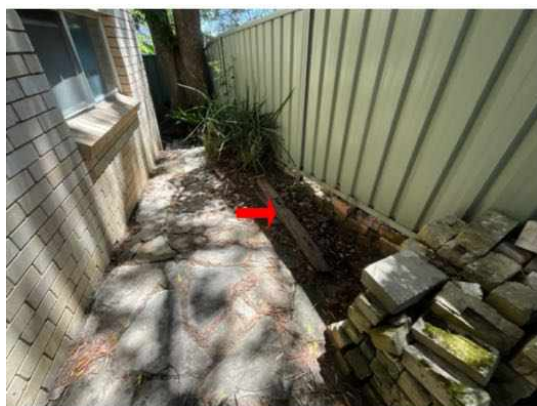
## Finding 6.05

Building:	Main Building
Location:	Yard, subfloor
Finding:	Stored timbers - subfloor space or external area
Information:	The storing of timbers in the subfloor space or around the external property increases the risk of termite activity being present. As they are likely to come into contact with weather conditions or excessive moisture wood rot is likely to develop on timbers that are not treated.

It is highly recommended that any stored timbers be immediately removed from areas in which they may attract any termite / timber pest attack. Minimisation of risk / prevention of termite attack is far more adequate than dealing with the presence of termite activity.

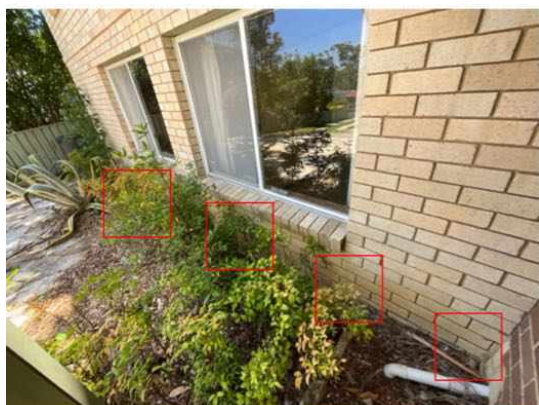
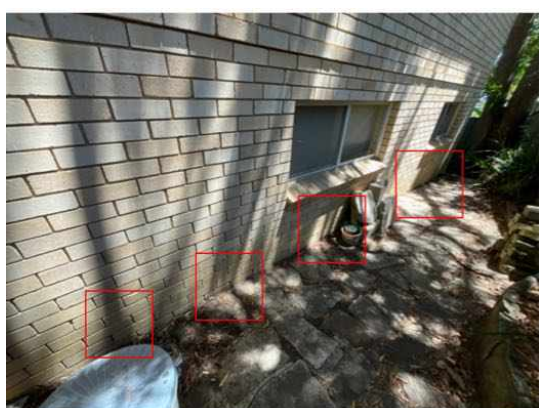
### Finding 6.06

Building:	Main Building
Location:	Extension
Finding:	Bridging or breaching of termite barriers - weep holes
Information:	Bridging is the spanning of a termite barrier or inspection zone so that subterranean termites are provided with passage over or around that barrier.

external property. Therefore if any termite activity leading into weep holes becomes easily detectable during frequent pest inspections.

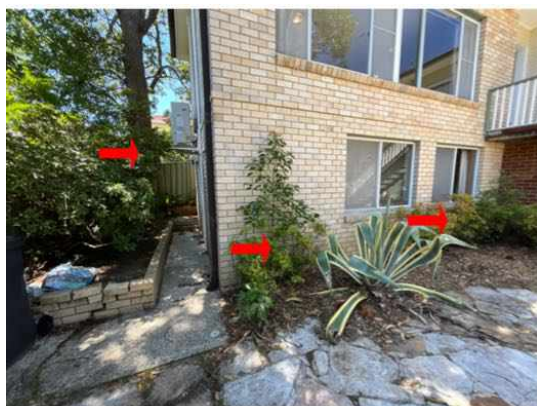
### Finding 6.10

Building:	Main Building
Location:	Vegetation
Finding:	Vegetation - Abutting property
Information:	Vegetation against external wall may have an invasive root system. If there are weak points in the brick work or concrete slab, it is possible for the roots to gain entry into these areas. Once the roots have gained entry, it is possible for termites to gain concealed entry via these roots. It is recommended to remove the vegetation and root system where possible.

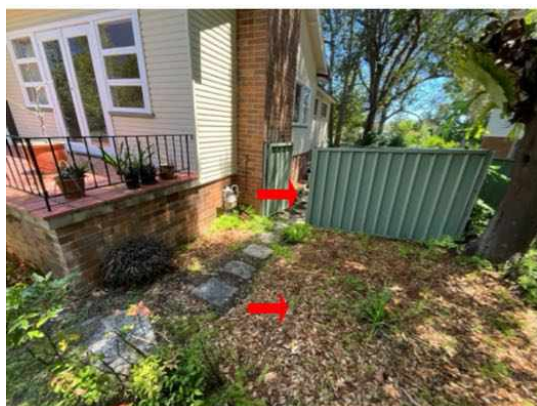
### Finding 6.11

Building:	Main Building
Location:	Garden beds
Finding:	Garden Beds
Information:	Garden beds were found to be evident in the garden area. These garden beds can include untreated timber, and with a combination of moisture from watering/hosing can make conditions conducive to termite activity and termite ingress.

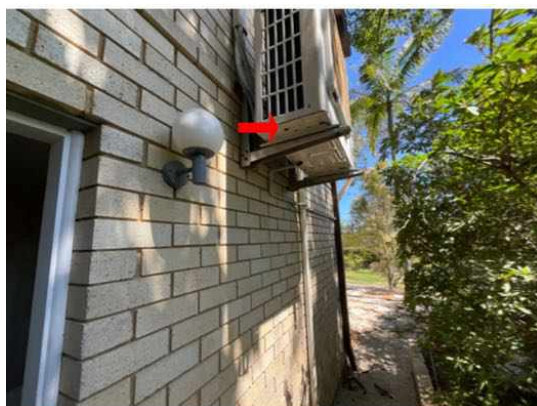
### Finding 6.12

Building:	Main Building
Location:	Rear Elevation
Finding:	Overflow - Not plumbed for drainage
Information:	The overflow is not plumbed or connected to suitable drainage, which has resulted in the surrounding area becoming excessively damp. These damp conditions can lead to secondary defects such as rot, rust or corrosion of associated building elements, the formation of fungal decay, or even the creation of potential slip hazards. When coupled with poor site drainage, pooling of water may also attract termite activity to this area. It is highly recommended that a qualified plumber be appointed to install adequate drainage to the overflow. These works will ensure that the area remains dry and free of any secondary defects.

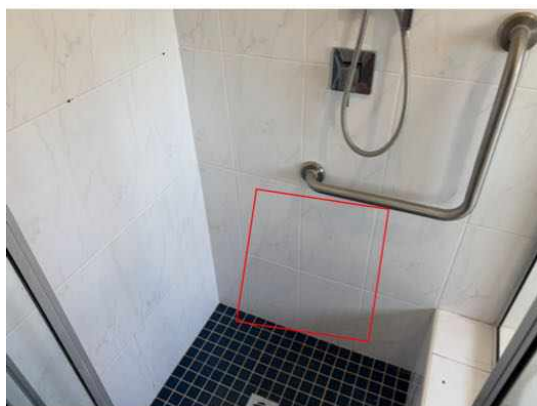
### Finding 6.13

Building:	Main Building
Location:	Bathroom
Finding:	Shower damp - Sealant and grout
Information:	Damp is evident to the lower 400mm of wall to the shower alcove. This defect is quite common, and is suspected to have been caused by moisture permeating or leaching through the grouting and sealant in this area, which shows evidence of deterioration. Leaking pipes within the wall is also a possible cause however this seems unlikely in this instance as there is no moisture build up around the taps or transferring to the other side of the wall. There appears to be no sealant around the tap spindles which may be a small contributing factor.

Always ensure that sealant and grout is in good condition to prevent any moisture issues occurring in the future.

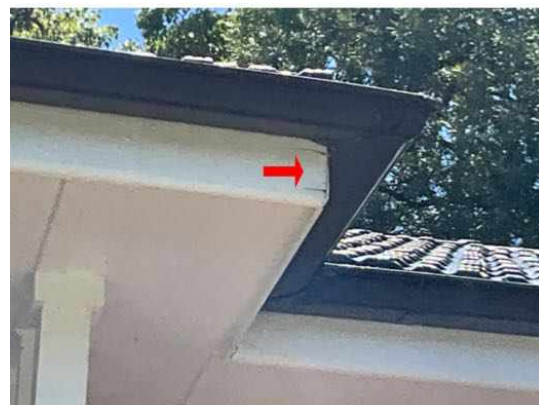
### Finding 7.02

Building:	Main Building
Location:	Fascias

A licensed plumber may be appointed to assess the cause of excessive moisture and to provide advice on any remedial works as required. A licensed carpenter may also be required to replace affected building materials.

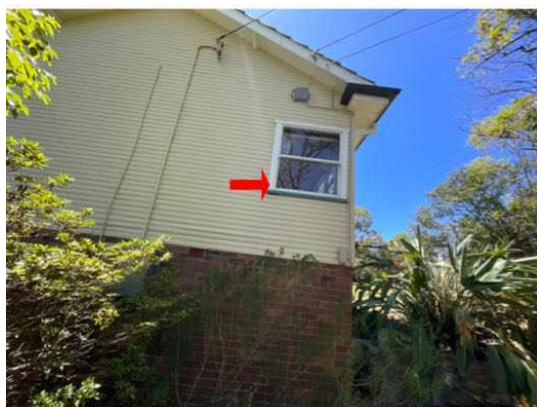
### Finding 7.03

Building:	Main Building
Location:	Rear Elevation
Finding:	Windows - Wood rot
Information:	Wood rot was found to be affecting external windows. Wood rot, also known as Fungal Decay, occurs when timbers and other cellulose building materials are exposed to damp conditions on an ongoing basis.

Repair and/or replacement of affected window frames may be a necessary step in protecting surrounding building elements from such deterioration. Remedial works should be performed by a qualified carpenter or registered builder as soon as possible to prevent any further damage.

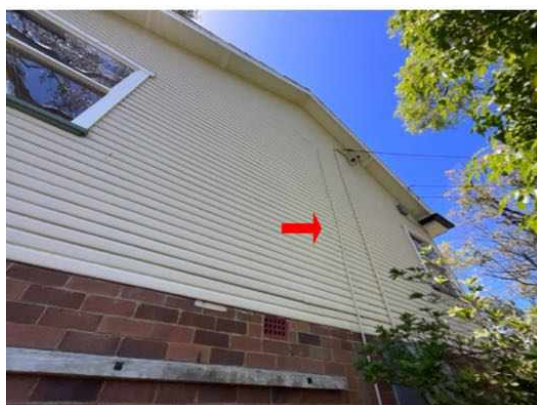
### Finding 7.04

Building:	Main Building
Location:	Exterior walls - right side
Finding:	Weatherboards - Rotting
Information:	The external weatherboards show signs of fungal decay (wood rot) in several sections. This wood rot is suspected to have developed over a prolonged period of time due to frequent weather exposure, which is expected in a property of this age and condition

To maintain the condition of the external wall cladding, any severely affected weatherboards should be substituted as soon as possible with pre-treated replacements. Where weatherboards have rotted due to excessive moisture other than rain penetration, the cause of the moisture should be identified immediately by a licensed plumber. A qualified carpenter should be appointed to repair and replace rotting weatherboards.

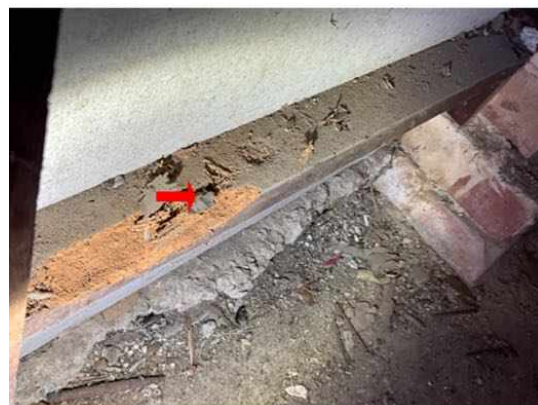
## Finding 8.02

Building: Main Building

As no live wood borer activity was identified treatment is not required at this time. Replacement of affected timbers may be considered by the client.
