Building and Timber Pest Inspection Report VR

Inspection Date: Fri, 13 Feb 2026

Property Address: 4 Cornelius Place, Regentville NSW 2745

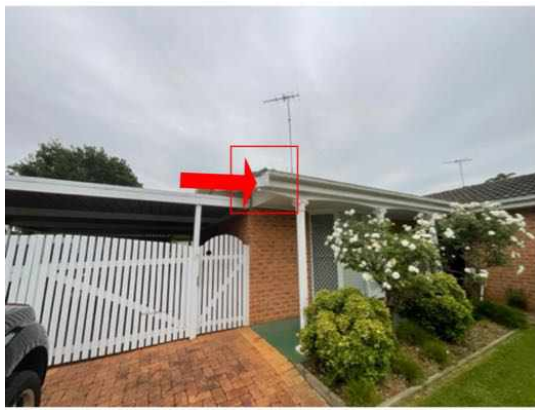
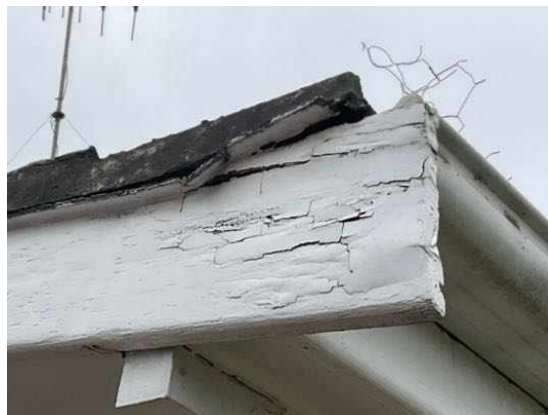
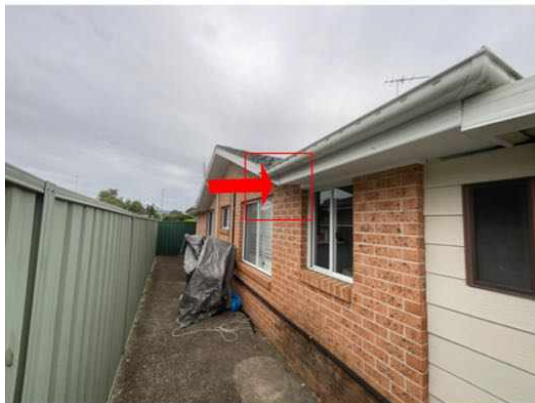
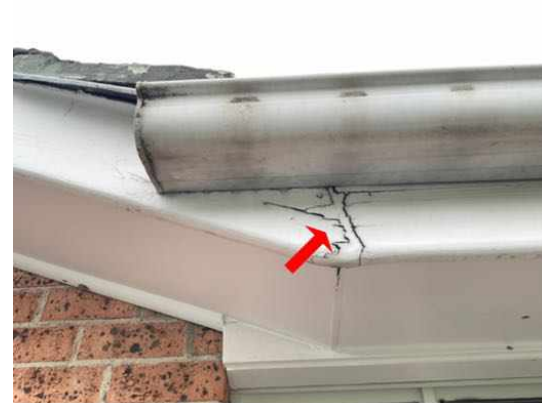
Building:	Main Building
Location:	Roof Exterior - Front & Right
Finding:	Fascia or Barge ends - Wood rot.
Information:	Wood Rot to Fascias and Barges – Fungal Decay Noted

Wood rot (Fungal Decay) was identified affecting sections of the fascias and barges in this area. These building elements are particularly vulnerable to moisture exposure due to their location and function.

- Fungal decay typically develops when timber is exposed to moisture for extended periods.
- In this case, deterioration is likely due to poor roof plumbing maintenance, inadequate sealing or painting, and frequent weather exposure.
- This condition is considered general wear and tear, particularly in older buildings, but may accelerate if not addressed.

- If left unmanaged, wood rot can spread to adjacent timber structures and compromise roof integrity.
- It may also create conducive conditions for timber pest activity, particularly termites, and increase maintenance and repair costs over time.

- Engage a roof plumber to inspect all associated roof plumbing (gutters, downpipes, flashings) to identify the source of moisture ingress.
- Replace or repair affected fascias and bargeboards as needed to protect surrounding components.
- For minor repairs, a qualified carpenter or general handyperson may be appointed at the client's discretion.
- Implement a regular maintenance schedule including painting, sealing, and clearing of roof plumbing to prevent recurrence.

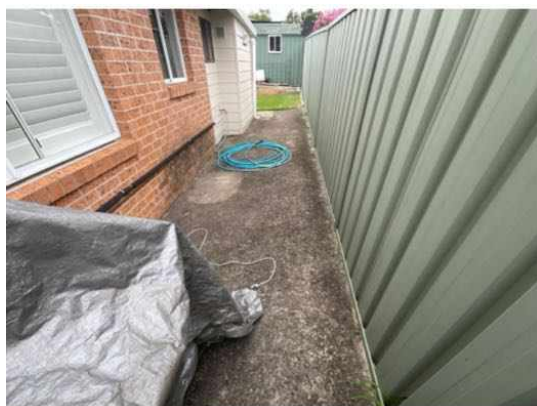
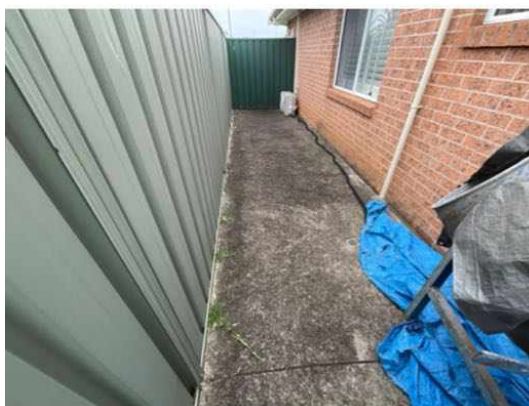
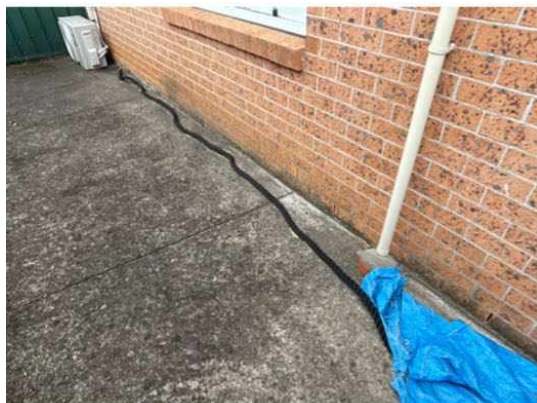
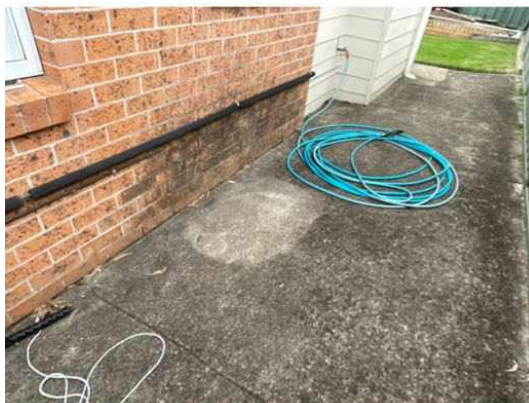
Finding 3.02

Building:	Yard
Location:	Exterior - right side
Finding:	Site Drainage & Surface Water Management.
Information:	Observation:

The site drainage in this area was found to be average at the time of inspection, creating a potential risk of water pooling during periods of rainfall. According to good building and drainage standards, surface water should flow away from the structure,

- Concrete paving slopes towards the right side of the property
- Signs of moisture staining to lower wall.

- Pooling water near the building or in pedestrian areas
- Reduced effectiveness of termite management systems if slab edges or weep holes are exposed to moisture

- Assess the current site grading and drainage system
- Complete or upgrade surface drains as needed
- Re-level the concrete paving if required to prevent water accumulation

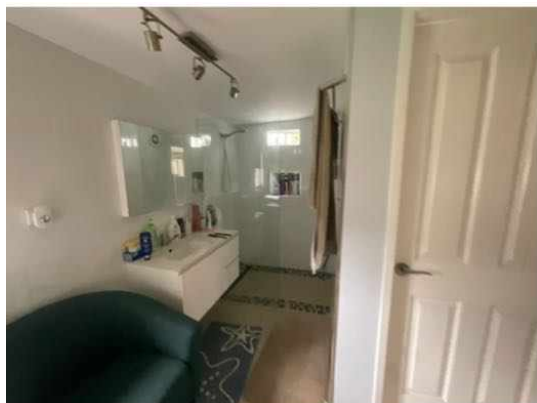
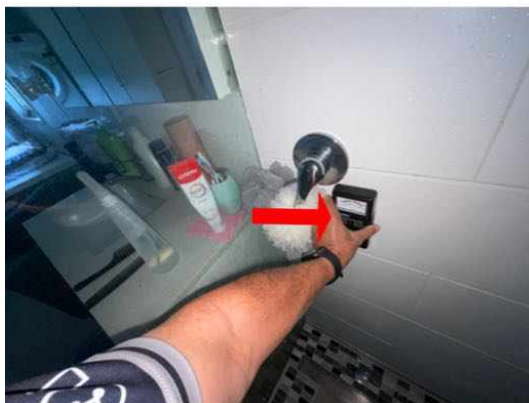
Finding 3.03

Building:	Main Building
Location:	Bathroom 2
Finding:	Moisture Defect – Damp to Shower Alcove Wall
Information:	Damp was evident to the wall of the shower alcove at the time of inspection. This condition is suspected to be caused by either leaking pipes or fittings within the adjoining wall, or missing or deteriorated sealant around the tap penetrations.

Damp—also referred to as structural damp—relates to the presence of unwanted moisture within building materials. In wet areas such as shower recesses, damp is commonly caused by internal water leaks, failed waterproofing, or degraded sealant and grout.

- Mould and fungal growth
- Decay of surrounding building materials, including tile adhesive, grout, paint, and render
- Long-term deterioration of wall framing or linings behind the wet area

A qualified plumber or bathroom renovation specialist should be engaged to identify the source of the damp and undertake necessary remedial works. This may include resealing, plumbing repairs, or further invasive investigation.

Ongoing maintenance of grout and sealant is essential to prevent future moisture issues.

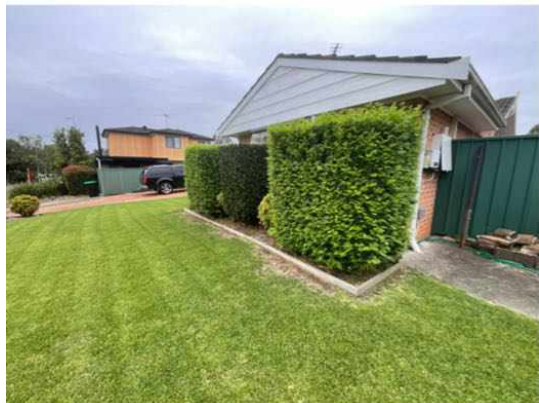
Garden beds were observed directly against the perimeter of the building. This condition can result in water pooling or retention during rainfall or from regular watering/hosing, which may lead to moisture ingress beneath the structure.

- Persistent moisture buildup around the base of the building creates an environment that is conducive to termite activity and timber decay.
- Plants and vegetation close to or in contact with external walls can provide shade and cover, further increasing the likelihood of termite infestation.
- Garden beds may also conceal weep holes, slab edges, or termite barriers, reducing visibility during inspections and allowing for undetected termite entry.

It is strongly recommended that garden beds be removed or relocated away from the building perimeter. Maintaining a clear inspection zone around the structure helps reduce moisture retention and improves visibility during regular pest inspections. This preventative measure significantly lowers the risk of termite ingress and related structural damage.

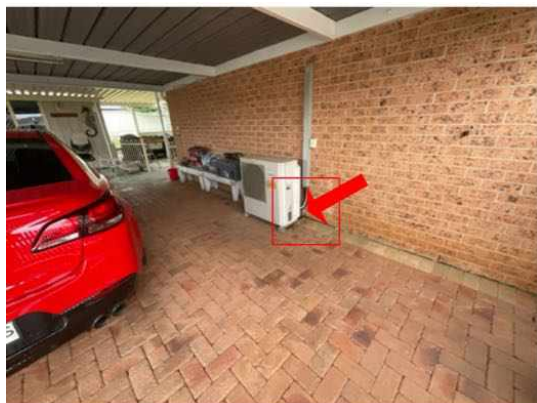
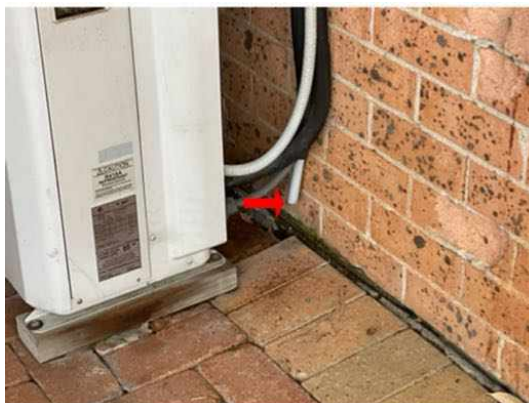
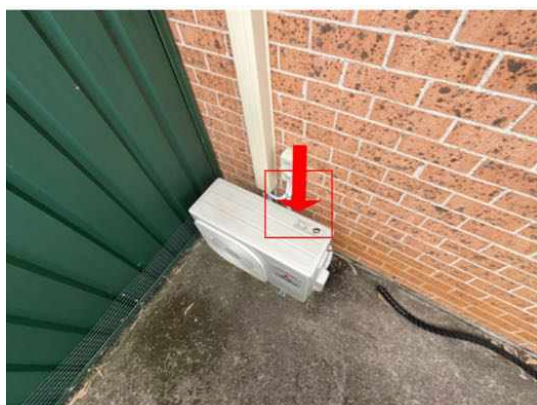
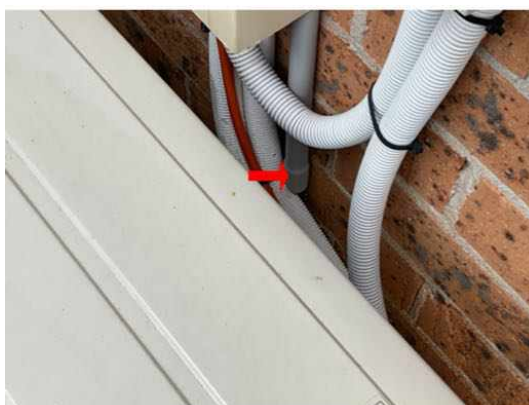
Finding 6.03

Building:	Main Building
Location:	All External Areas
Finding:	Overflow Management – Risk of Termite Activity..
Information:	Observation: Water Pooling from HWS and Air Conditioning Overflows

Water discharge from the Hot Water System (HWS) pressure relief valve and air conditioning unit overflows was observed discharging close to the base of the structure, contributing to water pooling around the building perimeter.

Persistent moisture near the foundation or subfloor area significantly increases the likelihood of termite activity. Termites are highly attracted to damp environments, and stagnant water near structural elements provides ideal conditions for foraging and infestation.

It is highly recommended that all overflows from the HWS and air conditioning units be redirected away from the building, preferably via fixed drainage or extension piping, to prevent water accumulation near the structure.

These minor corrective works should be undertaken promptly to minimise the risk of both termite ingress and potential structural damage due to ongoing moisture exposure.
