# Building and Timber Pest Inspection Report

Inspection Date: Wed, 25 Mar 2026

Property Address: 5 Kirby Dr, Killara VIC 3691, Australia

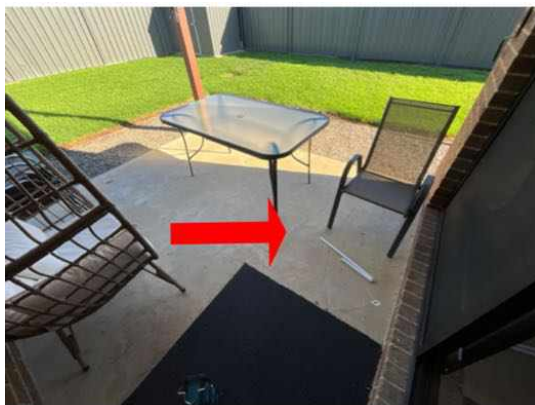
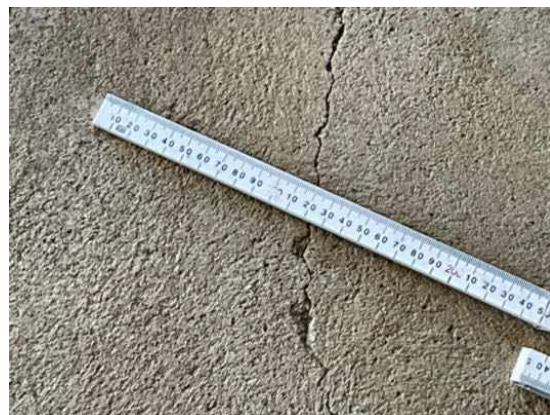
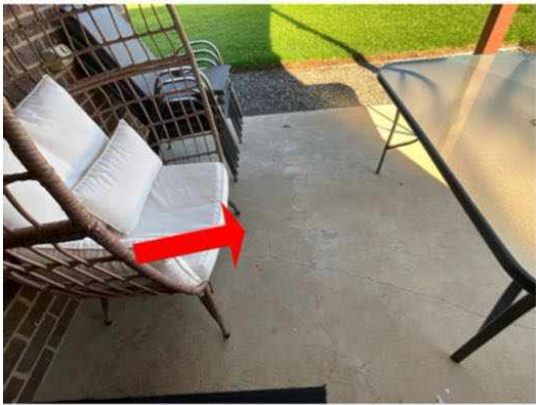
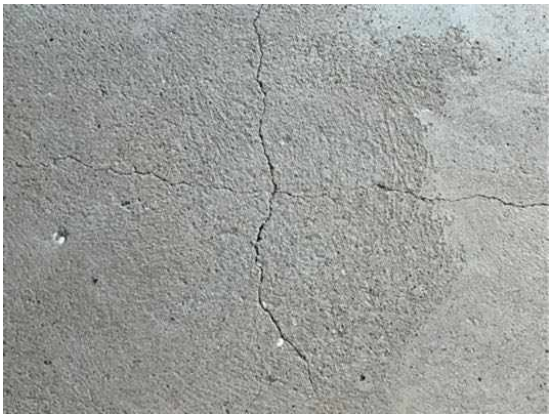
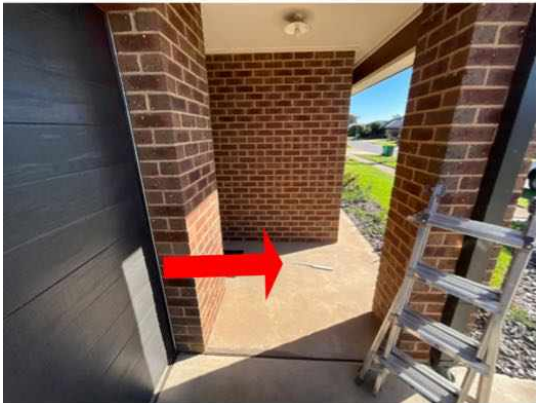
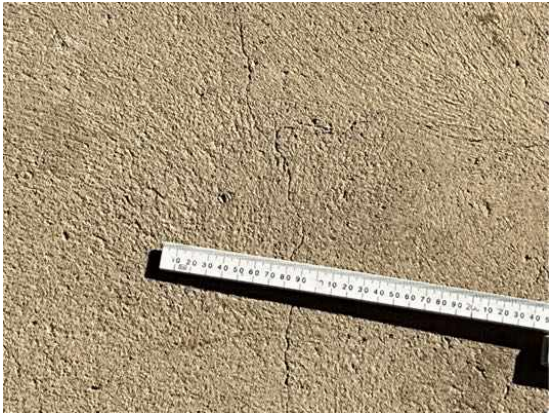
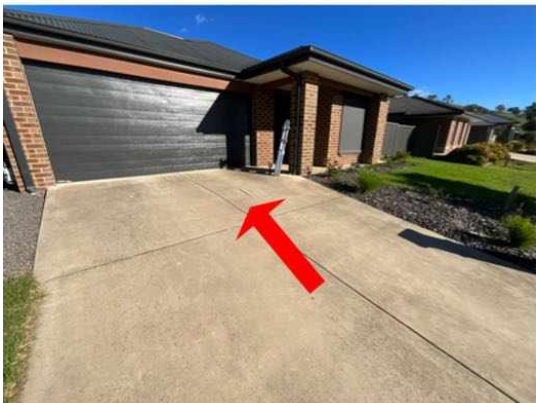
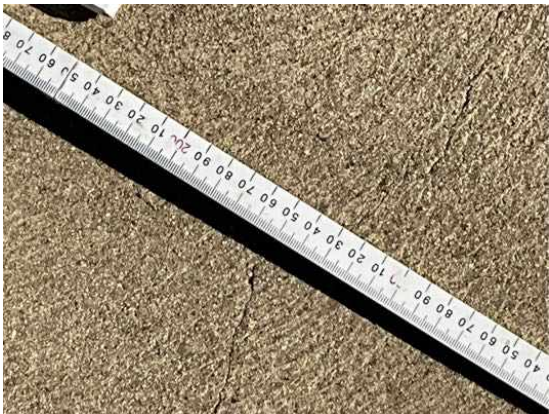
#### Finding 3.01

Building: Building 1  
 Location: Alfresco, driveway area  
 Finding: Cracking - External Concrete Paving Damage Category 1 - Fine (less than 2mm)  
 Information: Fine cracks were identified in external concrete paving. Although fine cracks are quite noticeable, they are often only considered to be an appearance defect, and usually do not indicate any structural damage. To be considered a Category 1 or fine crack, the crack is found to be less than 2mm in width.

Generally the cause of a hairline crack in existing concrete paving such as driveways and pathways is indicative of the expansion and contraction of the concrete. Such causes are generally due to environmental factors, such as moisture levels, weather conditions, root systems of nearby trees or the soil types on which they are laid.

Fine cracks may also be due to poor original installation of the concrete. Factors such as poor compaction of the sub surface and/or inadequate reinforcing of the slab may create cracking and other secondary defects.

Monitoring of all cracking should be conducted frequently. Always contact a building inspector should cracks widen, lengthen, or become more numerous.

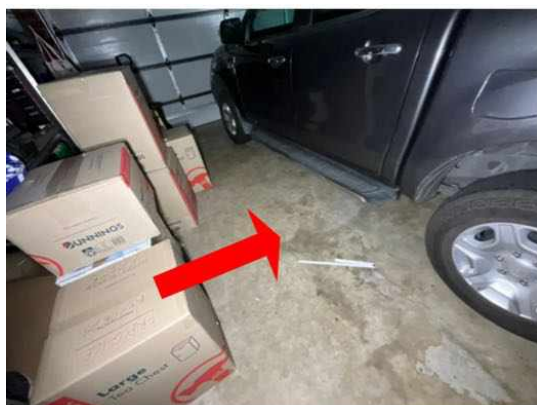
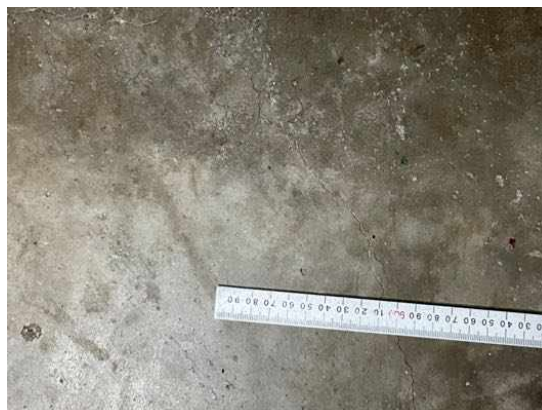
**Finding 3.02**

Building: Building 1  
 Location: Garage  
 Finding: Crack in concrete slab - Category 1  
 Information: A crack coded as Category 1 was identified in the slab. A Category 1 crack is described as a fine but noticeable crack, with the slab at an otherwise reasonable level.

To be considered Category 1, the approximate width of the crack is less than 1.0mm, or a less than 10mm change in offset when a 3m straight edge is placed over the defect.

Category 1 cracks should be monitored for a period of 12 months. At the end of the monitoring period, identified cracks that are rated greater than Category 2 are considered defects, and require rectification.

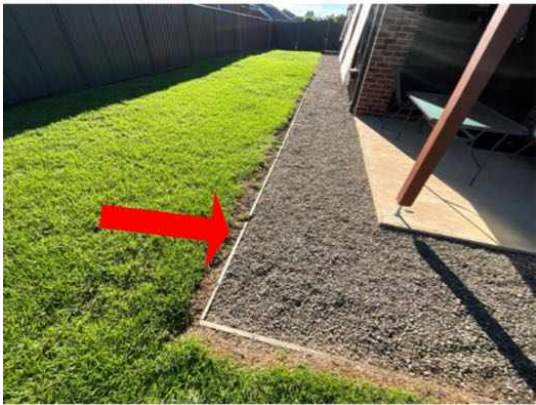
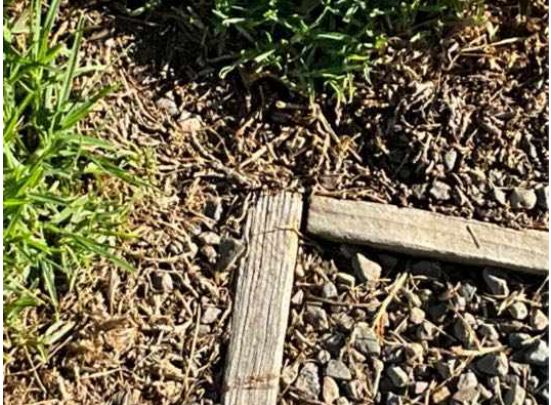
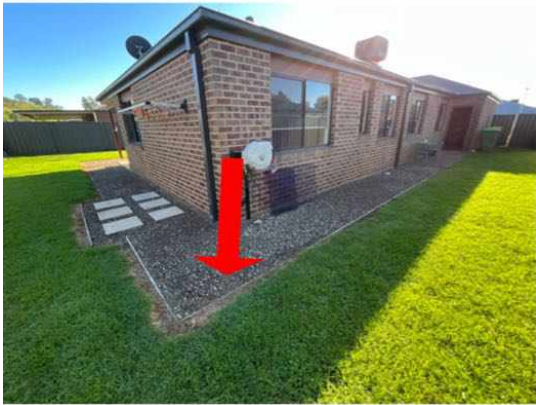
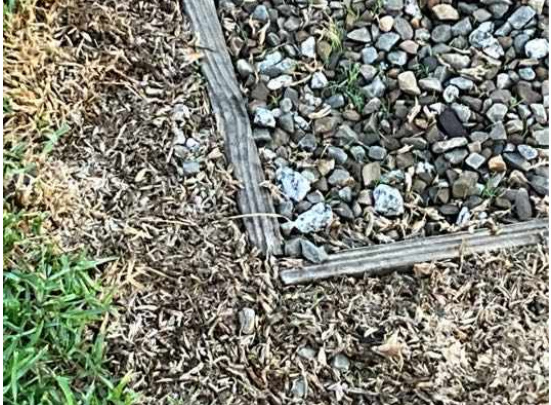
### Finding 6.01

Building:	Building 1
Location:	Yard - Back
Finding:	Untreated or non-durable timbers in a hazardous environment
Information:	To reduce the risk of timber pest attack it is essential that timber used in a hazardous environment (e.g. in direct contact with the ground or frequently exposed to damp conditions) is of sufficient durability and/or is adequately preservative treated.

Untreated timbers in direct contact with the ground are likely to develop severe wood rot and/or fungal decay if left unattended creating attraction for subterranean termites to infest the timbers from surrounding areas.

If untreated or non-durable timbers are found to be in a hazardous environment it is highly advised that replacement of these building elements be performed as soon as possible to aid the protection of the property against termite / timber pest attack.

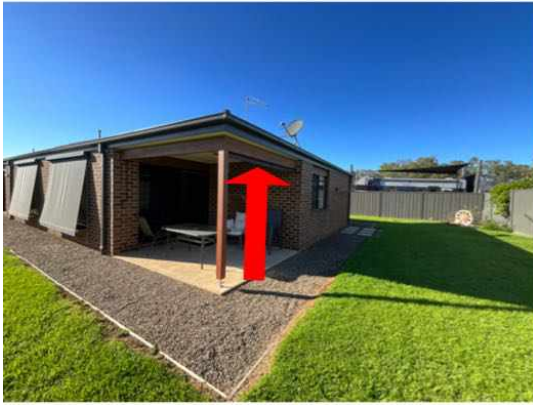
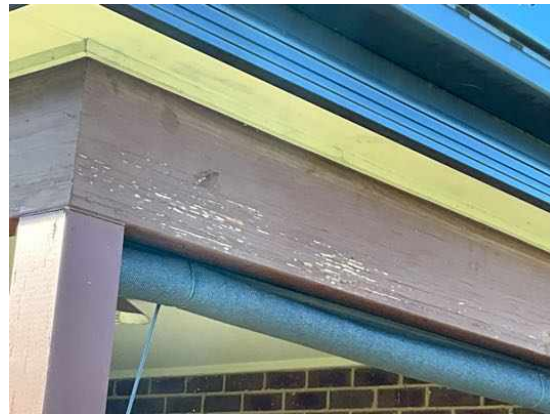
**Finding 6.02**

Building: Building 1  
Location: Alfresco  
Finding: Timber - exposed to weather  
Information: External timbers that are frequently exposed to harsh weather conditions require adequate protection in order to maintain their condition. Where timbers have not been painted or treated adequately, general deterioration is likely to occur at an accelerated rate.

If left unattended, replacement of these timbers is likely to be necessary in the short-term future. Adequate treatment of these timbers is required as soon as possible by a painting contractor or general handyman.

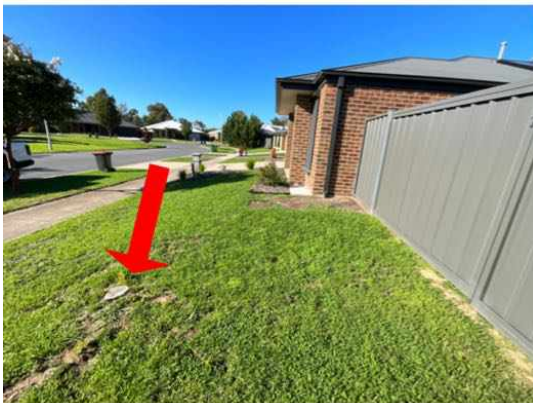
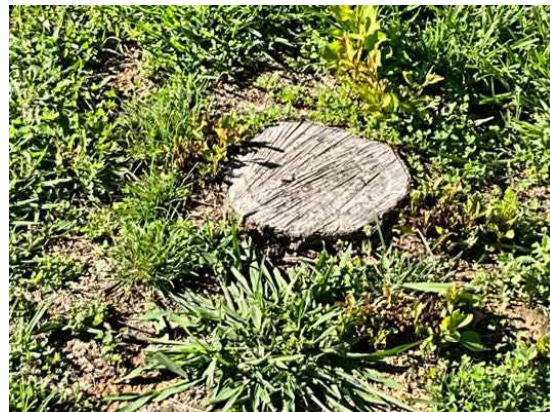
### Finding 6.03

Building:	Building 1
Location:	Yard - Front
Finding:	Tree Stump in Ground
Information:	Any tree stumps in the yard not removed during the tree removal process provides the opportunity for Termite infestation and is likely to be subject to decay from damp conditions against the stump.

All tree stumps should be removed by professional tree removal services where possible. Meanwhile regular inspections are advised to identify any termite activity in the areas identified.

Services for tree stump removal should be contacted as soon as possible to reduce the risk of timber pest attack.

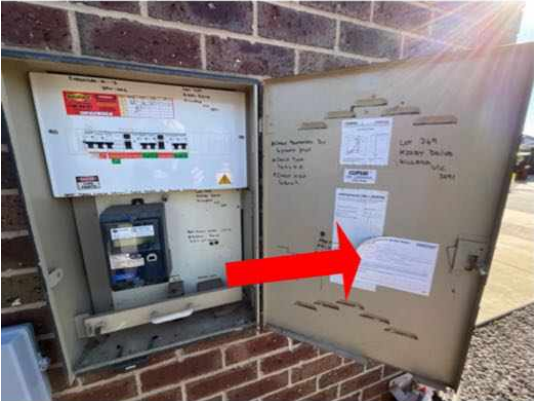
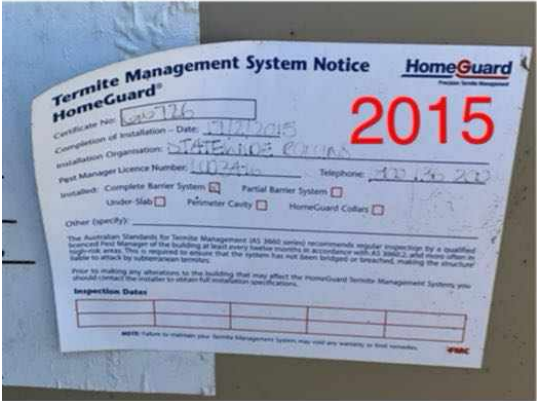
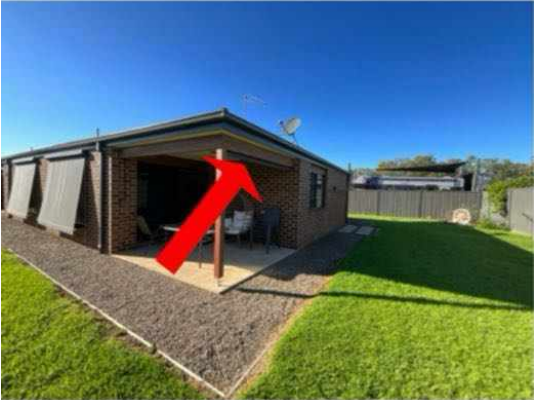
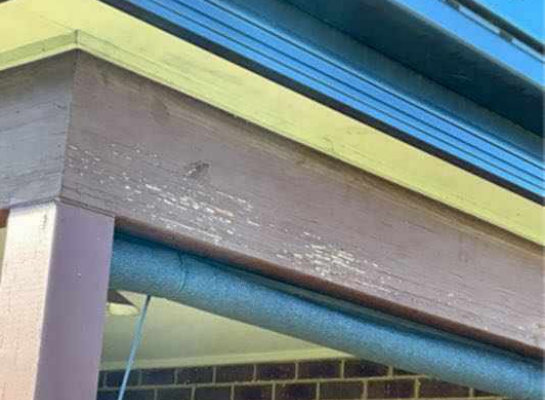
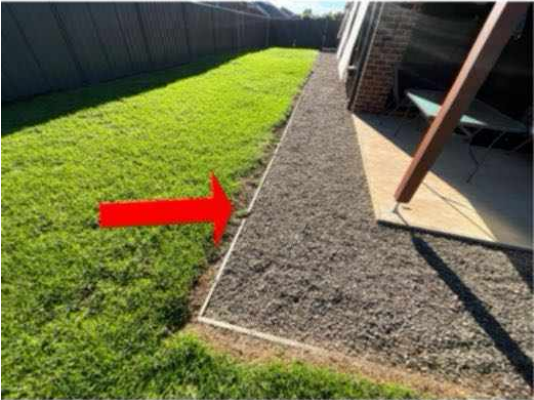
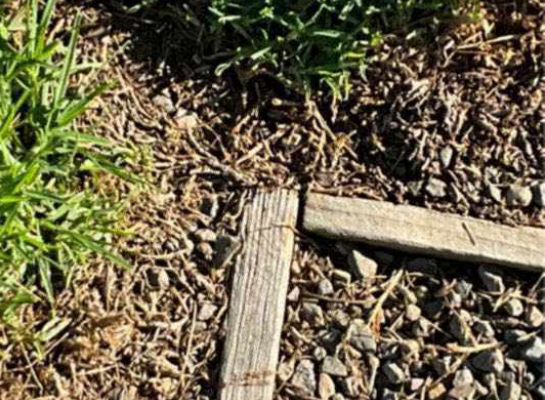
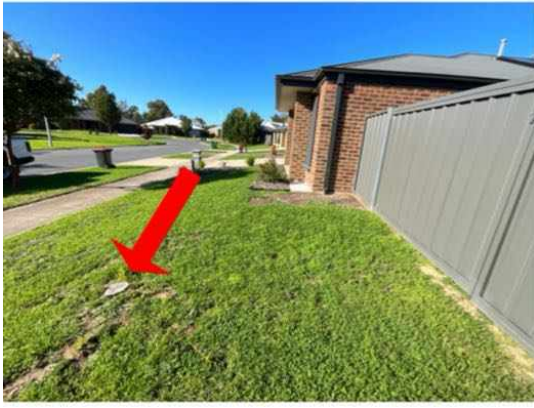
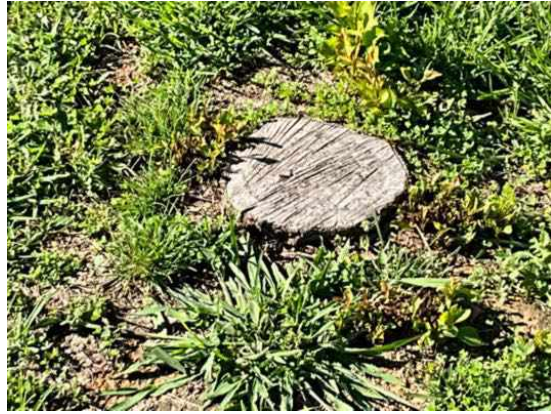
### Finding 6.04

Building:	Building 1
Location:	All External Areas
Finding:	Termite Management System- evidence of a chemical installation
Information:	The application of a post-construction chemical termite barrier is highly recommended for all properties, particularly if live termite activity has been found on the site

previously. Such barriers are highly effective in preventing termite attack on any timber building elements throughout the property.

A durable notice has been placed in the switchboard unit to indicate current termite barriers. At the time of inspection, it appeared as though a termite management system has been installed. The recency of any treatment cannot be determined.

The client may consider gaining further advice from a pest controller as to the costs and procedures involved with this application. It is recommended that obtaining such advice be a short-term priority.

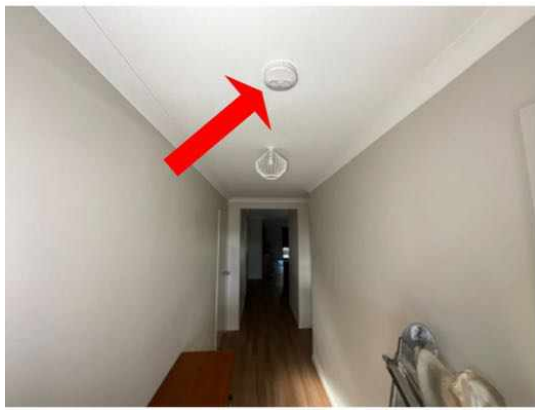
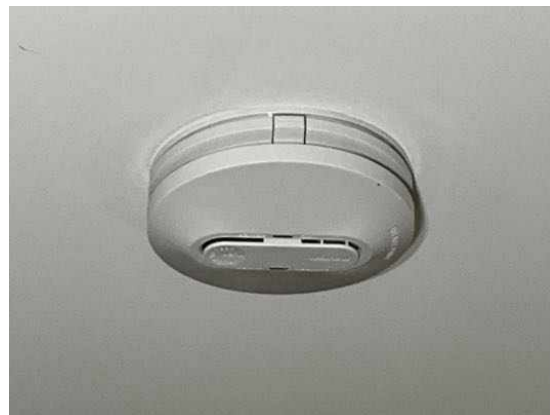
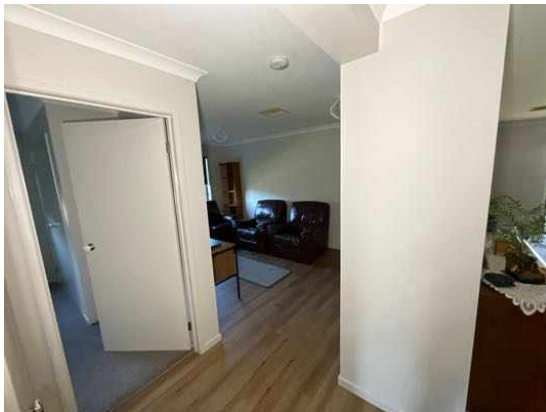
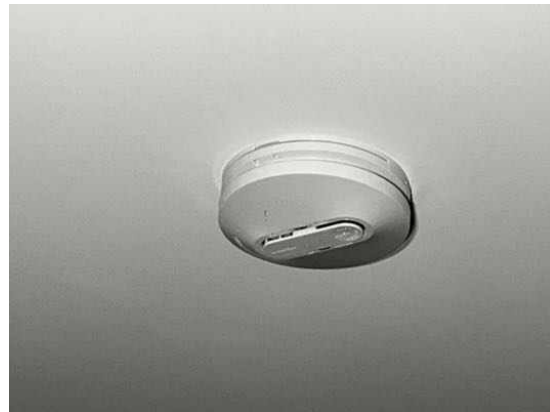
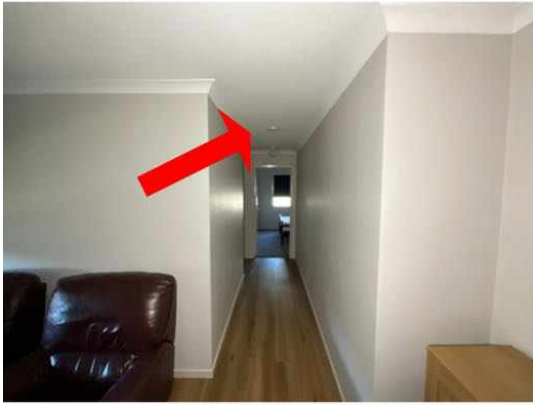
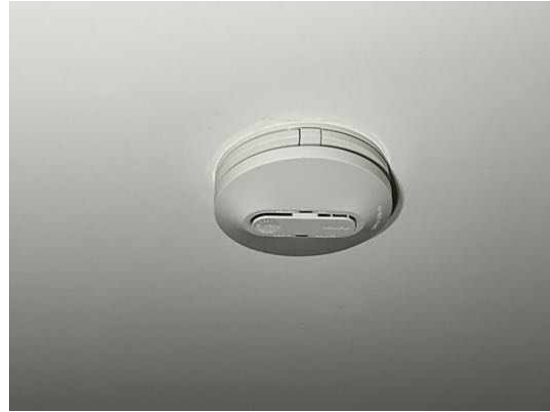
Building: Building 1  
Location: All Internal Areas  
Finding: Smoke detectors- Working  
Information: The smoke detectors were found to be functional at the time of inspection.

Monitoring should be ongoing to ensure the safety of the occupants.

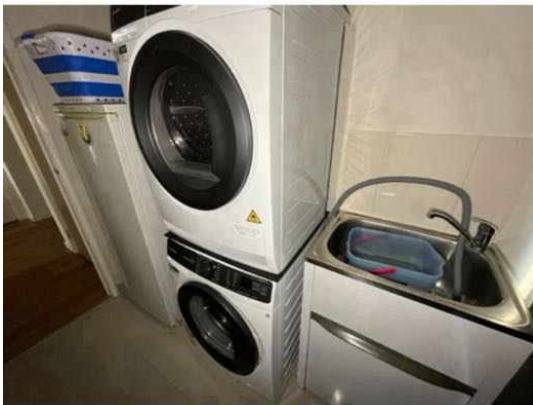
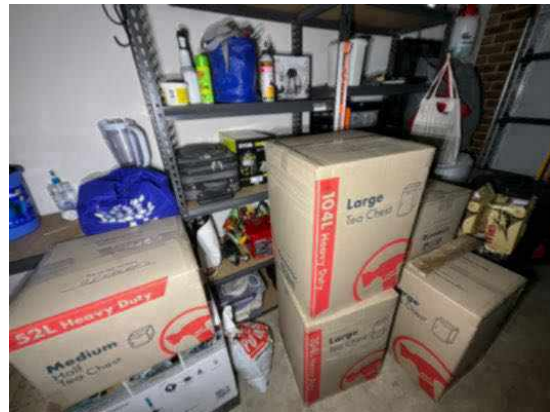
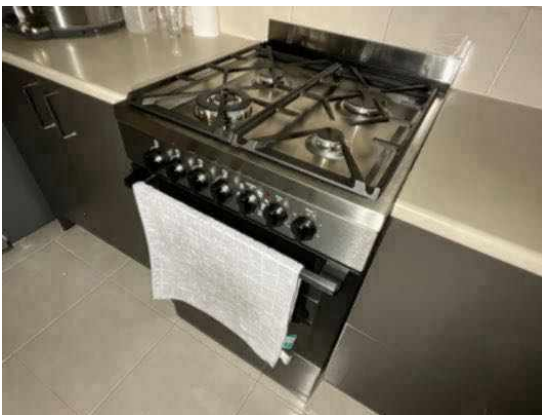
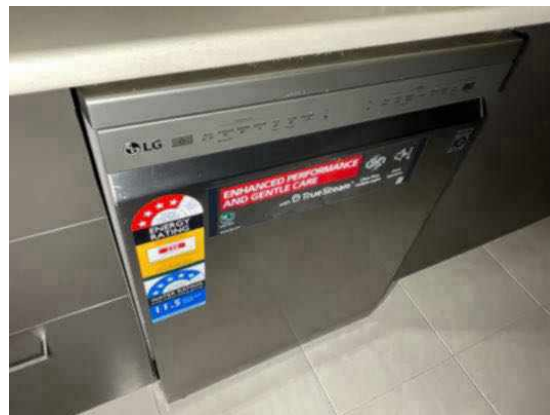
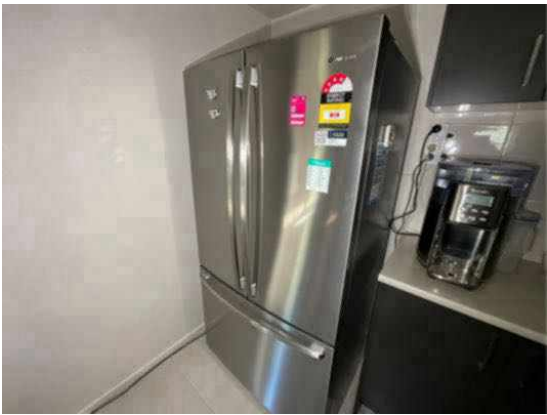
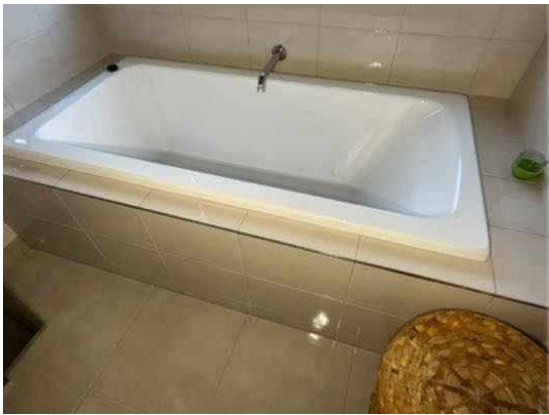
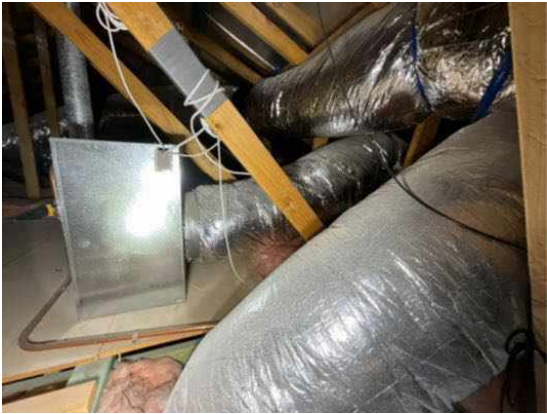
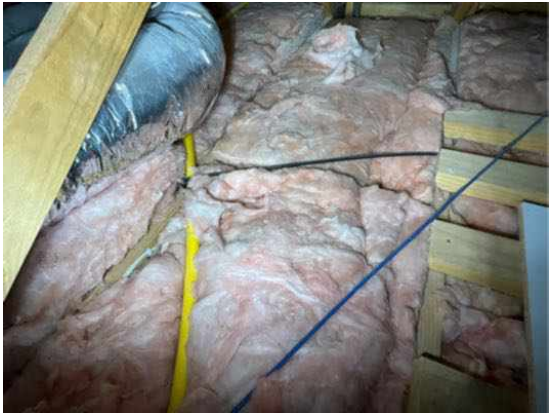
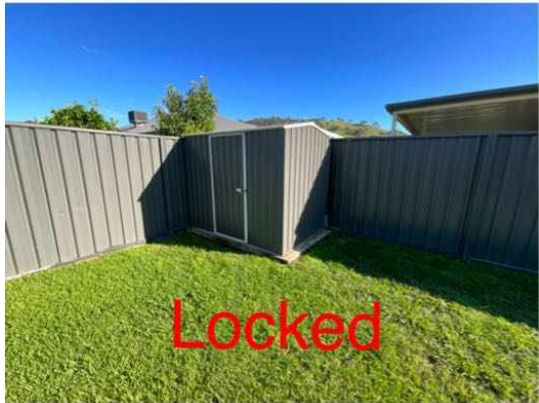
Building: Building 1  
 Location: All Areas  
 Finding: Additional Photos - Obstructions and Limitations  
 Information: These photographs are an indication of the obstructions and limitations which impeded full inspection of the property at the time of inspection. These obstructions can hide an array of defects and should be removed to allow full inspection to be carried out. A re-inspection is recommended once the areas are made accessible.
