# Building and Timber Pest Inspection Report

Inspection Date: Fri, 13 Mar 2026

Property Address: 26 Buffalo Cres, Thurgoona NSW 2640,  
Australia

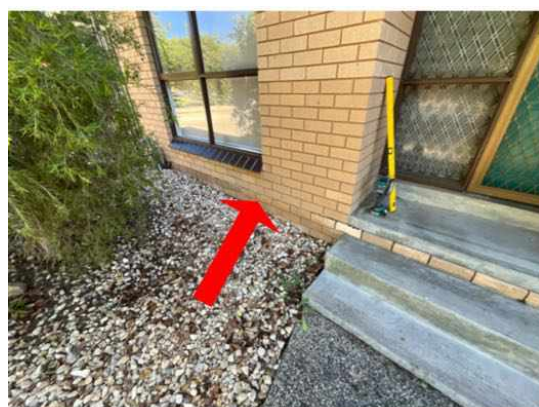
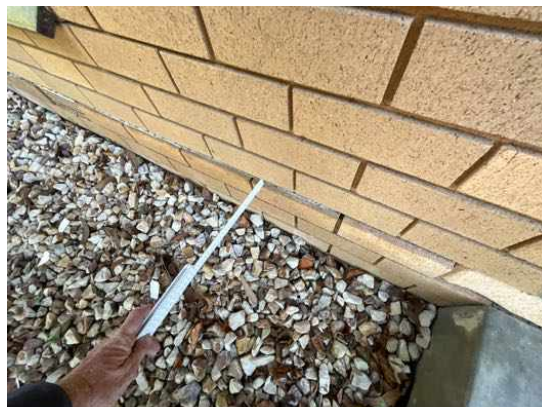
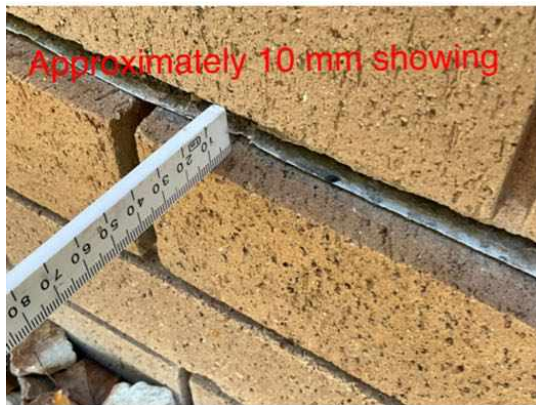
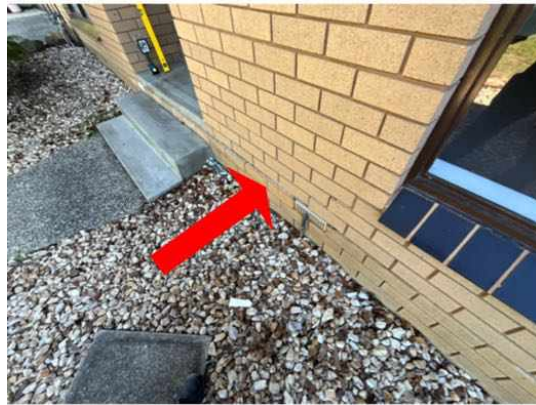
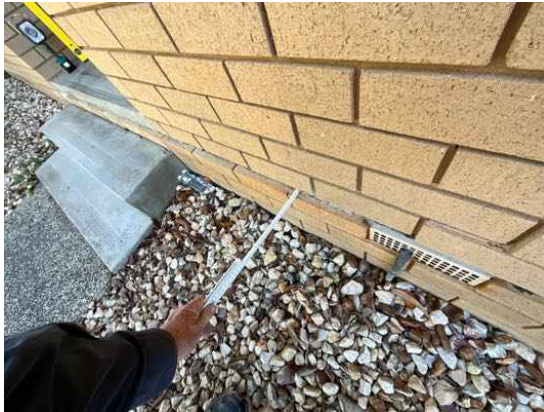
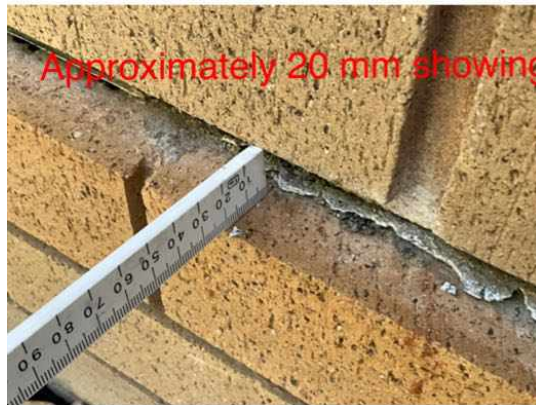
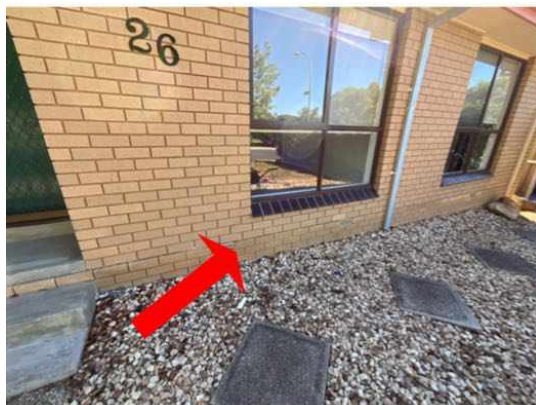
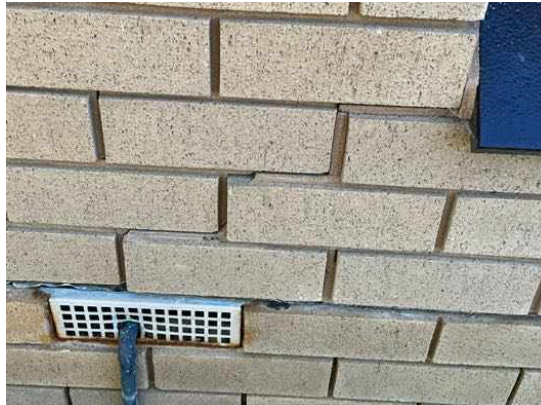
Building: Building 1  
Location: Front wall  
Finding: Brickwork- movement  
Information: Although some movement is noticeable, no further movement could be found with force applied to the structure.

In this case the movement in the brickwork appears old. No other areas of movement were found.

Cracking/ movement of this nature can generally be repaired with minor filling and should be conducted by a qualified bricklayer if required.

Always contact a Licensed Builder or bricklayer immediately should cracks/ movement increase.

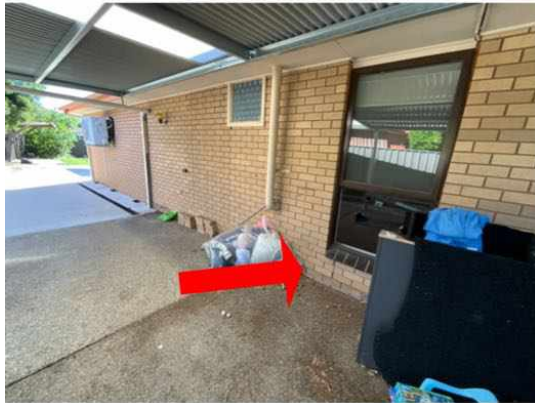
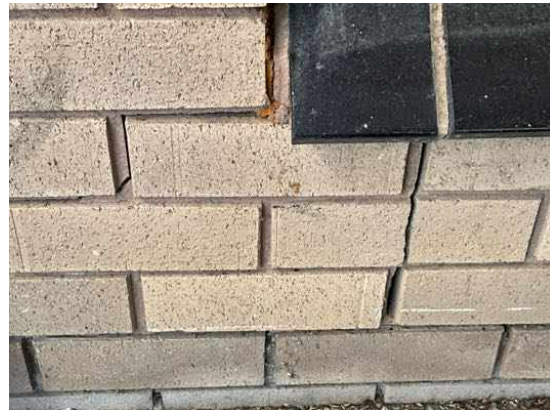
### Finding 3.01

Building:	Building 1
Location:	Carport
Finding:	Brickwork - Step cracking
Information:	Step cracking was identified to the brickwork in this area at the time of inspection. Step cracking, which is similar to other forms of cracking, has a variety of possible causes. However, the most common is the subsidence of adjacent footings.

Step cracking is a relatively common defect, and is most likely to occur adjacent to windows, doors and other openings. Mortar failure in the gaps between affected bricks indicates the stresses and tensions affecting the wall.

Where step cracking is extensive or severe, the client is advised to consult a structural engineer. Minor step cracking can be used as a warning sign to address factors causing stress to the wall, which can include the effect of surrounding trees, water leaks, soil erosion, or even the presence of reactive soils in the surrounding area.

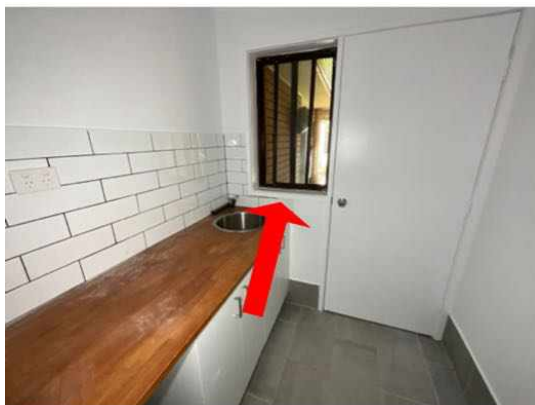
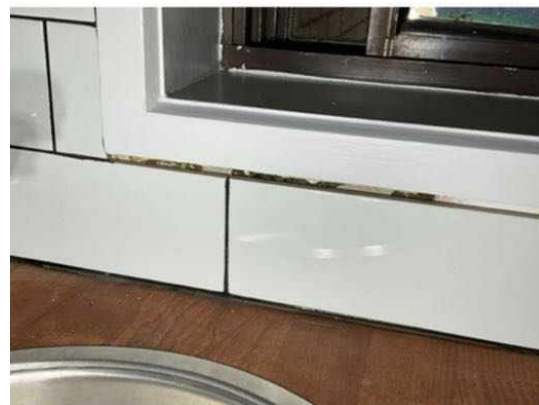
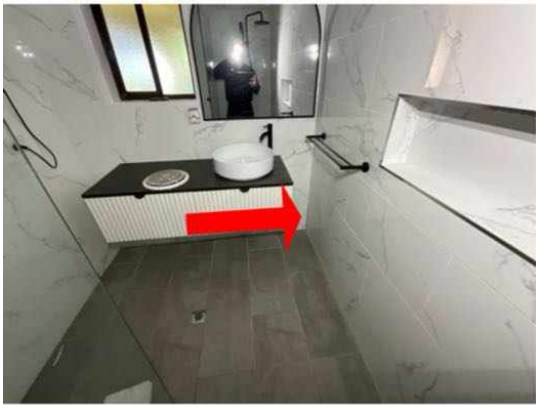
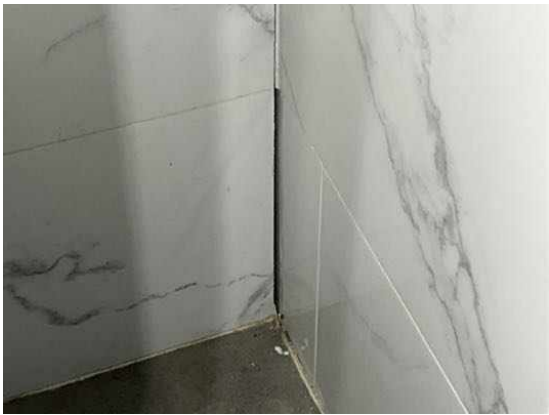
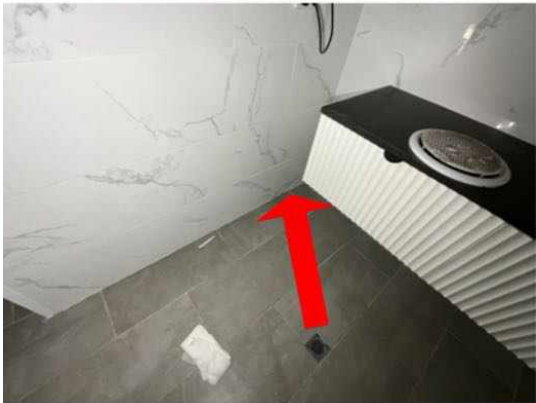
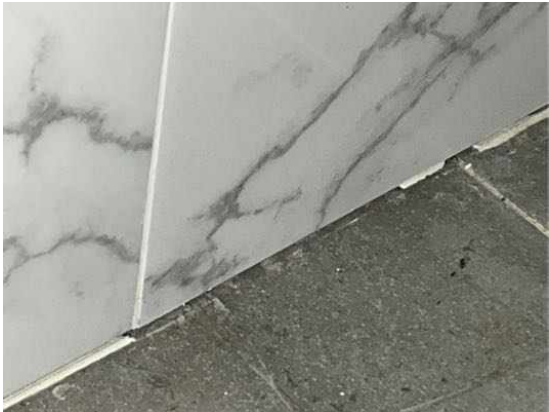
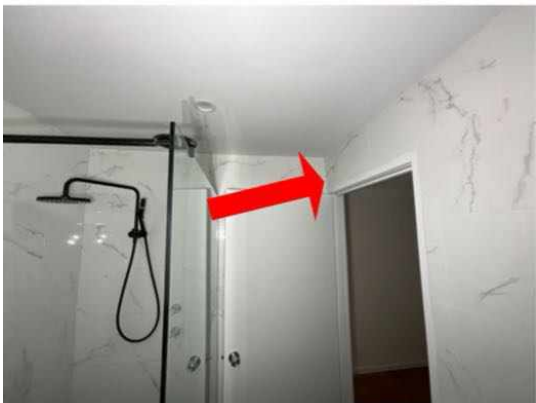
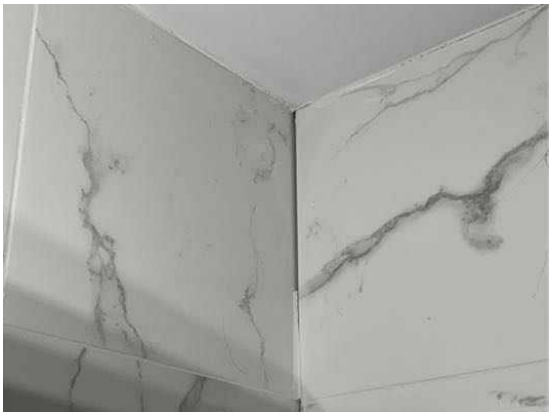
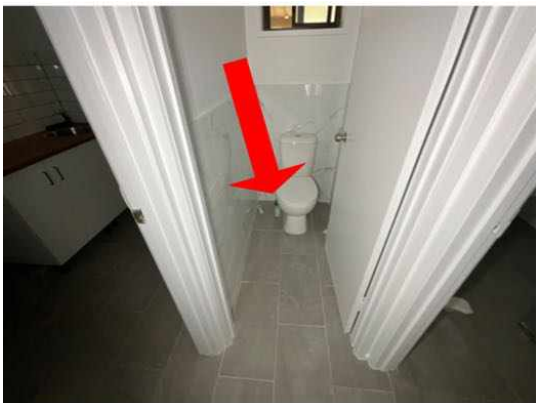
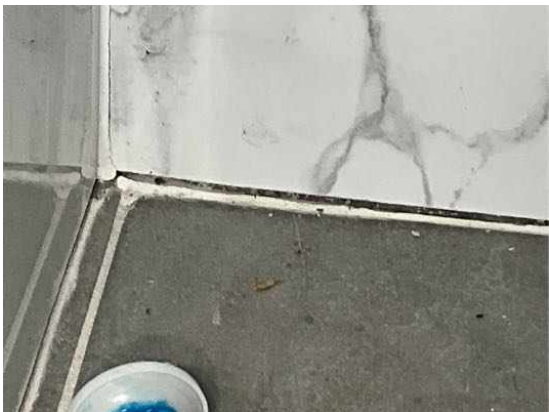
### Finding 3.02

Building:	Building 1
Location:	Laundry, bathroom, Wc
Finding:	Inadequate sealant or Grout
Information:	This area has a lack of effective Sealant or Grout. This is allowing the ingress of water to the structure inside the wall.

The presence of water encourages Termite attack, Mould and Fungal Decay.

A Tiler or General Handy person must be contacted as soon as possible to effect repairs and prevent further deterioration.

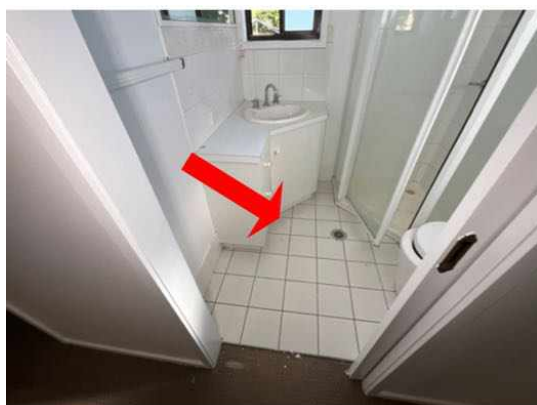
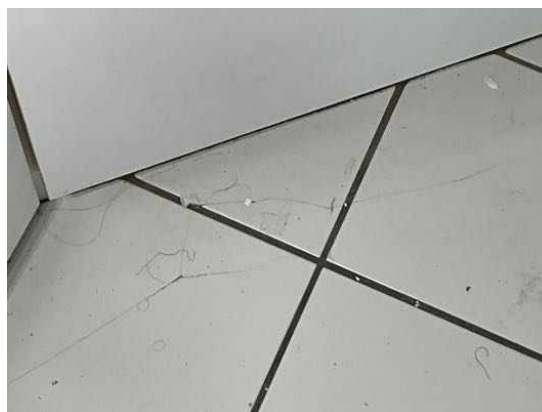
Finding 3.03

Building: Building 1  
 Location: Bathroom  
 Finding: Cracked floor tiles  
 Information: Cracking in the floor tiles was evident in this area at the time of inspection. It is suspected that this cracking has occurred as a result of minor settlement or impact damage.

Cracked tiles throughout the household detract from the overall appearance of the affected areas however it is unlikely to create or lead to any secondary defects.

While not considered a matter of urgency, replacement of cracked floor tiles is recommended at the clients discretion. A tiling contractor may be appointed to perform these works. Where cracks become more numerous, contact a licensed building inspector for further investigation.

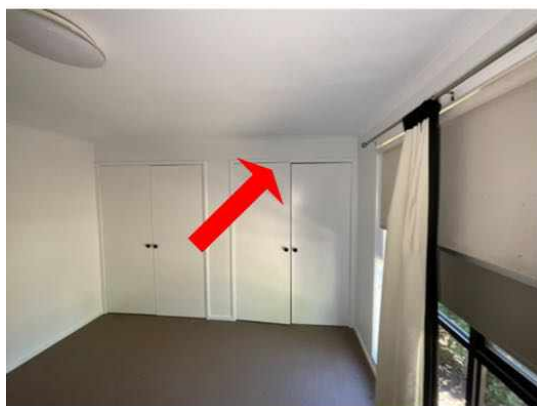
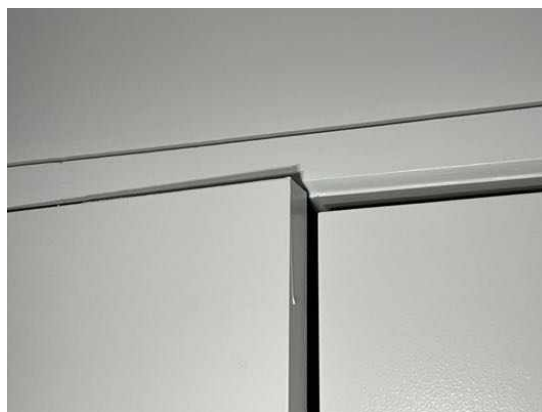
### Finding 3.04

Building: Building 1  
 Location: Bedroom 3  
 Finding: Door- Binding  
 Information: Binding and/or jamming of this door is evident during standard operation. This defect inhibits the functionality of the affected door as well as creating potential for secondary defects to associated building elements, such as damage to the floor covering.

A door that binds to flooring or to the associated door frame may have several causes, ranging from minor defects, such as poor installation of the door or deteriorated hinges, through to major structural issues, such as damage to subfloor structures.

A qualified carpenter or general handyperson should be appointed to perform minor rectification works at client discretion.

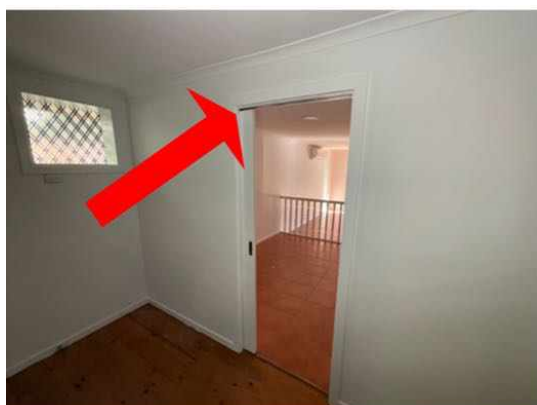
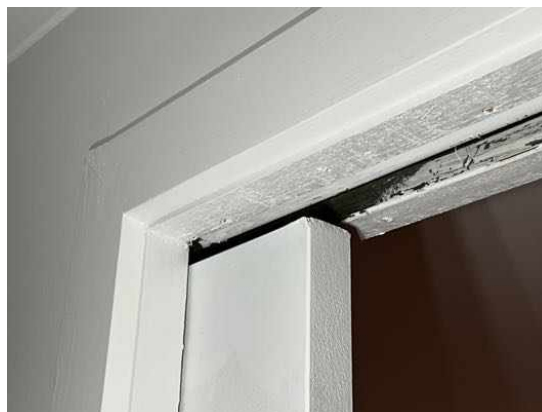
### Finding 3.05

Building:	Building 1
Location:	Living Room
Finding:	Door- Stiff to slide
Information:	The door in this area was jammed and difficult to slide along the associated tracks at the time of the inspection. Restricted function of the affected door may pose as a potential safety hazard if required for emergency egress from the building.

Generally, factors such as general age of the building element and a lack of maintenance are the usual causes for this type of defect.

Replacement of door hardware or tracks may be required, as well as minor repairs and cleaning. A registered builder or general handy person will be required to repair the affected doors.

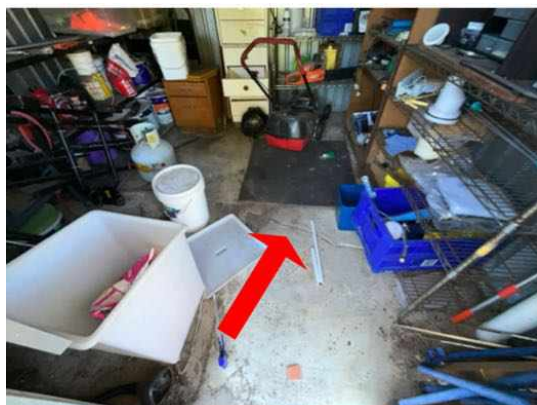
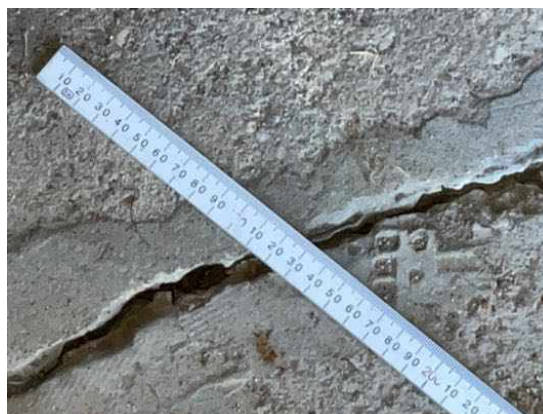
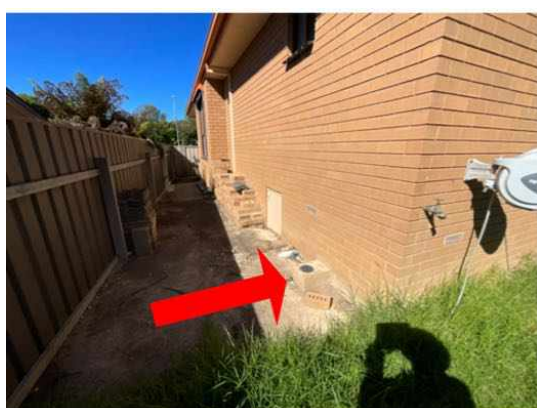
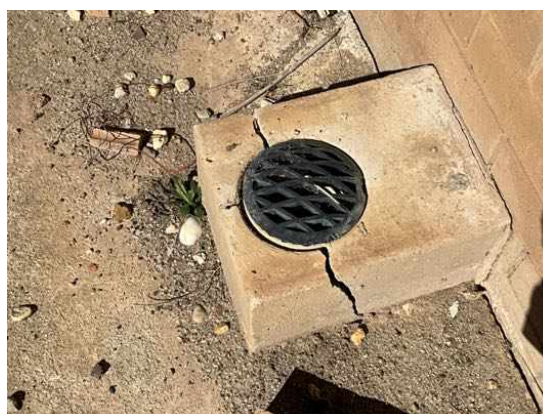
### Finding 3.06

Building:	Building 1
Location:	Shed, side yard
Finding:	Cracking - External Concrete Paving Damage Category 4 - Gaps in Slab (4mm - 10mm +)
Information:	Gaps in the slab were identified in external concrete paving. Gaps in the slab are

significant and are likely to lead to the development of safety hazards and secondary defects if left unmanaged, such as the creation of a trip hazard.

General age and expected deterioration of the paved areas is a common cause of this type of cracking. However, expansion and contraction of the slab may also have occurred due to environmental factors. Such factors include variable moisture and weather conditions, the presence of trees and their roots having a settling or lifting affect on the soil, or the effect of load bearing, e.g. heavy vehicles over a sustained period of time.

Cracking to this degree may also be due to poor original installation of the concrete. Factors such as poor compaction of the sub surface and/or inadequate reinforcing of the slab may create cracking and other secondary defects. Gaps in the concrete paving may also have a more significant structural cause, such as subsidence of soils.

Where gaps in the concrete paving are adjacent to structural elements of the building, the advice of a Structural Engineer is advisable before undertaking repairs. Significant repair and likely replacement of the concrete paving is probable.

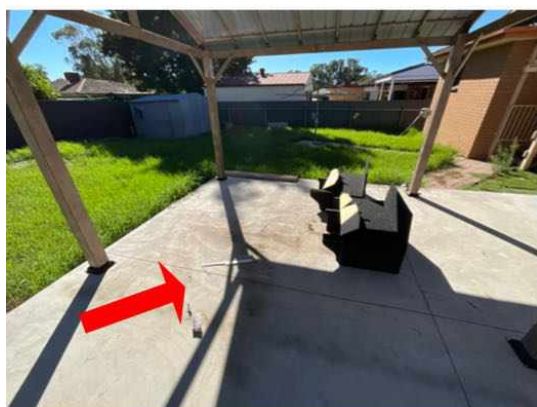
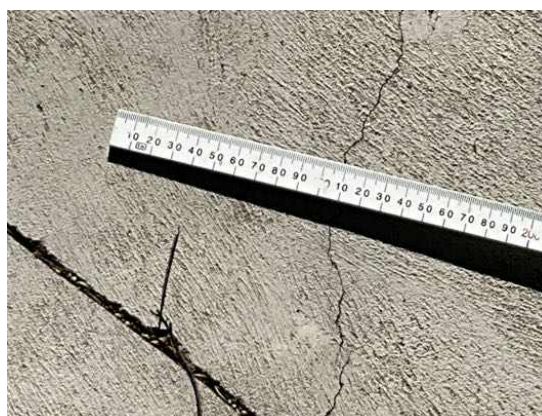
### Finding 3.07

Building:	Building 1
Location:	Alfresco
Finding:	Cracking - External Concrete Paving Damage Category 1 - Fine (less than 2mm)

Information: Fine cracks were identified in external concrete paving. Although fine cracks are quite noticeable, they are often only considered to be an appearance defect, and usually do not indicate any structural damage. To be considered a Category 1 or fine crack, the crack is found to be less than 2mm in width.

Generally the cause of a hairline crack in existing concrete paving such as driveways and pathways is indicative of the expansion and contraction of the concrete. Such causes are generally due to environmental factors, such as moisture levels, weather conditions, root systems of nearby trees or the soil types on which they are laid.

Fine cracks may also be due to poor original installation of the concrete. Factors such as poor compaction of the sub surface and/or inadequate reinforcing of the slab may create cracking and other secondary defects.

Monitoring of all cracking should be conducted frequently. Always contact a building inspector should cracks widen, lengthen, or become more numerous.

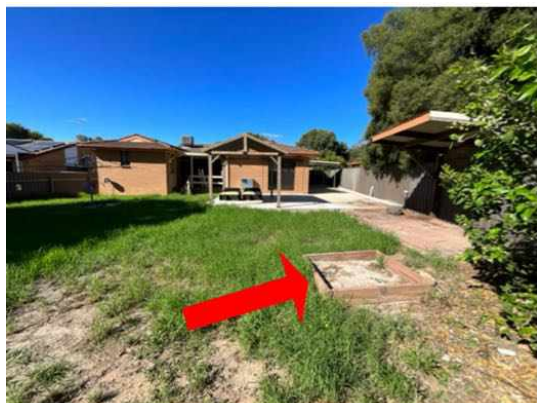
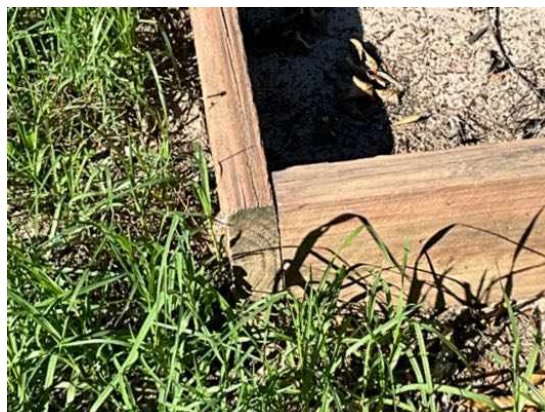
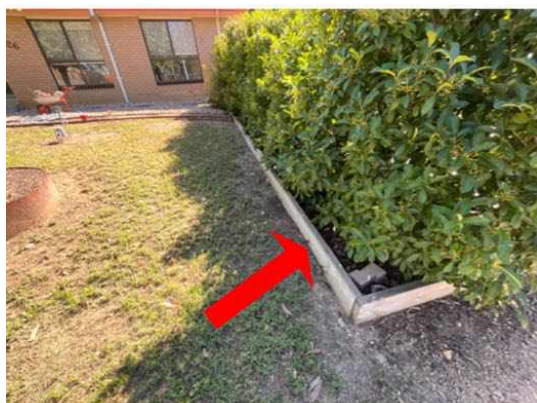
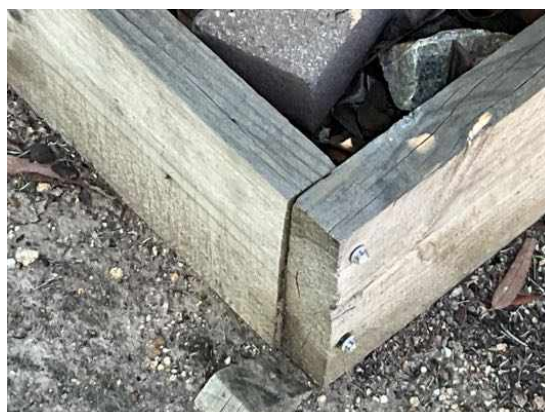
Building:	Building 1
Location:	Yard - Back, front
Finding:	Untreated or non-durable timbers in a hazardous environment
Information:	To reduce the risk of timber pest attack it is essential that timber used in a hazardous

environment (e.g. in direct contact with the ground or frequently exposed to damp conditions) is of sufficient durability and/or is adequately preservative treated.

Untreated timbers in direct contact with the ground are likely to develop severe wood rot and/or fungal decay if left unattended creating attraction for subterranean termites to infest the timbers from surrounding areas.

If untreated or non-durable timbers are found to be in a hazardous environment it is highly advised that replacement of these building elements be performed as soon as possible to aid the protection of the property against termite / timber pest attack.

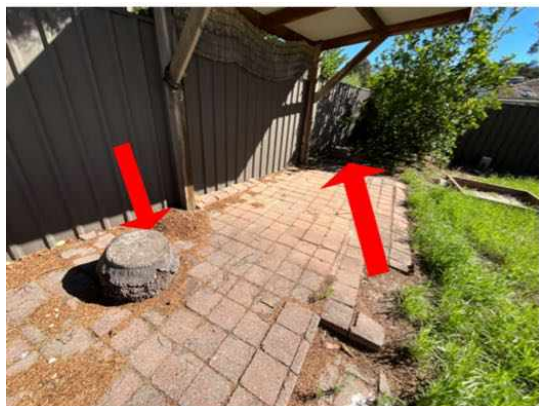
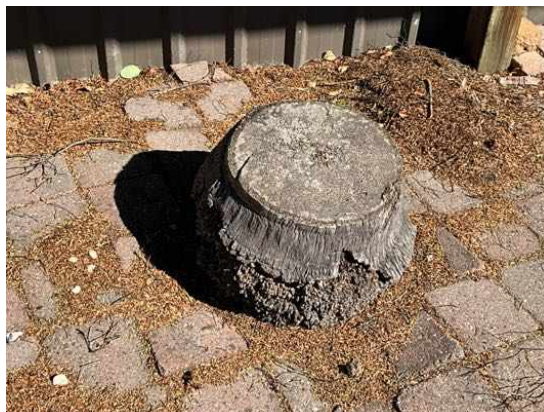
**Finding 6.02**

Building: Building 1  
 Location: Yard - Back  
 Finding: Tree Stump in Ground  
 Information: Any tree stumps in the yard not removed during the tree removal process provides the opportunity for Termite infestation and is likely to be subject to decay from damp conditions against the stump.

All tree stumps should be removed by professional tree removal services where possible. Meanwhile regular inspections are advised to identify any termite activity in the areas identified.

Services for tree stump removal should be contacted as soon as possible to reduce the risk of timber pest attack.

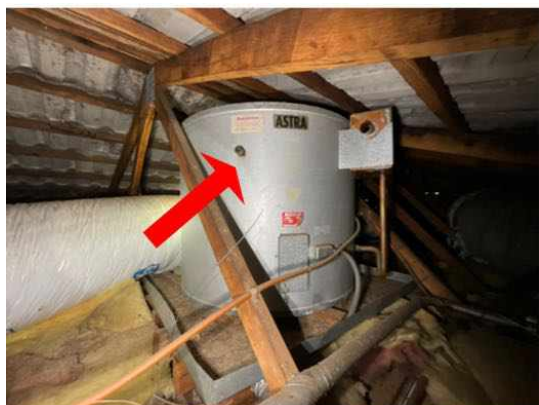
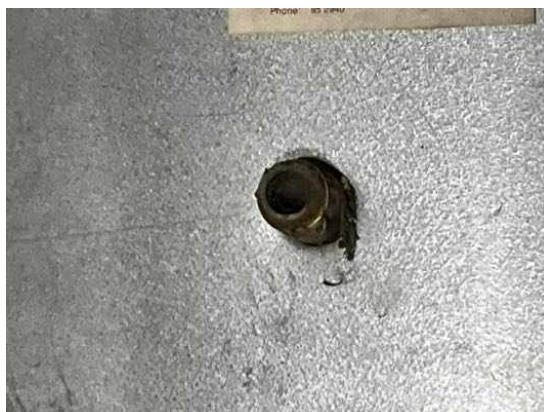
### Finding 6.03

Building: Building 1  
Location: Roof Void  
Finding: Gravity-Fed HWS - Disconnected  
Information: It was noted at the time of inspection that a disconnected gravity-fed hot water system (HWS) remains in this area.

Despite this plumbing structure being unused, it is likely to be storing residual water, and is therefore susceptible to rust and corrosion. If allowed to continue, rust and corrosion is likely to lead to damage to adjoining building elements, and may also make the area susceptible to termite or timber pest activity.

While it is a costly exercise to remove the disused gravity-fed HWS, it is advisable in the short-term future to prevent any further damage to the area. Further consultation with a licensed plumber is required to gain further advice on removal of the structure.

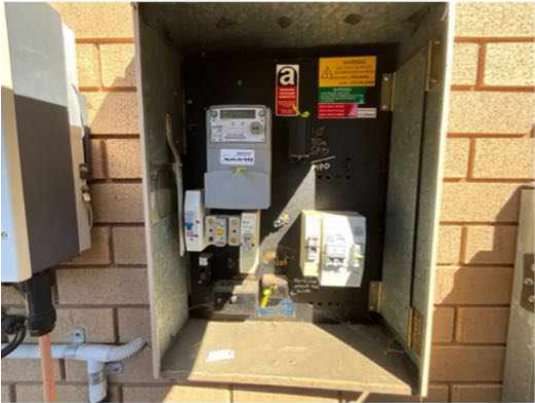
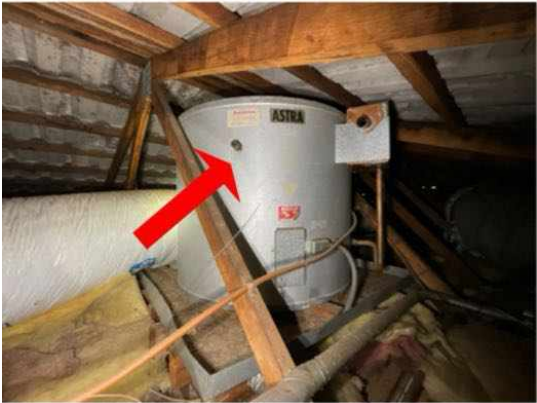
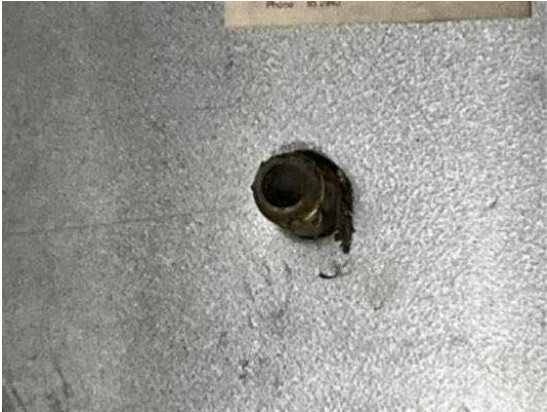
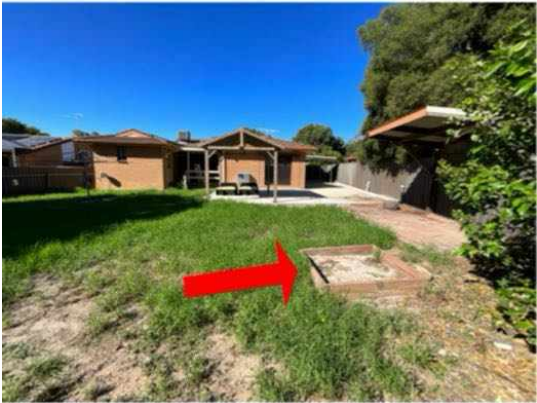
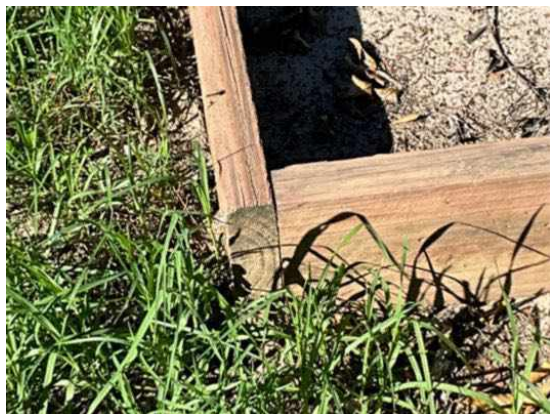
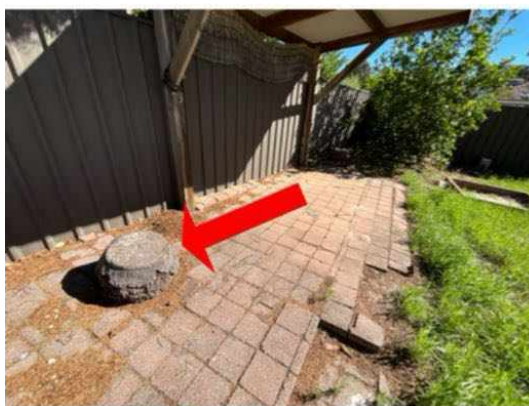
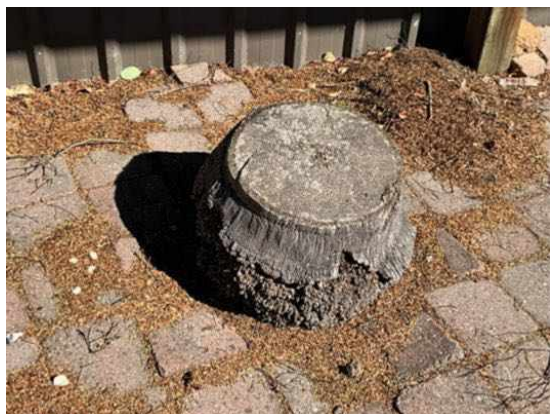
### Finding 6.04

Location: All External Areas  
Finding: Termite Management System - no evidence of a chemical installation  
Information: The application of a post-construction chemical termite barrier is highly recommended for all properties, particularly if live termite activity has been found on the site previously. Such barriers are highly effective in preventing termite attack on any timber building elements throughout the property.

A durable notice should be placed in the switchboard unit to indicate current termite barriers. At the time of inspection, it appeared as though no termite management system has been installed, with no evidence to suggest preventative works taking place.

The client may consider gaining further advice from a pest controller as to the costs and procedures involved with this application. It is recommended that obtaining such advice be a short-term priority.

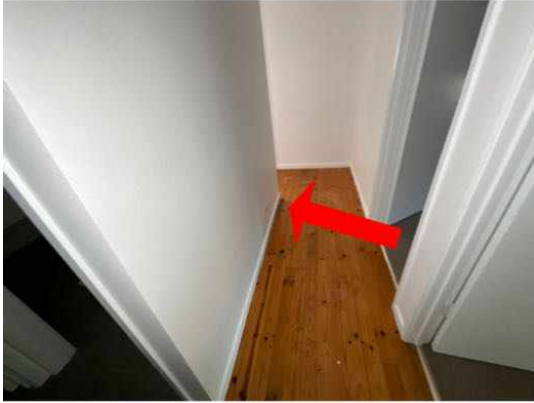
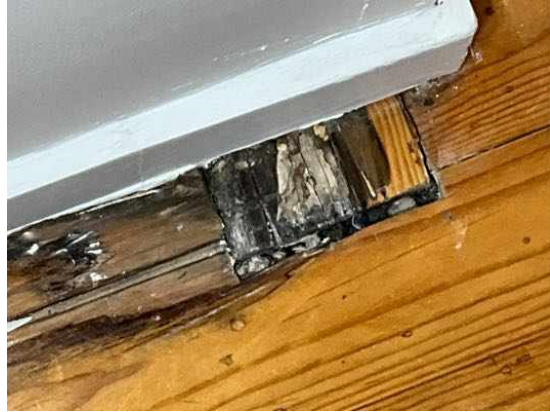
### Finding 7.01

Building:	Building 1
Location:	Hall
Finding:	Fungal decay - present (localised)
Information:	Fungal decay also known as wood decay or wood rot generally refers to the deterioration of timber elements when in contact with excessive levels of moisture for a prolonged period of time.

In this case although the affected timber element is in a decaying state the extent of any visible damage appears to be localised to a specific area and is yet to spread to other parts of the building element or affect adjoining structures. The fungal decay is therefore likely to be of a relatively superficial nature with minimal impact on the structural integrity or tensile strength of the timber element.

This is probably a remnant of the old bathroom fit out.

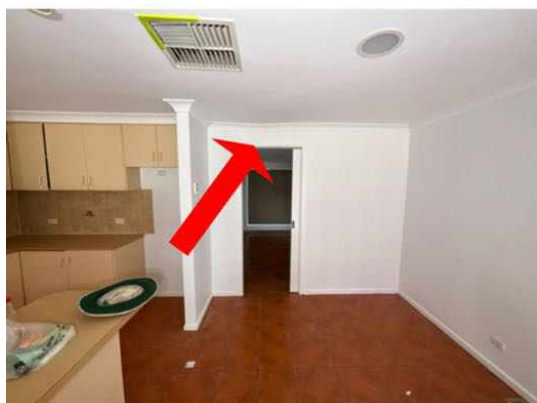
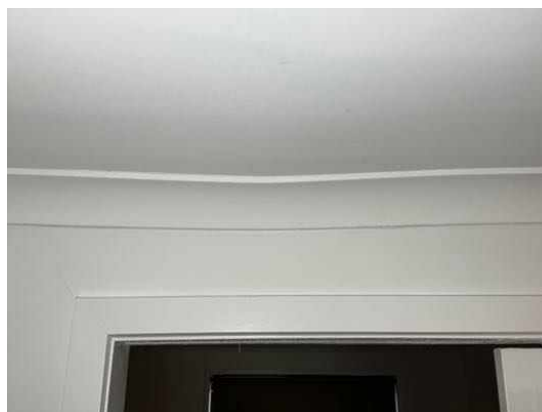
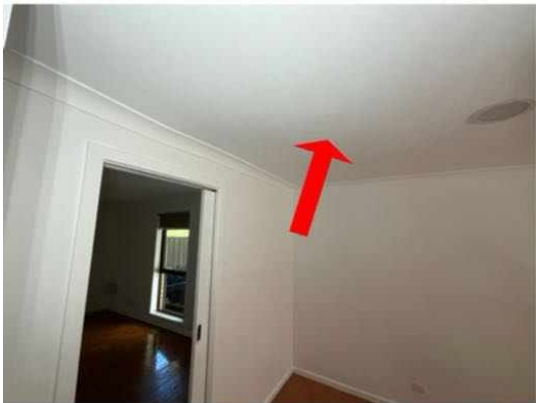
Building: Building 1  
Location: Dining Room  
Finding: Cornice- sagging, staining  
Information: The cornice in this area is sagging. This may be due to age or poor initial installation.

Stain- Water staining to ceiling linings in this area was evident at the time of inspection. Water staining indicates that surfaces have been exposed to excessive moisture over time. The minerals and other elements in the water lead to staining, which may graduate to corrosion and deterioration if left unmanaged.

While mostly an appearance defect, water staining can be indicative of more serious defects, which may be currently concealed by interior ceilings.

A plasterer or handyman should be contacted soon to restore the area and prevent further deterioration.

Where water staining is active, a licensed plumber must be consulted to identify the cause of the staining and to provide advice on any reparation works that may be required. Replacement of any damaged structures is advised.

Conversely, where water staining is old and inactive, affected building materials may be repaired or replaced at client discretion.

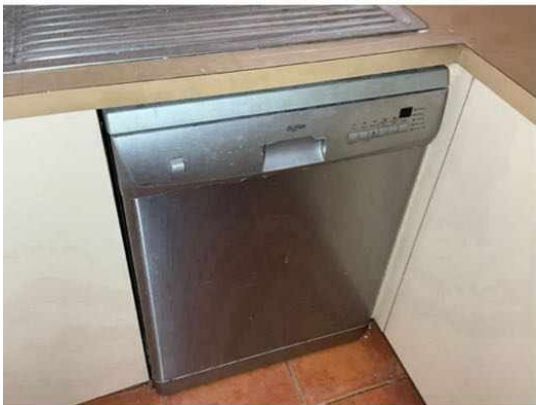
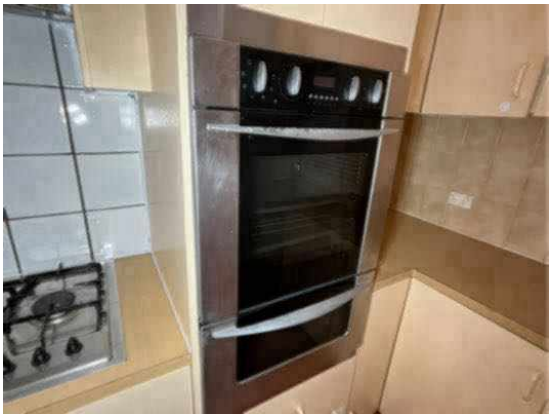
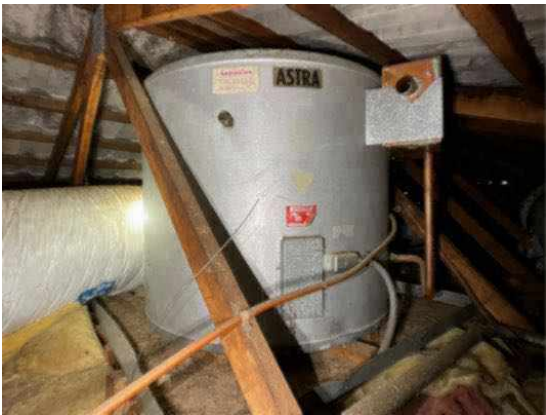
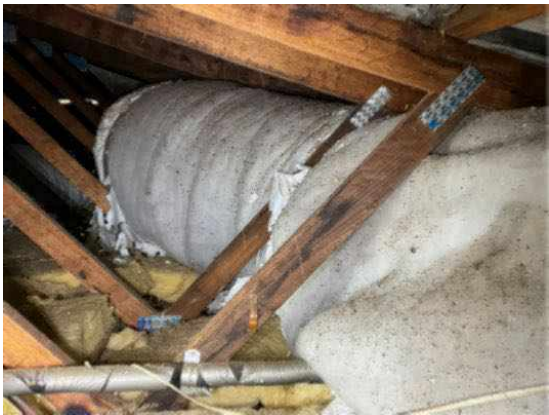
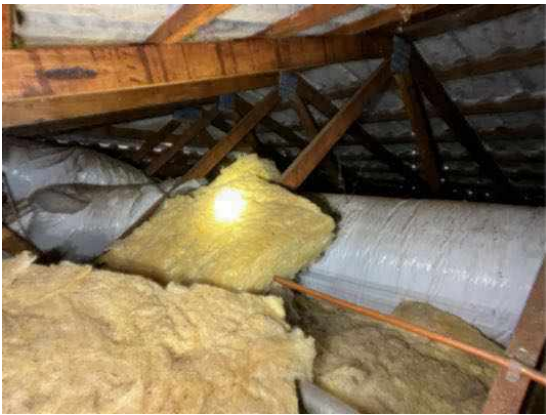
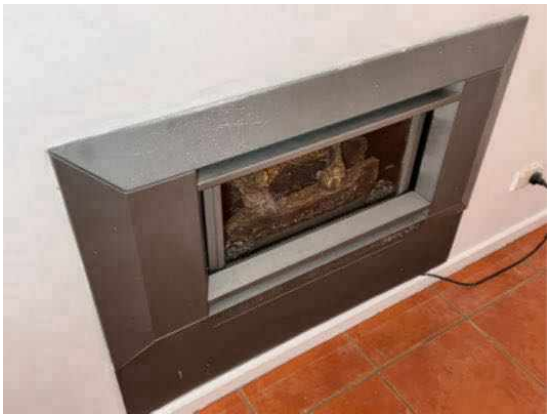
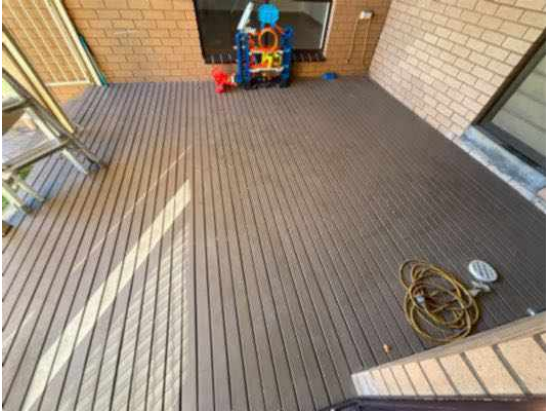
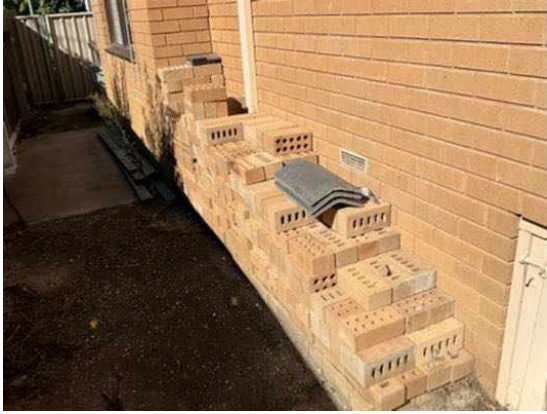
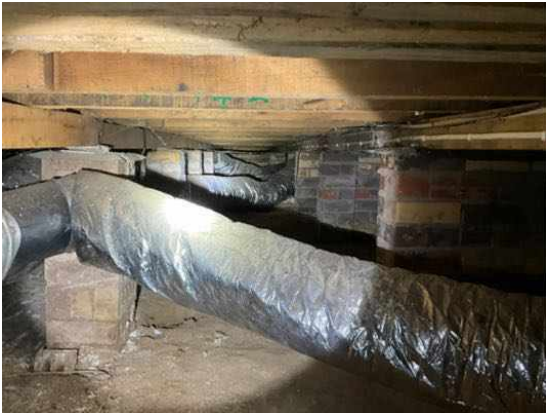
Building: Building 1  
Location: All Areas  
Finding: Additional Photos - Obstructions and Limitations  
Information: These photographs are an indication of the obstructions and limitations which impeded full inspection of the property at the time of inspection. These obstructions can hide an array of defects and should be removed to allow full inspection to be carried out. A re-inspection is recommended once the areas are made accessible.
