Building and Timber Pest Inspection Report

Inspection Date: Mon, 16 Mar 2026

Property Address: 24 Rose St, Liverpool NSW 2170, Australia

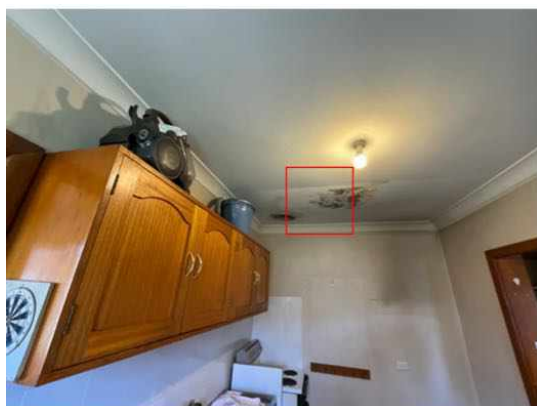
Building:	Main Building
Location:	Granny flat
Finding:	Ceiling - Water damaged
Information:	Water damage to the ceiling lining is generally an indication of excessive moisture being present in the roof void, usually via a leak to the roof covering.

Where water damage is evident to the ceiling, the primary requirement is to identify and rectify the source of the leak. A roof restoration specialist should be appointed as soon as possible to identify the leak and perform rectification works as necessary, ensuring the water damage is restricted.

Once the leak is repaired, consultation with relevant tradespeople, including plasterers and painters, is advised. Rectification works may include replacement of ceiling lining or minor repainting, depending on the extent of the damage.

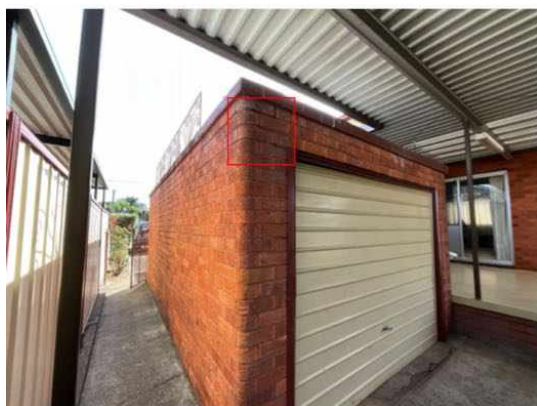
Building:	Main Building
Location:	Carport
Finding:	Brickwork - Step cracking
Information:	Step cracking was identified to the brickwork in this area at the time of inspection. Step cracking, which is similar to other forms of cracking, has a variety of possible causes. However, the most common is the subsidence of adjacent footings.

Step cracking is a relatively common defect, and is most likely to occur adjacent to windows, doors and other openings. Mortar failure in the gaps between affected bricks indicates the stresses and tensions affecting the wall.

Minor step cracking can be used as a warning sign to address factors causing stress to the wall, which can include the effect of surrounding trees, water leaks, soil erosion, or even the presence of reactive soils in the surrounding area. Damage of this category is required to be monitored for a period of 12 months, after which time a crack rated at Category 2 or above is considered a defect requiring rectification, such as minor repairs and repointing. Always contact your building inspector should cracks widen, lengthen, or grow more numerous.

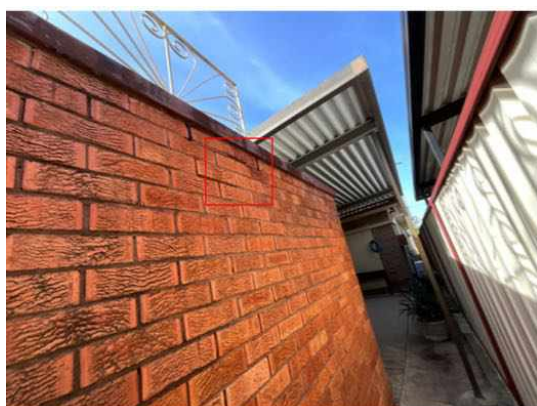
Building:	Main Building
Location:	Carport
Finding:	Mortar - Deteriorated (Erosion)
Information:	The mortar in this area was found to be deteriorated. Mortar, or 'bedding', is the material which fills joints and intersections between bricks in masonry walls and structures.

Commonly referred to as corrosion or erosion, the bricks and mortar are aged and likely to have been affected by a variety of factors, including moisture, salt-based deterioration, and more.

Mortar and brickwork should be replaced to ensure the structure remains in their intended location and to prevent gaps, which would allow water or moisture ingress and secondary damage as a result.

This can be addressed by a licensed bricklayer.

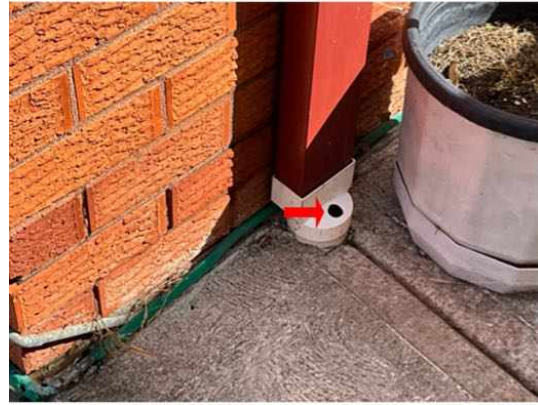
Building: Main Building
Location: Multiple areas
Finding: Stormwater drain - Not connected/Damaged
Information: The roof plumbing is not adequately connected to stormwater drainage on the site. This disconnection negatively impacts the functional capacity of the roof plumbing.

Where roof plumbing doesn't drain adequately, the area at the base perimeter can become excessively damp, potentially creating an environment that is susceptible to rust and corrosion of surrounding building elements, as well as attracting termites and other pests.

It is highly recommended that a plumber be appointed to further inspect the area and to install adequate drainage equipment where necessary.

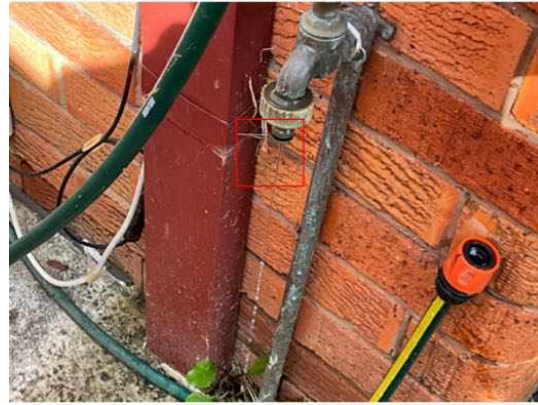
Building:	Main Building
Location:	Front right corner
Finding:	Washers - Degraded
Information:	The washers on the taps in this area appear to have degraded as a result of general ageing. Degraded washers generally result in slow, persistent leakage from taps and plumbing hardware.

Replacement of washers will ensure that water wastage does not occur and that the persistent water leak does not result in secondary damage to surrounding structures. Such damage may range from rust and corrosion to damage of surfaces, e.g. bench tops, etc.

A qualified plumber should be appointed to replace degraded washers and to further inspect associated plumbing fixtures and fittings. Where water damage has occurred, a carpenter or cabinet maker may be appointed to replace affected building elements.

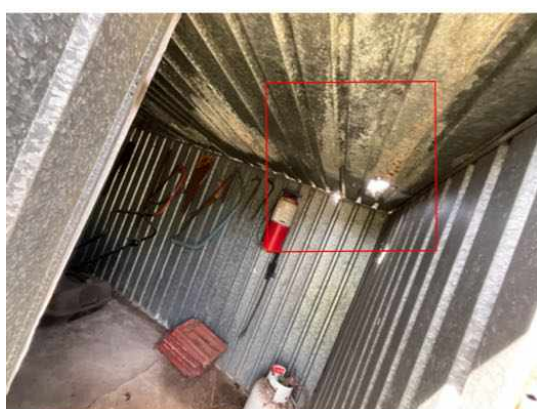
Building:	Main Building
Location:	Outboundings
Finding:	Deteriorated components
Information:	It was identified that some elements around the exterior of the home have suffered from environmental effects with replacement required.

Secondary defects are likely if the issue is not addressed. A licensed carpenter should be appointed for repairs immediately.

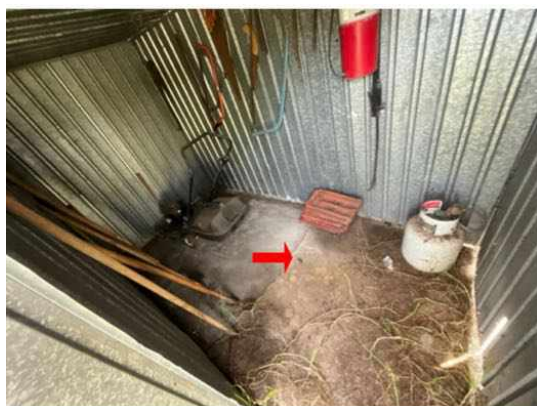
Building:	Main Building
Location:	Sheds
Finding:	Crack in concrete slab - Category 3
Information:	A crack coded as Category 3 was identified in the slab. A Category 3 crack is described as a wide crack with obvious curvature or change in level, affecting the slab.

The approximate width of the crack to be considered Category 3 is greater than 2.0mm, or a change in offset of 15-25mm when a 3m straight edge is placed over the defect.

Category 3 cracks to slabs exceed allowable Standards and Tolerances, and are considered defects requiring rectification.

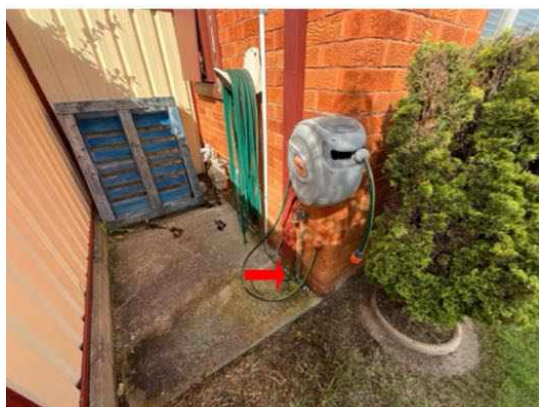
Building:	Main Building
Location:	External tap
Finding:	Tap - No drain
Information:	The external tap in this area was noted to have no drain at the time of inspection.

This keeps the surrounding surfaces damp while using the tap, which becomes conducive to termite activity.

A licensed plumber must be appointed to ensure an appropriate drain is installed.

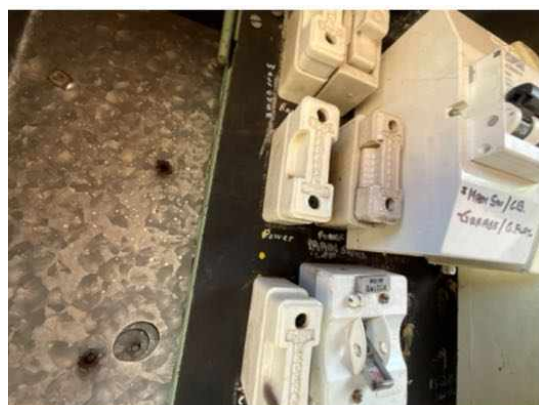
The electrical switchboard while appearing to have adequate safety switches installed has old ceramic fuses in place.

While this on its own on is not considered a defect it is noted for the clients consideration that a switchboard upgrade may be required in the short to mid term to improve the functionality of the electrical system. A licensed electrician could be appointed to provide quotation for the works at the client's discretion which may in turn expose other required works to bring the system up to a compliant state.
