Building and Timber Pest Inspection Report

Inspection Date: Sat, 28 Mar 2026

Property Address: 8 Lone Pine Ave, Chatswood NSW 2067,
Australia

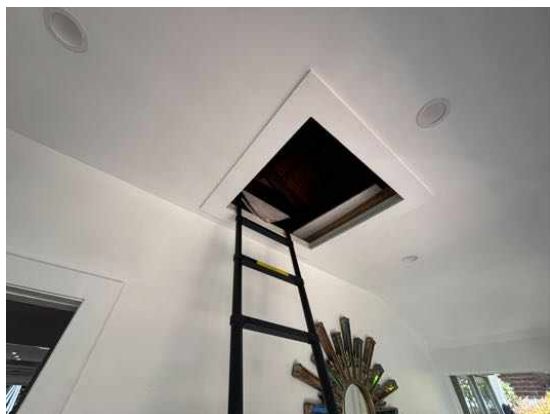
Building:	Main Building
Location:	Roof Void
Finding:	Vent - Extracted into Roof Space
Information:	During the inspection, it was noted that the exhaust vent has been improperly terminated into the roof space instead of being ducted to the exterior of the property.

This configuration is a defect as it allows moist air to accumulate within the roof cavity, increasing the risk of condensation, mould growth, and deterioration of insulation or timber framing. Proper ventilation is essential to maintain a healthy indoor environment and protect the structural integrity of the building. It is recommended that the vent be appropriately re-routed to discharge externally in compliance with relevant building standards.

A licensed mechanical ventilation contractor/electrician should be appointed as soon as possible to provide further consultation on the scope of these works and to provide quotations for any necessary works.

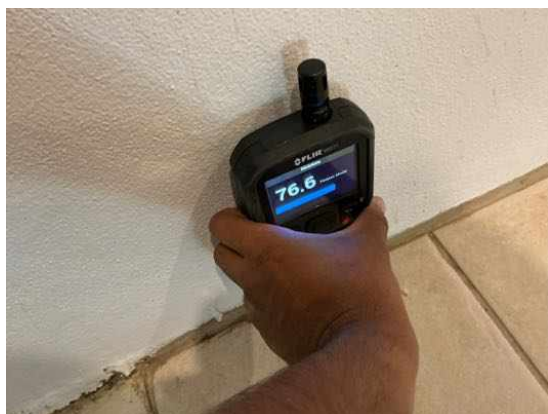
Building:	Main Building
Location:	Bedroom 4, Study, Lower Level Lounge
Finding:	Damp - Rising
Information:	At the time of inspection, rising damp was identified within the property. This condition results from the upward movement of moisture through porous building materials, such as bricks, sandstone, or mortar, via capillary action. A damp-proof course (DPC), an impermeable barrier installed at the base of walls above ground level during construction, is typically used to prevent rising damp. However, the absence, deterioration, or bridging of the DPC can compromise its effectiveness, specially in older buildings, leading to moisture ingress. Inadequate site drainage, which allows water to accumulate around the foundation, is a common contributing factor to this issue.

If left unaddressed, rising damp can pose significant health risks due to mould growth and cause extensive damage to building elements, including wall finishes such as paint and plasterwork. The current condition should be monitored over a 12-month period to assess its progression.

It is strongly recommended that the client engage a qualified damp-proofing specialist for remedial actions. Additionally, consulting a qualified plumber or drainage specialist to assess and improve site drainage is advised to mitigate further risks. Monitoring the condition for 12 months is essential to evaluate its status and prevent potential

recurrence or further damage.
