Building and Timber Pest Inspection Report

Inspection Date: Tue, 17 Feb 2026

Property Address: 8/8 Galloway St, North Parramatta NSW
2151, Australia

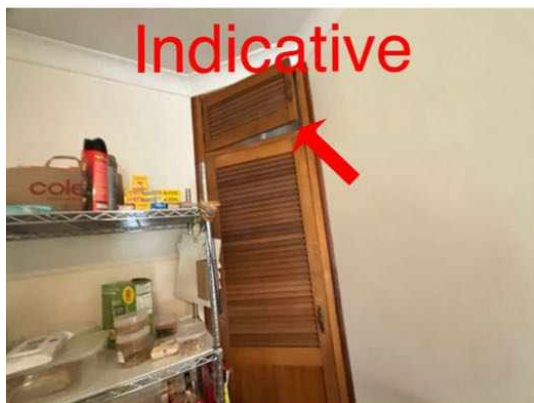
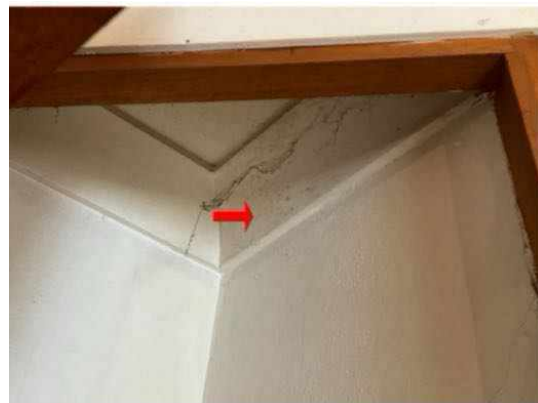
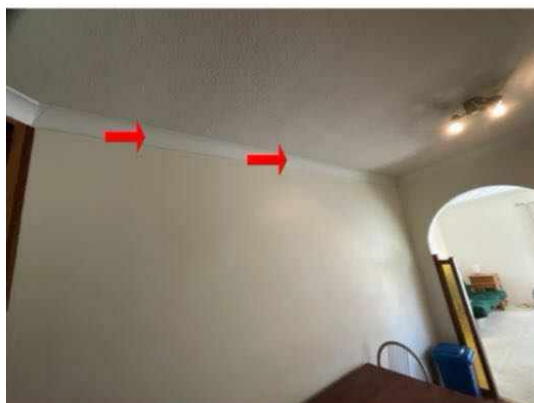
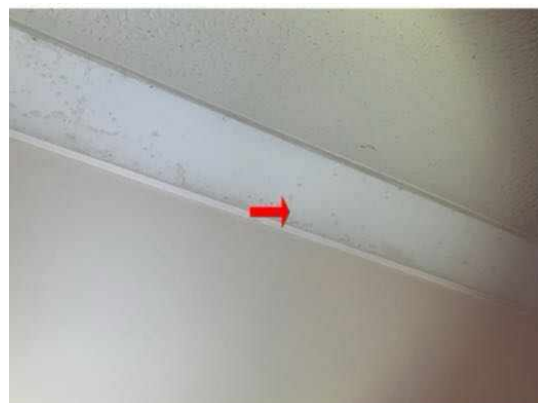
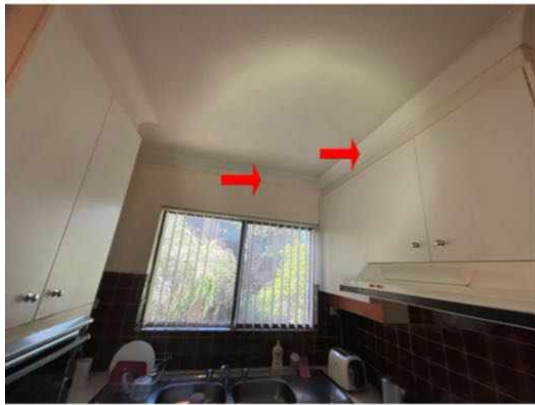
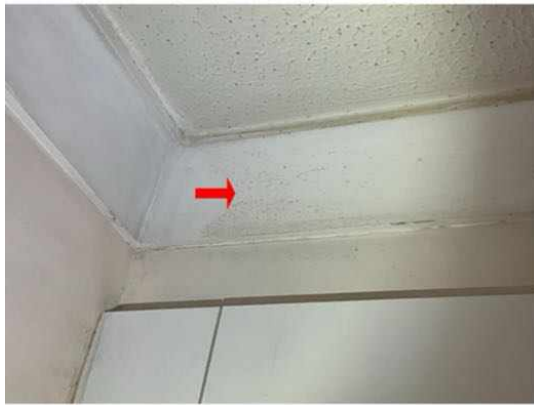
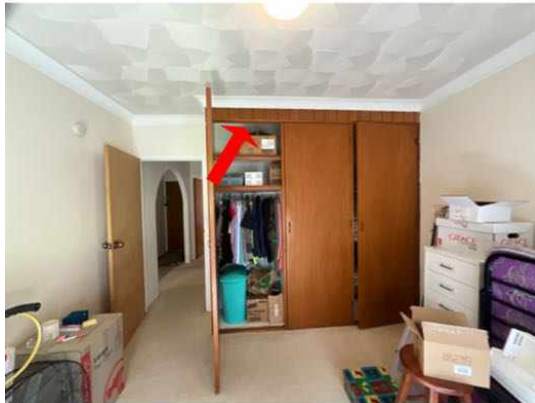
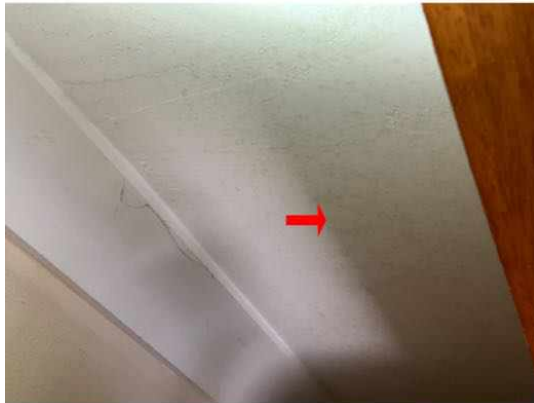
Building:	Main Building
Location:	Multiple areas
Finding:	Mould - Present
Information:	Evidence of mould growth was noted, which is believed to have grown due to lack of ventilation to the area. Where evidence of mould growth was noted, there may be environmental, biological or health issues associated with the report. A specialist inspection by a suitably qualified environmental health inspector is warranted, where mould is extensive or where any queries regarding air quality spores or other related issues apply.

Generally, the client is advised to ensure that the general environment is free of moisture and humidity to aid in the prevention of mould formation and development. Any mould found during the inspection should be cleaned immediately by a cleaning contractor or the homeowner as applicable.

A safety hazard is due to mould. A mould remediation contractor is required to treat this mould urgently.

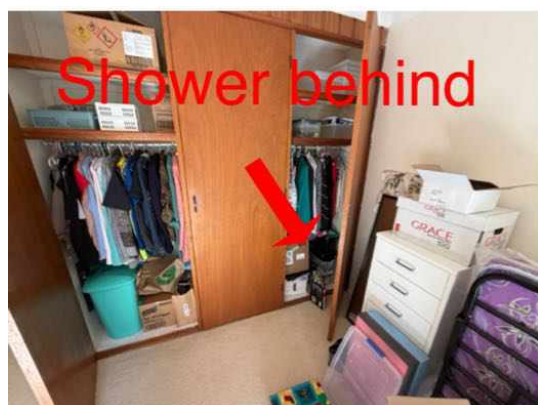
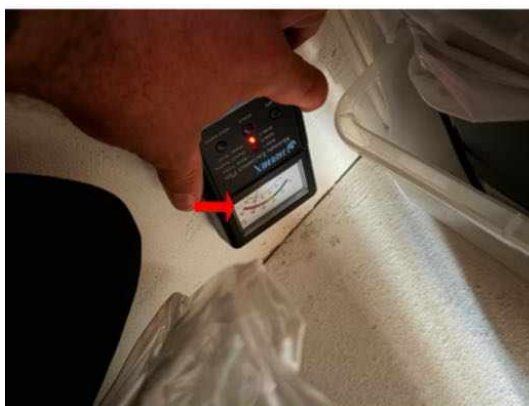
Finding 2.01

Building:	Main Building
Location:	Master bedroom cupboard
Finding:	Water leak suspected - Internal
Information:	A water leak is suspected in this area at the time of inspection. Internal water leaks can be detrimental to surrounding building elements; their potential causes include damage to plumbing fittings and fixtures, through to water damage and deterioration of associated building elements.

Rust, corrosion, decay and water damage are potential outcomes where a minor water leak is left unattended. More serious defects may also result, such as electrical hazards, or water damage to structural building elements.

In extreme cases, structural damage may develop due to a prolonged water leak. It is highly advised that a bathroom specialist be appointed urgently for further assessment and repair.

Access moisture was measured to the master bedroom cupboard behind the shower. A bathroom specialist must be appointed urgently for further assessment and to complete any require required rectification.

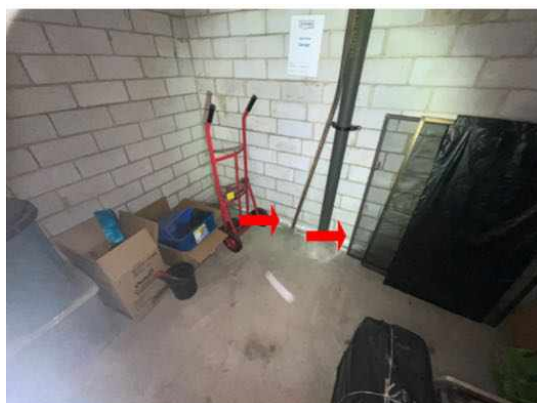
Finding 2.02

Building:	Main Building
Location:	Garage
Finding:	Exterior walls - Lateral damp
Information:	Lateral penetrating damp refers to the sideways movement of moisture, predominantly from the surrounding ground, which tends to affect basement walls and other earth-retaining walls. The implications of unmanaged damp range from mould fungi growth, wood rot and decaying building materials, to finishes including lifting, bubbling, peeling and staining of paint, plaster and wallpaper.

It is important to address damp conditions as the World Health Organisation notes that excess moisture leads - on almost all indoor materials - to the growth of microbes such as moulds, fungi and bacteria, which subsequently emit spores and other matter into the indoor air. Exposure to these contaminants is associated with a wide range of respiratory and other health-related problems. Additionally, the development of damp in timber building elements also provides an environment that is conducive to termite / timber pest attack.

Structural waterproofing barriers or tanking barriers are often used to protect internal surfaces against the effects of lateral penetrating dampness. These types of work are generally undertaken where the source of the penetrating damp cannot be prevented.

Immediate consultation with a licensed builder is advised to address the cause of the damp and to perform remedial works as necessary. A landscaper must be appointed immediately to lower the external ground levels.

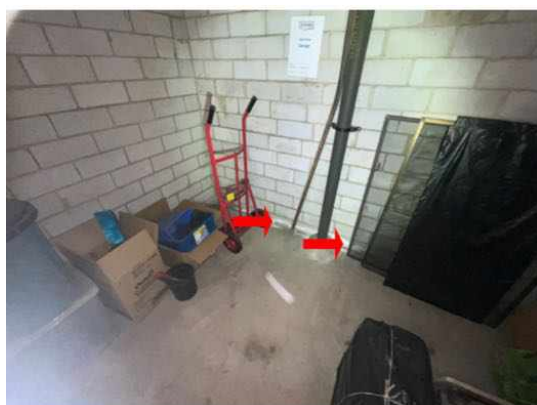
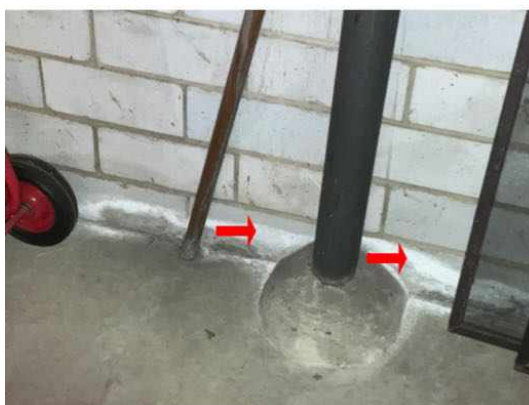
Finding 3.01

It is typically seen as white salt deposits on the surfaces of concrete pavement or mortar between bricks or tiles. While detracting from the overall appearance of the affected area, efflorescence is not likely to develop into secondary damage if left unmanaged.

Generally, soluble salt deposits can be removed by dry brushing with a stiff-bristled brush. Repeated dry brushing is an ideal treatment for eliminating this forming of efflorescence. A cleaning contractor or general handyperson may be appointed to perform these works at the discretion of the client.

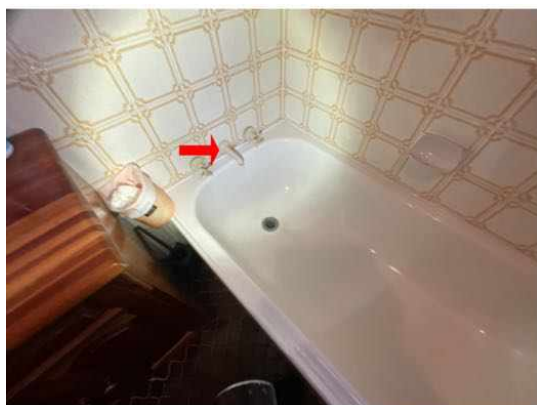
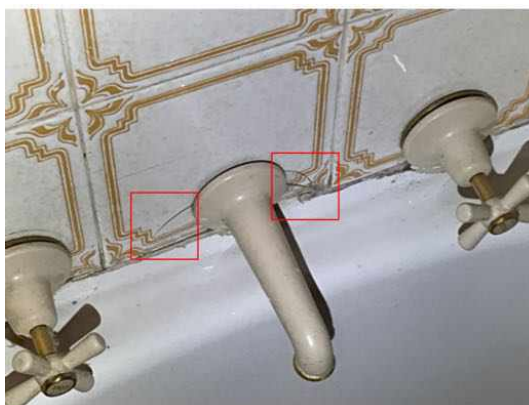
Finding 3.02

Building: Main Building
 Location: Bathroom
 Finding: Wet area tiles - Cracked or damaged
 Information: Cracking was evident to the tiling in this area at the time of inspection. While the cracking appears to be minor, this area is frequently exposed to water, allowing potential for water penetration into adjoining sections of walls or flooring.

If left unmanaged, water penetration to these areas may lead to subsequent water damage, which is likely necessitate repair work to affected building elements.

A bathroom specialist should be appointed to determine the integrity of the bathroom waterproofing membrane. If the membrane was found to be intact then relatively minor works to replace the cracked tiles should be carried out to ensure no further damage occurs. The re-application of silicone and grouting throughout remaining tile work is also advised, to further protect the area against water penetration.

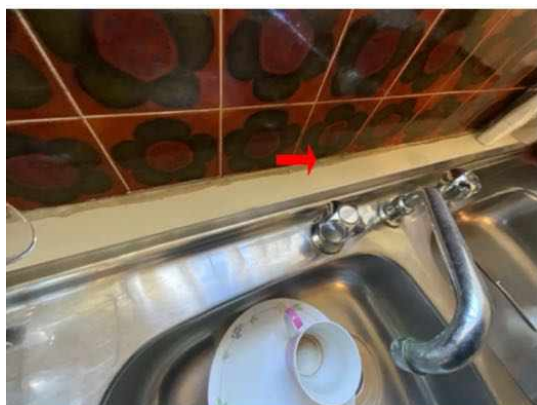
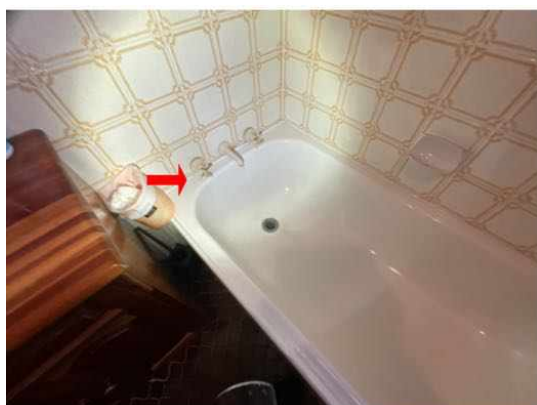
Finding 3.03

Building: Main Building
 Location: Multiple areas
 Finding: Sealant and grouting - Missing or damaged
 Information:

It was noted on inspection that sealant or grout is degraded to this area.

Different materials and floor areas move at different rates, generally causing cracking to grout or sealant at this point. A flexible sealant is required to allow for expected expansion and contraction, while keeping the joint water tight and protective of all associated building materials.

Flexible and mould resistant materials should be applied to affected areas to prevent any subsequent water damage that is likely to occur. Regular maintenance and replacement of damage or missing or damaged sealant and grout is highly recommended to the wet areas, as this is a regular wear and tear defect. Sealant and grouting in areas that come into regular contact with water should be maintained for the long term care of your property.

A sealant specialist should be appointed to complete these works as soon as possible.

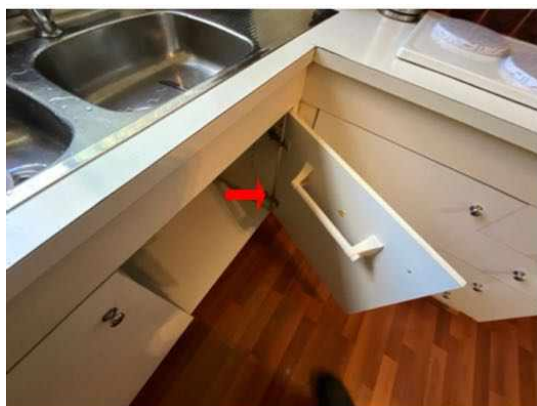
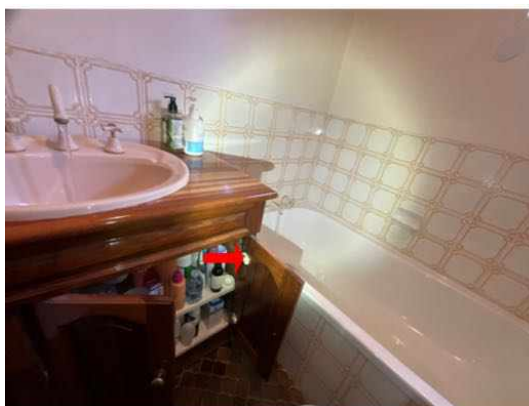
Finding 3.04

Building: Main Building
 Location: Kitchen, bathroom
 Finding: Cabinetry - Loose hinges
 Information:

Cupboard doors and or drawers are not level and detract from the operational state of the cabinetry. Upon further inspection, it was noted that the hinges to the cupboard doors have deteriorated over time and, as a result, have come loose from their original fixing.

To improve operation of the affected cupboard doors, a licensed cabinetmaker may be appointed to replace the faulty hinges. Such works should be completed at discretion of the client.

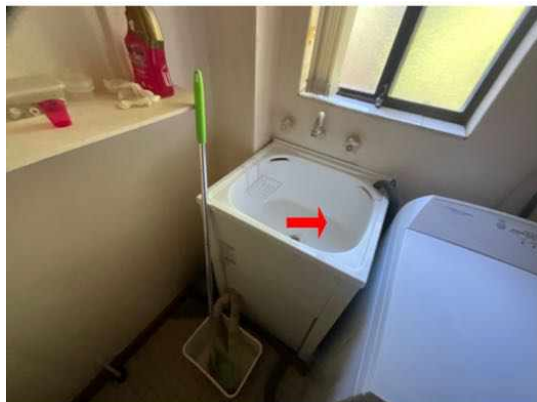
Finding 3.05

Building: Main Building
 Location: Laundry
 Finding: Fitting or fixture - Loose sink
 Information:

The laundry sink in this area is loose and can be moved with minimal force applied by hand. The sink should be fixed firmly to the wall and/or floor.

If left unmanaged, the sink may move and cause damage to pipes, fitting and finishes.

A licensed plumber should be appointed to perform these rectification works.

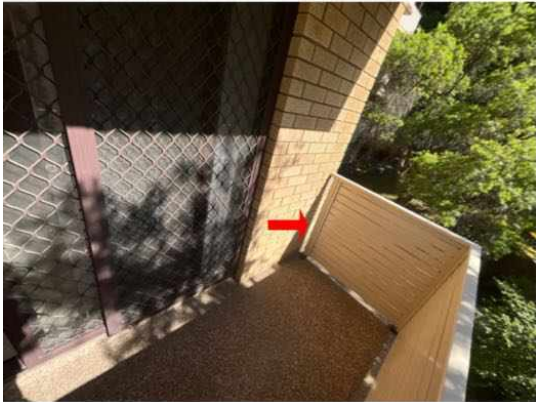
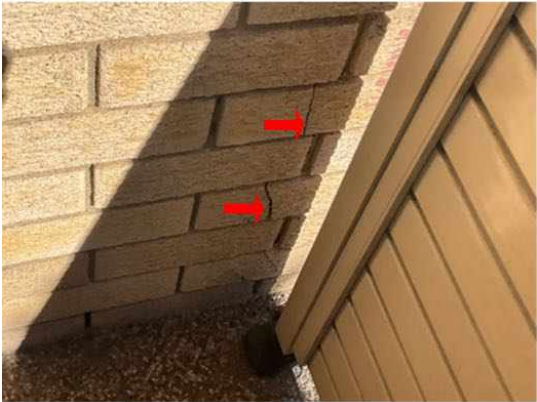
Finding 3.06

Building: Main Building
 Location: Master bedroom balcony
 Finding: Brickwork - Cracking [Fine]
 Information:

Although fine cracks are quite noticeable, they are often only considered to be an appearance defect and usually do not indicate any structural damage. Generally, the cause of a fine crack is indicative of a separation between brickwork and mortar throughout the structure, but single bricks may also show cracks of this nature.

Cracking of this nature can generally be repaired with minor filling and should be

conducted by a qualified bricklayer.

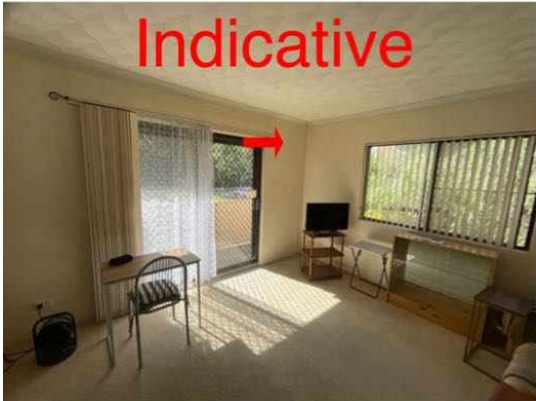
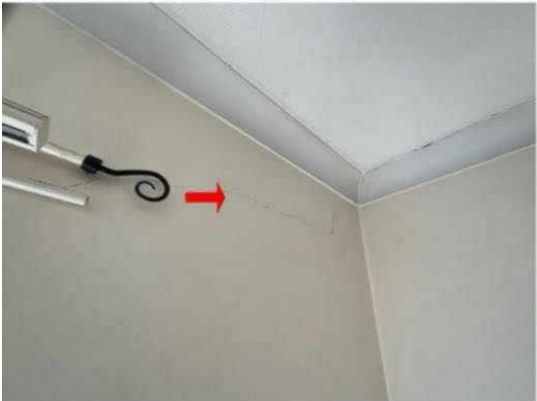
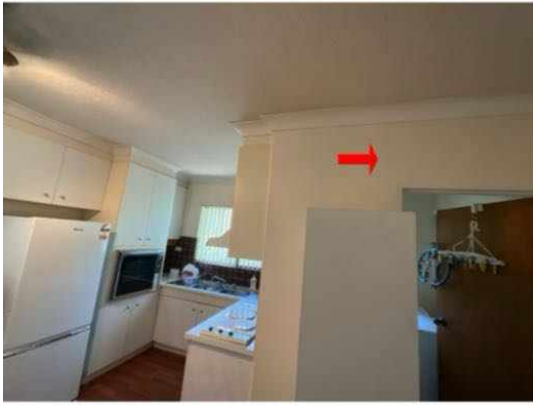
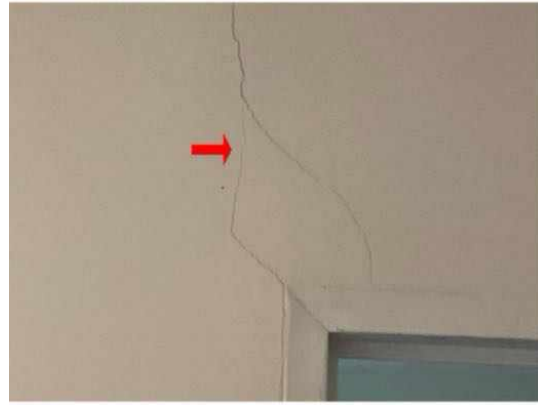
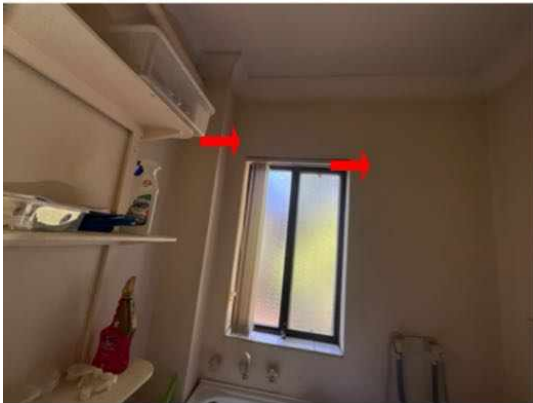
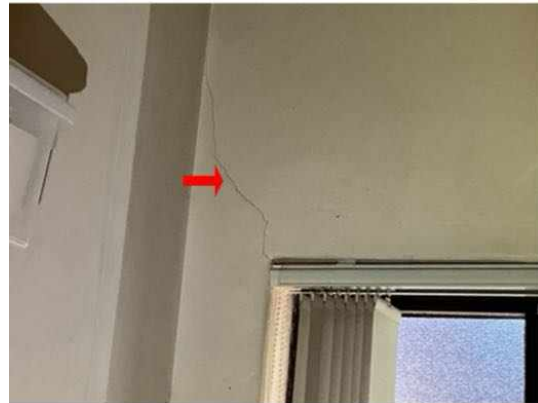
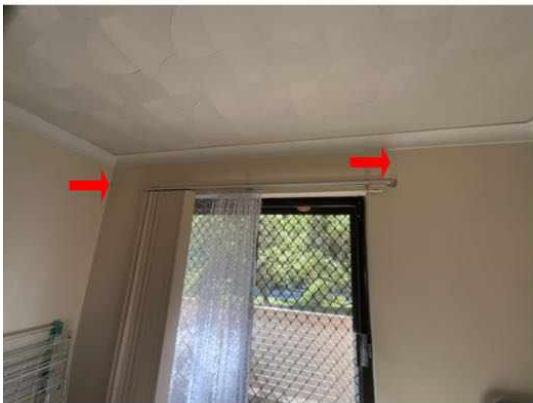
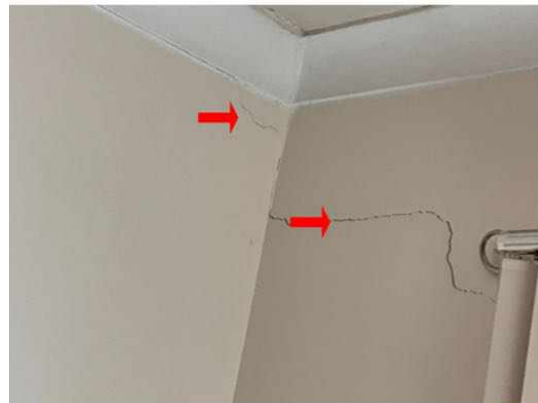
Finding 3.07

Building: Main Building
 Location: Multiple internal walls
 Finding: Cracks to internal render - Category 1
 Information: It has been observed that cracking to internal rendered surfaces has occurred. The degree of damage falls within Category 1, described as fine cracks that do not need repair and which are less than 1.0mm in width limit.

Damage of this category is not considered a defect for rectification. Always contact your building inspector should cracks widen, lengthen, or become more numerous.

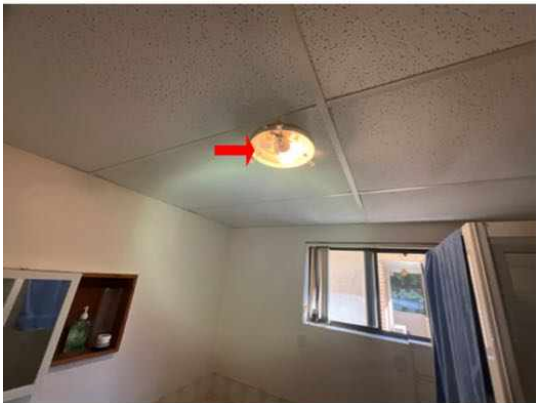
Finding 3.08

Finding: Light cover - Missing (Cosmetic)

Information: The light cover in this area was found to be missing at the time of inspection. Breakage occurs generally when the building materials have aged and decayed, but may also be indicative of impact damage to the building element (accidental or deliberate). This is mainly a cosmetic defect which can be replaced by the home owner.

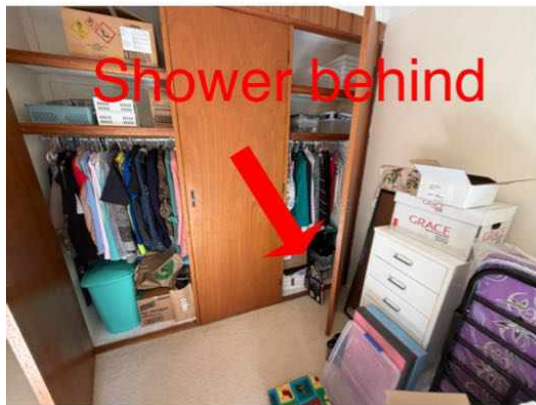
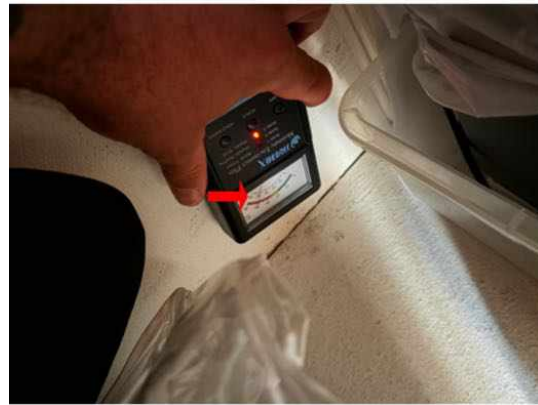
Building:	Main Building
Location:	Master bedroom cupboard
Finding:	Water leak suspected - Internal
Information:	A water leak is suspected in this area at the time of inspection. Internal water leaks can be detrimental to surrounding building elements; their potential causes include damage to plumbing fittings and fixtures, through to water damage and deterioration of associated building elements.

Rust, corrosion, decay and water damage are potential outcomes where a minor water leak is left unattended. More serious defects may also result, such as electrical hazards, or water damage to structural building elements.

In extreme cases, structural damage may develop due to a prolonged water leak. It is highly advised that a bathroom specialist be appointed urgently for further assessment and repair.
