Building and Timber Pest Inspection Report

Inspection Date: Tue, 10 Mar 2026

Property Address: 6 Beatrice St, Preston VIC 3072, Australia

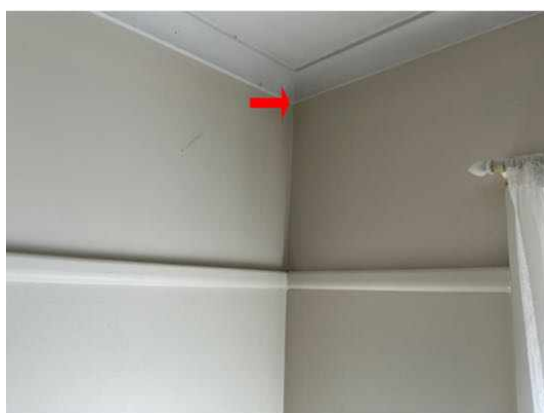
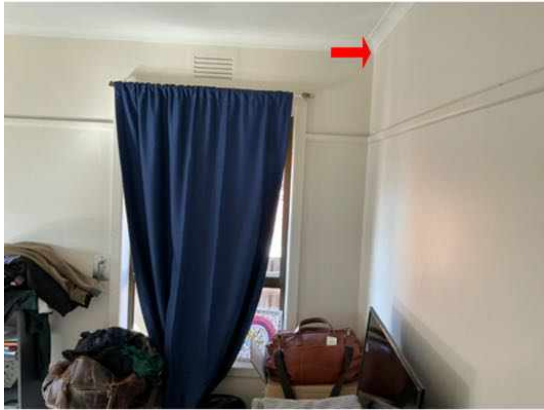
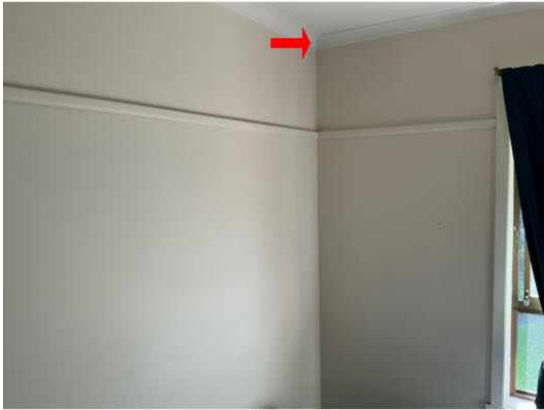
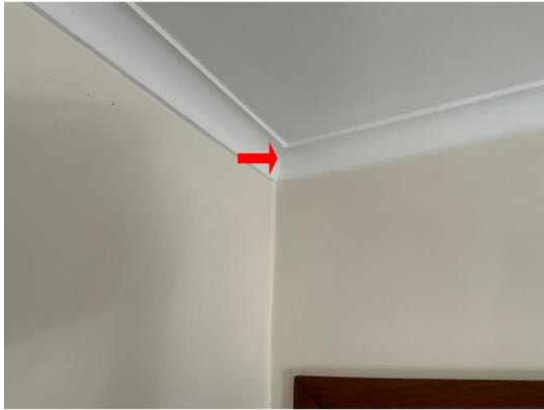
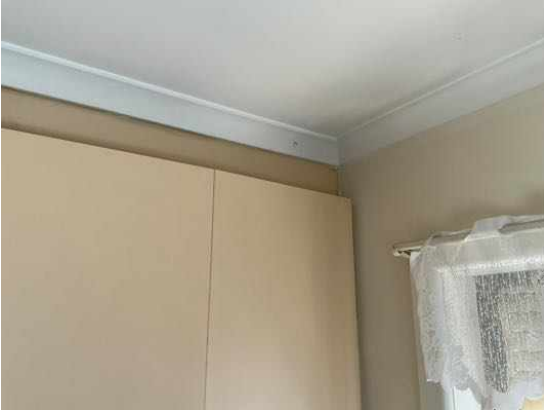
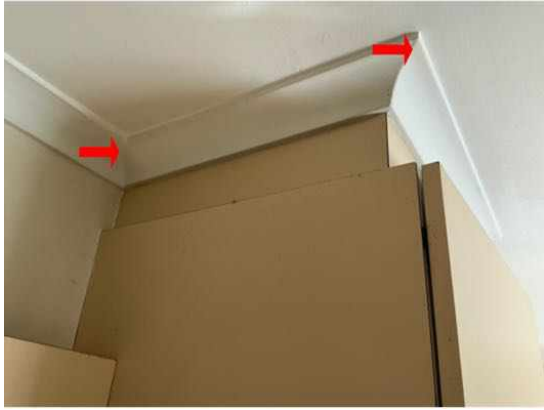
Building:	Main Building
Location:	All Areas
Finding:	Cracking - Damage Category 1 - Fine (up to 1mm)
Information:	Although fine cracks are quite noticeable, they are often only considered to be an appearance defect, and usually do not indicate any structural damage. Generally, the cause of a fine crack is indicative of a separation between building materials and finishes (e.g. paint, plaster, etc.) along joins.

In this instance client have indicate that these cracks become visible after roof leaks. However the leaks have been repaired, and hence no change in terms of sizes.

Cracking of this nature can generally be repaired with minor sanding, filling and/or repainting. Such works should be performed by a qualified Painter or a general Handyman.

Monitoring of all cracking should be conducted frequently. Always contact a Building Inspector should cracks widen, lengthen, or become more numerous.

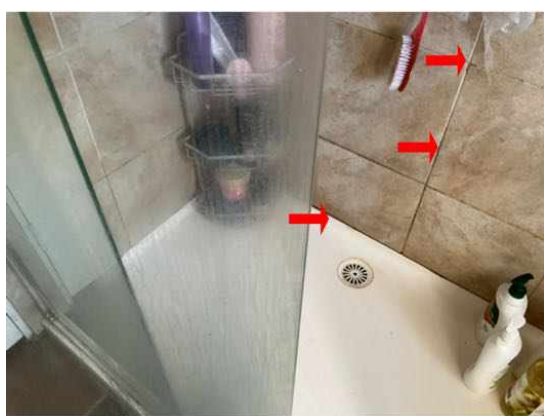
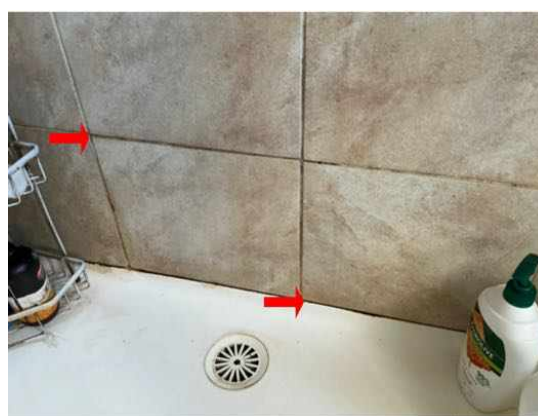
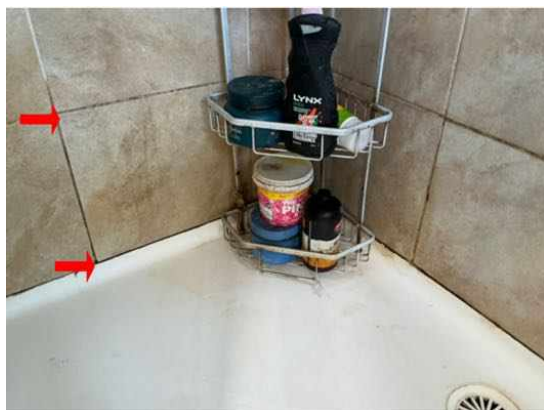
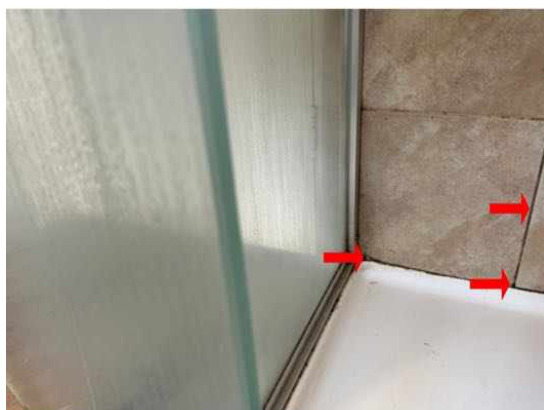
Finding 3.02

Building:	Main Building
Location:	Bathroom
Finding:	Sealant and grouting - Missing or damaged
Information:	During inspection, it was observed that the sealant or grout has degraded to the tiled shower wall. A flexible sealant is necessary to accommodate the anticipated expansion and contraction while maintaining the joint water-tight and protective of all associated building materials.

The absence of sealant between tiles can cause water to seep into the wall behind it.

Unmanaged damp in the kitchen area is likely to facilitate the formation and development of mould and fungi growth, causing the decay of associated building materials and compromising their structural integrity. It is crucial to address damp conditions, as the World Health Organisation states that excess moisture leads to the growth of microbes such as moulds, fungi, and bacteria, which subsequently emit spores and other matter into the indoor air. Exposure to these contaminants is associated with a wide range of respiratory and other health-related issues. Damp conditions also create a conducive environment for termite infestation.

Regular maintenance and replacement of damaged, missing, or damaged sealant and grout are highly recommended for wet areas, as this is a regular wear-and-tear defect. Sealant and grouting in areas that come into regular contact with water should be maintained for the long-term care of your property.

Consultation with a sealant specialist is advised immediately to perform remedial works as necessary. Epoxy grout is highly recommended

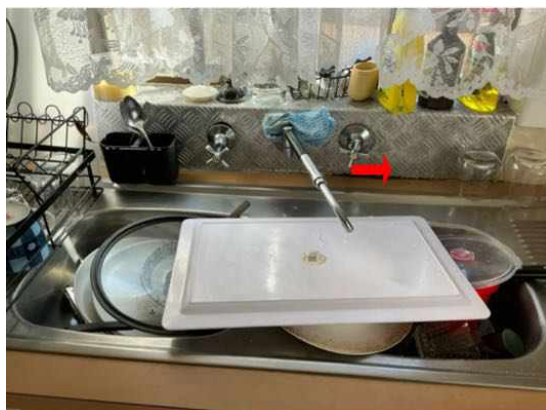
Finding 3.03

Building:	Main Building
Location:	Kitchen
Finding:	Sealant- Missing
Information:	The lack of sealant between splash back and sink can cause water damp to the wall behind it.

Unmanaged damp in the Kitchen area is likely to facilitate the formation and development of mould and fungi growth, decaying associated building materials and compromising their structural integrity of associated elements. It is important to address damp conditions , as the World Health Organisation notes that excess moisture leads - on almost all indoor materials - to growth of microbes such as moulds, fungi and bacteria, which subsequently emit spores and other matter into the indoor air. Exposure to these contaminants is associated with a wide range of respiratory and other health-related problems. Damp conditions also create a conducive environment for termite infestation.

Consultation with a sealant specialist is advised immediately to perform remedial works as required.

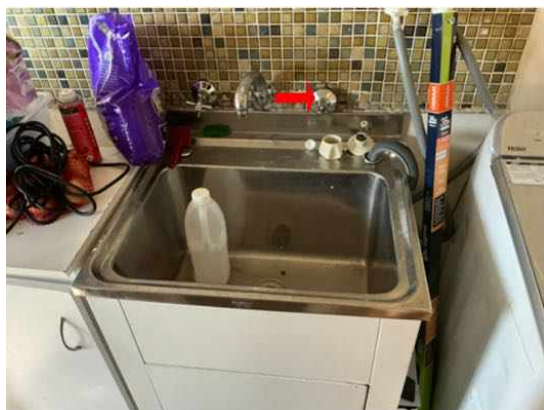
Finding: Tap handle- Broken

Information: The tap handle of the laundry trough has not been broken. This tap handle being broken creates potential for water leaks and subsequent water damage to the surrounding area.

Where taps or spouts are broken , a qualified plumber should be appointed to re-fix the plumbing fitting as soon as possible .

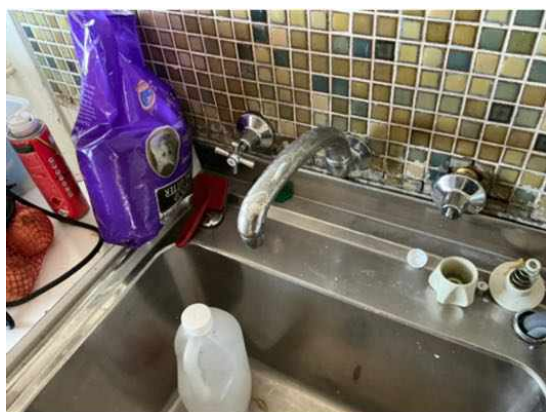
Finding 3.06

Building:	Main Building
Location:	Laundry
Finding:	Sealant and grouting - Missing or damaged
Information:	During inspection, it was observed that the sealant or grout has degraded to the tiled splashback and bench top in the kitchen. A flexible sealant is necessary to accommodate the anticipated expansion and contraction while maintaining the joint water-tight and protective of all associated building materials.

The absence of sealant between tiles can cause water to seep into the wall behind it.

Regular maintenance and replacement of damaged, missing, or damaged sealant and grout are highly recommended for wet areas, as this is a regular wear-and-tear defect. Sealant and grouting in areas that come into regular contact with water should be maintained for the long-term care of your property.

Consultation with a sealant specialist is advised immediately to perform remedial works as necessary.

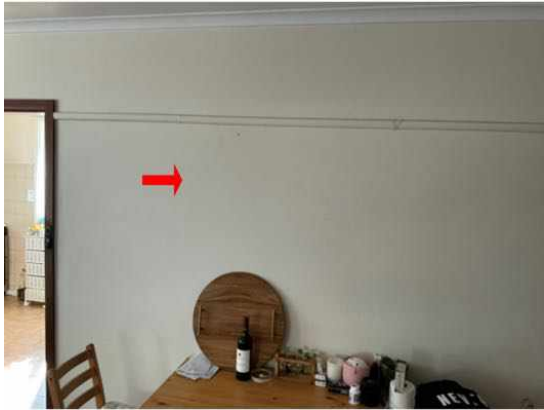
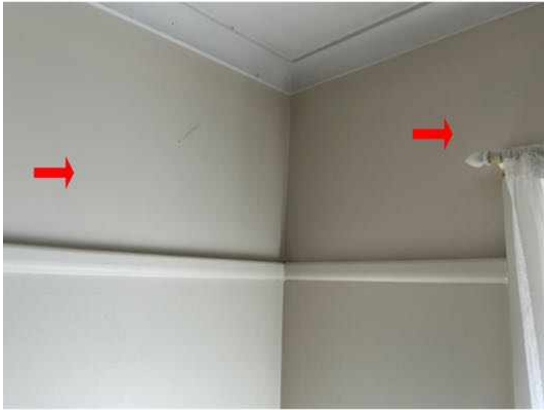
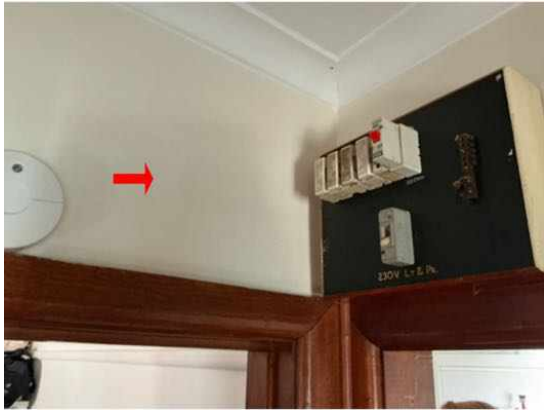
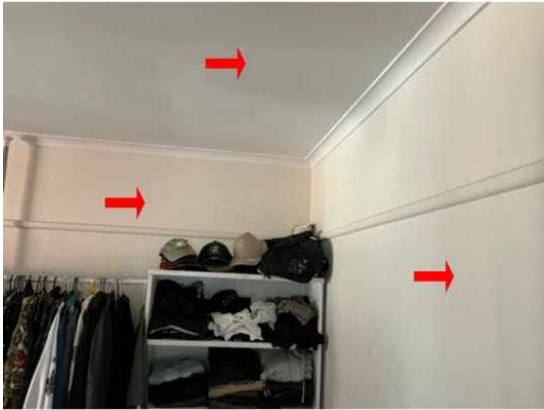
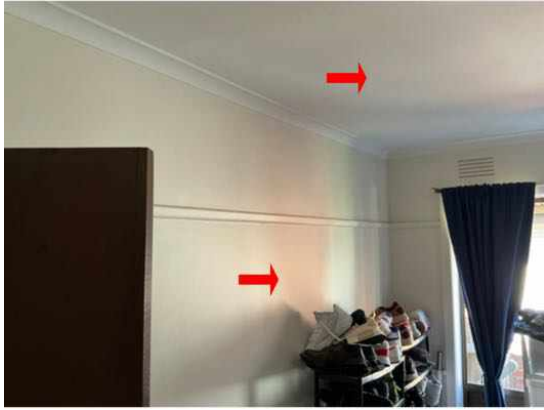
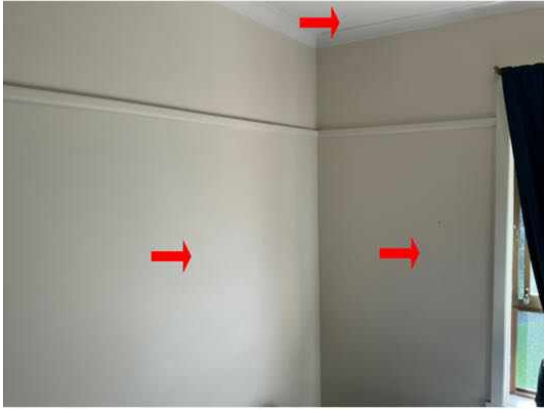
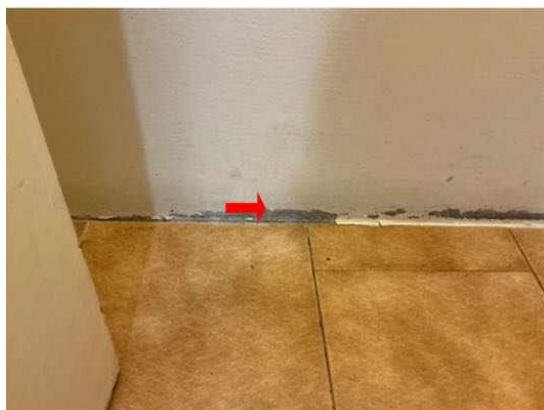
Finding 3.07

Building:	Main Building
Location:	All Internal Areas
Finding:	Internal Painting Deteriorated
Information:	Much of the internal paintwork including but not limited to ceiling, walls, doors and windows have been neglected and require attention to prepare and re-paint.

Whilst incomplete or missing paint finish is generally an appearance defect, it can also lead to the development of secondary building defects over time. Incomplete areas of paint finish expose the area to moisture, potentially accelerating the deterioration of underlying building materials.

Degraded paint finishes should be sanded back, filled, leveled and painted, as applicable. Where inadequate or missing paint protection has led to the deterioration of the associated building element, repair and/or replacement of this building element may be required.

A Painting contractor should be appointed as soon as possible to perform necessary works to aid the appearance of the affected area and to ensure the area is protected against further deterioration. Alternatively, the Homeowner following manufacturer instructions may perform these works.

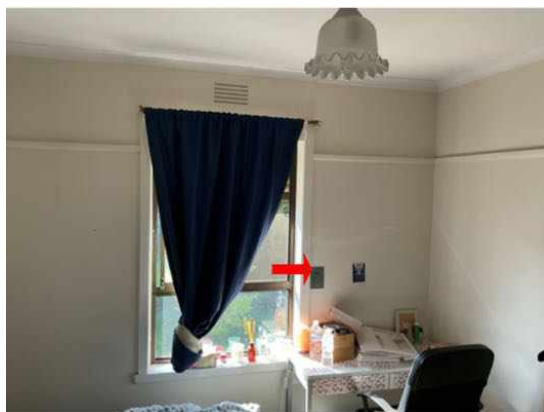
Finding 3.08

Building: Main Building
 Location: All Areas
 Finding: Window Roller Shutter - Missing handle/ Broken
 Information: The handle to the window roller shutter was missing at the time of the inspection. Absence of the handle limits the operation of the shutter may pose as a safety risk.

Replacement of the handle should be conducted as soon as possible. A general handy person or qualified carpenter should be appointed to perform these works to improve the operational state of the affected window shutter and improve the safety of the internal area.

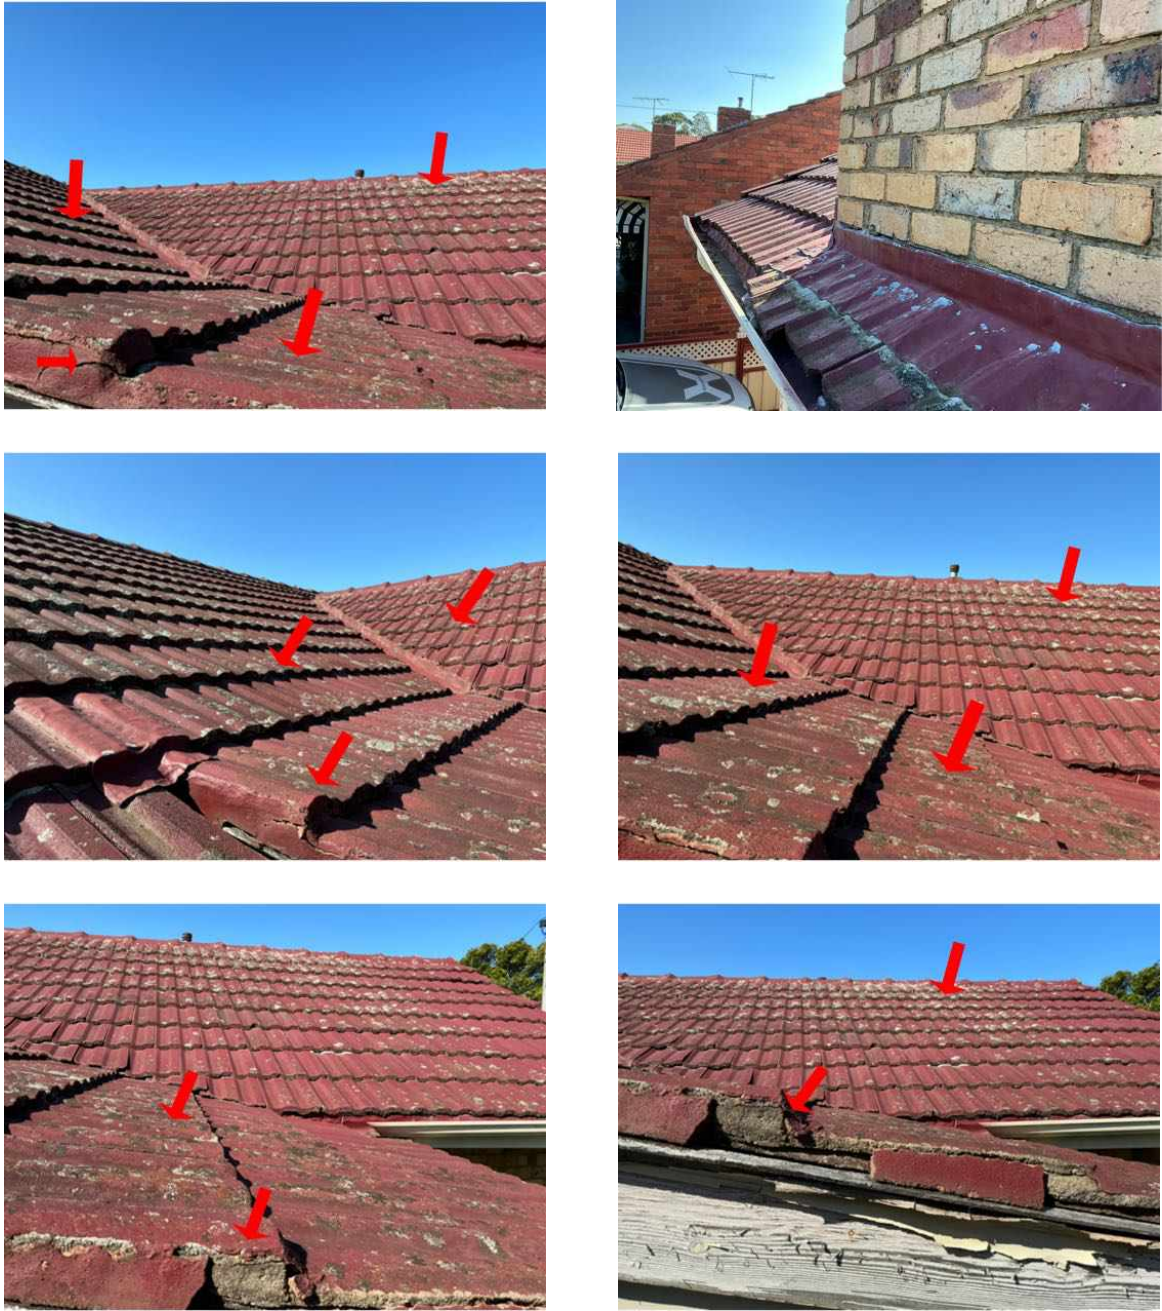
Finding 3.09

Building: Main Building
 Location: Roof Exterior
 Finding: Roof tiles - Weathered
 Information: Upon inspection of the exterior roofing, the majority of roof tiles were considered to be in a fair condition. While weathering of the tiles is consistent with the age of the property, maintenance works are required.

Isolated areas of mortar have come loose in the valleys and minor cracking is also

Where left unmanaged, deteriorating roof tiles are likely to lead to a number of secondary defects, including minor water leaks and weather exposure to internal roofing structures.

Consultation with a roofing contractor is highly advised to gain advice on cost of remedial works that may be required in the short to medium term. Remedial works are likely to increase the longevity of the exterior roofing structure.

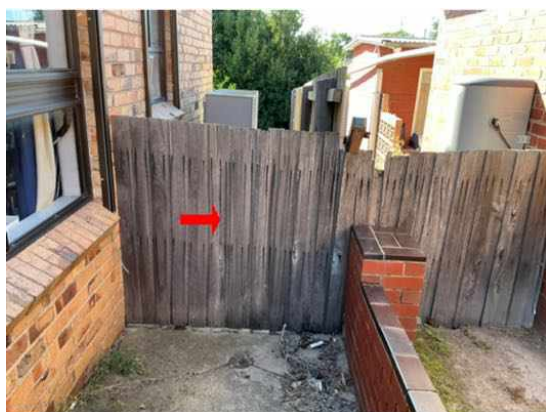
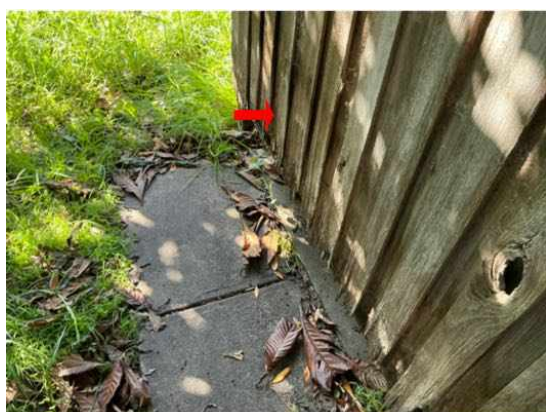
Finding 3.10

Building: Main Building
 Location: Fencing
 Finding: Fencing - Deteriorated
 Information: It was noted at the time of inspection that sections of the fencing throughout the property have deteriorated. Typically fencing deteriorates due to age and or wear, rot and or rust which is generally expected for a structure of this age, due to prolonged exposure to weather conditions. Sometimes inadequate installation or maintenance can be to blame.

If left unattended, it is likely that further damage will occur. It is suspected that repair of several elements of the fencing may be required however replacement may be a consideration of the client also.

A licensed fencing contractor should be appointed to provide further advice and perform rectification works as necessary.

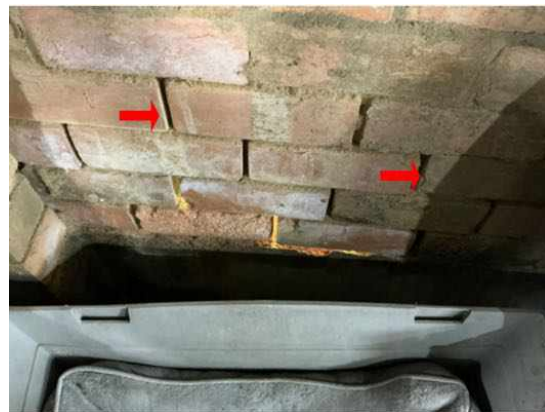
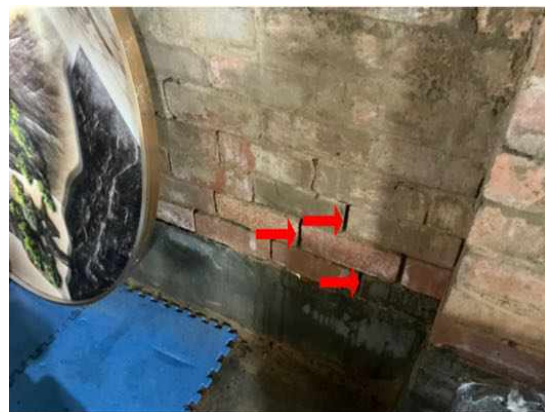
Finding 3.11

Building: Main Building
 Location: Garage
 Finding: Brickwork - Deteriorated mortar throughout the wall
 Information: Mortar, or 'bedding', is the material which fills joints and intersections between bricks in masonry walls and structures. Sections of mortar in this brickwork were identified as

having deteriorated, which is generally expected for a property of this age and condition.

Mortar may deteriorate as a result of age of building materials, minor movement of bricks, or frequent exposure to weathering. Mortar should be replaced to ensure that bricks remain in their intended location and to prevent gaps, which would allow water or moisture ingress and secondary damage as a result.

Mortar deterioration can be addressed by a Bricklayer where areas of deterioration are localised and easily accessible. Alternatively, appointment of a registered Builder is advised, to repoint large areas of decaying mortar. Where secondary structural defects have become evident, consultation with a Structural Engineer may be required.

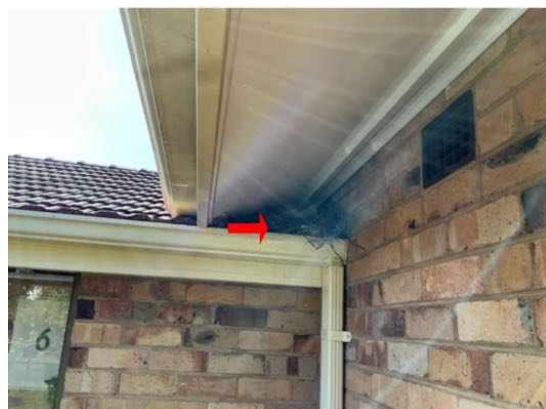
Blocked gutters are likely to lead to high levels of moisture in the affected areas. Such moisture will not only cause rust and decay of the associated building materials, but can also provide conditions that are conducive to termite and timber pest activity. Blockages in gutters should therefore be removed immediately to ensure dry conditions are maintained.

Consult a Licensed Plumber for further specific advice on remedial works that may be required. In the interim, it is highly advised that blocked gutters be removed by the homeowner or a general handyperson as a matter of urgency.

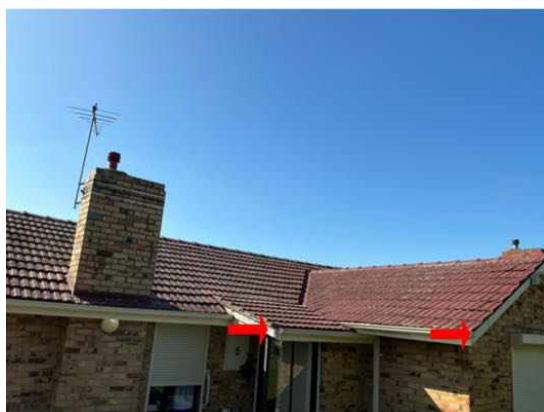
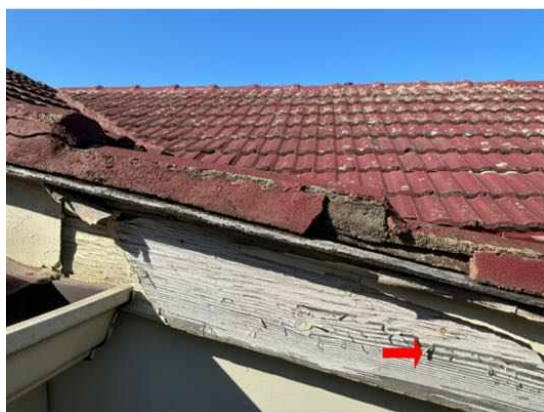
Finding 7.01

Building:	Main Building
Location:	All External Areas
Finding:	Fascias - Wood rot
Information:	Wood rot was found to be affecting fascias and barges in this area, evidenced by the presence of mould on the surface in some areas. Wood rot, also known as Fungal Decay, occurs when timbers and other cellulose building materials are exposed to damp conditions on an ongoing basis.

It is likely that this wood rot has developed as a result of faults in the roof plumbing, creating excessive moisture in this areas. Frequent exposure to rain and other weather

conditions also make fascias and barges susceptible to accelerated deterioration.

Early intervention and regular maintenance will prolong the useful life of these building elements. Prior to any works being performed, the cause of the moisture that has created the visible wood rot should be identified and addressed in a suitable manner.

It is advised that a roof plumber be appointed to inspect all roof plumbing and subsequently identify the cause of the wood rot. Replacement of affected fascias and barges may then be a necessary step in protecting surrounding building elements from such deterioration.

A qualified plumber may be appointed to assess the cause of excessive moisture and to provide advice on any remedial works as required. A qualified carpenter or registered builder may also be required to replace affected building materials.
