Building and Timber Pest Inspection Report

Inspection Date: Wed, 5 Nov 2025

Property Address: 7 Courtenay Rd, Rose Bay NSW 2029,
Australia

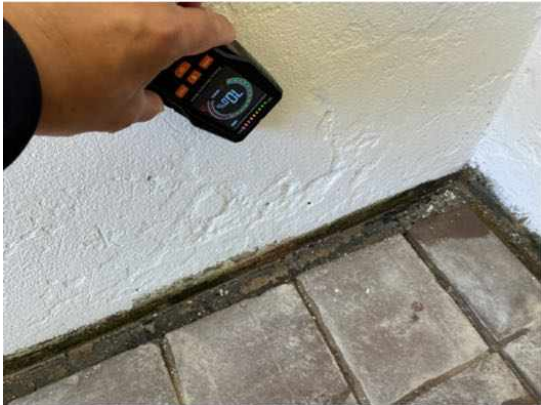
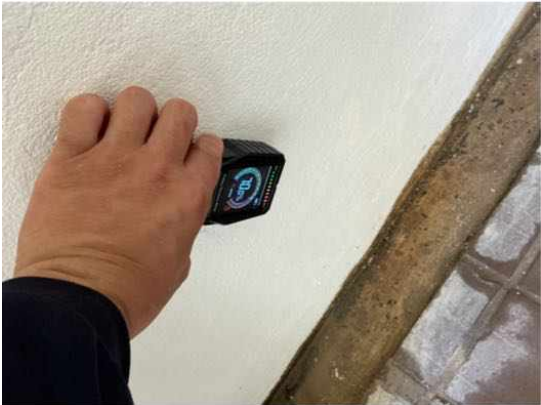
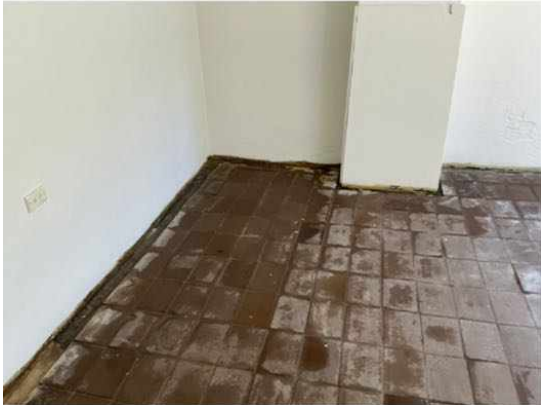
Finding 3.01

Building:	Studio
Location:	All Internal Areas
Finding:	Damp - Rising
Information:	Rising damp describes the upward movement of water in low sections of building elements (e.g. walls) by capillary action - the movement of water through porous materials such as bricks, sandstone or mortar.

Rising damp is generally managed by the installation of a damp proof course during construction. A Damp Proof Course (DPC) is an impermeable barrier at the base of the wall above ground level. However, many 19th Century buildings have no damp course installed, or the materials have failed. The DPC may have been omitted as a consequence of poor workmanship, or it may have been bridged where materials built up against the side of the house allow moisture ingress above the DPC level.

Left unmanaged, rising damp can lead to health problems resulting from mould growth and can have major implications on affected building elements, including wall finishes like paint and plasterwork.

The first step in addressing rising damp is to diagnose the cause. The identified cause should be addressed first before addressing the appearance and other defects which have resulted from the rising damp. If the original cause is not resolved, further cases of damp are likely to ensue, resulting in secondary defects.

Consultation with a qualified plumber is advised immediately to identify the cause of the damp and perform remedial works as required.

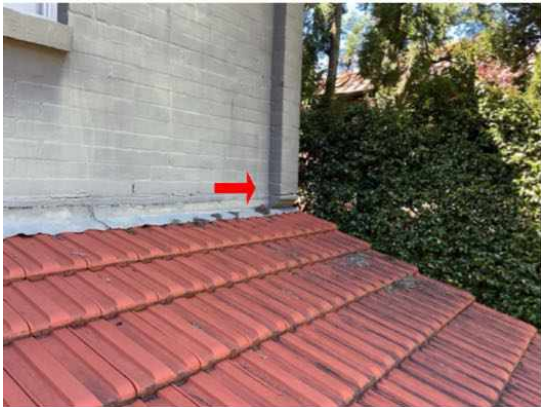
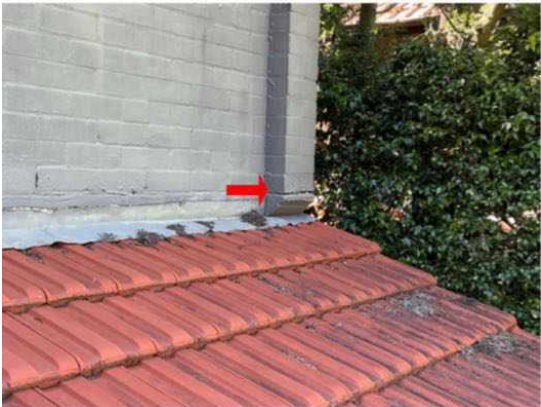
Finding 3.02

Building: Main Building
Location: Front Elevation
Finding: External Wall Gap Observation
Information: During the inspection, it was noted that there is a visible gap in one section of the external wall. The gap may allow water penetration or contribute to moisture ingress over time if left unsealed. It is recommended that the area be properly sealed and monitored to prevent potential deterioration or structural issues in the future.

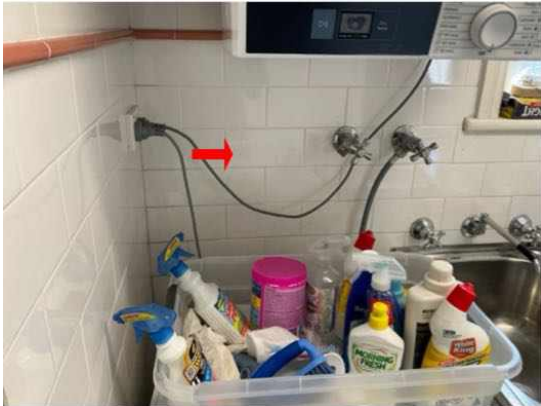
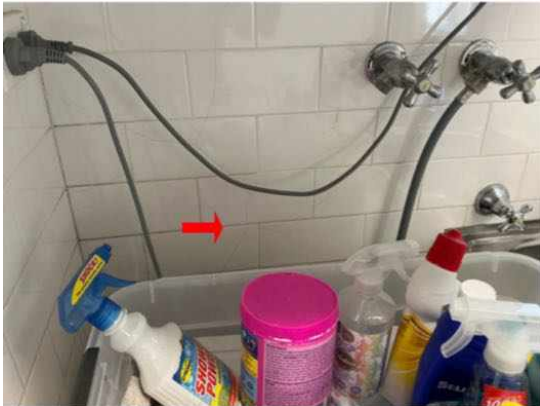
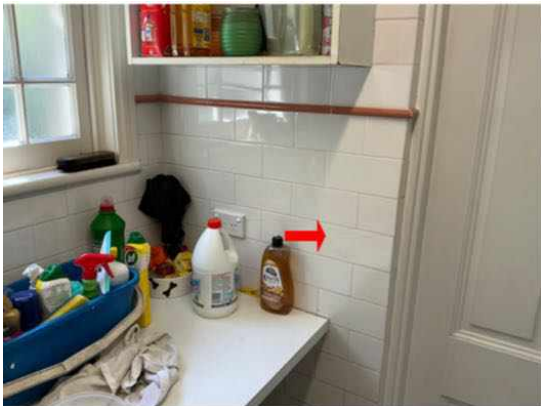
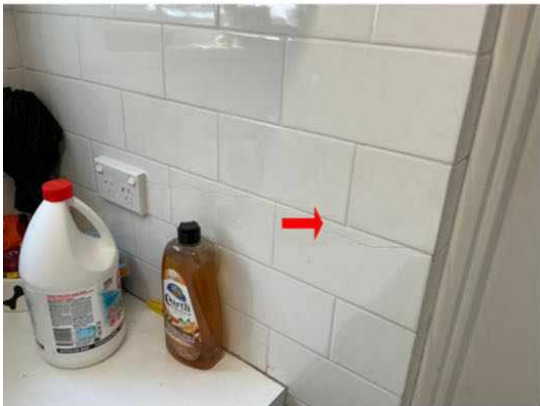
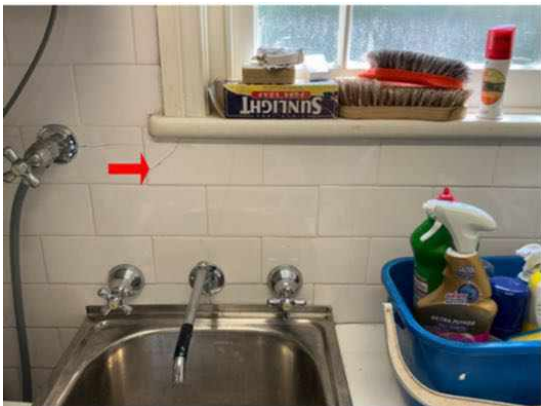
Finding 3.03

Building: Main Building
Location: Laundry
Finding: Cracked Wall Tile Noted
Information: During the inspection, a crack was noted in the wall tile at this location. While this appears to be a cosmetic issue and does not currently affect the structural integrity of the wall, it may impact the overall appearance and could worsen over time if not addressed. A tiler or general handyman would be suitable to assess and repair or replace the damaged tile.

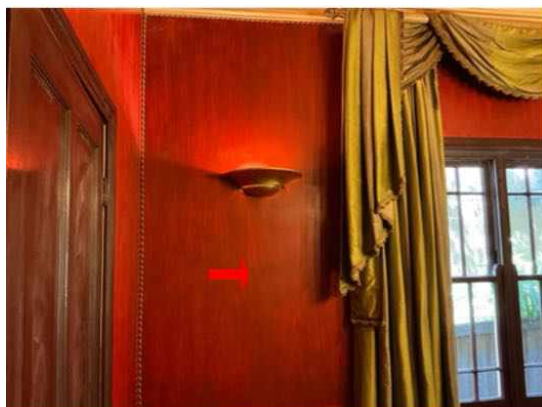
Finding 3.04

Location: Dining Room
 Finding: Cracks to internal render - Category 0
 Information: It has been observed that cracking to internal rendered surfaces has occurred. The degree of damage falls within Category 0, and is described as hairline cracking, which is less than 0.1mm in width. Damage of this category is not considered a defect for rectification.

No rectification is required at this time. Always contact your building inspector should cracks widen, lengthen, or become more numerous.

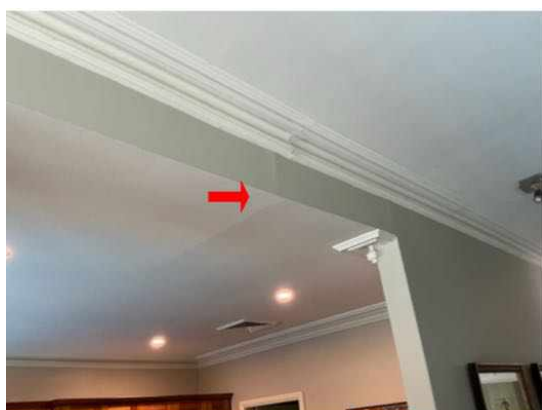
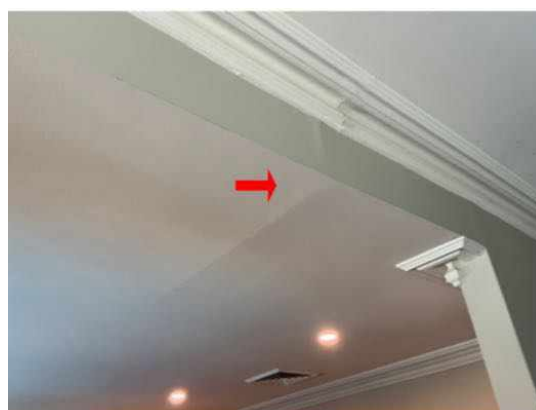
Finding 3.05

Building: Main Building
 Location: Kitchen
 Finding: Ceiling - Sagging
 Information: Sections of the ceiling were found to be sagging at the time of inspection. Sagging to the fixed ceiling structure generally indicates that fixings (e.g. nails or glue) have become loose and require reattachment.

Where minor sagging is evident, comparatively minor works, such as re-gluing of ceiling sheets, may be required. Such works may be performed by relevant tradespeople, such as plasterers and painters.

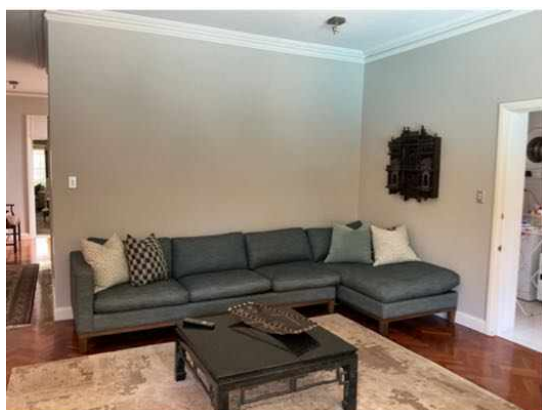
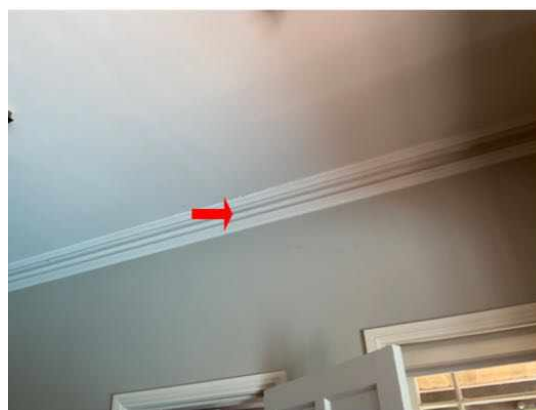
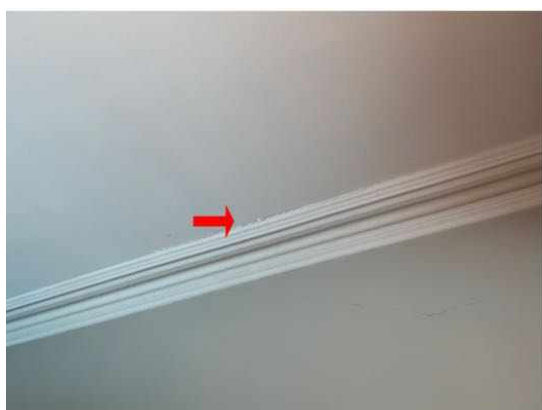
Finding 3.06

Building:	Main Building
Location:	Lounge Room
Finding:	Cracking - Damage Category 1 - Fine (up to 1mm)
Information:	Although fine cracks are quite noticeable, they are often only considered to be an appearance defect, and usually do not indicate any structural damage. Generally, the cause of a fine crack is indicative of a separation between building materials and finishes (e.g. paint, plaster, etc.) along joins.

Cracking of this nature can generally be repaired with minor sanding, filling and/or repainting. Such works should be performed by a qualified painter or a general handyman.

Monitoring of all cracking should be conducted frequently. Always contact a building inspector should cracks widen, lengthen, or become more numerous.

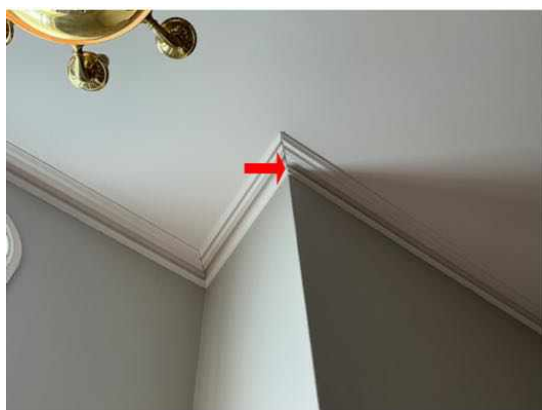
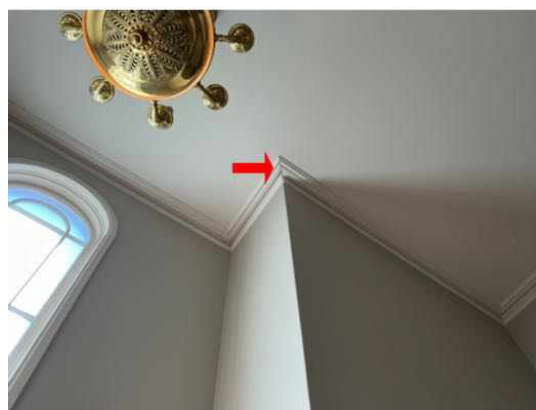
Finding 3.07

Building:	Main Building
Location:	Void
Finding:	Cracking - Damage Category 1 - Fine
Information:	Although fine cracks are quite noticeable, they are often only considered to be an

appearance defect, and usually do not indicate any structural damage. Generally, the cause of a fine crack is indicative of a separation between building materials and finishes (e.g. paint, plaster, etc.) along joins.

Cracking of this nature can generally be repaired with minor sanding, filling and/or repainting. Such works should be performed by a qualified painter or a general handyman.

Monitoring of all cracking should be conducted frequently. Always contact a building inspector should cracks widen, lengthen, or become more numerous.

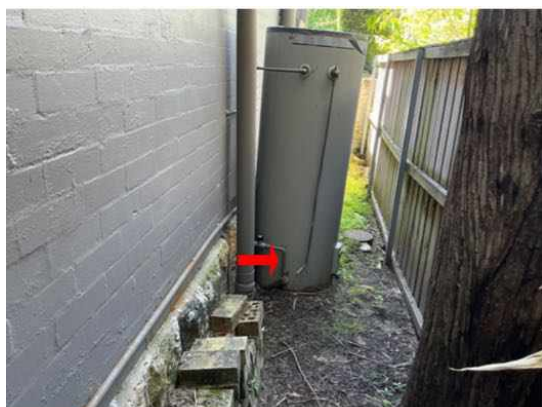
Finding 6.01

Building:	Main Building
Location:	Exterior walls - right side
Finding:	HWS Overflow - Not Connected
Information:	The Hot Water System (HWS) overflow was found to be disconnected from storm water drainage and is creating excessive moisture in the surrounding area.

These damp conditions can lead to secondary defects such as rot, rust or corrosion of associated building elements, the formation of fungal decay, or even the creation of potential slip hazards. When coupled with poor site drainage, pooling of water may also attract termite activity to this area.

It is highly recommended that a licensed plumber be appointed to connect the HWS overflow in order to prevent such an environment from being created. These minor works should be carried out as soon as possible.

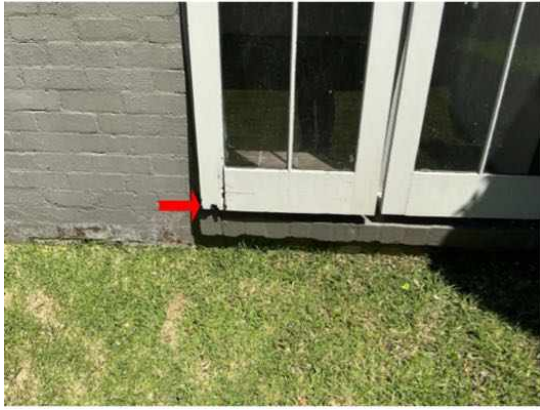
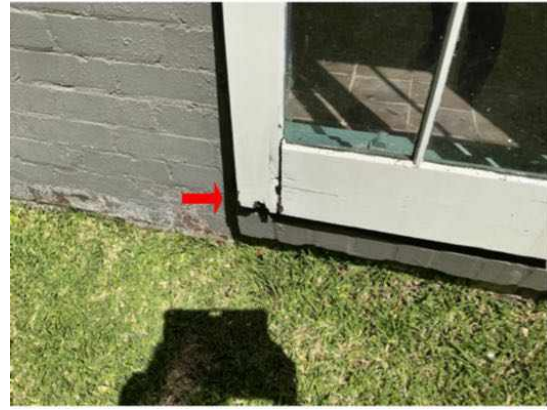
Finding 7.01

Building:	Studio
Location:	Window
Finding:	Fungal decay - present (localised)
Information:	Fungal decay also known as wood decay or wood rot generally refers to the deterioration of timber elements when in contact with excessive levels of moisture for a prolonged period of time.

The development of fungal decay is accelerated by temperatures in the range of 5degreeC to 40degreeC as well as the presence of oxygen. Generally fungal decay develops on timber elements that are in use in an external environment which are exposed to rain penetration.

In this case although the affected timber element is in a decaying state the extent of any visible damage appears to be localised to a specific area and is yet to spread to other parts of the building element or affect adjoining structures. The fungal decay is therefore likely to be of a relatively superficial nature with minimal impact on the structural integrity or tensile strength of the timber element.

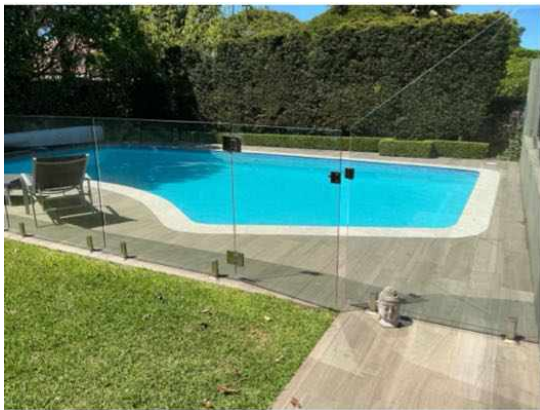
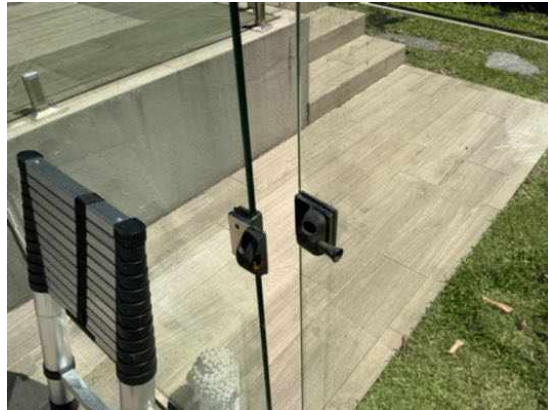
Building:	Main Building
Location:	Pool Area
Finding:	Pool Gate Not Self-Closing (Outside Scope of Inspection)
Information:	During the inspection, it was noted that the pool gate does not self-close as required. Inspection of the swimming pool area is outside the scope of this report; however, this observation is noted as a courtesy reminder, as a non-self-closing gate may present a potential safety concern and should be rectified by a licensed contractor if necessary.

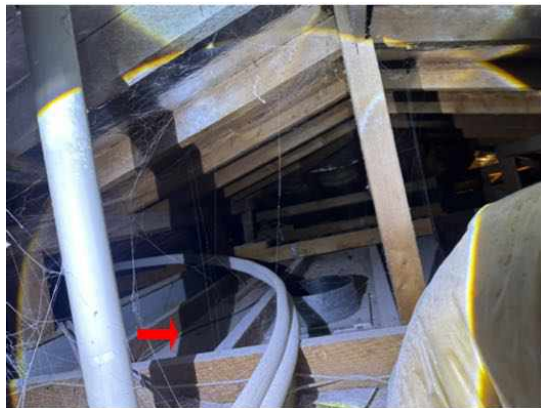
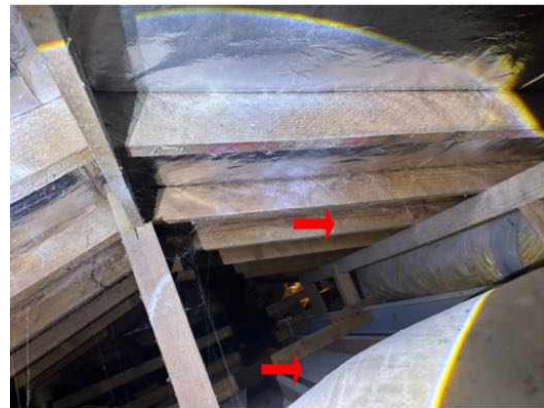
Building: Main Building
Location: Roof Void
Finding: Insulation - Missing
Information: Upon inspection of the roof void it was noted that insulation is not present.

Insufficient insulation will result in a comparatively higher cost to heat and cool a property as there is a lack of Insulation (or uneven coverage of insulation) which works as a barrier to heat transfer. This helps to keep out unwanted heat in summer and preserves warmth inside your home in winter. It can also help soundproof your home from unwanted airborne noise transfer.

Where insulation is absent, the area does not meet current Australian Standards. Installation of adequate insulation is required and should be conducted as soon as possible.
