Building and Timber Pest Inspection Report

Inspection Date: Thu, 26 Feb 2026

Property Address: 201A Wellington Rd, CHESTER HILL, NSW,
2162, Australia

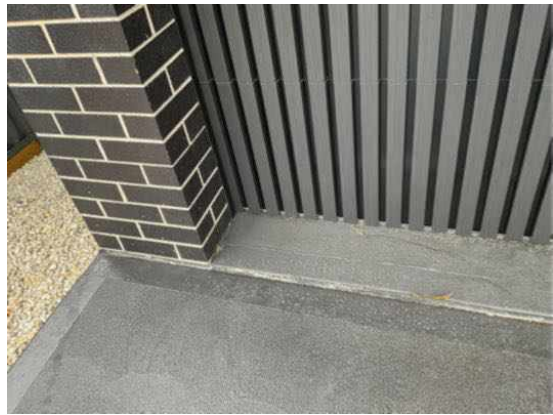
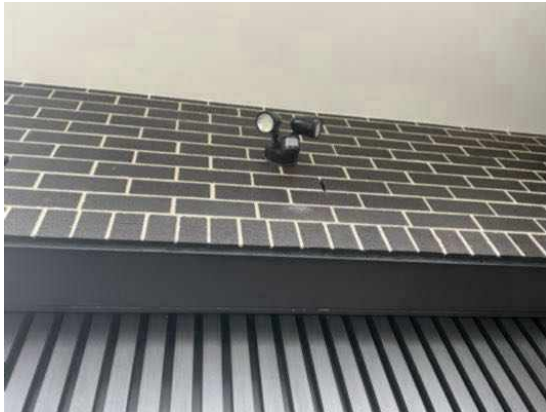
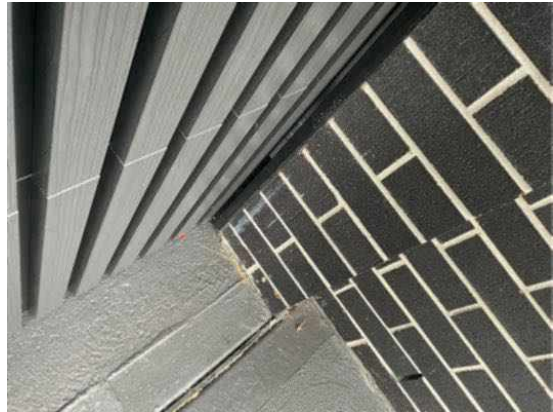
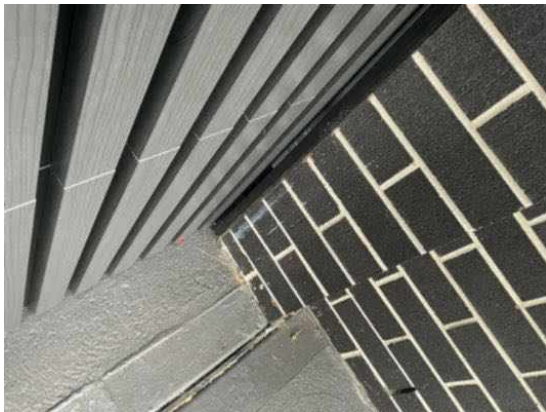
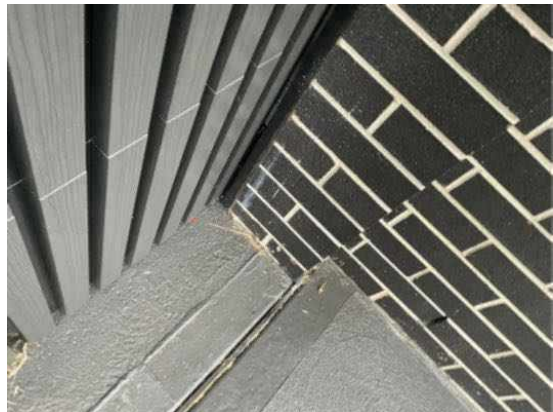
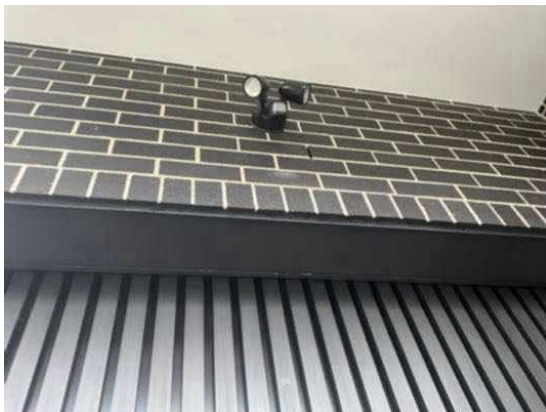
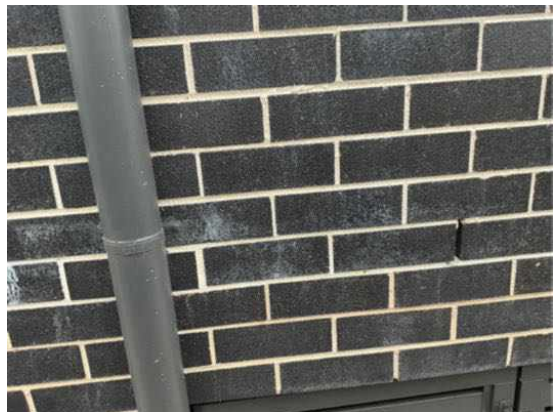
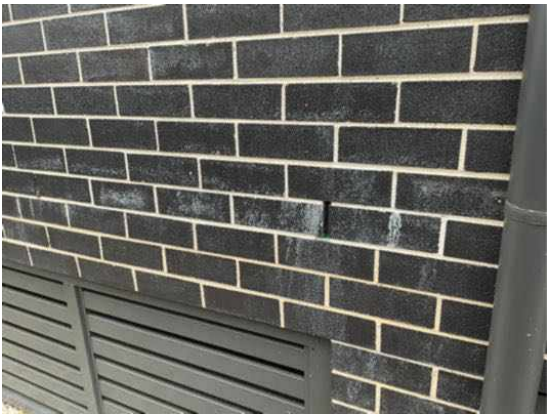
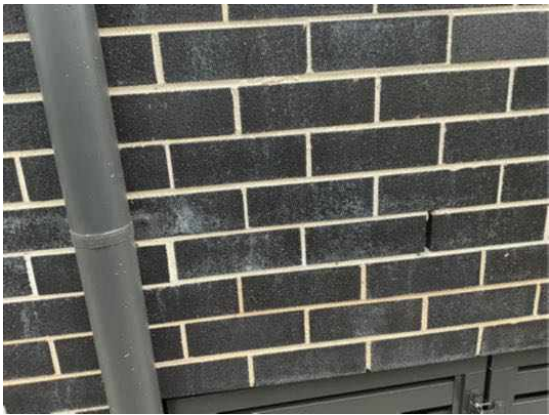
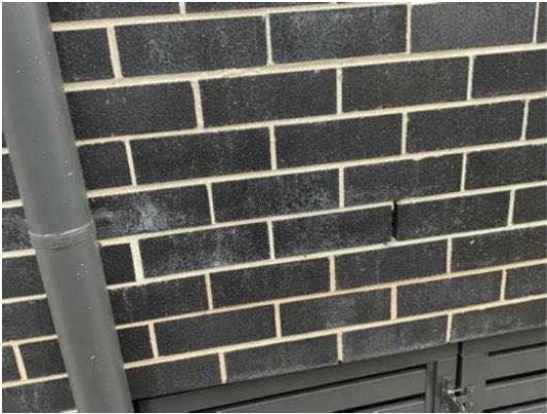
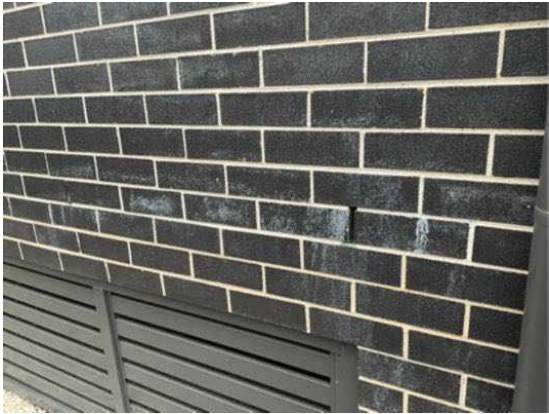
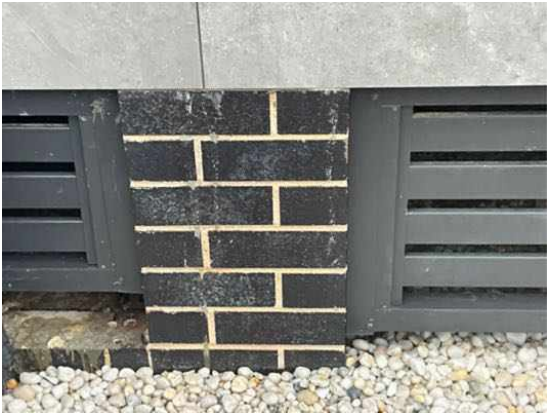
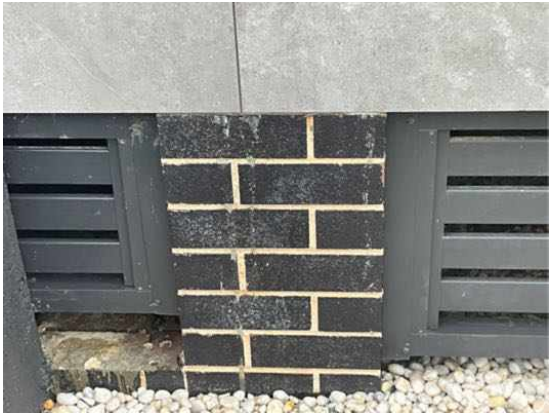
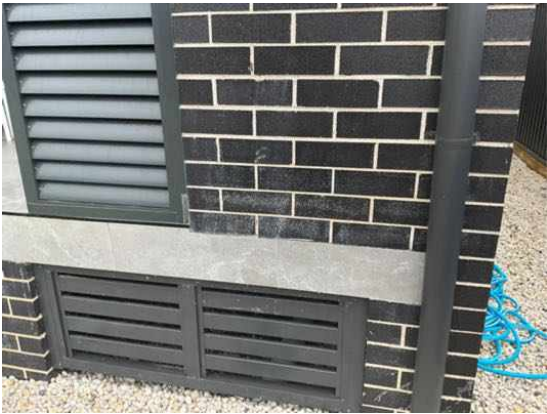
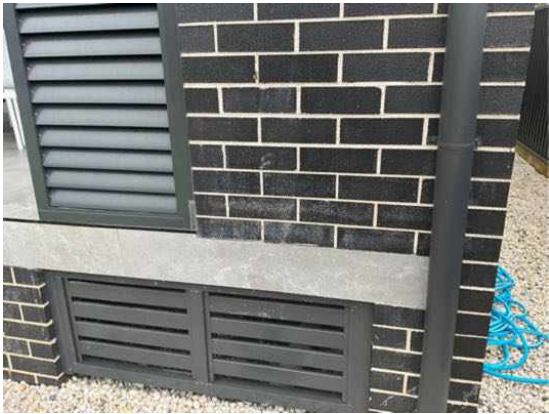
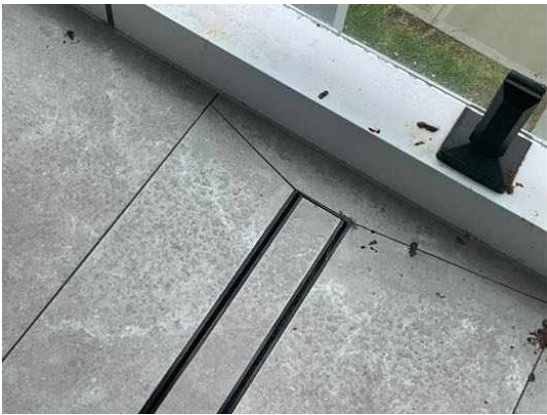
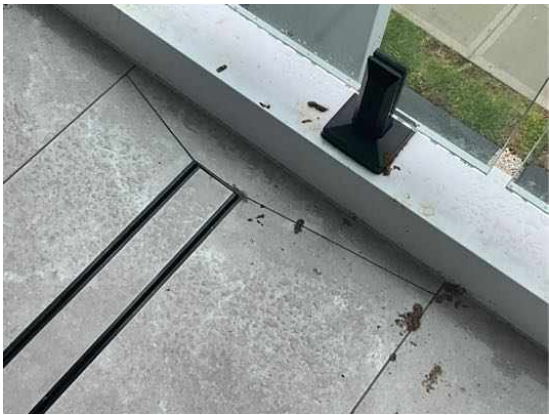
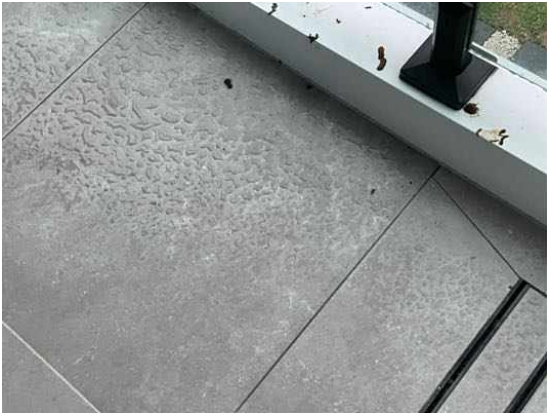
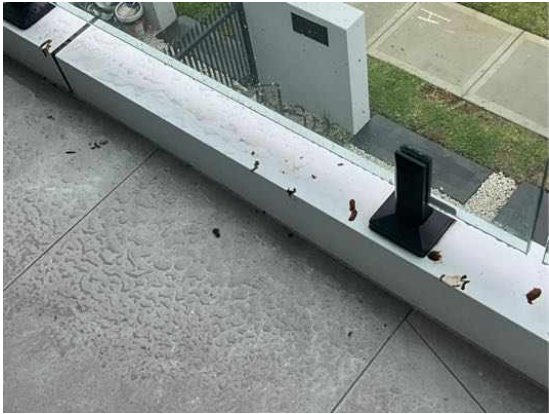
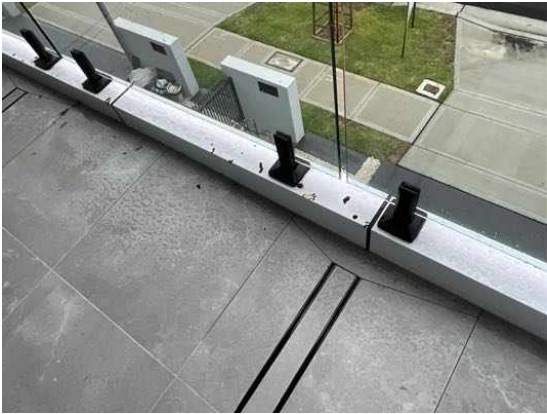
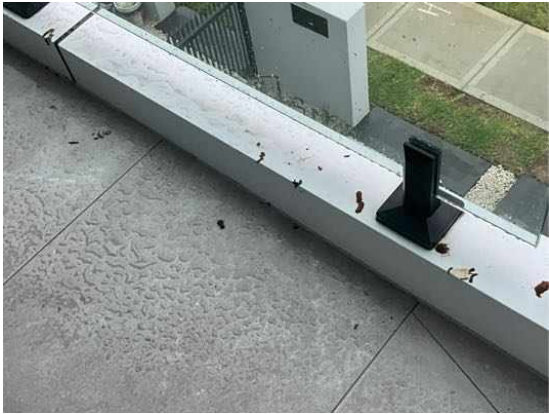
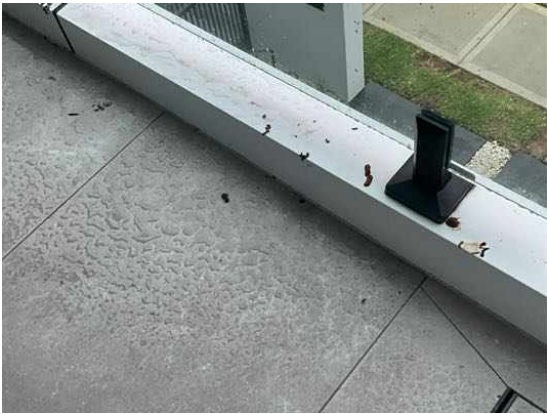
Finding 3.01

| Finding: | Cleaning required |
| Information: | It was observed that the house requires cleaning. |

Works are defective where windows are not clean, floors are not swept, mopped or vacuumed as appropriate, tiles, sinks, basins, baths, windows or any other area throughout the property are not cleaned, and shelving, drawers and cupboards are not ready for use not cleaned and ready for use at handover.

This is to be referenced against the Australian Standards & Tolerances clause 19.8 Cleaning.

This is to be addressed prior to handover.

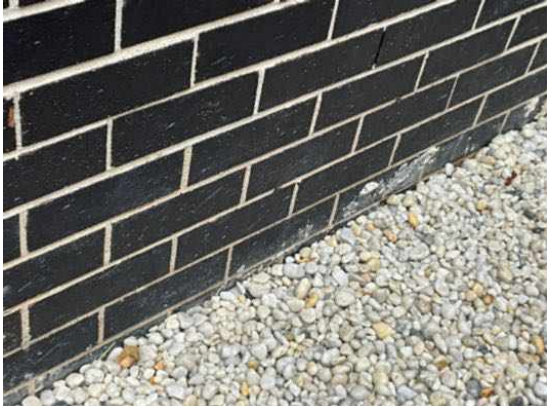
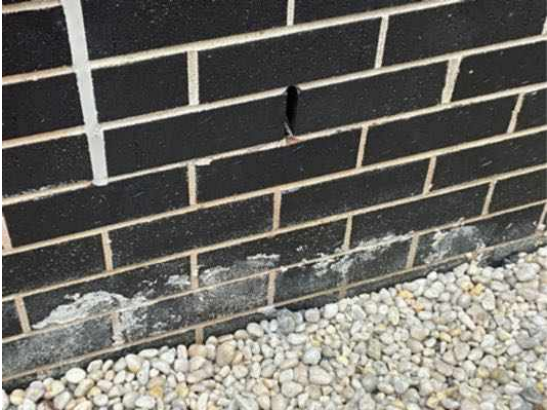
Finding 3.02

Building: Main Building
Location: All Areas
Finding: Brickwork - Excessive mortar (AS4455)
Information: It was observed at the time of inspection that several bricks in this area of brickwork require cleaning to remove excessive mortar. While not likely to cause secondary defects, excessive mortar detracts from the overall appearance of the area and should therefore be removed.

At the time of inspection, this area does not meet contractual requirements regarding acceptable finishes. The responsible contractor should be appointed to complete these works in order to comply with standards and regulations. Such works should be completed prior to final handover.

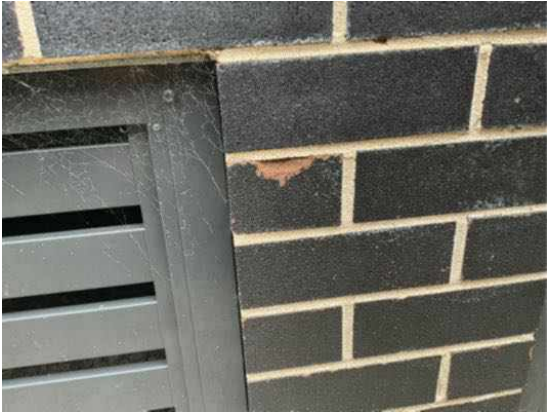
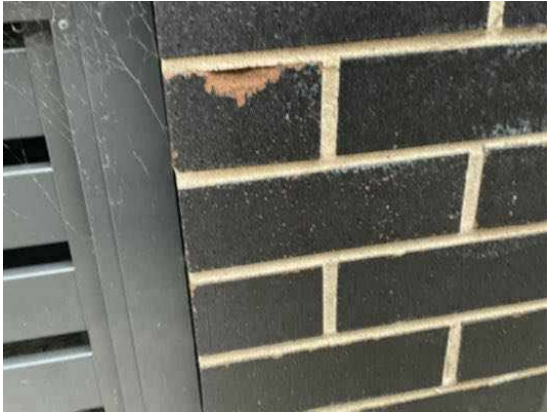
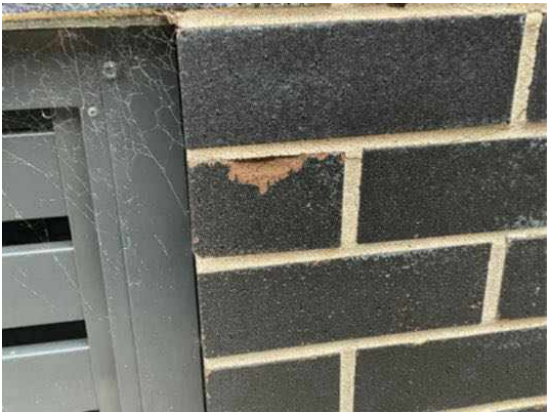
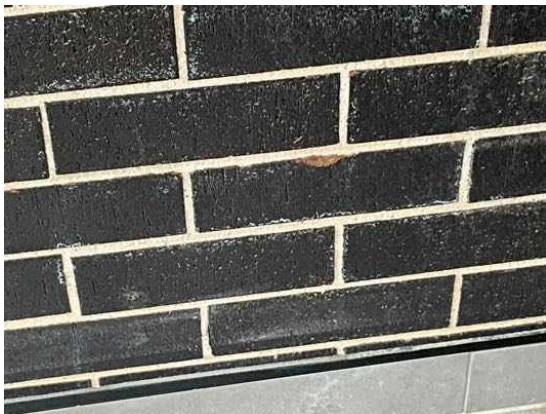
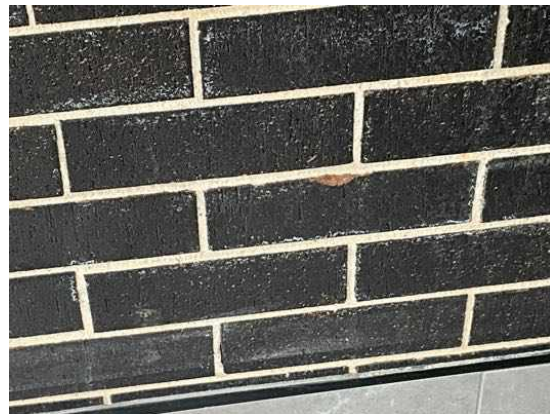
Finding 3.04

Finding: Masonry Facing Defective
Information: Instances of holes in the mortar to the external brickwork have been identified. Masonry faces are required to be free of damage with reference to Guide To Standards & Tolerances 2017.

3.9 Voids and holes in mortar

Voids and holes in mortar in masonry walls, with the exception of weepholes and vents, are defective if they are visible from normal viewing position, which is 1.5 meters.

All known defects must be rectified prior to handover.

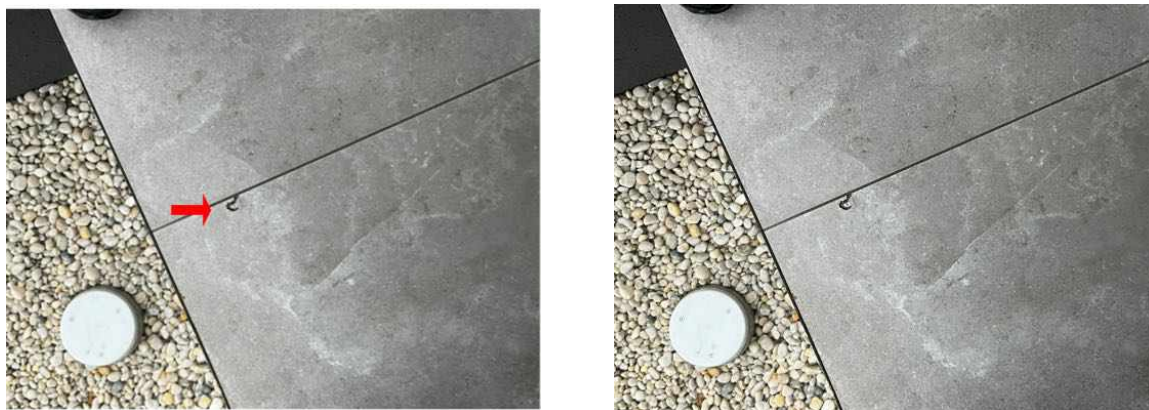
Finding 3.05

| Finding: | Tiles - Chipped |
| Information: | Cracked, pitted, chipped, scratched or loose tiles |

Tiles are defective if they are cracked, pitted, chipped, scratched or loose at handover.

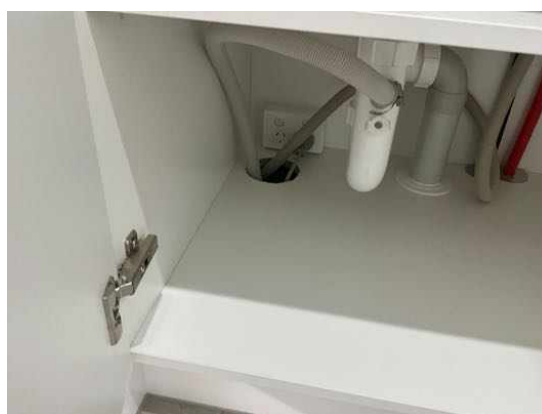
Risk:

- Pests like mice or cockroaches can enter through the gap.
- Water can get in and cause mould or damage to the cabinet.
- It looks untidy and is hard to keep clean.

Who Can Fix It:

A plumber or handyman can seal the hole using a cover plate, grommet, or suitable sealant.

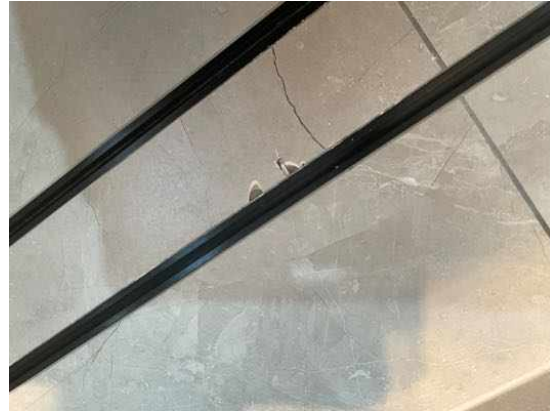
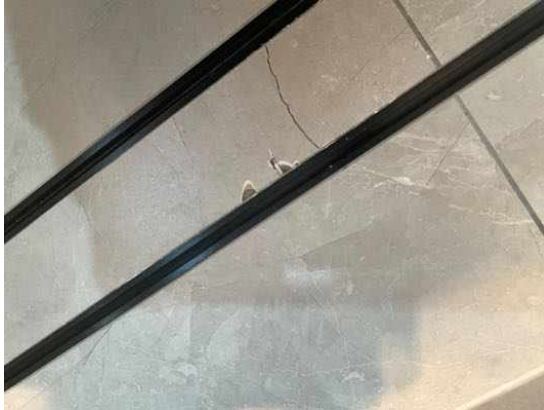
Finding 3.09

Building: Main Building
 Location: Bathroom
 Finding: Tiles - Chipped
 Information: Cracked, pitted, chipped, scratched or loose tiles

Tiles are defective if they are cracked, pitted, chipped, scratched or loose at handover.

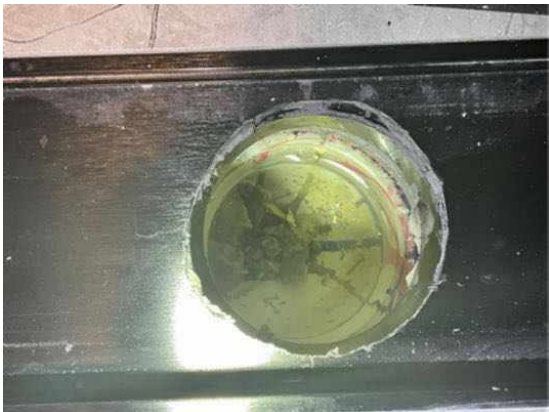
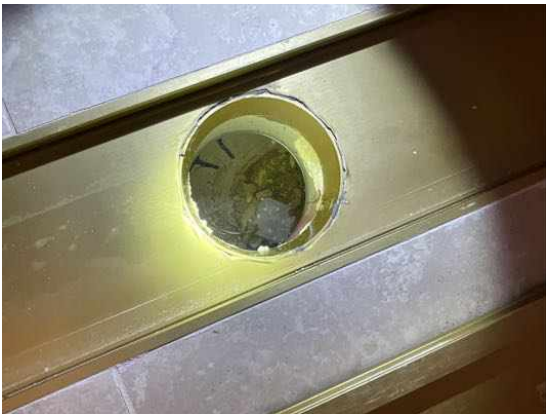
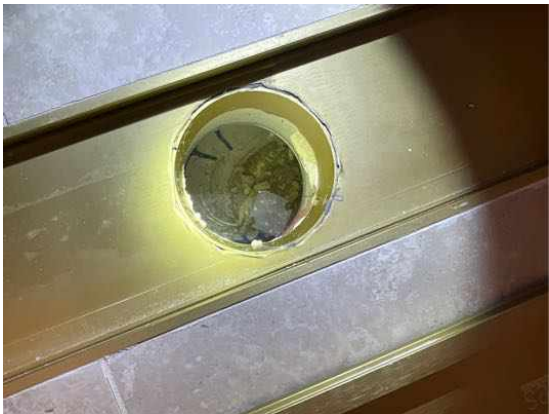
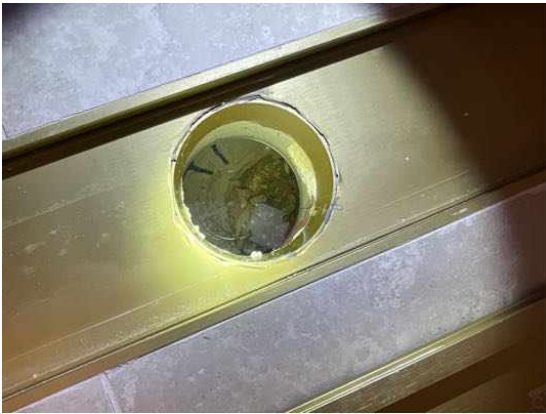
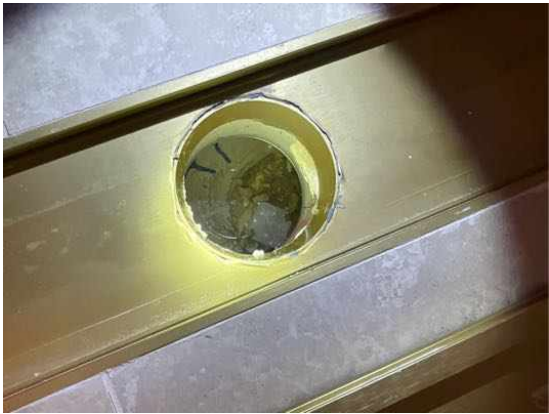
Finding 3.10

| Information: | It was noted that there is builder debris in the floor waste drainage. Debris in the plumbing system may lead to blockages in the future. |

This is referenced against the Australian Standards and Tolerances clause 19.8 Cleaning - Owners are entitled to expect that the building site and works are clean and tidy on completion.

Building sites are defective if they are not clear of building debris. All floor wastes need to be checked and cleared prior to handover.

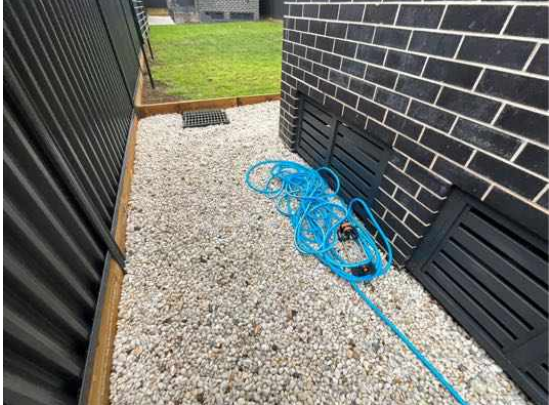
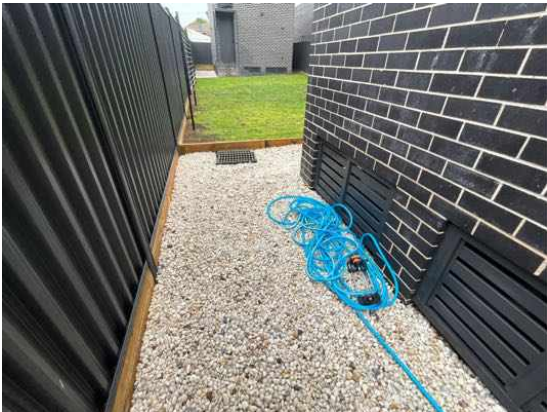
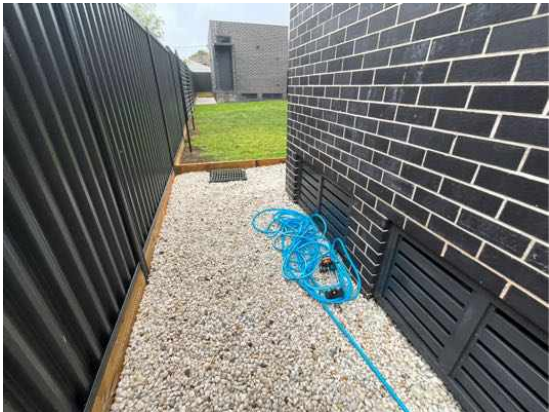
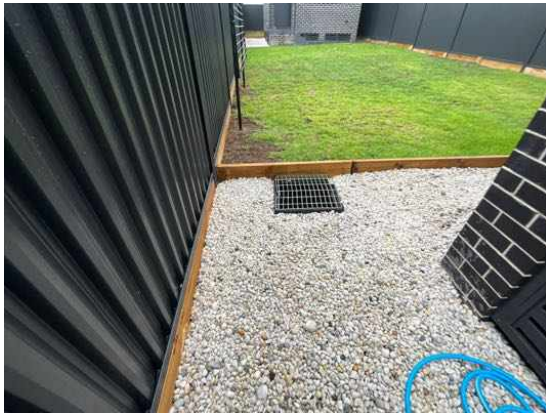
Building: Main Building
Location: All Areas
Finding: Timber on ground / conducive conditions to termite damage
Information: Timber on the ground is indeed conducive to termite damage. Termites are known to thrive in moist environments, and wood in contact with soil or moisture is more susceptible to infestation.

To prevent this, it's important to keep timber elevated and away from direct ground contact. Regular inspections and proper termite control measures are also essential to protect your wooden structures from termite damage.

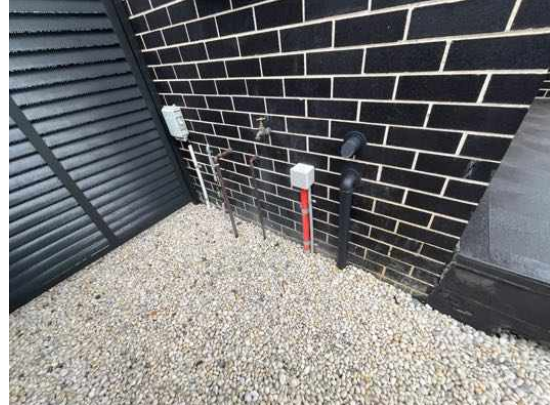
Finding 6.02

| Information: | There is no drain installed under the tap, leading to water accumulation and creating conducive conditions for timber pests. This defect needs immediate attention to prevent potential damage and pest infestation. |

1. Water Accumulation: Without proper drainage, water can accumulate around the base of the tap, leading to persistent dampness in the surrounding area.
2. Timber Pest Infestation: The damp environment created by standing water is highly conducive to timber pests, such as termites and wood borers, which thrive in moist conditions and can cause significant damage to wooden structures.
3. Structural Damage: Prolonged exposure to moisture can lead to wood rot and deterioration of structural timber, compromising the integrity of the building.
4. Health Hazards: Persistent dampness can also promote mold and mildew growth, posing health risks to occupants.
5. Aesthetic Damage: Water stains and damage to finishes and materials around the tap area can detract from the appearance of the building and lead to costly repairs.

A licensed plumber or a qualified building contractor can address this defect by:

3. Repair and Prevention: Inspecting and repairing any existing water damage and implementing measures to prevent future water accumulation and pest infestations.

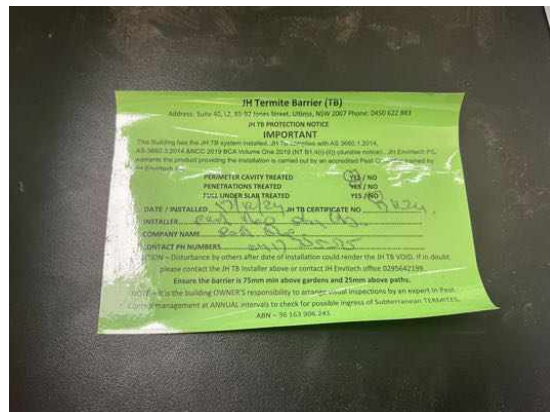
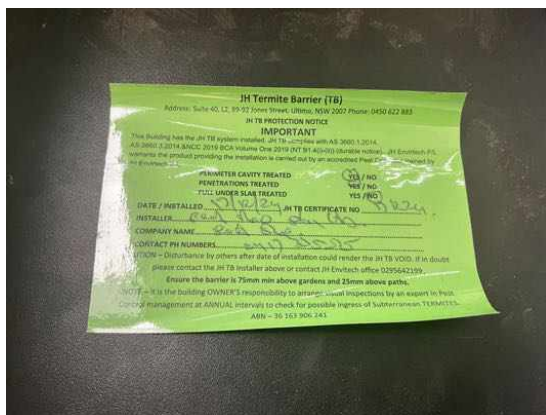
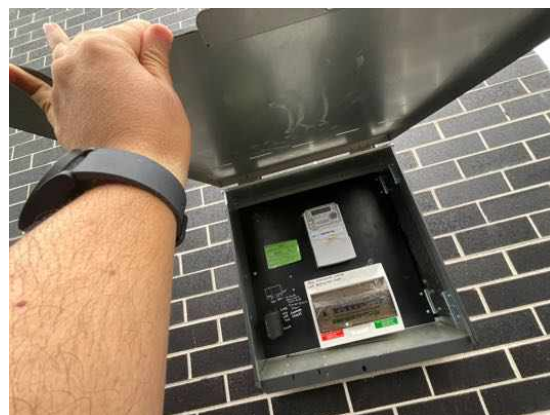
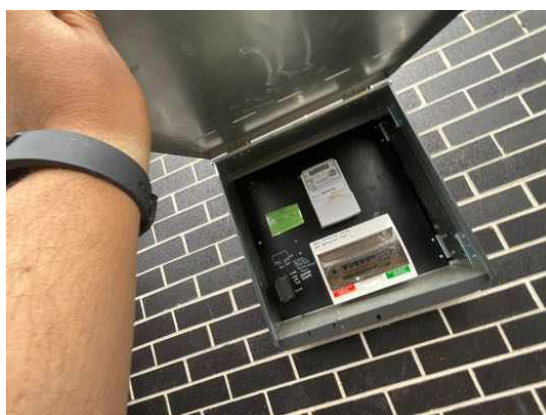
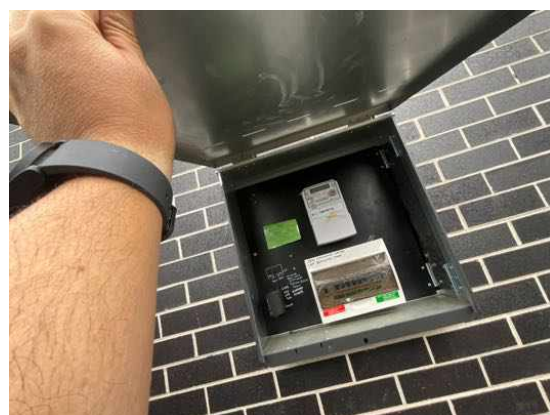
A durable notice placed in the switchboard unit to indicate termite barriers at the time of inspection.

Client must seek further information from the vendor or real estate agent if the conditions of termite management systems were maintained as per the label or seek advise from licensed pest controller.
