# Building and Timber Pest Inspection Report

Inspection Date: Tue, 10 Mar 2026

Property Address: 1/15B Barrenjoey Close, Woodbine

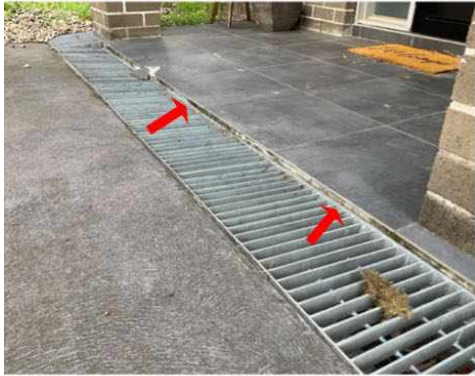
#### Finding 1.02

Building:	Building 1
Location:	Porch
Finding:	Trip safety hazard
Information:	Only one section of the 4 sections of the front porch grate is level creating a small trip hazard. The uneven surface poses a risk to pedestrians, particularly the elderly, children, and individuals with mobility impairments. This requires urgent repair and it appears the right grate sections can be levelled.

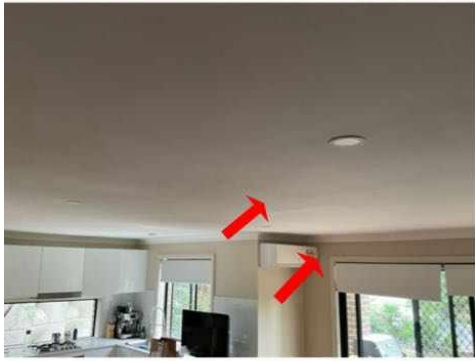
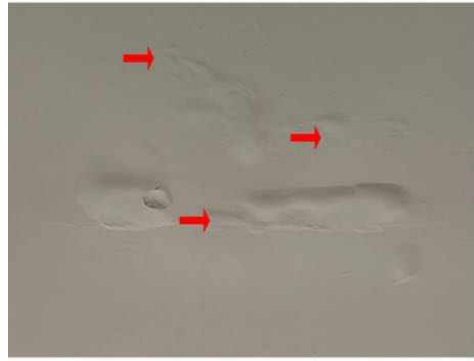
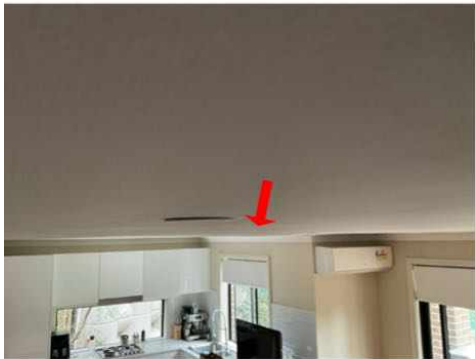
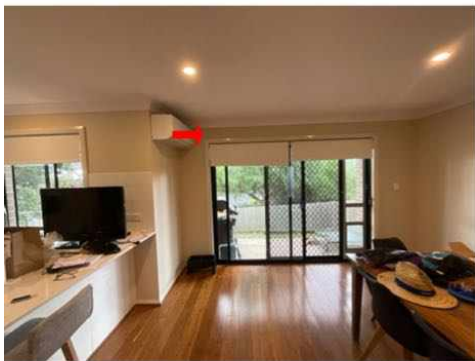
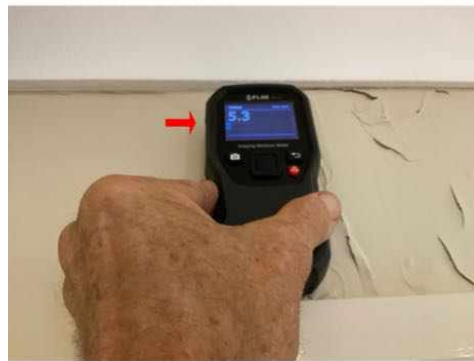
Building:	Building 1
Location:	Dining Room
Finding:	Ceiling and wall - Water stained and sagging
Information:	Water staining to ceiling and wall linings and plaster damage in this dining room areas was evident at the time of inspection. Water staining indicates that surfaces have been exposed to excessive moisture over time. The minerals and other elements in the water lead to staining, which may graduate to corrosion and deterioration if left unmanaged.

A low moisture reading of 9.4 in the middle of the ceiling under the bathroom shows moisture is present. The rear wall showed a low reading of 5.3. All surrounding areas to these damaged plaster areas recorded a zero reading for reference. The external rear eave behind the rear wall showed minor mould but no moisture evident.

Water staining can be indicative of more serious defects, which may be currently concealed by interior ceilings.

The excessive moisture found in the dining room ceiling under the bathroom may be related to this bath leak however it appears the bathroom waterproofing membrane has failed meaning major bathroom works may be required.

Where water staining is active here, a licensed plumber must be consulted to identify the cause of the staining and to provide advice on any reparation works that may be required. Replacement of any damaged structures is advised.

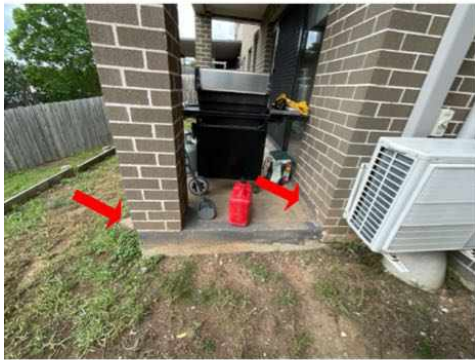
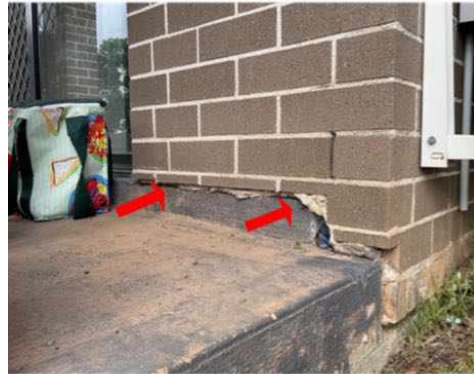
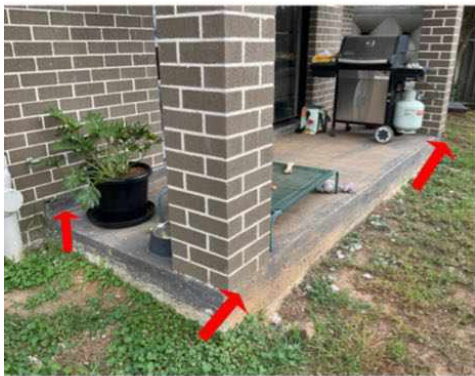
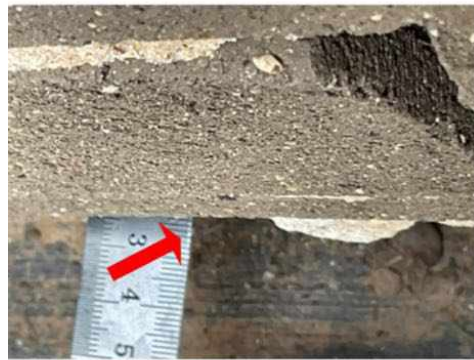
### Finding 3.02

Building: Building 1  
 Location: Walls  
 Finding: Masonry overhanging concrete slabs  
 Information: The rear lower verandah wall brickwork and pillars overhang the slab by up to 26mm.

‘ A masonry course is defective if it is laid on a concrete slab or strip footing so as to project over the edge of the slab or footing by more than 15mm ‘.

These areas should be restrengthened by a concreter or licensed builder to prevent possible step cracking in the above brickwork.

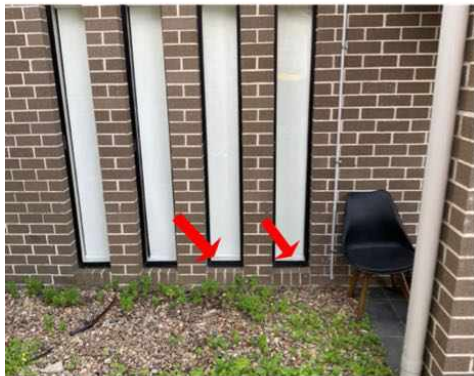
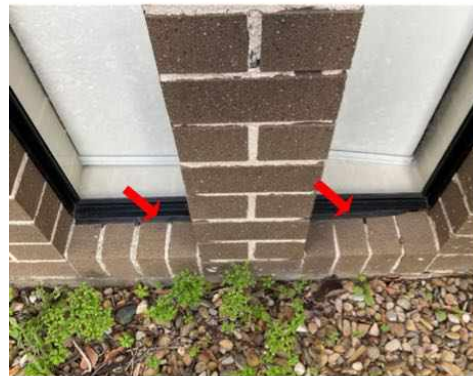
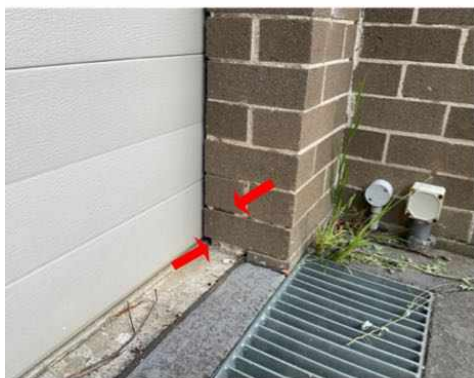
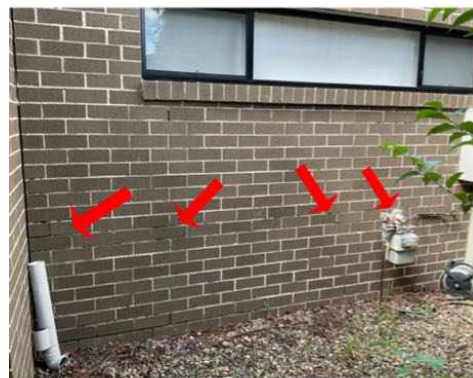
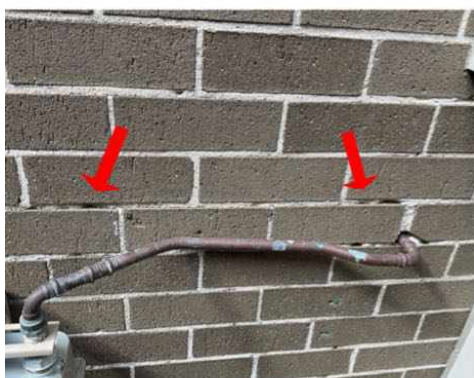
### Finding 3.03

Building:	Building 1
Location:	Walls
Finding:	Brickwork - Deteriorated mortar
Information:	Mortar, or 'bedding', is the material which fills joins and intersections between bricks in masonry walls and structures. Sections of mortar in this brickwork were identified as having deteriorated, which is generally expected for a property of this age and condition.

Mortar may deteriorate as a result of age of building materials, minor movement of bricks, or frequent exposure to weathering. Mortar should be replaced to ensure that bricks remain in their intended location and to prevent gaps, which would allow water or moisture ingress and secondary damage as a result.

Mortar deterioration can be addressed here by a bricklayer where areas of deterioration are localised and easily accessible. Alternatively, appointment of a registered builder is advised, to repoint large areas of decaying mortar. If left to deteriorate further, some bricks may become loose leading to further defects.

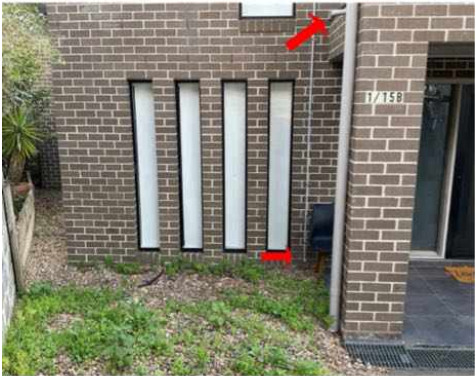
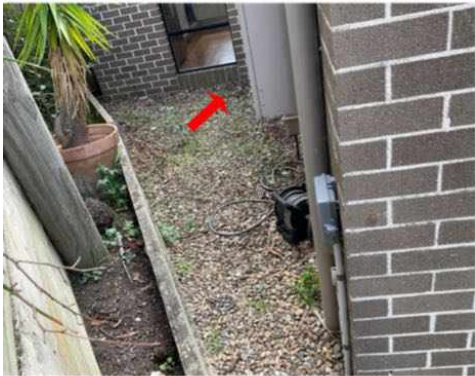
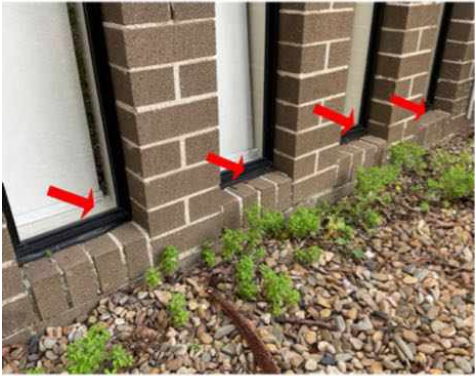
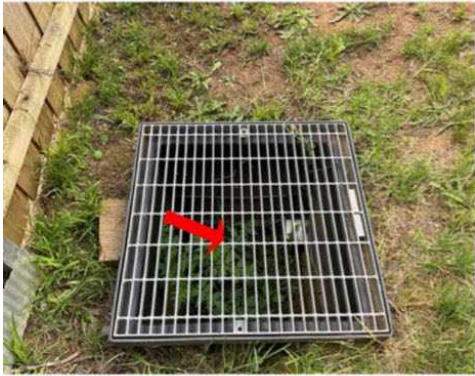
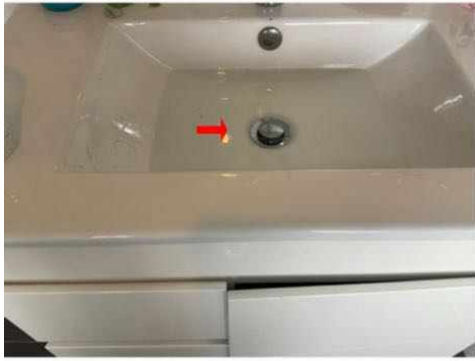
### Finding 3.04

Building: Building 1  
Location: Front wall, drains, vanity  
Finding: Site drainage - Inadequate  
Information: The site drainage in these areas was found to be inadequate at the time of inspection, creating potential for subsequent water damage to associated building elements.

No left wall drainage is evident. The brickwork to the front windows should allow water to runoff but these bricks slope toward the house. The air conditioner and hot water system overflows run against the house walls. Most gutters and drains need to be cleaned of debris. The bathroom vanity was slow to drain and may be partially blocked.

It is important that water does not lie against the base of walls; surrounding paths and ground levels should be sloped to drain water away from walls. Downpipes should not discharge stormwater onto lower walls or plinths. Stormwater should be carried away by large, regularly cleaned drains. Ground levels may need to be lowered to expose a buried DPC.

Where site drainage is inadequate, installation of an Agricultural (Aggie) Drain may be required. A qualified plumber should be appointed to further inspect the property and perform any remedial works required. Secondary defects are likely to occur if left unmanaged.

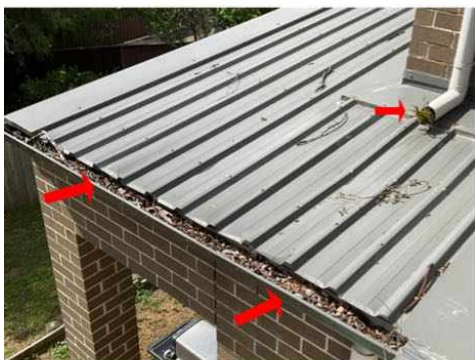
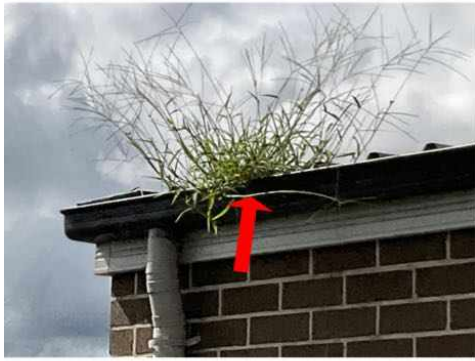
### Finding 3.05

Building:	Building 1
Location:	Roof exterior
Finding:	Gutters - Full and blocked
Information:	The guttering on around the roof was found to be blocked at the time of the inspection. Roof plumbing structures, such as guttering and downpipes, should be free of all debris to prevent blockages. Blockages of the guttering and downpipes will lead to pooling and accumulated water overflows, which is likely to subsequently flood eaves and exterior walls.

Blocked gutters are likely to lead to high levels of moisture in the affected areas which can cause rust and decay of the gutters and downpipes and wood rot to adjoining timber areas. Blockages in gutters should therefore be removed immediately to ensure dry conditions are maintained.

It is highly advised that gutters be cleaned by the homeowner or a general handyperson as a matter of urgency.

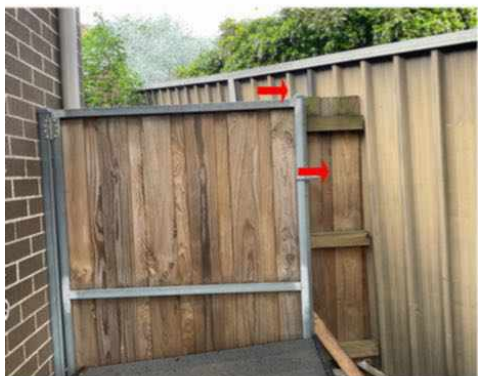
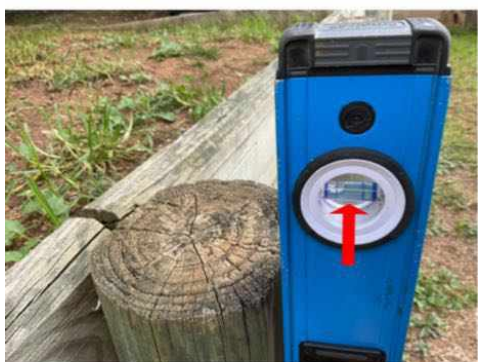
### Finding 3.06

Building:	Building 1
Location:	Pictured fences
Finding:	Fence and one area of rear retaining wall leaning
Information:	Evidence of damage to the pictured left fence and part of the rear left yard wall was identified at the time of the inspection. The likely cause of this fence and wall leaning is not enough concrete used in the post footings. If left unmanaged these areas may deteriorate further. This has meant the left gate binds on the fence and cannot be closed fully.

The cost of repairing the left fence is often shared between neighbours.

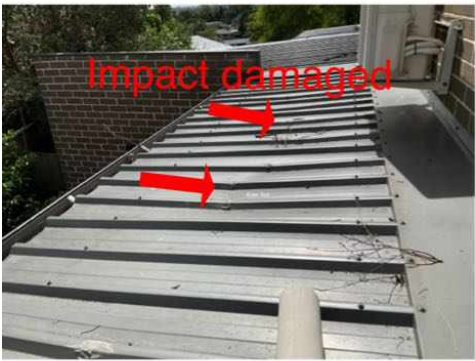
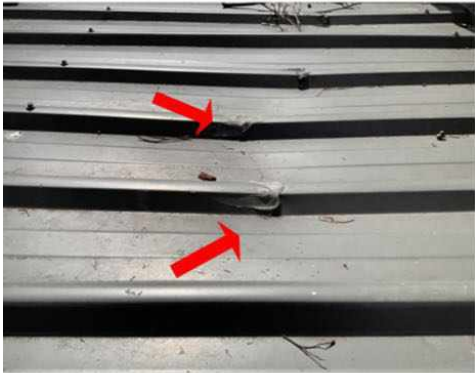
### Finding 3.07

Building:	Building 1
Location:	Roof Exterior level 1
Finding:	Roofing areas damaged (numerous dents)
Information:	Upon inspection of the exterior roofing, the majority of the lower roof areas were considered to be in a fair condition due to numerous damaged sheets which appear to have been walked on and very full gutters. These dented sheets have had sealant applied. They will need to be checked annually for leaks or replaced.

Remedial works are likely to increase the longevity of the exterior roofing structure. The upper roof had no safe access for inspection.

Consultation with a roofing contractor is highly advised to gain advice on cost of remedial works that may be required in the short to medium term.

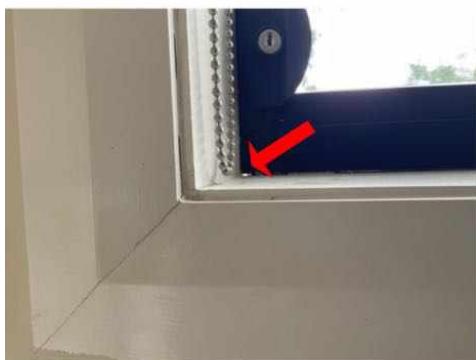
**Finding 3.08**

Building: Building 1  
Location: Pictured Areas  
Finding: Sealant (external) - Missing.  
Information: It was noted on inspection that areas of external sealant was missing to small areas of the external walls.

Flexible sealants should be applied to these affected areas to prevent any subsequent water damage that is likely to occur.

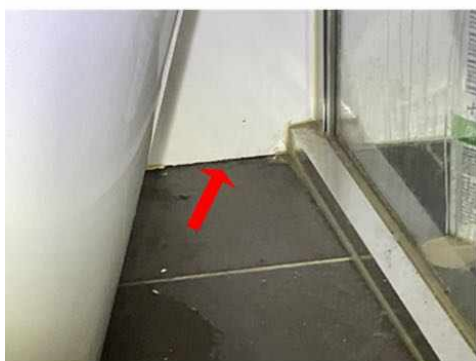
### Finding 3.09

Building:	Building 1
Location:	Bathroom
Finding:	Sealant and grouting - Missing or damaged
Information:	It was noted on inspection that sealant or grout is degraded to these pictured wet areas.

Different materials and floor areas move at different rates, generally causing cracking to grout or sealant at this point. A flexible sealant is required to allow for expected expansion and contraction, while keeping the joint water tight and protective of all associated building materials.

Flexible and mould resistant materials should be applied to affected areas to prevent any subsequent water damage that is likely to occur. Regular maintenance and replacement of damage or missing or damaged sealant and grout is highly recommended to the wet areas, as this is a regular wear and tear defect. Sealant and grouting in areas that come into regular contact with water should be maintained for the long term care of your property.

A sealant specialist or tiling contractor should be appointed to complete these works as soon as possible

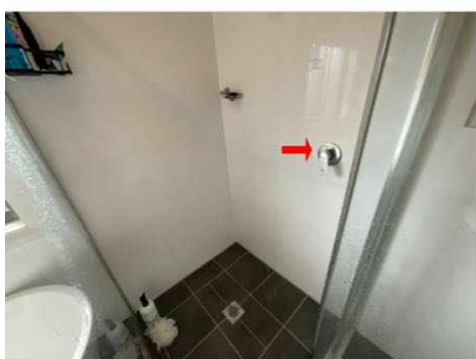
### Finding 3.10

Building:	Building 1
Location:	Bathroom
Finding:	Tap - Water hammer
Information:	This tap shows evidence of water hammer being present. Water hammer, a pressure surge resulting when a fluid is forced to suddenly change direction, is a common defect in plumbing fittings, particularly those that are aged and not frequently maintained. Water hammer is generally caused by factors that create high water pressure in the affected plumbing fixture, usually evidenced by a faint banging noise during operation of the affected tap.

Although water hammer is generally considered to be a minor defect, subsequent damage such as erosion of tap hardware and/or water damage to associated building elements is likely to occur if left unmanaged.

A licensed plumber should be appointed as soon as possible to replace any affected tap hardware and perform any remedial works as necessary. Please be advised that the appointment of a cabinet maker or qualified carpenter may be necessary if water damage to associated building elements has occurred.

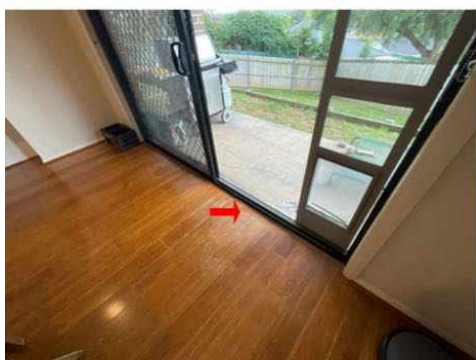
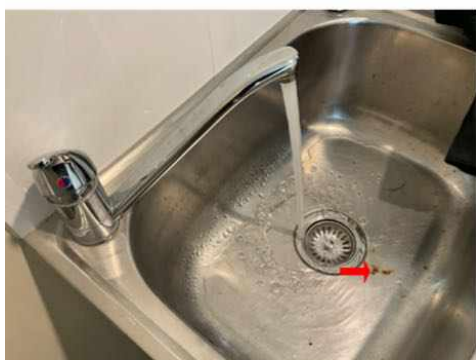
### Finding 3.11

Location: Pictured areas  
 Finding: Building elements - Damaged  
 Information: Evidence of damaged areas was identified at the time of the inspection. These include -

1. The rear sliding door track is bent not affecting its operation.
2. The laundry tub has rusted.

A carpenter would be the trade responsible for rectification of these areas when convenient.

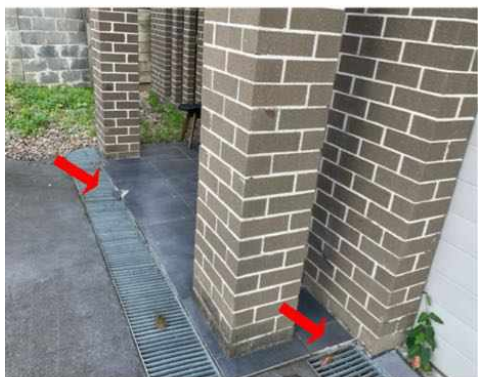
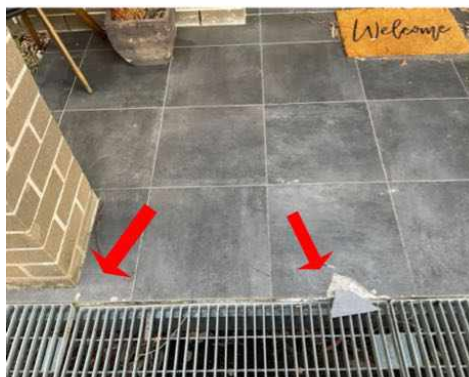
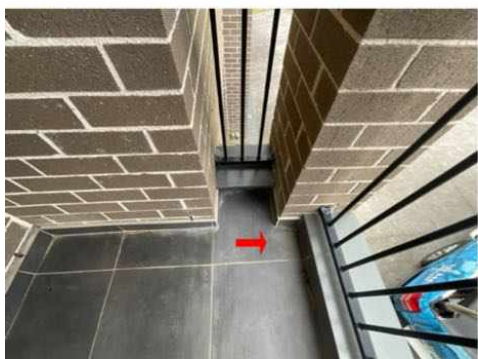
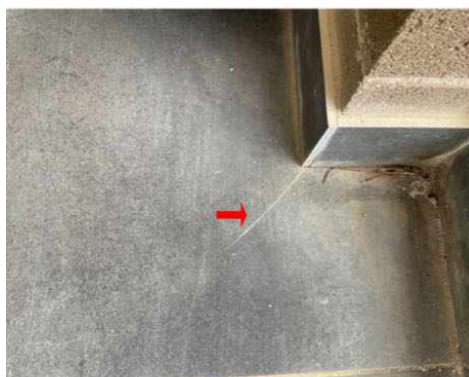
### Finding 3.12

Building: Building 1  
 Location: Verandahs  
 Finding: Tiles cracked  
 Information: Cracked tiles were evident in these pictured areas at the time of inspection. It is suspected that this cracking has occurred as a result of minor settlement or impact damage.

A small area of the adjacent porch concrete has also cracked. Cracked tiles throughout the household detract from the overall appearance of the affected areas. In

wet areas of kitchens and bathrooms, it can lead to water damage of adjoining walls and floors.

Replacement of cracked tiles is recommended as soon as possible. A tiling contractor may be appointed to perform these works. Where cracks become more numerous, contact a licensed building inspector for further investigation.

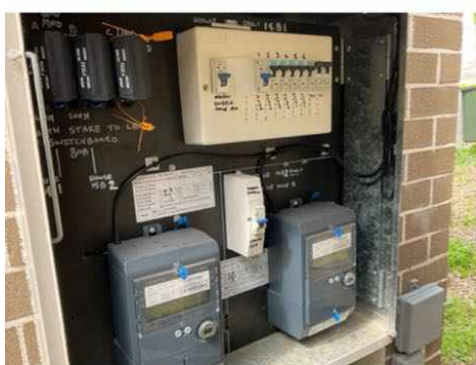
Information: The application of a post-construction chemical termite barrier is highly recommended for all properties. Such barriers are highly effective in preventing termite attack on any timber building elements throughout the property.

A durable notice should be placed in the switchboard unit to indicate current termite barriers. At the time of inspection, the durable notice was evident and it appeared as though no chemical termite management system has been installed, with no evidence to suggest preventative works taking place since the property was built.

The client may consider gaining further advice from a pest controller as to the costs and procedures involved with a 'chemical' application. It is recommended that obtaining such advice be a short-term priority.

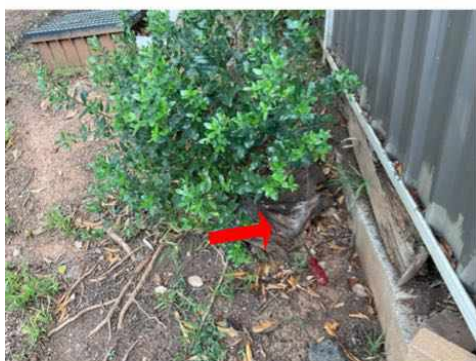
### Finding 6.03

Building:	Building 1
Location:	North yard area
Finding:	Tree stumps - left in ground
Information:	Tree stumps left in ground provide opportunity for termite attack as they are likely to be subject to rot and decay providing an attractive food source. Treatment and/or Removal of the stump is highly recommended. A pest controller and tree removalist should be engaged to perform such works.

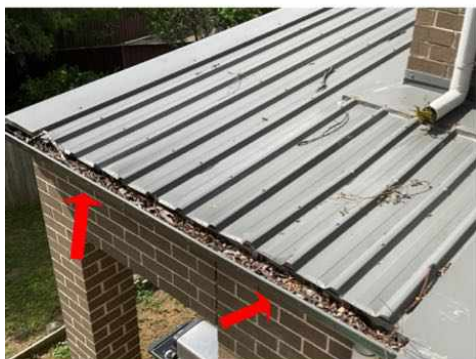
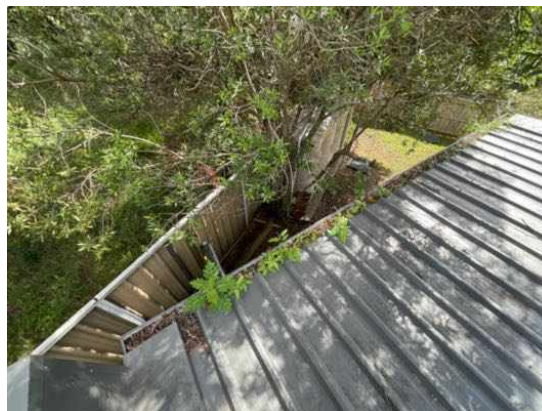
### Finding 6.04

Building:	Building 1
Location:	Roof exterior
Finding:	Gutters - Full and blocked
Information:	The guttering on around the roof was found to be blocked at the time of the inspection. Roof plumbing structures, such as guttering and downpipes, should be free of all debris to prevent blockages. Blockages of the guttering and downpipes will lead to pooling and accumulated water overflows, which is likely to subsequently flood eaves and exterior walls.

Blocked gutters are likely to lead to high levels of moisture in the affected areas. Such moisture will not only cause rust and decay of the associated building materials, but

can also provide conditions that are conducive to termite and timber pest activity. Blockages in gutters should therefore be removed immediately to ensure dry conditions are maintained.

It is highly advised that gutters be cleaned by the homeowner or a general handyman as a matter of urgency.

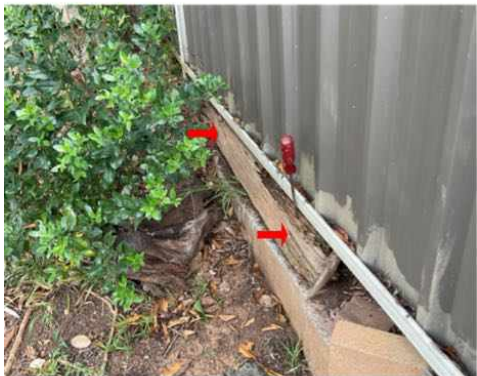
Building:	Building 1
Location:	North yard area
Finding:	Evidence of wood borer activity identified
Information:	Wood borer damage was found in one fence timber. These are small beetles that colonise in exposed timber elements are a common timber pest that are regularly mistaken for termites. Although wood borer activity is generally not detrimental to the affected timber they may lead to serious damage and necessitate replacement of certain building elements if left unattended.

The other commonly known borer the Anobium borer is more likely to attack floorboards and may cause severe structural damage to flooring areas.

As no live wood borer activity was identified treatment is not required at this time and this timber should be discarded.

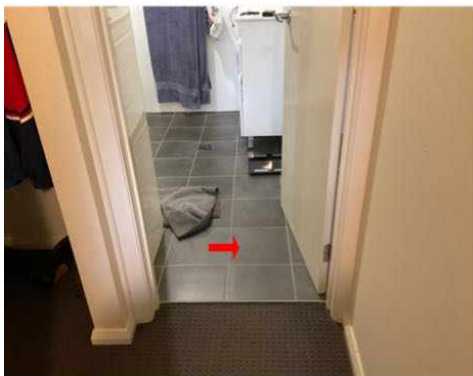
Building: Building 1  
 Location: Bathrooms and laundry  
 Finding: Waterproofing membranes - Information Only  
 Information: Internal Water Proofing Membranes, are crucial in preventing water ingress into the property is important to know that the Membrane System used is to Australian Standards and has been installed correctly.

With older property's where this information is unavailable all wet areas should be monitored. If any leaks, water staining, peeling or bubbling of the paint become evident to any adjacent walls or ceilings below a licensed builder or waterproofing specialist is recommended to investigate further.
