Building and Timber Pest Inspection Report

Inspection Date: Fri, 30 Jan 2026

Property Address: 23 Cayman Pl, Parrearra QLD 4575,
Australia

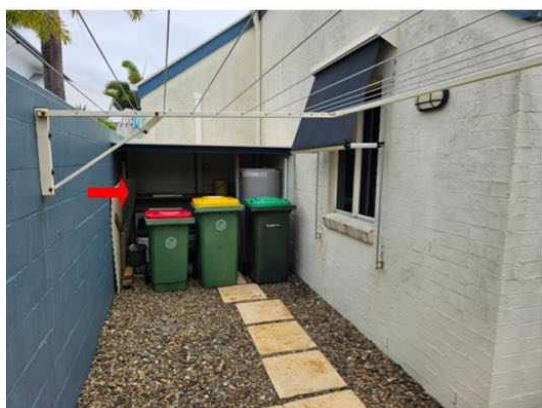
Finding 3.01

Building: Main Building
 Location: Rear elevation
 Finding: Air conditioner casing - rusted
 Information: The air conditioner casings of the two rear outdoor units are rusted. It does not appear to affect the operation of the system. It is possible that the metal may be able to be treated and repainted.

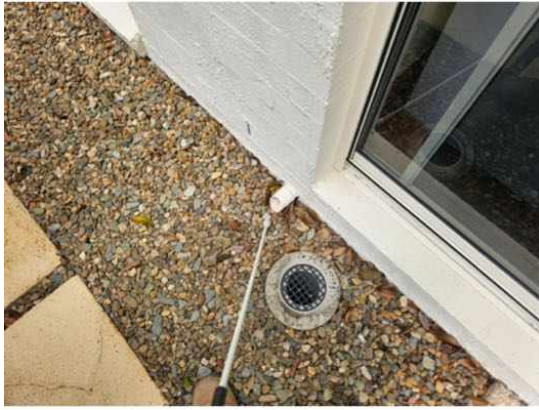
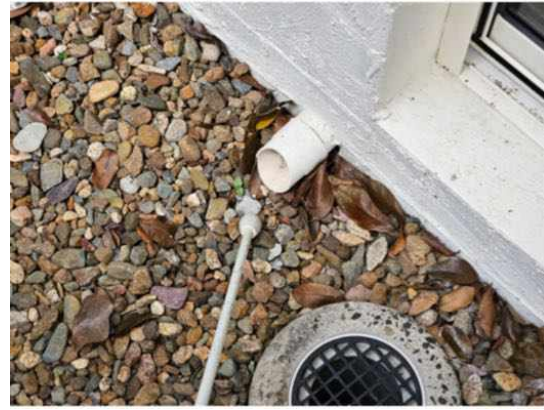
Finding 3.02

Building: Main Building
 Location: Laundry
 Finding: Dry waste vermin flap - broken
 Information: The floor waste in the laundry is a dry waste and the exit point is adjacent to the sliding glass door of the laundry. These waste exit points have a vermin proof flap attached to the external opening.

The flap on the is waste is missing. A replacement should be fitted at the clients discretion to prevent vermin from entering the property.

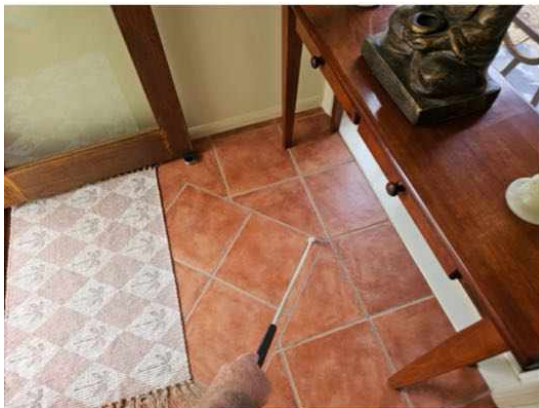
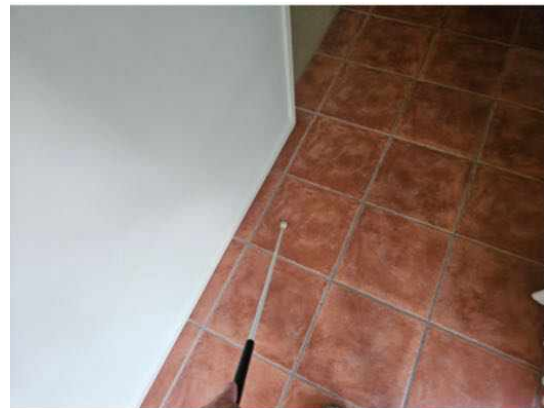
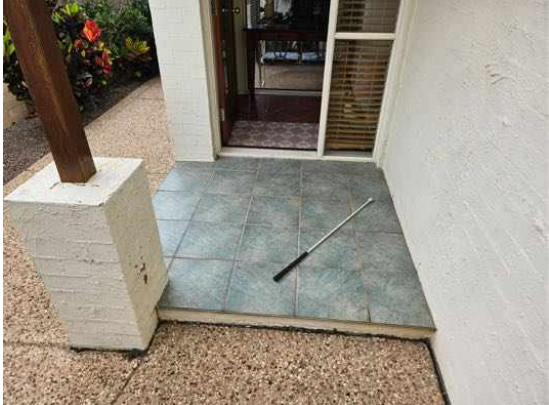
Finding 3.03

The term 'drummy' refers to tiles that have become detached from their fixing, despite otherwise being in relatively good condition. Such defects are generally caused by physical or moisture damage to the area. Drummy tiled areas may also be a direct result of poor workmanship during the construction process.

Tiled areas may swell and shrink with changes in air humidity if the area has sustained moisture damage. Any exposure to moisture is capable of causing tiled areas to become drummy and/or cracked over a prolonged period of time. Drummy tiled areas generally require removal and replacement of affected tiles.

Specialist trades are available for these types of services. A licensed builder may be required to undertake works if damage is extensive or if secondary building defects have resulted. Otherwise, it is advised that a tiling contractor or a tile adhesive injection service may be appointed to perform works as necessary.

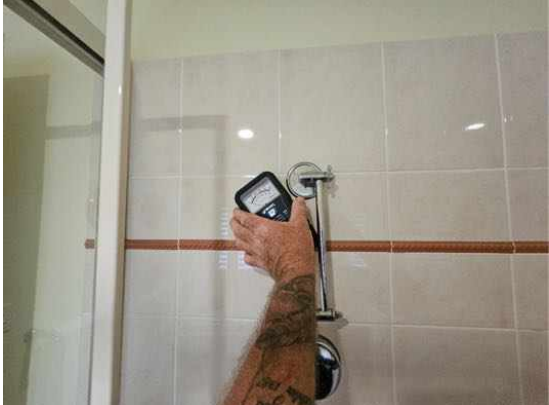
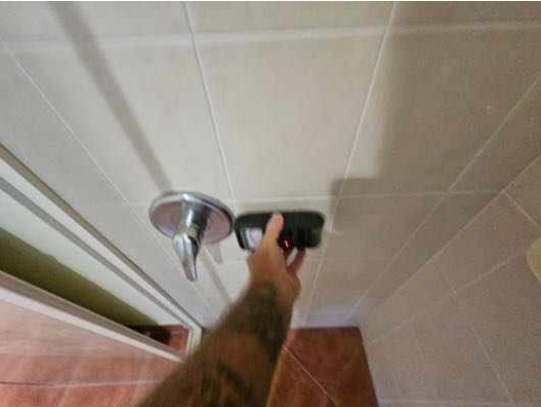
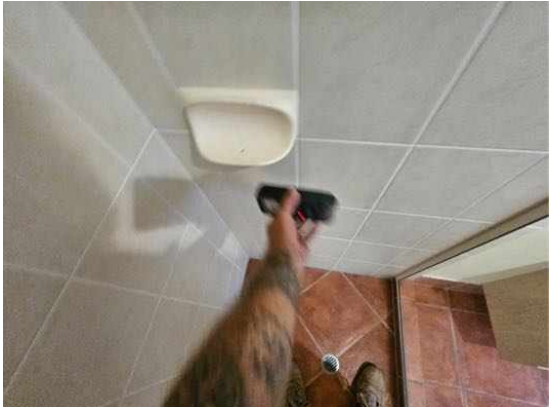
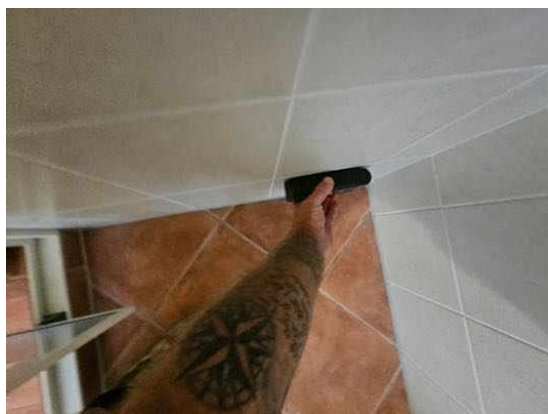
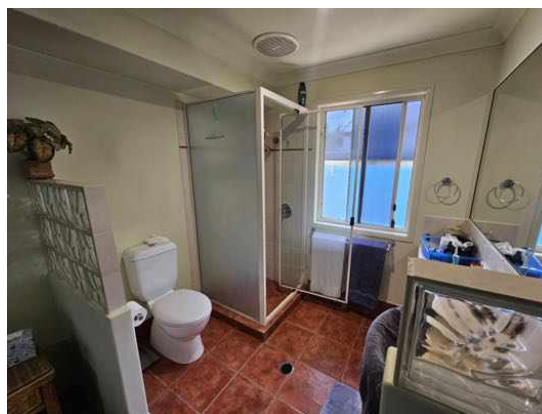
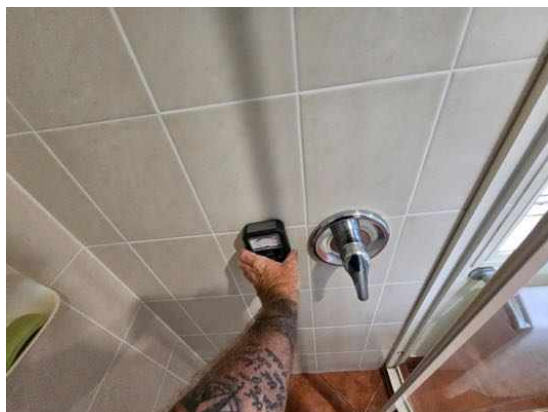
Finding 3.04

Building: Main Building
 Location: Ensuite, bathroom
 Finding: No moisture detected in bathroom / ensuite
 Information: On the day of inspection the showers in the bathroom/s and ensuite are measure for moisture using a "Tramex" moisture meter. During this inspection no moisture was detected in these areas and the tiled / sheeted surfaces appear to be in good order.

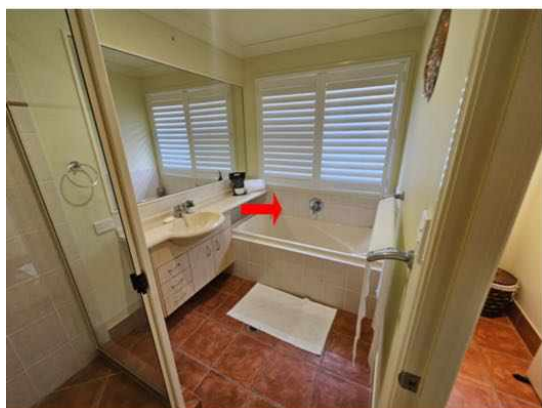
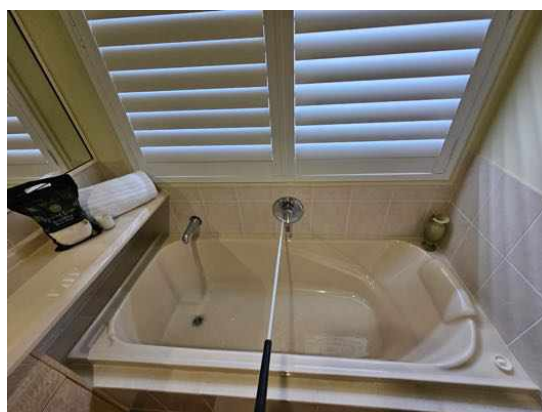
Finding 3.05

Information: Evidence of water hammer has been noted to be present in the bath mixer tap. Water hammer is generally caused by factors that create high water pressure in the affected plumbing system usually evidenced by a banging or vibrating noise during operation of a tap or appliance.

Although water hammer is generally considered to be a minor defect, increased stress by hydraulic shock within the water pipes can cause weaknesses to develop and in worst cases for a pipe to burst. Water hammer can also accentuate the movement of

poorly fixed water pipes which can lead to fatigue cracks or friction holes developing.

Securely fixing loose water pipes and installing shock absorbing devices designed to lessen the effect of water hammer, can be a solution for affected water reticulation systems.

A licensed plumber should be appointed to advise on any remedial works as necessary.

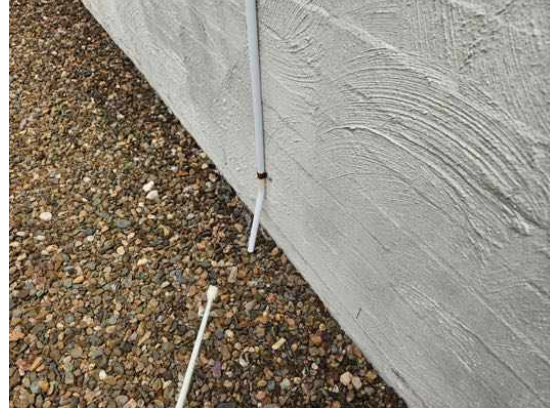
Finding 6.01

| Finding: | Air conditioner - Disconnected drain |
| Information: | The Air Conditioner (A/C) overflow was found to be disconnected from storm water drainage and could create excessive moisture in the surrounding area. |

Such leaking creates an environment which is conducive to an array of defects, including water damage to associated building elements and the attraction of termite or timber pest infestation.

It is recommended that a licensed plumber be appointed to connect the A/C overflow to a drainage source in order to prevent such an environment from being created. An

alternative is to extend the overflow further into the garden away from the building perimeter.

These minor works should be carried out in the short term.

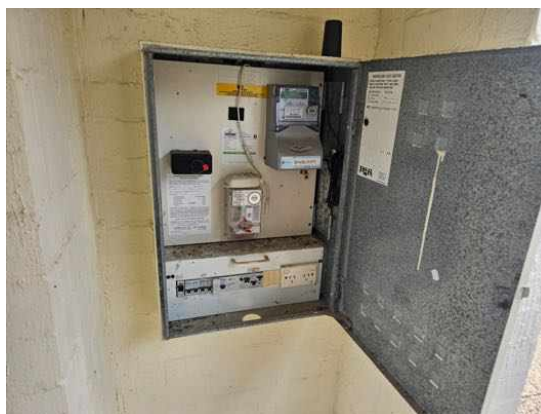
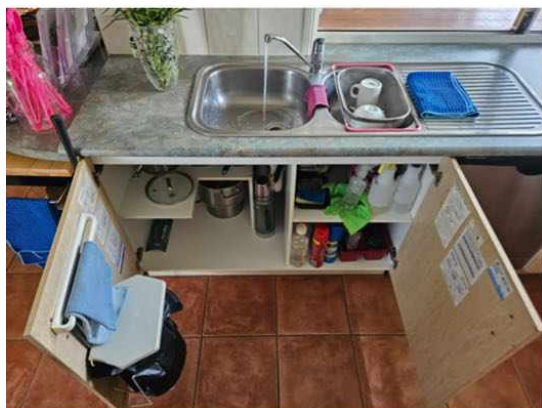
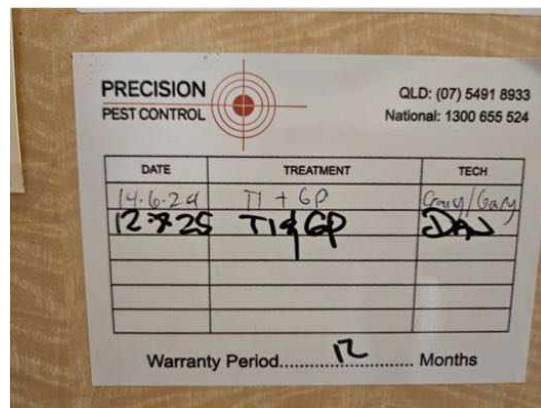
Building: Main Building
 Location: Meter box, kitchen cupboard
 Finding: Durable pest inspection notice
 Information: On the day of inspection it was noted that the durable timber pest inspection / treatment notice was in place and the most current inspection was notated and in date. These notices / stickers are to verify the timber pest inspection dates, the inspector, and, at times, the currency and type of timber pest system / barrier in place or being used in and around the property.

The client is advised to maintain annual inspections with the company listed or a company of their choosing.

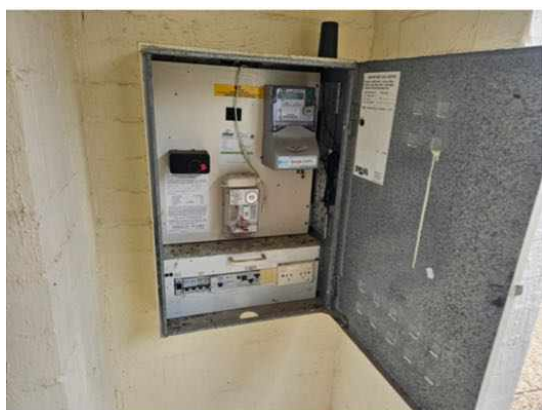
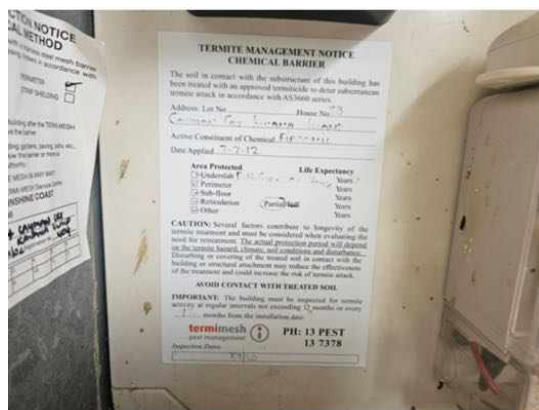
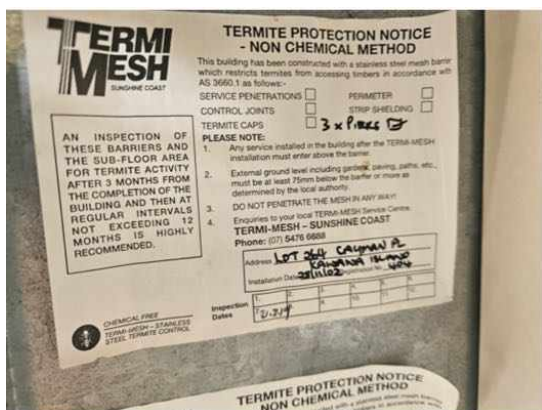
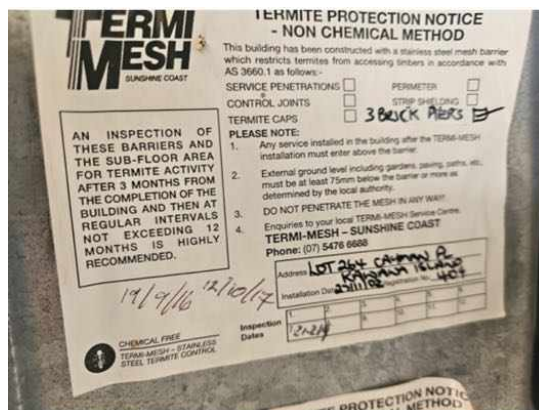
The building employs a physical barrier system to the perimeter and slab penetrations and has applied a chemical barrier in the past. In order for a barrier system to be effective, the property must have regular inspections at intervals of not greater than 12 months. Depending on the risk profile attributed to the property, these inspections may be recommended at lesser time periods.
