Building and Timber Pest Inspection Report

Inspection Date: Mon, 16 Mar 2026

Property Address: 44 Brooklyn Rd, Brooklyn NSW 2083,
Australia

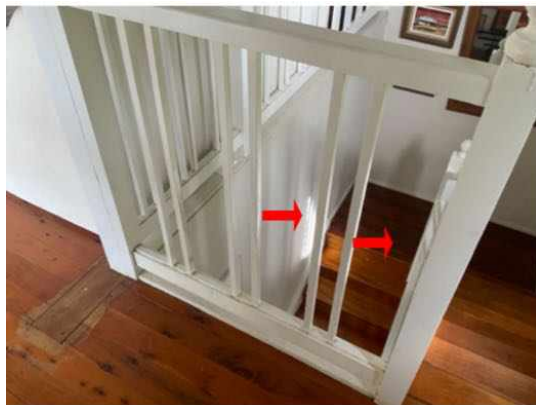
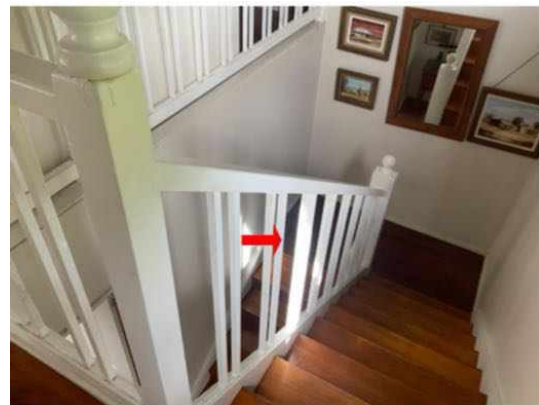
Building:	Main Building
Location:	Stairs - Internal
Finding:	Balustrade - Suspected Non-Compliance
Information:	The balustrade was measured and found to be less than the present building regulation requirement of 1000mm high. Additionally the gaps between the balustrade cladding were found to be greater than the present building regulation requirement of 125mm.

This defect creates a potential safety hazard and should be rectified as soon as possible to ensure the safety of the area and to meet present building standards and regulations.

A registered builder should be contacted to discuss possible rectification solutions.

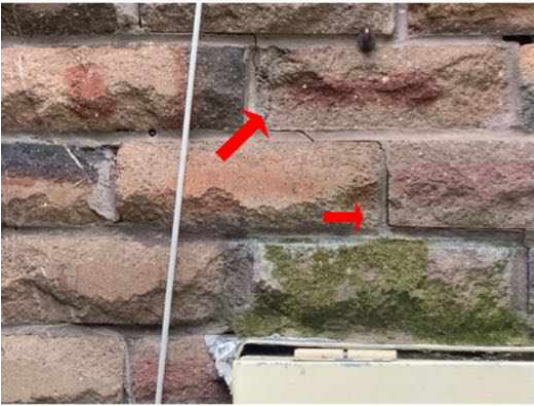
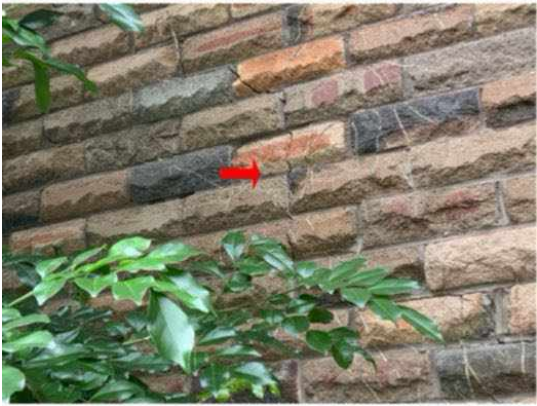
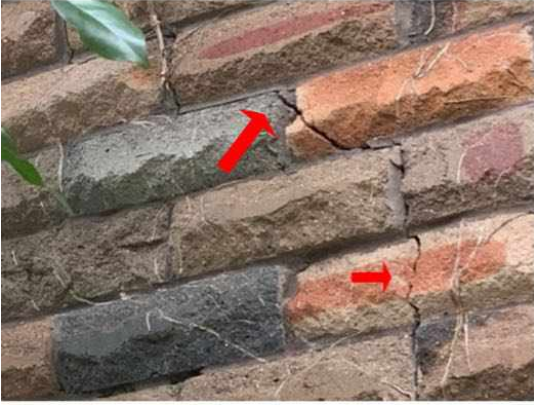
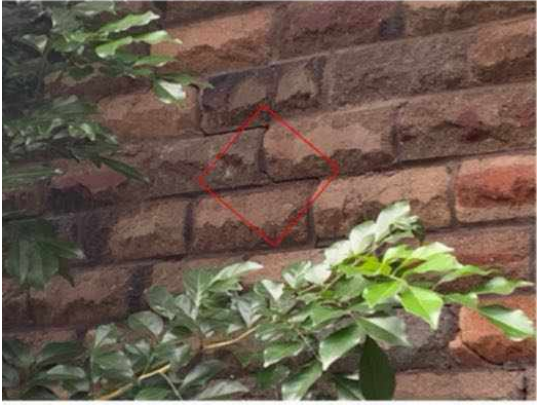
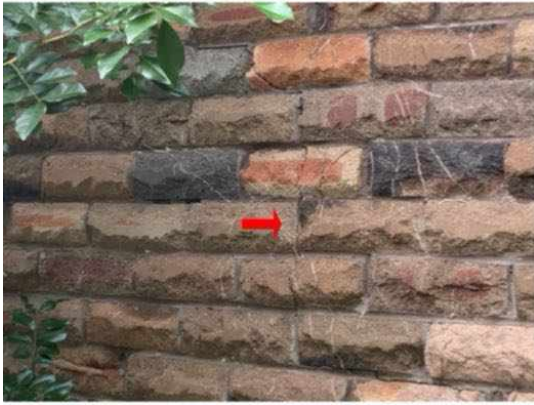
Finding 2.01

Building:	Main Building
Location:	Exterior walls - right side
Finding:	Brickwork - Cracking [Repair required]

Major cracking was identified to the brickwork in this area. Cracks of this type are likely to have been caused by minor expected movement of building elements, but may also have a structural cause that is more significant.

A crack of this size may be repaired by extensive filling. Additionally, further remedial works to associated building elements, such as eave sheeting or external door frames, is likely to be required.

A qualified bricklayer should be contacted immediately to estimate and perform repair and restoration works. Consultation with a structural engineer may be required where structural instability is found to be the underlying cause of the cracking.

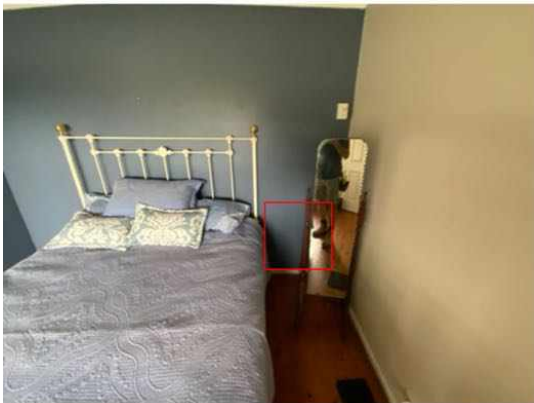
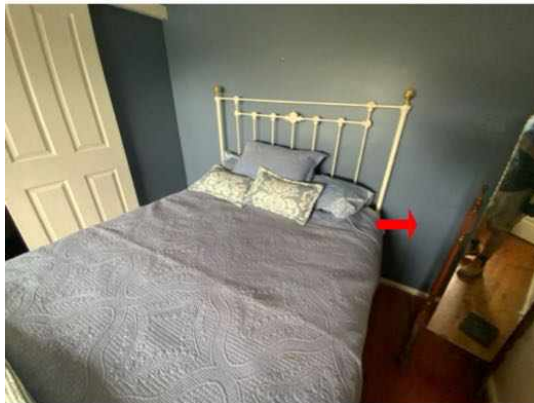
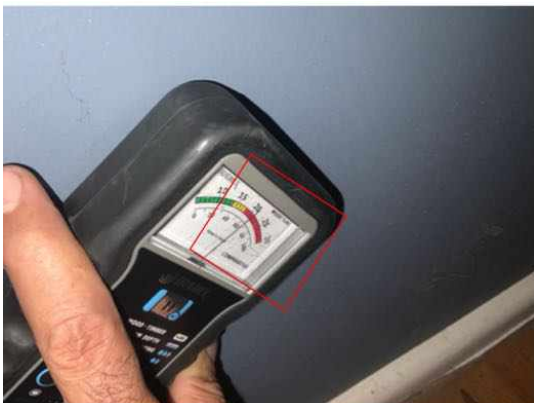
Finding 2.02

Building:	Main Building
Location:	Bedroom - Master
Finding:	Evidence of excessive moisture was present at the time of inspection
Information:	Excessive moisture can attract termites and produce conditions that promote termite attack, fungal growth and wood decay. Excessive moisture is generally caused by deteriorated, inadequate or missing roof drainage, leaking plumbing pipes or fixtures, poorly plumbed HWS overflows or condenser units and poor site drainage. It is highly recommended that all plumbing and drainage fixtures and fittings be maintained regularly in order to prevent excessive moisture being present in the external / internal property.

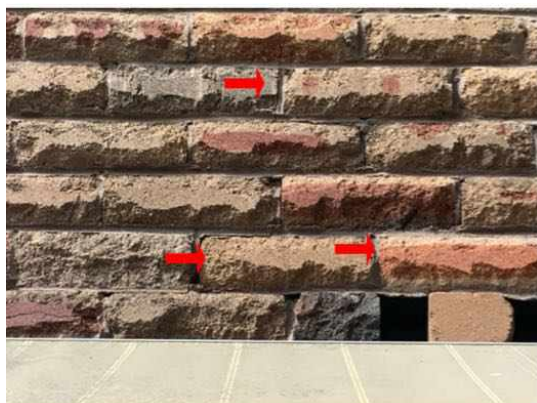
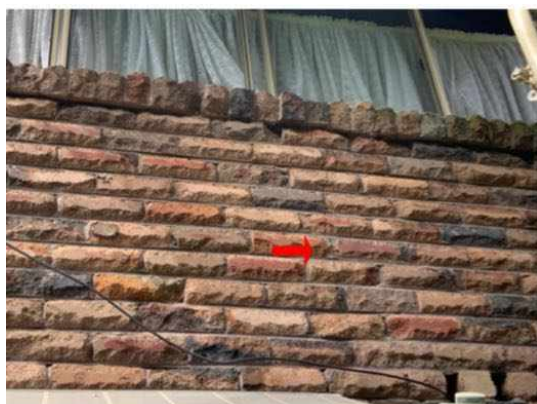
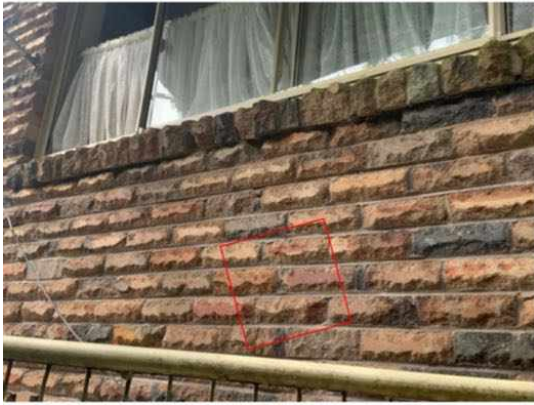
Finding 3.01

Building:	Main Building
Location:	Exterior walls - right side
Finding:	Brickwork - Step cracking
Information:	Step cracking was identified to the brickwork in this area at the time of inspection. Step cracking, which is similar to other forms of cracking, has a variety of possible causes. However, the most common is the subsidence of adjacent footings.

Step cracking is a relatively common defect, and is most likely to occur adjacent to windows, doors and other openings. Mortar failure in the gaps between affected bricks indicates the stresses and tensions affecting the wall.

Where step cracking is extensive or severe, the client is advised to consult a structural engineer. Minor step cracking can be used as a warning sign to address factors causing stress to the wall, which can include the effect of surrounding trees, water leaks, soil erosion, or even the presence of reactive soils in the surrounding area.

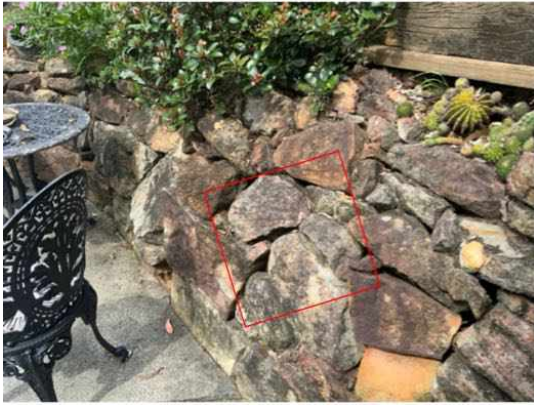
Finding 3.02

Building: Main Building
 Location: Exterior walls - rear
 Finding: Retaining wall - Defective

Information: The retaining wall in this area was found to be defective at the time of inspection. Generally, defective retaining walls are caused by poor original design or material use. However, deteriorated retaining walls may also be a result of substandard construction, poor site drainage or unmanaged stormwater flows.

If left unmanaged, the retaining wall may become a safety hazard if it continues to destabilise.

Significant repair and replacement should be expected. Where retaining walls are considered structural walls, a structural engineer / surveyor should be consulted regarding required remedial works. Otherwise, a landscaper or retaining wall installer may be appointed to repair or replace the wall, at the discretion of the client.

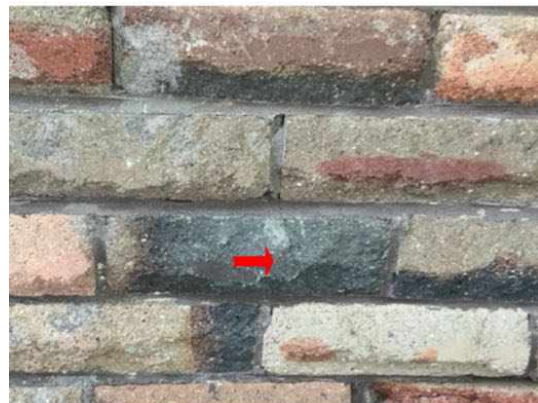
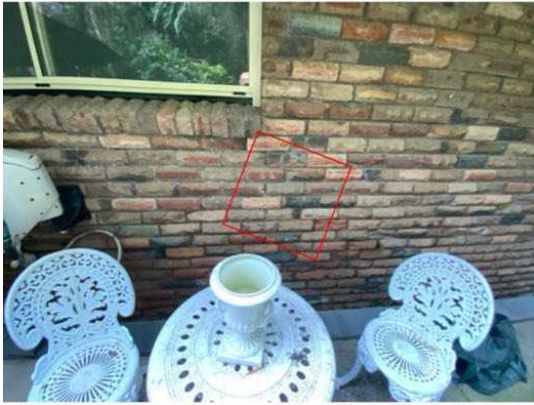
Finding 3.03

Building:	Main Building
Location:	Exterior walls - rear
Finding:	Brickwork - Cracking noticeable
Information:	There were several cracks and or crack repairs evident to external brickwork.

Noticeable cracks are a common occurrence in external brickwork and are a likely result of age expected building movement, general expansion, and/or contraction of building materials in different weather conditions. Noticeable cracks in brickwork may develop if left unattended, with potential for necessitating major remedial works or replacement of the brickwork.

It is highly advised that a qualified bricklayer be appointed to provide necessary works to cracked brickwork to prevent any further damage. Such works should be conducted as soon as possible.

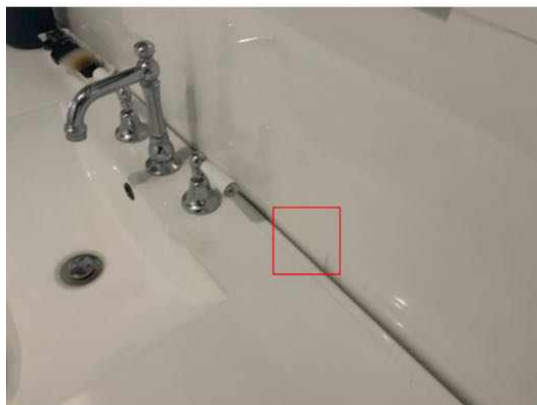
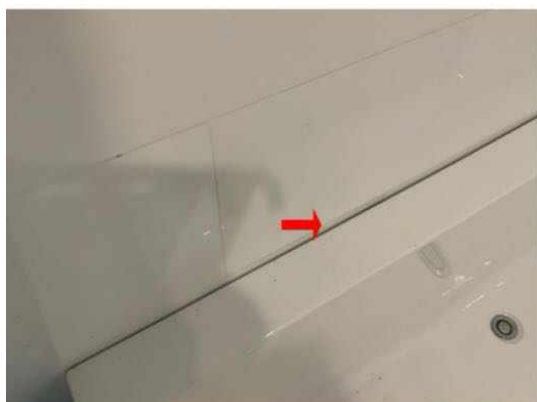
Finding 3.05

Building: Main Building
 Location: Bathroom
 Finding: Bathroom cabinetry - not sealed
 Information: Areas of bathroom cabinetry have not been fully sealed or have been sealed in a substandard manner. All junctions between bench tops and adjoining surfaces are defective if they are not sealed with an agreed or suitable flexible sealant or if leaks occur or where they are not installed to manufacturer's instructions.

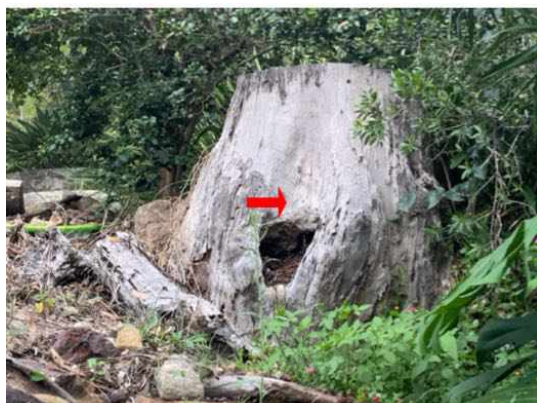
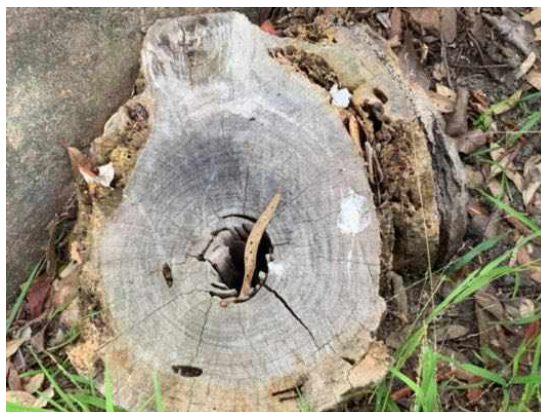
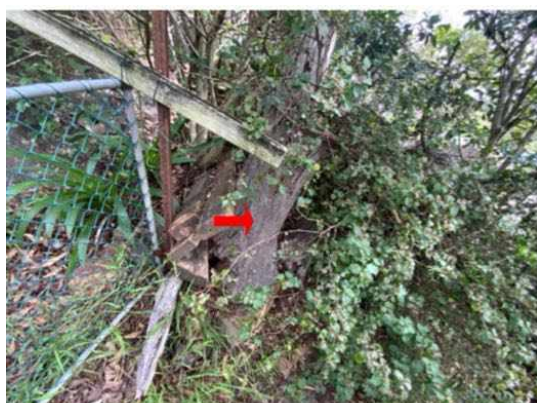
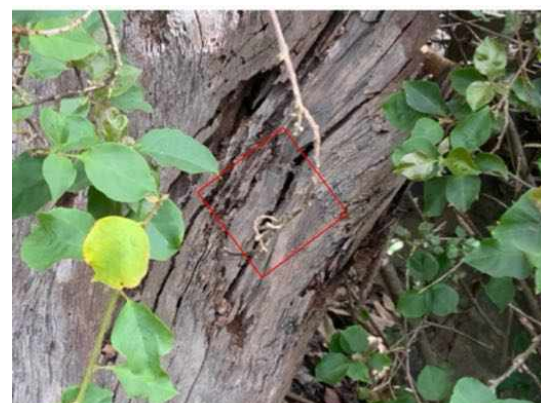
Building: Main Building
 Location: Exterior walls - rear
 Finding: Tree stumps
 Information: Where tree stumps are in direct contact with the ground and consequently moisture or dampness they become conducive to termite activity as they can provide an environment that is attractive to termite infestation.

The removal of any tree stumps that may be conducive to termite activity should be removed as soon as possible to minimise the risk of termite attack or alternatively drill and testing all tree stumps will be required to determine the presence of termite activity

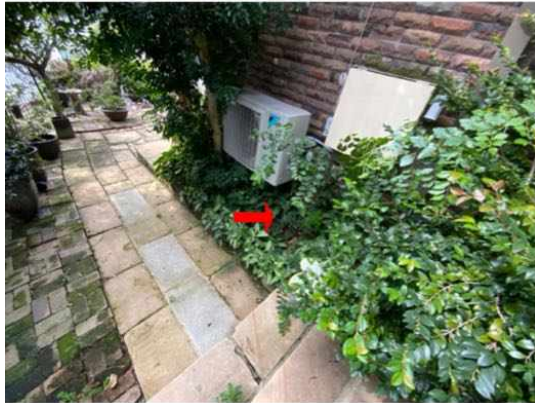
Finding 6.01

Building:	Main Building
Location:	Exterior walls - front
Finding:	Bridging - Vegetation
Information:	Where vegetation obstructs inspection of building elements, also known as bridging as it provides a bridging point for the access of termites, full inspection can not be achieved. Consequently moisture or dampness may be present and the areas becomes conducive to termite activity. Plants against or very close to buildings

The removal and replanting of species that do not provide "cover" or cutting back of existing vegetation will assist greatly in preventing Bridging from occurring.

The removal of any such materials that may be conducive to termite activity should be carried out as soon as possible and arrange re inspection to minimize the risk of termite attack.

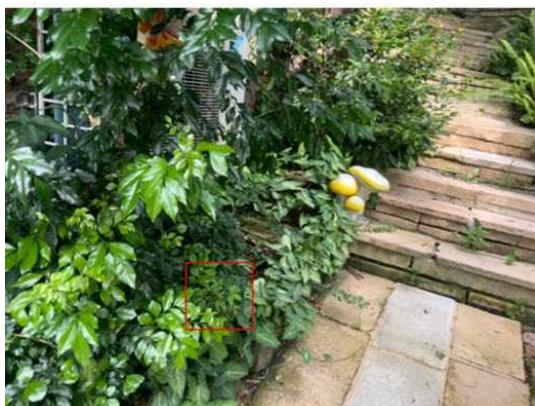
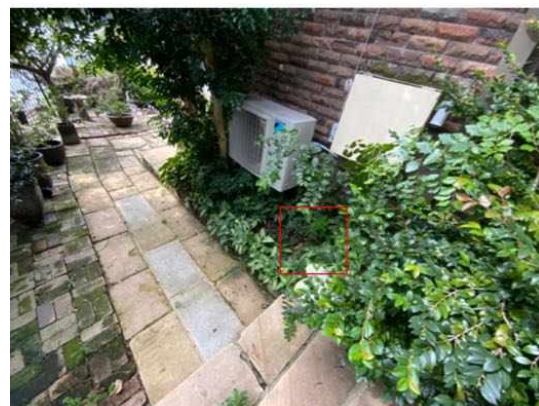
Finding 6.02

Building:	Main Building
Location:	Exterior walls - right side
Finding:	Garden Beds - Conditions Conducive to Termites
Information:	Garden beds were found to be evident in the garden area. These garden beds can include untreated timber, and with a combination of moisture from watering hosing can make conditions conducive to termite activity and termite ingress.

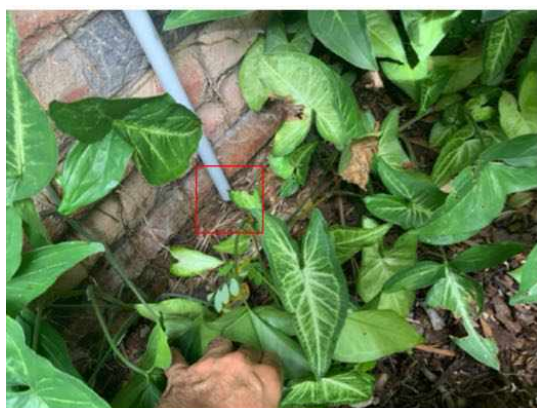
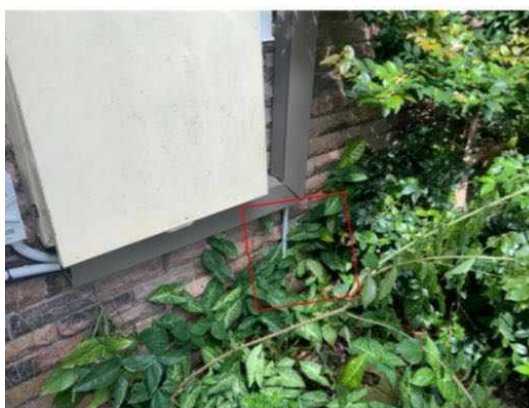
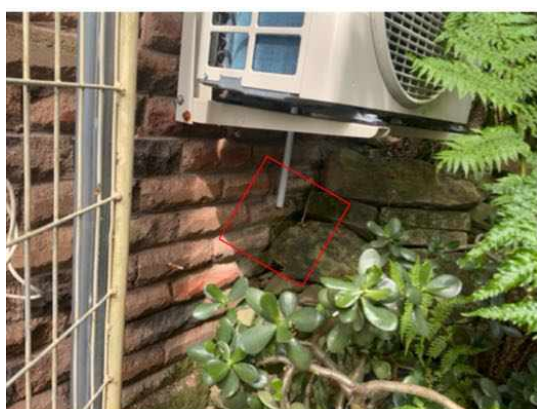
Finding 6.03

Finding: Air conditioner - Disconnected overflow
 Information: The Air Conditioner (A/C) overflow was found to be disconnected from storm water drainage and is creating excessive moisture in the surrounding area.

Such leaking creates an environment which is conducive to an array of defects, including water damage to associated building elements and the attraction of termite or timber pest infestation.

It is highly recommended that a licensed plumber be appointed to connect the A/C overflow in order to prevent such an environment from being created. These minor works should be carried out as soon as possible.

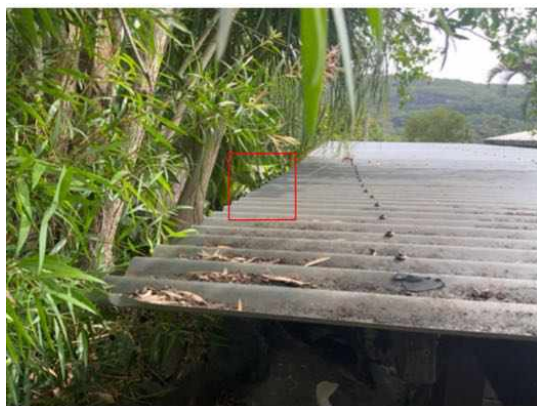
Finding 6.04

Building: Main Building
 Location: Exterior walls - rear
 Finding: Roof plumbing - Missing
 Information: Some sections of the roof are not adequately drained via gutters and downpipes. Gutters and downpipes that are not installed adequately are likely to result in excessively damp conditions against the exterior surfaces and around the base perimeter of the building.

Excessive moisture creates an environment which accelerates the deterioration of

building elements in the area, as well as being conducive to termite and pest infestation. Such an environment is likely to necessitate repair and/or replacement of building elements, which are prone to sustaining wood rot, rust or corrosion.

A roofing plumber should be appointed as soon as possible to install relevant roof plumbing materials. Depending on the extent of the damage, repair and/or replacement of damaged building elements may be required.

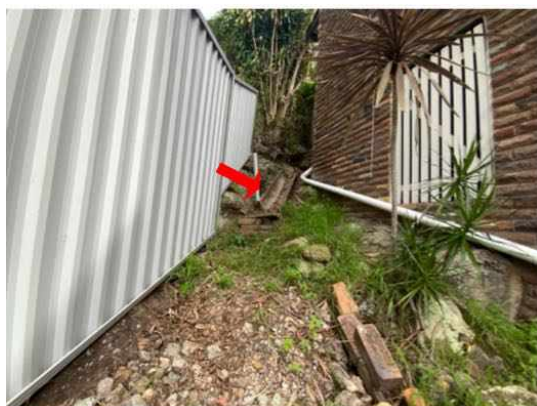
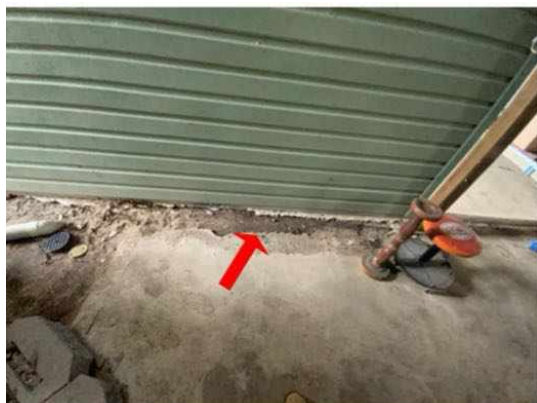
Finding 6.05

Building:	Main Building
Location:	Exterior walls - left side
Finding:	Site drainage - Inadequate
Information:	The site drainage in this area was found to be inadequate at the time of inspection, creating potential for subsequent water damage to associated building elements.

It is important that water does not lie against the base of walls; surrounding paths and ground levels should be sloped to drain water away from walls. Downpipes should not discharge stormwater onto lower walls or plinths. Stormwater should be carried away by large, regularly cleaned drains. Ground levels may need to be lowered to expose a buried DPC.

Where site drainage is inadequate, installation of an Agricultural (Aggie) Drain may be required. A qualified plumber should be appointed to further inspect the property and perform any remedial works as necessary. Water damage and secondary defects are likely to occur if left unmanaged.

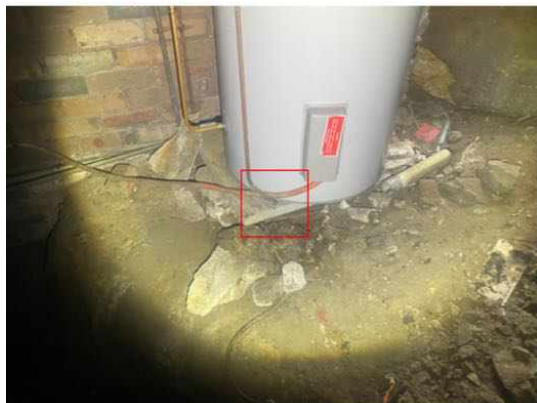
Finding 6.06

Building:	Main Building
Location:	Subfloor
Finding:	HWS Overflow - Not Connected
Information:	The Hot Water System (HWS) overflow was found to be disconnected from storm water drainage and is creating excessive moisture in the surrounding area.

These damp conditions can lead to secondary defects such as rot, rust or corrosion of associated building elements, the formation of fungal decay, or even the creation of potential slip hazards. When coupled with poor site drainage, pooling of water may also attract termite activity to this area.

It is highly recommended that a licensed plumber be appointed to connect the HWS overflow in order to prevent such an environment from being created. These minor works should be carried out as soon as possible.

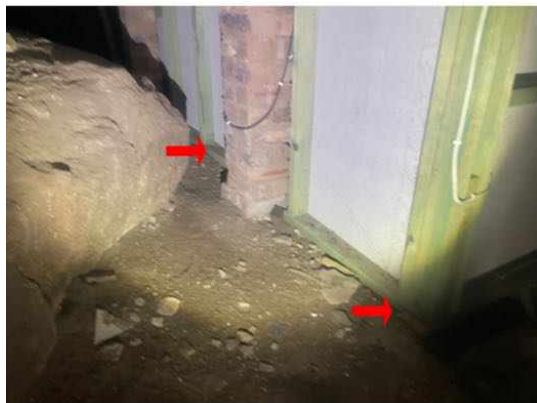
Finding 6.07

Building:	Main Building
Location:	Subfloor
Finding:	Untreated or non-durable timbers in a hazardous environment
Information:	To reduce the risk of timber pest attack it is essential that timber used in a hazardous environment (e.g. in direct contact with the ground or frequently exposed to damp conditions) is of sufficient durability and/or is adequately preservative treated.

Untreated timbers in direct contact with the ground are likely to develop severe wood rot and/or fungal decay if left unattended creating attraction for subterranean termites to infest the timbers from surrounding areas.

If untreated or non-durable timbers are found to be in a hazardous environment it is highly advised that replacement of these building elements be performed as soon as possible to aid the protection of the property against termite / timber pest attack.

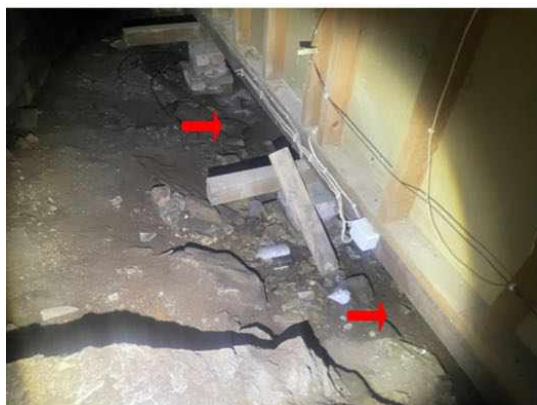
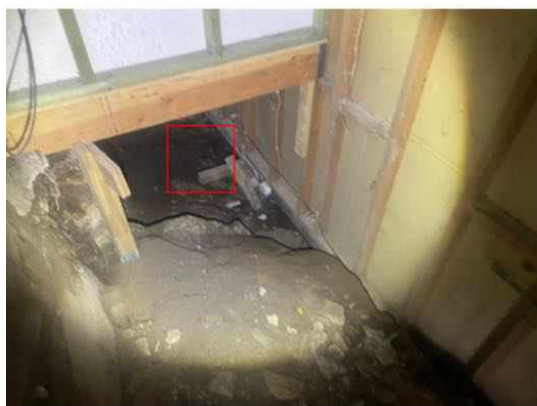
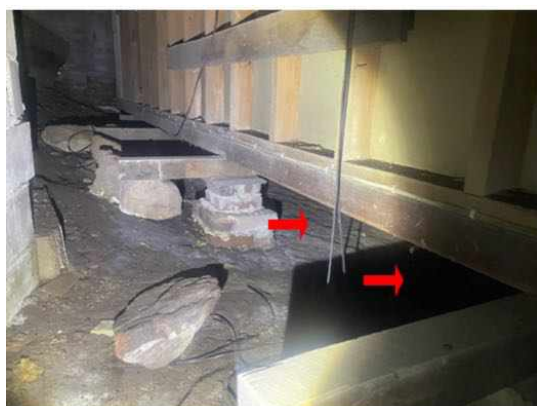
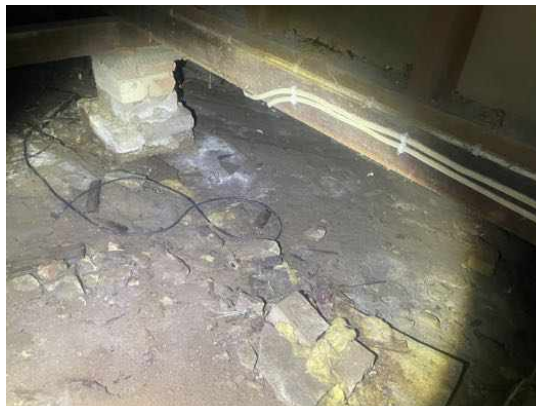
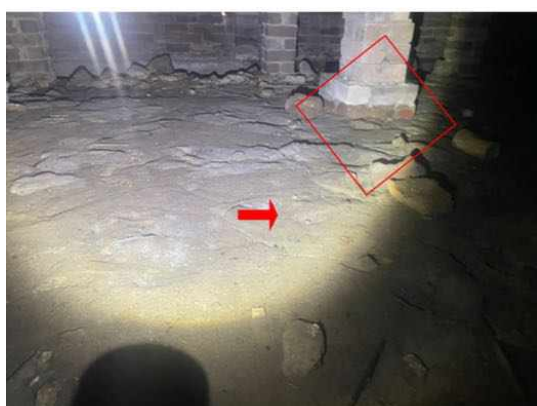
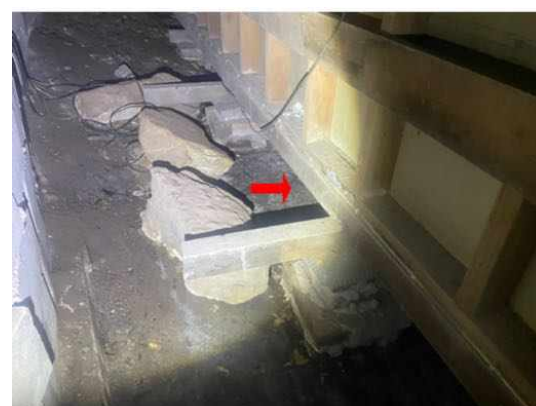
Finding 6.08

Building:	Main Building
Location:	Subfloor
Finding:	subfloor drainage poorly drained
Information:	Poor drainage leads to excessive moisture, entering the subfloor area and being retained in the soil, which overtime can destabilise the foundations and promote timber pest activity such as fungal decay and termite.

Generally, to ensure that water drains away from the footings, the profile of the ground adjacent to the building should slope away from the base of the exterior walls, and all stormwater drainage should be maintained in good condition and free from blockage.

If the ground level of the subfloor area is fully or partly below, the surrounding ground level, then well designed retaining walls with appropriate drainage are required to prevent water entering the subfloor area.

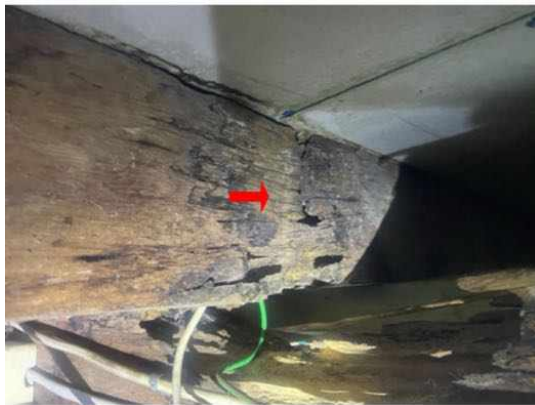
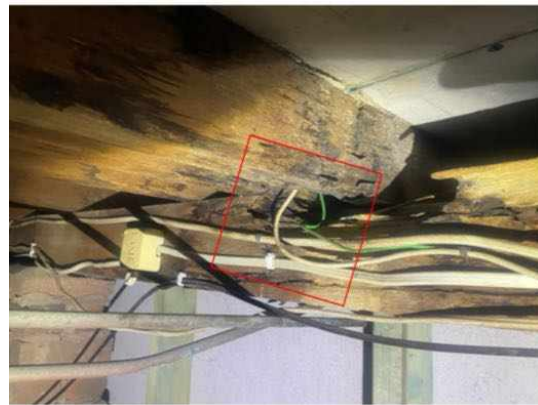
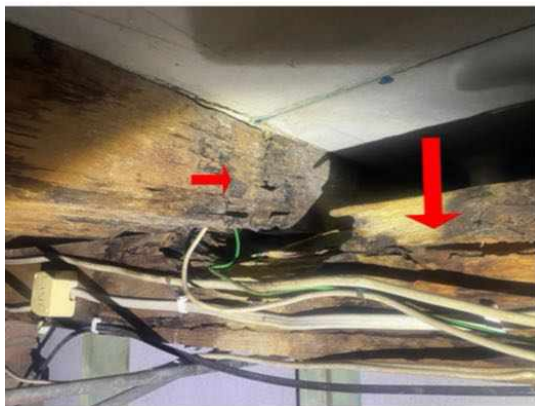
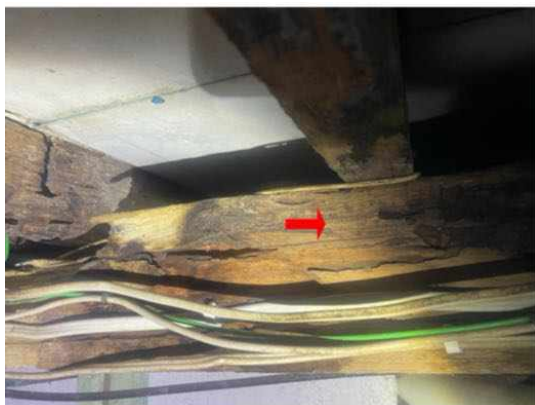
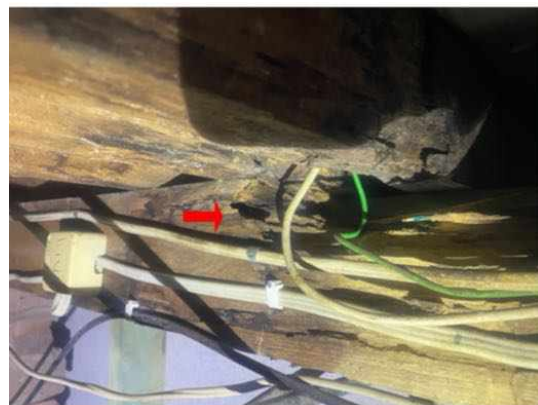
Finding 7.01

Building:	Main Building
Location:	Subfloor
Finding:	Subfloor structure - Wood rot
Information:	The subfloor structures are showing signs of deterioration and wood rot (fungal decay) of the timbers. It is suspected that this defect has developed as a result of an old leak in the bathroom.

Damp conditions cause the timbers to fail, resulting in the subfloor structures failing to bear the load (or weight) of the building as originally intended. Without repairs and maintenance, including potential replacement of affected elements, it is likely that serious structural faults will result, as well as an array of minor defects.

Where wood rot is present to any structural timber, rectification or replacement of the affected timber building element is required. The adequate timeframe for such works are dependent on the severity of the rot. Where rot has developed to become widespread, replacement of sections of the subfloor structure may be required. Consultation with a structural engineer or registered builder specialising in re-stumping is highly advised as soon as possible.

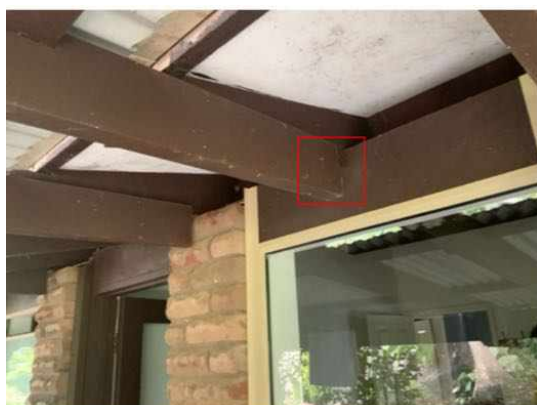
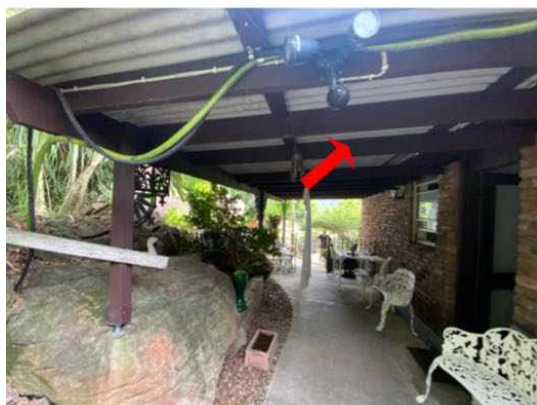
Building:	Main Building
Location:	Exterior walls - rear
Finding:	Structure - Old and non-compliant
Information:	This structure, whilst appearing to provide adequate structural support, does not comply with contemporary building practices and current Australian Standards.

It is advised that this structure be inspected by a registered builder or structural engineer on a relatively frequent basis to ensure that the structural integrity does not falter over time.

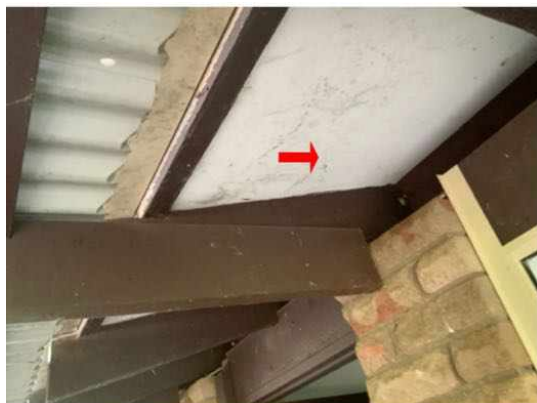
Building:	Main Building
Location:	Exterior walls - rear
Finding:	Asbestos - Suspected ACM Identified on Site
Information:	Reporting on Asbestos is outside the Scope of this Report. This suspected defect is highlighted as a caution only. We suspect, based on our experience in the building industry, that there is a higher risk of the identified building element containing asbestos.

As Asbestos Reporting is outside the scope of this report, we advise that you consider a separate Asbestos Inspection and Condition Audit, which can include the taking of samples for definitive confirmation of the presence of Asbestos.

In the interim, the client is advised to act with caution, especially when considering any damage to building materials general wear and tear renovations extensions demolition and general maintenance activities due to the suspected presence of Asbestos.

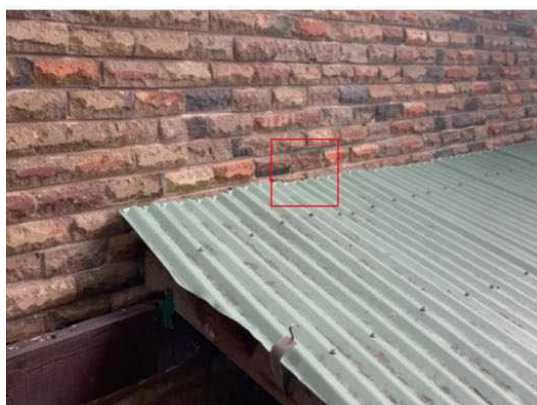
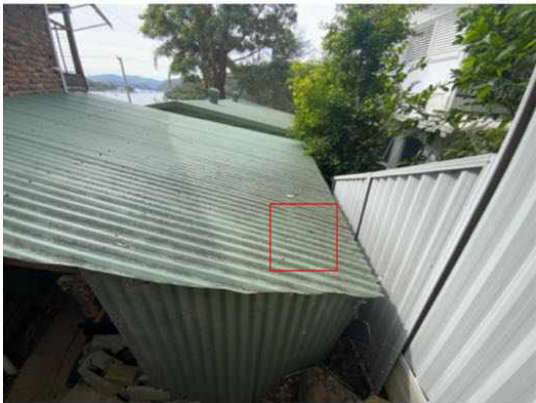
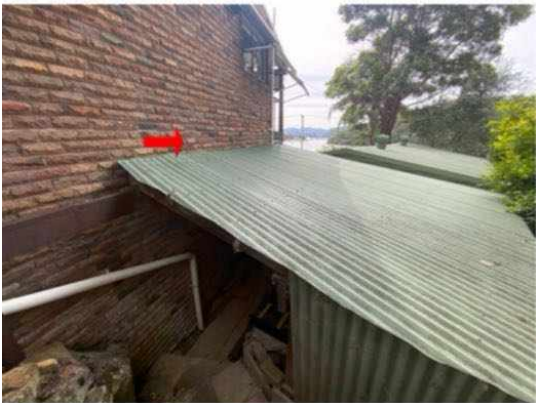
Building: Main Building
Location: Exterior walls - left side
Finding: Structure - Old and non-compliant
Information: This structure, whilst appearing to provide adequate structural support, does not comply with contemporary building practices and current Australian Standards.

It is advised that this structure be inspected by a registered builder or structural engineer on a relatively frequent basis to ensure that the structural integrity does not falter over time.
