# Building and Timber Pest Inspection Report

Inspection Date: Thu, 5 Mar 2026

Property Address: 8 Chaplin Cres, Quakers Hill NSW 2763,  
Australia

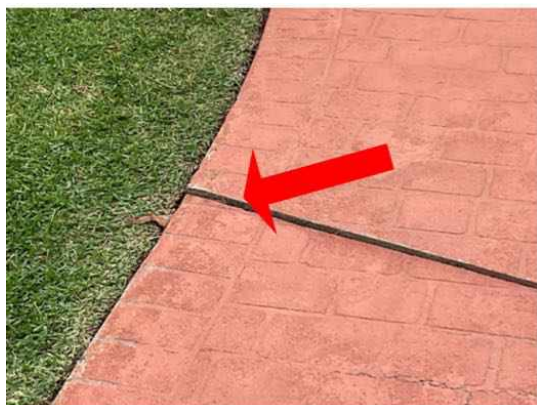
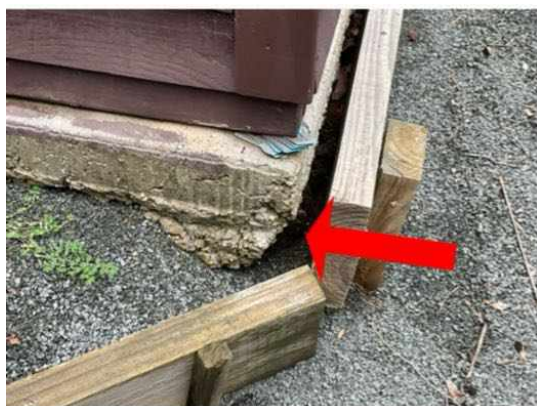
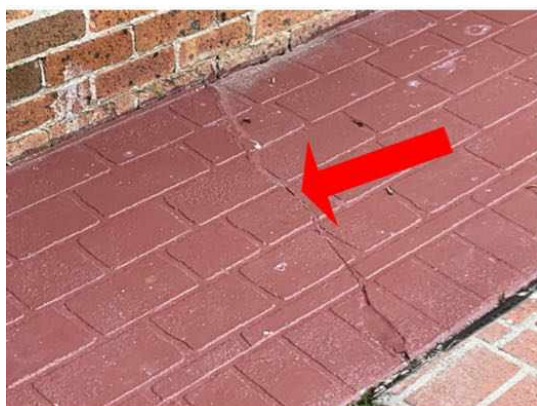
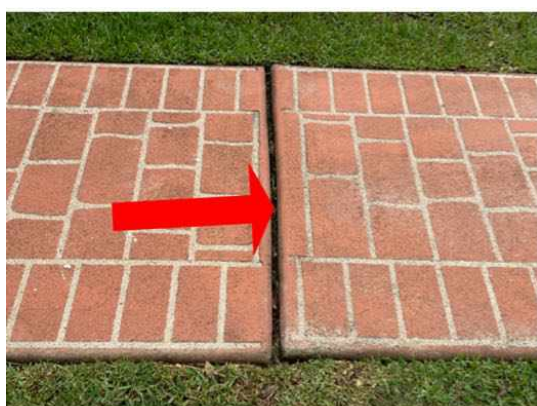
Building: Main Building  
Location: All External Areas  
Finding: Concrete paving - Erosion  
Information: Erosion under concrete paving was identified at the time of inspection. For all the concrete paving without the right support, concrete will crack, sink and cease to be sturdy. It's imperative to fix erosion under concrete immediately as well as improve rainwater drainage away from the building foundations.

Suggestion of the inspection from the structure engineer and A qualified tradesmen to be nominated to fix the defect as soon as possible.

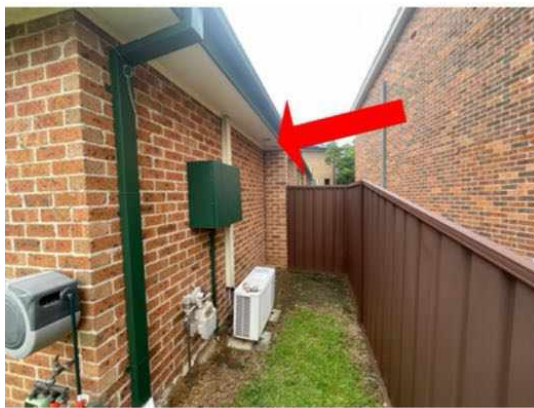
### Finding 3.03

Building:	Main Building
Location:	All External Areas
Finding:	External Vent Grille - missing
Information:	The external vent grille is missing / dislodged, leaving the vent opening exposed. This condition may allow vermin, insects, moisture, and debris to enter the building cavity.
	Supply and install a suitable external vent grille and ensure it is securely fixed and sealed.

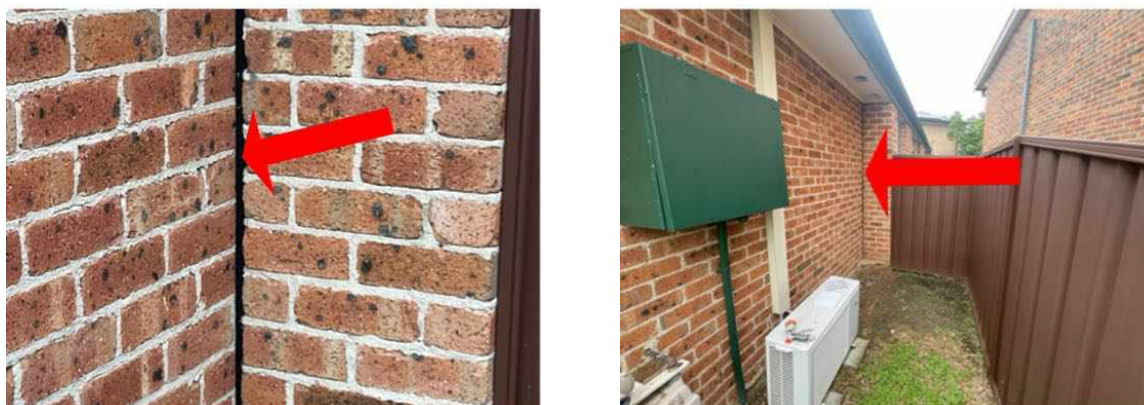
### Finding 3.04

Building:	Main Building
Location:	Exterior walls
Finding:	Articulation joints - Inadequate
Information:	The articulation or control joints throughout the exterior brickwork were deemed as insufficient at the time of inspection. Mortar, a non-compressive material, is still evident

in some of the joints, not allowing the joints to do their job and allow the brick walls to expand and contract as required during different weather conditions.

Articulation joints must be cleaned of all non-compressive material and then sealed with an appropriate flexible sealant. Failure to perform these necessary works is likely to lead to excessive moisture ingress into these joints, or cracking to the brick walls during extreme weather conditions, which may carry major implications for associated building elements if left unmanaged.

These preventative works are important in ensuring the structural integrity of the associated brickwork. Appointment of a qualified builder or bricklayer is advised to perform remedial works as necessary.

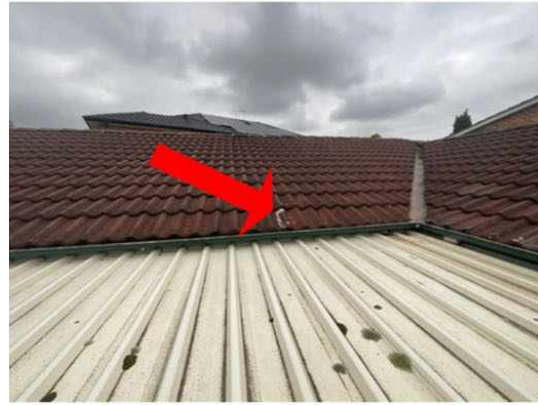
### Finding 3.05

Building:	Main Building
Location:	Roof Exterior
Finding:	Roof tiles - Broken
Information:	Upon inspection of the exterior roof covering, broken roofing tiles were identified. Broken and friable roof tiles are generally the result of ageing and weathering of what is essentially a porous material.

If left to further deteriorate, broken and brittle roof tiles are likely to lead to water penetration via the roof into the ceiling space, causing secondary damage to ceiling linings, insulation and roof structures. Broken roof tiles are also likely to detract from the effectiveness of the roof drainage system, creating potential for secondary damage to the exterior roof covering and roof plumbing.

Replacement of broken tiles is required and should be performed by a roofing contractor as soon as possible.

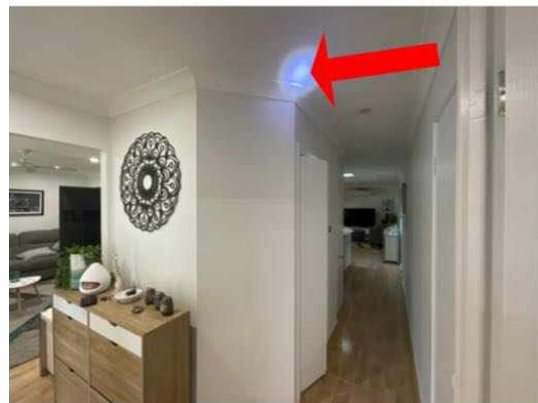
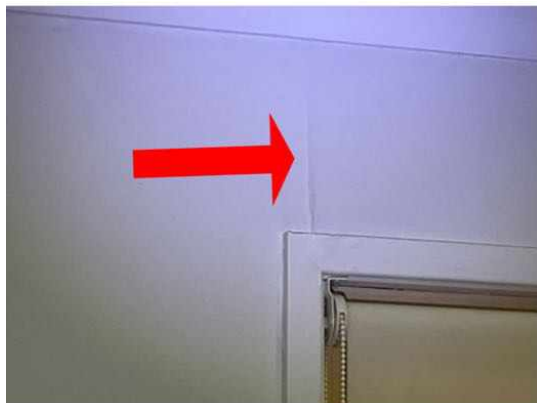
### Finding 3.06

Building:	Main Building
Location:	All Internal Areas
Finding:	Cracking - Damage Category 1 - Fine (up to 1mm)
Information:	Although fine cracks are quite noticeable, they are often only considered to be an appearance defect, and usually do not indicate any structural damage. Generally, the cause of a fine crack is indicative of a separation between building materials and finishes (e.g. paint, plaster, etc.) along joins.

Cracking of this nature can generally be repaired with minor sanding, filling and/or repainting. Such works should be performed by a qualified painter or a general handyman.

Monitoring of all cracking should be conducted frequently. Always contact a building inspector should cracks widen, lengthen, or become more numerous.

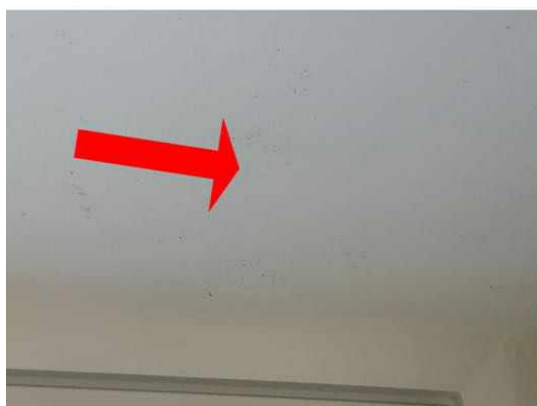
### Finding 3.07

Building:	Main Building
Location:	Ensuite
Finding:	Bathroom Ceiling - Mould Growth
Information:	Minor mould growth was observed to the bathroom ceiling along the joint line. This is likely due to condensation and elevated moisture levels within the bathroom environment.

While the mould appears localised and minor at the time of inspection, prolonged moisture exposure may lead to further deterioration of paint finishes and potential substrate damage.

- Clean and treat affected areas with an appropriate mould removal solution.
- Repaint with mould-resistant paint if required.
- Improve ventilation (ensure exhaust fan is operational and ducted externally).
- Monitor for recurrence.

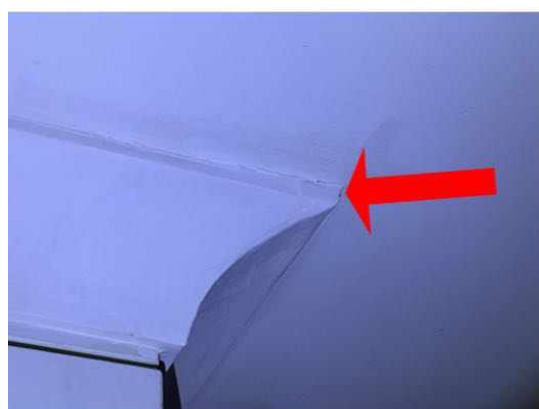
### Finding 3.08

Building:	Main Building
Location:	Bedroom - Master
Finding:	Cornices - Sagging
Information:	Sagging and uneven cornices generally indicate that the building materials have swollen, due to contact with water, or the movement of the ceiling joints or that fixings (e.g. nails or glue) have become loose and require reattachment. In some cases, sagging and uneven surfaces may also indicate that there are structural issues causing surfaces to warp, twist, or sag.

Where sagging appears to be major, appointment of a structural engineer is advised to further inspect the property. Otherwise, minor works such as re-gluing of wall/ceiling sheets may be required and should be performed by an aptly qualified plasterer or carpenter.

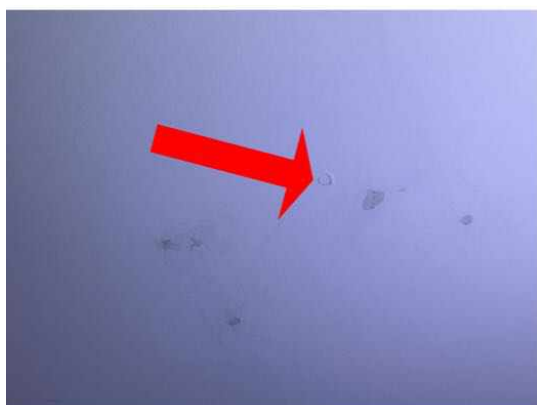
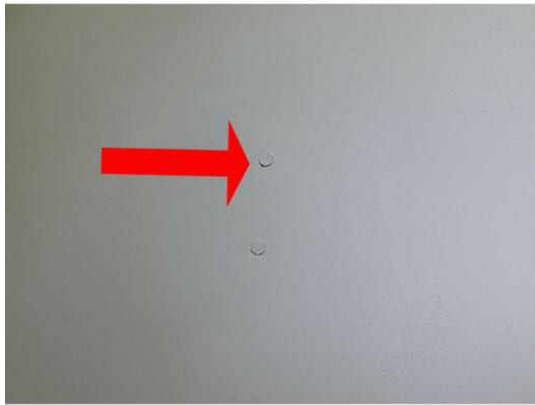
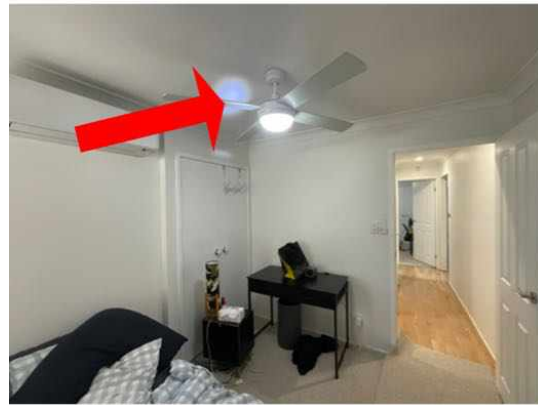
Building:	Main Building
Location:	Bedroom 2
Finding:	Ceiling nails - Popping
Information:	Numerous popped nails were identified in the internal ceiling at the time of inspection. Nails and screws hold simply by the friction between them and the surface they are applied to. Over time, the nails and screws can back out, which is often a result of general ageing and deterioration of the building structure.

If left unmanaged, the ceiling sheets may become loose and unstable, increasing the rate of deterioration of the internal ceiling and creating potential for the development of secondary defects.

Re-fastening of popped nails will help to maintain the stability of the internal ceiling and associated building elements. Such minor works will also help to improve the appearance of the affected area and secure the ceiling sheets, so as to prevent the onset of ceiling sagging. These works should be performed by a qualified carpenter or plasterer at client discretion.

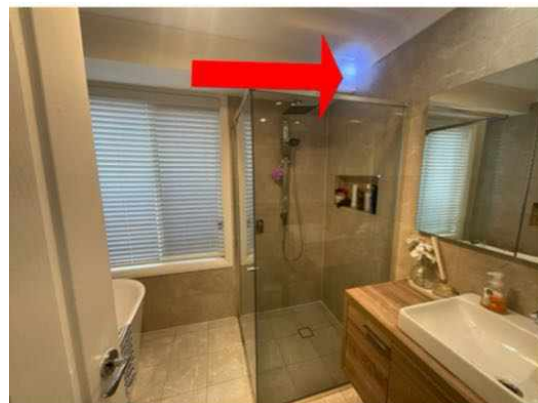
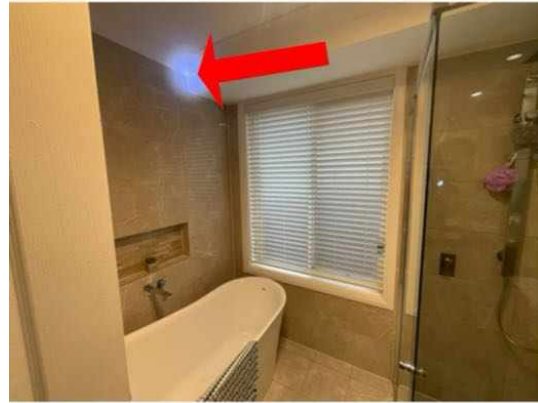
### Finding 3.11

Building:	Main Building
Location:	All Internal Areas
Finding:	Painted surface - Bubbling
Information:	Sections of paint in this area was found to have bubbled and deteriorated. Paint bubbling is generally an indication of excessive moisture in the area, that is currently hidden by the painted surface.

The presence of excessive moisture can have major implications on associated building elements if left unattended. While only seemingly minor at this stage, the damage cannot be determined due to the paint obstructing any further inspection of the damage.

It is highly advised that the affected paint be cleaned to allow a further, more invasive inspection by a licensed plumber. Failure to act on this defect may necessitate major works in the future.

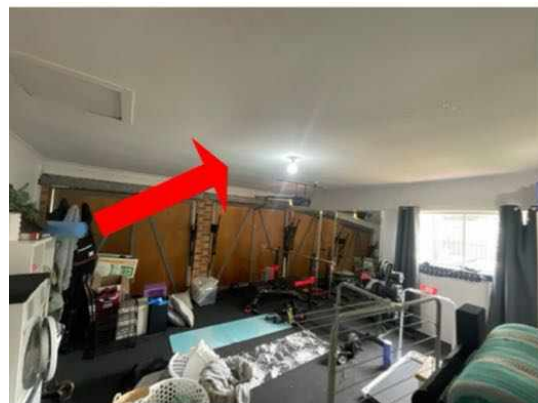
### Finding 3.12

Information: Sections of the ceiling were found to be sagging at the time of inspection. Sagging to the fixed ceiling structure generally indicates that the building materials have swollen, due to contact with water, or that fixings (e.g. nails or glue) have become loose and require reattachment.

Where minor sagging is evident, comparatively minor works, such as re-gluing of ceiling sheets, may be required. Such works may be performed by relevant tradespeople, such as carpenter and painters. Where excessive moisture has caused the roofing structure to swell and sag, the source of the water leak should primarily be identified prior to any remedial works being performed.

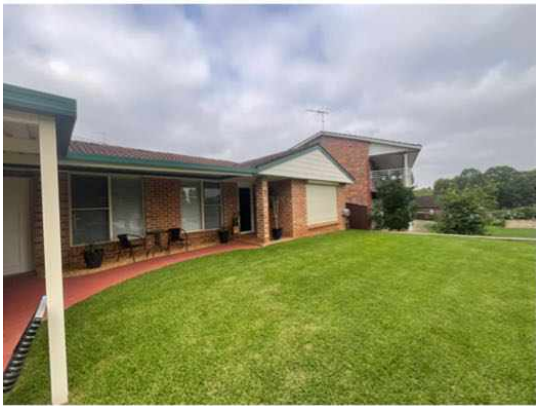
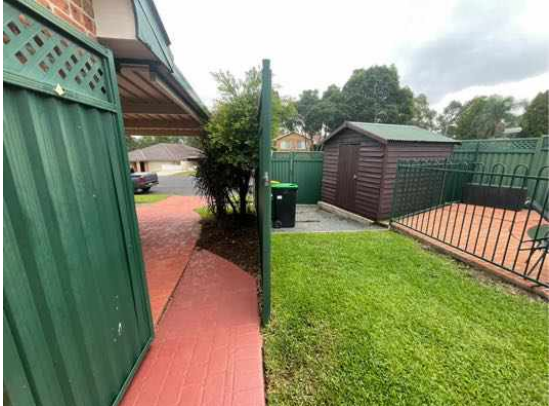
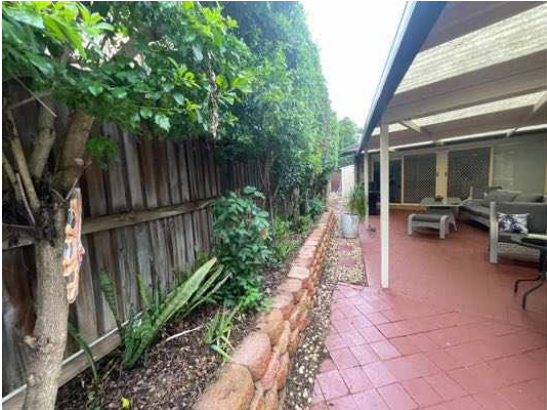
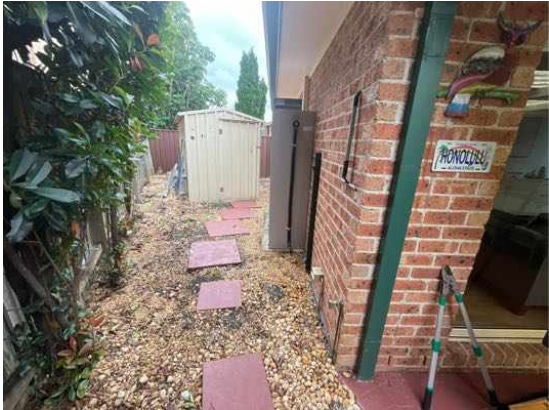
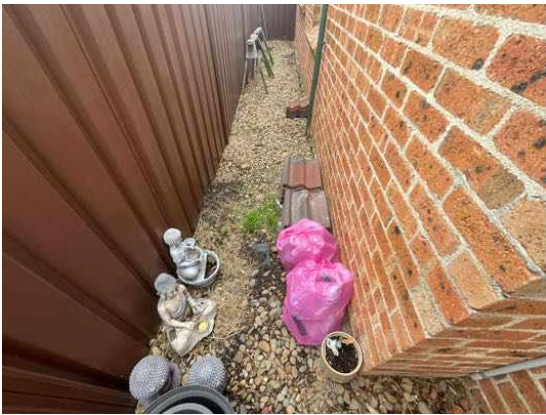
### Finding 6.01

Building: Main Building  
Location: All Areas  
Finding: Garden Beds - Conditions Conducive to Termites  
Information: Garden beds were found to be evident in the garden area. These garden beds can include untreated timber, and with a combination of moisture from watering hosing can make conditions conducive to termite activity and termite ingress.

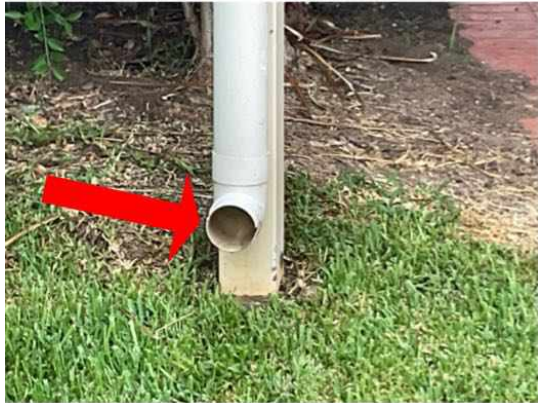
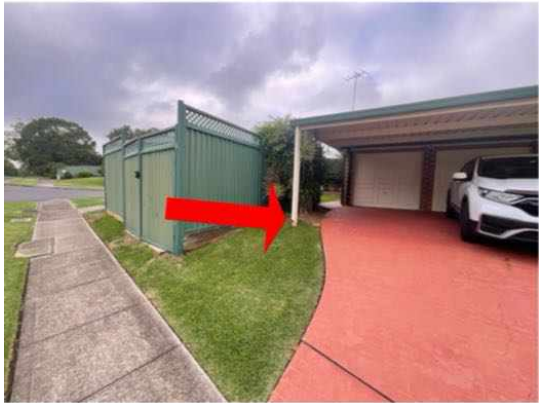
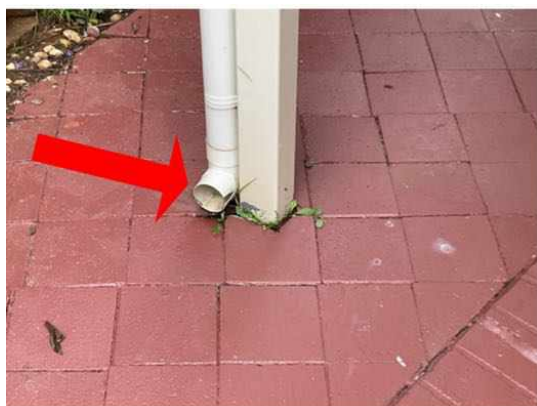
**Finding 6.02**

Building: Main Building  
Location: All Areas  
Finding: Overflow - Not plumbed for drainage  
Information: The overflow is not plumbed or connected to suitable drainage, which has resulted in the surrounding area becoming excessively damp. These damp conditions can lead to secondary defects such as rot, rust or corrosion of associated building elements, the formation of fungal decay, or even the creation of potential slip hazards. When coupled with poor site drainage, pooling of water may also attract termite activity to this area. It is highly recommended that a qualified plumber be appointed to install adequate drainage to the overflow. These works will ensure that the area remains dry and free of any secondary defects.

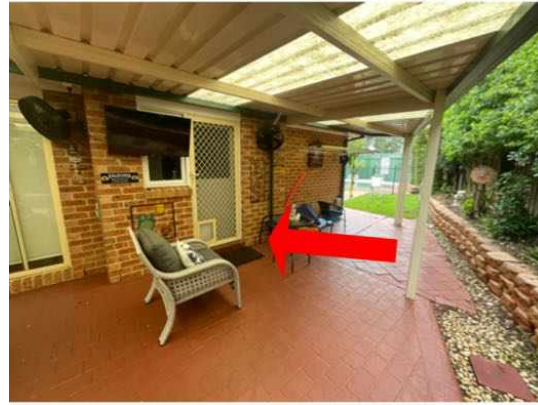
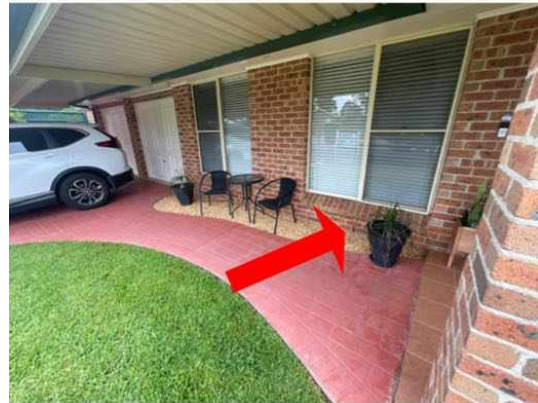
### Finding 6.03

Building:	Main Building
Location:	All Areas
Finding:	Bridging or breaching of termite barriers - weep holes
Information:	Bridging is the spanning of a termite barrier or inspection zone so that subterranean termites are provided with passage over or around that barrier.

Weep holes in the exterior brickwork of the property are designed to allow condensation that may build up between the brickwork and subsequent timber framework to drain from within the wall hence preventing any deterioration of the timber building elements.

Additionally build-up of moisture is likely to occur if weep holes are covered further attracting termite activity to these areas.

It is highly recommended that weep holes are left exposed in all areas throughout the external property. Therefore if any termite activity leading into weep holes becomes easily detectable during frequent pest inspections.

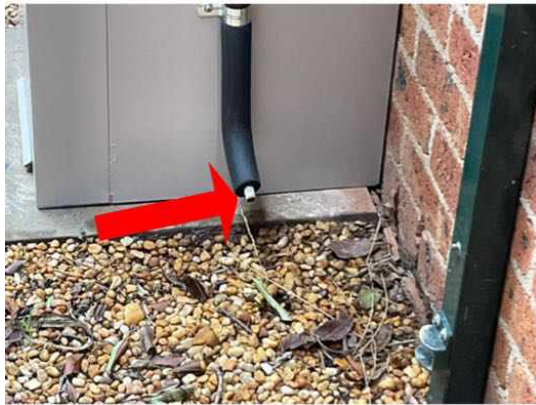
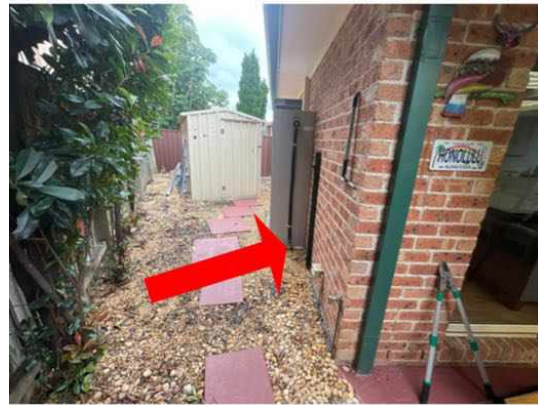
### Finding 6.04

Building:	Main Building
Location:	All Areas
Finding:	HWS Overflow - Not Connected
Information:	The Hot Water System (HWS) overflow was found to be disconnected from storm water drainage and is creating excessive moisture in the surrounding area.

These damp conditions can lead to secondary defects such as rot, rust or corrosion of associated building elements, the formation of fungal decay, or even the creation of potential slip hazards. When coupled with poor site drainage, pooling of water may also attract termite activity to this area.

It is highly recommended that a licensed plumber be appointed to connect the HWS overflow in order to prevent such an environment from being created. These minor works should be carried out as soon as possible.

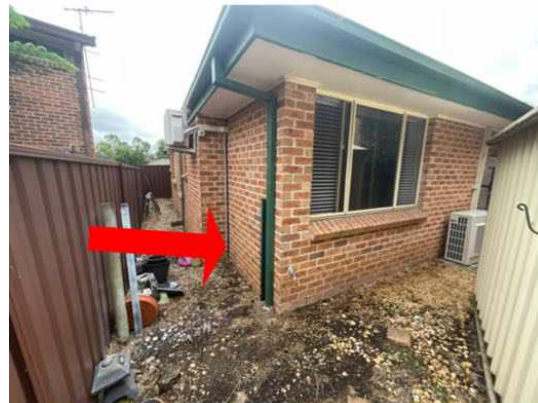
### Finding 6.05

Building:	Main Building
Location:	All Areas
Finding:	Air conditioner - Disconnected overflow
Information:	The Air Conditioner (A/C) overflow was found to be disconnected from storm water drainage and is creating excessive moisture in the surrounding area.

Such leaking creates an environment which is conducive to an array of defects, including water damage to associated building elements and the attraction of termite or timber pest infestation.

It is highly recommended that a licensed plumber be appointed to connect the A/C overflow in order to prevent such an environment from being created. These minor works should be carried out as soon as possible.

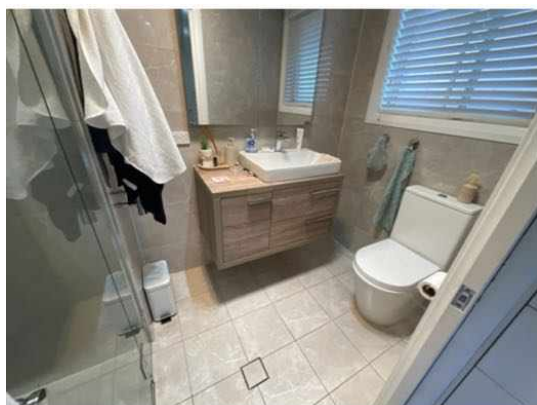
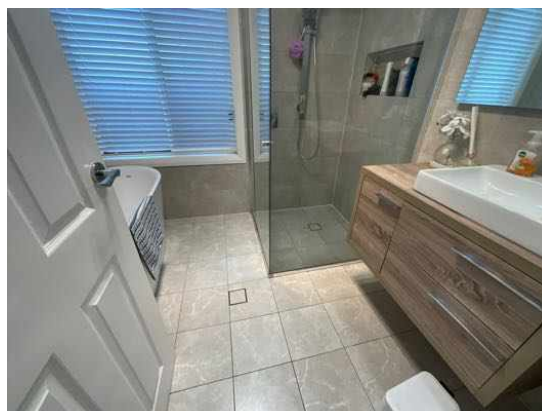
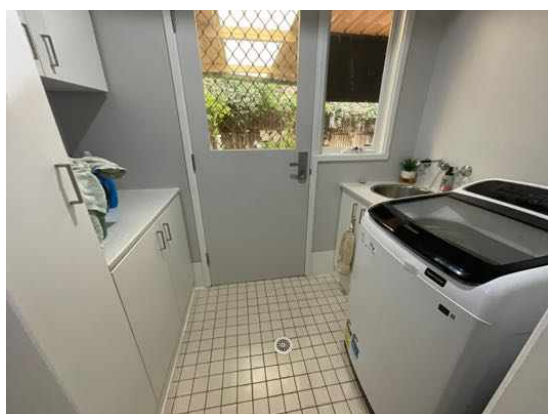
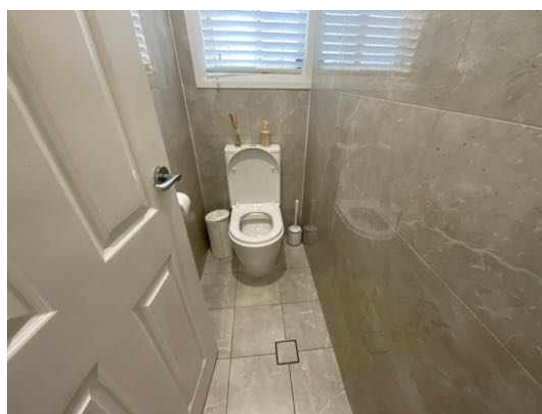
Building: Main Building  
 Location: All Areas  
 Finding: Water Proofing Membranes - Information Only  
 Information: Internal Water Proofing Membranes, are crucial in preventing water ingress into the property is important to know that the Membrane System used is to Australian Standards and has been installed correctly. Please refer to the original Building Documents or Maintenance Schedule for the relevant information including; - Membrane used and Manufacturers Specifications. - The Installer and Installation Certification. Especially with older property's where this information is unavailable, all wet areas should be monitored. Generally new waterproofing with a certificate may only have a guarantee of 8yrs. If any leaks, water staining, peeling or bubbling of the paint become evident to any adjacent walls or ceilings below a licensed builder or waterproofing specialist is recommended to investigate further.

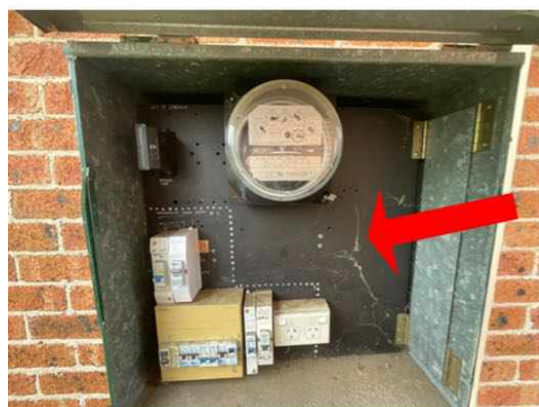
A durable notice should be placed in the switchboard unit to indicate current termite barriers. At the time of inspection, it appeared as though no termite management system has been installed, with no evidence to suggest preventative works taking place.

The client may consider gaining further advice from a pest controller as to the costs and procedures involved with this application. It is recommended that obtaining such advice be a short-term priority.
