Building Inspection Report

Inspection Date: Thu, 15 Jan 2026

Property Address: 52 Willoughby Rd, Crows Nest NSW 2065,
Australia

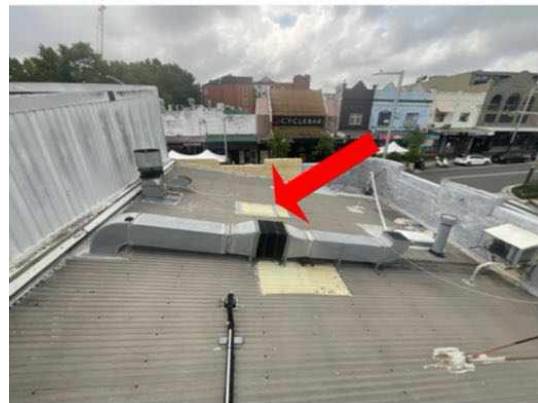
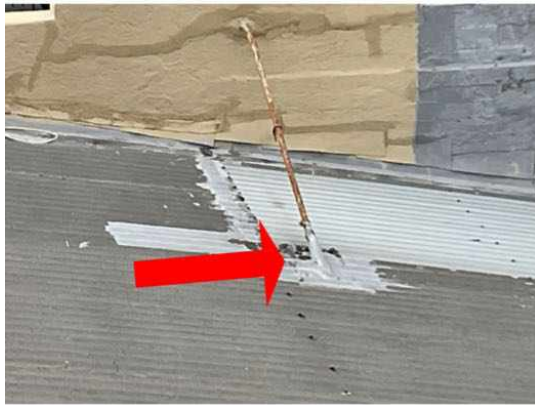
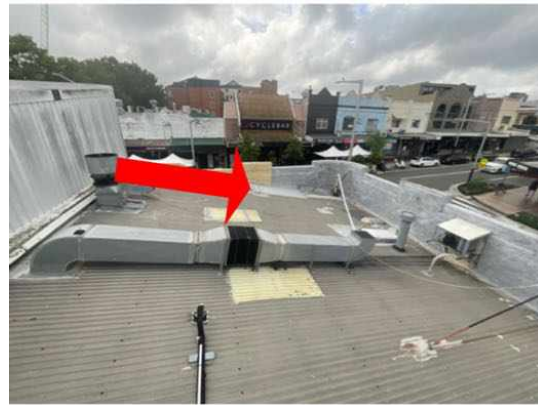
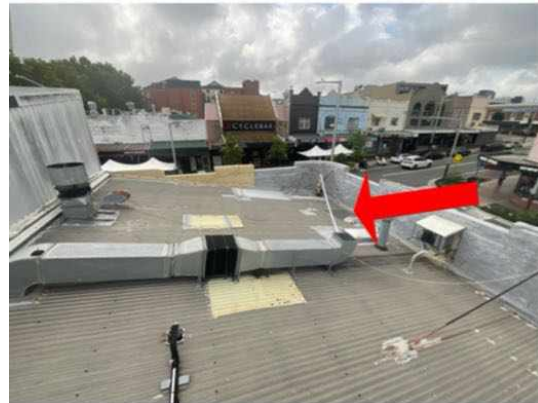
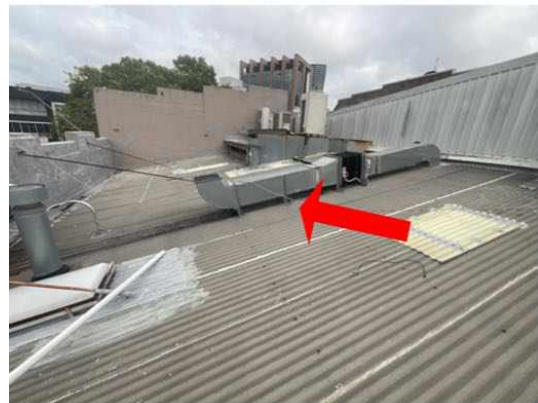
Defects 2.01

Building: Main Building
Location: Roof Exterior
Finding: Exterior roof - Leaking
Information: Active roof leaks were evident at the time of inspection. Roof leaks can have a number of causes, including damage to roof coverings, deterioration of roof fixtures and fittings, or loosely associated materials (fascias etc.).

Where water leaks are active, rain penetration is likely to cause water damage to associated structures and building elements in this area, which can have a range of implications. If left unmanaged, the development of major structural damage to the roofing and associated structures may occur.

A roof plumber should be appointed as soon as possible to primarily identify the cause of the leak, and to provide subsequent repair works as necessary. Depending on the extent of the damage, replacement of sections of the roof covering and/or roofing structures may be required, and may be performed by a registered builder or qualified carpenter.

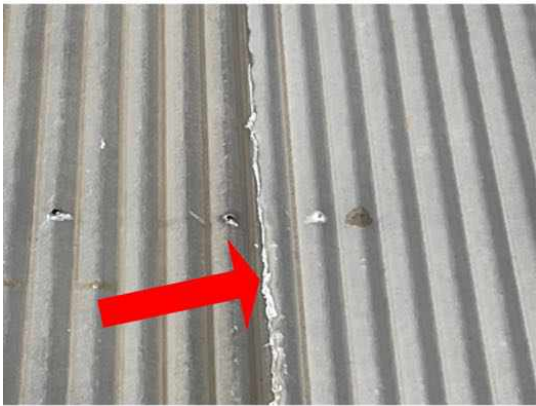
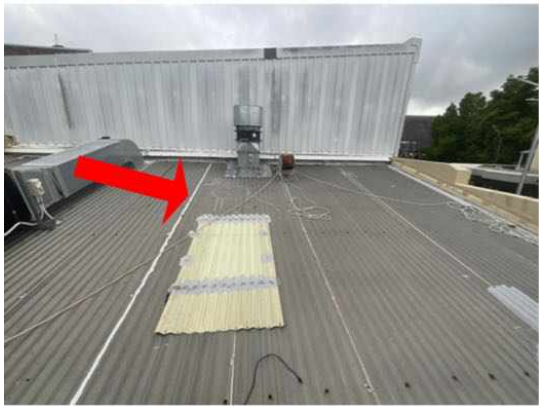
Defects 2.02

Building:	Main Building
Location:	Roof Exterior
Finding:	Roof exterior - Inadequate silicone work
Information:	The silicone work performed to the roofing exterior appears to have been completed to an unsatisfactory standard. Inadequate silicone was evident in many sections of roof area providing a blemish on the appearance as well as detracting from the drainage of the area.

A roofing contractor or general handyman may be appointed to perform these works at client discretion.

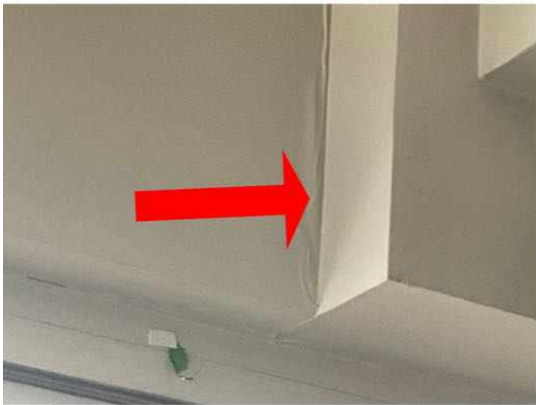
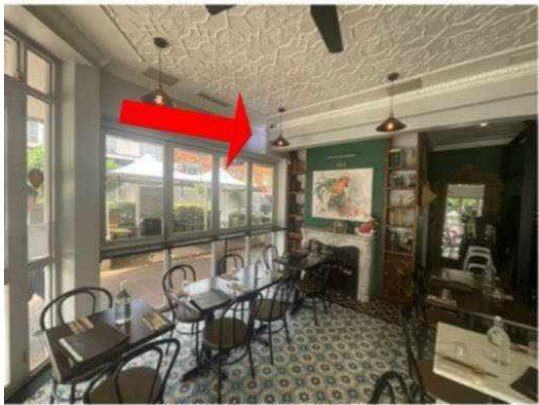
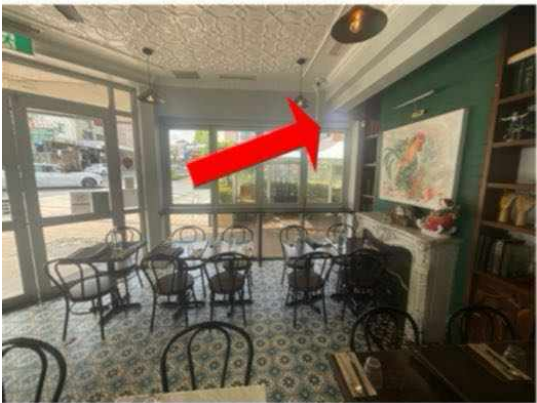
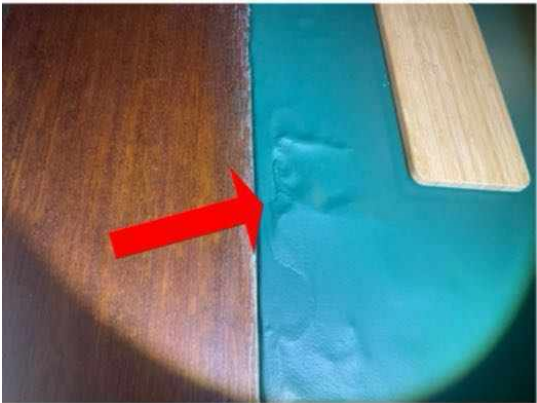
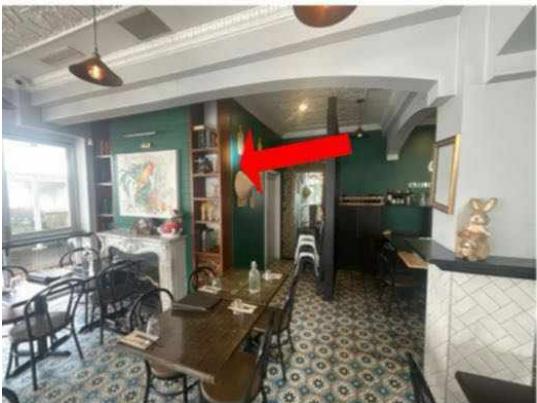
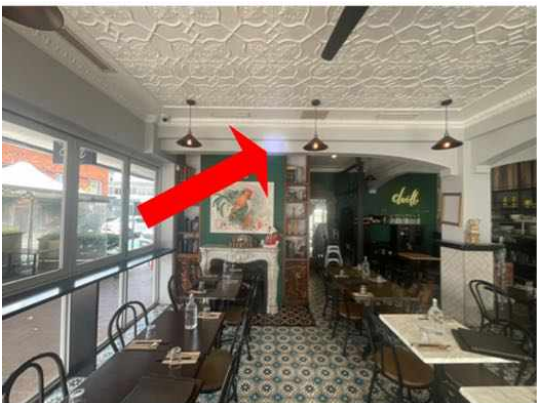
Defects 2.03

Building: Main Building
Location: All Internal Areas
Finding: Painted surface - Bubbling
Information: Sections of paint in this area was found to have bubbled and deteriorated. Paint bubbling is generally an indication of excessive moisture in the area, that is currently hidden by the painted surface.

The presence of excessive moisture can have major implications on associated building elements if left unattended. While only seemingly minor at this stage, the damage cannot be determined due to the paint obstructing any further inspection of the damage.

It is highly advised that the affected paint be cleaned to allow a further, more invasive inspection by a licensed plumber. Failure to act on this defect may necessitate major works in the future.

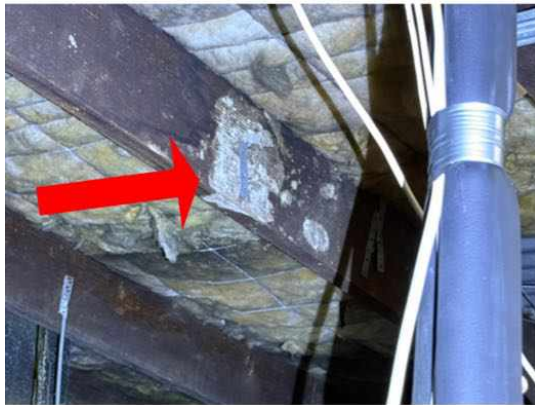
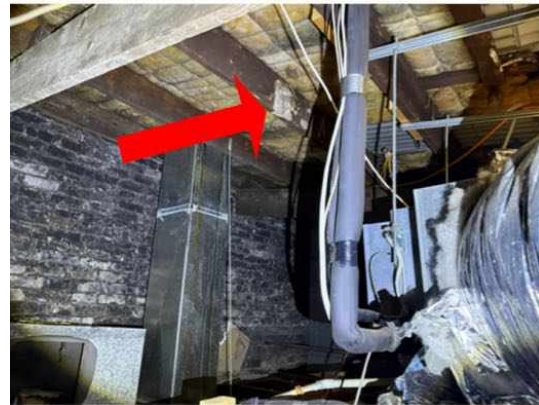
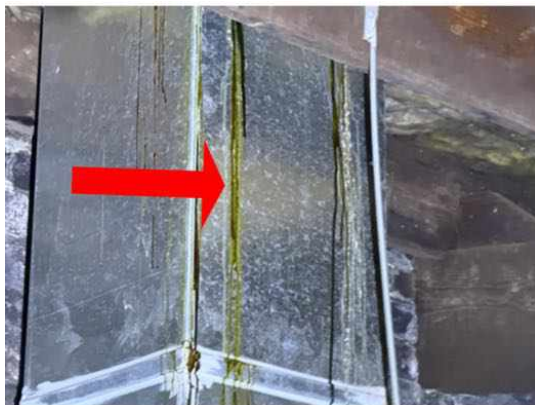
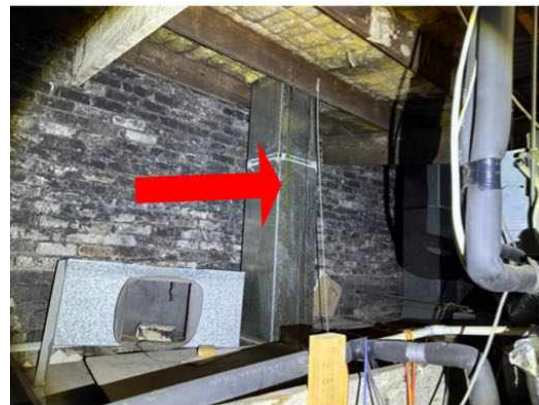
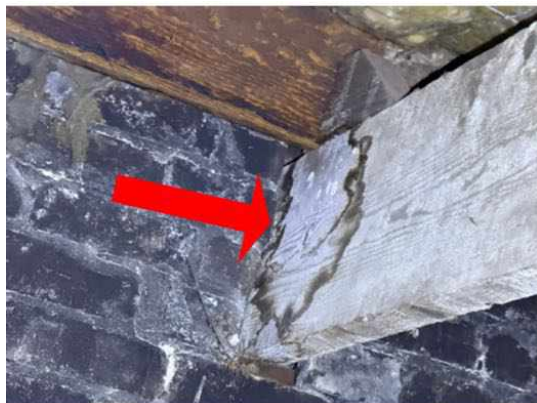
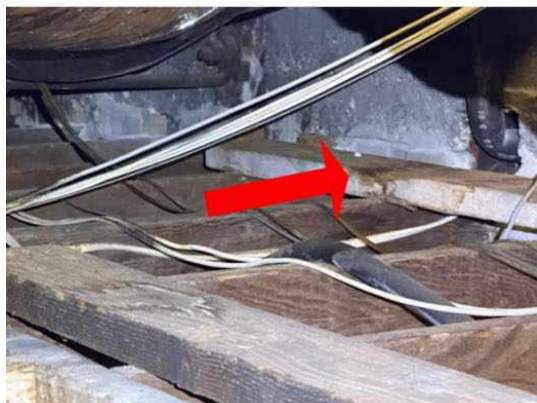
Defects 2.04

Building: Main Building
Location: Roof Void
Finding: Roof void - Water ingress
Information: Evidence of water ingress was observed within the roof void, including moisture staining, water marks, and discolouration to timber members and adjacent surfaces. Localised dampness and residue staining were noted on structural elements, indicating a history of moisture exposure. This condition is consistent with an active or previous roof leak.

Ongoing moisture exposure may lead to deterioration of timber elements, corrosion of fixings, reduced performance of insulation, and potential mould growth if not rectified.

A licensed roofing contractor should be engaged to investigate and identify the source of water ingress (e.g. roof covering, flashing, penetrations, or drainage components) and carry out necessary repairs. Affected materials should be allowed to dry and be assessed for damage, with repairs or replacement undertaken as required.

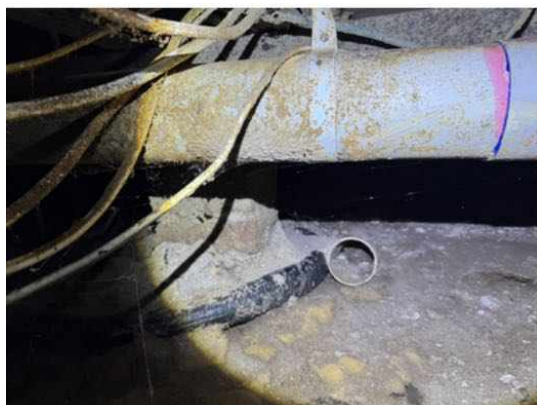
Defects 2.05

Building:	Main Building
Location:	Subfloor
Finding:	Subfloor - Excessive moisture and inadequate subfloor conditions
Information:	The subfloor shows deterioration typical of older homes, including damp brickwork, aged piers, and exposed cabling. While these issues are common in homes over 60 years old and not currently showing signs of failure, these conditions require attention to prevent further issues.

- Efflorescence and damp staining on internal brick walls, indicating rising damp or poor drainage.
- Damaged/makeshift brick piers and packing under bearers.
- Loose and unsupported electrical cabling.
- Signs of poor ventilation and moisture buildup.

We recommend further evaluation and maintenance to prolong the building's life and safety.

- Engage a builder to rectify subfloor supports and improve drainage.
- Consult a damp-proofing specialist for rising damp treatment.
- Improve subfloor ventilation.
- Have a licensed electrician secure and protect cabling.

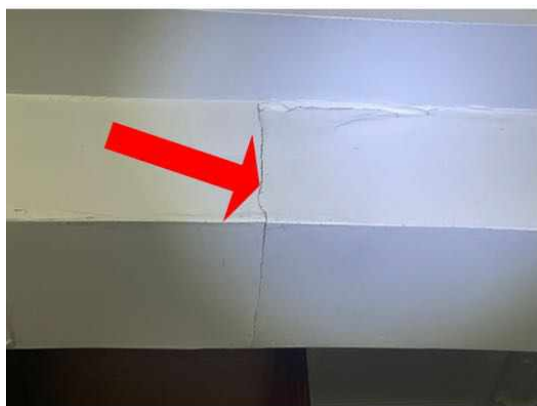
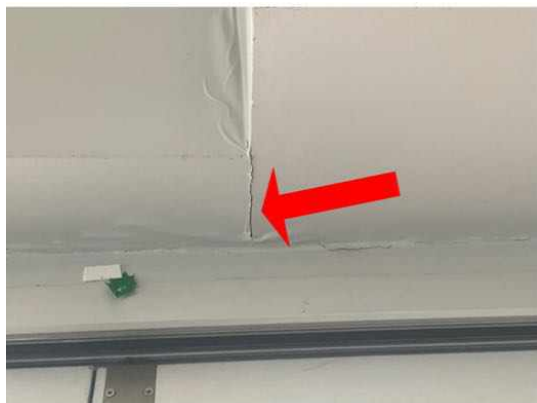
Defects 3.01

Building:	Main Building
Location:	All Internal Areas
Finding:	Cracking - Damage Category 1 - Fine (up to 1mm)
Information:	Although fine cracks are quite noticeable, they are often only considered to be an appearance defect, and usually do not indicate any structural damage. Generally, the cause of a fine crack is indicative of a separation between building materials and finishes (e.g. paint, plaster, etc.) along joints.

Cracking of this nature can generally be repaired with minor sanding, filling and/or repainting. Such works should be performed by a qualified painter or a general handyman.

Monitoring of all cracking should be conducted frequently. Always contact a building inspector should cracks widen, lengthen, or become more numerous.

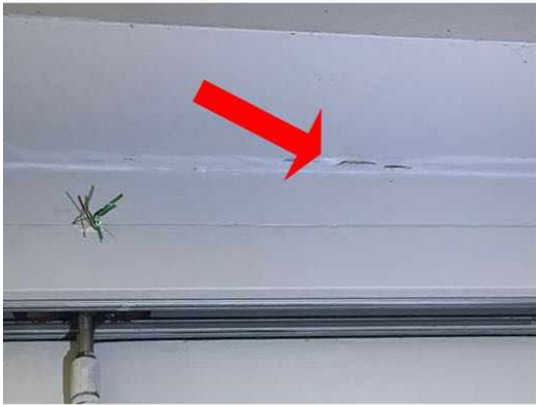
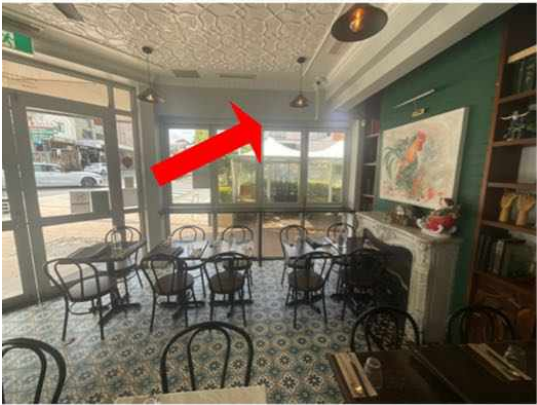
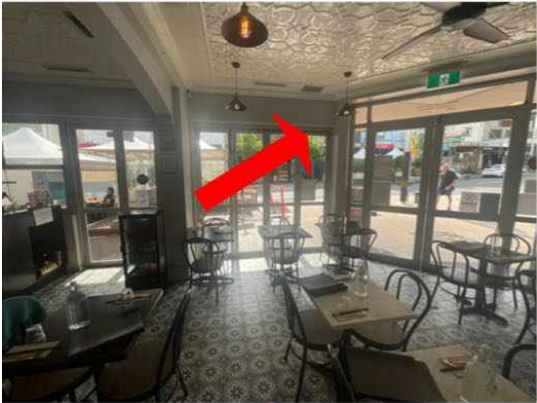
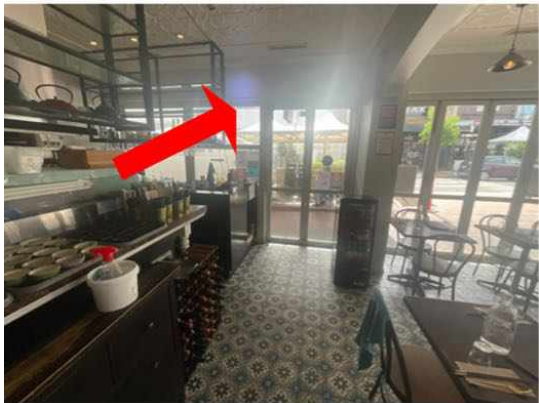
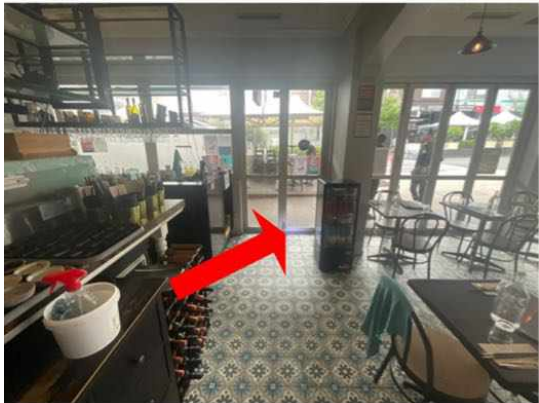
Defects 3.02

Building:	Main Building
Location:	All Internal Areas
Finding:	Internal painting deteriorated
Information:	Much of the internal paintwork including but not limited to windows, doors, walls, ceilings and other internal fittings have been neglected and require attention to prepare and re-paint.

Whilst incomplete or missing paint finish is generally an appearance defect, it can also lead to the development of secondary building defects over time. Incomplete areas of paint finish expose the area to moisture, potentially accelerating the deterioration of underlying building materials.

Degraded paint finishes should be sanded back, filled, leveled and painted, as applicable. Where inadequate or missing paint protection has led to the deterioration of the associated building element, repair and/or replacement of this building element may be required.

A painting contractor should be appointed as soon as possible to perform necessary works to aid the appearance of the affected area and to ensure the area is protected against further deterioration. Alternatively, the homeowner following manufacturer instructions may perform these works.

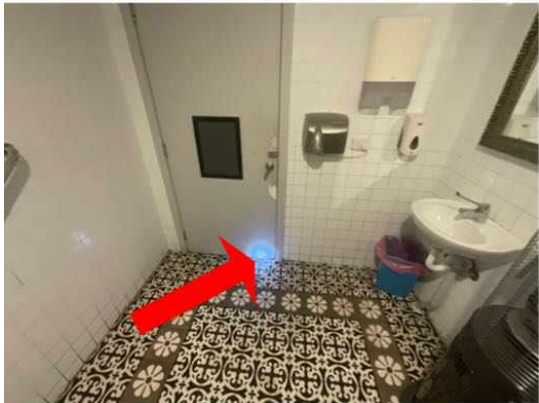
Defects 3.03

Building: Main Building
 Location: Toilet (WC)
 Finding: Door - swelling and damage at the bottom edge
 Information: Swollen and damaged door base in bathroom due to moisture exposure. Edges show fraying and surface degradation.

Replace or seal the affected door. Ensure door edges are properly sealed to prevent future water damage.

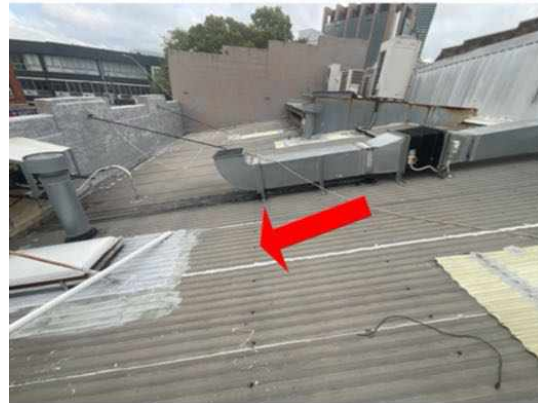
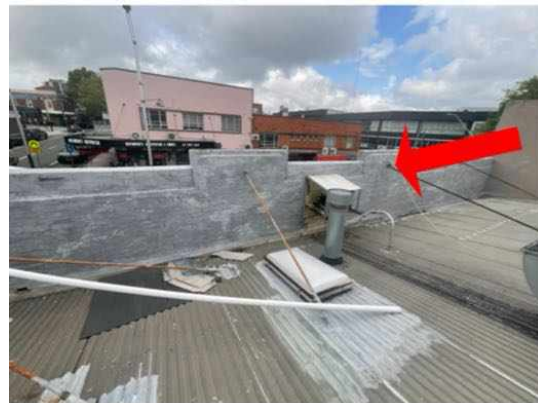
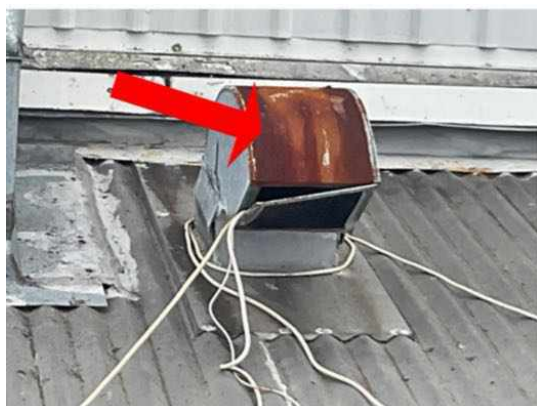
Defects 3.04

Building: Main Building
Location: Roof Exterior
Finding: Building element - Rusted or corroded
Information: This building element shows evidence of rusting and corrosion, which is likely to have developed as a result of excessive exposure to moisture and or inadequate coatings.

As surface rust provides no protection to the underlying iron, the deteriorating condition is likely to worsen if not addressed in the short-term future.

Where possible, the use of galvanized (treated) metals or aluminium coated metals aid in rust prevention, as does regular general maintenance. Rust formation can be controlled with coatings, such as paint, that isolate the iron from the environment.

Rusting and corrosion should be managed by ideally removing or limiting the affected surface from exposure to moisture. A registered builder may be appointed to replace any building elements that have been severely affected by rust or water damage.
