Building and Timber Pest Inspection Report

Inspection Date: Sat, 28 Feb 2026

Property Address: 5/4 Forest Grove Dr, Kanahooka NSW
2530, Australia

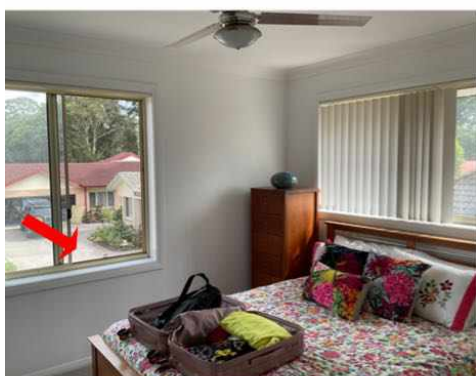
Building:	Building 1
Location:	Bedroom
Finding:	Window opening restrictors missing.
Information:	The Building Code of Australia rules require all openable windows (where the internal floor is more than 2m above the ground outside) in residential rooms to be fitted with a suitable screen or restrictor. Windows located 1.7m above the floor level do not require protection.

Window restrictors are required where people who are vulnerable to the risk of falling have access to windows. This means this window above ground level which does not have another fall prevention safety measure in place, such as a balcony or balustrade should have a restrictor.

This needs to be added urgently for the safety of all persons.

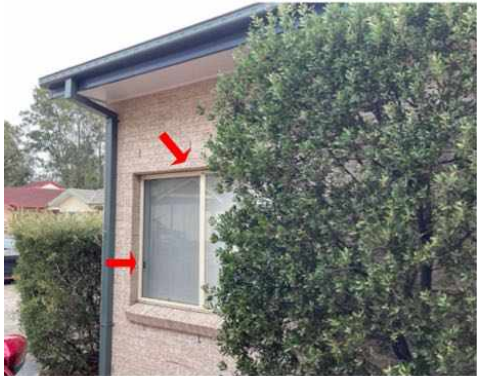
Building:	Building 1
Location:	Pictured Areas
Finding:	Sealant or flashing (external) - Missing.
Information:	It was noted on inspection that areas of external sealant or flashing was missing to small areas of some external windows.

Flexible sealants should be applied to these affected areas to prevent any subsequent water damage that is likely to occur.

A sealant specialist or carpenter should be appointed to complete these works.

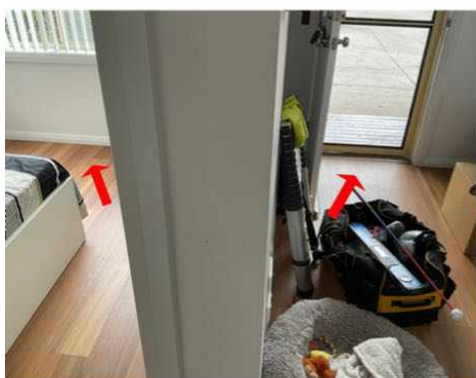
Building: Building 1
 Location: Front rooms
 Finding: Flooring - Uneven
 Information: The internal flooring in these areas is slightly out of level and uneven. Uneven flooring is likely to indicate minor defects such as expected movement of the foundations of the property, but may also indicate subsidence of the associated subfloor stumps.

It is thought the recent piercing works has rectified the previous movement that has occurred.

It is advised that the flooring be closely monitored to identify any further movement. Where flooring remains relatively unchanged for an extended period of time (i.e. several months), it is likely that this defect has been caused by expected movement of the foundations of the property.

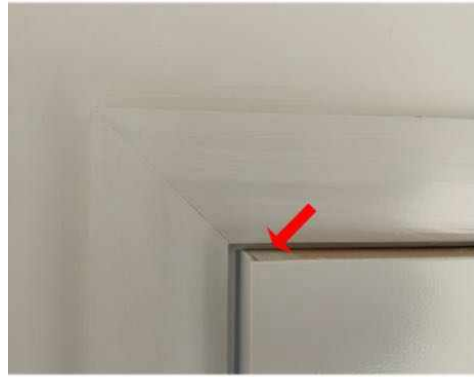
Finding 3.05

Building: Building 1
 Location: Bedroom - Master
 Finding: Doors - Binding/jamming/ not latching
 Information: Binding and/or jamming of the upstairs door and the lower bedroom door not latching was evident during standard operation. This defect inhibits the functionality of the affected doors.

A door that binds to flooring or to the associated door frame may have several causes, ranging from minor defects, such as poor installation of the door or deteriorated hinges, through to major structural issues, such as damage to subfloor structures.

For these minor causes, a qualified carpenter or general handyperson should be appointed to perform minor rectification works at client discretion.

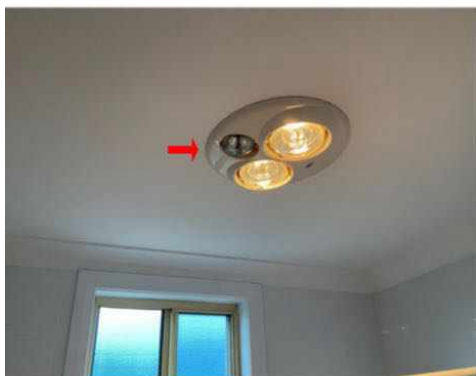
Building: Building 1
Location: Pictured external areas
Finding: Building elements - Damaged
Information: Evidence of minor missing or damaged areas was identified at the time of the inspection. These include -

1. The rear fence has minor impact damage.
2. The shower screen door is loose and requires repair.
3. The bathroom fan is noisy on start up and requires a service.

A carpenter would be the trade responsible for rectification of these areas when convenient.

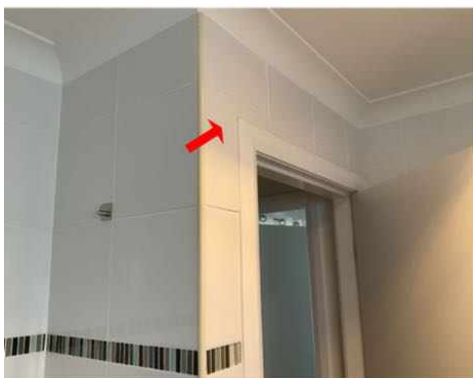
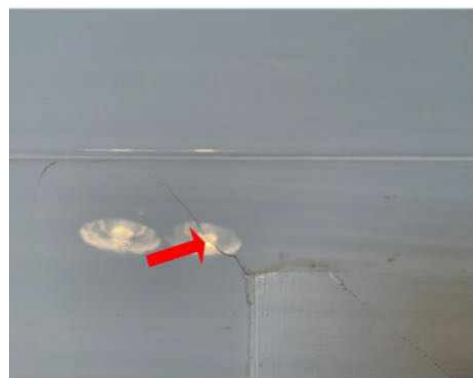
Finding: Tile cracked

Information: One crack tile was evident in these pictured areas at the time of inspection. It is suspected that this cracking has occurred as a result of minor settlement.

Cracked tiles throughout the household detract from the overall appearance of the affected areas. In wet areas of kitchens and bathrooms, it can lead to water damage of adjoining walls and floors.

Replacement of cracked tiles is recommended as soon as possible. A tiling contractor may be appointed to perform these works. Where cracks become more numerous, contact a licensed building inspector for further investigation.

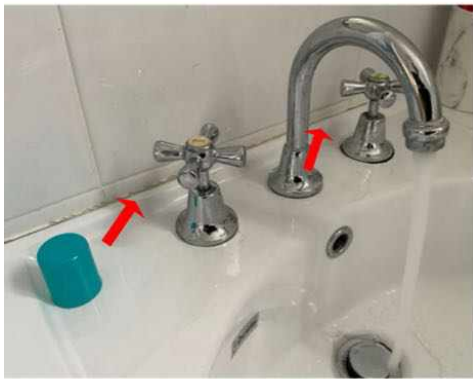
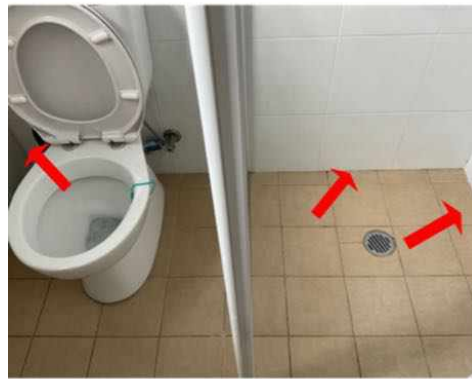
Finding 3.11

Finding: Sealant and grouting - Missing or damaged

Information: It was noted on inspection that sealant or grout is degraded to these pictured wet areas.

Different materials and floor areas move at different rates, generally causing cracking to grout or sealant at this point. A flexible sealant is required to allow for expected expansion and contraction, while keeping the joint water tight and protective of all associated building materials.

Flexible and mould resistant materials should be applied to affected areas to prevent any subsequent water damage that is likely to occur. Regular maintenance and replacement of damage or missing or damaged sealant and grout is highly recommended to the wet areas, as this is a regular wear and tear defect. Sealant and grouting in areas that come into regular contact with water should be maintained for the long term care of your property.

A sealant specialist or tiling contractor should be appointed to complete these works as soon as possible

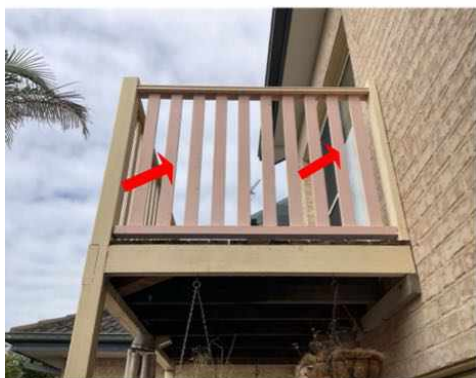
Building:	Building 1
Location:	Pictured rear deck
Finding:	Unfinished construction
Information:	The painting of this structure appears to be incomplete.

A painting contractor should be appointed immediately to complete this construction process as only undercoat has been applied to some areas.

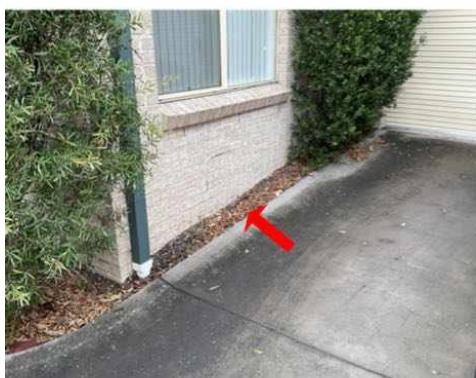
Building:	Building 1
Location:	Most walls
Finding:	Bridging - Vegetation and decking
Information:	Where vegetation and decking obstructs inspection of building elements, also known as bridging as it provides a bridging point for the access of termites, full inspection can not be achieved. Consequently moisture or dampness may be present and the areas becomes conducive to termite activity. Plants and decks against or very close to buildings provide cover, shade and can provide an environment that is attractive to termite infestation.

If the slab edge is not properly exposed there is a high risk of termite attack. Sometimes, in order to determine the type of slab, a suitably qualified person such as an architect or builder may be required to consult the construction plans.

Where the slab edge cannot be properly inspected, it is highly recommended that termite or timber pest inspections be carried out every 6-12 months to aid protection of the property against infestation.

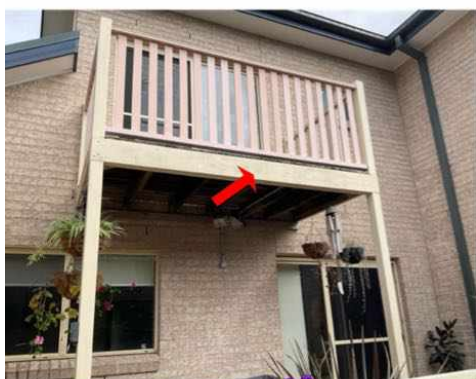
Building:	Building 1
Location:	Rear deck
Finding:	Elevated structure inspections
Information:	While this rear deck appears in good condition, where any elevated Structure (deck, balcony, verandah etc) is present, and this elevated structure is designed to accommodate people, you MUST have this structure checked by an engineer or other suitably qualified person.

You should also arrange annual inspections of the structure by an engineer or other suitably qualified person to ensure any maintenance, that may become necessary, is identified. Care must be taken not to overload the structure.
