Building and Timber Pest Inspection Report

Inspection Date: Tue, 17 Mar 2026

Property Address: 6/15 Ray Rd, Epping NSW 2121, Australia

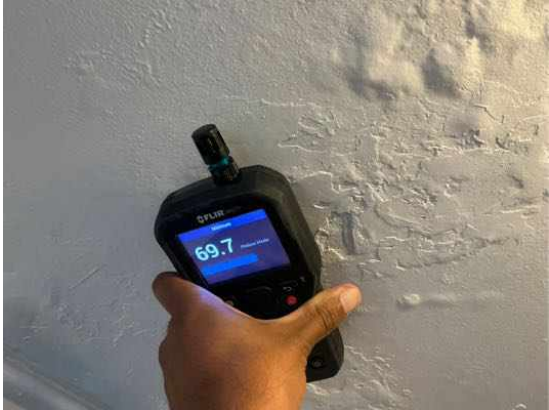
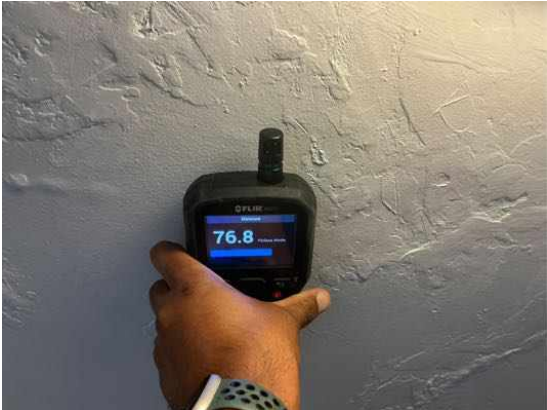
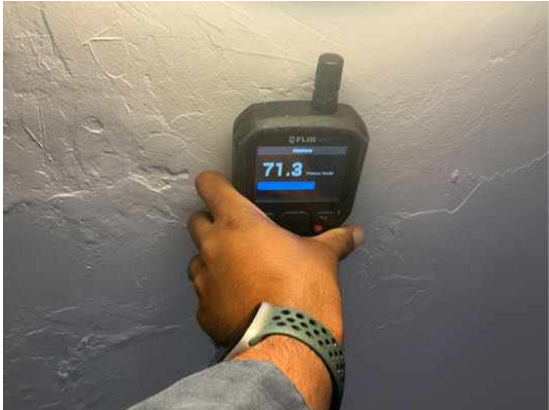
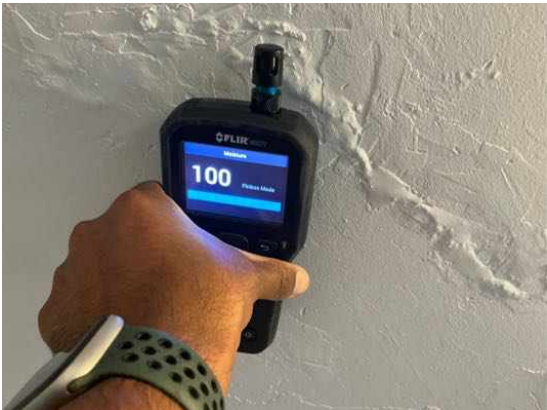
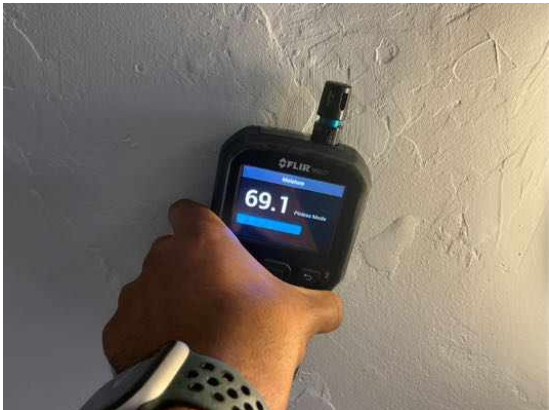
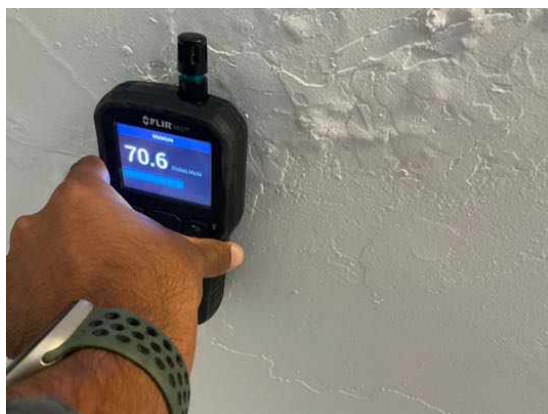
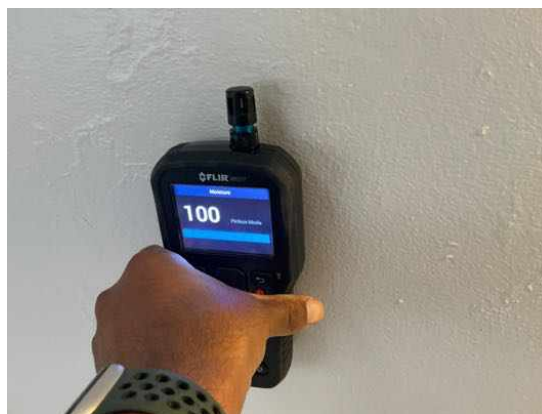
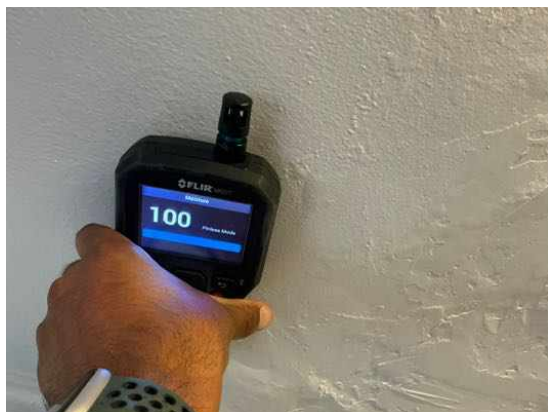
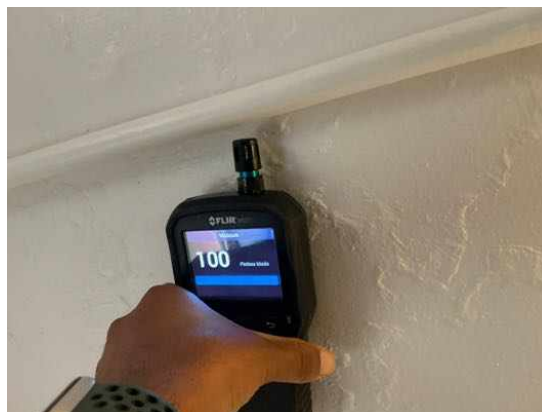
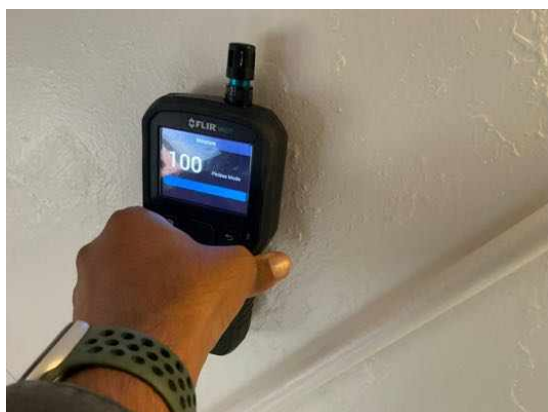
Building:	Main Building
Location:	Bathroom
Finding:	Elevated Moisture & Substandard Ceiling Repairs
Information:	At the time of inspection, evidence of previous water ingress was noted to the ceiling area, including visible patching and irregular finishes. The real estate agent advised that recent waterproofing works had been carried out by the current owner; however, moisture meter readings taken during the inspection recorded maximum levels (up to 100) in multiple areas, indicating the presence of significant retained moisture within the substrate.

While it is acknowledged that recently completed waterproofing works can result in elevated moisture readings for a period of time (often several weeks to months while the area dries out), the readings observed are considered high and warrant further attention. If the waterproofing works have not been carried out correctly or professionally, there is a risk of ongoing water ingress and further deterioration.

Additionally, the ceiling repairs appear to be of substandard workmanship, with poor

The client is advised to closely monitor the area over time for any signs of worsening conditions, including staining, bubbling, peeling paint, or mould growth.

patching and uneven finishes noted. The affected areas should be properly repaired and refinished by a qualified painter once the moisture issue has been confirmed as resolved and the substrate has adequately dried.

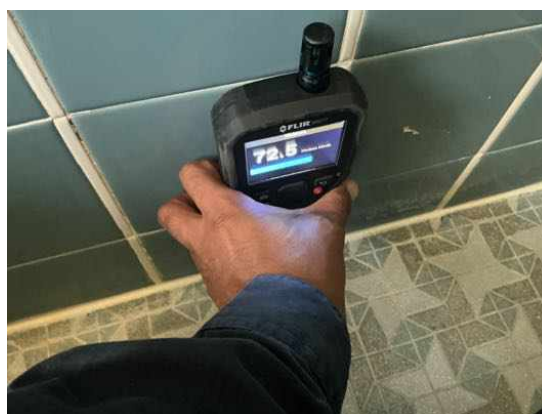
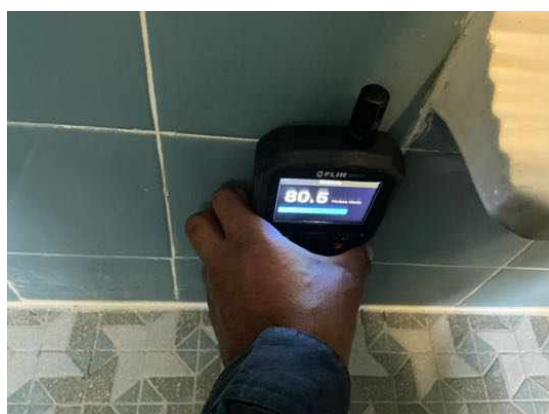
Finding 3.01

Building:	Main Building
Location:	Bathroom
Finding:	Excessive Moisture - Shower Damp
Information:	At the time of inspection, excessive moisture was noted within the shower area, which is a common issue in wet areas due to the continual exposure to water. This condition is typically caused by moisture seeping through grout lines and settling behind tiles, resulting in localised high-moisture zones. Provided there is no evidence of water

staining or elevated moisture readings on the opposite side of the wall, this is considered a minor defect.

However, persistently damp conditions may act as conducive conditions for termite activity, as termites are strongly attracted to moisture-rich environments. It is recommended that the client ensures regular use of the exhaust fan and maintains adequate ventilation after shower use to promote drying and reduce long-term moisture build-up, thereby also reducing the risk of attracting termites.

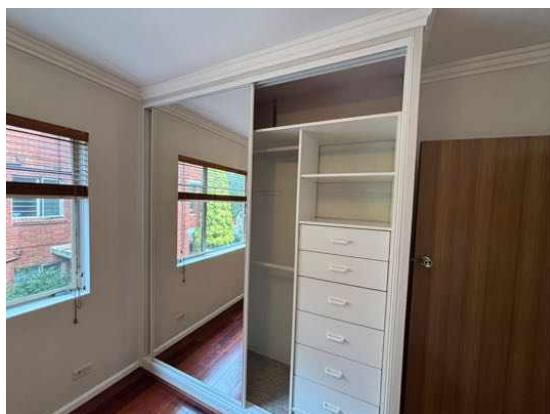
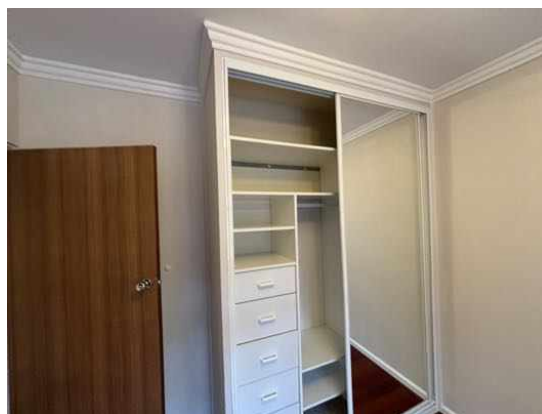
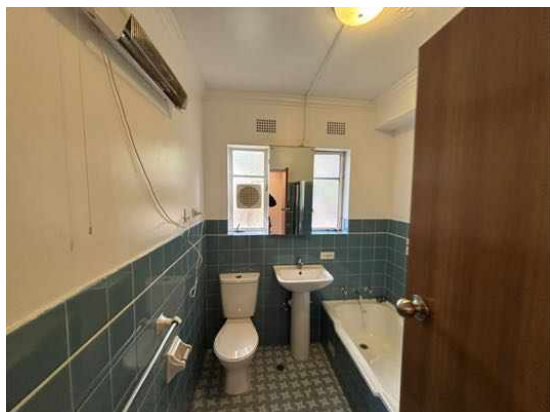
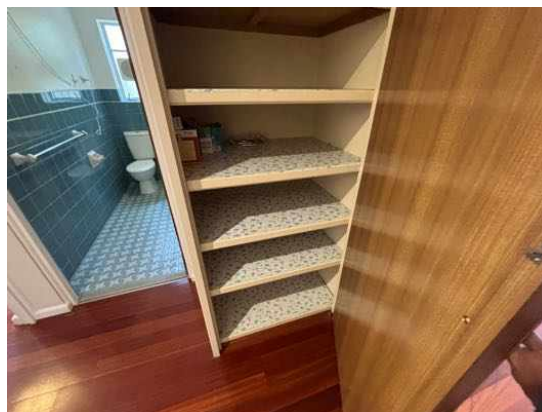
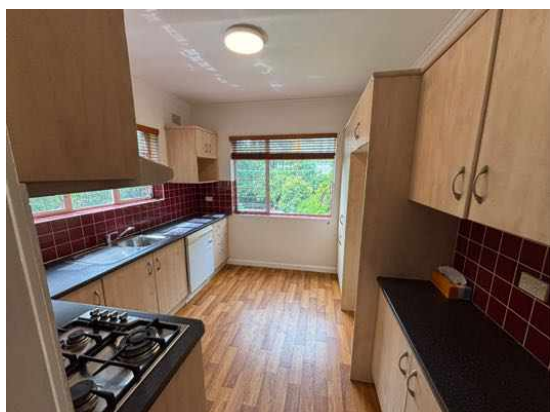
Information: The accompanying photographs provide clear evidence of the obstructions and limitations that restricted a comprehensive inspection of the internal areas of the property at the time of assessment. These obstructions, which may include furniture, personal belongings, stored items, or structural elements such as wall coverings and built-ins, significantly hindered the ability to thoroughly evaluate these areas. It is important to note that such obstructions can potentially conceal a wide array of defects, ranging from hidden structural damage, water leaks, pest infestations, or electrical issues, to deteriorating materials that may not be visible during the initial inspection.

The presence of these impediments means that critical areas of the property were not accessible, and therefore, any underlying defects that may affect the integrity and safety of the property could remain undetected. These hidden defects, if left unaddressed, could worsen over time and may result in costly repairs or pose potential safety hazards to the occupants.

It is highly recommended that all obstructions be cleared to facilitate a complete and thorough inspection of the internal areas. Once the obstructions have been removed and full access is available, a re-inspection should be carried out to ensure that any previously concealed issues can be properly identified and rectified. This follow-up inspection will provide a more accurate assessment of the property's internal condition and help the client make informed decisions about any necessary repairs or maintenance.

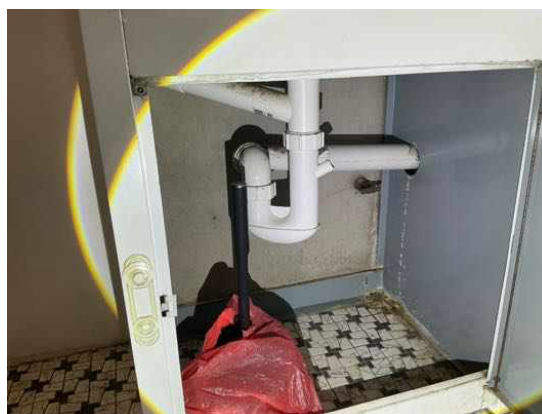
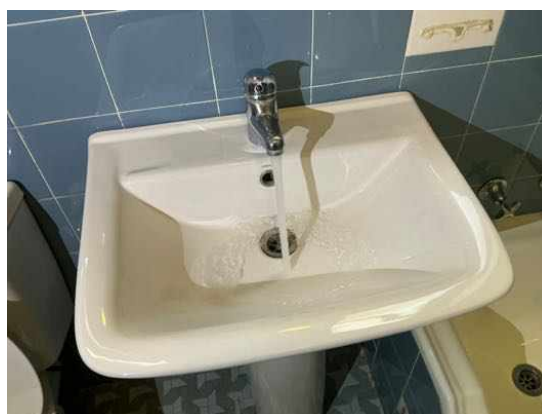
It is important to note that while a visual inspection of cupboards and cabinetry beneath sinks and vanities was undertaken, stored personal items and fixtures presented obstructions that limited full visibility of the internal areas. As per standard inspection practices, inspectors are not permitted to move or disturb personal belongings during the inspection process. Therefore, only visible and accessible sections were inspected, and concealed water damage or plumbing defects may not have been detected.

Given this, a re-inspection is recommended after all obstructions have been cleared to allow for a comprehensive assessment of these areas. Regular maintenance and monitoring of plumbing and drainage systems is also advised to ensure ongoing functionality and early detection of potential issues.

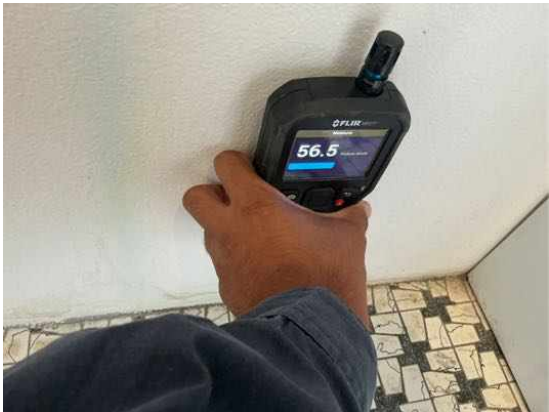
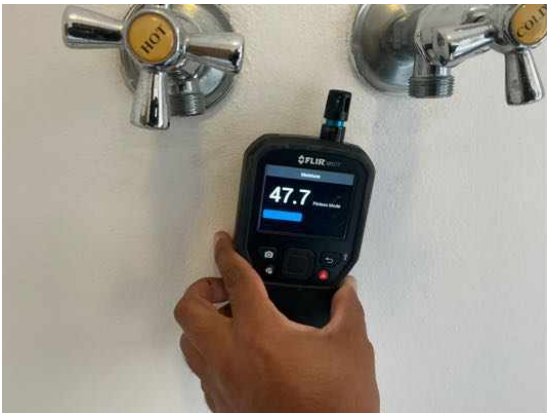
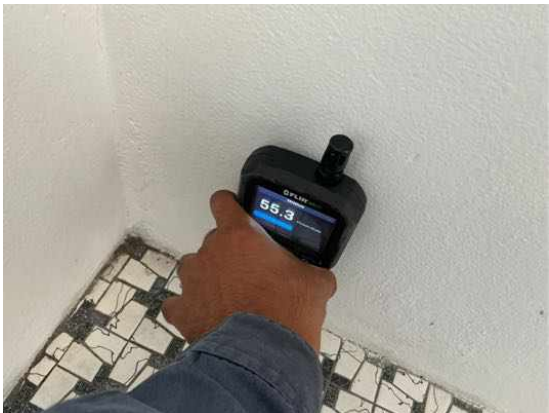
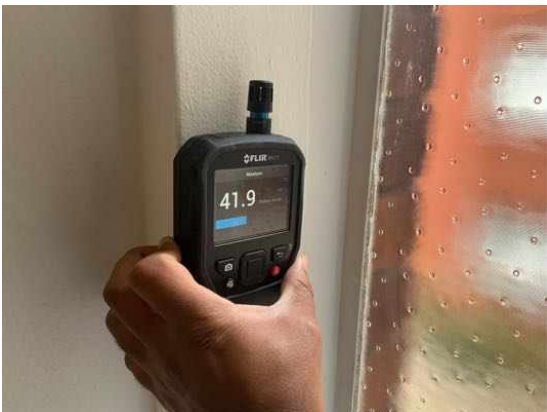
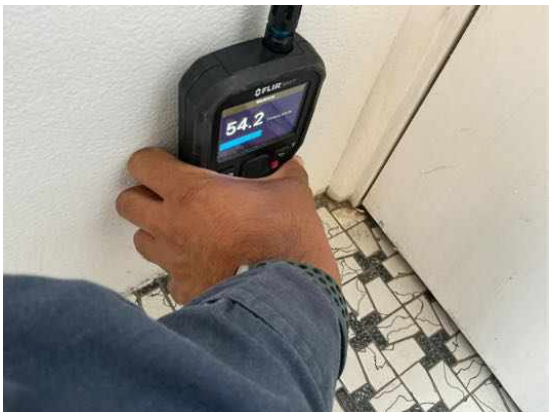
Building:	Main Building
Location:	All Areas
Finding:	Additional Photos - Moisture Meter Readings
Information:	<p>Additional moisture meter reading photos have been provided for the property to offer further clarity on areas tested during the inspection. These photos are intended to give a visual reference for the specific locations where moisture levels were measured.</p> <p>These readings were taken at the time of the inspection to assess any potential moisture-related issues within the property. Any defects related to moisture that were identified during the inspection have been separately mentioned in the defect statements within the report.</p>
