Building and Timber Pest Inspection Report

Inspection Date: Thu, 19 Mar 2026

Property Address: 33 John Batman Ave, Werrington County
NSW 2747, Australia

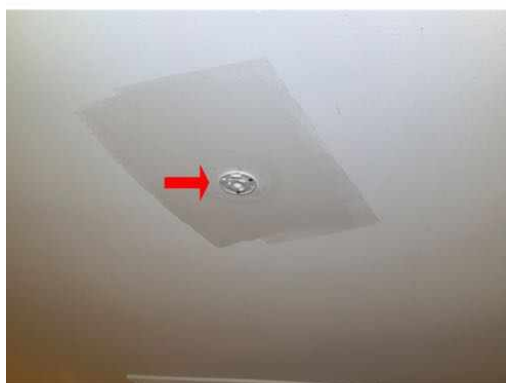
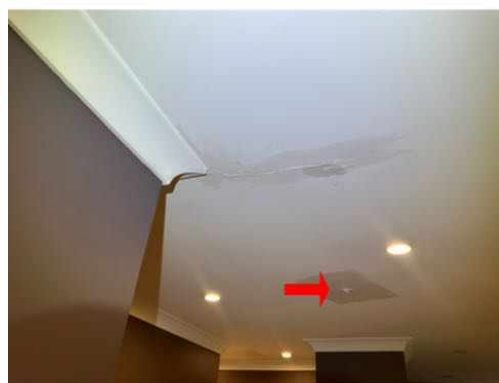
Please note that this defect is highlighted as a caution only. We suspect, based on our experience in the building industry, that the absence of smoke detectors, or their poor condition, should be addressed as a matter of urgency to improve occupant safety.

Always ensure sufficient working and suitable smoke detectors are installed prior to occupying any building. Additionally, it is advised that all smoke detectors be tested by the homeowner on a monthly basis.

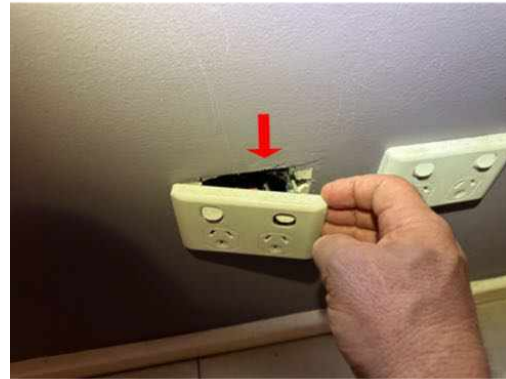
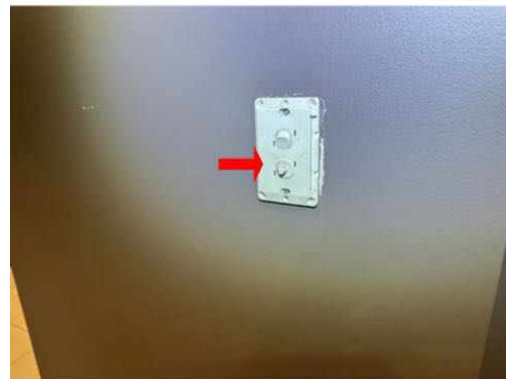
Finding 1.02

Building:	Main Building
Location:	Bedroom - Master > Rear Left
Finding:	Electrical fittings: Deteriorated damage.
Information:	The electrical fitting in this area was found to be showing signs of deterioration at the time of inspection.

Left unmanaged, the fitting is unlikely to cause further damage to surrounding building elements. However, the broken fitting may create a safety hazard if there is potential contact with persons in the area.

Repair and/or replacement of the broken fitting is advised. A Licensed electrician should be appointed to repair/replace the fitting immediately.

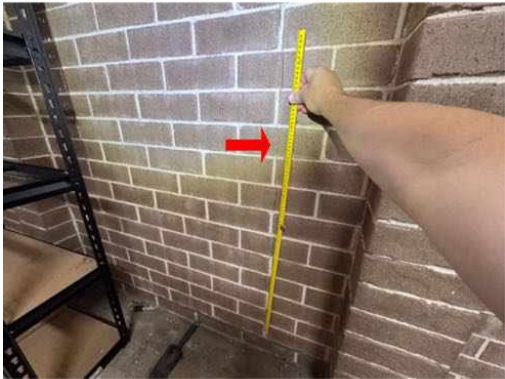
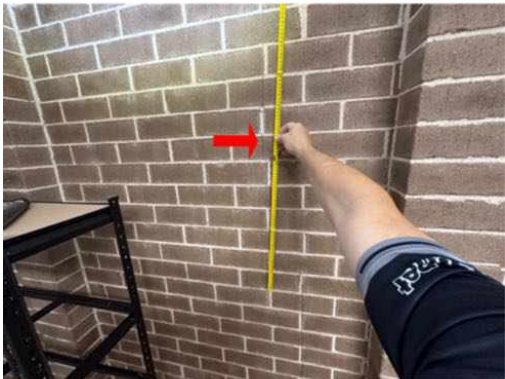
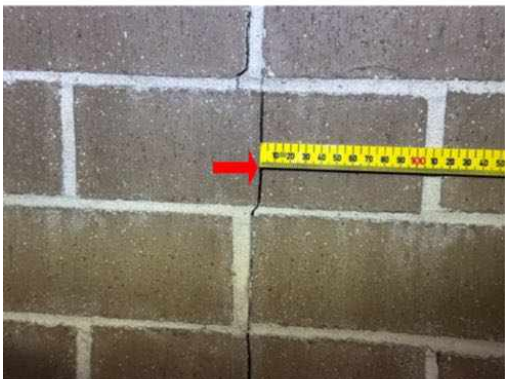
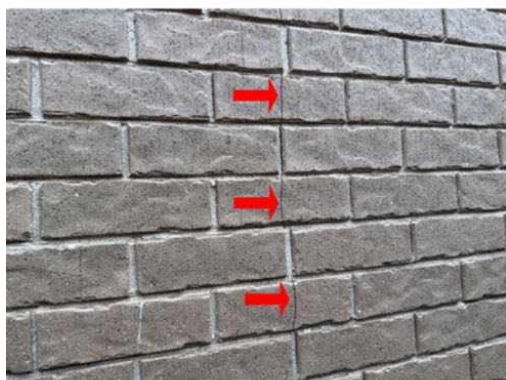
Finding 2.01

Building:	Main Building
Location:	Exterior walls - right side > Centre Right
Finding:	Brickwork - Cracking noticeable
Information:	There were several cracks and or crack repairs evident to external brickwork.

Noticeable cracks are a common occurrence in external brickwork and are a likely result of age expected building movement, general expansion, and/or contraction of building materials in different weather conditions. Noticeable cracks in brickwork may develop if left unattended, with potential for necessitating major remedial works or replacement of the brickwork.

It is highly advised that a qualified bricklayer be appointed to provide necessary works to cracked brickwork to prevent any further damage. Such works should be conducted as soon as possible.

Always monitor these cracks and contact a structural engineer should cracks widen, lengthen, or become more numerous.

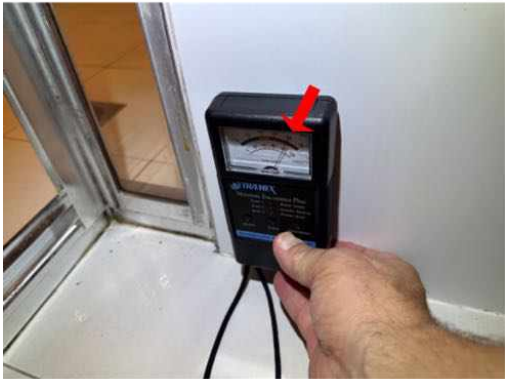
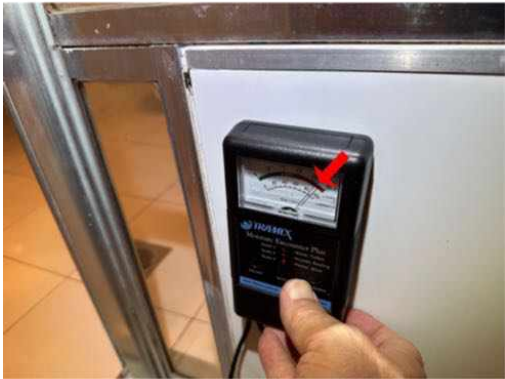
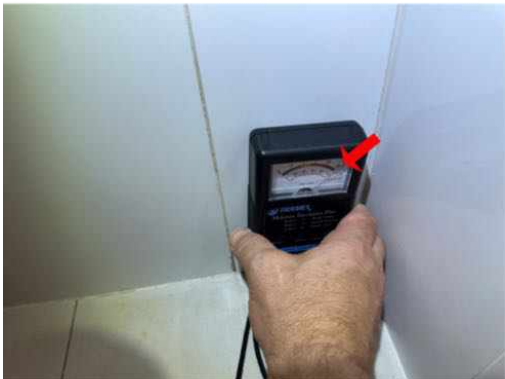
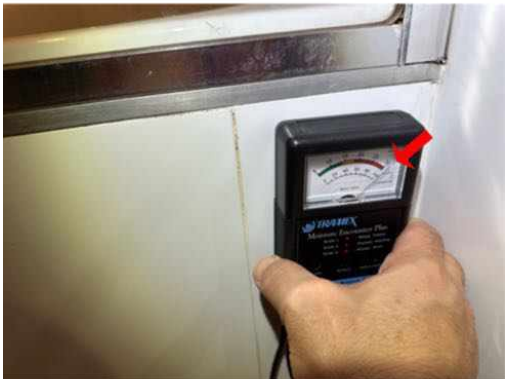
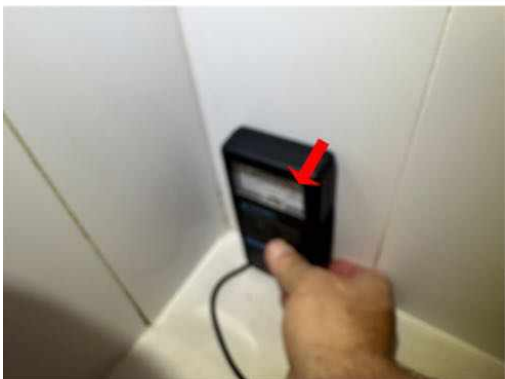
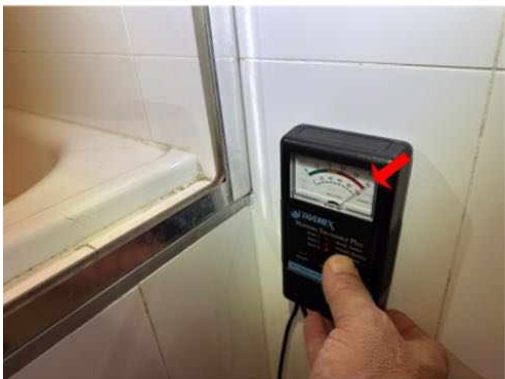
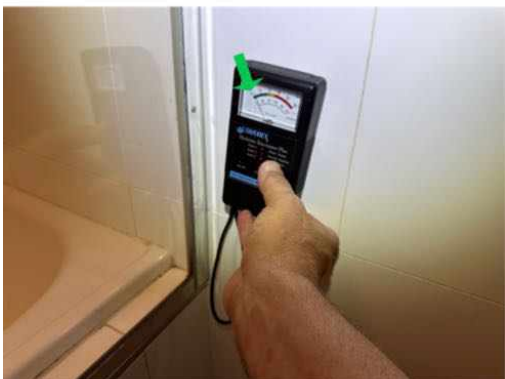
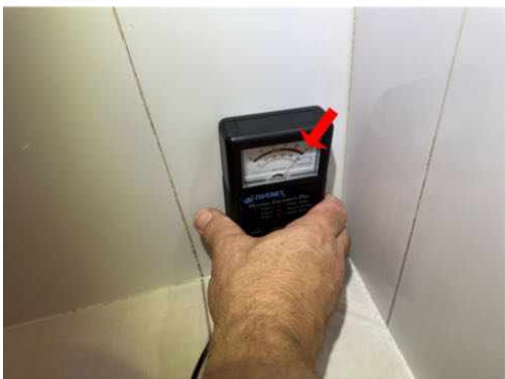
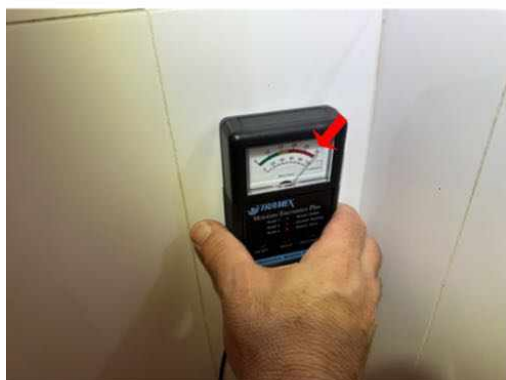
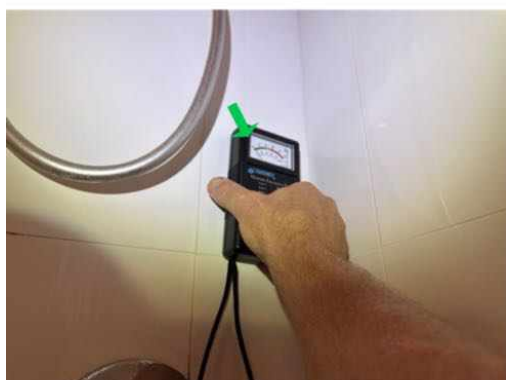
Finding 2.02

Building:	Main Building
Location:	Bathroom > Centre,Rear
Finding:	Moisture meter: used in Shower area.
Information:	A moisture meter was used during the inspection and isolated spots of excessive moisture was detected to accessible walls inside the property at the time of inspection.

It was noted on inspection that sealant or grout is in fair condition to most of the tiled shower alcove, with some areas requiring maintenance.

Different materials and floor areas move at different rates, generally causing cracking to grout or sealant at this point. A flexible sealant is required to allow for expected expansion and contraction, while keeping the joint water tight and protective of all associated building materials.

Flexible and mould resistant materials should be applied to affected areas to prevent any subsequent water damage that is likely to occur. Regular maintenance and replacement of damage or missing or damaged sealant and grout is highly recommended to the wet areas, as this is a regular wear and tear defect. Sealant and grouting in areas that come into regular contact with water should be maintained for the long term care of your property.

Monitoring the area is advised and if any visual signs of excessive moisture appear (peeling paint, mould) then consultation with a qualified plumber or bathroom specialist would be advised to identify the cause of damp and to perform remedial works as required.

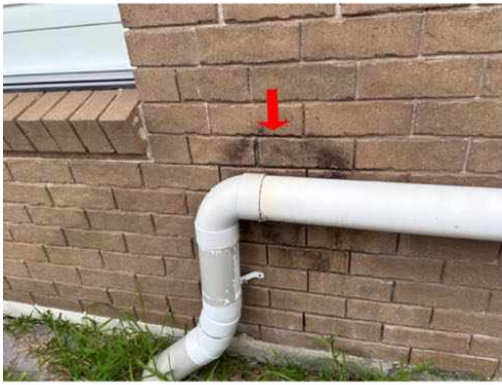
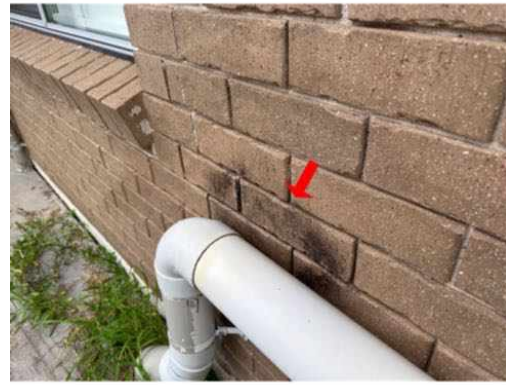
Finding 3.01

Building:	Main Building
Location:	Exterior walls - rear > Centre Left
Finding:	Water staining
Information:	Water staining was evident in this area at the time of inspection. Water staining indicates that surfaces have been exposed to excessive moisture over time. The minerals and other elements in the water lead to staining, which may graduate to corrosion and deterioration if left unmanaged.

While mostly an appearance defect, water staining can be indicative of more serious defects, which may be currently concealed by other building elements.

Where water staining is active, a licensed plumber must be consulted to identify the cause of the staining and to provide advice on any reparation works that may be required. Replacement of any broken or damaged structures is advised.

Conversely, where water staining is old and inactive, affected building materials may be repaired or replaced at client discretion. A qualified carpenter or registered builder may be appointed to perform these works.

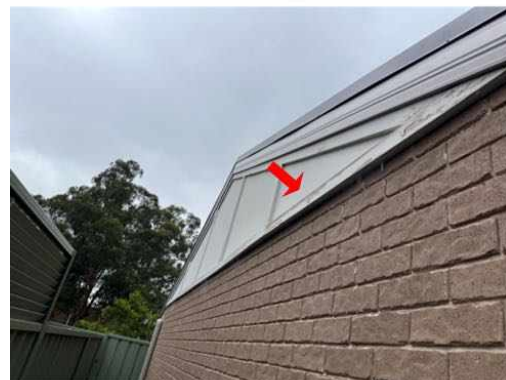
Finding 3.02

Building:	Main Building
Location:	Exterior walls - right side > Centre Right
Finding:	External painting deteriorated
Information:	Some of the external paintwork including external fitments have been neglected and require attention to prepare and re-paint.

Whilst incomplete or missing paint finish is generally an appearance defect, it can also lead to the development of secondary building defects over time. Incomplete areas of paint finish expose the area to moisture, potentially accelerating the deterioration of underlying building materials.

Degraded paint finishes should be sanded back, filled, leveled and painted, as applicable. Where inadequate or missing paint protection has led to the deterioration of the associated building element, repair and/or replacement of this building element may be required.

A painting contractor should be appointed as soon as possible to perform necessary works to aid the appearance of the affected area and to ensure the area is protected against further deterioration. Alternatively, the homeowner following manufacturer instructions may perform these works.

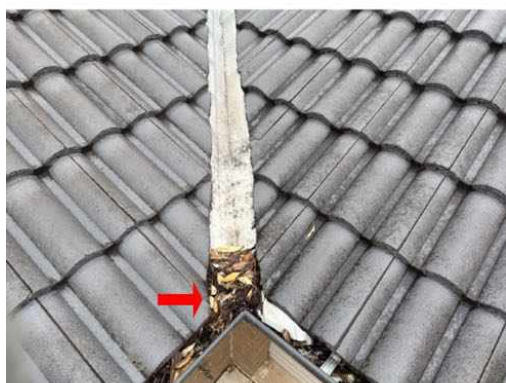
Finding 3.03

Building:	Main Building
Location:	Roof Exterior > Front
Finding:	Gutters - Blocked
Information:	Roof plumbing structures, such as guttering and downpipes, should be free of all debris to prevent blockages. Blockages of the guttering and downpipes will lead to pooling and accumulated water overflows, which is likely to subsequently flood eaves and exterior walls.

Blocked gutters are likely to lead to high levels of moisture in the affected areas. Such moisture will not only cause rust and decay of the associated building materials, but can also provide conditions that are conducive to termite and timber pest activity. Blockages in gutters should therefore be removed immediately to ensure dry conditions are maintained.

Consult a Licensed Plumber for further specific advice on remedial works that may be required. In the interim, it is highly advised that blocked gutters be removed by the homeowner or a general handyperson as a matter of urgency.

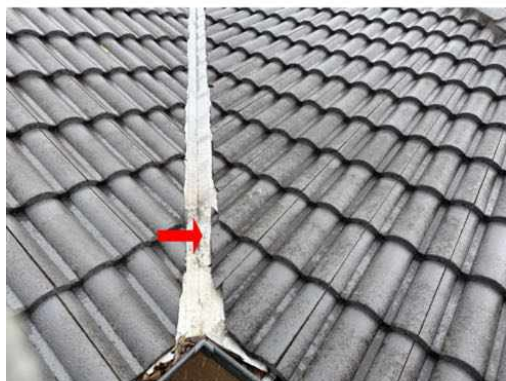
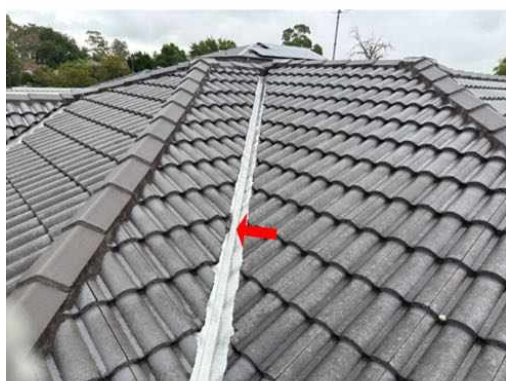
Finding 3.04

Building:	Main Building
Location:	Roof Exterior > All Areas
Finding:	Roof tiles - Weathered
Information:	Upon inspection of the exterior roofing, the majority of roof tiles were considered to be in a fair condition. While weathering of the tiles is consistent with the age of the property, maintenance works are required.

Isolated areas of mortar have come loose in the valleys and minor cracking is also present. Re-pointing and re-sealing the may be considered as an interim solution by

Where left unmanaged, deteriorating roof tiles are likely to lead to a number of secondary defects, including minor water leaks and weather exposure to internal roofing structures.

Consultation with a roofing contractor is highly advised to gain advice on cost of remedial works that may be required in the short to medium term. Remedial works are likely to increase the longevity of the exterior roofing structure.

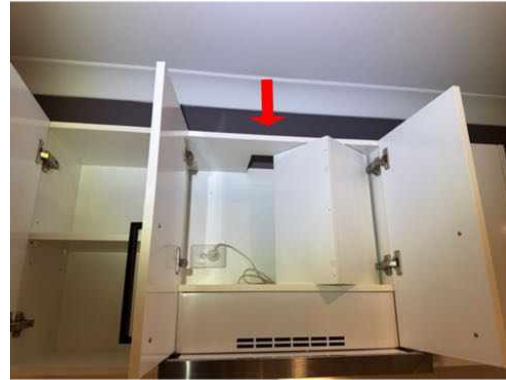
Finding 3.05

Building:	Main Building
Location:	Kitchen > Centre Right
Finding:	Rangehood - Flue disconnected
Information:	The range hood flue has not been connected and is allowing the emission of steam and evaporative moisture into the ceiling space above.

While this does not create high potential for secondary defects, development of grease is likely to occur in the surrounding area, necessitating regular cleaning and maintenance.

Consultation with a licensed electrician may be required to reconnect the flue and thus allow the emission of gases into the external environment. Works should be completed

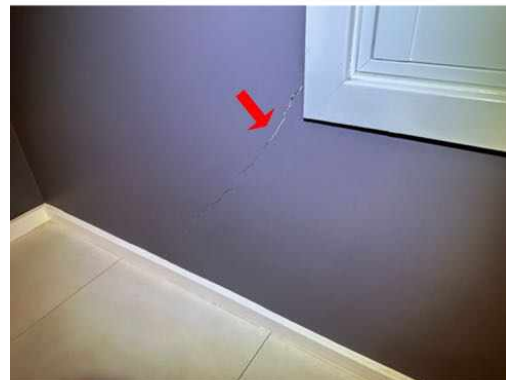
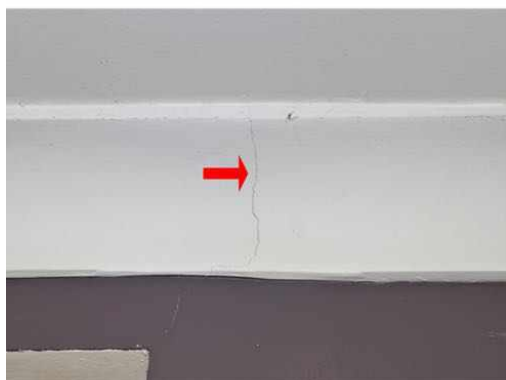
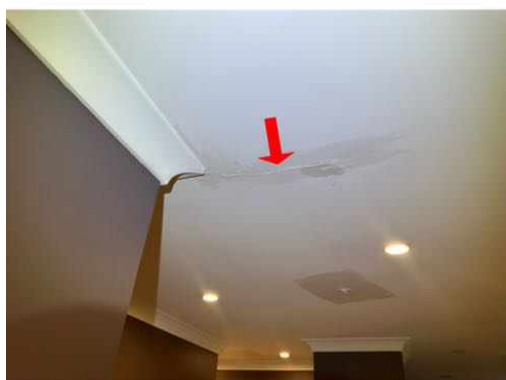
Finding 3.06

Building:	Main Building
Location:	All Areas > All Areas
Finding:	Cracking - Damage Category 1 - Fine (up to 1mm)
Information:	Although fine cracks are quite noticeable, they are often only considered to be an appearance defect, and usually do not indicate any structural damage. Generally, the cause of a fine crack is indicative of a separation between building materials and finishes (e.g. paint, plaster, etc.) along joins.

Cracking of this nature can generally be repaired with minor sanding, filling and/or repainting. Such works should be performed by a qualified painter or a general handyman.

Monitoring of all cracking should be conducted frequently. Always contact a building inspector should cracks widen, lengthen, or become more numerous.

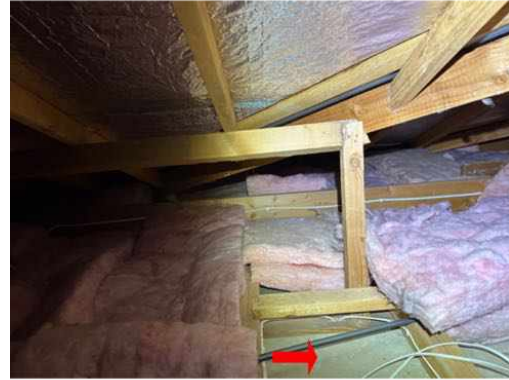
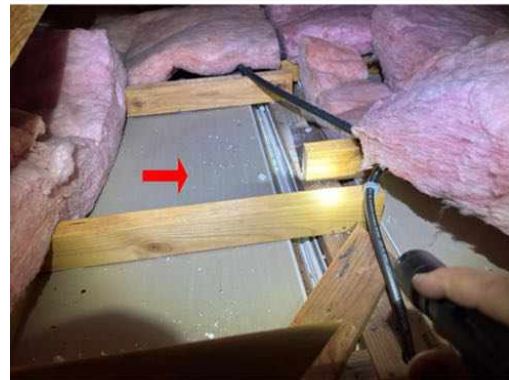
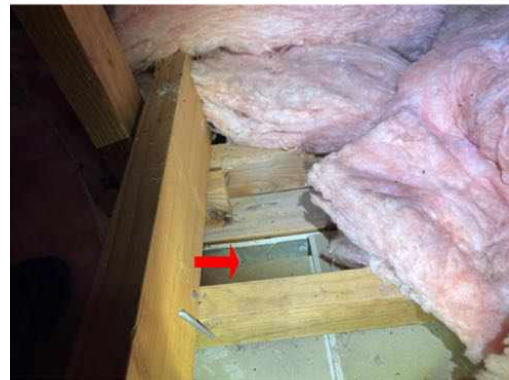
Finding 3.07

Building:	Main Building
Location:	Roof Void > All Areas
Finding:	Insulation - Inadequate
Information:	Upon inspection of the roof void it was noted that there is a lack of adequate insulation.

The level of insulation in the property does not meet current Australian Standards. Installation of adequate insulation is required and should be conducted as soon as possible.

Caution should be exercised when accessing the roof void. Do not attempt to stand on the framework to the underside of the trusses and be aware there is a potential for electric shock if contact is made with exposed or faulty electrical wiring.

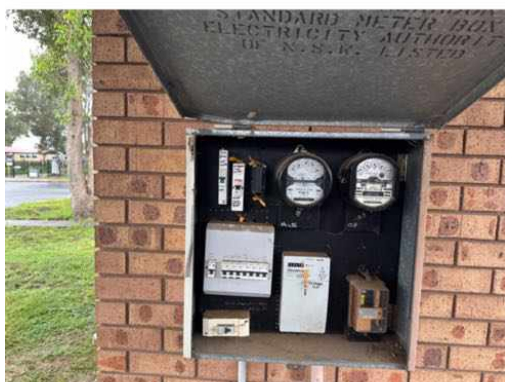
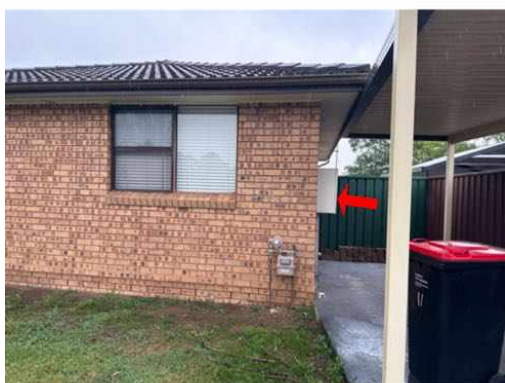
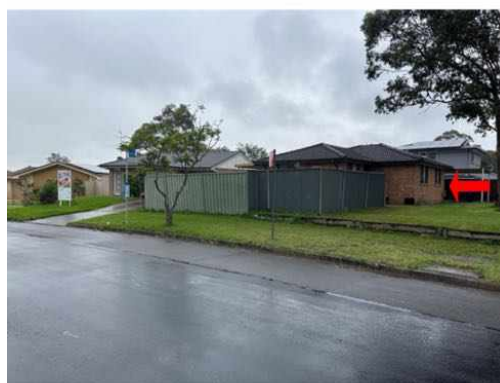
Building:	Main Building
Location:	Electrical Switchboard 11 Angel St > Front Right
Finding:	Termite Management System - no evidence of a chemical installation
Information:	The application of a post-construction chemical termite barrier is highly recommended for all properties, particularly if live termite activity has been found on the site previously. Such barriers are highly effective in preventing termite attack on any timber building elements throughout the property.

A durable notice should be placed in the switchboard unit to indicate current termite barriers. At the time of inspection, it appeared as though no termite management system has been installed, with no evidence to suggest preventative works taking place.

The client may consider gaining further advice from a pest controller as to the costs and procedures involved with this application. It is recommended that obtaining such advice be a short-term priority.

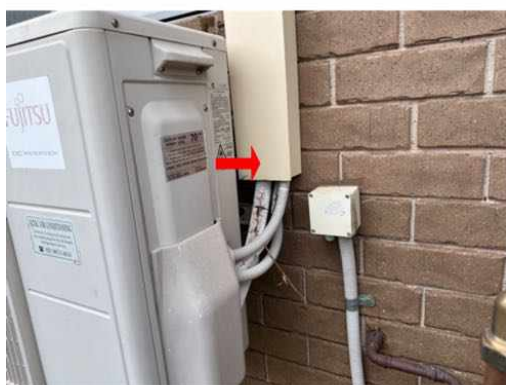
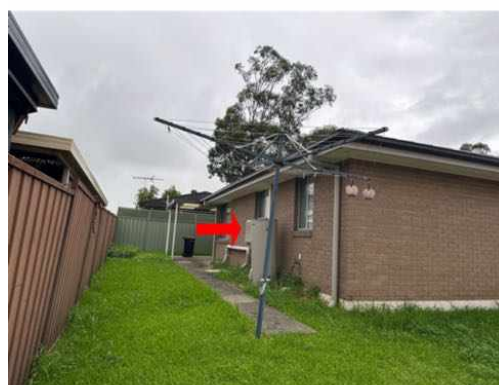
Finding 6.02

Building:	Main Building
Location:	Exterior walls - rear > Centre

Finding: Air conditioner - Disconnected overflow
 Information: The Air Conditioner (A/C) overflow was found to be disconnected from storm water drainage and is creating excessive moisture in the surrounding area.

Such leaking creates an environment which is conducive to an array of defects, including water damage to associated building elements and the attraction of termite or timber pest infestation.

It is highly recommended that a licensed plumber be appointed to connect the A/C overflow in order to prevent such an environment from being created. These minor works should be carried out as soon as possible.

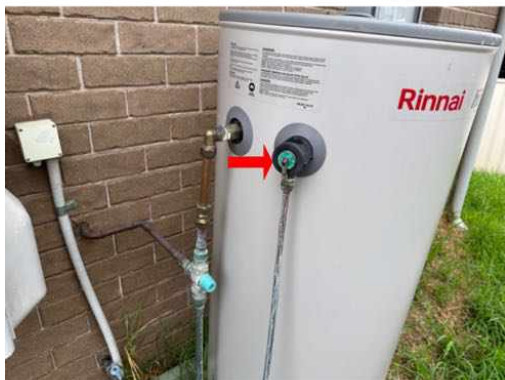
Finding 6.03

Building: Main Building
 Location: Exterior walls - rear > Centre
 Finding: HWS Overflow - Not Connected
 Information: The Hot Water System (HWS) overflow was found to be disconnected from storm water drainage and is creating excessive moisture in the surrounding area.

These damp conditions can lead to secondary defects such as rot, rust or corrosion of associated building elements, the formation of fungal decay, or even the creation of potential slip hazards. When coupled with poor site drainage, pooling of water may also attract termite activity to this area.

It is highly recommended that a licensed plumber be appointed to connect the HWS overflow in order to prevent such an environment from being created. These minor works should be carried out as soon as possible.

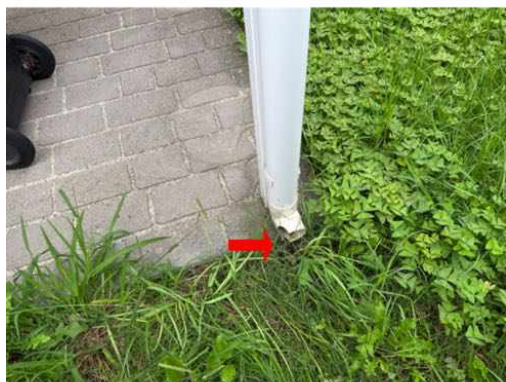
Finding: Awning down pipes - Disconnected overflow
Information: The awning down pipe overflow was found to be disconnected from storm water drainage and is creating excessive moisture in the surrounding area.

Such leaking creates an environment which is conducive to an array of defects, including water damage to associated building elements and the attraction of termite or timber pest infestation.

It is highly recommended that a licensed plumber be appointed to connect the awning down pipes overflow in order to prevent such an environment from being created. These minor works should be carried out as soon as possible.
