Building and Timber Pest Inspection Report

Inspection Date: Sat, 21 Mar 2026

Property Address: 88 Arthur St, Grafton NSW 2460, Australia

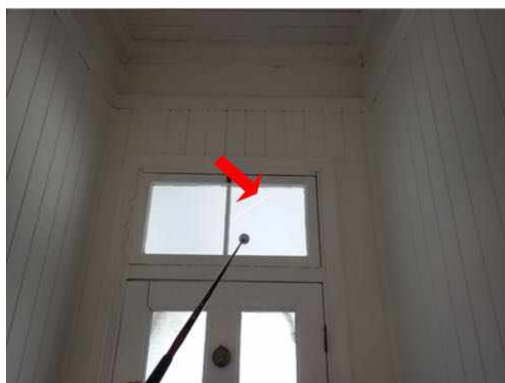
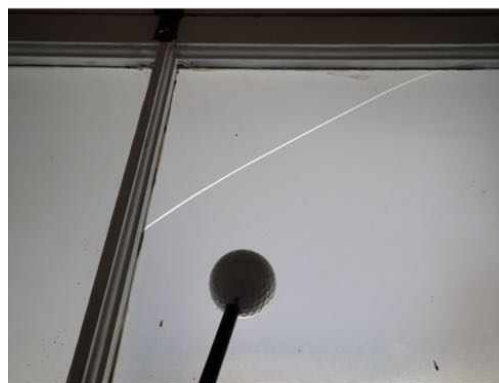
Finding 1.01

Building:	Main Building
Location:	Front balcony window above door
Finding:	Cracked Glass Pane – Front Balcony Window Above Door
Information:	A cracked glass pane was identified to the front balcony window located above the door. This condition may have resulted from impact, stress, or movement and can compromise the integrity of the glazing. The damaged glass is prone to further cracking and potential failure and presents a safety risk due to the potential for breakage. Replacement of the affected pane is recommended. A licensed glazier should be engaged to assess and carry out repairs as required.

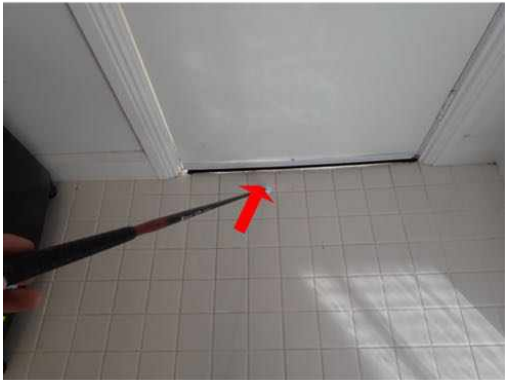
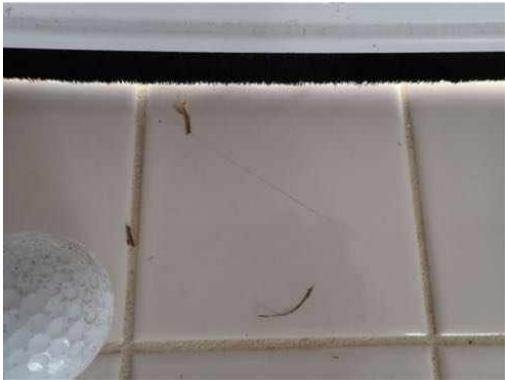
Finding 3.01

Building:	Main Building
Location:	Laundry
Finding:	Cracked Floor Tile – Laundry
Information:	A cracked floor tile was identified within the laundry area. This may be due to movement in the substrate, poor installation, or impact damage. Cracked tiles can allow moisture ingress leading to deterioration of underlying materials. Repairs are recommended to prevent further damage. A licensed tiler or suitably experienced handyman should be engaged to assess and carry out repairs as required.

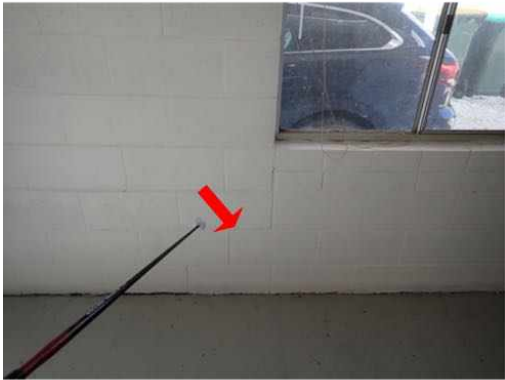
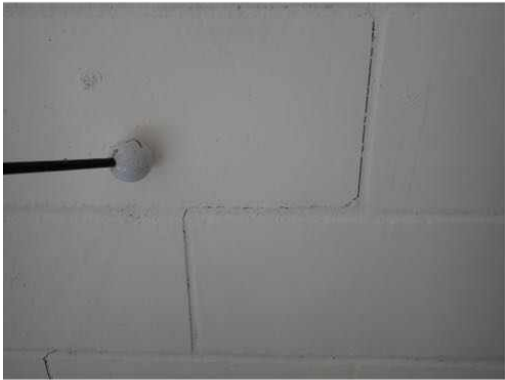
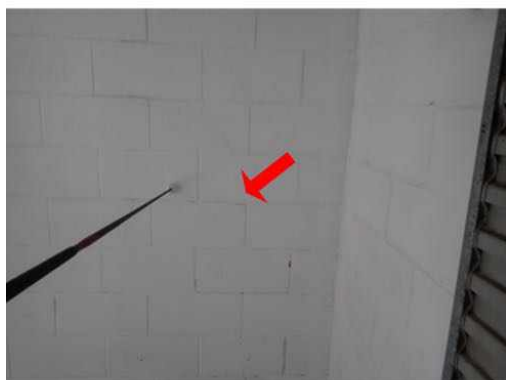
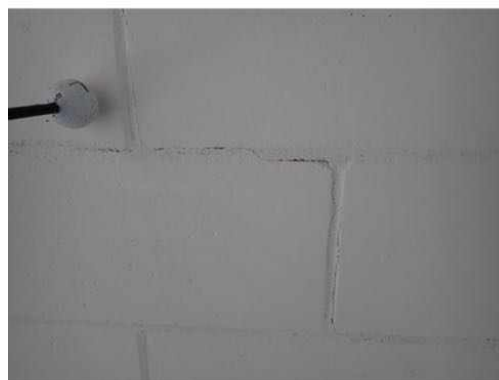
Finding 3.02

Building: Main Building
Location: Garage
Finding: Minor Step Cracking – Garage Blockwork Wall
Information: Minor step cracking was identified to the blockwork wall within the garage. This type of cracking is commonly associated with minor movement or settlement and is typical in masonry construction. While considered minor at the time of inspection, ongoing movement may lead to further deterioration if not addressed. Repairs may be carried out as required. A licensed builder or suitably experienced handyman should be engaged to assess and carry out repairs as necessary.

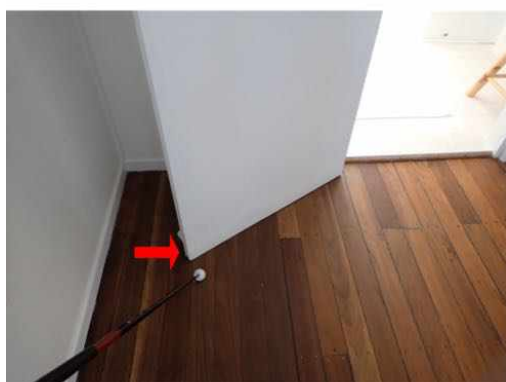
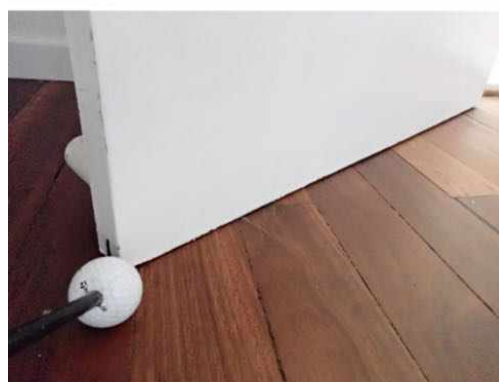
Finding 3.03

Building:	Main Building
Location:	Bathroom
Finding:	Bathroom Door Catching on Timber Flooring
Information:	The bathroom door was observed catching on the timber flooring during operation. This may be due to movement in the structure, swelling of materials from moisture, or misalignment of door hardware. Continued use in this condition may cause further damage to the door, flooring, or hinges. Adjustment or repair is recommended. A licensed carpenter or suitably experienced handyman should be engaged to assess and carry out repairs as required.

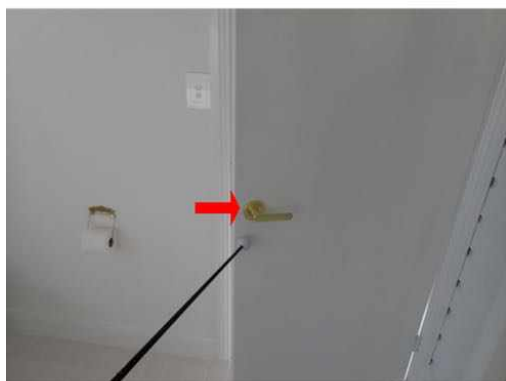
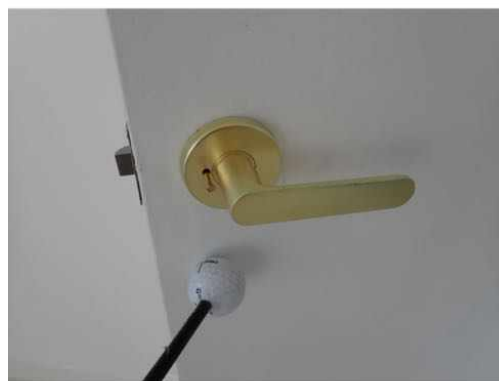
Finding 3.04

Building:	Main Building
Location:	Bathroom
Finding:	Loose Door Handle – Bathroom
Information:	The bathroom door handle was found to be loose at the time of inspection. This is likely due to worn fixings, poor installation, or general wear and tear. Continued use in this condition may lead to failure of the handle or difficulty operating the door. Repair or re-fixing is recommended. A licensed carpenter or suitably experienced handyman should be engaged to assess and carry out repairs as required.

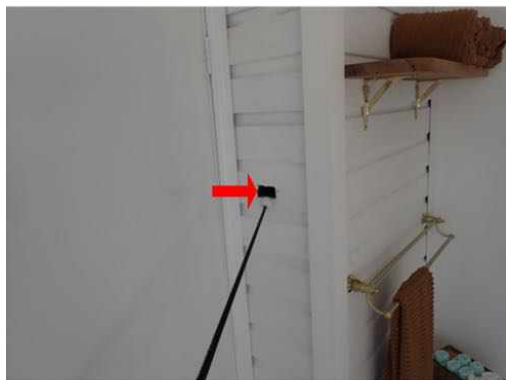
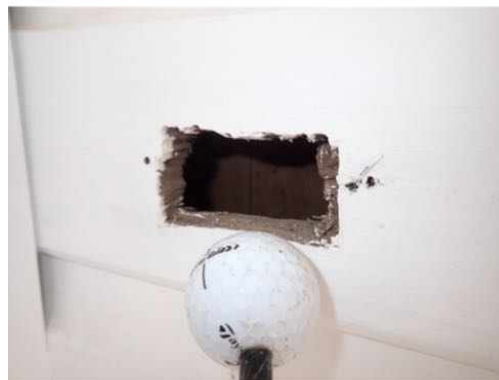
Finding 3.05

Finding: Hole in Internal Weatherboard Cladding – Bathroom

Information: A hole was identified in the internal weatherboard cladding within the bathroom, likely from a previous electrical fitting. This condition may allow pest ingress and can lead to deterioration of underlying building materials if left unaddressed. Repairs are recommended to maintain the integrity of the wall lining. A licensed carpenter or suitably experienced handyman should be engaged to assess and carry out repairs as required.

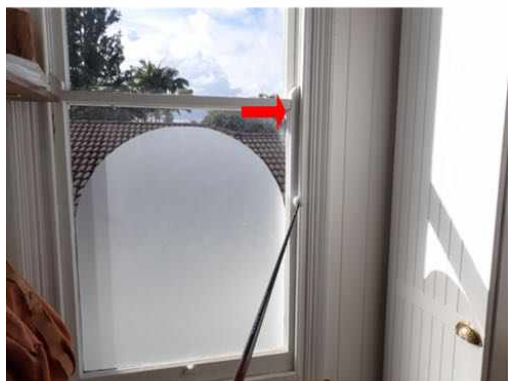
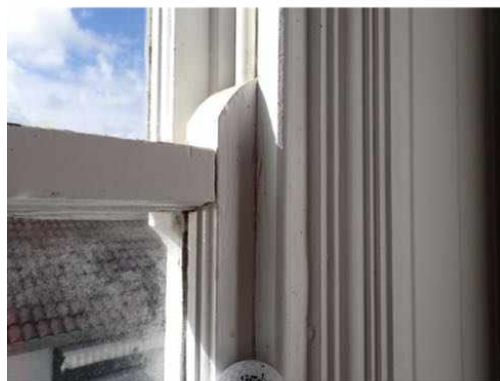
Finding 3.06

Finding: Walk-in Robe Window Unable to Open

Information: The window within the walk-in robe could not be opened at the time of inspection. This may be due to paint build-up, faulty hardware, or swelling of materials. Inoperable windows can restrict ventilation. Repair or adjustment is recommended. A licensed carpenter or suitably experienced handyman should be engaged to assess and carry out repairs as required.

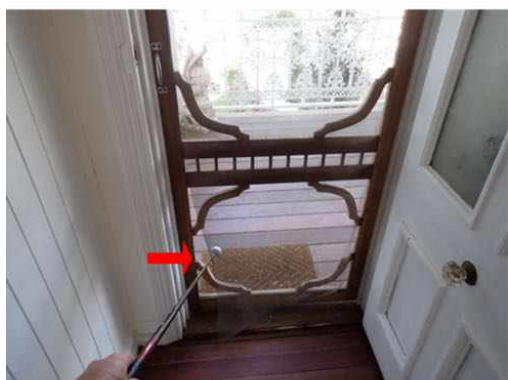
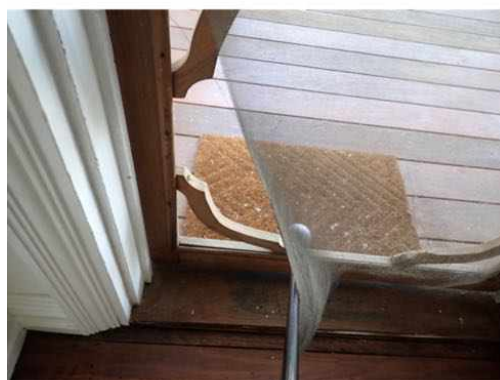
Finding 3.07

Building:	Main Building
Location:	Front balcony window above door
Finding:	Damaged Flyscreen – Balcony Door
Information:	The flyscreen to the balcony door was found to be damaged at the time of inspection. This condition may allow insect ingress and reduce the effectiveness of the screen. The damage may be due to wear and tear, impact, or deterioration over time. Repair or replacement is recommended. A licensed carpenter or suitably experienced handyman should be engaged to assess and carry out repairs as required.

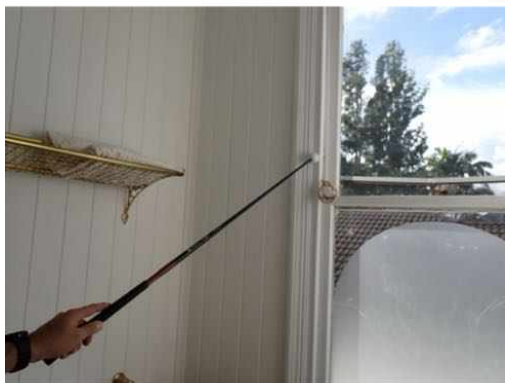
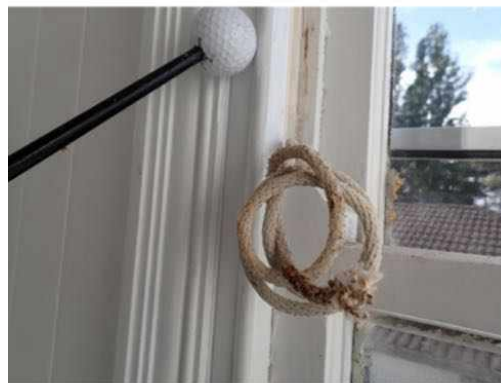
Finding 3.08

Building:	Main Building
Location:	Ensuite
Finding:	Broken Sash Cords – Ensuite Window
Information:	Broken sash cords were identified to the ensuite window. This condition can prevent the window from operating correctly and may result in the sash not remaining in position when opened. The damage is typically due to wear and tear over time. Repair or replacement of the sash cords is recommended to restore proper operation. A licensed carpenter or suitably experienced handyman should be engaged to assess and carry out repairs as required.

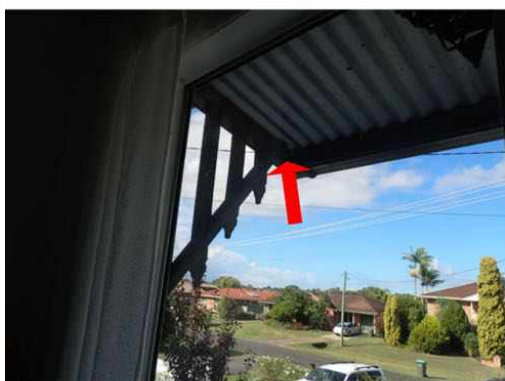
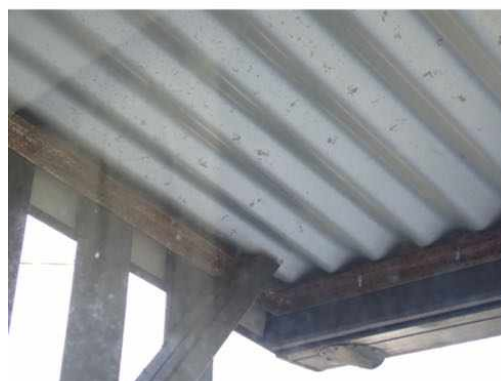
Finding 3.09

Finding: Surface Rust – Bedroom Window Hood Frame

Information: Surface rust was identified to the bedroom window hood frame. This condition is typically associated with exposure to moisture and weathering and may lead to further corrosion if left unaddressed. Treatment and maintenance are recommended to prevent deterioration. A licensed painter or suitably experienced handyman should be engaged to clean, treat, and recoat the affected areas as required.

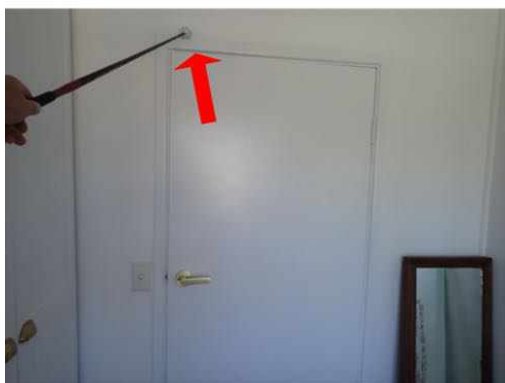
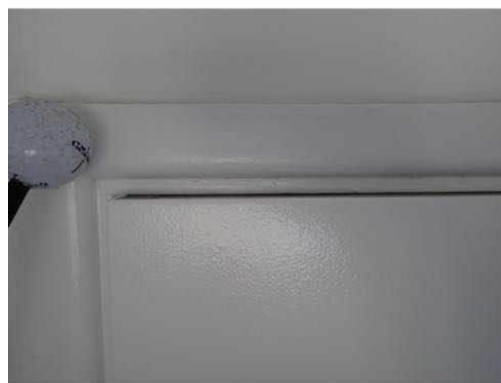
Finding 3.10

Finding: Bedroom Door Catching on Door Jamb

Information: The bedroom door was observed catching on the door jamb during operation. This may be due to movement in the structure, swelling of materials, or misalignment of door hardware. Continued use in this condition may cause further damage to the door, jamb, or hinges. Adjustment or repair is recommended. A licensed carpenter or suitably experienced handyman should be engaged to assess and carry out repairs as required.

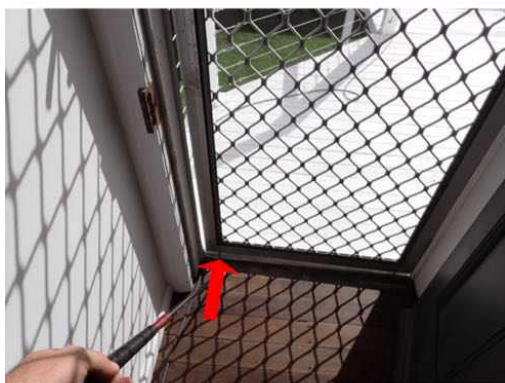
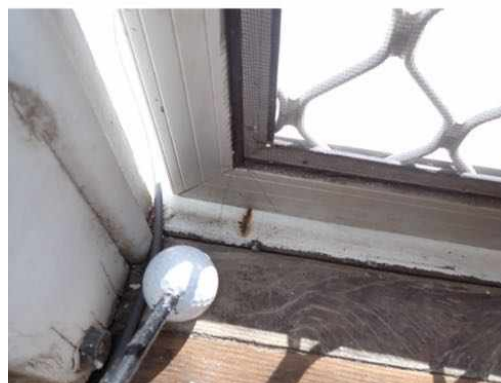
Finding 3.11

Building:	Main Building
Location:	Door to rear decked area
Finding:	Security Door Catching on Door Sill – Rear Deck Area
Information:	The security door to the rear deck area was observed catching on the door sill during operation. This may be due to movement in the structure, misalignment of the door, or wear to hinges or frame components. Continued use in this condition may cause further damage to the door, sill, or hardware. Adjustment or repair is recommended. A licensed carpenter or suitably experienced handyman should be engaged to assess and carry out repairs as required.

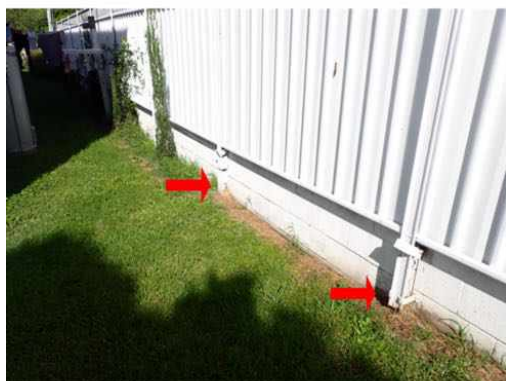
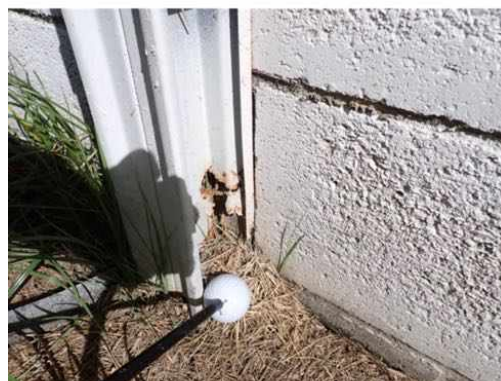
Finding 3.12

Building:	Yard
Location:	Fence along side boundary's
Finding:	Rust – Steel Fence Posts to Retaining Walls
Information:	Rust was identified to the base of the steel fence posts attached to the retaining walls. This condition is typically associated with prolonged exposure to moisture and may lead to further corrosion and reduced structural integrity over time. If left unaddressed, deterioration may continue and affect the stability of the fence. Treatment and maintenance are recommended. A licensed fencing contractor or suitably experienced

handyman should be engaged to assess, treat, and carry out repairs as required.

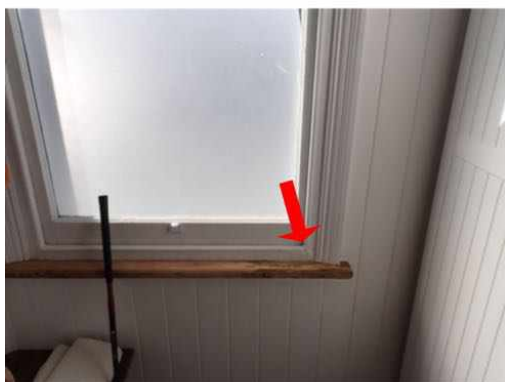
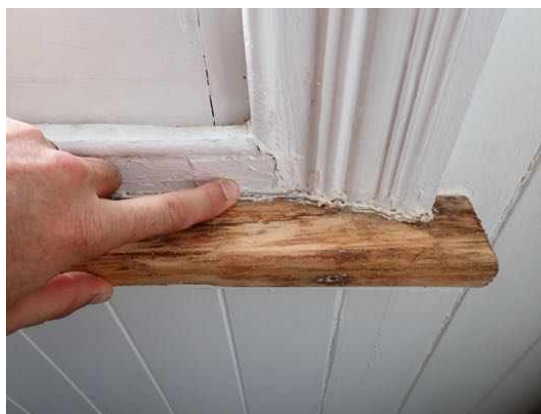
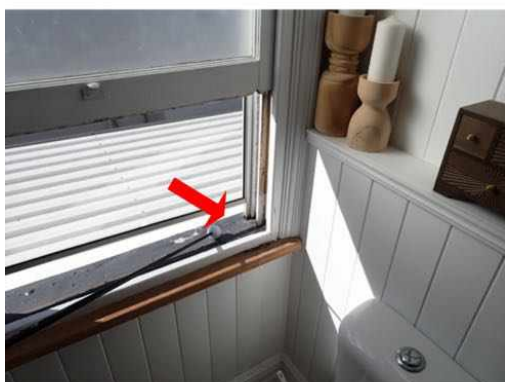
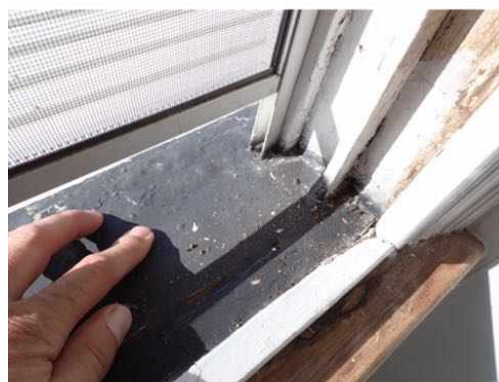
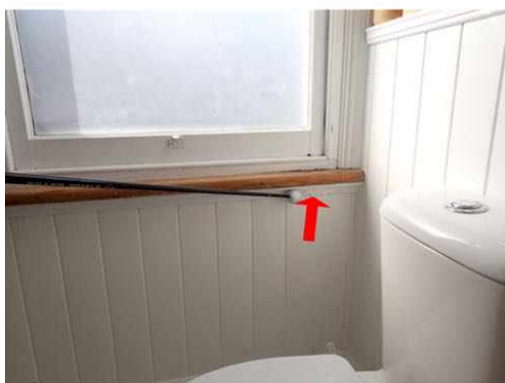
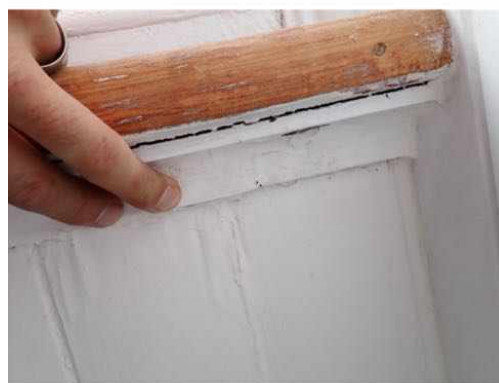
Finding 7.01

Building:	Main Building
Location:	Walk in robe and bathroom
Finding:	Wood Rot – Walk-in Robe and Bathroom Windows
Information:	Wood rot was identified to the window components within the walk-in robe and bathroom. This condition is typically associated with prolonged exposure to moisture and can lead to deterioration of the timber and reduced serviceability of the windows. If left unaddressed, further decay may occur. Repairs or replacement of affected timber elements are recommended. A licensed carpenter or suitably experienced handyman should be engaged to assess and carry out repairs as required.

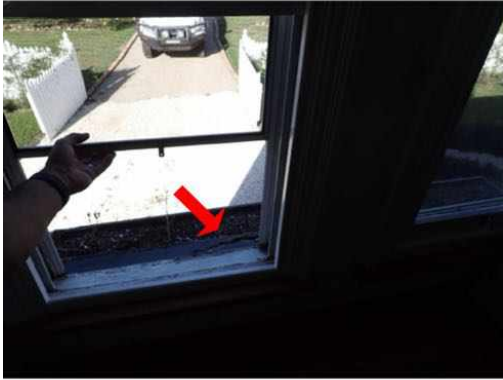
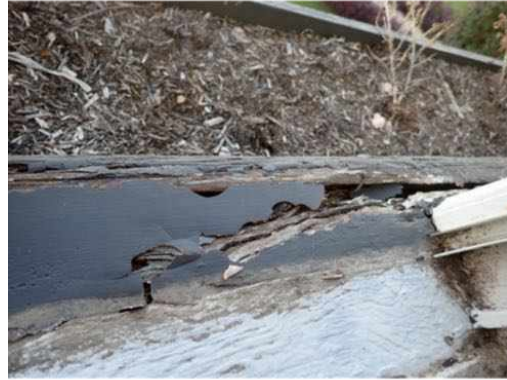
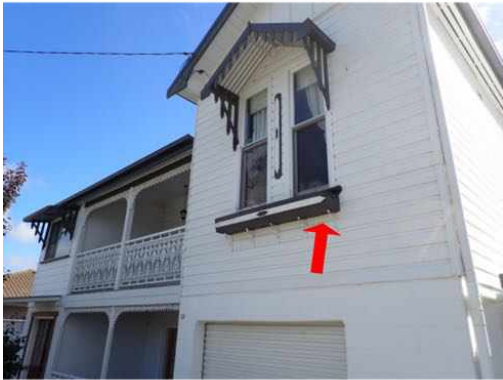
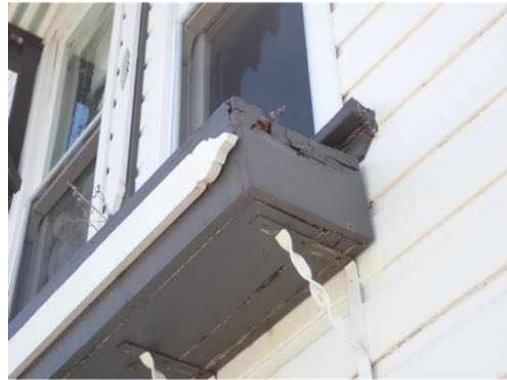
Finding 7.02

Building:	Main Building
Location:	Bedroom window
Finding:	Wood Rot – Bedroom Window and Planter Box
Information:	Wood rot was identified to the bedroom window components and adjacent planter box. This condition is typically associated with prolonged moisture exposure and can lead to deterioration of the timber and reduced structural integrity over time. Wood rot is also conducive to termite attack. If left unaddressed, further decay may occur. Repairs or replacement of affected timber elements are recommended. A licensed carpenter or suitably experienced handyman should be engaged to assess and carry out repairs as required.

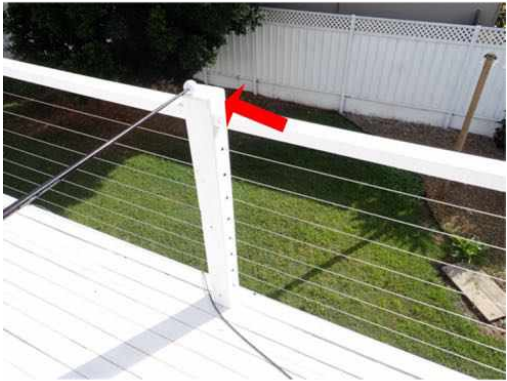
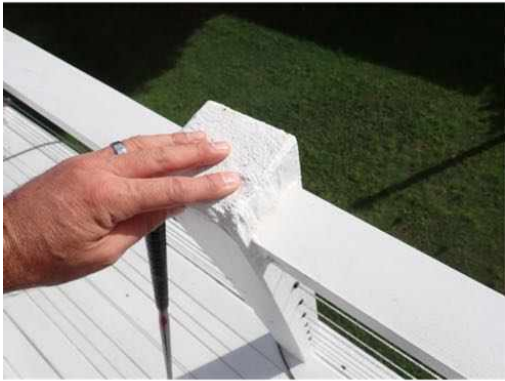
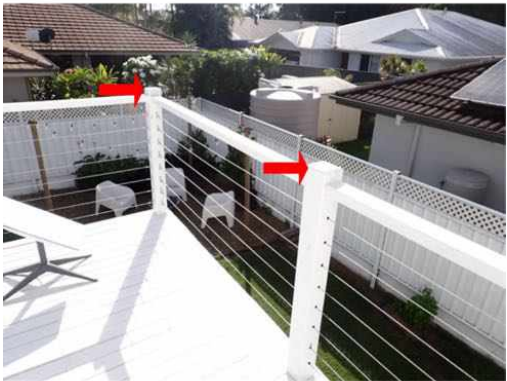
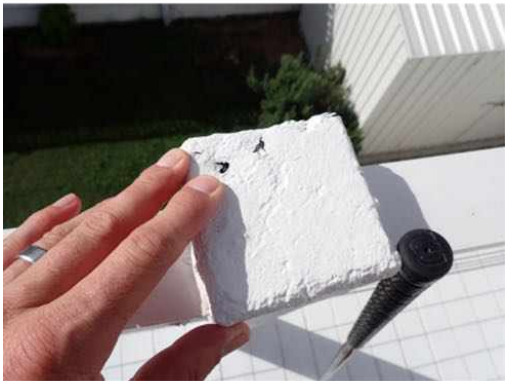
Finding 7.03

Building:	Main Building
Location:	Rear decked area
Finding:	Wood Rot – Rear Deck Timber Posts
Information:	Timber posts to the rear decked area were found to be soft at the top, indicating wood rot. This condition is typically associated with prolonged moisture exposure and may compromise the structural integrity of the posts over time. Wood rot is also conducive to termite attack. If left unaddressed, further deterioration may occur. Repair or replacement of the affected timber elements is recommended. A licensed carpenter or suitably experienced handyman should be engaged to assess and carry out repairs as required.

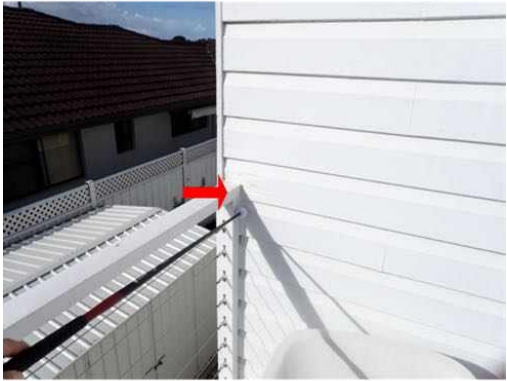
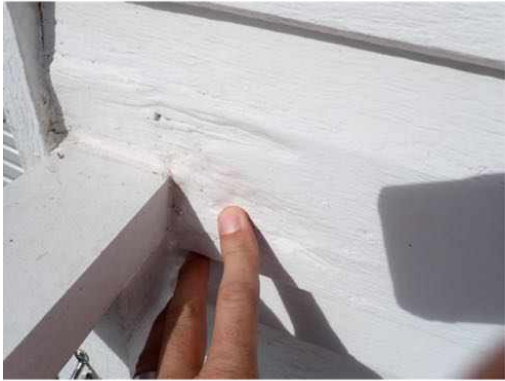
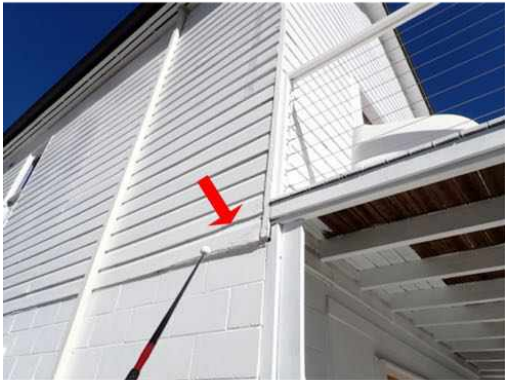
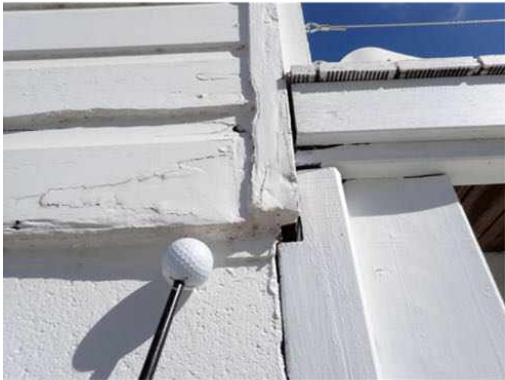
Finding 7.04

Building: Main Building
 Location: Rear right hand corner of building
 Finding: Wood Rot – Cladding to Right Hand Corner of Building
 Information: Wood rot was identified to the cladding at the right hand corner of the building. This condition is typically associated with prolonged moisture exposure and can lead to deterioration of the timber and reduced durability of the external envelope. Wood rot is also conducive to termite attack. If left unaddressed, further decay may occur. Repairs or replacement of the affected cladding are recommended. A licensed carpenter or suitably experienced handyman should be engaged to assess and carry out repairs as required.

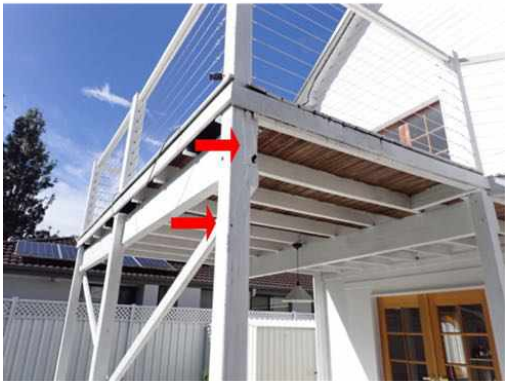
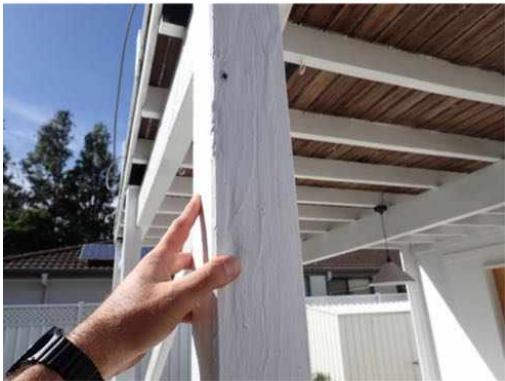
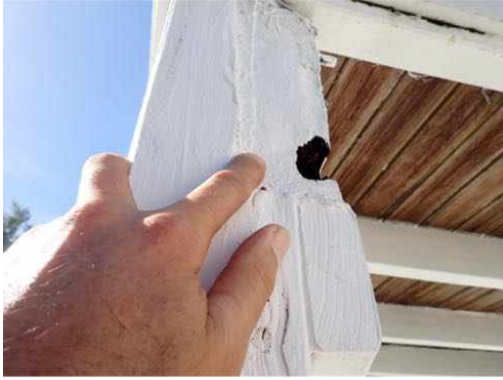
Finding 7.05

Building: Main Building
Location: Rear decked area
Finding: Wood Rot – Rear Deck Post and Bearer
Information: Wood rot was identified to the rear deck post and associated bearer. This condition is typically associated with prolonged moisture exposure and may compromise the structural integrity of these elements over time. Wood rot is also conducive to termite attack. If left unaddressed, further deterioration may occur. Repair or replacement of the affected timber elements is recommended. A licensed carpenter or suitably experienced handyman should be engaged to assess and carry out repairs as required.

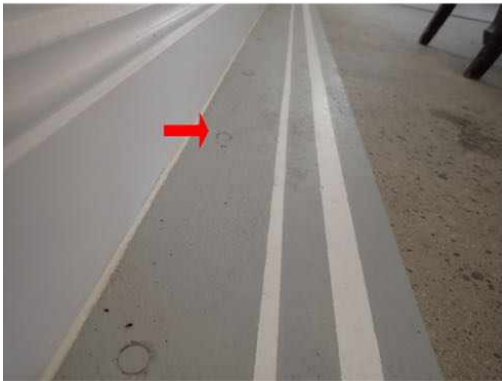
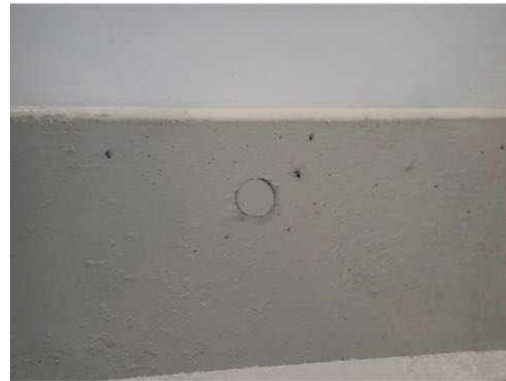
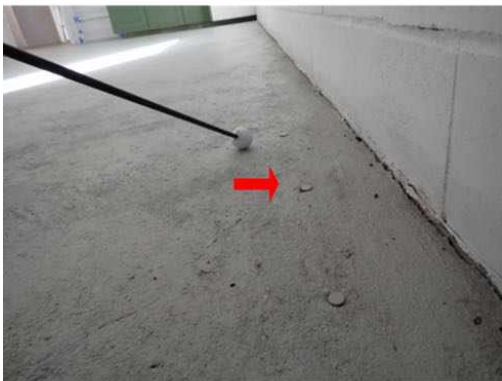
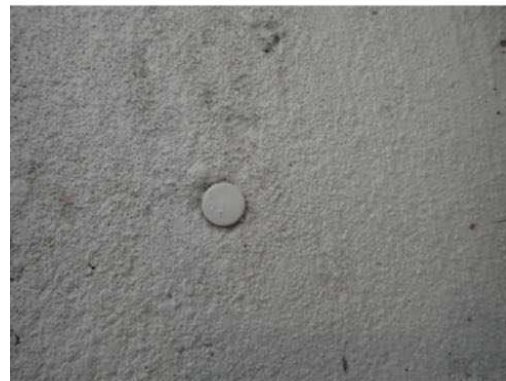
Building:	Main Building
Location:	Edge of concrete slab
Finding:	Evidence of a chemical treated zone barrier was identified
Information:	During inspection of the property, it was noted that works to install a chemical treated zone barrier had previously been completed. A chemical treated zone barrier is likely to ensure effective protection against termites.

However, we strongly recommend annual inspections of the barrier and surrounding areas as there are several factors that can lead to deterioration of the barrier and decrease its effectiveness.
