Building and Timber Pest Inspection Report

Inspection Date: Mon, 2 Mar 2026

Property Address: 24 Corven Ave, Elderslie NSW 2570,
Australia

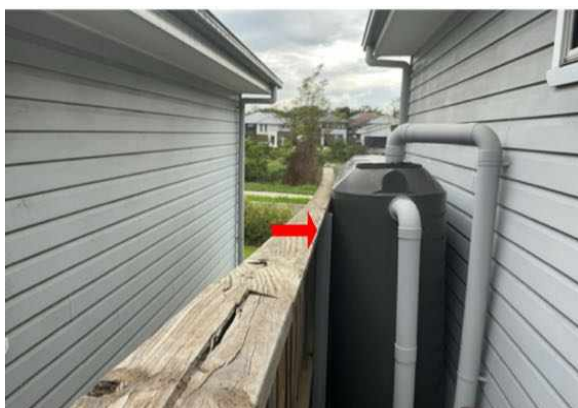
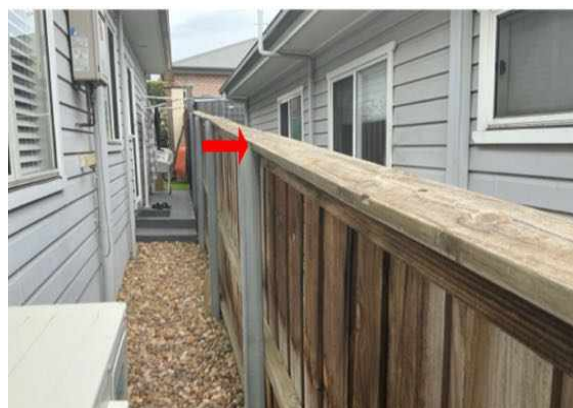
Finding 3.01

Building:	Main Building
Location:	Fencing
Finding:	Fencing (Deterioration Observed)
Information:	During the inspection, the property fencing was found to be in generally fair condition, however, some sections show signs of wear. This is likely due to factors such as the original design, material selection, environmental exposure, or the natural aging of the fence. Regular assessment and maintenance are advised to prevent further deterioration. It is also recommended to consult with a qualified fencing contractor for further advice.

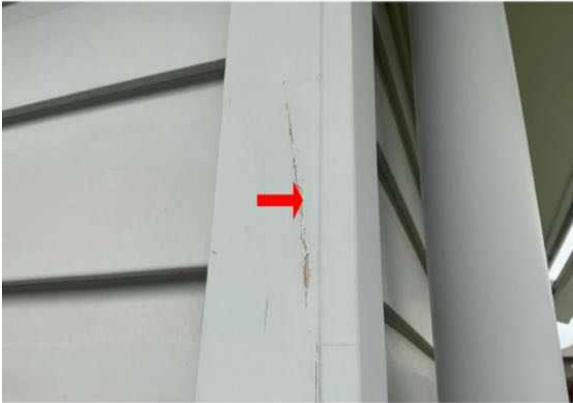
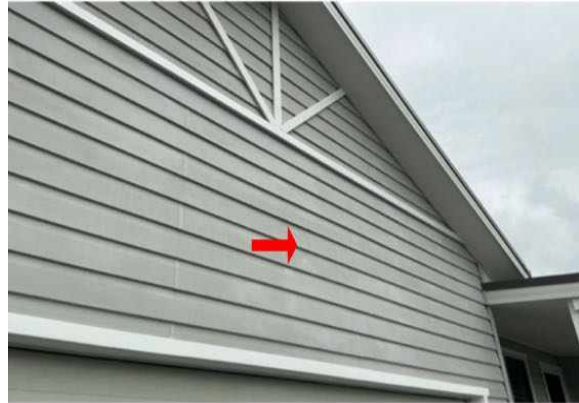
Finding 3.02

Building:	Main Building
Location:	Exterior walls
Finding:	External Painting Deteriorated
Information:	Due to frequent exposure to weather conditions, deterioration of the exterior painted surfaces is expected in a property of this age and condition. Where paint deterioration has occurred, the protective layer is compromised, which can lead to moisture ingress, surface degradation, and the eventual need for repair or replacement of the

affected building elements.

It is recommended to engage a qualified painting contractor to carry out the necessary preparation and repainting works. This will improve the appearance of the affected areas and help protect the underlying materials from further weather-related deterioration. Regular maintenance of external finishes is essential to prolong the life of building elements and maintain overall property condition.

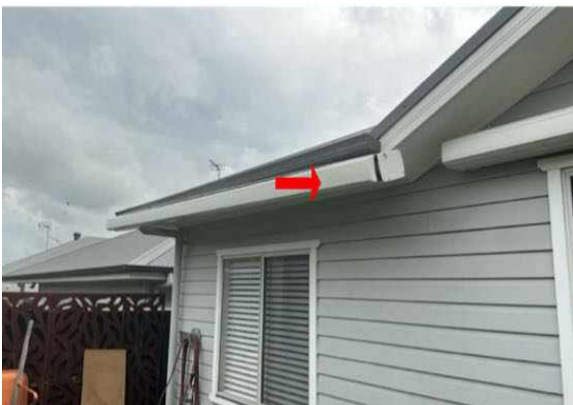
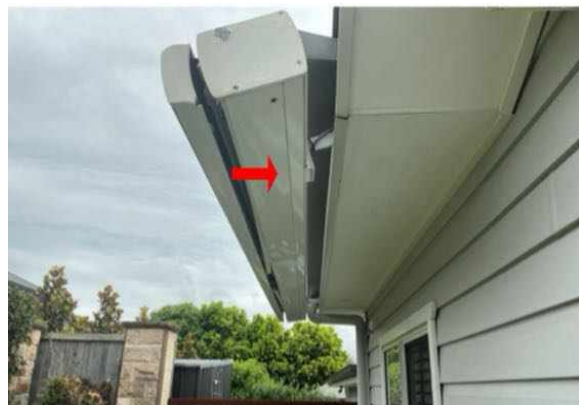
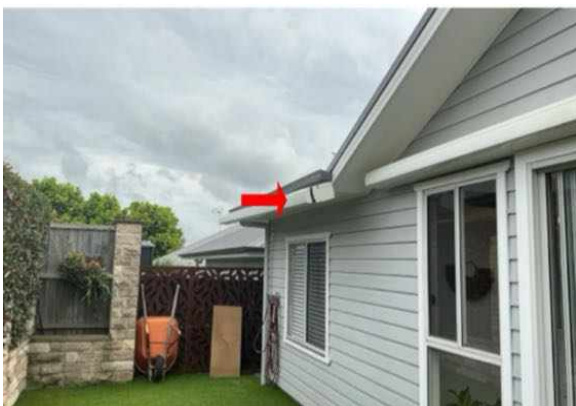
Finding 3.03

Building:	Main Building
Location:	Exterior walls
Finding:	Retractable Awning Installed Out of Level
Information:	During the inspection, the retractable awning was observed to be installed out of level. An uneven installation may place uneven stress on the frame and mechanical components.

Over time, this condition can accelerate wear and deterioration of the hardware and moving parts. Adjustment and realignment by a qualified tradesperson is recommended to ensure proper operation and prolong the lifespan of the awning system.

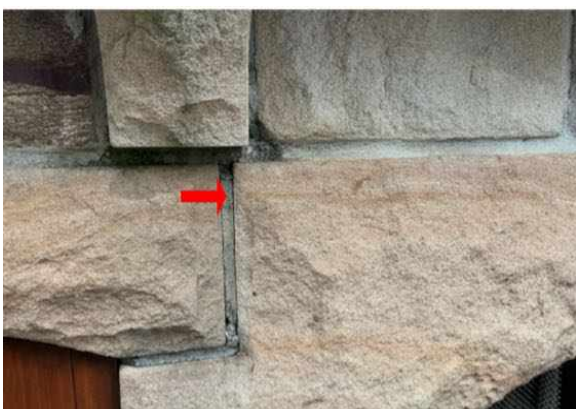
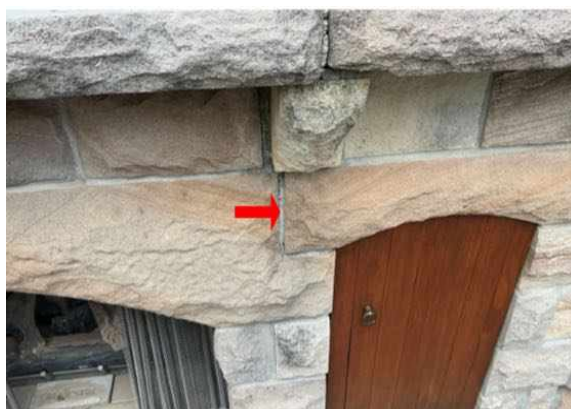
Finding 3.04

Building: Main Building
 Location: Exterior walls
 Finding: Step Cracking Outdoor Fireplace
 Information:

During the inspection, step cracking was observed in the masonry of the outdoor fireplace. Step cracking may indicate movement within the structure, which can occur due to settlement, thermal expansion, or foundation movement over time.

Monitoring of the affected area is recommended to determine whether further movement occurs. If cracking progresses or widens, assessment by a qualified builder or structural professional is advised to determine the cause and recommend appropriate remedial works.

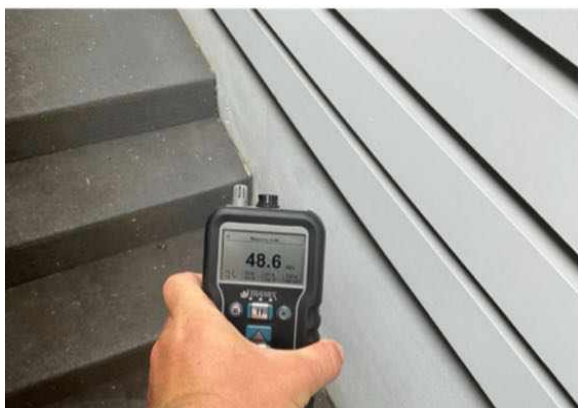
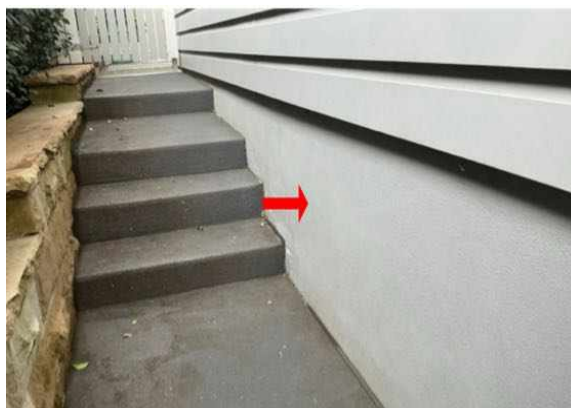
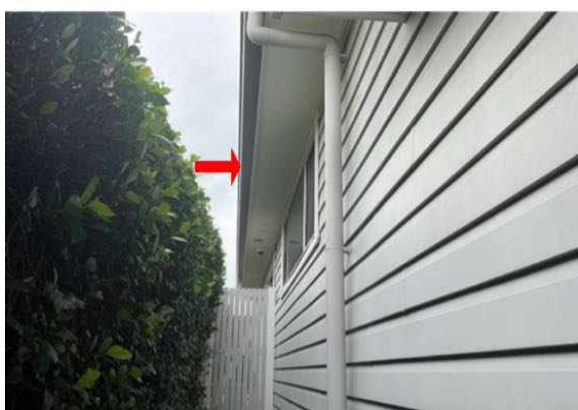
Finding 3.05

Building: Main Building
 Location: Exterior walls
 Finding: Gutters Insufficient Downpipes / Elevated Moisture at Slab Edge
 Information:

During the inspection, the guttering system was observed to have insufficient downpipes servicing the roof drainage. Non-invasive moisture testing conducted at the slab edge recorded elevated moisture levels, indicating ineffective stormwater

discharge in the left side area.

Inadequate drainage may result in moisture accumulation around the building perimeter, which can contribute to material deterioration, rising damp, and conditions conducive to termite activity over time. It is recommended that a qualified roof plumber assess the guttering system and install additional downpipes as required to improve stormwater management and reduce moisture exposure at the slab edge.

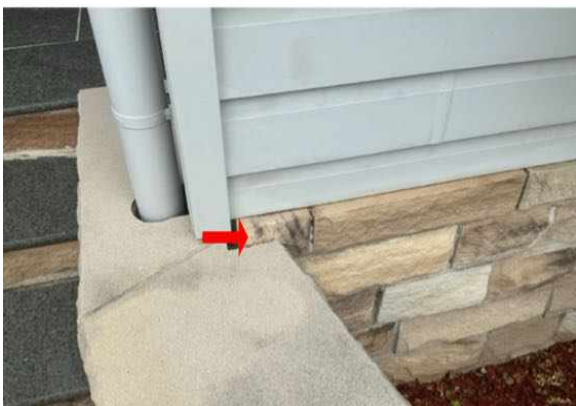
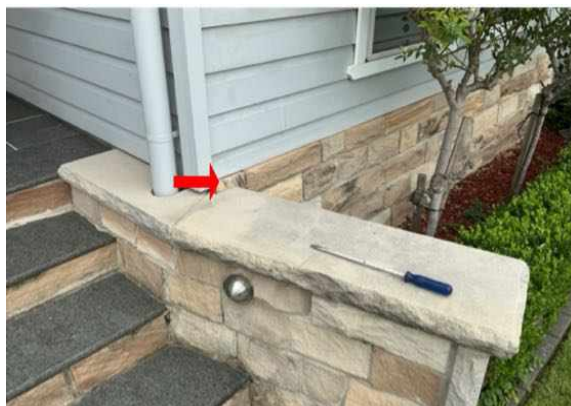
Finding 3.06

Building:	Main Building
Location:	Exterior walls
Finding:	Tiles Detached
Information:	The tiles have become detached from their original fixing, likely due to poor workmanship at the time of installation or subsequent physical or moisture-related damage. Detached tiles can continue to loosen over time and may allow moisture to penetrate beneath the surface, leading to further deterioration. To prevent further damage, it is recommended that a qualified tiling contractor be engaged to assess the affected areas and carry out the necessary repairs promptly.

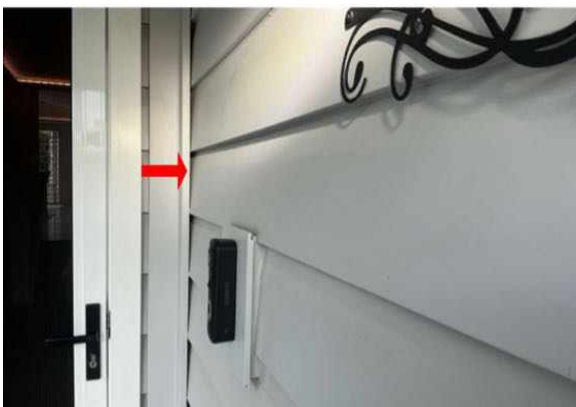
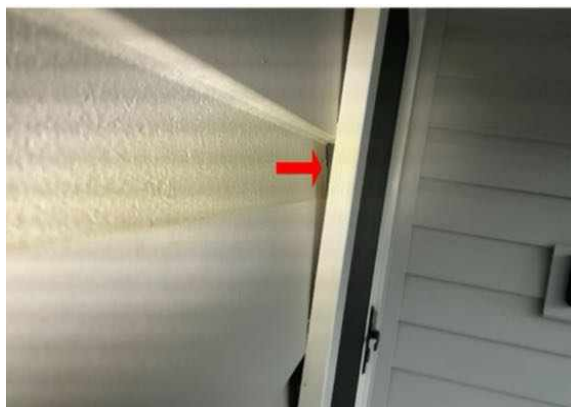
Finding 3.07

Building: Main Building
 Location: Exterior walls
 Finding: Gaps in Exterior Cladding
 Information:

During the inspection, gaps were observed at corner junctions and around window interfaces in sections of the exterior cladding. These openings may allow air penetration, and pest entry, potentially leading to deterioration of underlying building elements over time.

It is recommended that a qualified tradesperson seal and properly finish the affected areas to restore weatherproofing and maintain the integrity of the external building envelope.

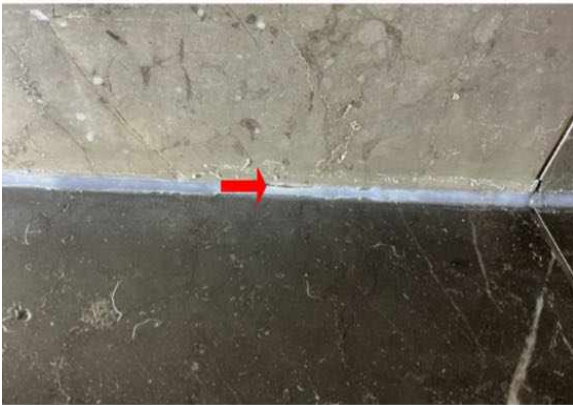
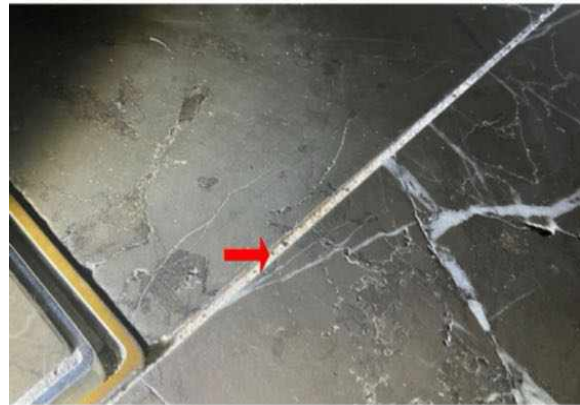
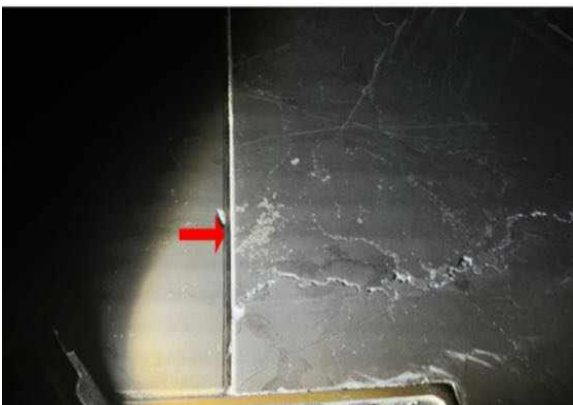
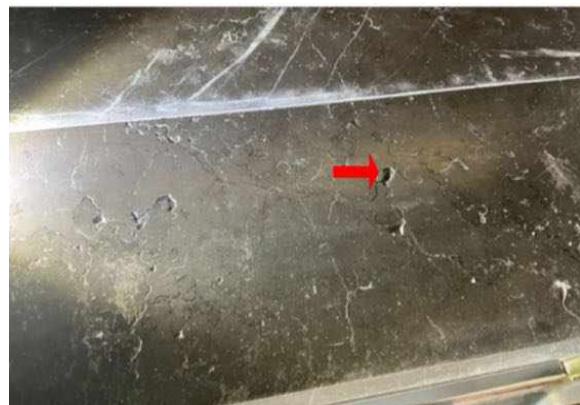
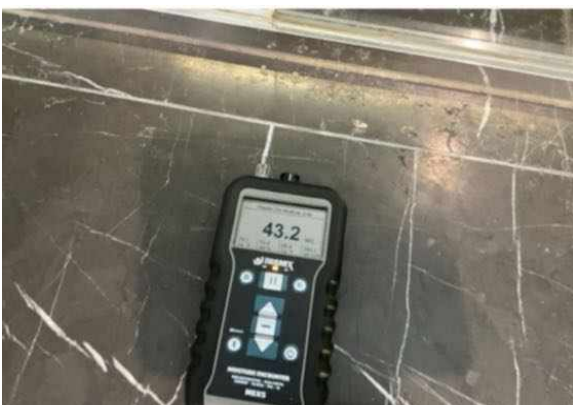
Finding 3.08

Building: Main Building
 Location: Ensuite
 Finding: Shower Elevated Moisture
 Information:

During the inspection, elevated moisture levels were recorded beneath the tiled surface in the shower area and extending beyond the shower, as measured using a non-invasive moisture meter. This indicates that water is penetrating behind the tiles

and affecting concealed areas, likely due to compromised waterproofing, deteriorated grout, or failed sealant joints. Prolonged moisture in these areas increases the risk of timber decay, fungal growth, and termite activity, and may compromise the structural integrity of surrounding building elements. It is recommended to conduct a further test and if water is exiting the shower area a qualified bathroom renovation specialist should be engaged to carry out appropriate remedial works. Regular inspection and maintenance of wet areas, along with continued moisture monitoring, are essential to prevent further deterioration.

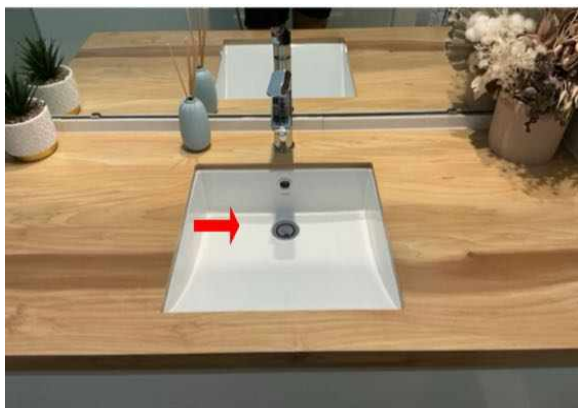
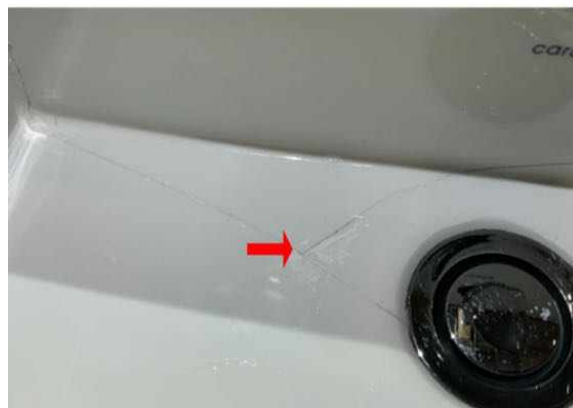
Finding 3.09

Location: Ensuite
 Finding: Cracked Ensuite Sink
 Information:

During the inspection, the ensuite bathroom sink was observed to be cracked. The damage affects the surface integrity of the basin and may worsen over time, potentially leading to leakage or hygiene concerns. The defect also detracts from the overall finish and functionality of the fixture.

Replacement of the damaged sink by a qualified plumber is recommended to restore proper serviceability and appearance.

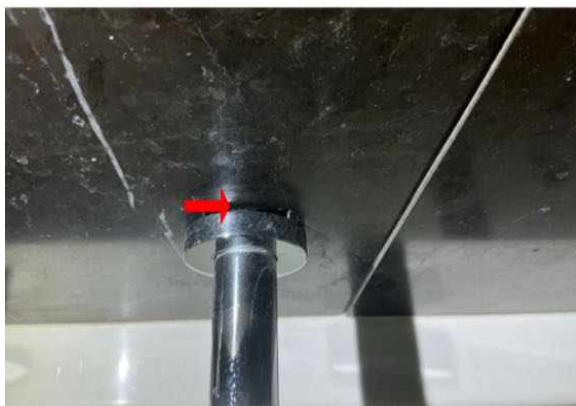
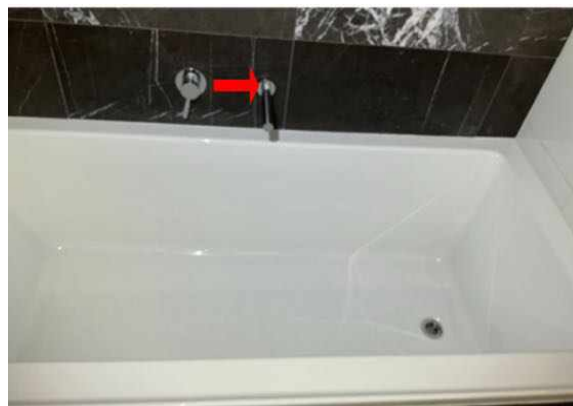
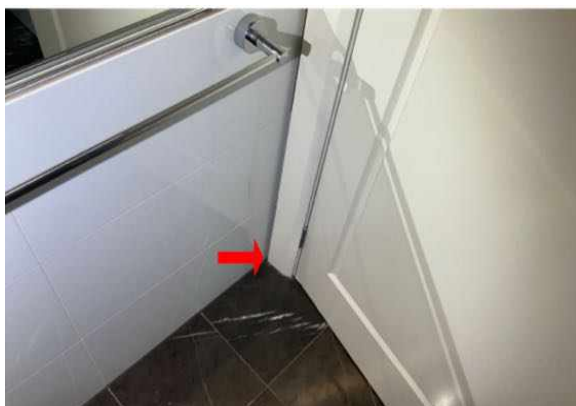
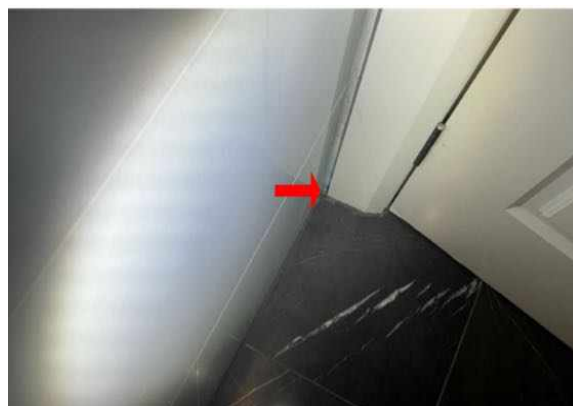
Finding 3.10

Building: Main Building
 Location: Main Bathroom
 Finding: Sealant to Junctions (Left Unfinished)
 Information: During the inspection, it was noted that the waterproof sealant was either unfinished or missing at several floor tile junctions. This can create a potential risk of water penetration, which may lead to moisture ingress, water damage, and deterioration of underlying materials over time.

It is recommended to have the affected junctions properly sealed using a suitable waterproof sealant to ensure compliance with waterproofing standards and provide effective long-term moisture protection.

Addressing this promptly is a straightforward maintenance task that will help prevent future water-related issues and preserve the durability and integrity of the tiled areas.

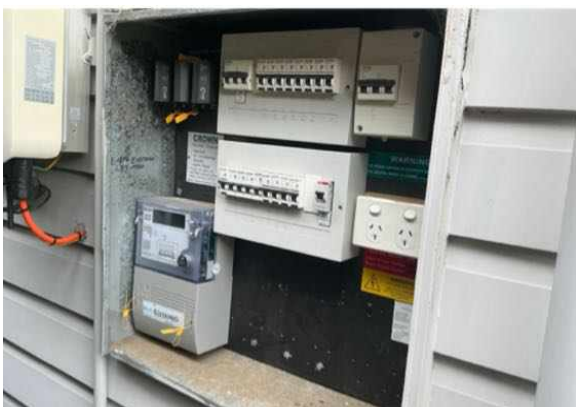
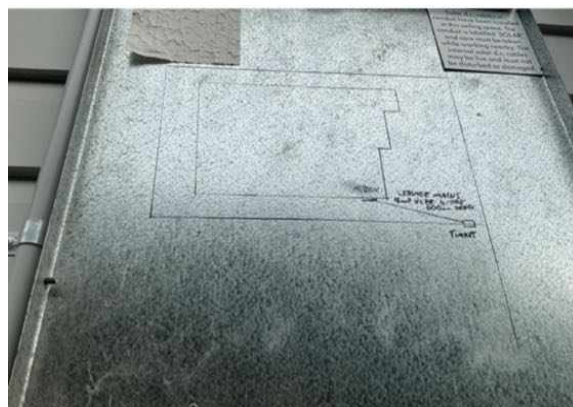
Building:	Main Building
Location:	Meter Box
Finding:	Termite Management (No Evidence of a Chemical Installation)
Information:	During the inspection, it was noted that no termite management system had been installed, and there was no evidence of preventative works. Applying a post-construction chemical termite barrier is essential for all properties, as these barriers are highly effective in preventing termite attacks on timber building elements. A durable notice should also be prominently displayed in the meter box to ensure awareness of the termite barriers in place. It is important for the client to seek further professional advice on implementing a termite management system. Failure to address this leaves

the property vulnerable to potential termite infestations.

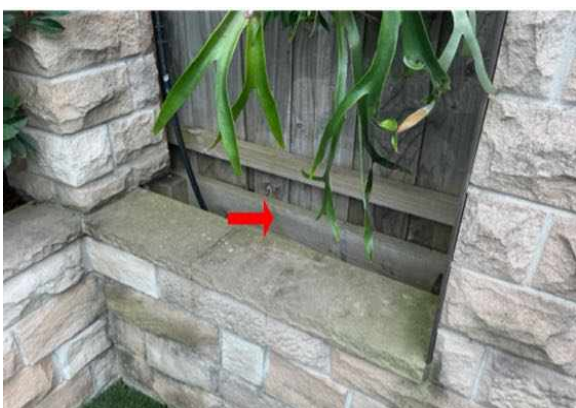
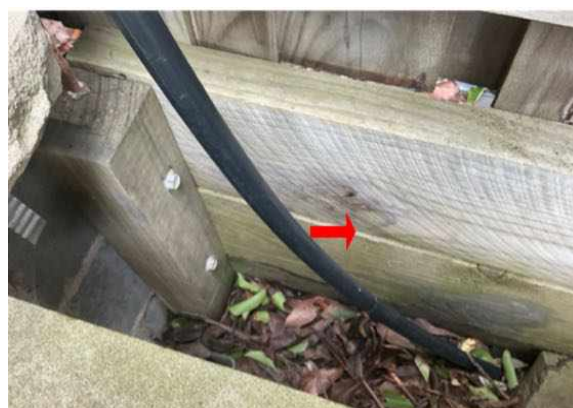
Finding 6.02

Building:	Main Building
Location:	All Areas
Finding:	In Contact With The Ground
Information:	During the inspection, wood and timber materials were observed in direct contact with the ground. This condition is highly conducive to timber pest activity, particularly termites, as it provides an ideal environment for infestation and timber decay due to elevated moisture levels, concealment, and direct access to cellulose material. Untreated or inadequately protected timber in ground contact significantly increases the risk of concealed termite entry and potential structural damage.

To reduce the risk of infestation, all ground-contacting timber should be promptly removed. It is recommended to engage a qualified pest control to assess the subfloor and implement appropriate termite management system, in accordance with AS 3660.2. Regular timber pest inspections, ideally every 90 days, are advised until all conducive conditions have been fully addressed.

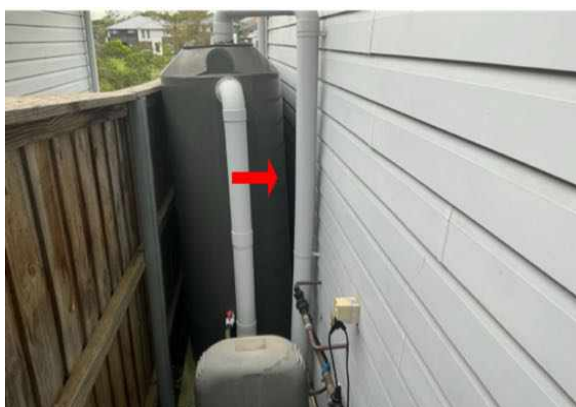
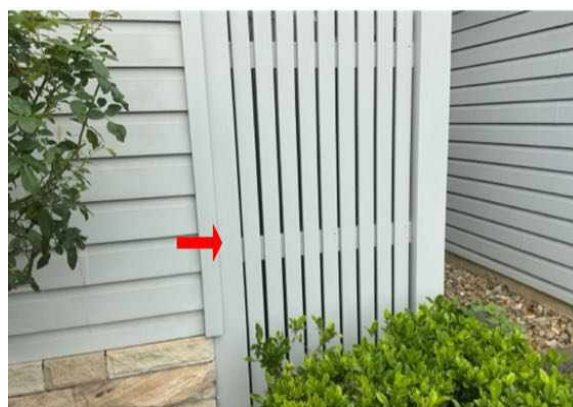
Finding 6.03

Location:	Exterior walls
Finding:	Bridging
Information:	Bridging of a termite physical barrier occurs when termites bypass a preventative measure designed to block or expose their access to a structure. This can happen when soil, vegetation, or debris accumulates against exterior walls above the barrier level. Appliances such as hot water units and air conditioning systems, or wooden structures like decks and porches that touch the ground and connect to the main building, can also contribute to bridging. Even structural modifications may unintentionally create pathways that allow termites to bypass barriers or inspection zones. These breaches provide termites with a direct and often undetectable route into the property, increasing the risk of substantial and unnoticed infestations that can cause extensive structural damage.

To safeguard your property from termite infestations, it is essential to maintain a minimum clearance of 75mm from the exposed slab edge. This clearance forces termites into the open, where they can be more easily detected during regular inspections. If this clearance is not achievable, it is crucial to conduct consistent timber pest inspections every 30 days or implement a post-construction termite management system compliant with Australian Standard AS 3660. Taking these precautionary measures helps ensure the property remains protected from termite threats and allows for early detection and intervention.

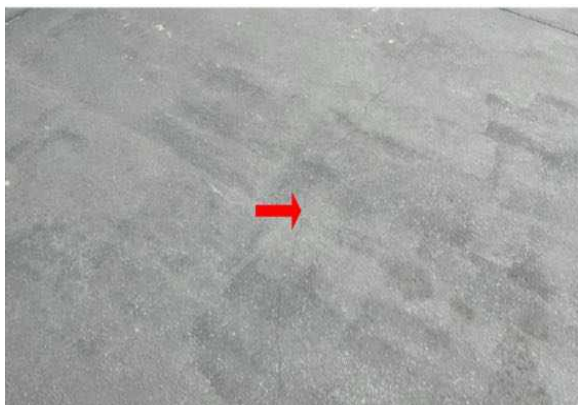
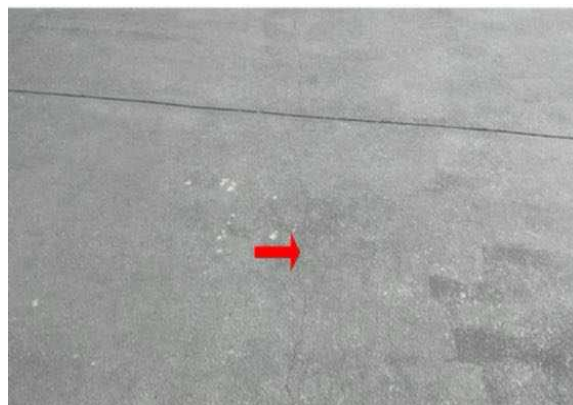
Building: Main Building
 Location: Exterior
 Finding: Concrete (Pavement) Cracking Category 1 - Fine
 Information: Fine cracks were observed in the external concrete paving. These cracks, typically are less than 2mm in width, and often considered to be an aesthetic defect rather than indicative of structural damage. They are commonly attributed to the natural expansion and contraction of the concrete, influenced by environmental factors such as moisture levels, weather conditions, roots of nearby trees, or soil erosion and settlement. While these fine cracks may also result from poor original installation practices such as inadequate sub-surface compaction or insufficient reinforcement, they generally do not pose significant structural concerns. However, it is recommended to monitor the cracks regularly for any changes. If the cracks widen,

lengthen, or increase in number, it is advisable to seek the expertise of a building inspector or builder for further inspection and to determine the appropriate course of action.

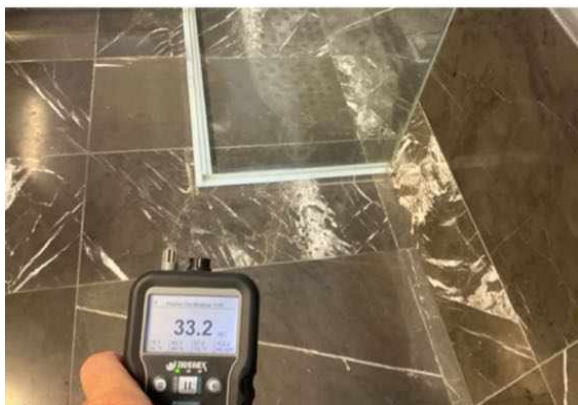
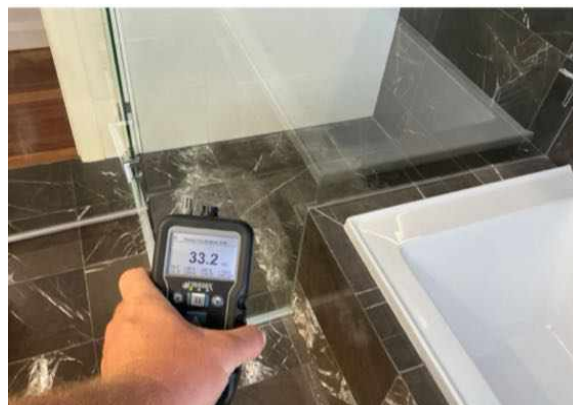
Building: Main Building
 Location: Main Bathroom
 Finding: Shower (For Your Information)
 Information: The shower was inspected by assessing the moisture content of the surrounding floor and walls, and no signs of moisture or moisture damage were detected in the accessible and visible areas at the time of inspection. To maintain the integrity of these areas, periodic inspections and routine maintenance of wet areas are essential. If any remedial work is needed, addressing it promptly will help prevent minor issues from escalating into more significant problems. This proactive approach ensures the long-term durability and functionality of the shower areas.
