## Building and Timber Pest Inspection Report VR

Inspection Date: Fri, 13 Mar 2026

Property Address: 4/17 The Crescent, Angourie NSW 2464,  
Australia

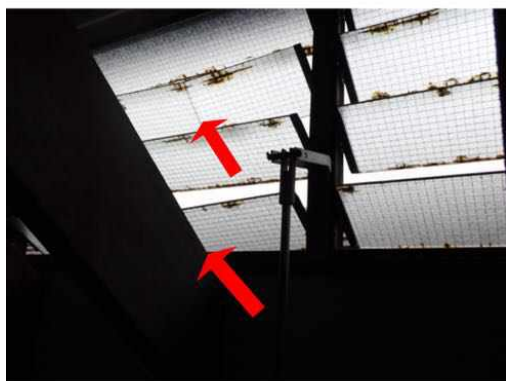
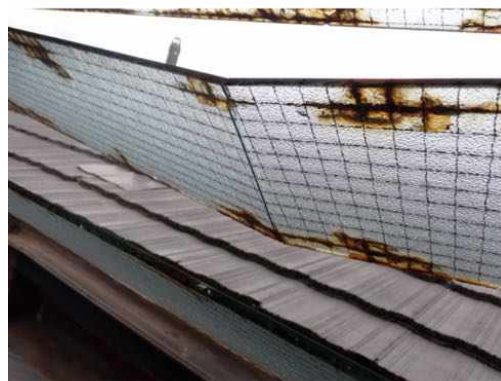
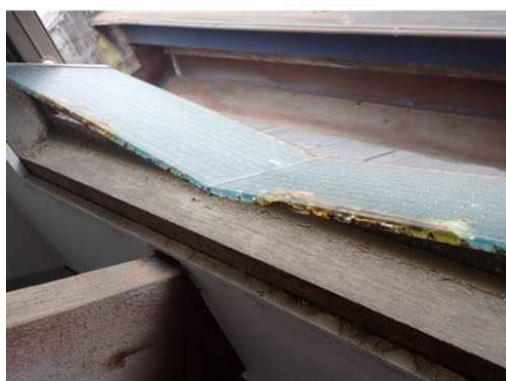
#### Finding 1.01

Building:	Main Building
Location:	Bathroom
Finding:	Window Louvre Blades – Broken Glass
Information:	Broken glass louvre blades were identified at the time of inspection. In plain English, some of the glass slats in the louvre window are cracked or broken which may affect operation and weather protection. Broken glass also presents a safety hazard. A glazier or suitably experienced handyman should replace the damaged louvre blades as soon as possible.

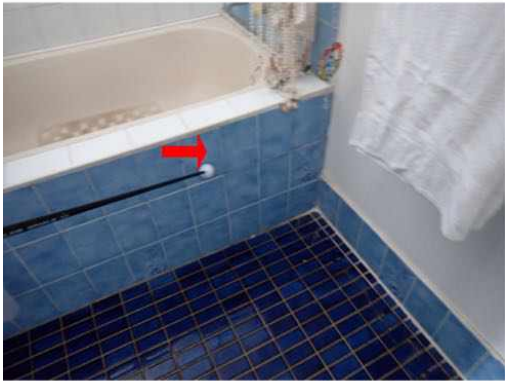
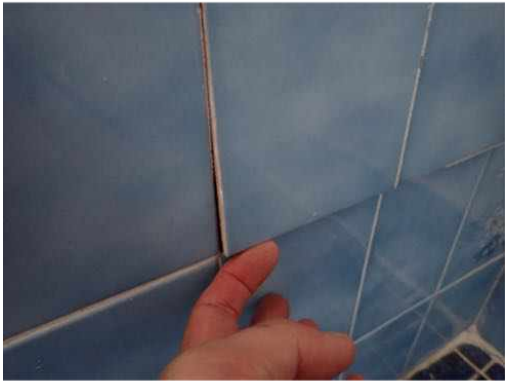
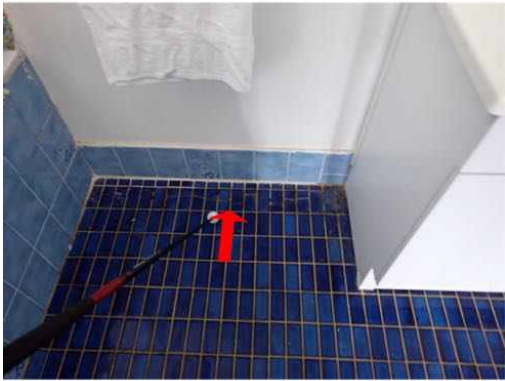
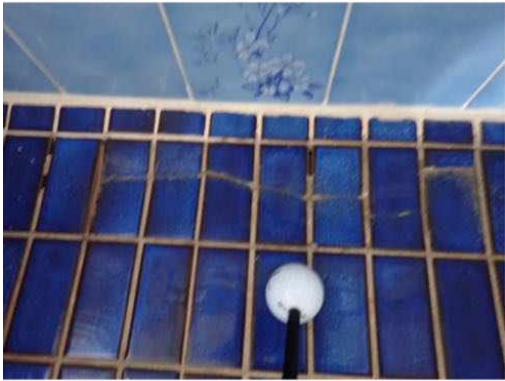
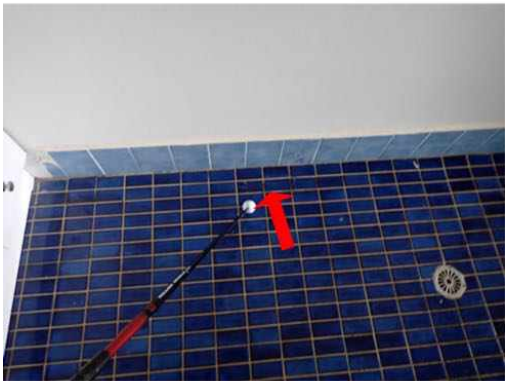
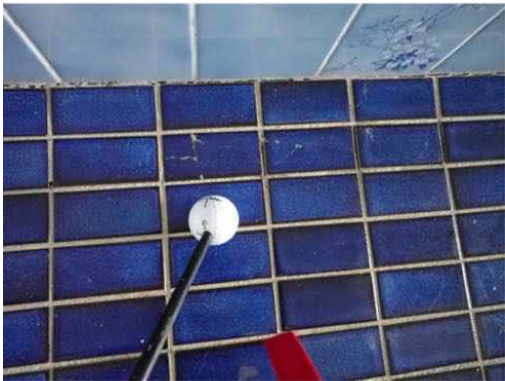
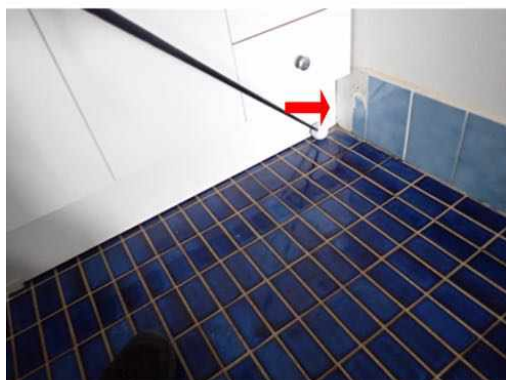
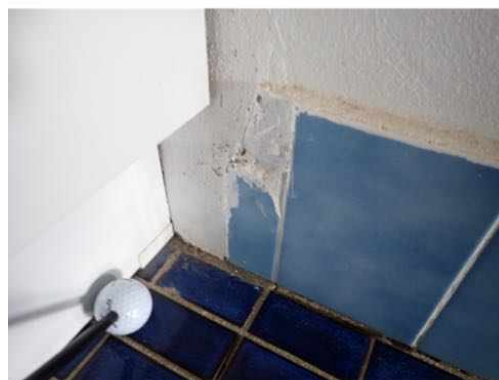
#### Finding 2.01

Building:	Main Building
Location:	Bathroom

Finding: Bathroom Tiles – Damaged and Missing  
Information: Damaged and missing tiles were identified in the bathroom at the time of inspection. In plain English, some tiles are broken or missing, which may allow water to penetrate behind the wall or floor surfaces and cause concealed damage to the underlying materials. A licensed tiler or suitably experienced handyman should assess and repair the tiles to prevent further deterioration. A licensed builder may also need to carry out further invasive investigation to determine the condition of the building materials beneath the tiles and carry out repairs accordingly.

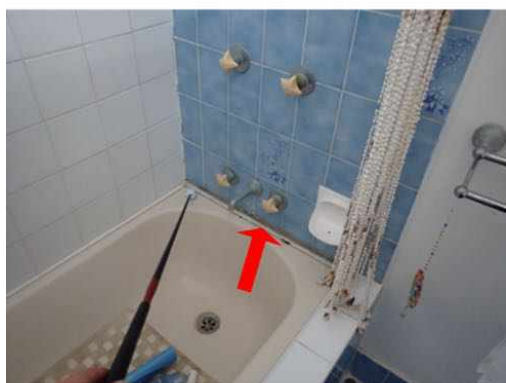
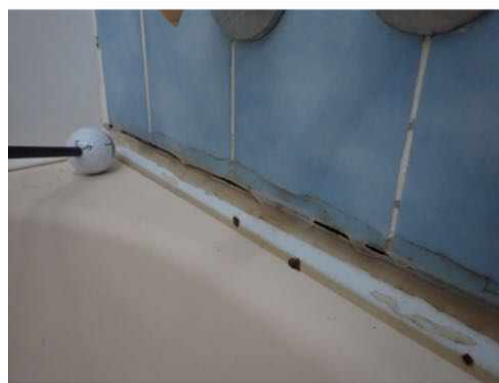
### Finding 2.02

Building:	Main Building
Location:	Bathroom
Finding:	Bath/Shower Area – Deteriorated Silicone
Information:	Deteriorated silicone was identified around the bath tub and shower area at the time of inspection. In plain English, the sealing around the bath and shower has worn out, which may allow water to penetrate behind the fixtures. This may cause damage to associated building materials if left unaddressed. A licensed tiler or suitably experienced handyman should remove and replace the silicone to prevent further deterioration. A licensed builder may also need to carry out further invasive investigation to determine the condition of the building materials beneath the tiles and carry out repairs accordingly.

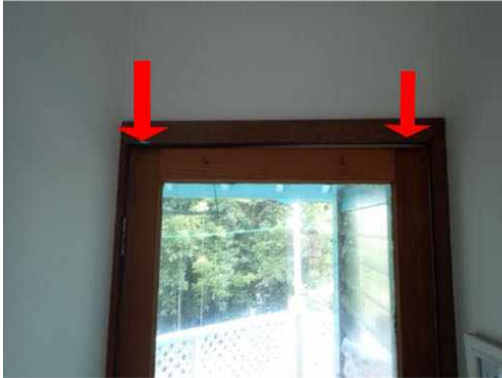
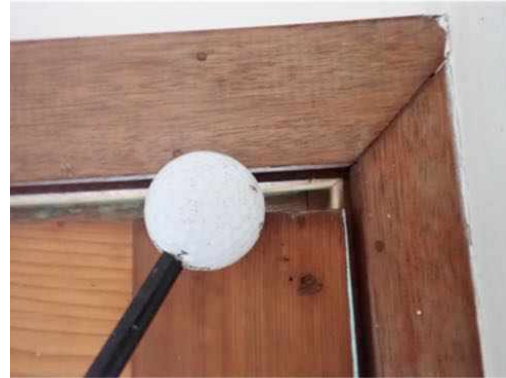
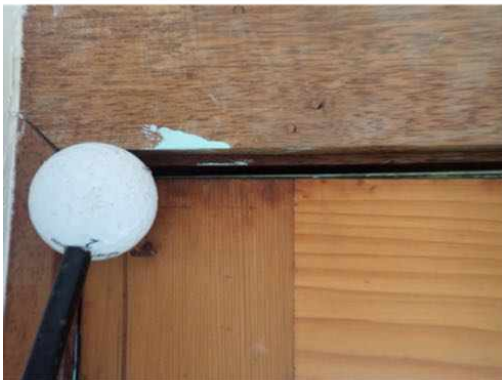
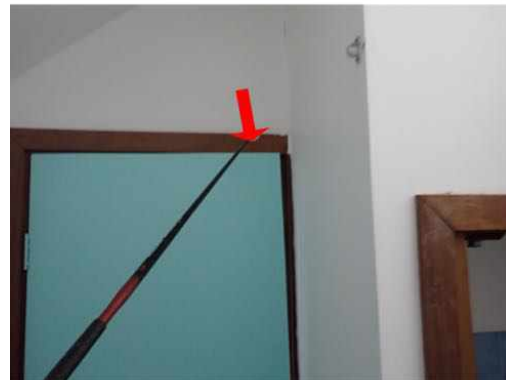
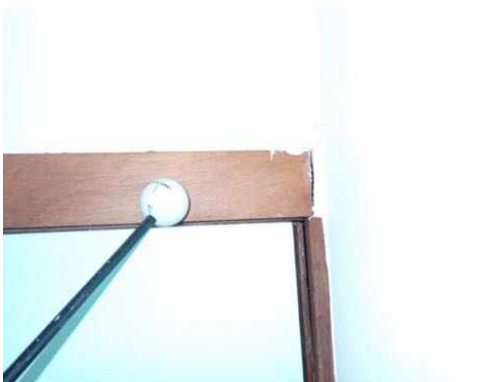
### Finding 3.01

Building:	Main Building
Location:	Entry door
Finding:	Front Entry and Bathroom Doors – Dropped
Information:	The front entry and bathroom doors were observed to have dropped at the time of

inspection. In plain English, the doors appears to have sagged slightly and may rub or catch on the frame during operation. This condition can occur over time due to general wear, hinge movement, or settlement. A carpenter or suitably experienced handyman should assess and adjust or repair the doors as required.

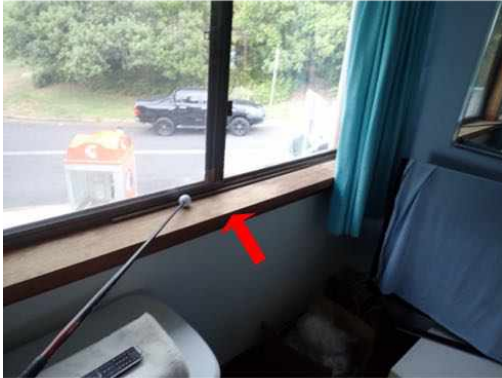
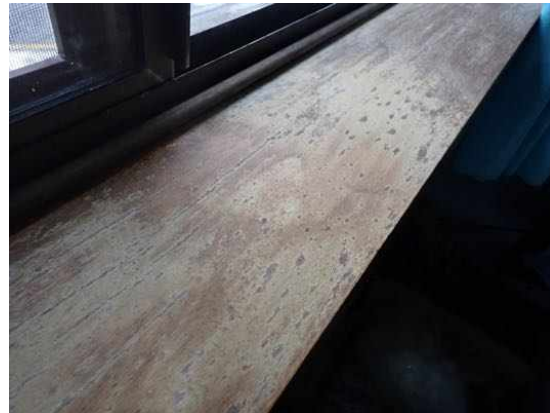
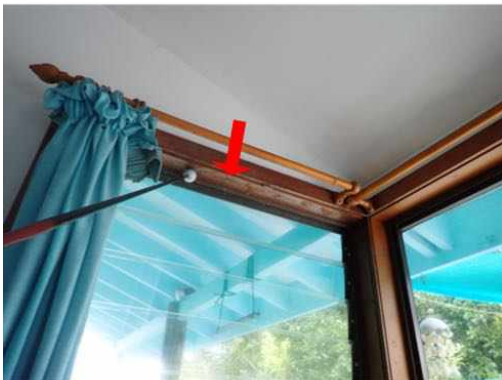
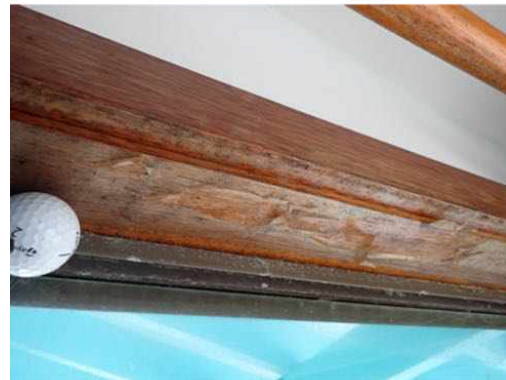
### Finding 3.02

Building:	Main Building
Location:	Windows
Finding:	Timber Window Frames – General Maintenance
Information:	The timber window frames were found to be in need of general maintenance at the time of inspection. In plain English, the timber frames show signs of weathering and

age-related deterioration. Maintenance such as sanding, sealing, and repainting is recommended to prevent further deterioration. A painter, carpenter, or suitably experienced handyman would be the appropriate trade to carry out the maintenance works.

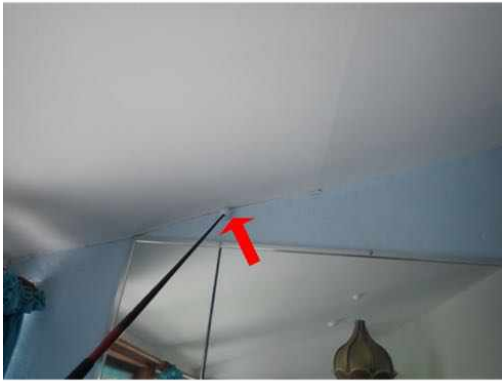
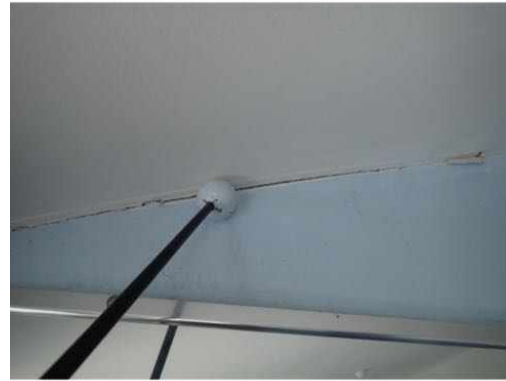
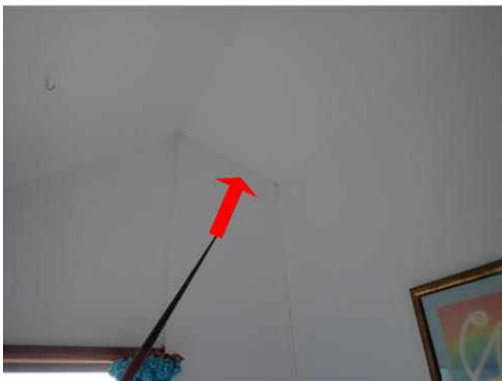
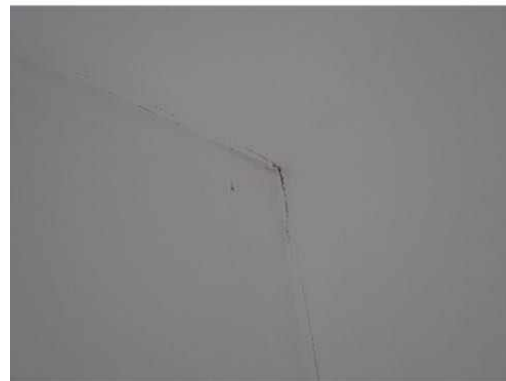
### Finding 3.03

Building:	Main Building
Location:	Ceilings
Finding:	Ceiling/Wall Junctions – Minor Cracks
Information:	Minor cracks were identified to the ceiling and wall cladding junctions at the time of inspection. In plain English, small cracks were noted where the walls meet the ceiling. This is a common defect and can occur due to normal movement and settlement of the building over time. A painter or suitably experienced handyman can repair and make good the affected areas.

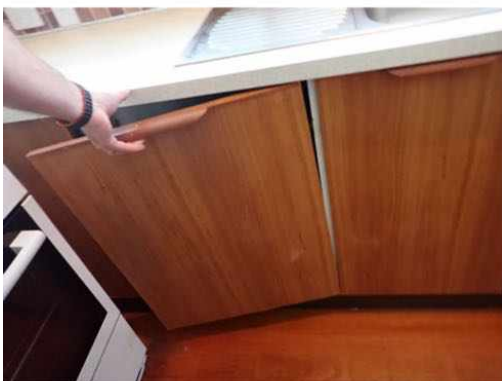
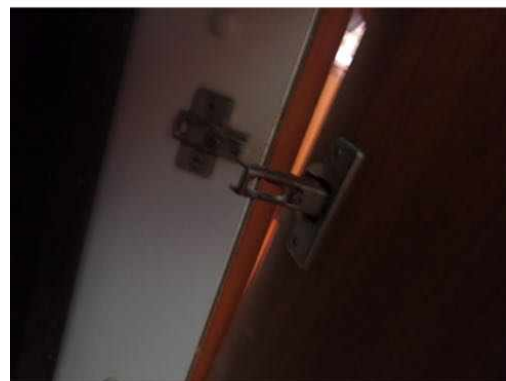
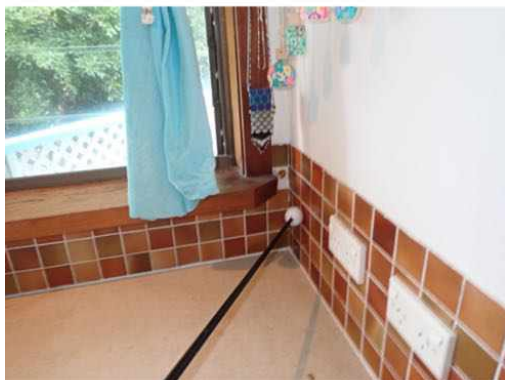
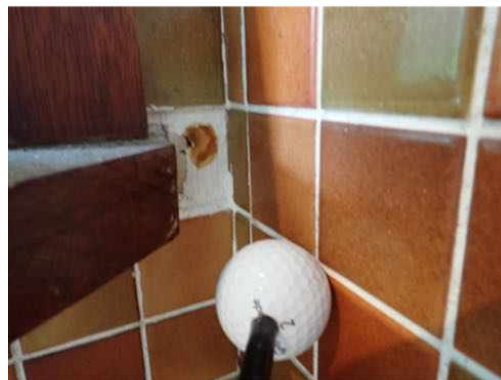
### Finding 3.04

Building: Main Building

Location: Kitchen

Finding: Kitchen – Fair Condition

Information: The kitchen was found to be in fair condition at the time of inspection with age-related wear and tear typical with a property of this age, including a missing tile to the splashback and damaged or deteriorated cabinet hinges. In plain English, the kitchen appears functional but shows general deterioration consistent with normal use over time. A cabinet maker or suitably experienced handyman can carry out maintenance or repairs where required.

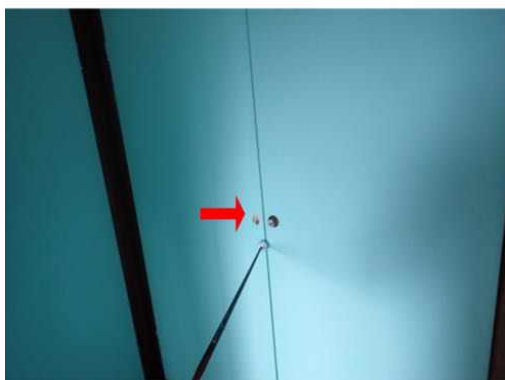
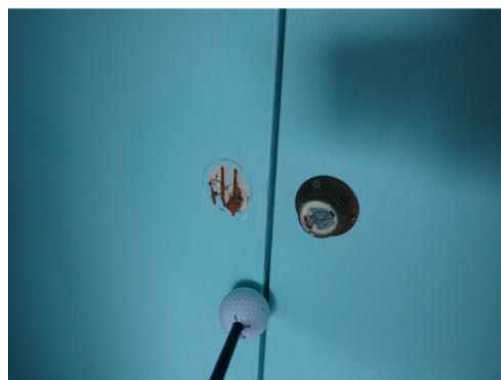
### Finding 3.05

Building:	Main Building
Location:	Bedroom
Finding:	Bedroom Robe – Missing Door Handles
Information:	Missing door handles were identified to the bedroom robe doors at the time of inspection. A cabinet maker or suitably experienced handyman can install replacement handles.

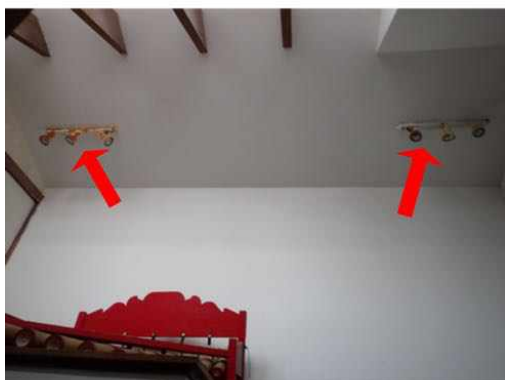
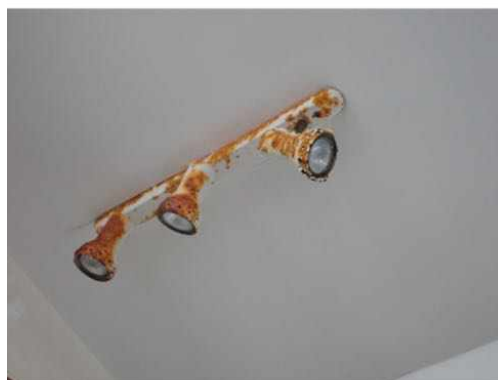
### Finding 3.06

Building:	Main Building
Location:	Bathroom
Finding:	Bathroom Light Fitting – Rust
Information:	Rust was identified to the bathroom light fitting at the time of inspection. In plain English, the light fitting shows signs of corrosion which can occur in wet areas over time due to moisture exposure. A licensed electrician should assess and replace the fitting if required.

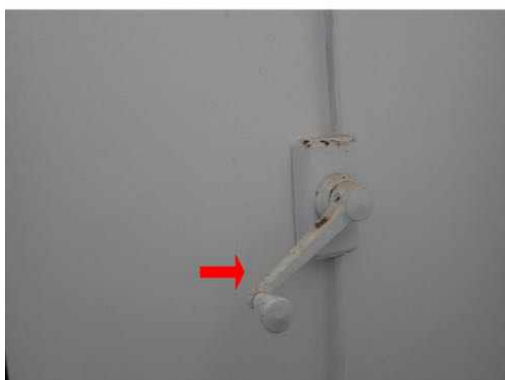
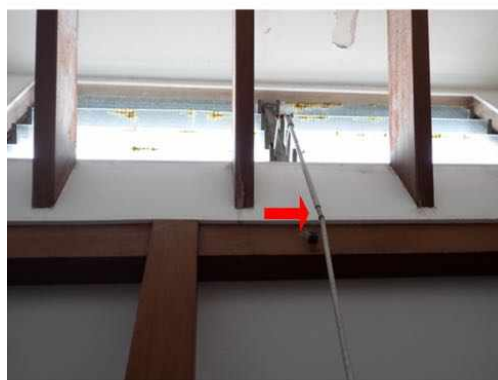
### Finding 3.07

Building:	Main Building
Location:	Bathroom
Finding:	Bathroom Window – Louvre Winder Not Working
Information:	The louvre winder to the bathroom window was not working at the time of inspection. In plain English, the mechanism used to open and close the louvre window is not operating correctly. A carpenter, window specialist, or suitably experienced handyman should assess and repair or replace the winder mechanism.

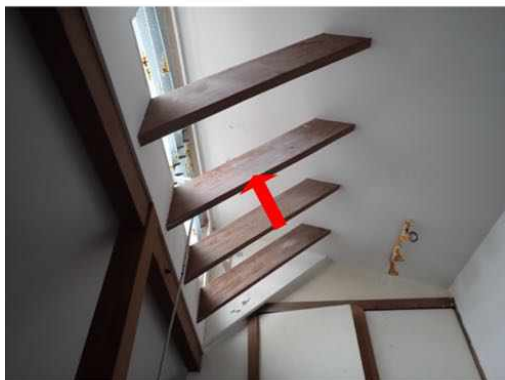
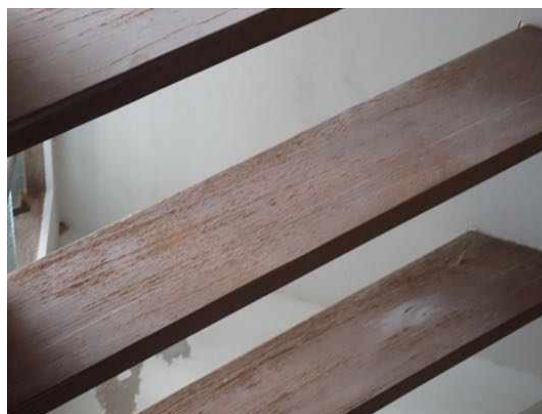
### Finding 3.08

Building:	Main Building
Location:	Bathroom
Finding:	Bathroom Feature Timber – General Maintenance
Information:	The feature timber in the bathroom near the window was found to be in need of general maintenance at the time of inspection. In plain English, the timber shows signs of wear and moisture exposure consistent with a wet area. Maintenance such as cleaning, sealing, or refinishing is recommended to prevent further deterioration. A painter or suitably experienced handyman would be the appropriate trade to carry out the maintenance works.

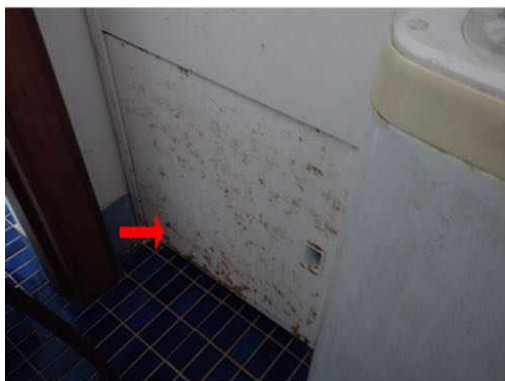
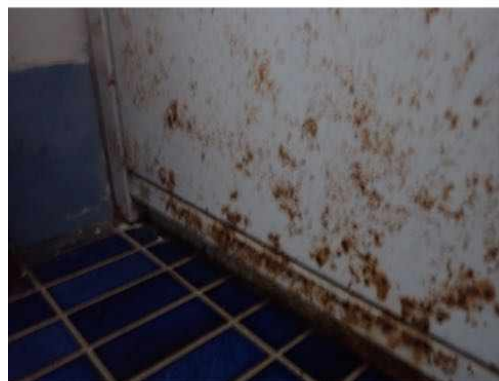
### Finding 3.09

Building:	Main Building
Location:	laundry cupboard
Finding:	Laundry Tub Cupboard – Rust
Information:	Rust was identified to the laundry tub cupboard at the time of inspection. In plain English, the cupboard shows signs of corrosion, likely due to moisture exposure in the laundry area. A cabinet maker, licensed plumber, or suitably experienced handyman can assess and repair or replace the affected cabinet as required.

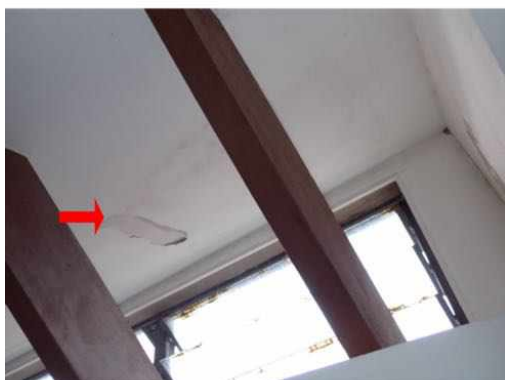
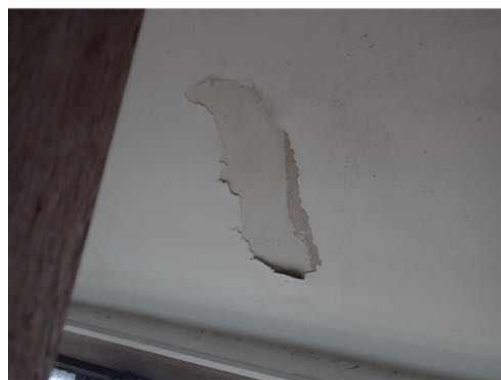
### Finding 3.10

Building:	Main Building
Location:	Bathroom
Finding:	Bathroom Ceiling – Paint Deterioration
Information:	Paint deterioration was identified to the bathroom ceiling at the time of inspection. In plain English, the paint finish to the ceiling shows signs of wear which is common in wet areas due to humidity over time. No elevated moisture readings were identified at the time of inspection. A painter or suitably experienced handyman can prepare and repaint the affected area. Ad deemed necessary.

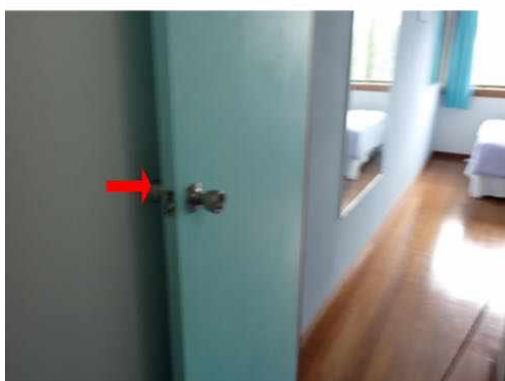
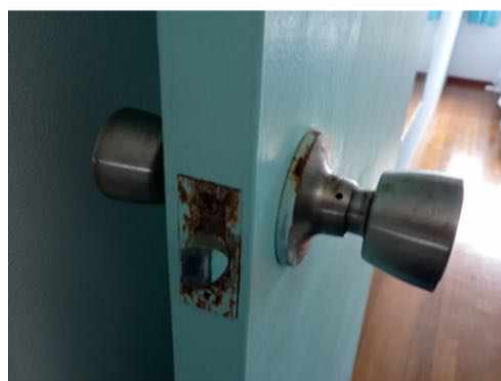
### Finding 3.11

Building:	Main Building
Location:	Bathroom
Finding:	Bathroom Door Hardware – Rust
Information:	Rust was identified to the bathroom door hardware at the time of inspection, although it was found to be in fair working order. In plain English, the door fittings show signs of corrosion which is common in wet areas over time due to moisture exposure. A carpenter or suitably experienced handyman can replace the hardware if deterioration continues.

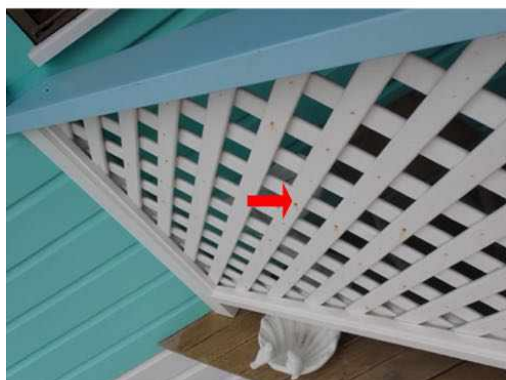
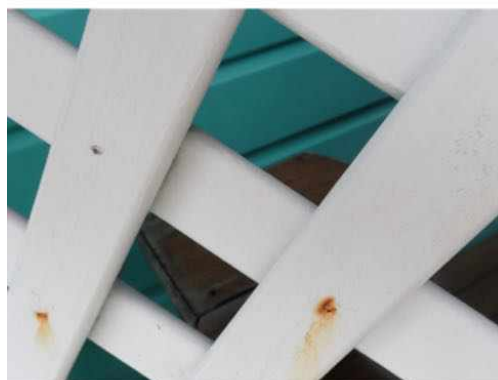
### Finding 3.12

Building:	Main Building
Location:	Decked area
Finding:	Deck Balustrade – Rusted Lattice Nails
Information:	Rust was identified to the nails fixing the timber lattice to the deck balustrade at the time of inspection. In plain English, the nails securing the lattice have started to corrode due to weather exposure over time. A carpenter or suitably experienced handyman can replace the affected fixings and carry out maintenance to prevent further deterioration.

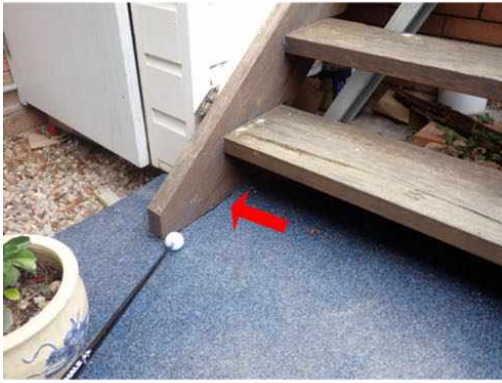
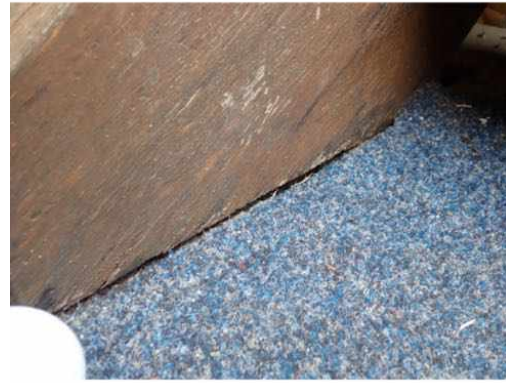
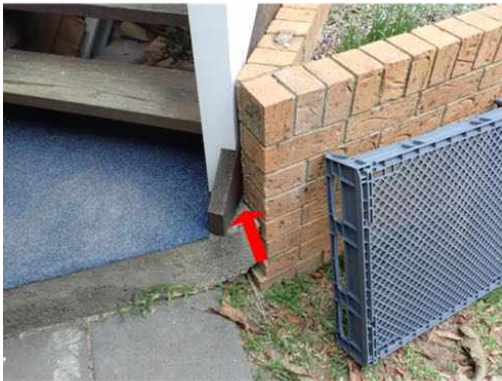
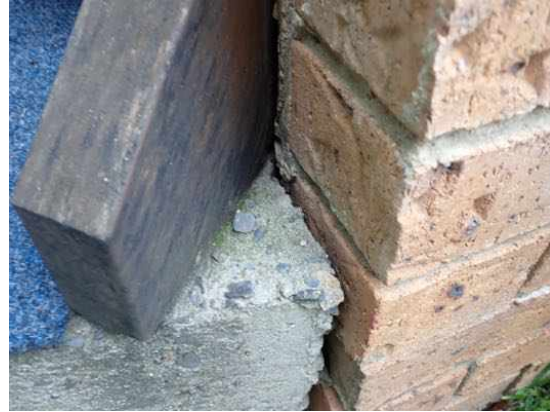
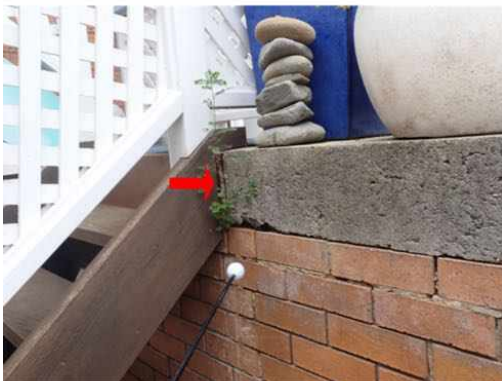
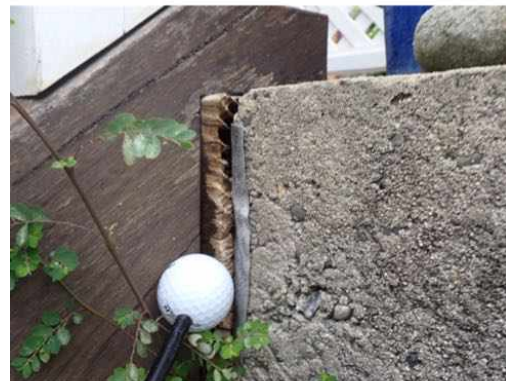
### Finding 6.01

Building:	Main Building
Location:	Entry stairs
Finding:	Timber Stairs in Contact With Ground / Masonry – Possible Termite Entry Point
Information:	Timber components of the entry stairs were observed to be in direct contact with, or in very close proximity to, the ground and connected brickwork/concrete elements. This condition can allow concealed termite entry and is considered conducive to timber pest attack. Direct timber-to-ground or timber-to-masonry contact may also accelerate timber deterioration through moisture transfer. A licensed builder or pest control specialist should assess the area and carry out rectification works if required, which may include separating the timber from the ground or masonry, installing appropriate barriers, and repairing or replacing affected components. A termite management plan should also be considered to reduce the risk of future termite activity.

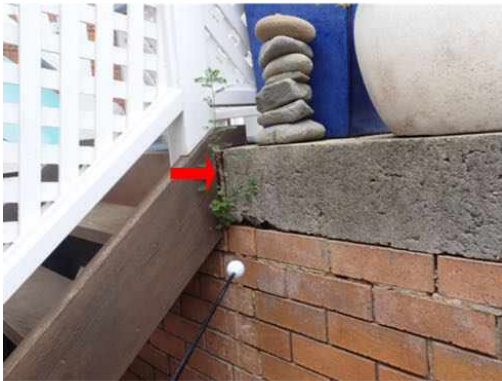
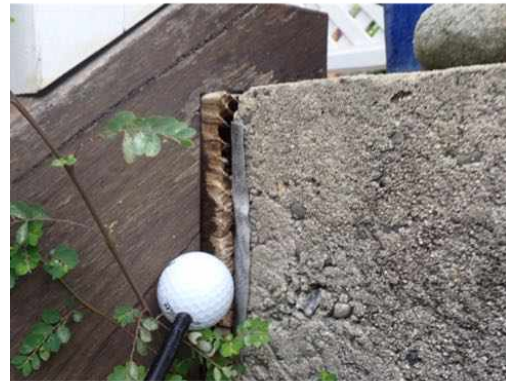
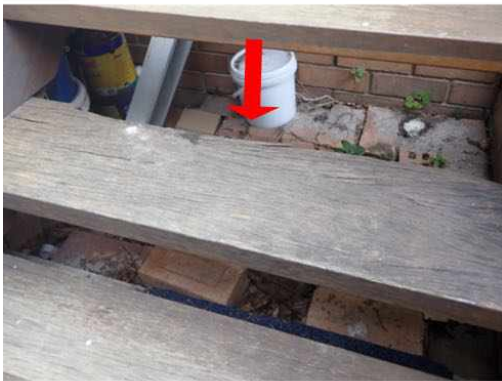
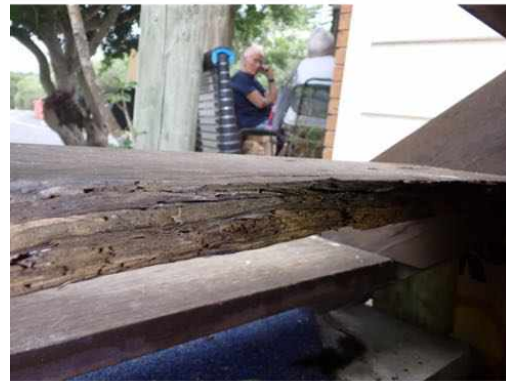
### Finding 7.01

Building:	Main Building
Location:	Entry stairs
Finding:	Wood Rot to Entry Timber Stairs
Information:	Wood rot was identified to the timber components of the entry stairs at the time of inspection. Deterioration of the timber may reduce the structural integrity and durability of the stair components and may worsen if left unaddressed. This condition is commonly associated with prolonged exposure to moisture and weathering. Repairs

or replacement of the affected timber components should be carried out by a licensed builder or qualified carpenter. Early repair is recommended to prevent further deterioration and potential safety issues.

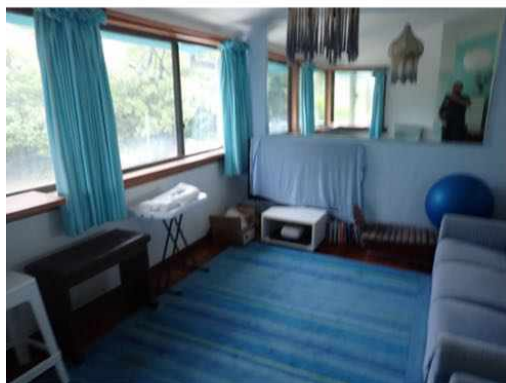
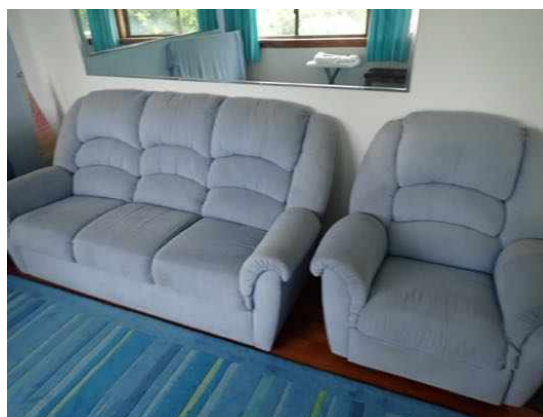
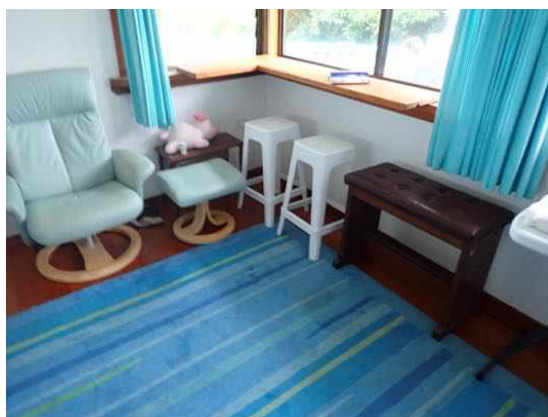
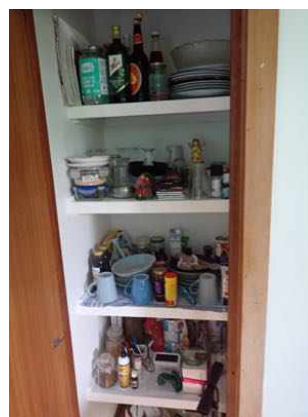
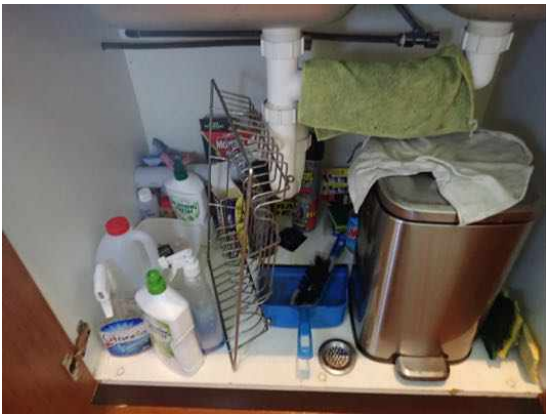
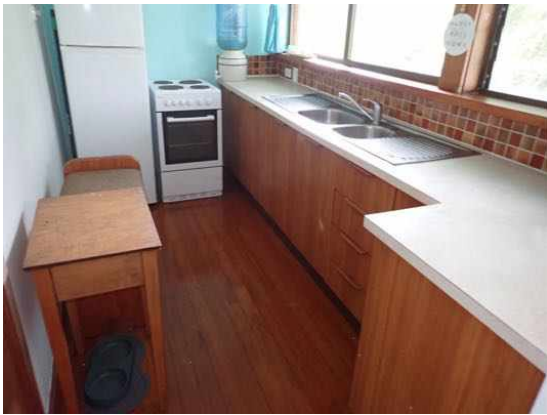
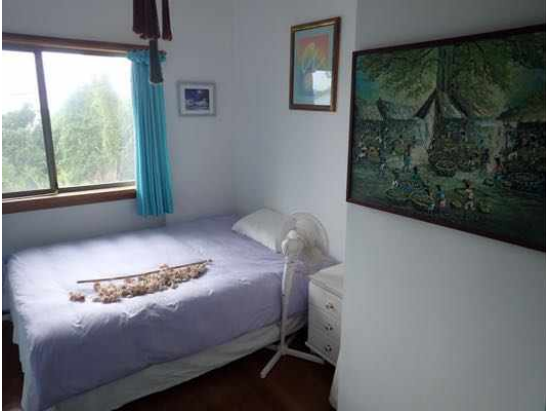
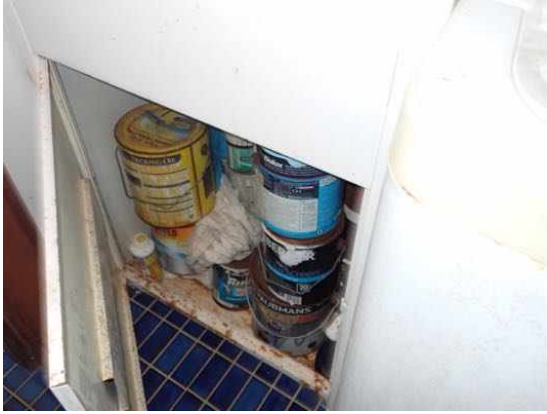
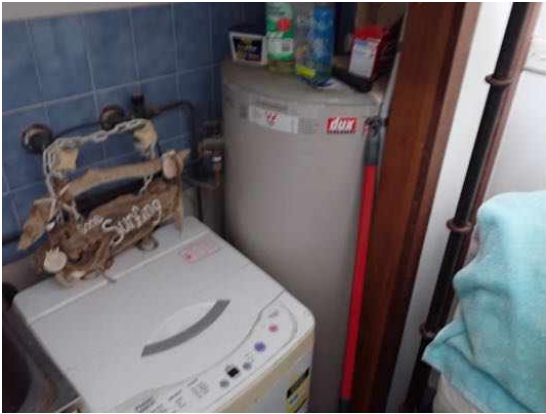
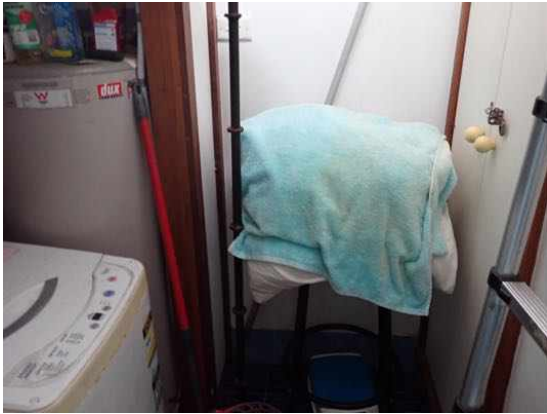
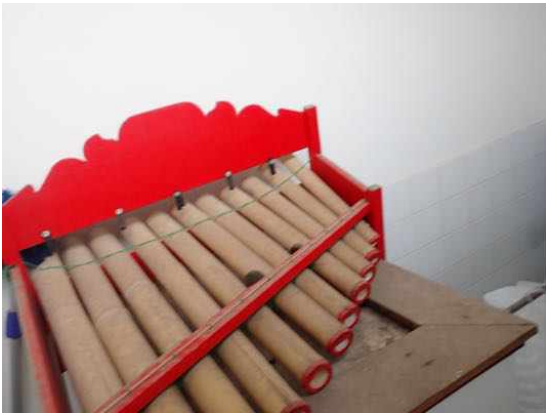
### Noted Item

Building: Main Building  
Location: All Areas  
Finding: Additional Photos - Obstructions and Limitations  
Information: These photographs are an indication of the obstructions and limitations which impeded full inspection of the area at the time of inspection. These obstructions can hide an array of defects and should be removed to allow full inspection to be carried out. A re-inspection is recommended once the areas are made accessible.
