Building and Timber Pest Inspection Report

Inspection Date: Fri, 27 Mar 2026

Property Address: 189 Church St, Glen Innes NSW 2370,
Australia

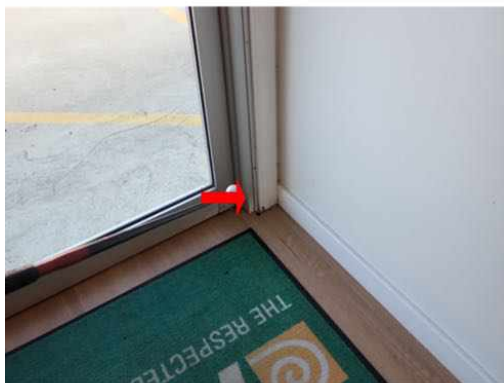
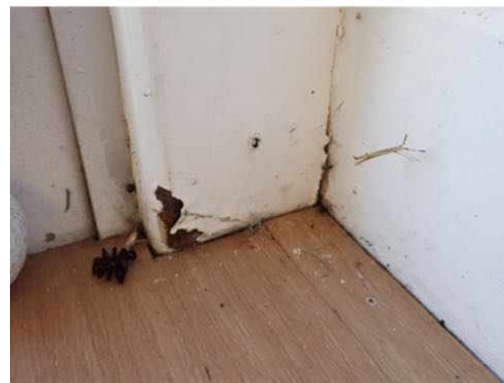
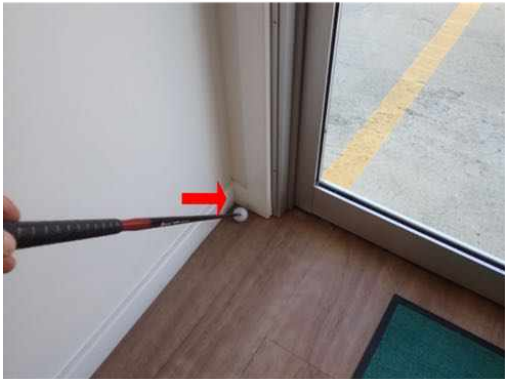
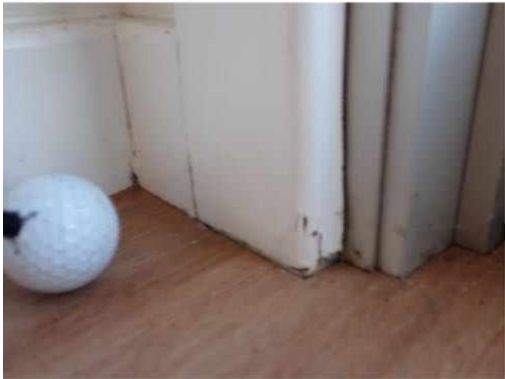
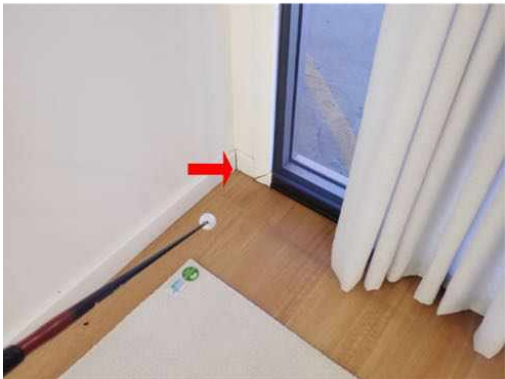
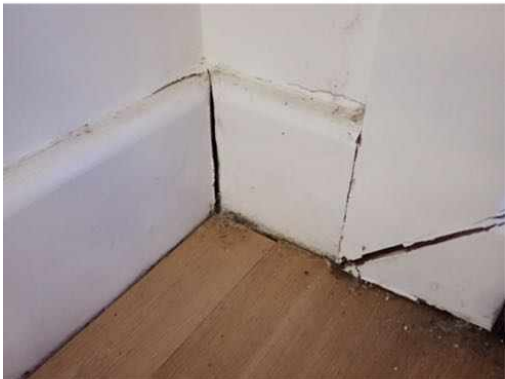
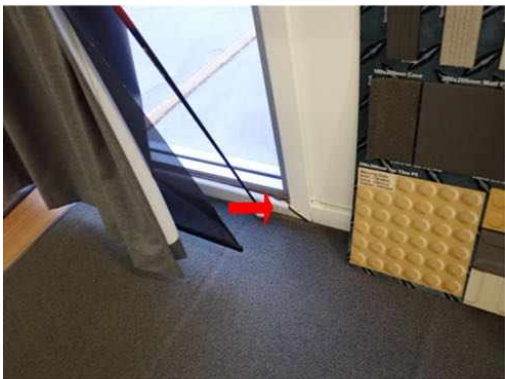
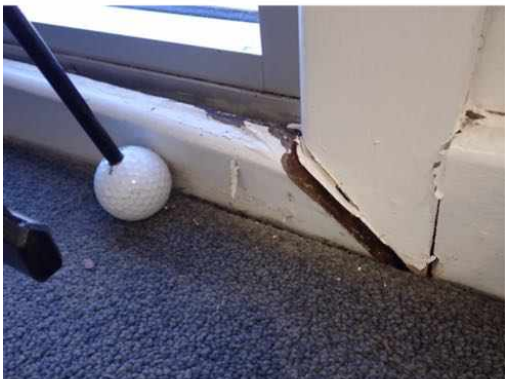
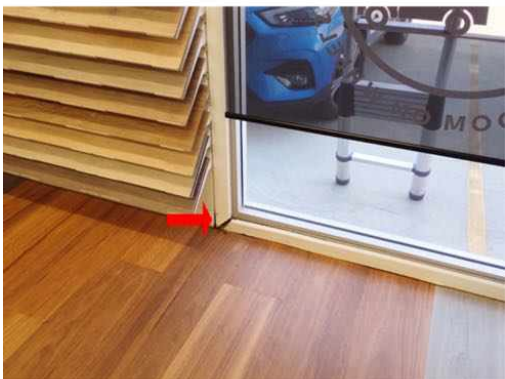
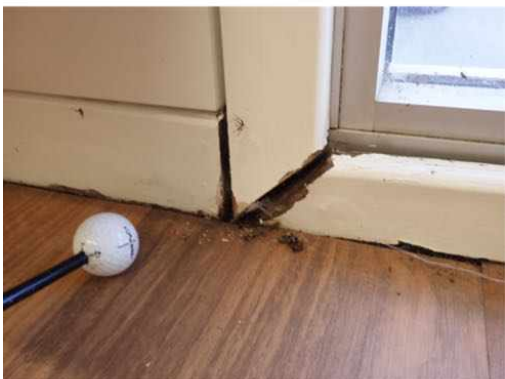
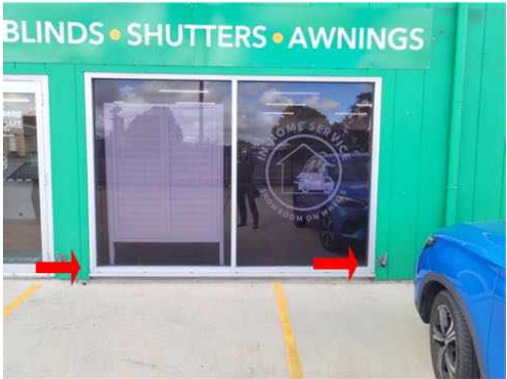
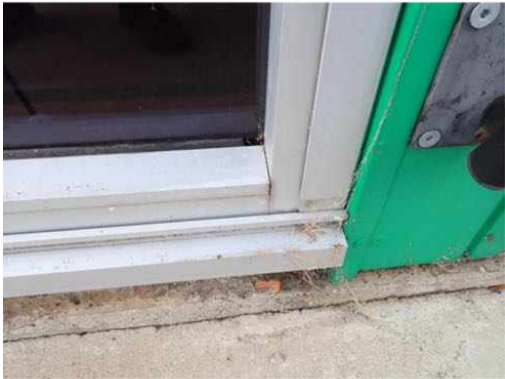
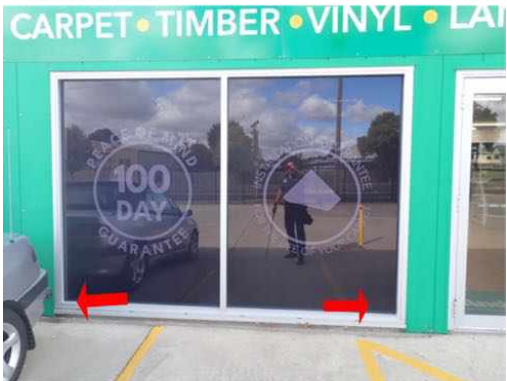
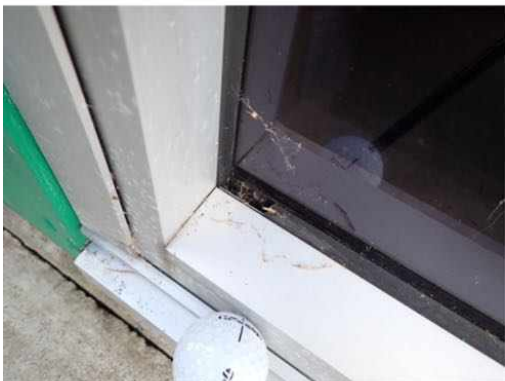
Finding 2.01

Building:	Main Building
Location:	Front wall windows and entry show room door
Finding:	Water Damage To MDF Skirtings And Architraves At Showroom Windows And Entry Door
Information:	Water damage was identified to the MDF skirtings and the bottoms of the architraves at the two showroom windows and the entry door, likely due to moisture ingress from the aluminium window and door frames or beneath the frames. A water test is recommended to confirm the source. If left unaddressed, continued moisture exposure may lead to further deterioration and conditions conducive to mould growth and timber decay. Repairs should be carried out by a licensed builder and/or window installer, including rectification of the moisture source and replacement of affected materials. Works should be undertaken as soon as practicable, with further investigation and repairs at the owner's discretion.

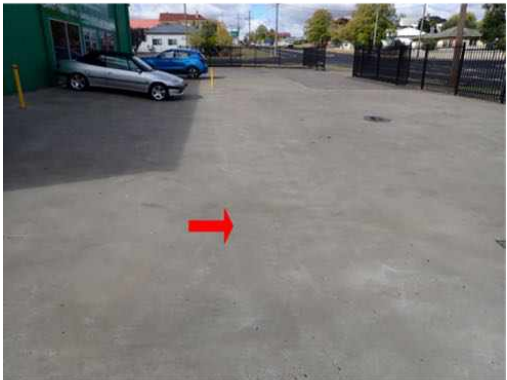
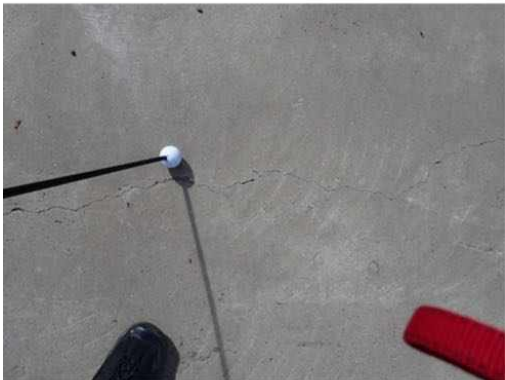
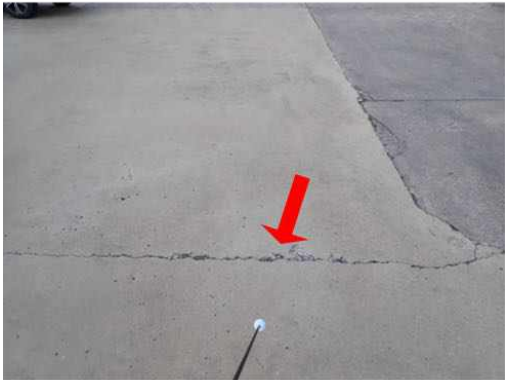
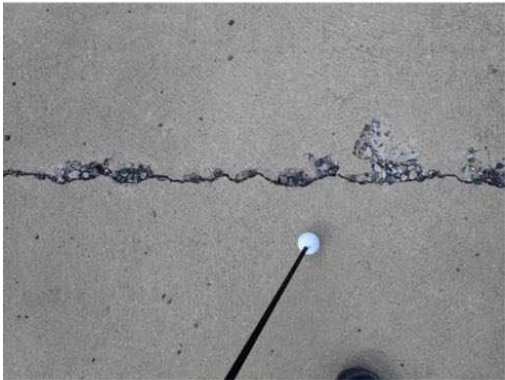
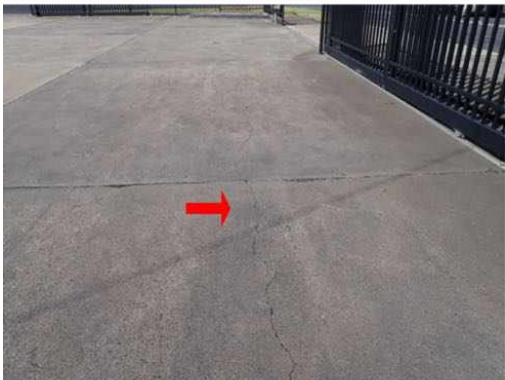
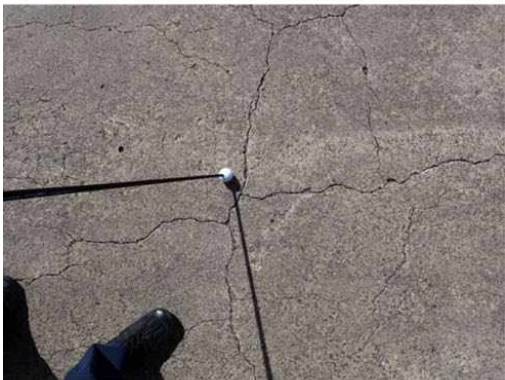
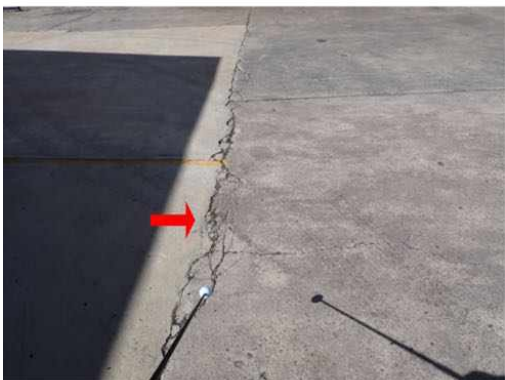
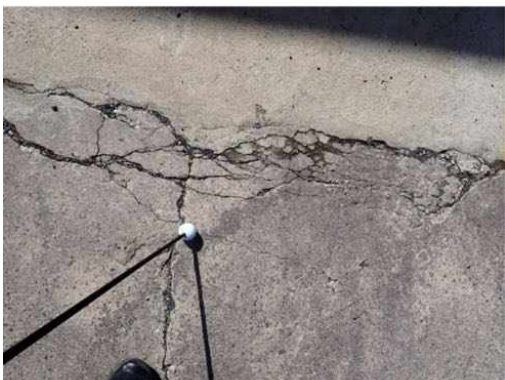
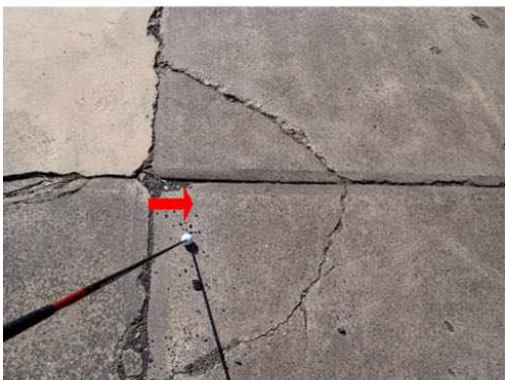
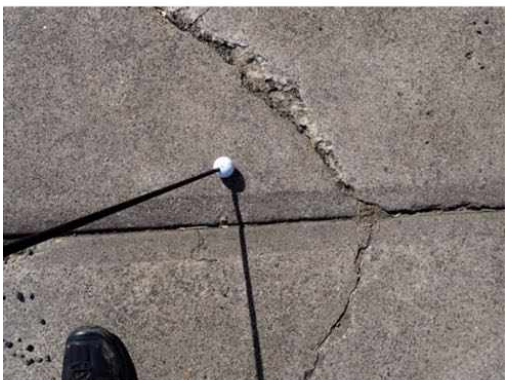
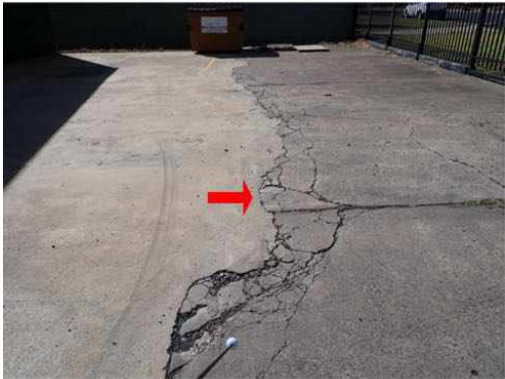
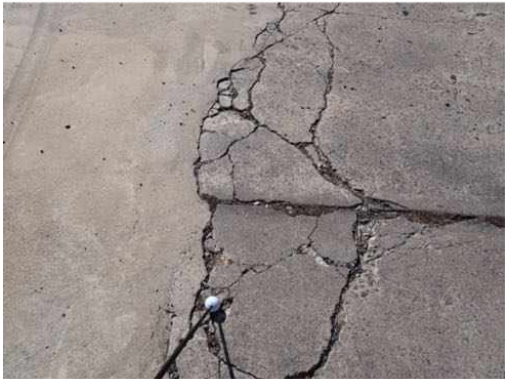
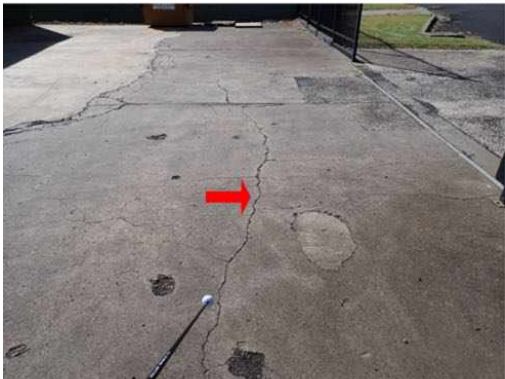
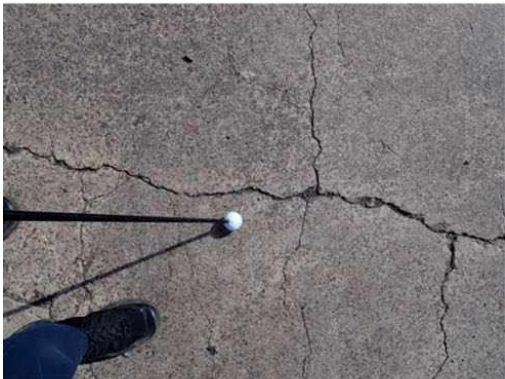
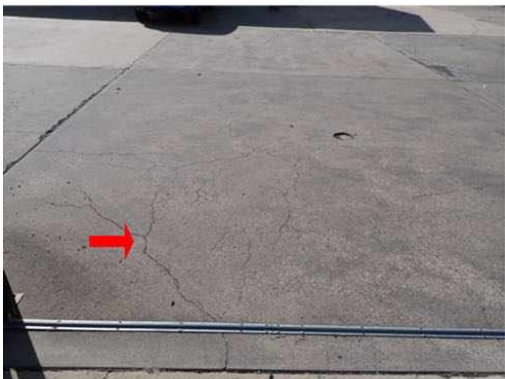
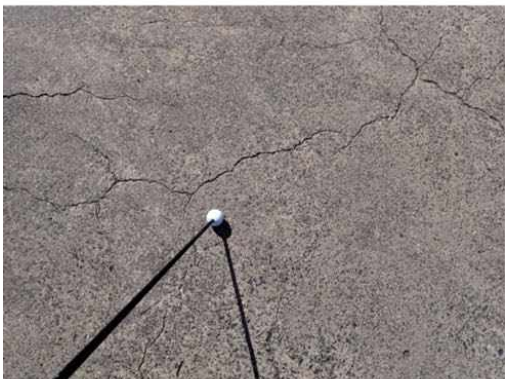
Finding 2.02

Building: Not Applicable
 Location: Concreted carpark area
 Finding: Major And Minor Cracks To Concrete Car Park
 Information: Major and minor cracking was identified to the concrete car park, with the majority of the larger cracks located at the southern end of the car park. The cracking is likely due to ground movement, settlement, age-related deterioration, or poor installation. If left unaddressed, further deterioration and potential trip hazards may develop. Repairs should be carried out by a suitably qualified concreter, including assessment, sealing, and repair of affected areas as required. Works should be undertaken when practical, with repairs at the owner’s discretion.

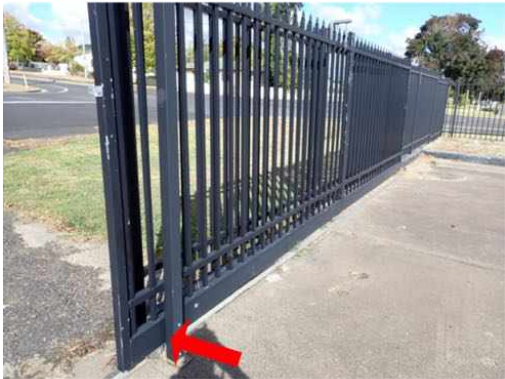
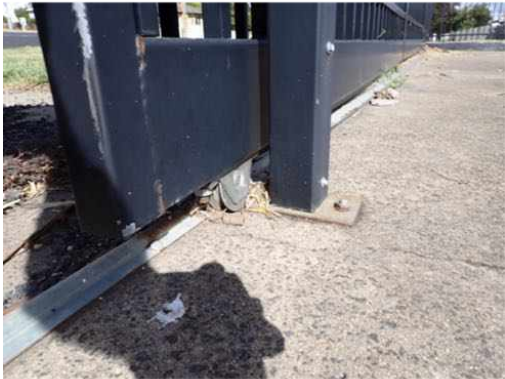
Finding 2.03

Building: Not Applicable
Location: Southern gate
Finding: Southern Roller Gate Not Operational
Information: The southern roller gate was not operational at the time of inspection, likely due to mechanical failure, wear and tear, or poor maintenance. If left unaddressed, the issue may impact security and functionality. Repairs should be carried out by a suitably qualified technician or door specialist, including inspection, repair, or replacement of faulty components as required. Works should be undertaken as soon as practicable, with repairs at the owner’s discretion.

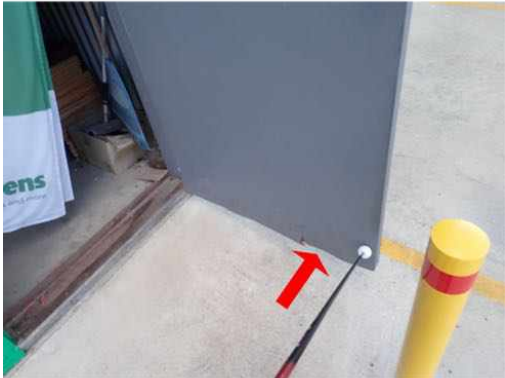
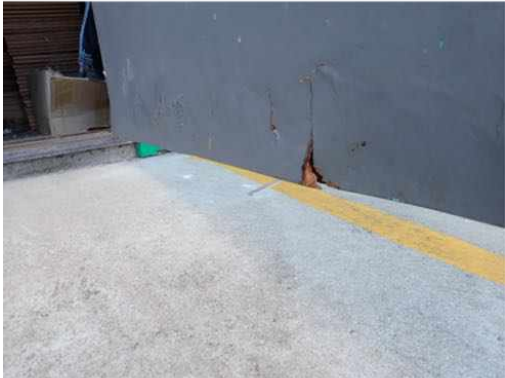
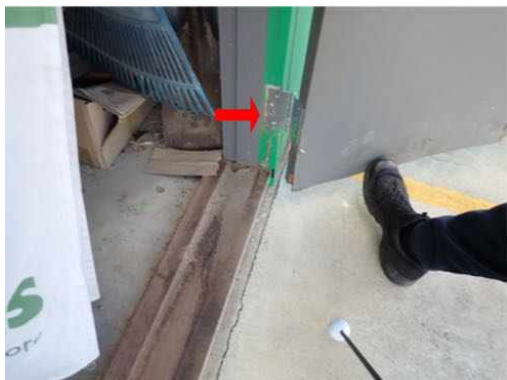
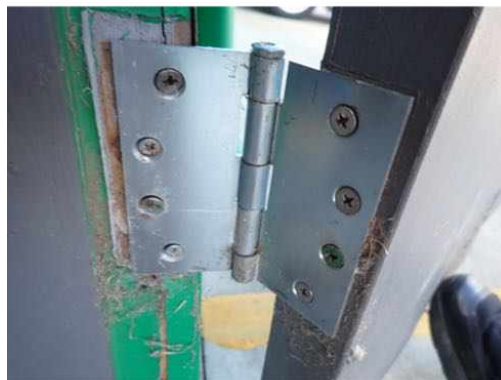
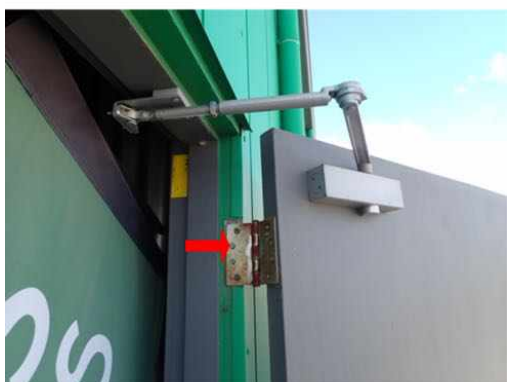
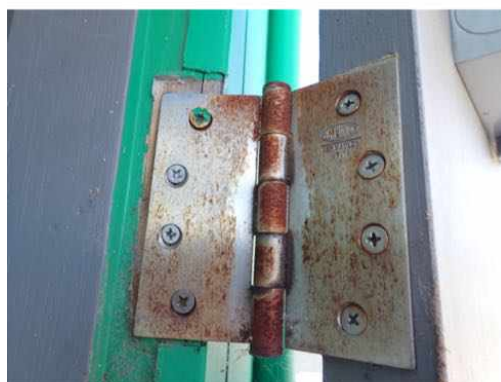
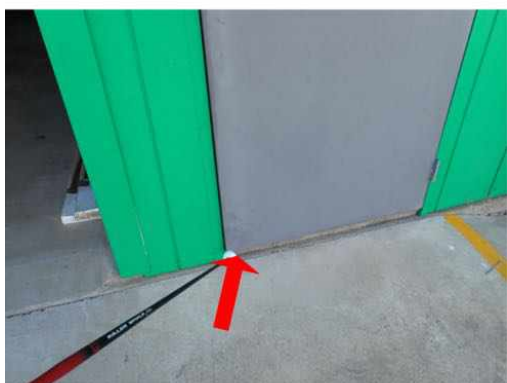
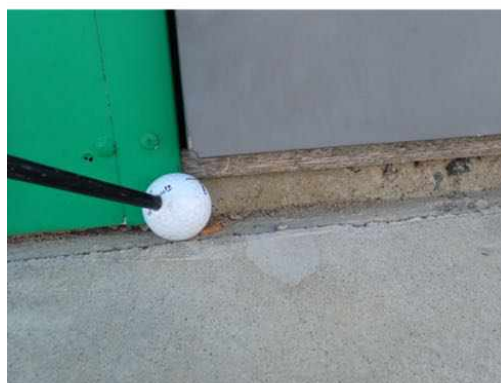
Finding 3.01

Building: Main Building
Location: Door next to roller door
Finding: Entry Door Adjacent To Roller Door In Poor Condition
Information: The door adjacent to the roller door was in poor condition, with water damage identified to the bottom of the door, poorly installed or deteriorated hinges, and the door catching on the threshold. The condition is likely due to moisture ingress and general wear or poor installation. If left unaddressed, further deterioration and operational issues may occur. Repairs should be carried out by a licensed builder or carpenter, including rectification of the moisture source, repair or replacement of the door and hardware, and adjustment to ensure proper operation. Works should be undertaken as soon as practicable, with repairs at the owner’s discretion.

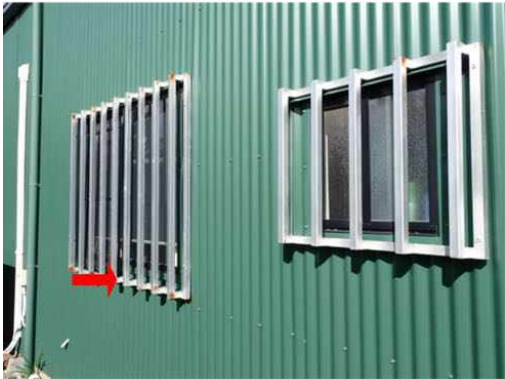
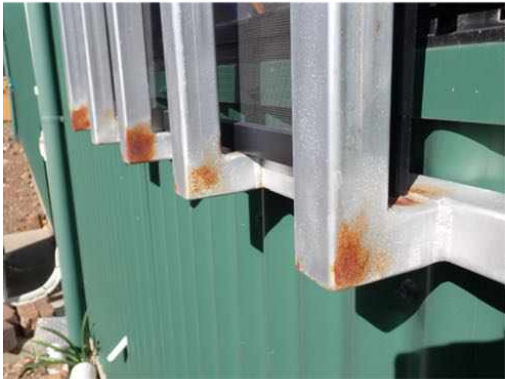
Finding 3.02

Building:	Main Building
Location:	Rear elevation
Finding:	Surface Rust To Rear Window Security Screens
Information:	Surface rust was identified to the rear window security screens, likely due to exposure to moisture and environmental conditions. If left unaddressed, the corrosion may progress and impact the longevity and appearance of the screens. Repairs should be carried out by a suitably qualified tradesperson, including cleaning, treatment, and repainting or replacement as required. Works should be undertaken when practical, with repairs at the owner's discretion.

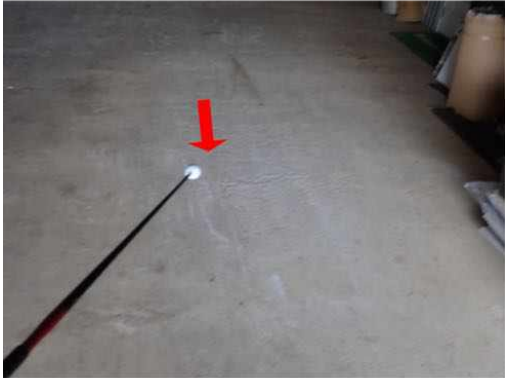
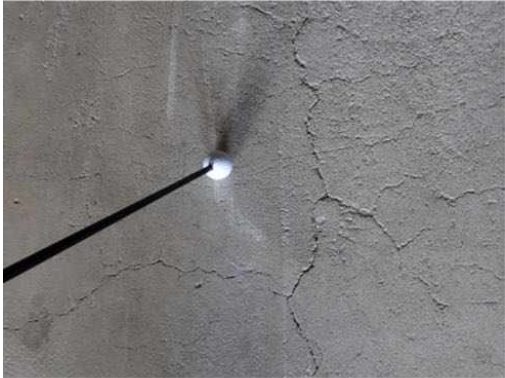
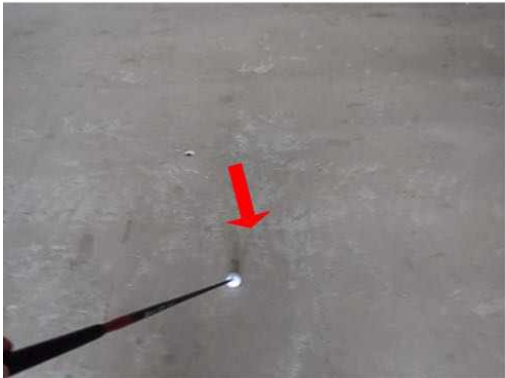
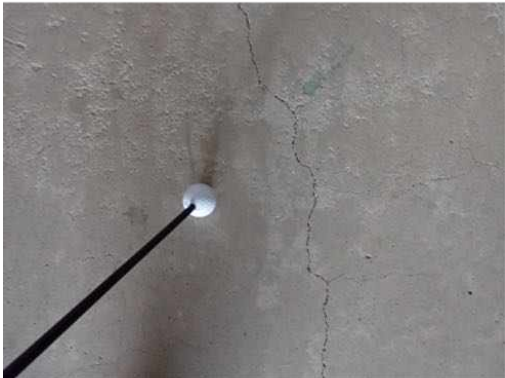
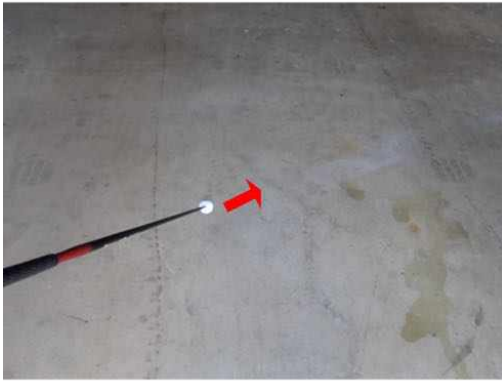
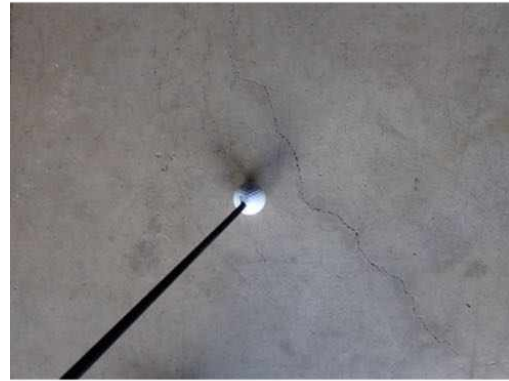
Finding 3.03

Building: Main Building
Location: Concreted carpark area
Finding: Minor Cracks To Warehouse Concrete Slab
Information: Minor cracking was identified to the warehouse concrete slab, likely due to normal shrinkage, settlement, or age-related movement. While common, continued movement or moisture ingress may lead to further deterioration over time. Repairs should be carried out by a suitably qualified concreter if required, including monitoring and sealing as necessary. Works can be undertaken when practical, with repairs at the owner’s discretion.

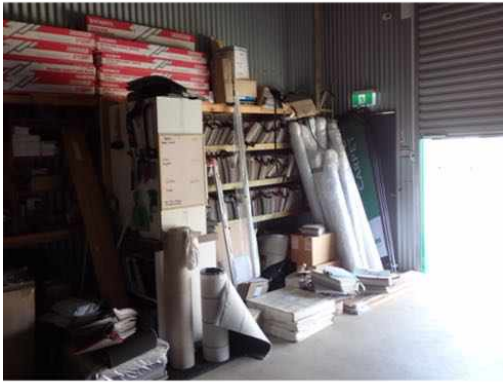
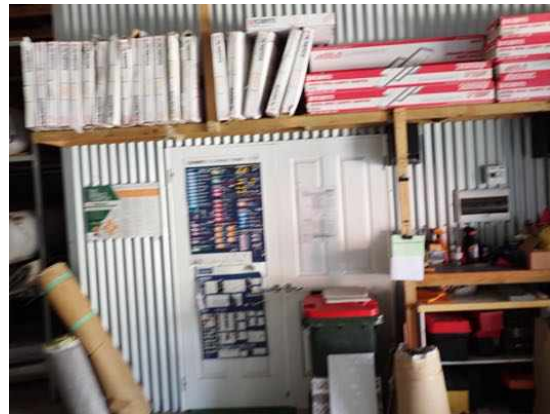
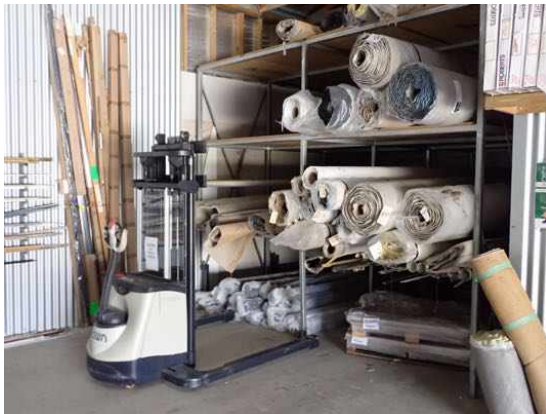
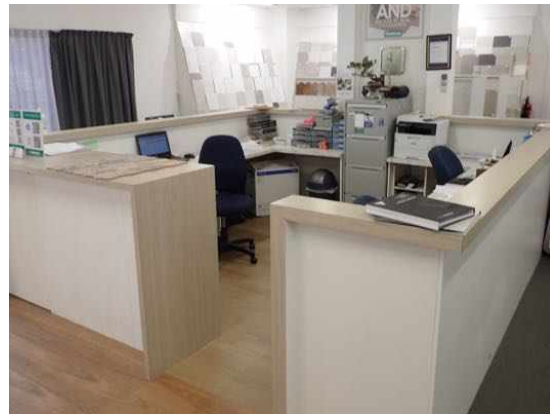
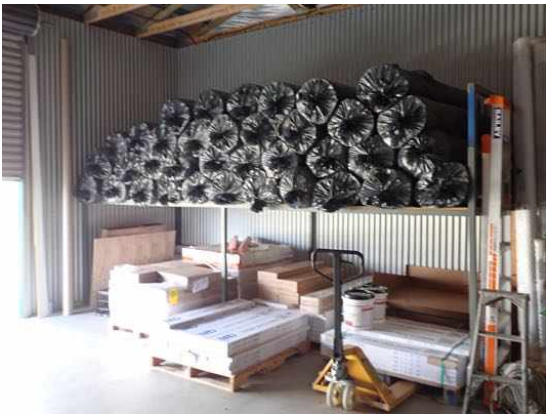
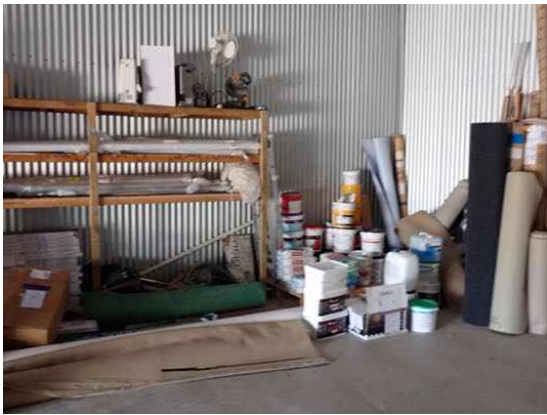
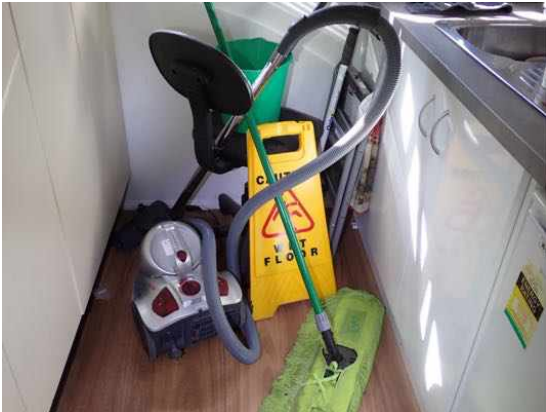
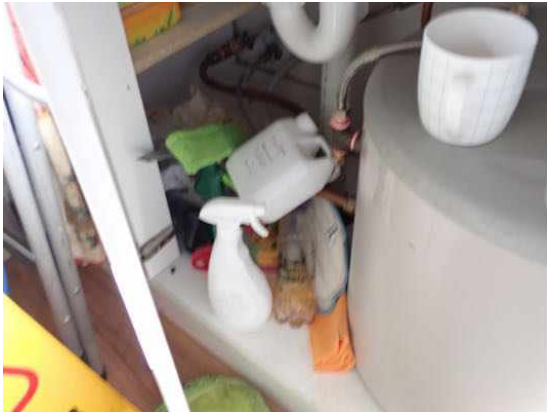
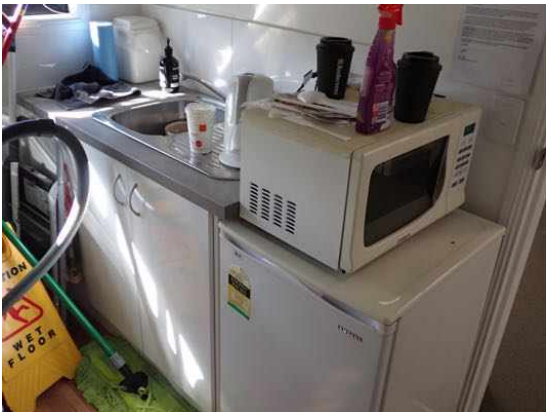
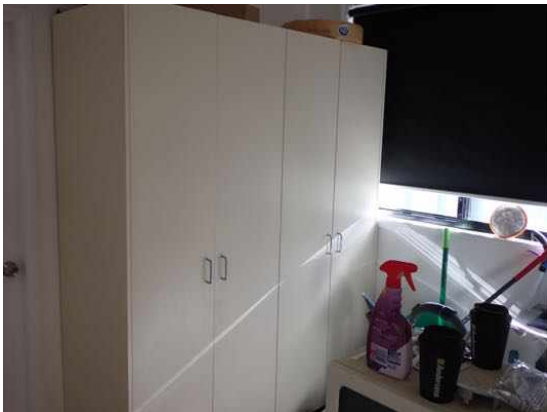
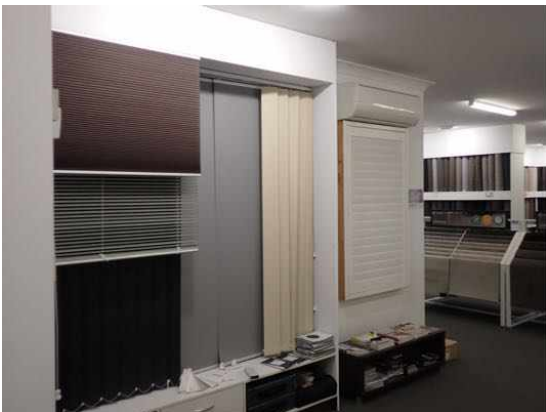
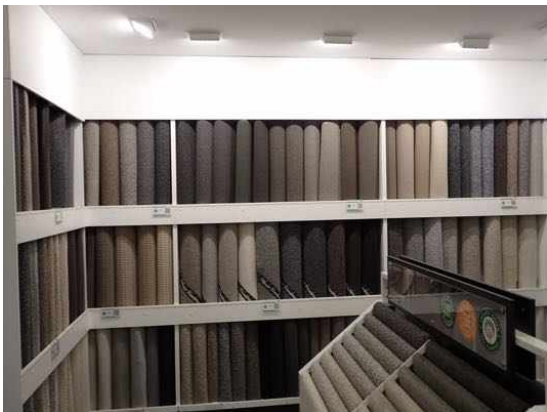
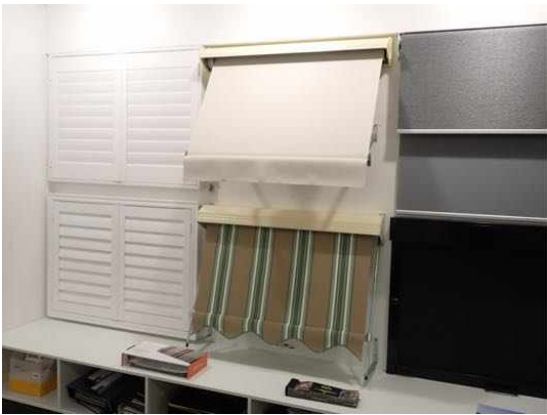
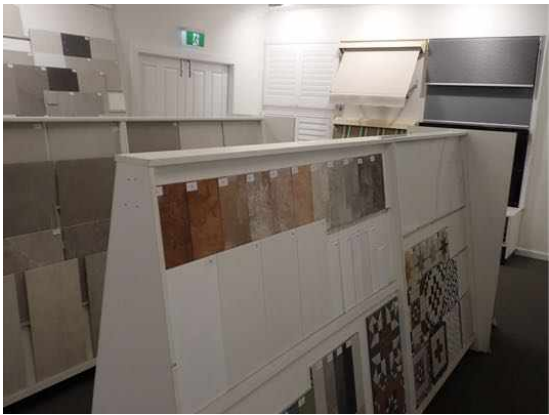
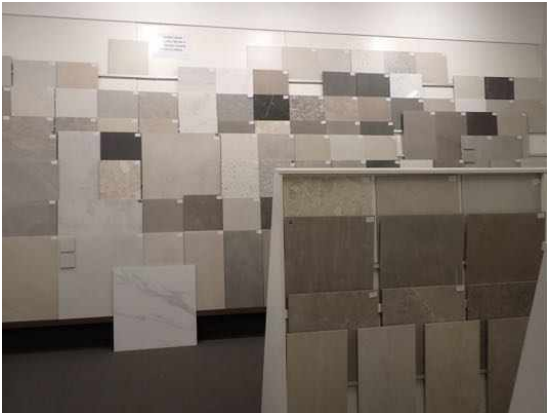
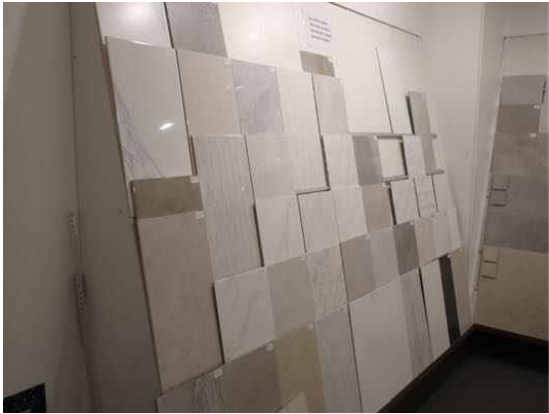
Noted Item

Building: Main Building
Location: All Areas
Finding: Additional Photos - Obstructions and Limitations
Information: These photographs are an indication of the obstructions and limitations which impeded full inspection of the area at the time of inspection. These obstructions can hide an array of defects and should be removed to allow full inspection to be carried out. A re-inspection is recommended once the areas are made accessible.
