# Building and Timber Pest Inspection Report

Inspection Date: Tue, 3 Mar 2026

Property Address: 9 Brown St, Willaston SA 5118, Australia

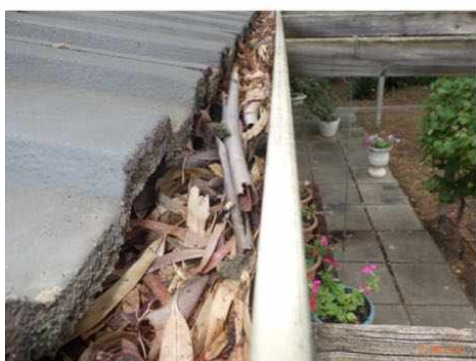
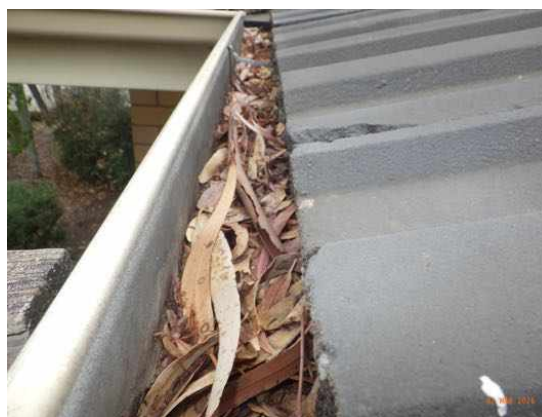
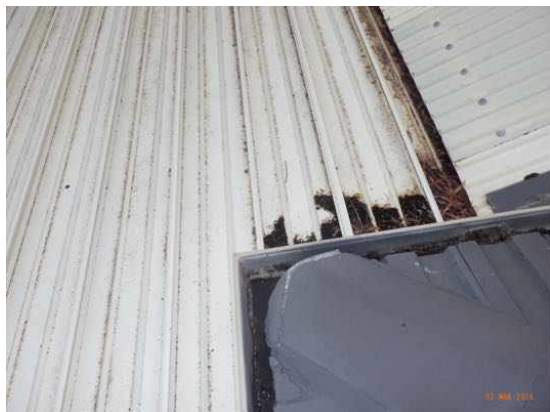
#### Finding 2.01

Blocked gutters are likely to lead to high levels of moisture in the affected areas. Such moisture will not only cause rust and decay of the associated building materials, but can also provide conditions that are conducive to termite and timber pest activity. Blockages in gutters should therefore be removed immediately to ensure dry conditions are maintained.

Consult a Licensed Plumber for further specific advice on remedial works that may be required. In the interim, it is highly advised that blocked gutters be removed by the homeowner or a general handyperson as a matter of urgency.

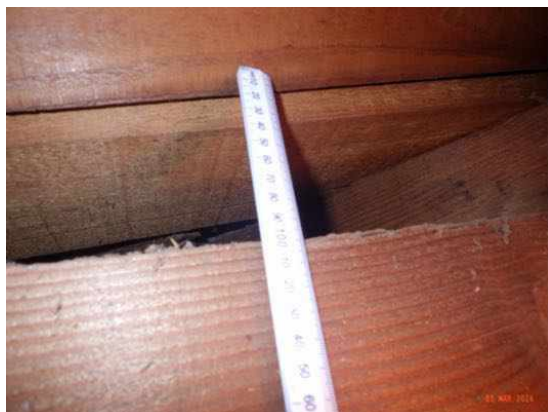
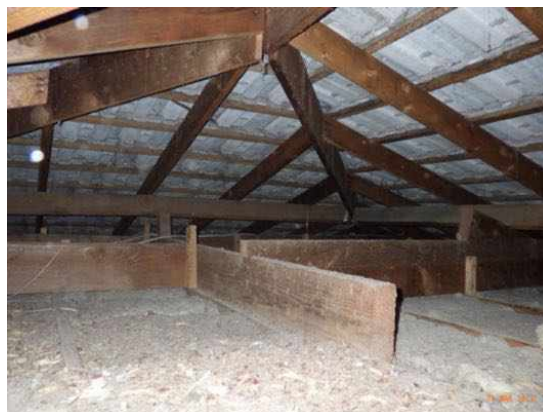
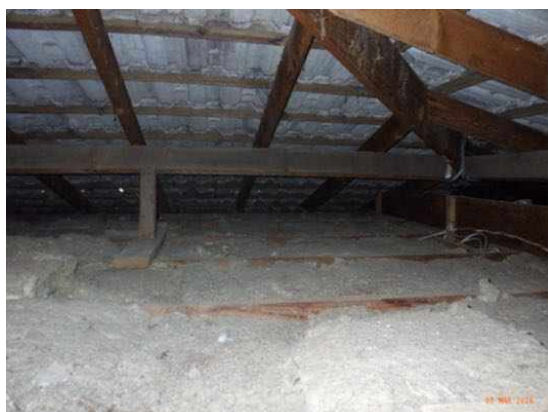
## Finding 2.02

Building:	Building 1
Location:	Roof Void
Finding:	Sagging roof
Information:	The roofing structure was found to be sagging in several sections at the time of inspection.

Sagging roof structures are likely to create strain on associated building elements, creating potential for secondary damage including the deterioration of roof coverings. The roof is also unlikely to have sufficient support, which may lead to further sagging if left unmanaged.

It is advised that a licensed builder be appointed to reposition and fix the valley and install additional struts in accordance with advice from a structural engineer.

While it would appear that this defect has been present for a long period of time repair is recommended in the short term to ensure the longevity and structural integrity of the dwelling.

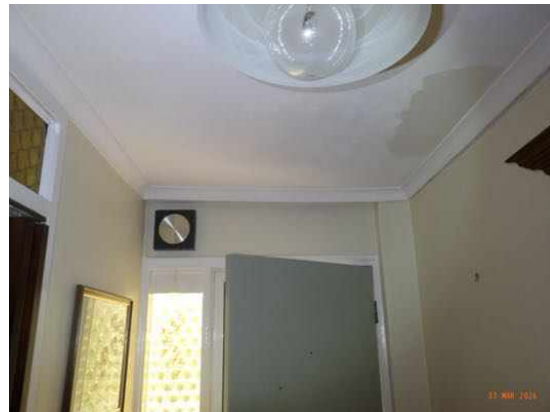
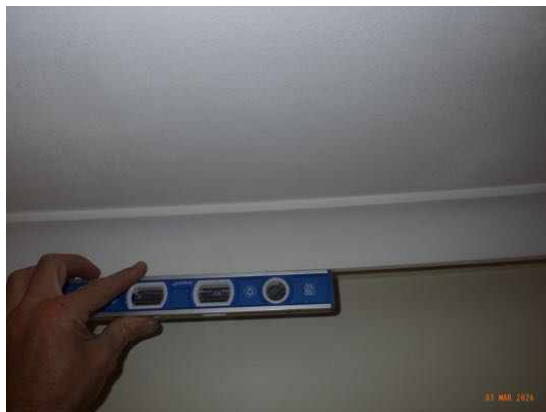
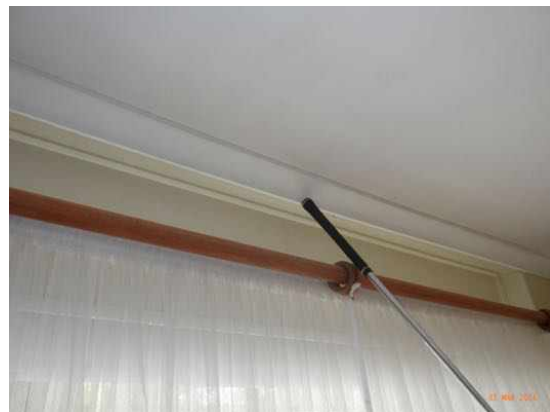
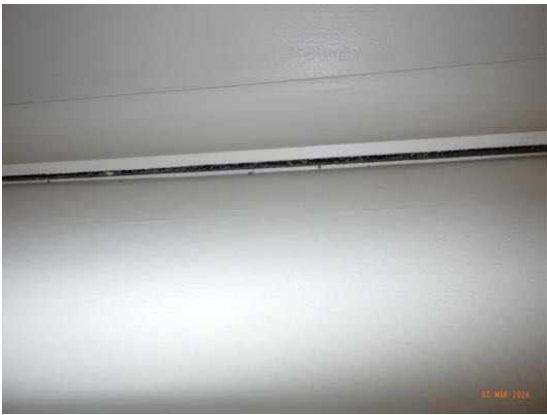
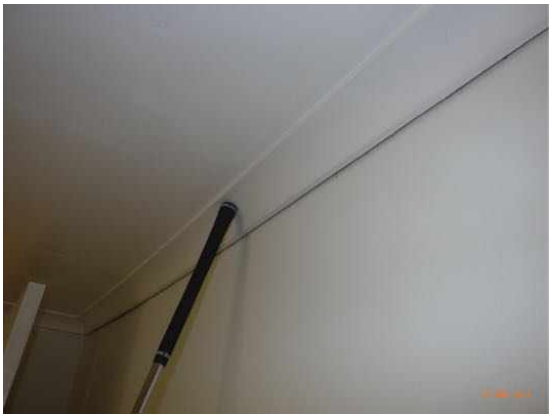
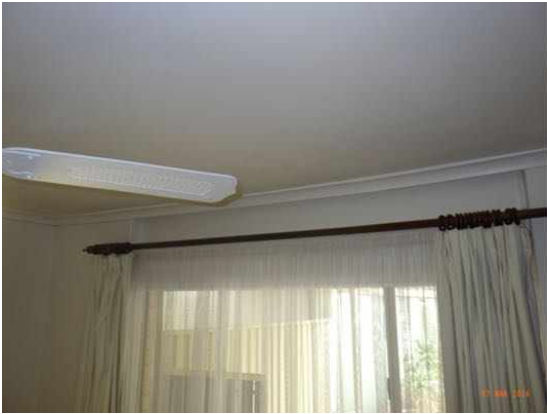
Information: Sections of the ceiling were found to be sagging at the time of inspection. Sagging to the fixed ceiling structure generally indicates that the building materials have swollen, due to contact with water, or that fixings (e.g. nails or glue) have become loose and require reattachment.

In some cases, sagging ceiling linings may also indicate that there are structural issues, causing surfaces to warp, twist or sag. Where sagging appears to be major, appointment of a structural engineer is advised to further inspect the property and identify the source and rectification works required.

Where minor sagging is evident, comparatively minor works, such as re-gluing of ceiling sheets, may be required. Such works may be performed by relevant tradespeople, such as plasterers and painters. Where excessive moisture has caused the roofing structure to swell and sag, the source of the water leak should primarily be identified prior to any remedial works being performed.

The appropriate action should be taken by the client as soon as possible to ensure that any potential further damage is limited.

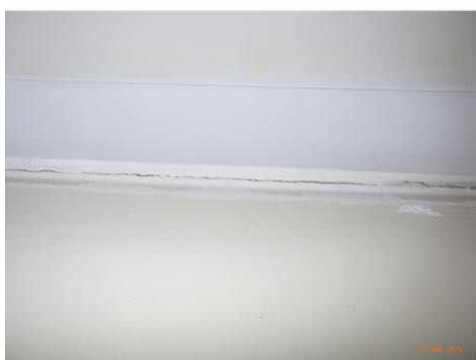
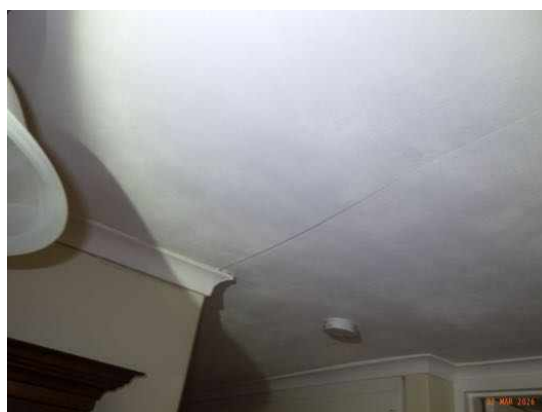
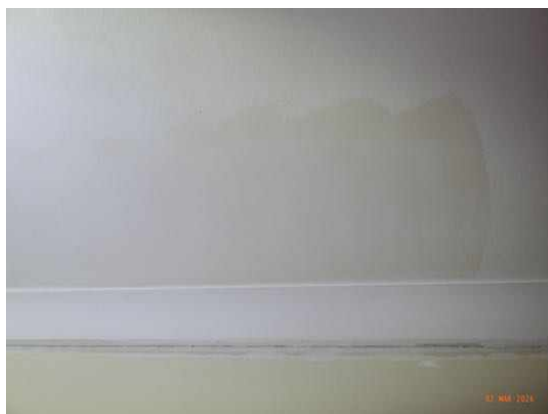
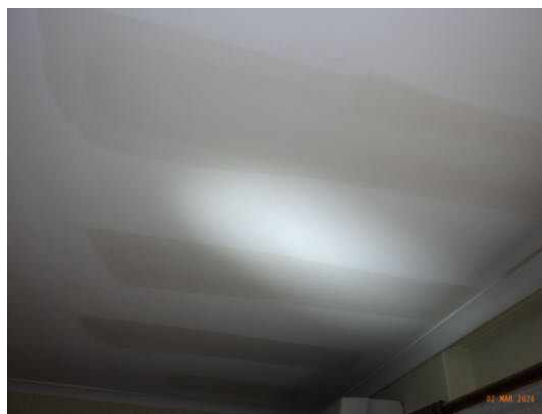
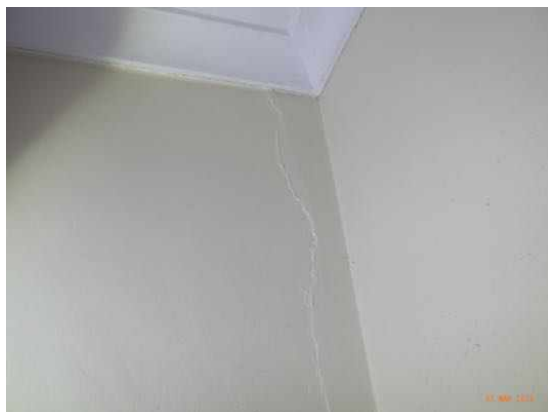
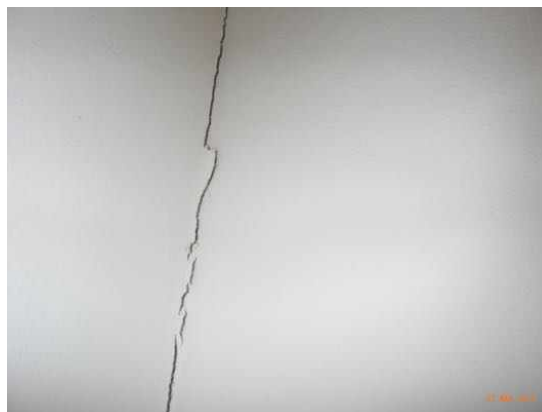
### Finding 3.04

Building:	Building 1
Location:	All Internal Areas
Finding:	Cracking - Damage Category 1 - Fine (up to 1mm)
Information:	There were fine cracks and or crack repairs evident to the walls and ceilings throughout the dwelling at the time of inspection.

Although fine cracks are quite noticeable, they are often only considered to be an appearance defect, and usually do not indicate any structural damage. Generally, the cause of a fine crack is indicative of a separation between building materials and finishes (e.g. paint, plaster, etc.) along joins.

Cracking of this nature can generally be repaired with minor sanding, filling and/or repainting. Such works should be performed by a qualified painter or a general handyman.

Monitoring of all cracking should be conducted frequently. Always contact a building inspector should cracks widen, lengthen, or become more numerous.

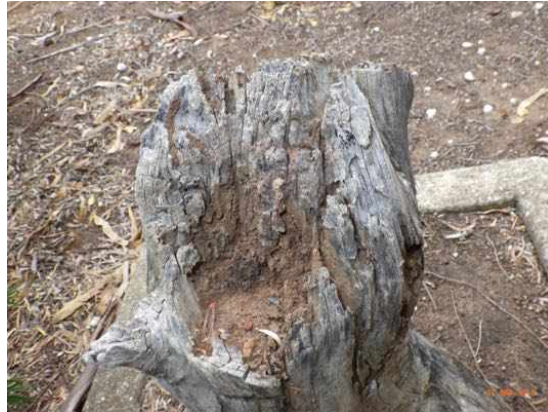
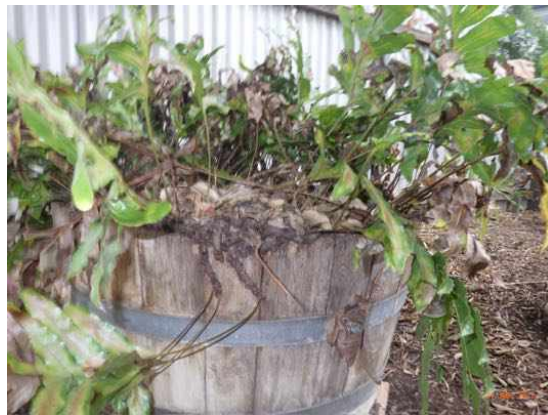
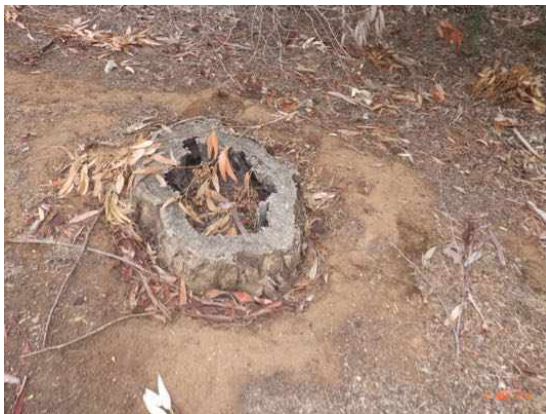
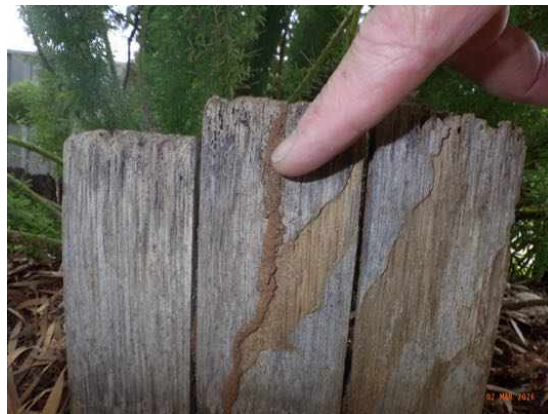
Building:	Building 1
Location:	All External Areas
Finding:	Evidence of termite damage - minor
Information:	Despite no live termite or timber pest activity being indicated, previous termite damage was found to have affected this area. This damage is considered to be inactive and is minor in nature.

It is advised that the area be visually inspected frequently to ensure that the condition of affected building materials does not worsen. At the time of inspection, damage is not structural and is only considered to be superficial.

A building contractor may be appointed to provide a further invasive inspection if further damage is evident.

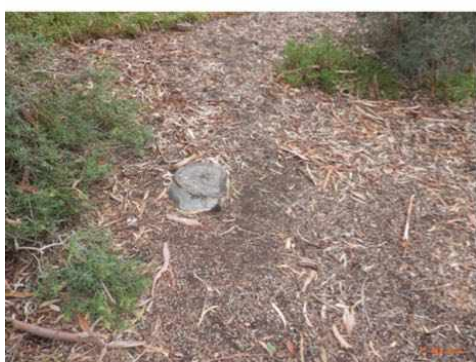
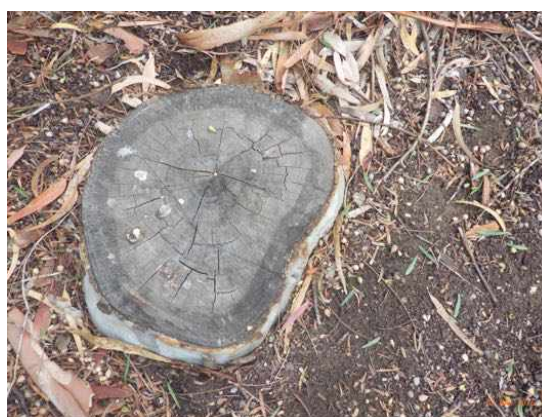
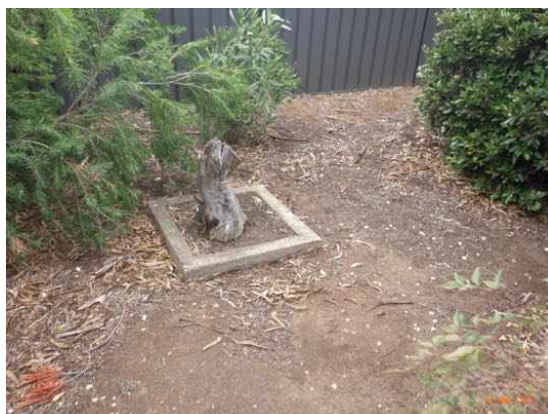
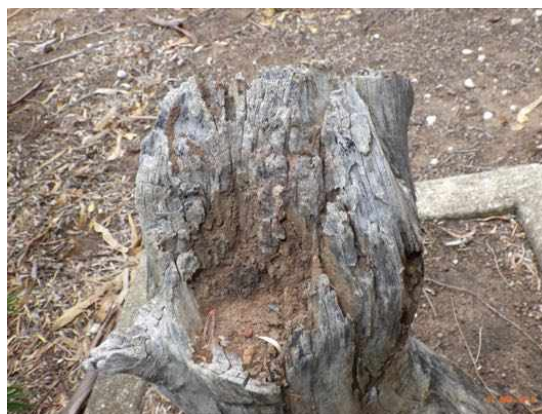
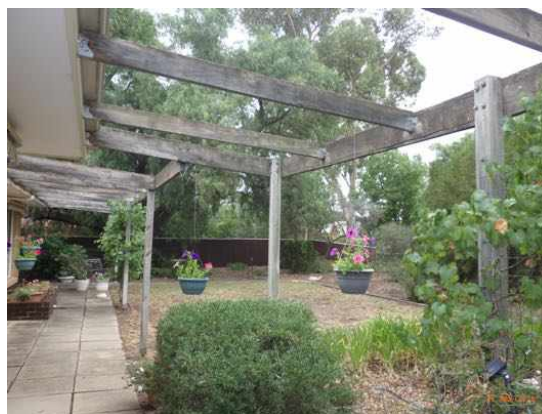
### Finding 6.01

Building:	Building 1
Location:	All External Areas
Finding:	Untreated or non-durable timbers in a hazardous environment
Information:	To reduce the risk of timber pest attack it is essential that timber used in a hazardous

Untreated timbers in direct contact with the ground are likely to develop severe wood rot and/or fungal decay if left unattended creating attraction for subterranean termites to infest the timbers from surrounding areas.

If untreated or non-durable timbers are found to be in a hazardous environment it is highly advised that replacement of these building elements be performed as soon as possible to aid the protection of the property against termite / timber pest attack. Failing this close monitoring is recommended in an attempt to identify termite infestation at an early stage.

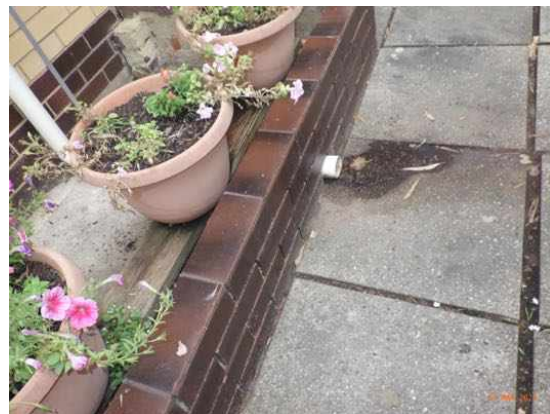
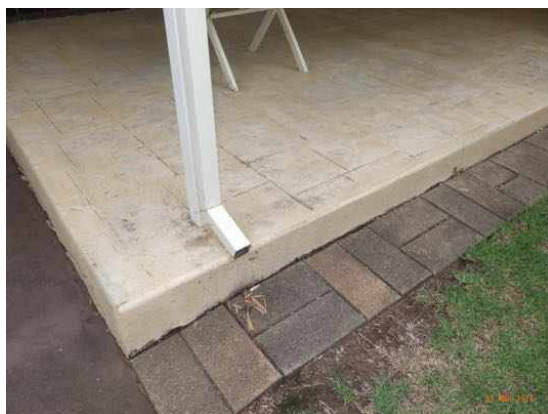
Where roof plumbing doesn't drain adequately, the area at the base perimeter can become excessively damp, potentially creating an environment that is susceptible to rust and corrosion of surrounding building elements, as well as attracting termites and other pests.

It is highly recommended that a plumber be appointed to further inspect the area and to install adequate drainage equipment where necessary.

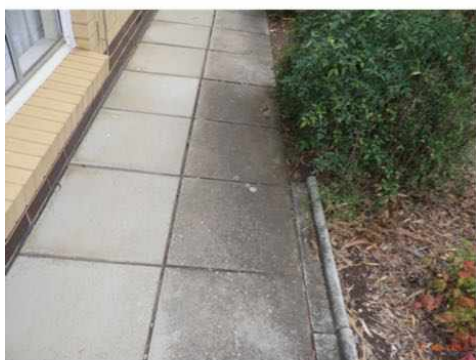
### Finding 6.05

Building:	Building 1
Location:	Front Elevation
Finding:	Perimeter Paving - Insufficient Fall
Information:	The perimeter paving or ground levels were found to have an inadequate slope away from the adjoining building structure, creating potential for water pooling in this area.

This standard ensures that excessive moisture does not pool around the base of building structures, which creates potential for water and structural damage, as well as making the area susceptible to termite and timber pest activity.

Where paving or ground levels do not have adequate fall, a licensed paving contractor should be appointed to install or remove and re-level pavement.

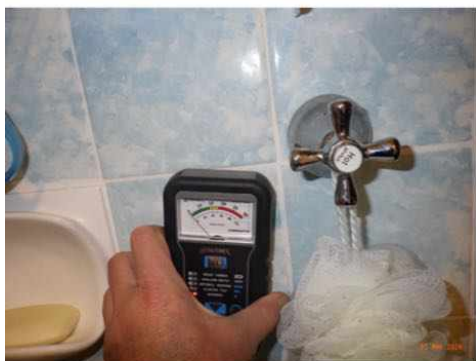
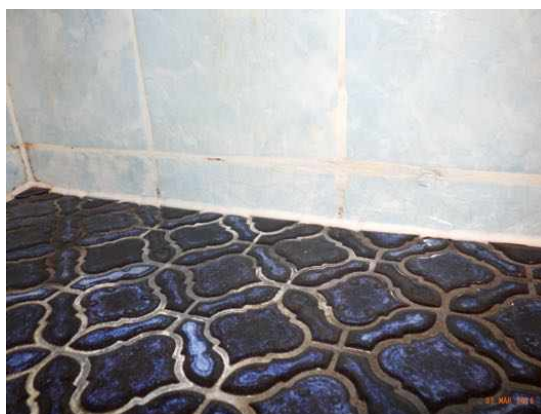
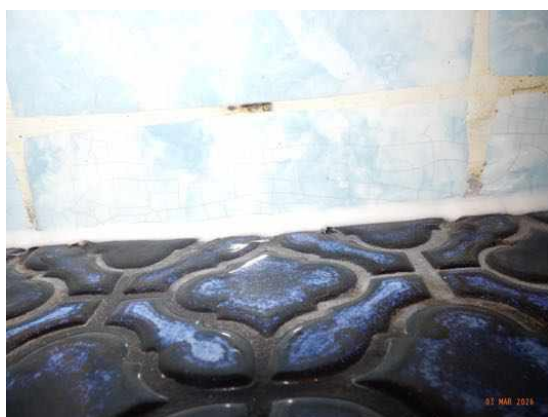
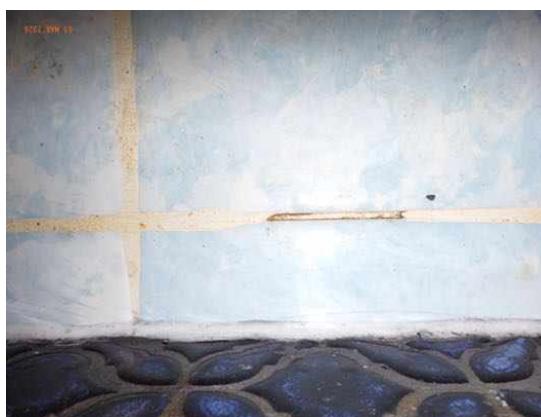
### Finding 6.06

Building:	Building 1
Location:	Bathroom
Finding:	Sealant and grouting - Regular maintenance
Information:	It was noted on inspection that sealant and grout has small areas of deterioration

Different materials and floor areas move at different rates, generally causing cracking to grout or sealant at this point. A flexible sealant is required to allow for expected expansion and contraction, while keeping the joint water tight and protective of all associated building materials.

Flexible and mould resistant materials should be applied to affected areas to prevent any subsequent water damage that is likely to occur. Regular maintenance and replacement of damage or missing or damaged sealant and grout is highly recommended to the wet areas, as this is a regular wear and tear defect. Sealant and grouting in areas that come into regular contact with water should be maintained for the long term care of your property.

A sealant specialist or tiling contractor should be appointed to complete these works as soon as possible
