# Building and Timber Pest Inspection Report

Inspection Date: Tue, 17 Mar 2026

Property Address: 8 Trixia Place, Leopold, Vic

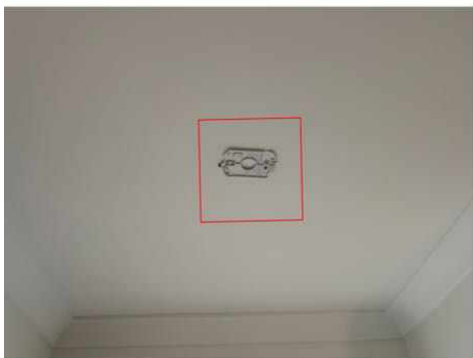
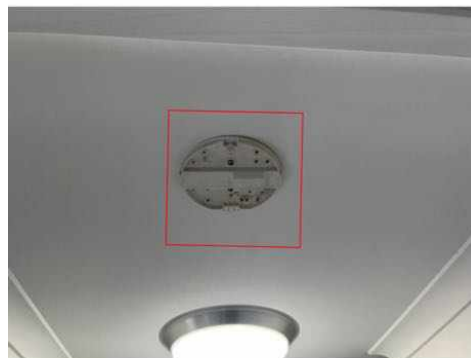
Please note that this defect is highlighted as a caution only. We suspect, based on our experience in the building industry, that the absence of smoke detectors, or their poor condition, should be addressed as a matter of urgency to improve occupant safety.

Always ensure sufficient working and suitable smoke detectors are installed prior to occupying any building. Additionally, it is advised that all smoke detectors be tested by the homeowner on a monthly basis.

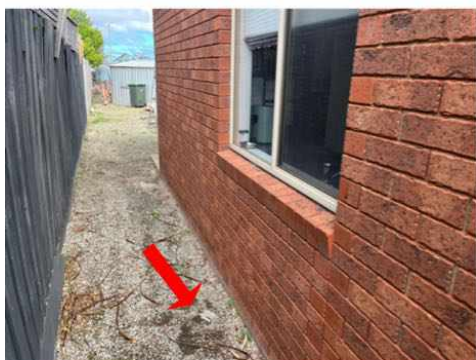
This item must be addressed to prevent secondary defects - blocked drains must be rectified immediately.

Consultation with a licensed plumber is required.

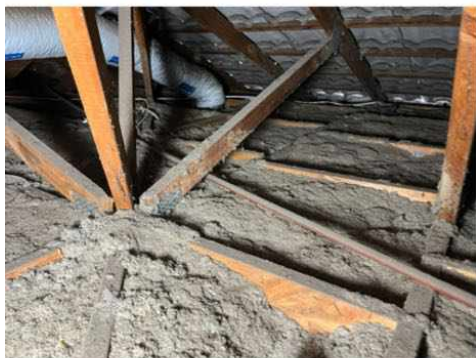
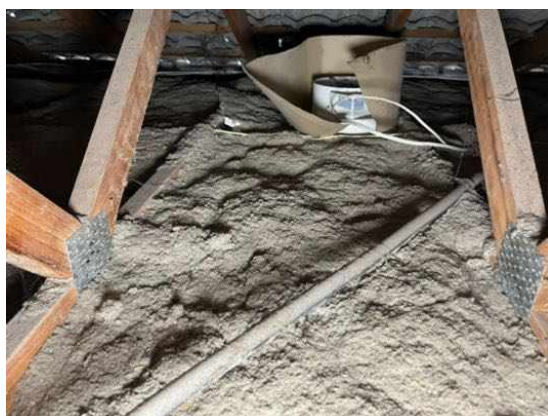
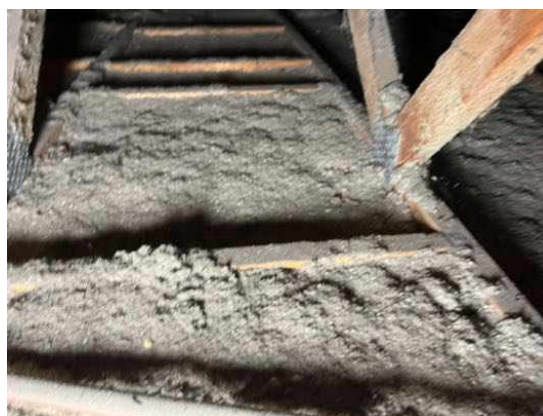
### Finding 3.02

Building:	Main Building
Location:	Roof Void
Finding:	Insulation - Reduced in volume
Information:	Insul-fluff is common in many older homes and is a loose form of insulation that is 'blown' into roof voids. While this type of insulation was considered effective at the time of installation, modern materials have surpassed it as the preferred insulator.

Note: insulation in the roof void also obstructs areas limiting the possibility of identifying termite activity or other timber pest damage.

It is highly advised that this insulation be removed and replaced with a more appropriate material.

This will ensure that the property is adequately insulated and will promote an increase in energy efficiency within the property. An insulation contractor should be appointed to provide further advice on replacement options and to perform works as necessary.

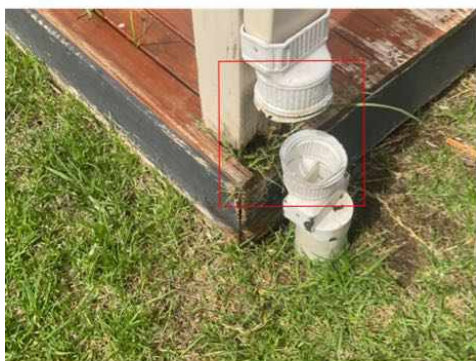
This failed plumbing connection negatively impacts the functional capacity of the roof plumbing. Water collected from the roof plumbing is now discharging near the footings and foundations of the dwelling which can damage the structure if left unattended.

It is highly recommended that a plumber be appointed to further inspect the area and to install adequate drainage equipment where necessary.

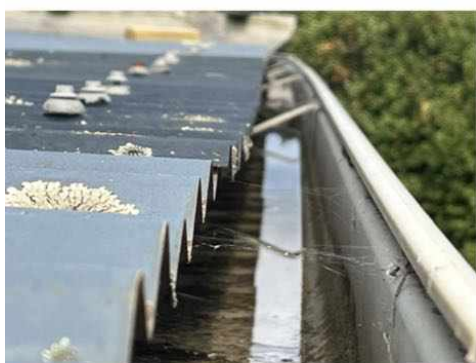
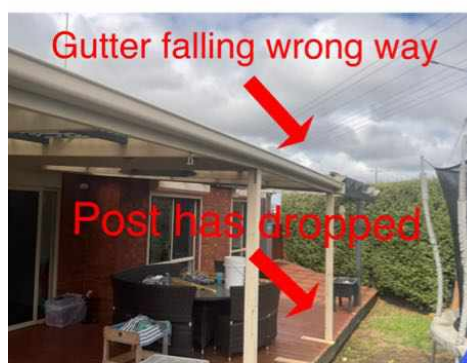
### Finding 3.05

Building: Main Building  
 Location: Yard - pergola LH Side  
 Finding: Gutters - Water pooling  
 Information: Water was found to be pooling in sections of the roof guttering. This is generally a secondary defect caused by blocked or partially blocked gutters. Such blockages and subsequent water pooling are likely to lead to rust and water damage to associated

Any areas of guttering that shows evidence of water pooling should be checked for partial or full blockages and any secondary damage that may have occurred as a result. Depending on the extent of the damage, building elements may require repair and/or replacement to ensure adequate roof drainage and function of exterior plumbing system.

A roofing plumber should be appointed as soon as possible to rectify this issue. It is highly advised that all gutters be maintained on a frequent basis to ensure the condition of roof plumbing.

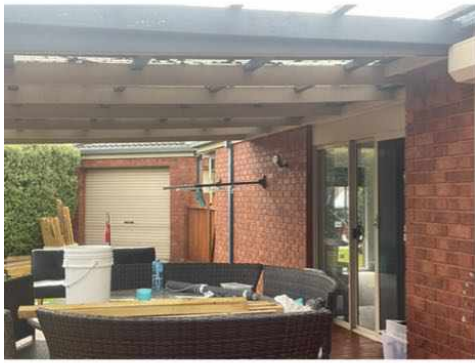
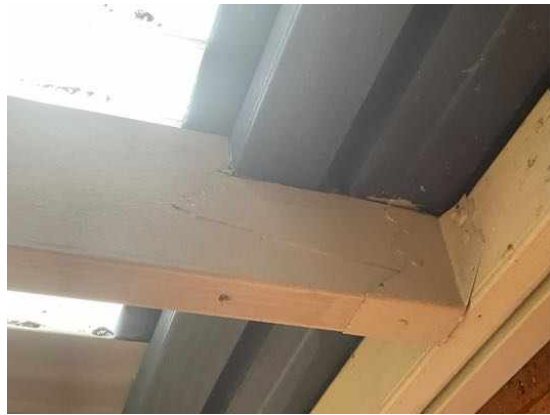
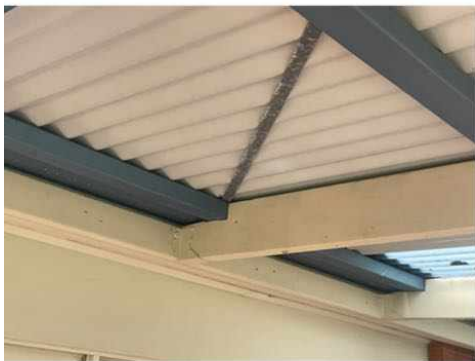
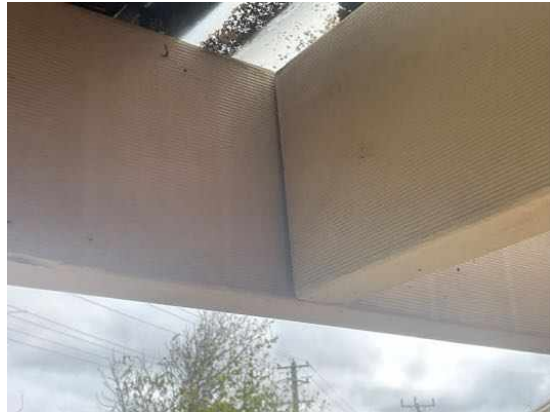
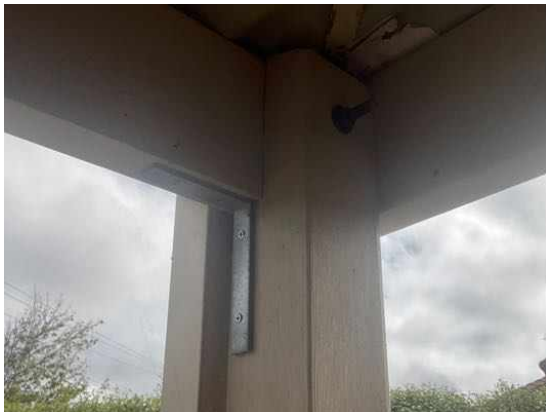
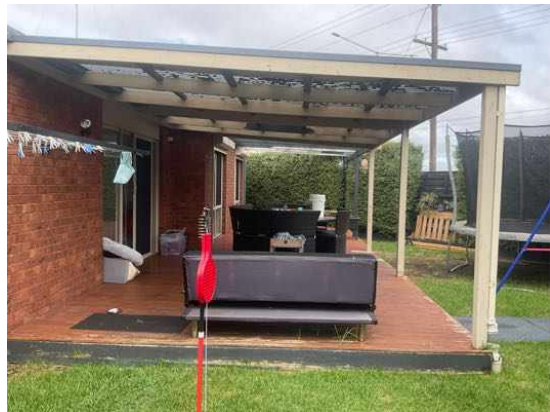
### Finding 3.06

Building:	Yard
Location:	Yard - pergola LH Side
Finding:	Unconventional handyman work
Information:	This handyman work appears to have been completed to a substandard level and does not comply with regular building practices.

Where handyman work is not completed satisfactorily, accelerated deterioration of the associated building elements is likely to occur and secondary defects to surrounding structures may develop.

It is highly recommended that the substandard work be rectified by professional services.

Rectification works are advised as soon as possible by the appropriate trades.

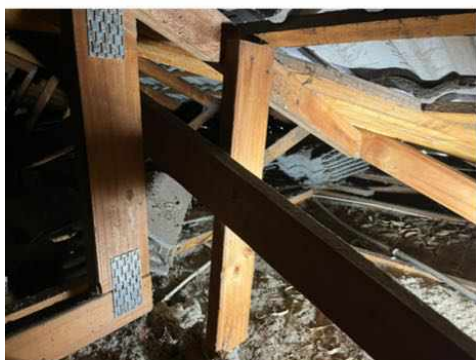
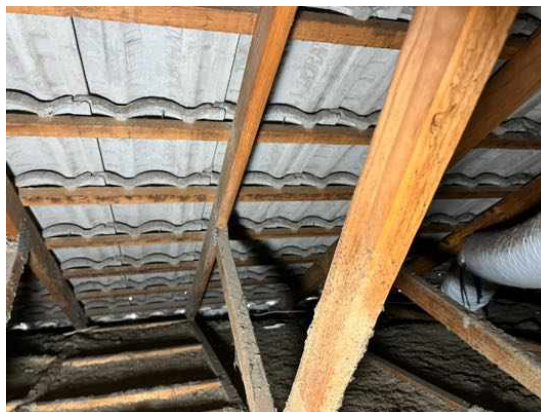
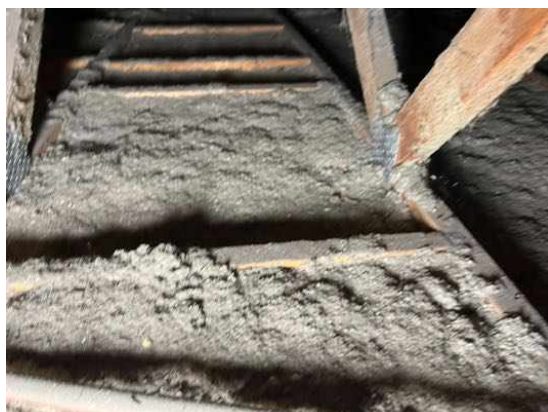
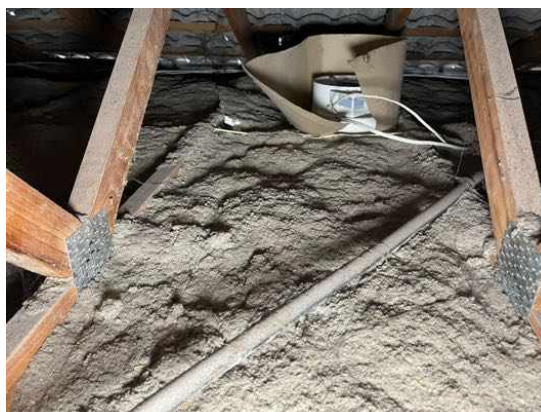
Building: Main Building  
 Location: Roof Void  
 Finding: Insulation in roof voids  
 Additional Photos - Obstructions and Limitations (Timber at risk of Termite damage)  
 Information: These photographs are an indication of the obstructions and limitations which impeded full inspection of the property at the time of inspection.

We were unable to gain access to inspect the timber components at risk of termite damage where insulation covers a large amount of timber.

A re-inspection is recommended once the areas are made accessible.

If the limitations are not able to be reduced by removing areas or creating a manhole, a termite treatment is the next best option to protecting these timber elements.

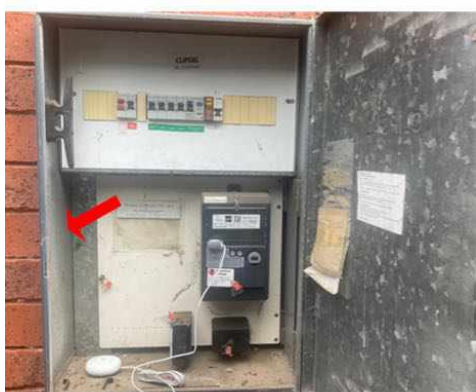
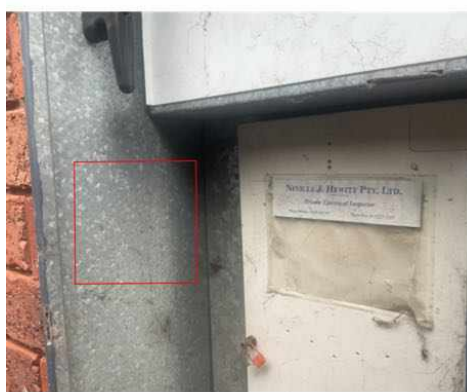
### Finding 6.02

Building: Main Building  
 Location: Meter Box  
 Finding: Termite Management System - no evidence of a chemical installation

A durable notice should be placed in the switchboard unit to indicate current termite barriers. At the time of inspection, it appeared as though no termite management system has been installed, with no evidence to suggest preventative works taking place.

The client may consider gaining further advice from a pest controller as to the costs and procedures involved with this application. It is recommended that obtaining such advice be a short-term priority.

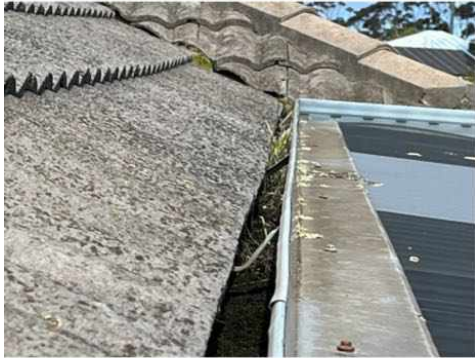
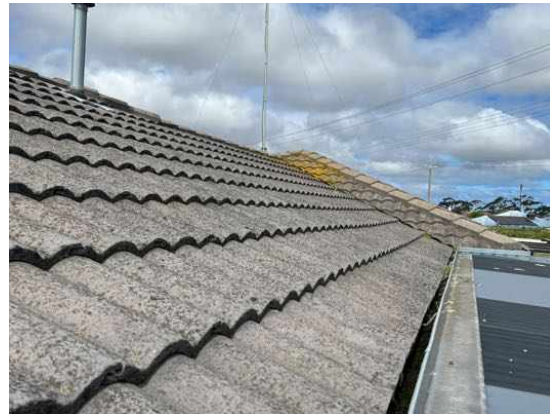
### Finding 6.03

**Building:** Yard  
**Location:** Yard - pergola LH Side  
**Finding:** Gutters - Blocked  
**Information:** Roof plumbing structures, such as guttering and downpipes, should be free of all debris to prevent blockages. Blockages of the guttering and downpipes will lead to pooling and accumulated water overflows, which is likely to subsequently flood eaves and exterior walls.

Blocked gutters are likely to lead to high levels of moisture in the affected areas. Such moisture will not only cause rust and decay of the associated building materials, but can also provide conditions that are conducive to termite and timber pest activity. Blockages in gutters should therefore be removed immediately to ensure dry conditions are maintained.

Consult a Licensed Plumber for further specific advice on remedial works that may be required. In the interim, it is highly advised that blocked gutters be removed by the

homeowner or a general handyman as a matter of urgency.

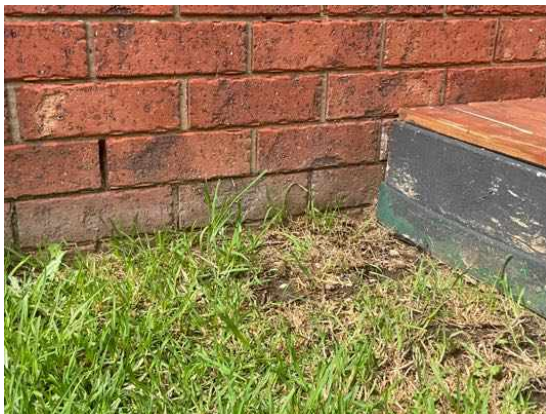
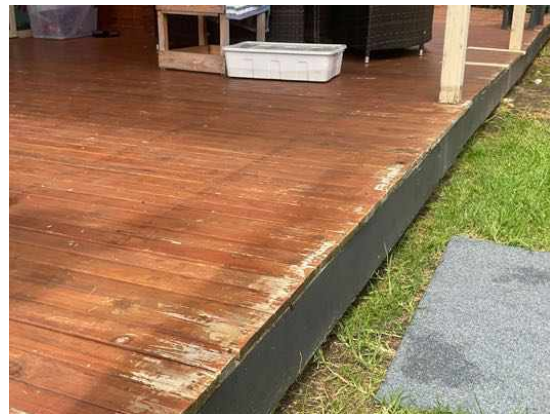
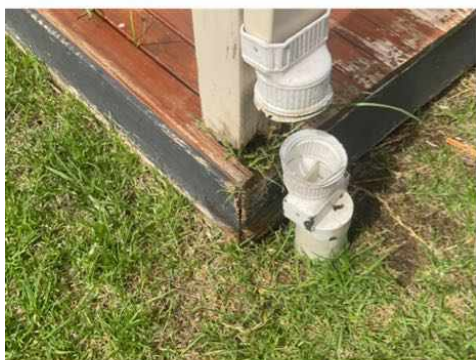
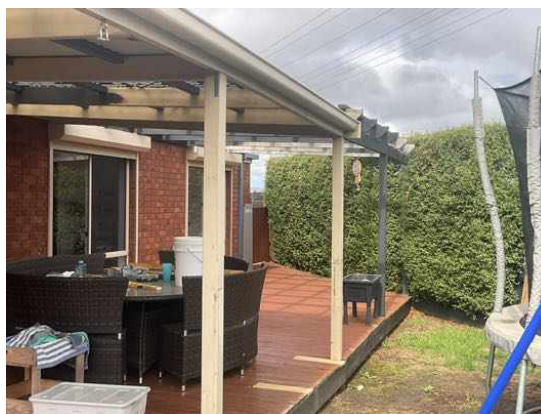
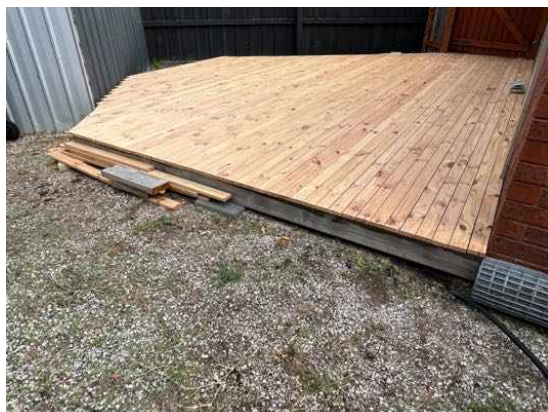
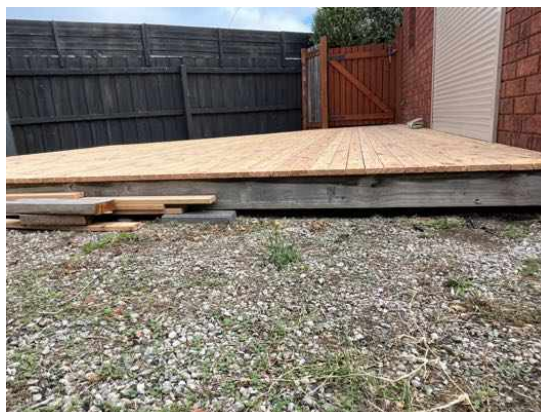
### Finding 6.04

Building: Yard  
 Location: Yard - RH Side  
 Finding: External Timber Decking - Obstruction (Unable to inspect underneath)  
 Information: Where the timber deck is installed close to the ground we are unable to inspect the timber frame for termite damage.

External timber structures are also constantly exposed to weather elements and can deteriorate in an accelerated manner, ongoing assessments are required.

It is highly recommended that a licensed pest controller be engaged to provide termite treatment to protect all timber structures.

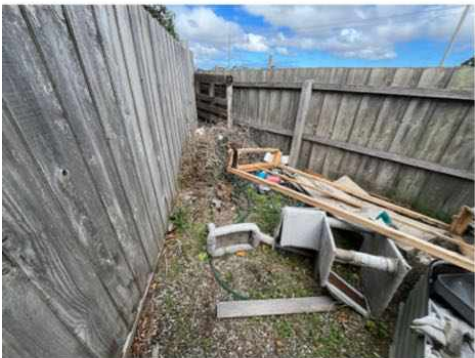
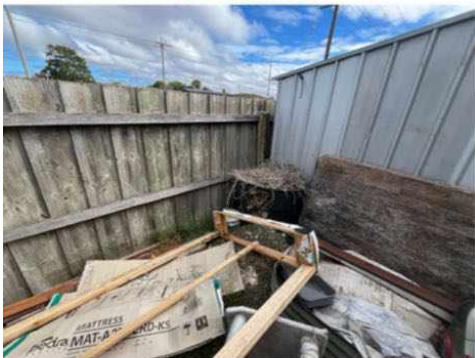
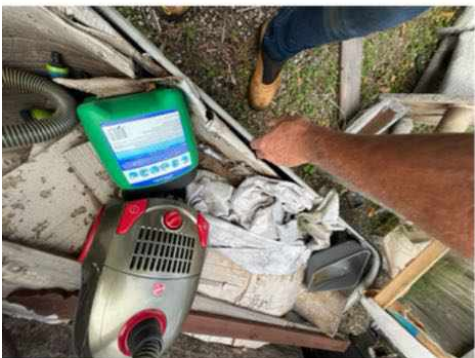
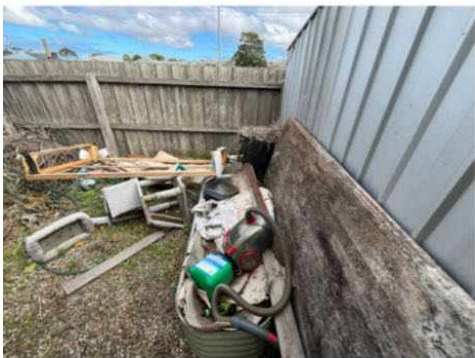
### Finding 6.05

Building:	Yard
Location:	Yard - Back (Behind Shed)
Finding:	Stored timbers - external area
Information:	The storing of timbers around the external property increases the risk of termite activity being present.

As timber is likely to come into contact with weather conditions or excessive moisture wood rot is likely to develop on timbers that are not treated.

It is highly recommended that any stored timbers be immediately removed from areas in which they may attract any termite / timber pest attack.

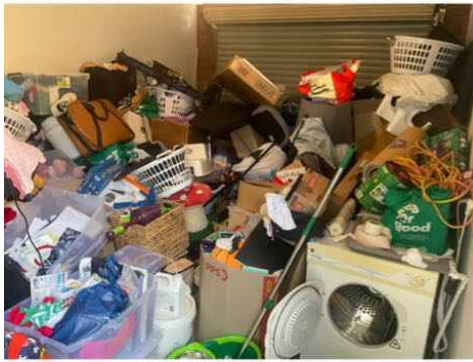
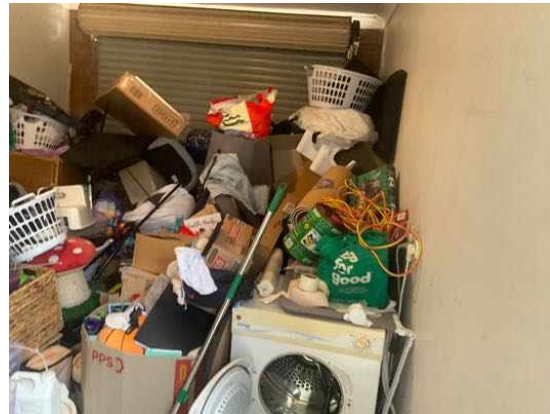
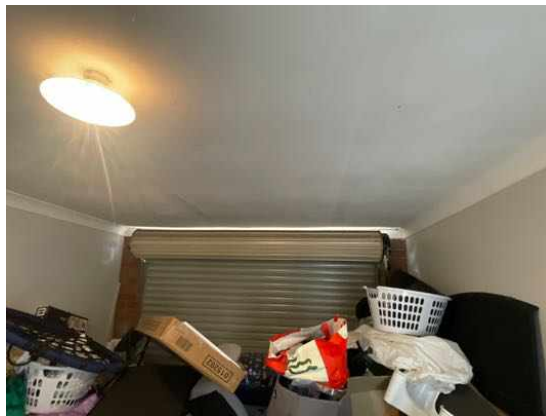
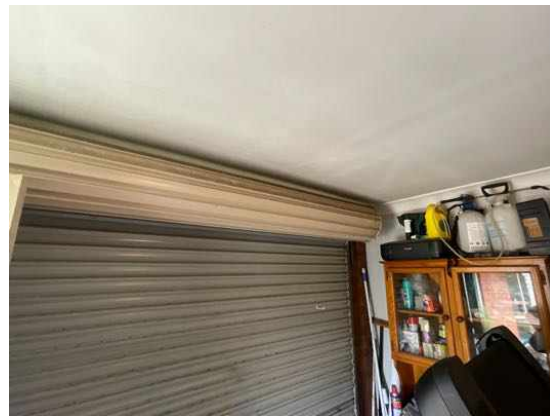
Finding 6.09

These obstructions can hide an array of defects and should be removed to allow full inspection to be carried out.

As no actual inspection was possible at the time of the inspection, there remains a high risk of hidden defects that can result in costly repair.

A re-inspection of the garage is recommended once the areas is made accessible for a visual inspection and testing for termite activity.

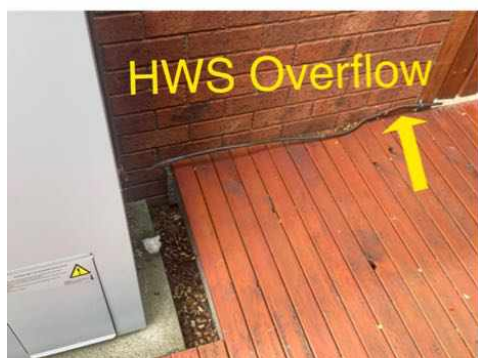
### Finding 6.10

Building: Yard  
 Location: Yard - RH Side  
 Finding: HWS Overflow - Not Connected  
 Information: The Hot Water System (HWS) overflow was found to be disconnected from storm water drainage and is creating excessive moisture in the surrounding area.

These damp conditions can lead to secondary defects such as rot, rust or corrosion of associated building elements, the formation of fungal decay, or even the creation of potential slip hazards. When coupled with poor site drainage, pooling of water may also attract termite activity to this area.

It is highly recommended that a licensed plumber be appointed to connect the HWS overflow in order to prevent such an environment from being created. These minor works should be carried out as soon as possible.

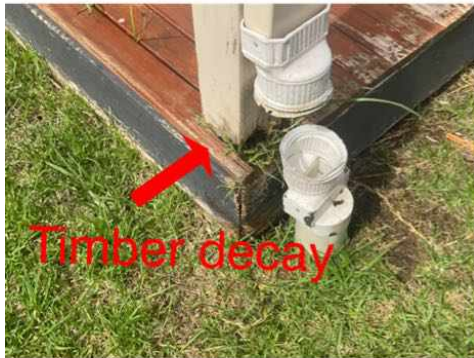
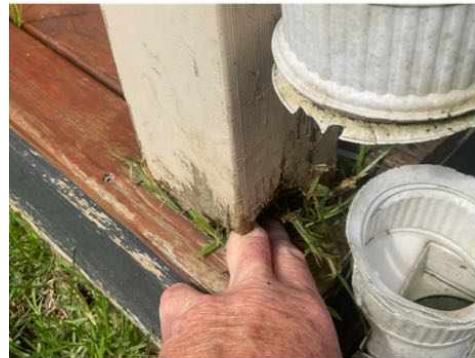
### Finding 7.01

Building:	Yard
Location:	Pergola posts - Yard LH Side
Finding:	Timber support post / Wood rot
Information:	This building element shows evidence of wood rot. Wood rot, also known as Fungal Decay which is classified as a timber pest, occurs when timbers and other cellulose building materials are exposed to damp conditions on an ongoing basis.

This could be the result of exposure to weathering over a prolonged period of time, and a leaking down pipe or the attraction of excessive moisture from other abutting building materials. Contributing factors also include poor air ventilation in the area.

In this instance the timber decay is well advanced and the timber posts are severely compromised. Several will need replacing.

Replacement of affected timbers may then be a necessary step in protecting surrounding building elements from such deterioration.

A qualified plumber may be appointed to assess the cause of excessive moisture and to provide advice on any remedial works as required.

A qualified carpenter or registered builder may also be required to replace affected building materials.

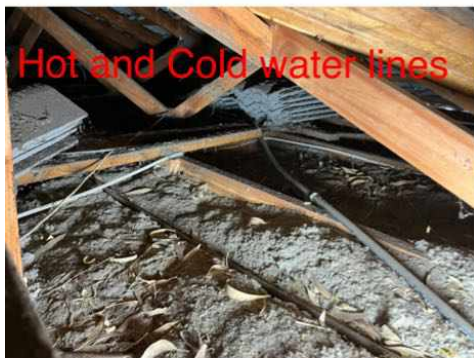
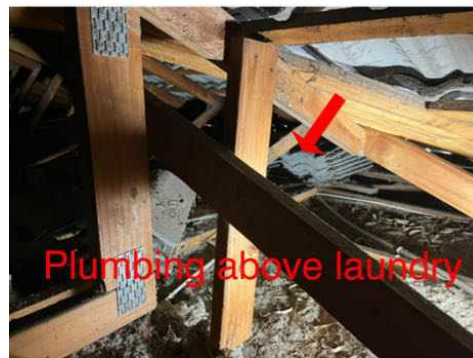
Building: Yard  
Location: Laundry  
Finding: Missing plumbing.  
Information: This item is addressed in the Tenancy - Property Management report.

There is both hot and cold water plumbing inside the roof void immediately above the laundry.

We could not see if the plumbing branches off and runs down the laundry wall. That will require a licensed plumber to investigate.
