# Building and Timber Pest Inspection Report

Inspection Date: Tue, 24 Mar 2026

Property Address: 6 Marshman Rd, Narangba QLD 4504,  
Australia

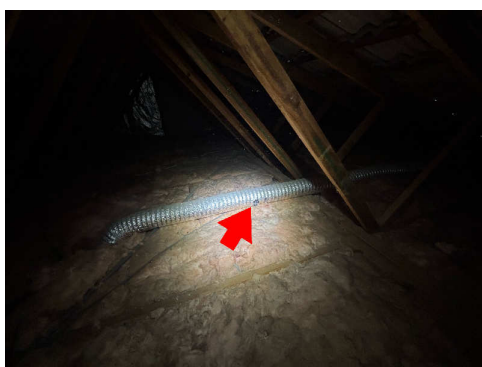
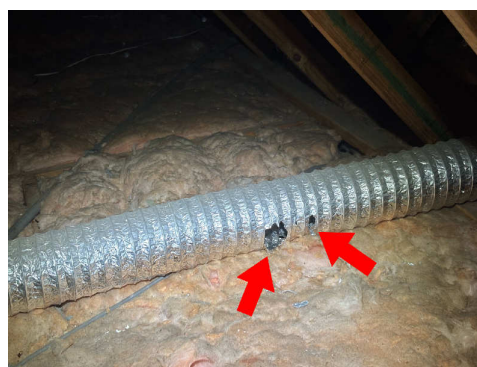
#### Finding 1.01

Finding: Rangehood - ducting damaged

Information: At the time of the inspection, it was noted that the rangehood ducting that is venting to the exterior was damaged, possibly eaten by rodents.

The positioning of this ducting and the damage to it, is likely to lead to a build-up of grease and grime in the surrounding area within the ceiling void, which can pose as a fire hazard in the roof void. The presence of insulation surrounding the flue adds to this fire safety risk.

Without full re-direction to the exterior of the building, the Rangehood is not considered fully operational and is deemed a minor safety hazard. It is therefore preferable that the ducting be repaired to ensure proper venting into the external environment.

A licensed plumber should be appointed as soon as possible to provide further consultation on the scope of these works and to provide quotations for any necessary works.

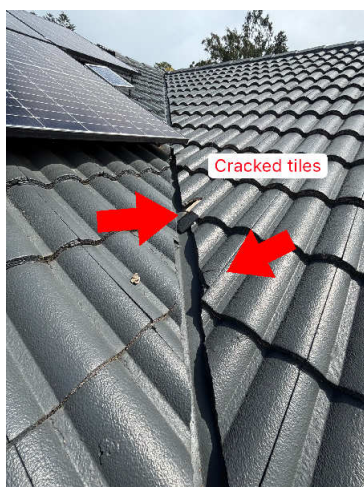
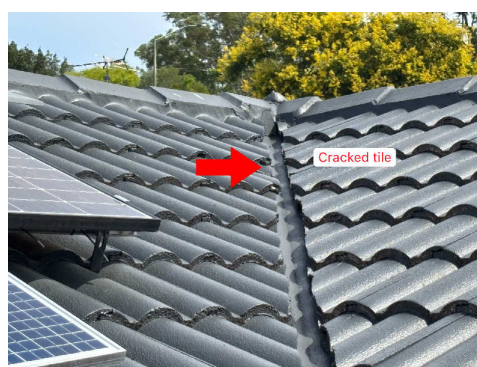
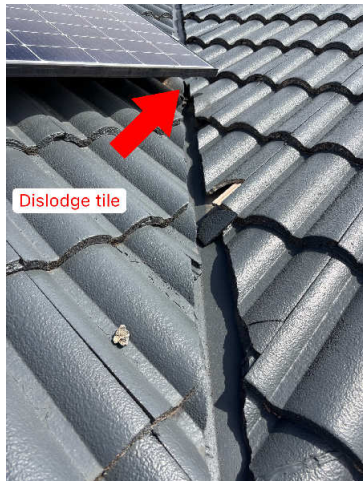
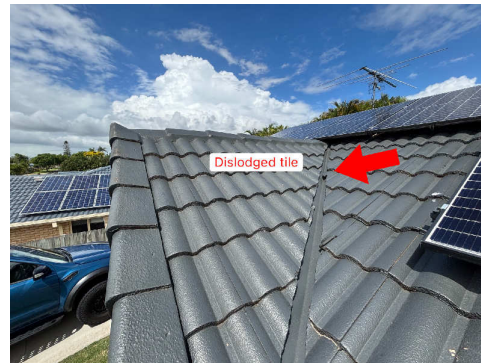
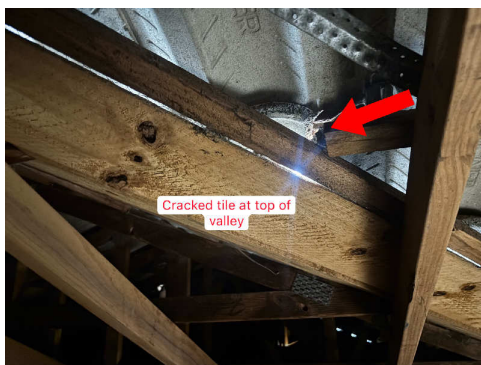
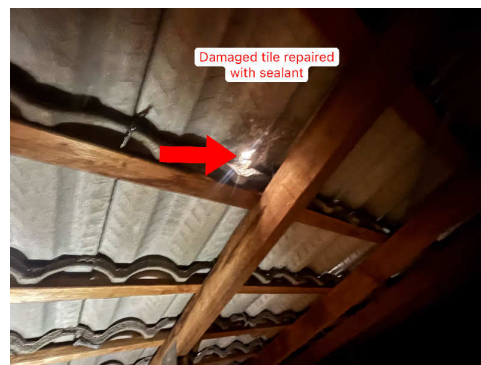
### Finding 3.01

Finding: Roof tiles - cracked tiles

Information: At the time of the inspection, it was noted that there were several cracked roof tiles in the valley above the front door. Dislodged tiles were also found in the valleys above the front door. A tile on the right hand side has a manufacturing defect that has been filled with sealant prior to the roof being re-painted. This tile may be under the solar panels. These areas are potential ingress points for moisture into the roof void.

This has been noted as a minor due to the fact that no visual evidence of moisture ingress was found. If left unaddressed there is a high chance that this will become a major defect.

Cracked and dislodged roof tiles were found in the valley above the front door. Elevated moisture levels were recorded on the shower wall in the ensuite.

A roofing contractor should be engaged to replace the cracked tiles and re-position the dislodged roof tiles. If accessible, the tile on the right hand side that has been repaired with sealant should be replaced. This should be done as a matter of urgency.

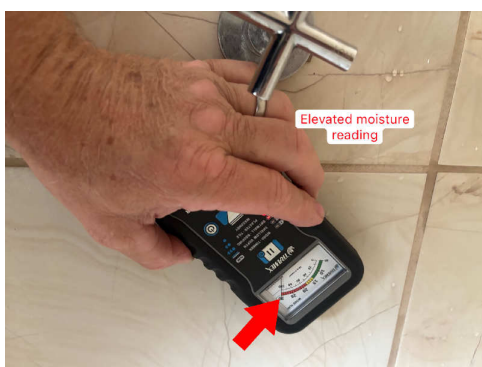
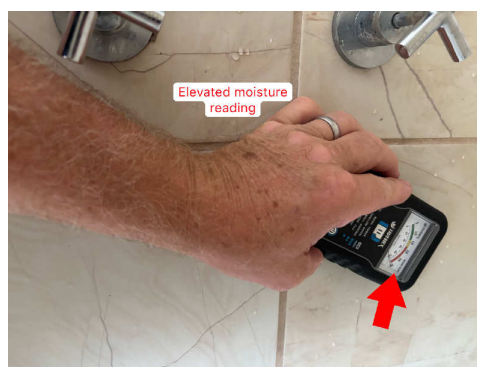
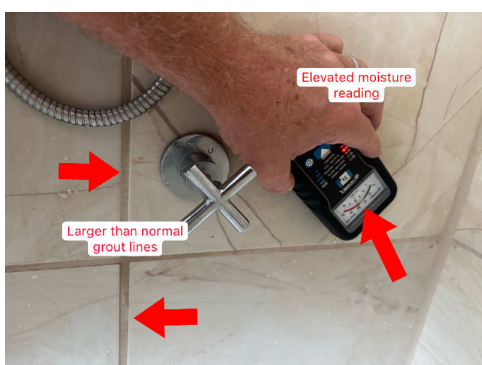
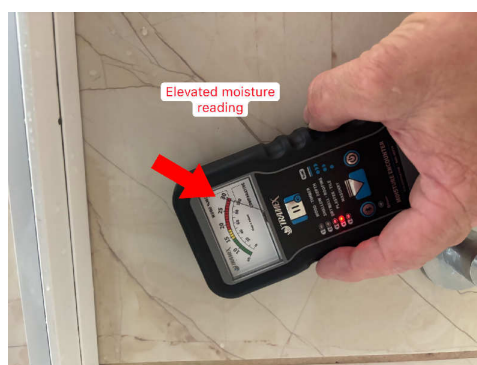
### Finding 3.02

Building: Main Building  
Location: Ensuite  
Finding: Ensuite - elevated moisture readings to shower wall

At the time of the inspection, it was noted that there were elevated moisture readings recorded beneath the taps on the shower wall in the ensuite. This may be due to the age of the materials. Grout and certain tiles can be porous. Larger than normal grout lines were found to the wall tiles.

Normal moisture readings were recorded on the bedroom side of this wall.

Moisture behind the wall tiles may have a negative affect on the wall tile glue. This could result in loose tiles.

A bathroom specialist could be engaged to replace the grout and seal the floor and wall tiles in the shower cubicle. This will give longevity to the bathroom. This can be done at the clients discretion.

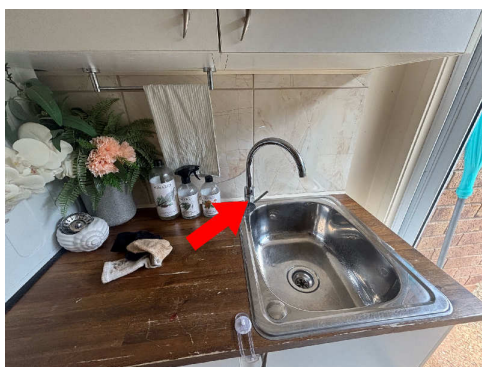
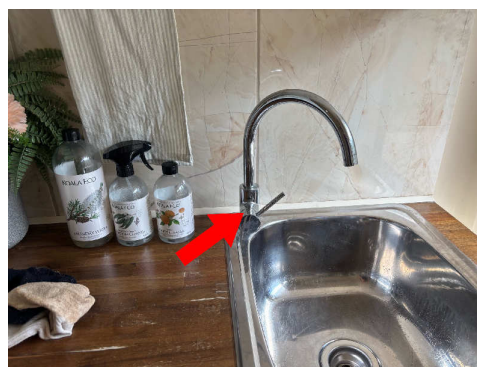
### Finding 3.03

Finding: Laundry tub mixer tap - loose

Information: At the time of the inspection, it was noted that the laundry tub mixer tap was not fully tightened and as a result there is some movement at the base during normal operation.

This may cause unnecessary stress to the associated building materials which can cause premature wear.

A licensed plumber should be engaged to re-secure the laundry mixer tap. This should be done as a short term priority.

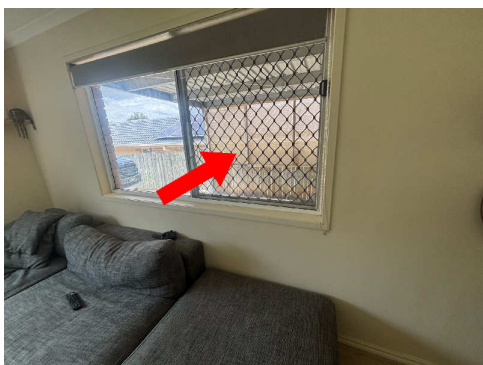
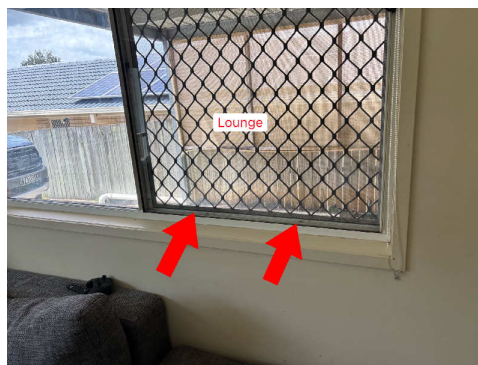
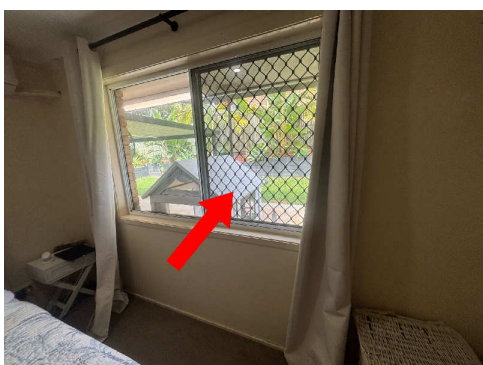
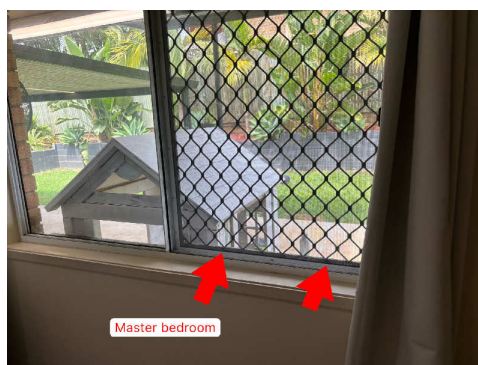
### Finding 3.04

Finding: Sliding windows - stiff to operate

Information: At the time of the inspection, it was noted that a sliding window in the lounge and a sliding window in the master bedroom were stiff to operate. This may be due to general wear and tear of the window runners.

A building maintenance professional could be engaged to assess the doors and replace the affected runners. This can be done at the clients discretion.

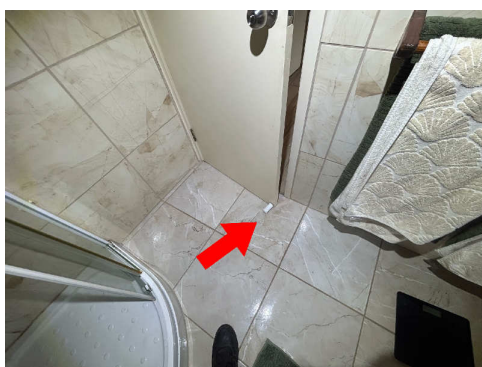
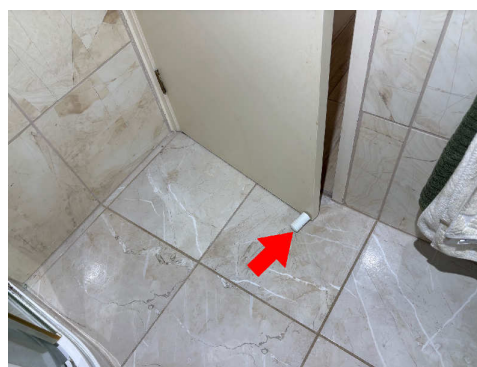
### Finding 3.05

Building: Main Building  
Location: Family bathroom  
Finding: Family bathroom - door stop too short

Information: At the time of the inspection, it was noted that the door stop in the family bathroom was too short and as a result does not stop the door handle from damaging the tiled wall.

Re-installation or replacement of a longer door stop is advised as soon as possible to prevent any subsequent damage to the door or associated structures.

A building maintenance professional may be appointed to perform these works at client discretion.

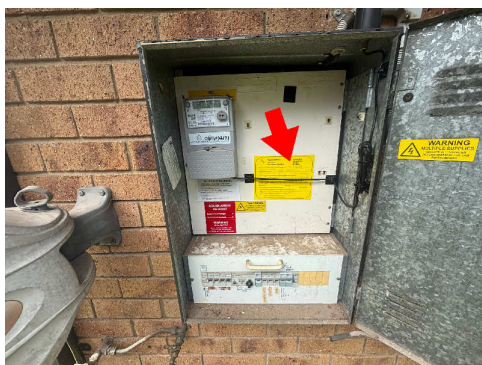
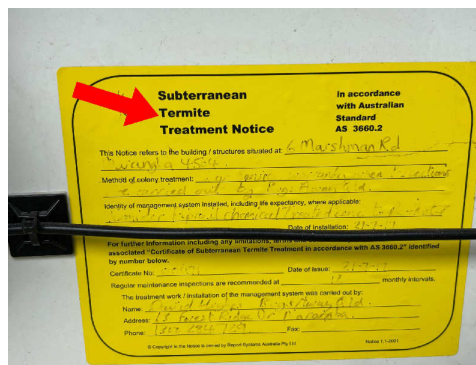
#### **Finding 6.01**

Building:	Main Building
Location:	All External Areas
Finding:	Termite Management System - no evidence of a current chemical installation

At the time of the inspection, no evidence of a current chemical termite management system was found. There is a durable notice in the meter box showing a chemical treatment was carried out on the 21/07/2017. A chemical termite treatment system traditionally has an expected lifespan of 5 - 8 years. It must be presumed that this treatment will no longer be effective. A termite and timber pest technician should be engaged to replenish the termite treatment system. This should be done as a matter of urgency.

A durable notice should be placed in the switchboard unit to indicate current termite barriers. At the time of inspection, it appeared as though no termite management system has been installed, with no evidence to suggest preventative works taking place.

The application of a post-construction chemical termite barrier is highly recommended for all properties, particularly if live termite activity has been found on the site previously. Such barriers are highly effective in preventing termite attack on any timber building elements throughout the property.

The client may consider gaining further advice from a pest controller as to the costs and procedures involved with this application. It is recommended that obtaining such advice be a short-term priority.

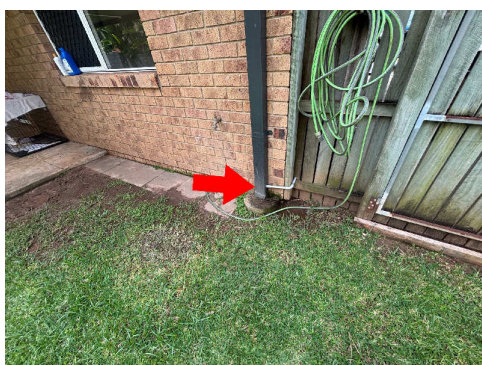
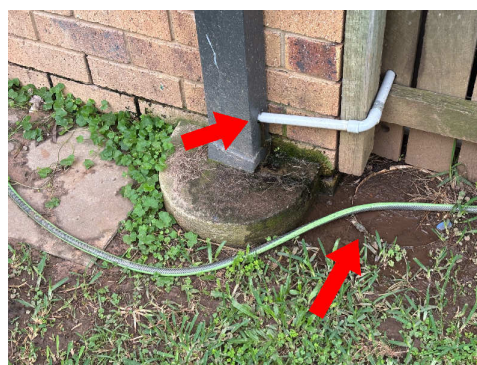
## Finding 6.02

Building: Main Building  
 Location: Rear elevation  
 Finding: Air conditioner - condensate drain leaking

At the time of the inspection, it was noted that the air conditioner condensate drain overflow that is connected to the stormwater system, at the rear of the dwelling, is leaking and as a result is draining next to the foundations of the dwelling.

Air conditioning overflows that are not connected properly to the storm water drainage and are draining near the foundation can create excessive moisture in the surrounding area.

Such leaking creates an environment which is conducive to an array of defects, including water damage to associated building elements and the attraction of termite or timber pest infestation.

It is highly recommended that a licensed plumber be appointed to connect the air conditioner overflow properly in order to prevent such an environment from being created. These minor works should be carried out as soon as possible.

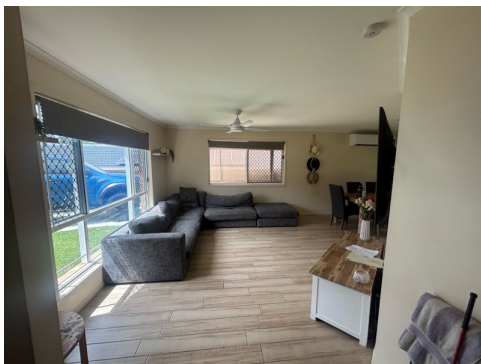
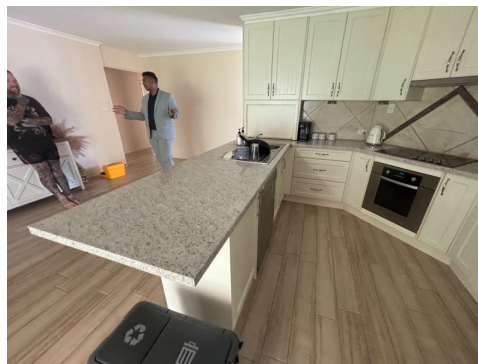
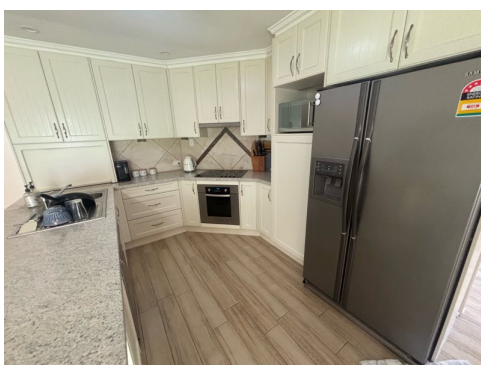
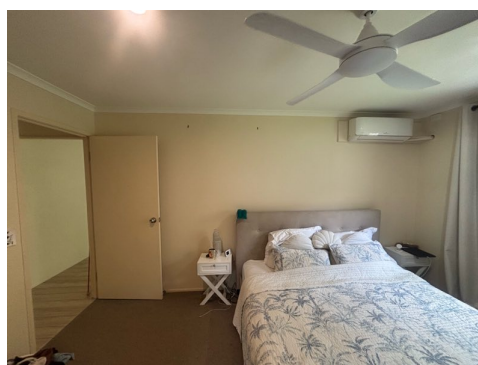
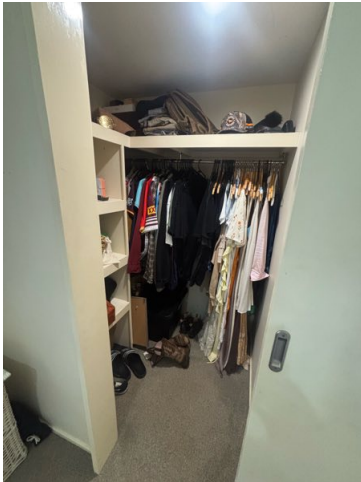
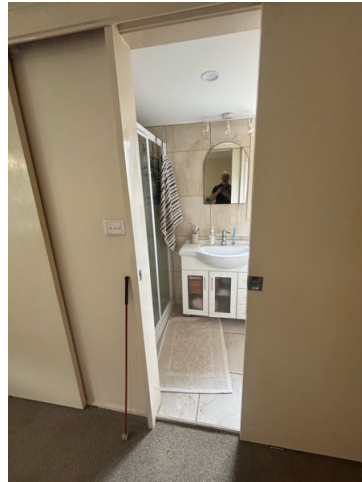
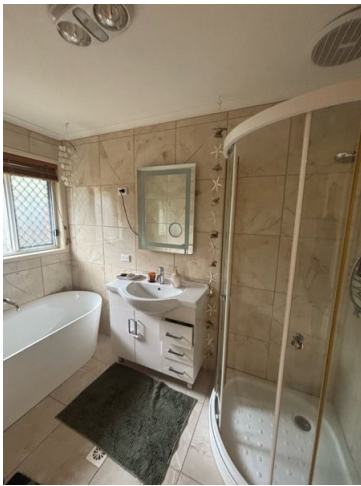
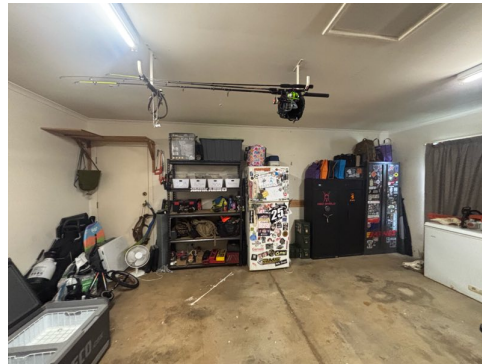
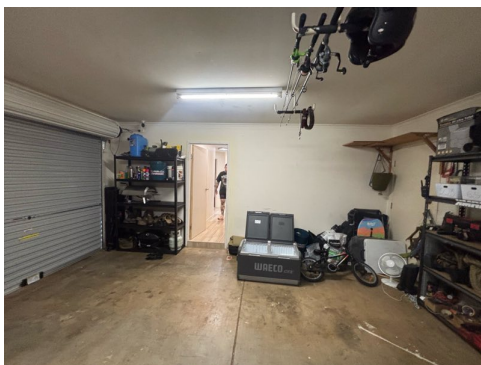
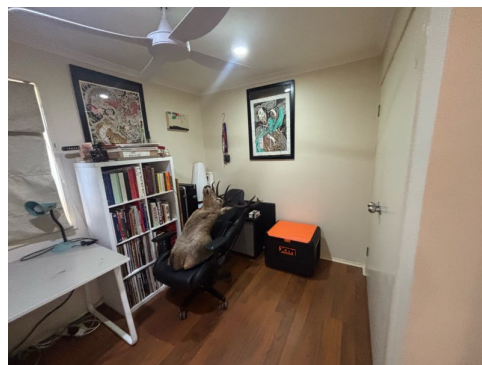
Finding: Obstructions and Limitations - Internal areas

Information: These photographs are an indication of the obstructions and limitations which impeded full inspection of the property of the internal areas at the time of inspection. These obstructions can hide an array of defects and should be removed to allow full inspection to be carried out. A re-inspection is recommended once the areas are made accessible.

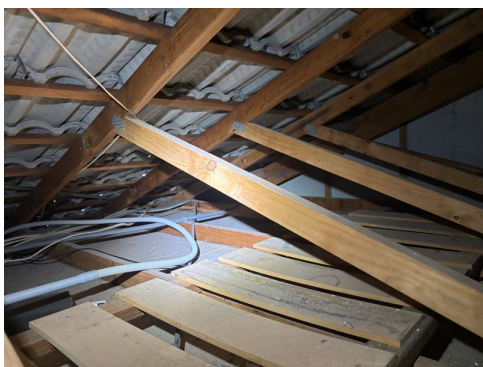
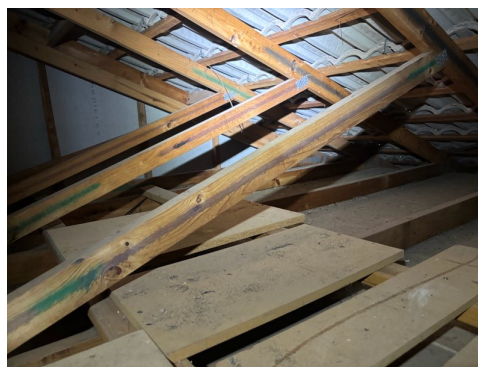
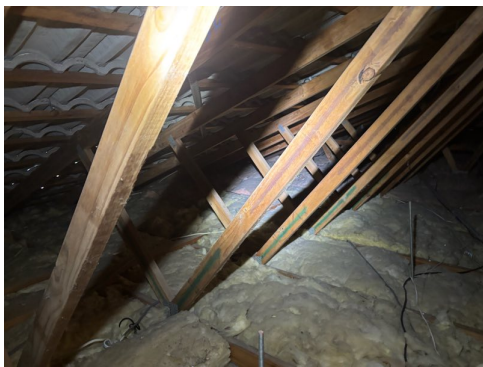
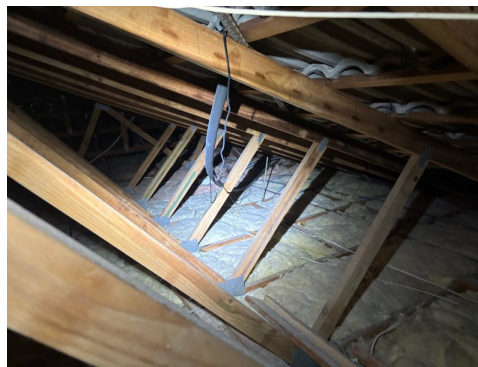
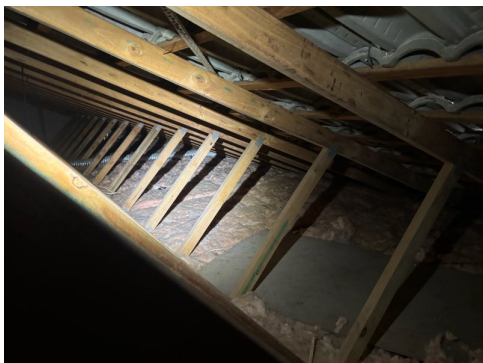
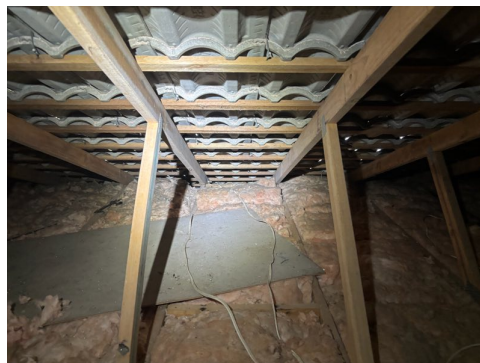
Finding: Obstructions and Limitations - Roof cavity

Information: These photographs are an indication of the obstructions and limitations which impeded full inspection of the property of the roof cavity at the time of inspection. These obstructions can hide an array of defects and should be removed to allow full inspection to be carried out. A re-inspection is recommended once the areas are made accessible.

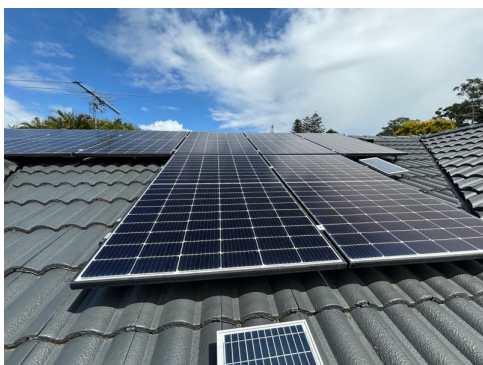
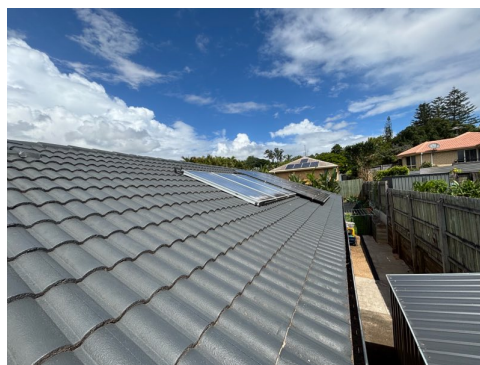
Finding: Obstructions and Limitations - Roof exterior

Information: These photographs are an indication of the obstructions and limitations which impeded full inspection of the property of the roof exterior at the time of inspection. These obstructions can hide an array of defects and should be removed to allow full inspection to be carried out. A re-inspection is recommended once the areas are made accessible.
