# Building and Timber Pest Inspection Report

Inspection Date: Thu, 12 Feb 2026

Property Address: 13 Roebuck Cres, Willmot NSW 2770,  
Australia

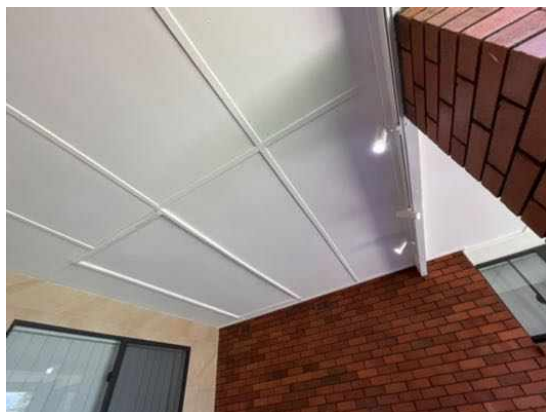
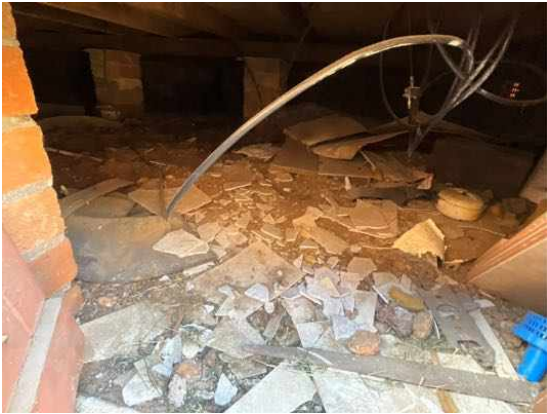
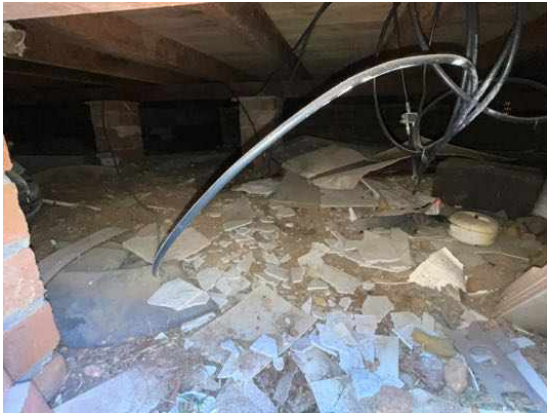
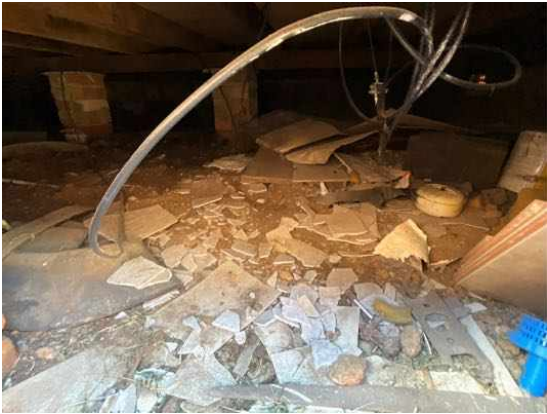
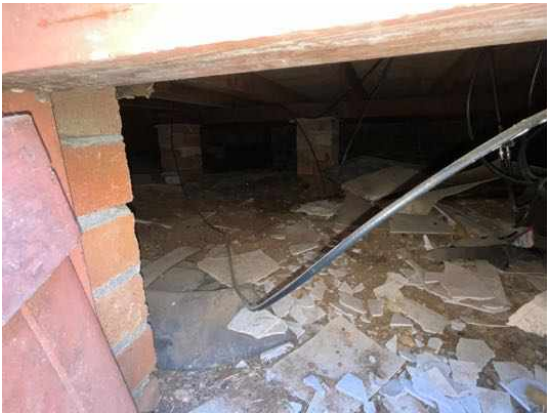
Building:	Main Building
Location:	All Areas
Finding:	Asbestos - Suspected ACM Identified on Site
Information:	Reporting on Asbestos is outside the Scope of this Report. This suspected defect is highlighted as a caution only. We suspect, based on our experience in the building industry, that there is a higher risk of the identified building element containing asbestos.

As Asbestos Reporting is outside the scope of this report, we advise that you consider a separate Asbestos Inspection and Condition Audit, which can include the taking of samples for definitive confirmation of the presence of Asbestos.

In the interim, the client is advised to act with caution, especially when considering any damage to building materials general wear and tear renovations extensions demolition and general maintenance activities due to the suspected presence of Asbestos.

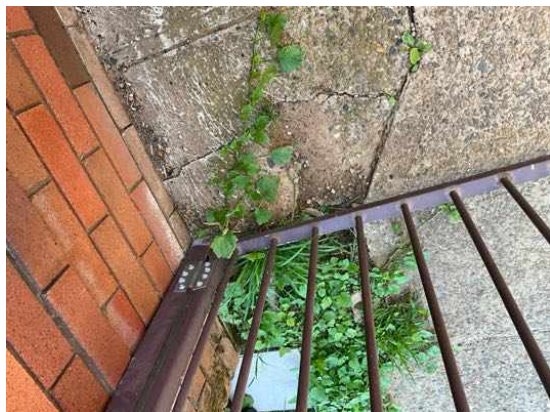
Building: Main Building  
Location: All Areas  
Finding: Noticeable Cracking in Concrete Slab  
Information: Noticeable cracking has been observed in the concrete slab, failing to meet the required construction and quality standards.

- Cracks are visible on the surface and may extend through the depth of the slab.
- Evidence of improper curing or inadequate reinforcement leading to cracking.

- Compromised structural integrity of the slab, potentially leading to failure under load.
- Water ingress through cracks, causing corrosion of reinforcement and further weakening the structure.
- Potential trip hazards and aesthetic issues, reducing the overall value and safety of the property.
- Increased maintenance and repair costs due to ongoing deterioration.

- A structural engineer should be engaged to assess the extent of the cracking and recommend appropriate repair methods.
- A licensed contractor or concrete repair specialist should carry out the recommended repairs under the guidance of the structural engineer.

A detailed inspection should be conducted post-repair to confirm compliance with the required standards and to ensure that the structural integrity of the concrete slab has been restored.

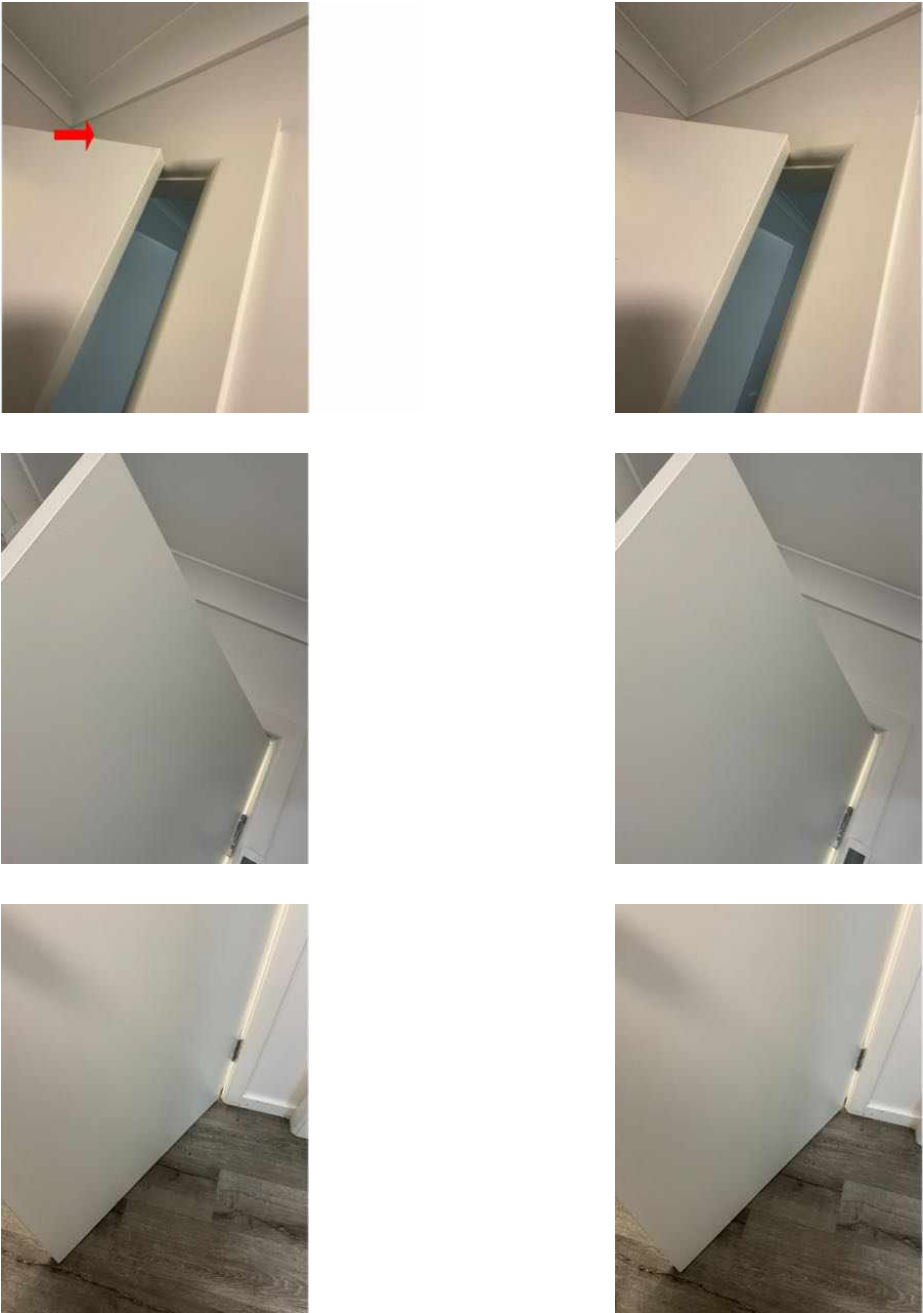
Building: Main Building  
 Location: Front door  
 Finding: Missing Door Stopper  
 Information: The door lacks a stopper, which is essential to prevent the door from swinging too far and potentially damaging the wall or the door handle. The absence of a door stopper increases the likelihood of impact damage to both the door and surrounding surfaces over time.

- **Damage Risk:** Moderate risk of damage to the door handle, wall, or door itself from repeated impacts when the door is opened forcefully or by a gust of wind.
- **Wear and Tear Risk:** Increased wear on door hardware and hinges due to the potential for abrupt stops without a dedicated stopper.

This issue is a minor defect but should be addressed to prevent potential damage and

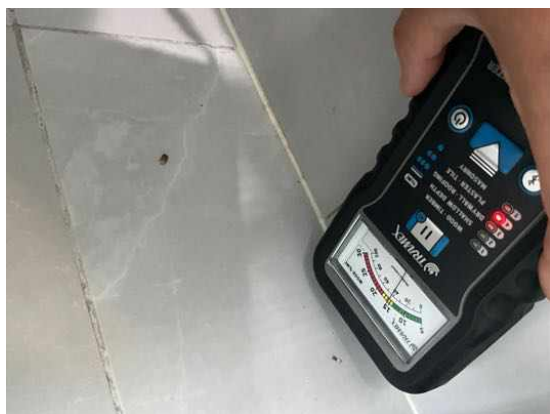
Finding: Shower - Damp  
Information: Damp is evident to the lower 300mm of wall to the shower alcove. This defect is quite common, and is suspected to have been caused by moisture permeating through the grouting in this area, which shows evidence of deterioration. Leaking pipes within the adjoining wall is also a possible cause.

Damp (or structural damp) refers to the presence of unwanted moisture in the structure of a building, either as the result of intrusion from outside, or condensation from within the structure. In the shower area, internal water leaks or other sources of excessive moisture are generally the cause of damp.

Unmanaged damp in the shower recess is likely to facilitate the formation and development of mould and fungi growth, decaying associated building materials and compromising their structural integrity. It is important to address damp conditions, as the World Health Organisation notes that excess moisture leads - on almost all indoor materials - to growth of microbes such as moulds, fungi and bacteria, which subsequently emit spores and other matter into the indoor air. Exposure to these contaminants is associated with a wide range of respiratory and other health-related problems.

Consultation with a qualified plumber or bathroom specialist is advised immediately to identify the cause of damp and to perform remedial works as required. Where excessive mould growth is present, further inspection by a specialist environmental health inspector should also be considered.

Always ensure that sealant and grout is in good condition to prevent any moisture issues occurring in the future.

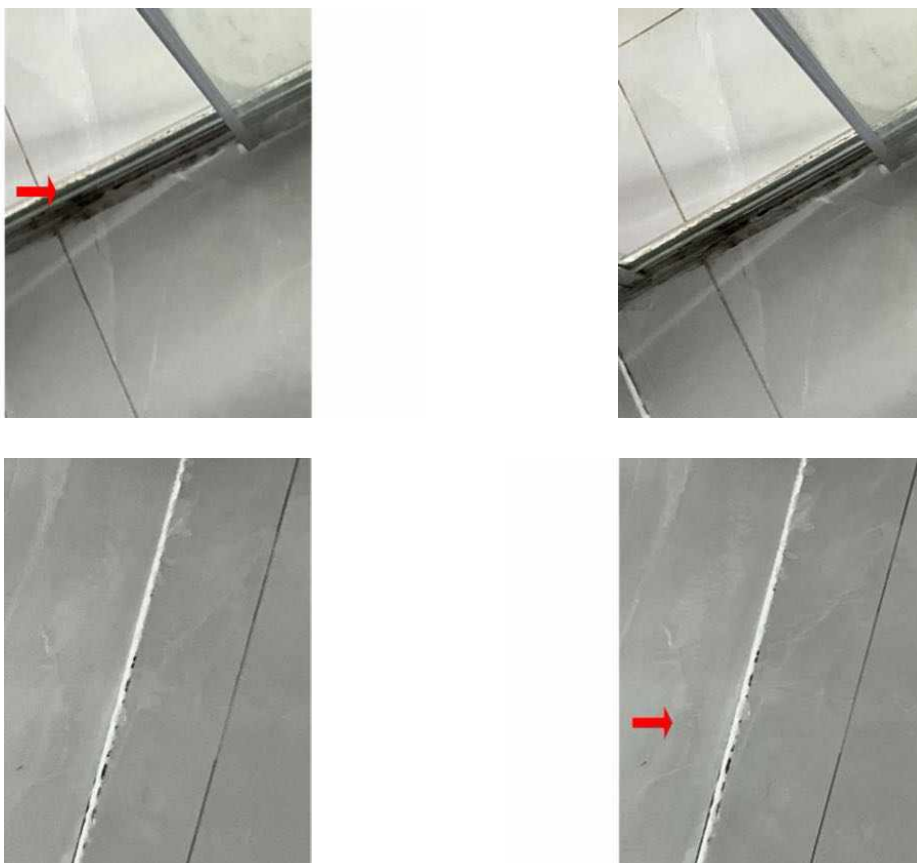
### Finding 3.10

Building:	Main Building
Location:	Bathroom 2
Finding:	Sealant and grouting - Missing or damaged
Information:	It was noted on inspection that sealant or grout is degraded to the tiled shower alcove and or other areas of the bathroom.

Different materials and floor areas move at different rates, generally causing cracking to grout or sealant at this point. A flexible sealant is required to allow for expected expansion and contraction, while keeping the joint water tight and protective of all associated building materials.

There appears to be excessive mould to the sealant and grout which will likely require scraping out and replacement.

Flexible and mould resistant materials should be applied to affected areas to prevent any subsequent water damage that is likely to occur. Regular maintenance and replacement of damage or missing or damaged sealant and grout is highly recommended to the wet areas, as this is a regular wear and tear defect. Sealant and grouting in areas that come into regular contact with water should be maintained for the long term care of your property.

A sealant specialist or tiling contractor should be appointed to complete these works as soon as possible

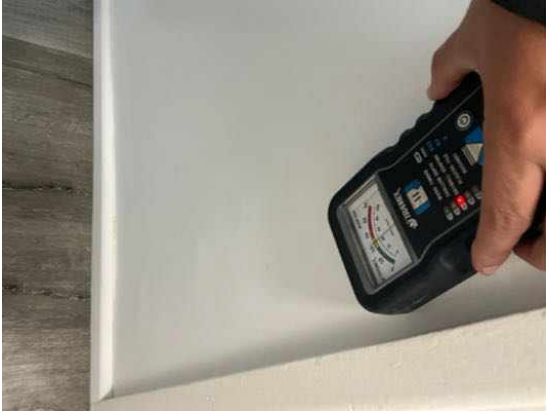
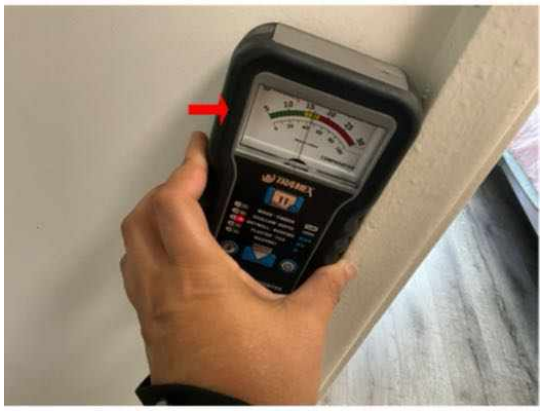
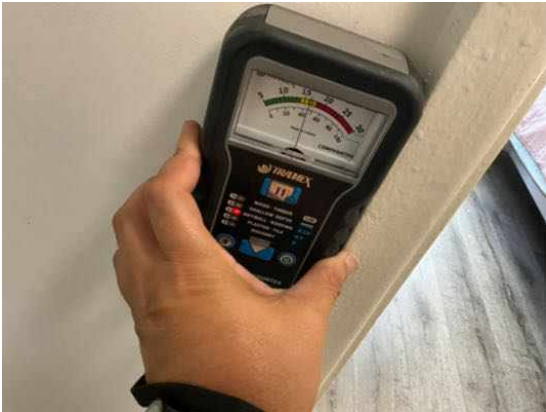
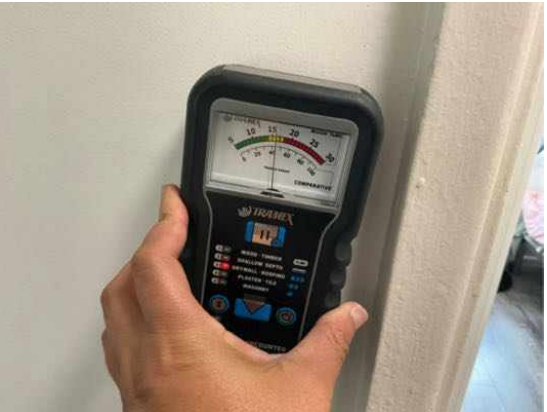
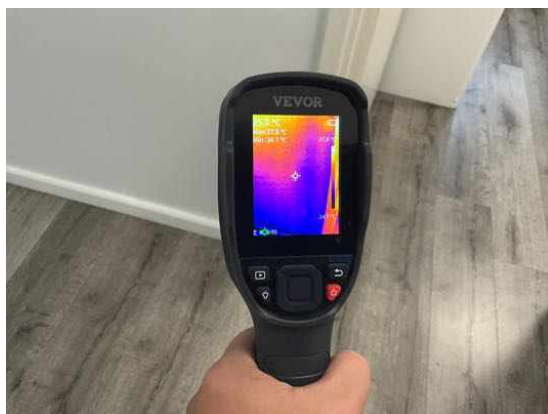
### Finding 3.11

Building:	Main Building
Location:	Bedroom
Finding:	Evidence of excessive moisture - Drywall
Information:	Excessive moisture is present at the time of , indicating a potential water leakage issue within the wall.

The prolonged presence of moisture can lead to mold growth, deteriorate the structure, and create an environment conducive to health hazards. Additionally, it may compromise the adhesive holding the tiles, leading to their detachment.

A licensed plumber or a qualified contractor specializing in water damage remediation should investigate the source of the moisture, fix any leaks, and address the damage. Additionally, replacing affected tiles and ensuring proper waterproofing are crucial to preventing future issues.

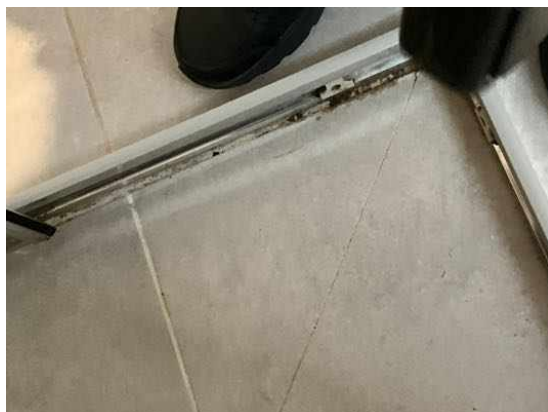
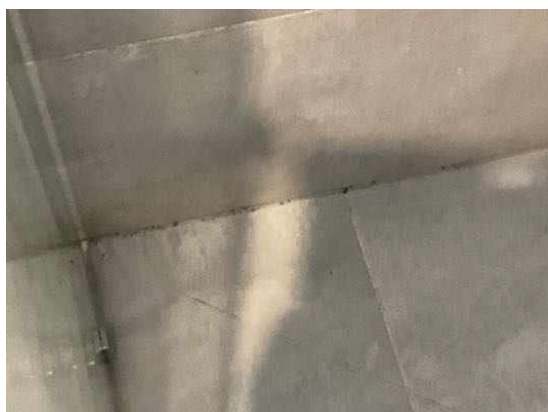
Building:	Main Building
Location:	Bathroom - Granny
Finding:	Sealant and grouting - Missing or damaged
Information:	It was noted on inspection that sealant or grout is degraded to the tiled shower alcove and or other areas of the bathroom.

Different materials and floor areas move at different rates, generally causing cracking to grout or sealant at this point. A flexible sealant is required to allow for expected expansion and contraction, while keeping the joint water tight and protective of all associated building materials.

There appears to be excessive mould to the sealant and grout which will likely require scraping out and replacement.

Flexible and mould resistant materials should be applied to affected areas to prevent any subsequent water damage that is likely to occur. Regular maintenance and replacement of damage or missing or damaged sealant and grout is highly recommended to the wet areas, as this is a regular wear and tear defect. Sealant and grouting in areas that come into regular contact with water should be maintained for the long term care of your property.

A sealant specialist or tiling contractor should be appointed to complete these works as soon as possible

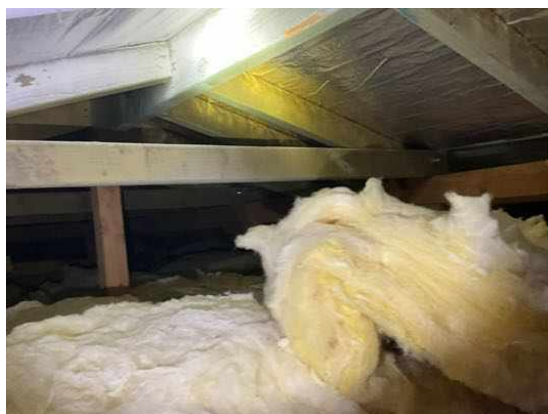
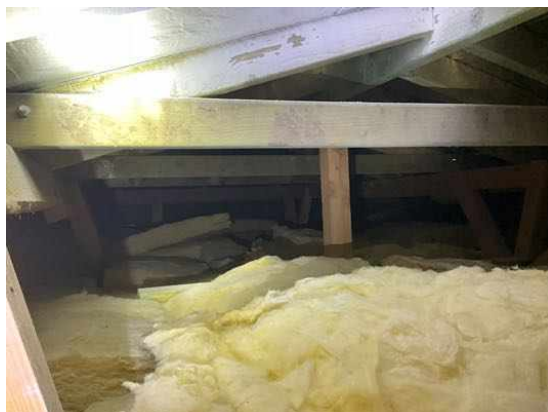
### Finding 3.16

Building:	Main Building
Location:	Roof Void - granny
Finding:	Insulation - Covering downlights
Information:	Sections of insulation in the roof void have been poorly installed or moved from their original position and are covering down light fittings. While the down lights have been fitted with appropriate protective covers, the presence of this insulation creates a potential fire hazard.

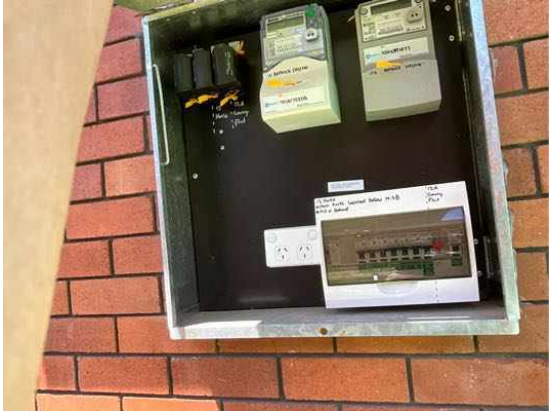
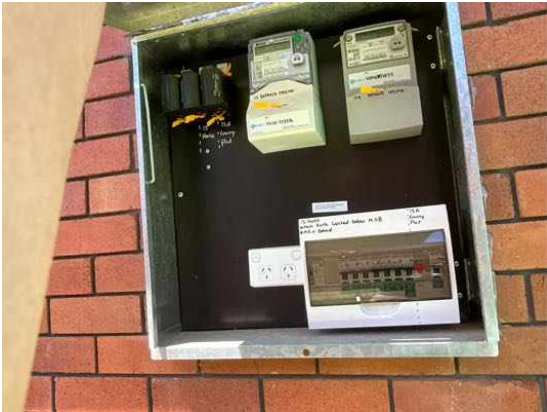
Building: Main Building  
 Location: Exterior walls - left side  
 Finding: No Evidence of Termite Management System - Durable notice / Legible Sticker  
 Information: The application of a pre & post-construction chemical termite barrier is highly recommended for all properties. Such barriers are highly effective in preventing termite attack on any timber building elements throughout the property.

Client must seek further information from the vendor or real estate agent if the

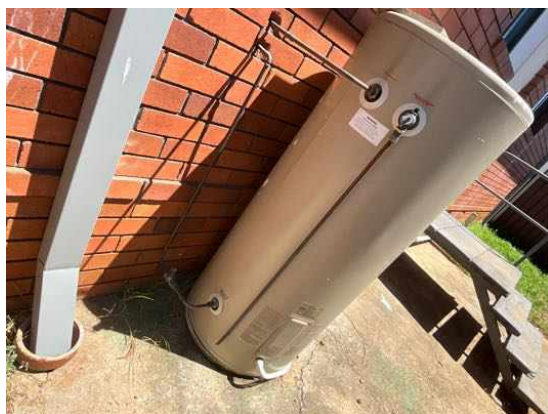
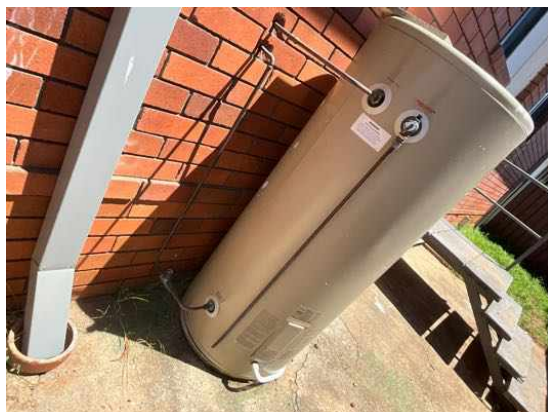
Recommended moving obstructions away from the external walls for further and future inspections.

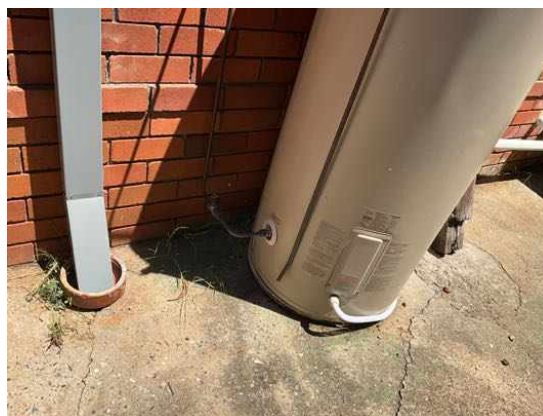
### Finding 6.04

Building:	Main Building
Location:	Exterior walls - rear
Finding:	HWS not connected - conducive conditions for timber pest attacks
Information:	The hot water system (HWS) is not connected, leaving exposed pipes and creating conducive conditions for timber pest attacks.

**Risk of Timber Pest Attack:** The risk of timber pest attack is heightened when the hot water system is not connected. Exposed pipes provide easy access points for timber pests like termites and ants to infiltrate the building structure. These pests are attracted to moisture, and the absence of flowing water through the system can lead to moisture buildup, creating an ideal environment for pests to thrive and cause damage to timber components within the building.

A licensed plumber or qualified plumbing technician should be engaged to reconnect the hot water system. They will assess the existing plumbing infrastructure, determine the appropriate connection points, and ensure proper installation and functionality of the HWS. Additionally, they may inspect for any signs of timber pest activity and recommend preventive measures, such as installing physical barriers or implementing moisture control measures, to deter pest infestations and protect the building from damage. Regular maintenance and inspections by homeowners or property managers are also essential to detect and address potential issues before they escalate.

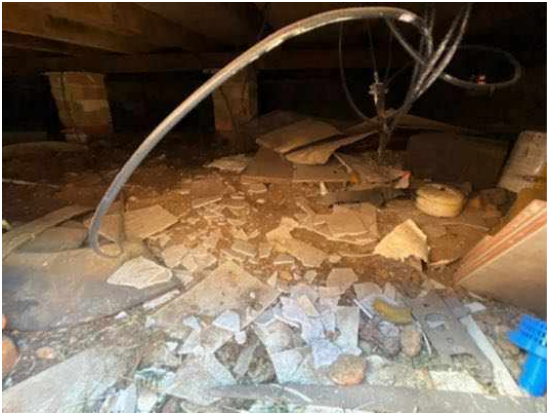
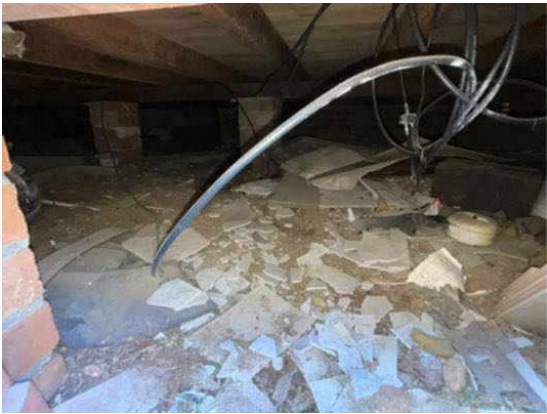
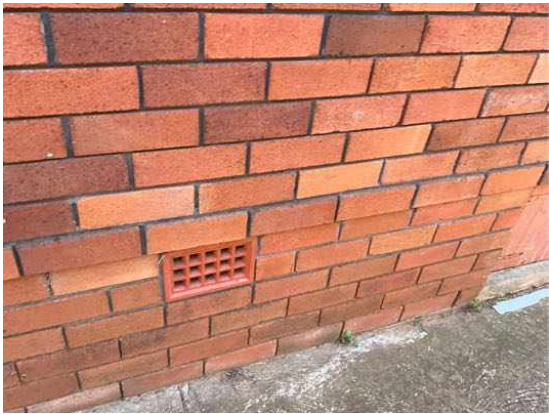
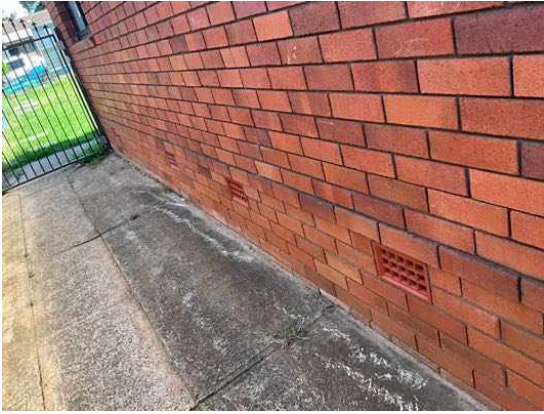
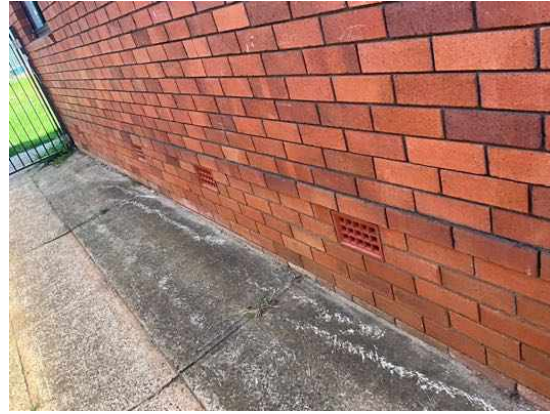
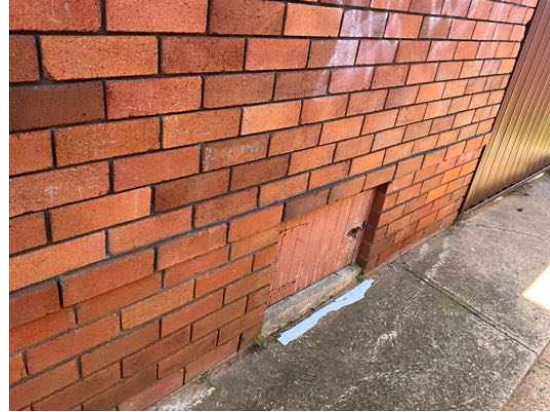
### Finding 6.05

Building:	Main Building
Location:	Subfloor
Finding:	Subfloor - poor ventilation, inadequate site drainage, water stains
Information:	The subfloor lacks adequate ventilation, suffers from inadequate site drainage, exhibits water stains, creating conducive conditions for timber pests such as termites.

Risk: The combination of poor ventilation, inadequate drainage, water stains significantly increases the risk of timber pest infestations. Termites are attracted to moist environments and can thrive in subfloors with high humidity levels and water damage. The lack of proper ventilation and drainage exacerbates moisture retention, providing an ideal habitat for timber pests to establish colonies and cause extensive damage to the subfloor structure. Additionally, water stains indicate previous or ongoing moisture issues, which further attract timber pests and contribute to the deterioration of timber materials.

A licensed pest control professional specializing in timber pest management should be consulted to assess the extent of the infestation and develop a comprehensive treatment plan. They can implement strategies to eliminate existing timber pests, such as termites and prevent future infestations by addressing underlying moisture issues. Additionally, a qualified plumber or builder may be needed to improve subfloor ventilation, enhance site drainage, repair water-damaged areas. Regular inspections and maintenance are essential to ensure ongoing protection against timber pests and maintain the structural integrity of the subfloor.

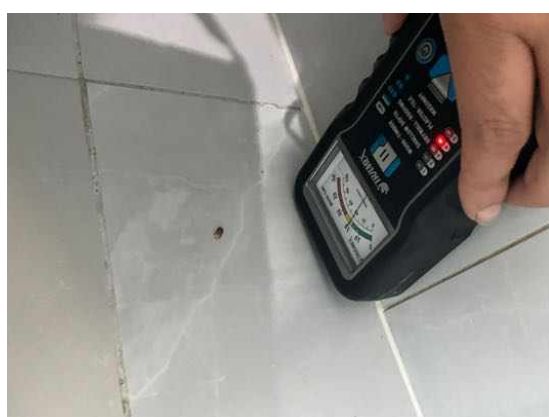
### Finding 6.06

Building:	Main Building
Location:	Bathroom
Finding:	Excessive moisture - Conducive to Timber pest
Information:	Excessive moisture can attract termites and produce conditions that promote fungal growth and wood decay.

Prior to any remedial works being performed a qualified plumber should be appointed to further inspect the property and to identify the cause of the excessive moisture. Works to remove affected building elements may then be necessary and should be performed by an appropriate tradesperson.

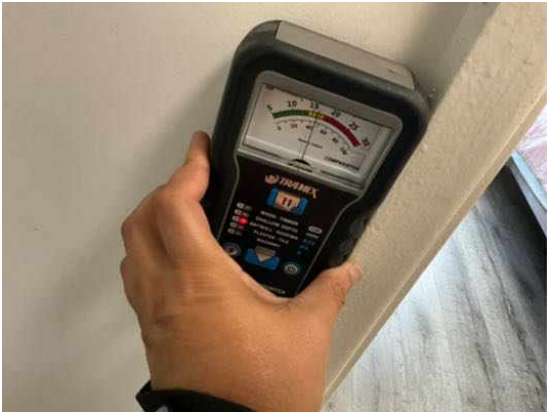
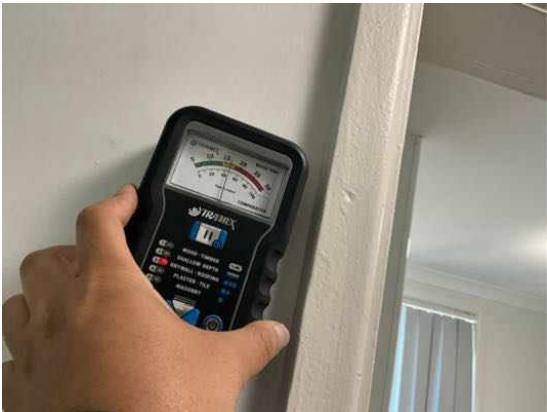
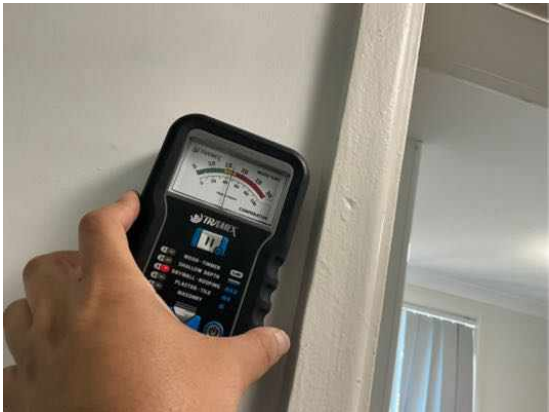
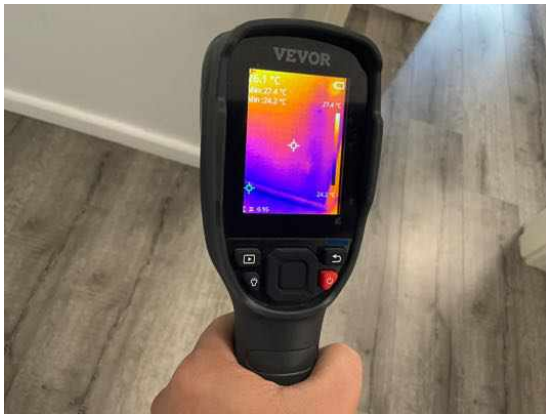
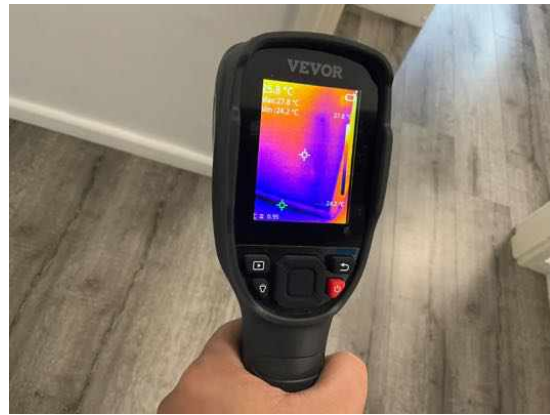
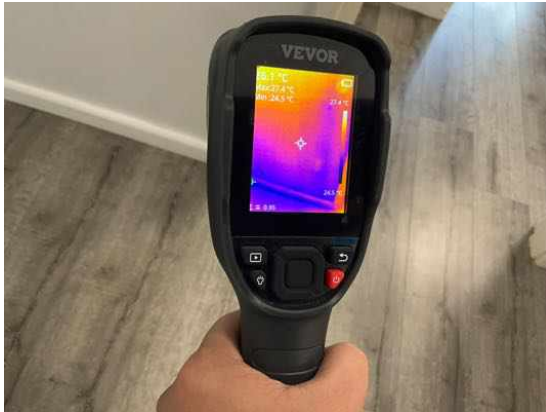
### Finding 6.07

Building:	Main Building
Location:	Bedroom
Finding:	Excessive moisture - Conducive to Timber pest
Information:	Excessive moisture can attract termites and produce conditions that promote fungal growth and wood decay.

Prior to any remedial works being performed a qualified plumber should be appointed to further inspect the property and to identify the cause of the excessive moisture. Works to remove affected building elements may then be necessary and should be performed by an appropriate tradesperson.

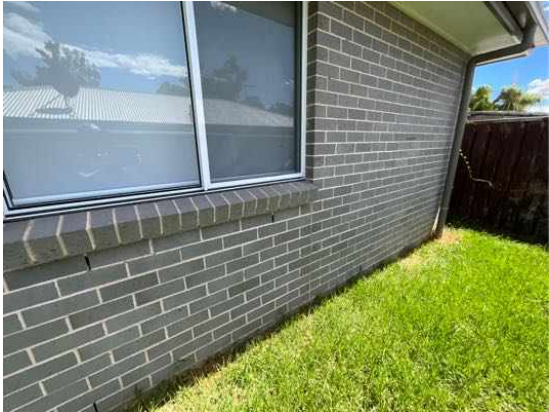
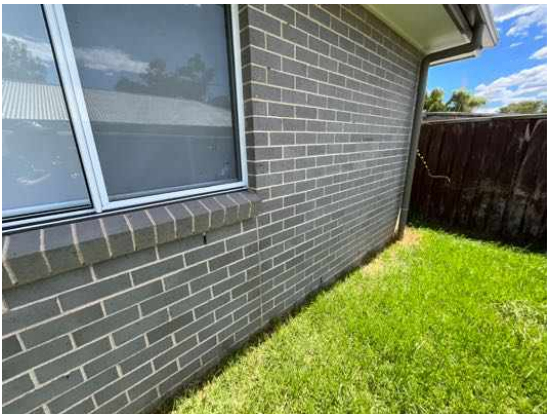
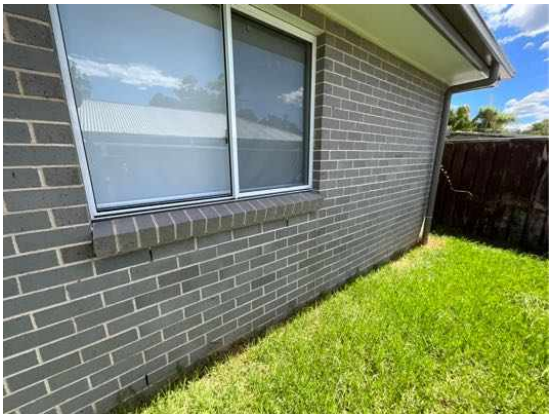
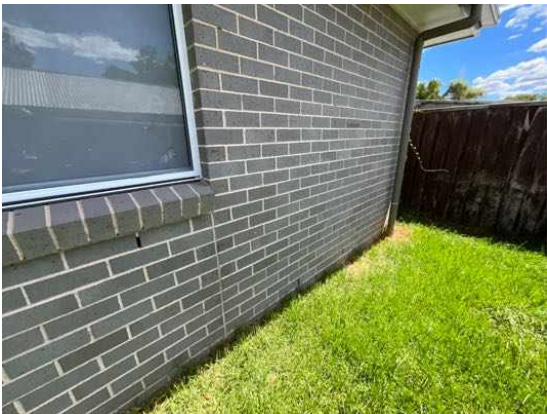
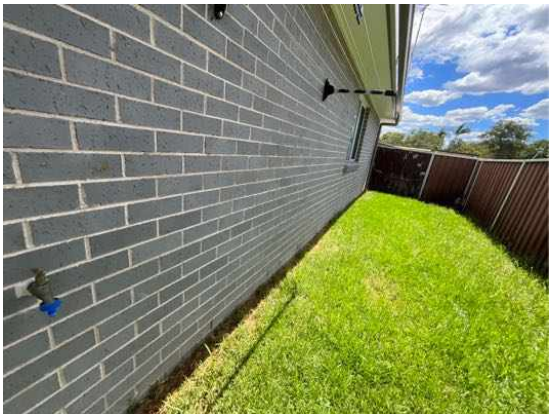
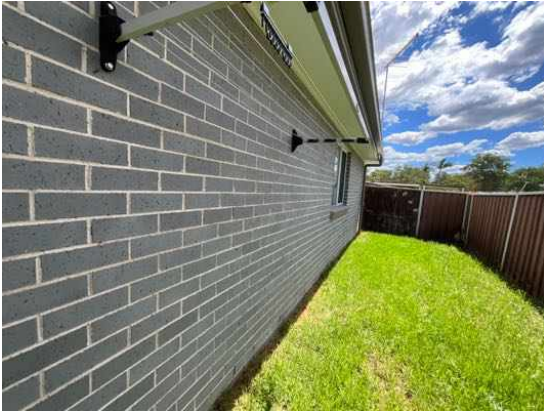
### Finding 6.08

Building:	Main Building
Location:	All Areas -
Finding:	Dense vegetation around a property can increase the risk of termite infestation
Information:	The presence of dense vegetation around a property can increase the risk of termite infestation, as it provides a conducive environment for them. To address this, consider maintaining a clear space between the vegetation and your home. If you suspect a termite issue, it's advisable to consult with a licensed pest control professional for inspection and treatment.

Where the slab edge cannot be properly inspected, it is highly recommended that termite or timber pest inspections be carried out every 6-12 months to aid protection of the property against infestation.

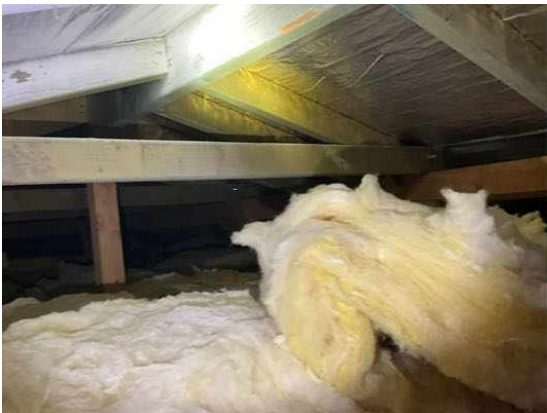
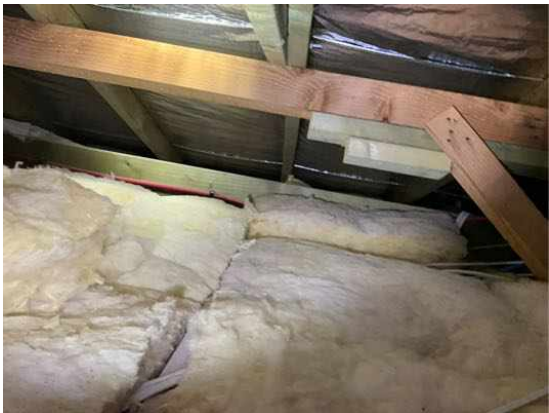
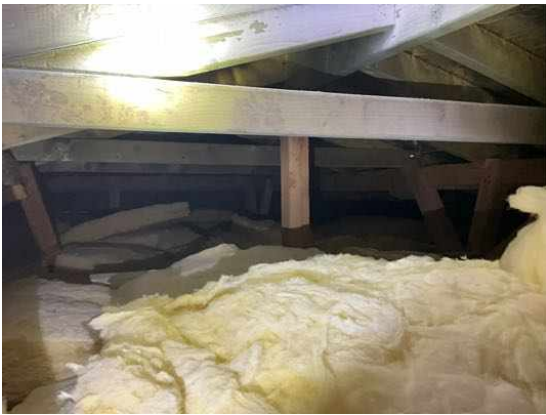
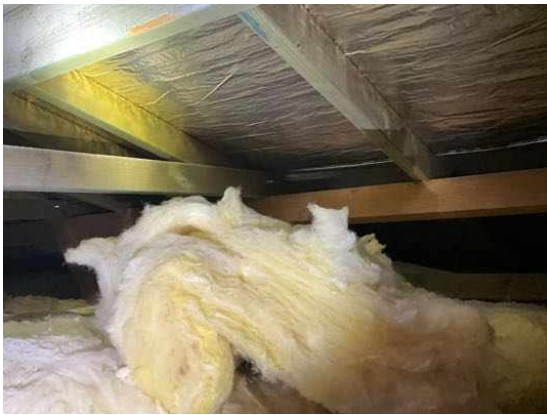
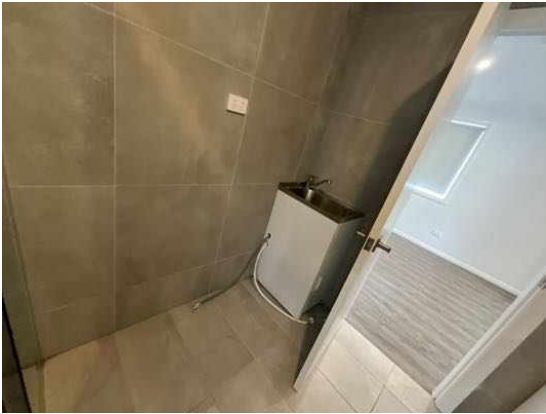
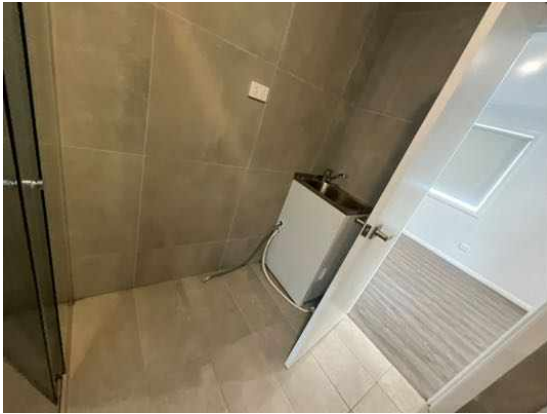
Building: Main Building  
Location: All Areas  
Finding: Additional Photos - Obstructions and Limitations  
Information: These photographs are an indication of the obstructions and limitations which impeded full inspection of the property at the time of inspection. These obstructions can hide an array of defects and should be removed to allow full inspection to be carried out. A re-inspection is recommended once the areas are made accessible.
