# Building and Timber Pest Inspection Report

Inspection Date: Wed, 4 Mar 2026

Property Address: 6 Hughes Ave, Penrith NSW 2750, Australia

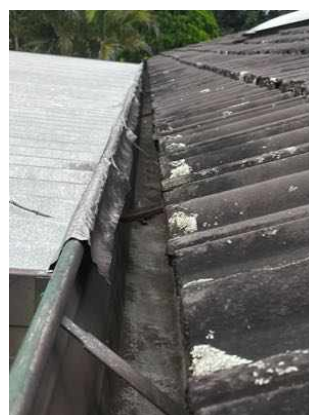
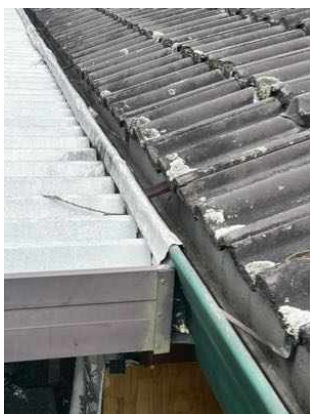
Building: Main Building  
Location: Alfresco roof  
Finding: Flashing defective -poor installation  
Information: Areas of flashing for for the colour bond roof or step flashings have been identified which are missing weathering folds anti-capillary breaks and sealing were identified.

Hence the water has penetrated into the timber sheet roof at the bottom of the alfresco.

Please consult a licensed roofer to inspect and remedy the situation.

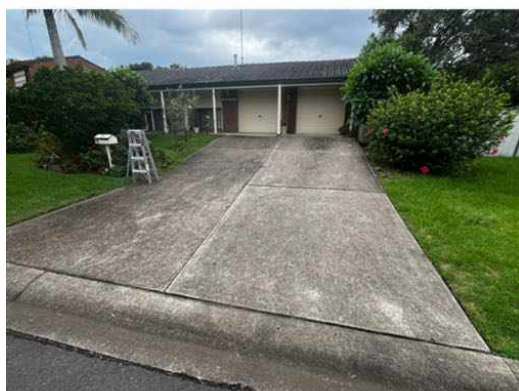
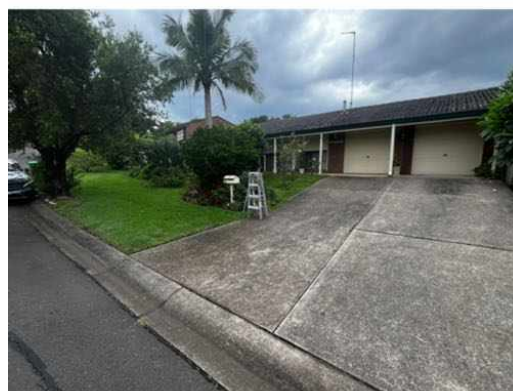
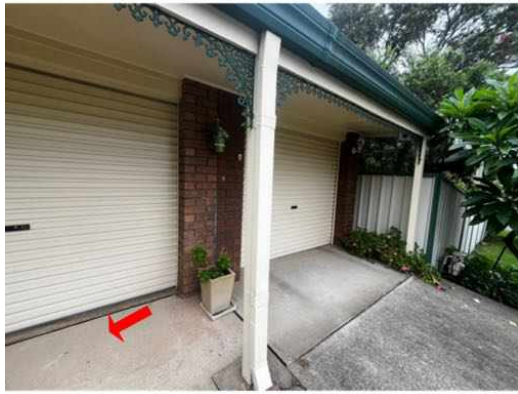
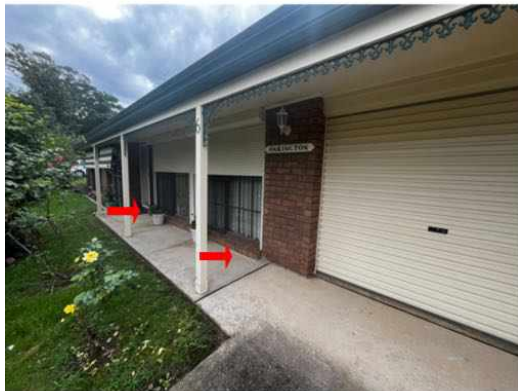
### Finding 3.01

Building: Main Building  
 Location: Driveway  
 Finding: Crack in concrete slab - Category 1  
 Information: A crack coded as Category 1 was identified in the slab. A Category 1 crack is described as a fine but noticeable crack, with the slab at an otherwise reasonable level.

To be considered Category 1, the approximate width of the crack is less than 1.0mm, or a less than 10mm change in offset when a 3m straight edge is placed over the defect.

Category 1 cracks should be monitored for a period of 12 months. At the end of the monitoring period, identified cracks that are rated greater than Category 2 are considered defects, and require rectification.

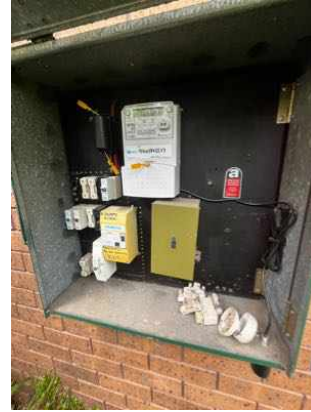
Building:	Main Building
Location:	Electrical Switchboard
Finding:	Termite Management System - no evidence of a chemical installation no Durable Notice
Information:	The application of a post-construction chemical termite barrier is highly recommended for all properties, particularly if live termite activity has been found on the site previously. Such barriers are highly effective in preventing termite attack on any timber building elements throughout the property.

barriers. At the time of inspection, it appeared as though no termite management system has been installed, with no evidence to suggest preventative works taking place.

The client may consider gaining further advice from a pest controller as to the costs and procedures involved with this application. It is recommended that obtaining such advice be a short-term priority.

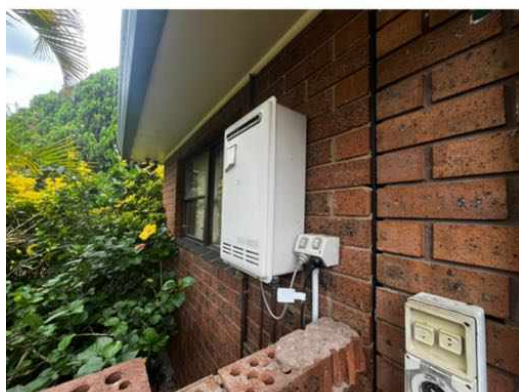
Building: Main Building  
 Location: Yard  
 Finding: Hot Water Unit  
 Information: The HWS appeared to be working in good condition during the inspection.

Water pressure appears to be normal, however, this is not an opinion of a licensed plumber.

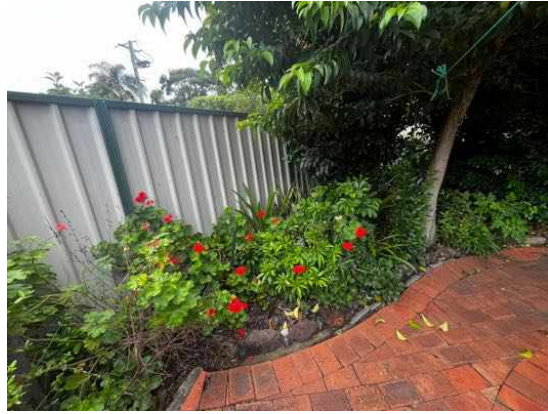
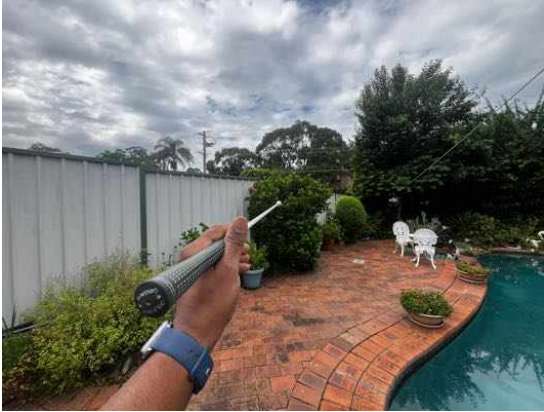
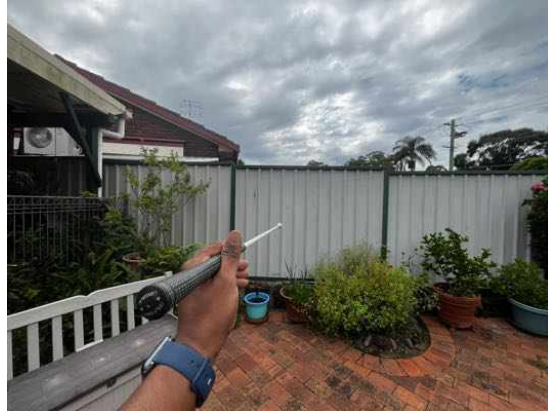
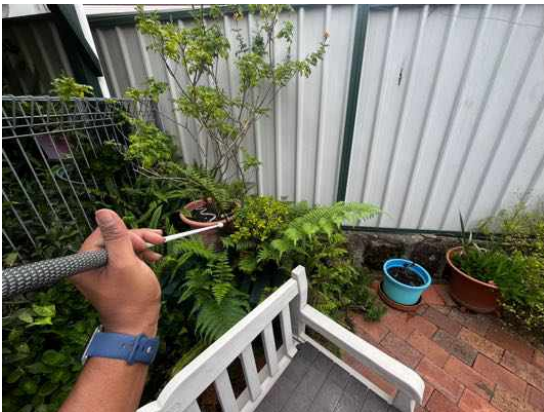
Building: Main Building  
 Location: Yard  
 Finding: Perimeter Fencing - Timber fence/ Colourbond Fence  
 Information: For your information photos taken at the time of inspection - During the inspection the Colourbond fence was inspected and found minor defects/ dents, deterioration but the fence at the back of the property Timber fence inspected.

Please appoint a fence installer to inspect and rectify the same at buyers convenience.

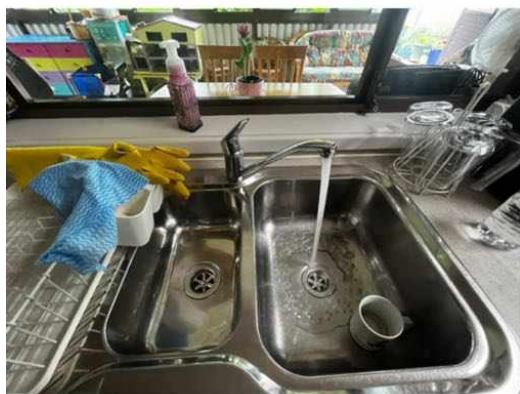
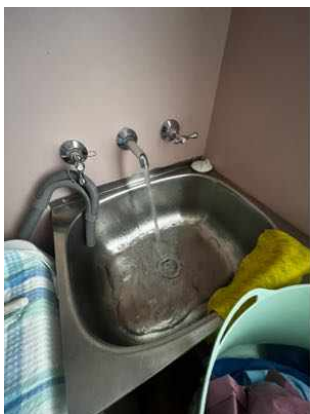
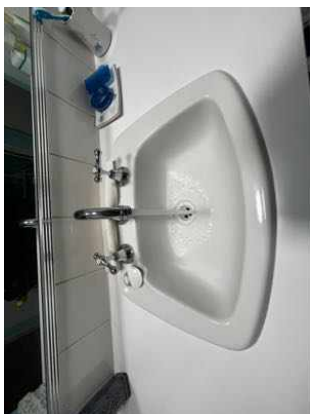
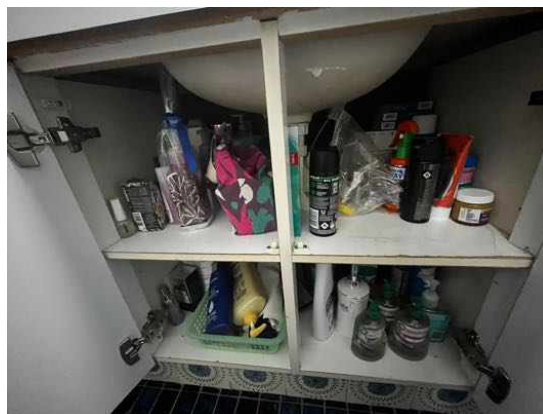
Building: Main Building  
 Location: All Areas  
 Finding: Cabinetry Plumbing - Kitchen/ Pantry cum Laundry  
 Information: Upon Inspection of the Kitchen and the Pantry/ Laundry and BBQ Kitchen all cupboards where sinks and basins with drainage plumbing were inspected and no evidence of leaks were present at the time of inspection.

NOTE: Please be aware that although cupboards have had a thorough inspection, obstructions in cupboards may conceal potential water damage, prevent a full inspection and conditions can change after the initial inspection was carried out, therefore damage may be found after obstructions are removed.

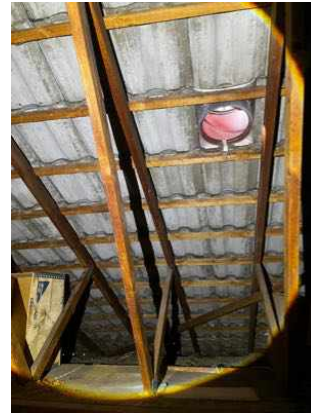
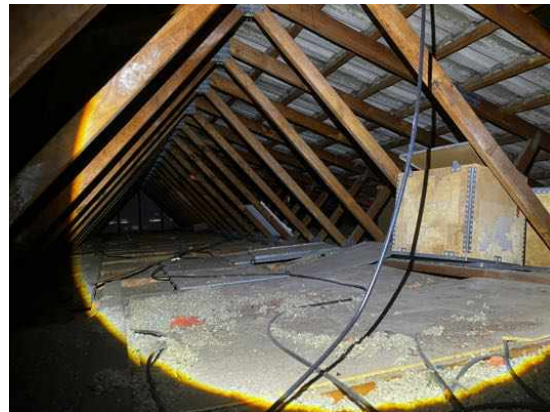
Building: Main Building  
Location: Roof Void  
Finding: Obstructions and Limitations - Roof space

Signs or Rust in the roofing sheets are visible during inspection. For a longevity of the structure and the property the buyer can consider replacing the rusted sheets if preferred.

These obstructions can hide an array of defects and should be removed to allow full inspection to be carried out.

A re-inspection is recommended once the areas are made accessible.

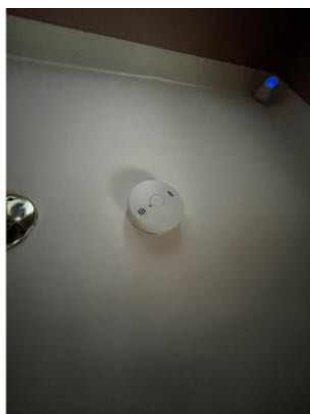
Building: Main Building  
 Location: All Internal Areas  
 Finding: Smoke Detector and Alarms  
 Information: Reporting on Smoke Detectors or Alarms, including hard wired smoke detection systems and their legislative requirements, is outside the Scope of this Report.

Additionally, it is advised that all smoke detectors be tested by the homeowner on a monthly basis.

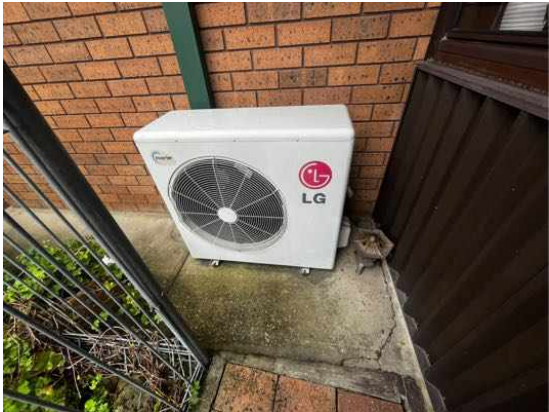
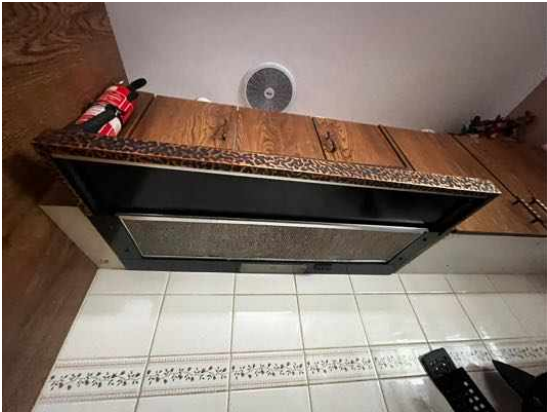
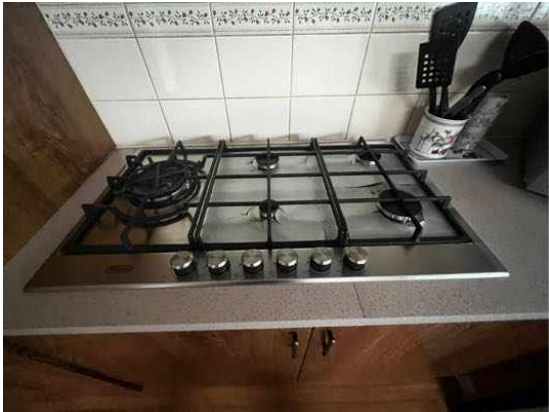
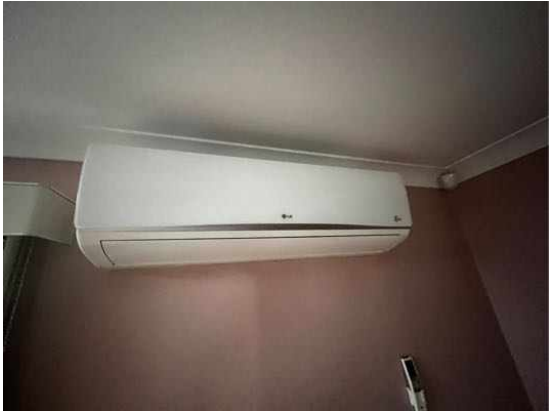
Building: Main Building  
 Location: Kitchen/ Laundry Bathroom  
 Finding: Plumbing/electrical/gas/aircon/appliances/pool equipment/fire safety etc  
 Information: Plumbing and electrical inspections are outside the scope of the building inspection and must be conducted by a Licensed and registered Trades person.

It is highly recommended that the client makes immediate arrangements to have the gas appliances checked by a licensed gas plumber to ensure that the appliances are working safely and efficiently.

We recommend all other installations be checked also.
