Building and Timber Pest Inspection Report

Inspection Date: Wed, 21 Jan 2026

Property Address: 39 Lachlan Cres, St Georges Basin NSW
2540, Australia

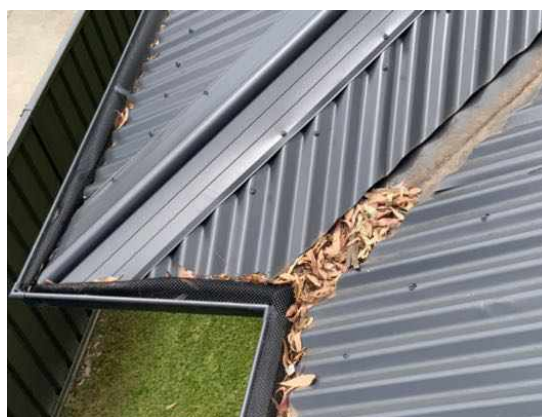
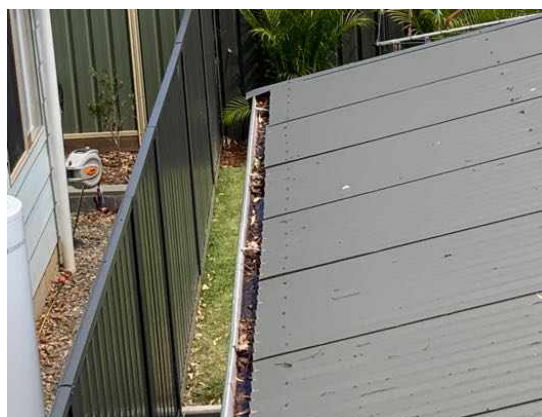
Blocked gutters are likely to lead to high levels of moisture in the affected areas. Such moisture will not only cause rust and decay of the associated building materials, but can also provide conditions that are conducive to termite and timber pest activity. Blockages in gutters should therefore be removed immediately to ensure dry conditions are maintained.

Consult a Licensed Plumber for further specific advice on remedial works that may be required. In the interim, it is highly advised that blocked gutters be removed by the homeowner or a general handyperson as a matter of urgency.

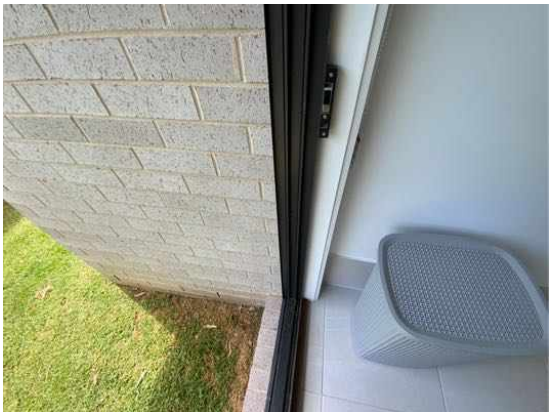
Building:	Main Building
Location:	All Areas
Finding:	Flyscreens - Missing to External Sliding Doors
Information:	Flyscreens were found to be missing to the windows in this area at the time of inspection. Whether the flyscreens have not been installed or have been removed post-installation, this missing building element detracts from the operational state of the window.

Where not replaced, missing flyscreens allow pest and insect ingress into the adjoining room/s. It is advised that all missing building elements be replaced in order to ensure the full function of all building structures.

A general handyperson may be appointed to replace flyscreens at the discretion of the client.

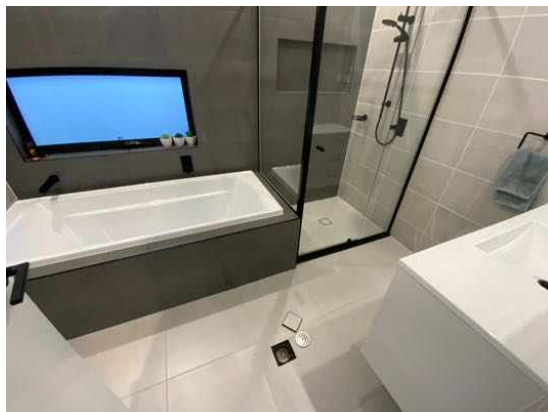
Finding 3.06

Building: Main Building
Location: Laundry & Bathroom
Finding: Installation - substandard or incomplete (Floor drain blocked)
Information: The installation of this building element appears to have been completed to a substandard level of workmanship or is incomplete. Generally substandard repairs or installation are related to poor workmanship, the use of inappropriate materials, or a failure to complete installation to a suitable standard.

Where installation is substandard and/or incomplete, the client should contact the responsible trade to undertake rectification. Unfinished and substandard building works are likely to degrade more quickly and may create potential for secondary defects to associated building elements.

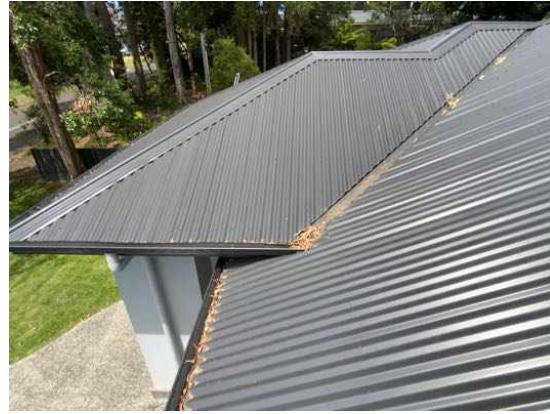
Blocked gutters are likely to lead to high levels of moisture in the affected areas. Such moisture will not only cause rust and decay of the associated building materials, but can also provide conditions that are conducive to termite and timber pest activity. Blockages in gutters should therefore be removed immediately to ensure dry conditions are maintained.

Consult a Licensed Plumber for further specific advice on remedial works that may be required. In the interim, it is highly advised that blocked gutters be removed by the homeowner or a general handyperson as a matter of urgency.

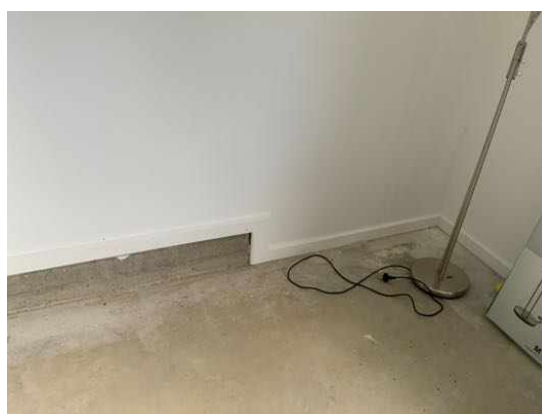
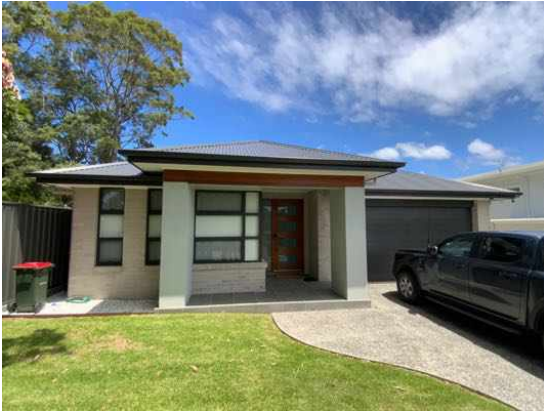
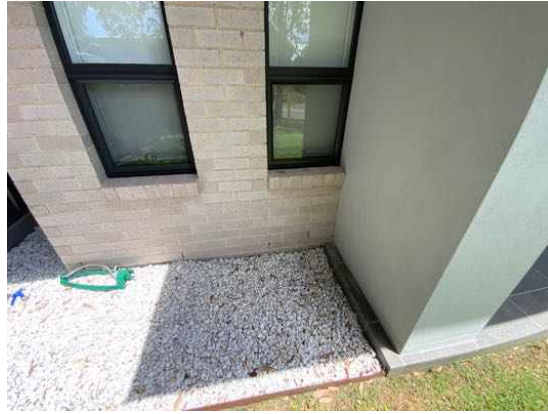
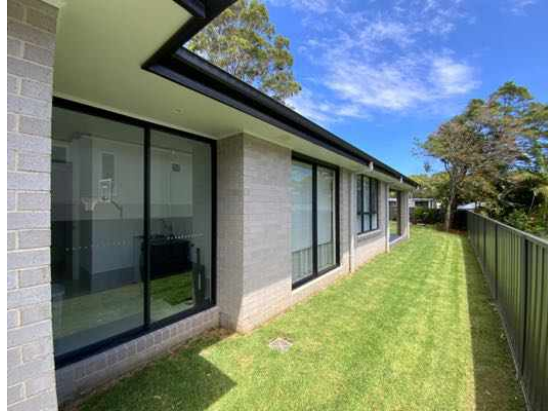
If the slab edge is not properly exposed there is a high risk of termite attack. Sometimes, in order to determine the type of slab, a suitably qualified person such as an architect or builder may be required to consult the construction plans.

Where the slab edge cannot be properly inspected, it is highly recommended that termite or timber pest inspections be carried out every 6-12 months to aid protection of the property against infestation.

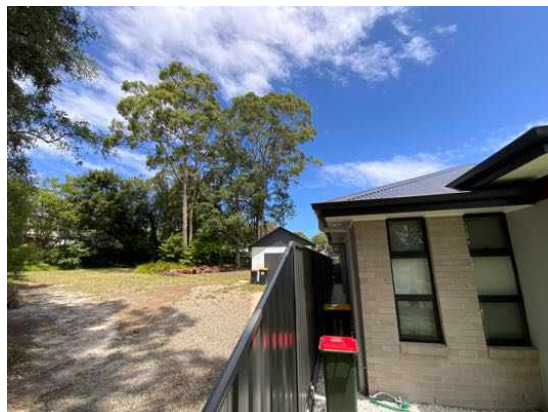
Finding 6.08

Building: Main Building
 Location: All Areas
 Finding: Trees within 50m of the property
 Information: Trees within 50m of the property can be conducive to termite activity. It is recommended an invasive inspection of all trees with 50m to the property be carried out by a qualified pest control expert.

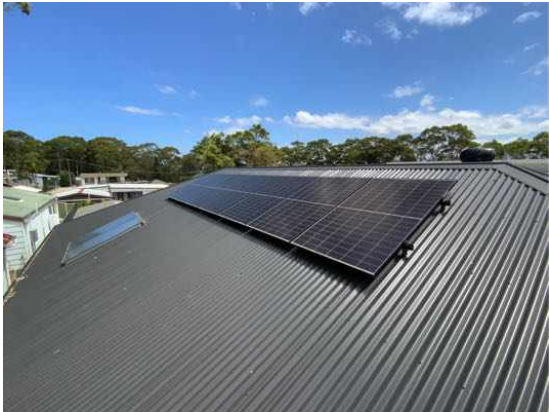
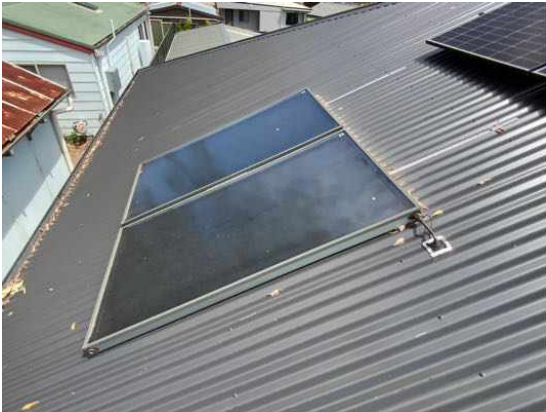
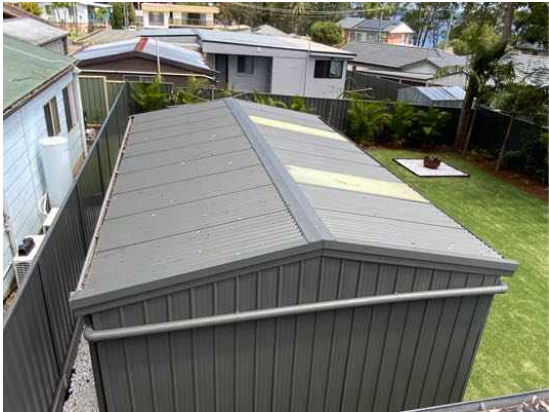
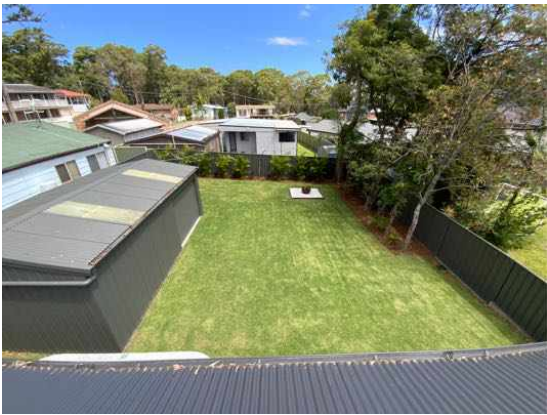
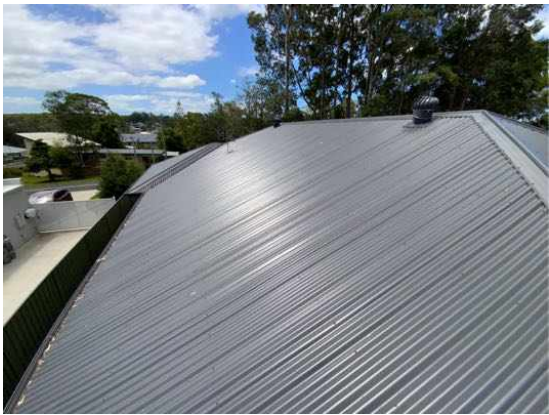
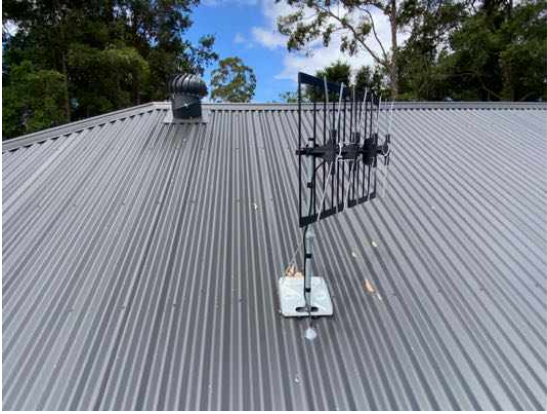
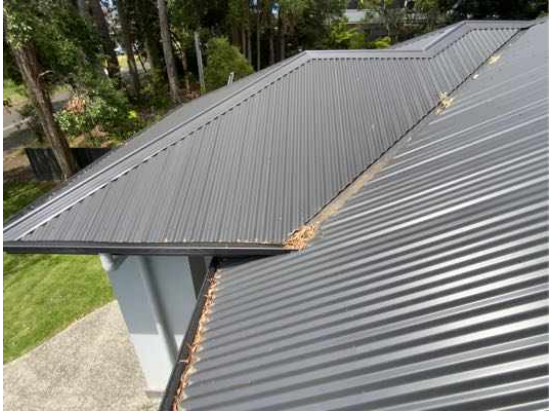
Building: Main Building
Location: Roof Exterior
Finding: Additional Photos - Obstructions and Limitations
Information: These photographs are an indication of the obstructions and limitations which impeded full inspection of the property at the time of inspection. These obstructions can hide an array of defects and should be removed to allow full inspection to be carried out. A re-inspection is recommended once the areas are made accessible.

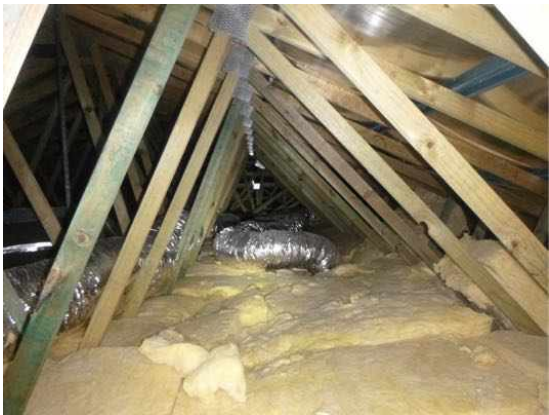
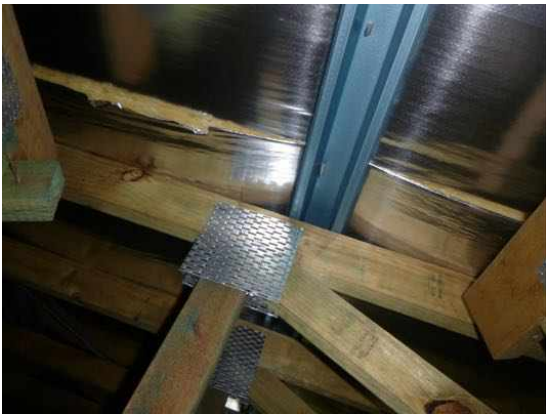
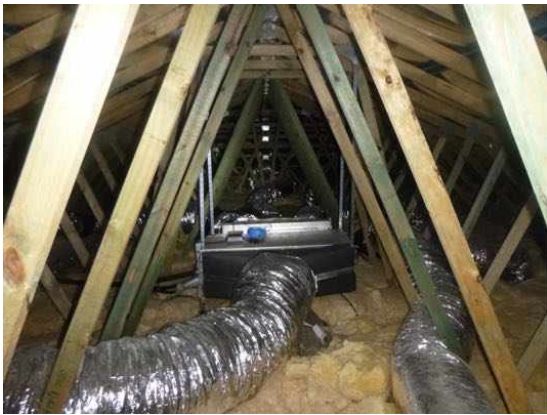
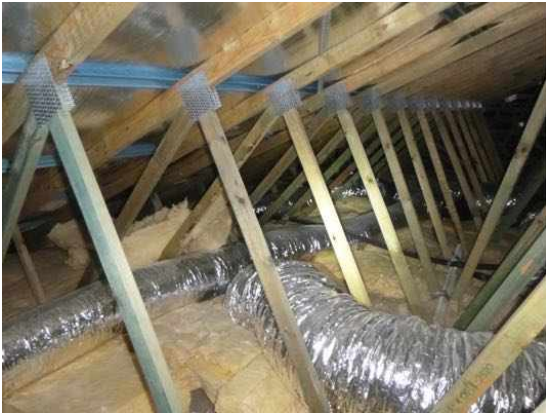
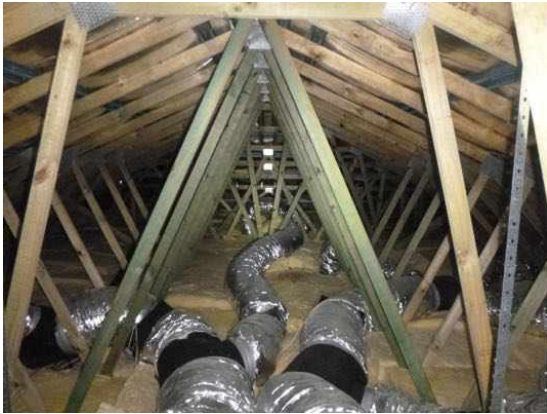
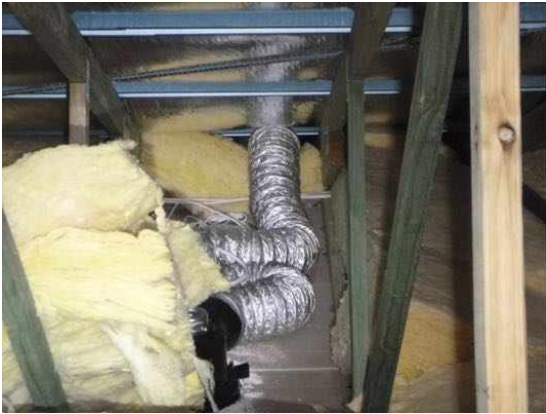
Building: Main Building
Location: Roof Void
Finding: Additional Photos - Obstructions and Limitations
Information: These photographs are an indication of the obstructions and limitations which impeded full inspection of the property at the time of inspection. These obstructions can hide an array of defects and should be removed to allow full inspection to be carried out. A re-inspection is recommended once the areas are made accessible.

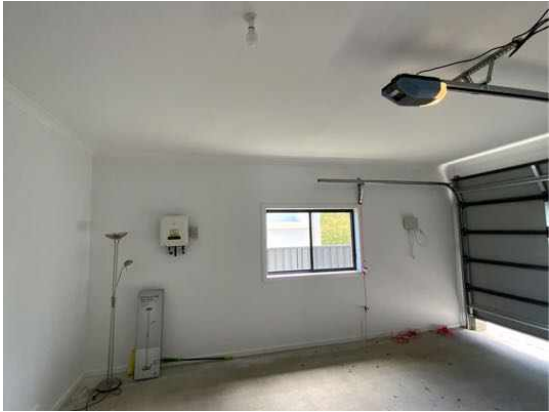
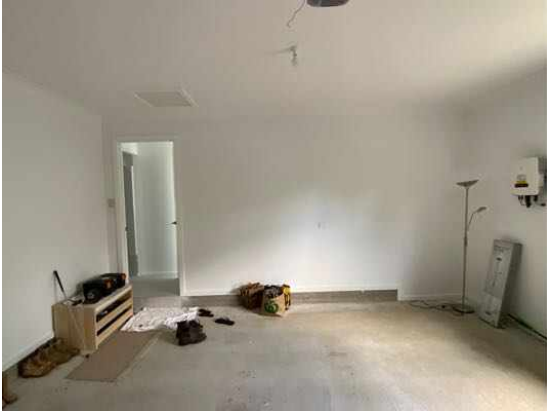
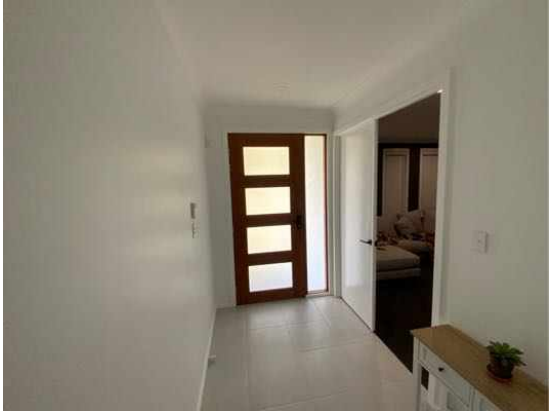
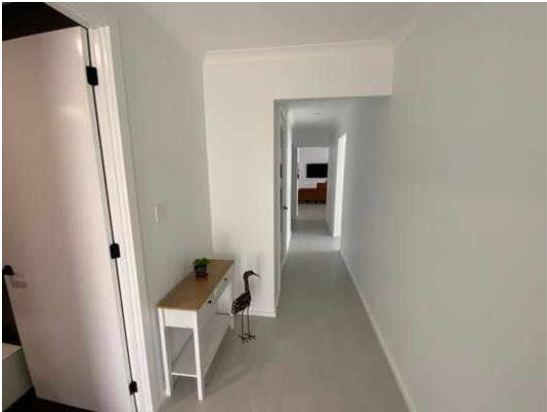
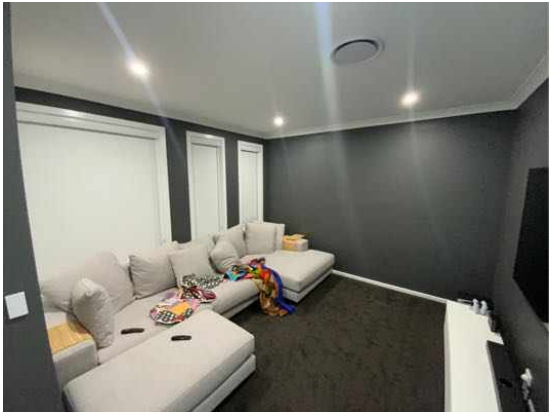
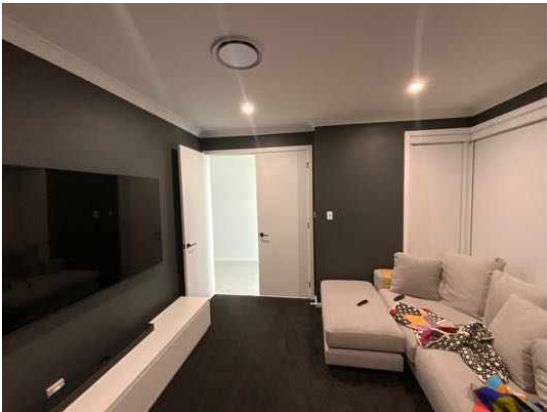
Building:	Main Building
Location:	All Areas
Finding:	Additional Photos - Obstructions and Limitations
Information:	These photographs are an indication of the obstructions and limitations which impeded full inspection of the property at the time of inspection. These obstructions can hide an array of defects and should be removed to allow full inspection to be carried out. A re-inspection is recommended once the areas are made accessible.
