Building and Timber Pest Inspection Report

Inspection Date: Tue, 31 Mar 2026

Property Address: 3/160 Cooper Rd, Yagoona NSW 2199,
Australia

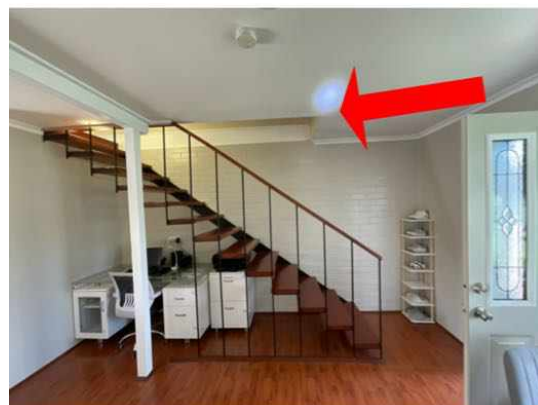
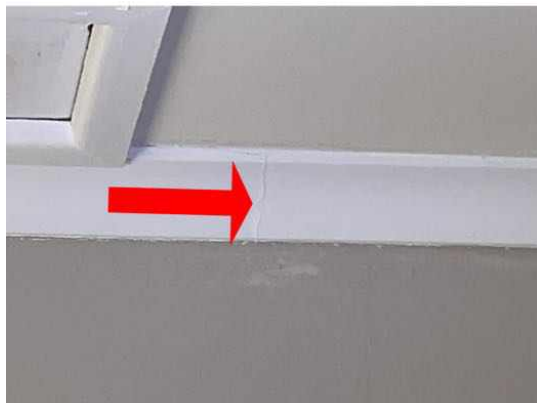
Building:	Main Building
Location:	All Internal Areas
Finding:	Cracking - Damage Category 1 - Fine (up to 1mm)
Information:	Although fine cracks are quite noticeable, they are often only considered to be an appearance defect, and usually do not indicate any structural damage. Generally, the cause of a fine crack is indicative of a separation between building materials and finishes (e.g. paint, plaster, etc.) along joins.

Cracking of this nature can generally be repaired with minor sanding, filling and/or repainting. Such works should be performed by a qualified painter or a general handyman.

Monitoring of all cracking should be conducted frequently. Always contact a building inspector should cracks widen, lengthen, or become more numerous.

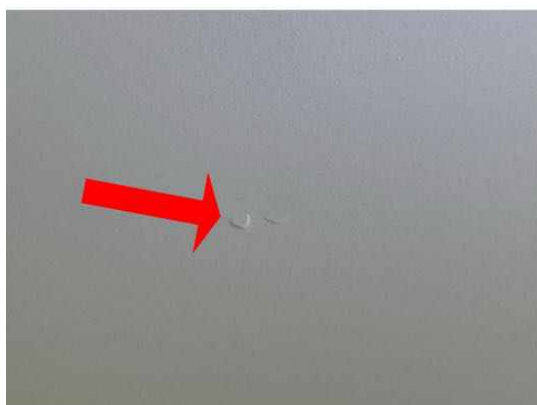
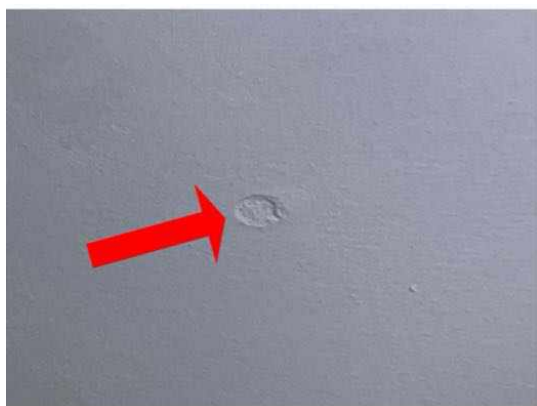
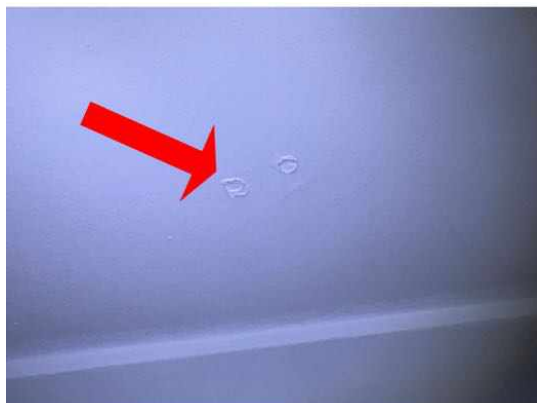
Finding 3.02

Building: Main Building
 Location: All Internal Areas
 Finding: Ceiling nails - Popping
 Information: Numerous popped nails were identified in the internal ceiling at the time of inspection. Nails and screws hold simply by the friction between them and the surface they are applied to. Over time, the nails and screws can back out, which is often a result of general ageing and deterioration of the building structure.

If left unmanaged, the ceiling sheets may become loose and unstable, increasing the rate of deterioration of the internal ceiling and creating potential for the development of secondary defects.

Re-fastening of popped nails will help to maintain the stability of the internal ceiling and associated building elements. Such minor works will also help to improve the appearance of the affected area and secure the ceiling sheets, so as to prevent the onset of ceiling sagging. These works should be performed by a qualified carpenter or plasterer at client discretion.

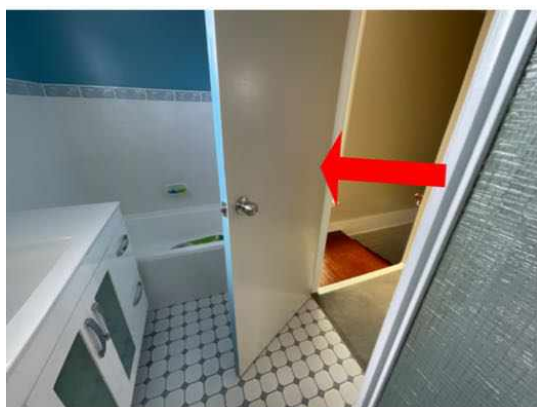
Building: Main Building
 Location: Bathroom
 Finding: Door frames - not square
 Information: It appears that one and / or more doors have been installed in a manner which is not consistent with acceptable standards of workmanship. The door frames are not square and or plumb and require rectification.

Deviation from the manufacturer's installation instructions is considered a defect with reference to Standards and Tolerances.

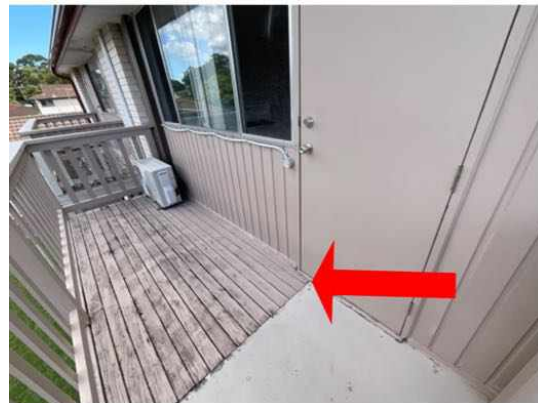
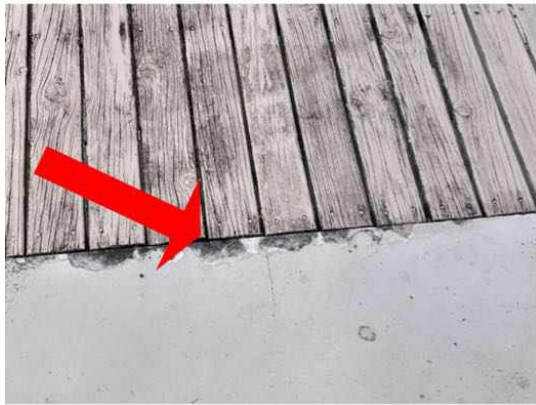
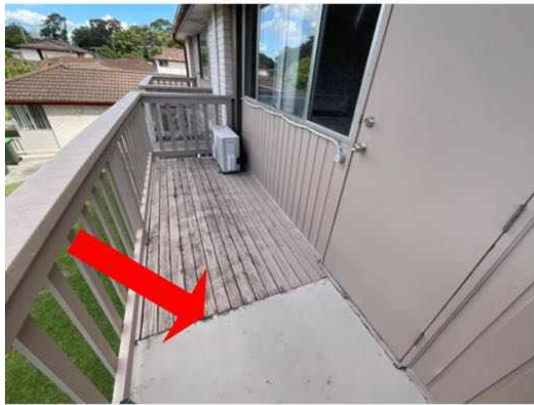
Finding 3.06

Building:	Main Building
Location:	Balcony
Finding:	Decking flooring - damaged
Information:	Damages to decking flooring were found during inspection. The decking timber flooring is typically resistant to water damage, but standing water and large amount of moisture as well as the weathers can eventually destroy the floor and delaminate the product.

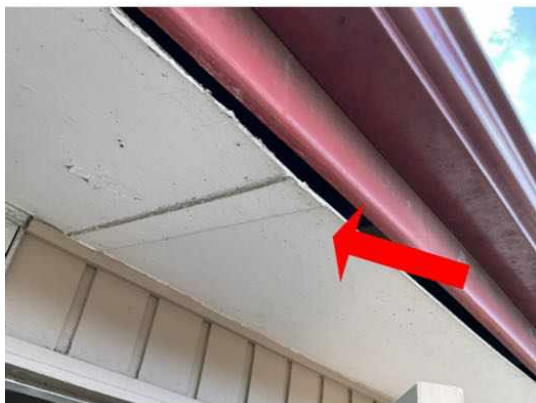
Finding 3.07

Finding: Eaves - Damaged

Information: The eaves around the external property were found to be in a visibly poor condition. The damage may have been sustained as a result of a number of possible causes, including poor roof drainage, leaking roof plumbing or minor impact damage.

The damage to the eave sheeting in this area detracts from the appearance of the structure, as well as potentially compromising the structural integrity of the roofing area.

Where eaves show moderate to severe damage, remedial works may be required. Where water damage is suspected as being the underlying cause, appointment of a licensed plumber is advised as a matter of urgency to identify the source of the water leak.

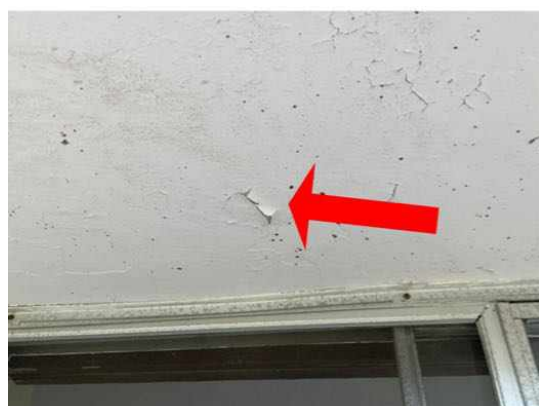
Finding 3.08

Information: Sections of paint in this area was found to have bubbled and deteriorated. Paint bubbling is generally an indication of excessive moisture in the area, that is currently hidden by the painted surface.

The presence of excessive moisture can have major implications on associated building elements if left unattended. While only seemingly minor at this stage, the damage cannot be determined due to the paint obstructing any further inspection of the damage.

It is highly advised that the affected paint be cleaned to allow a further, more invasive inspection by a licensed plumber. Failure to act on this defect may necessitate major works in the future.

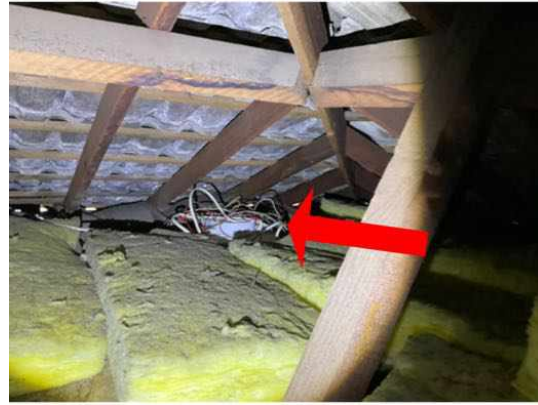
Finding 3.09

Finding: Extractor Fan - Vented into Roof Space

Information: The bathroom extractor flue was found to lead directly into the roof space, rather than venting to the exterior of the building. The positioning of this flue is likely to lead to a build-up of grease and grime in the surrounding area within the ceiling void, which can pose as a fire hazard in the roof void. The presence of insulation surrounding the flue adds to this fire safety risk. Without re-direction to the exterior of the building, the Rangehood is not considered fully operational and is deemed a minor safety hazard. It is therefore preferable that the flue be re-directed to vent into the external environment. A licensed plumber should be appointed as soon as possible to provide further consultation on the scope of these works and to provide quotations for any necessary works.

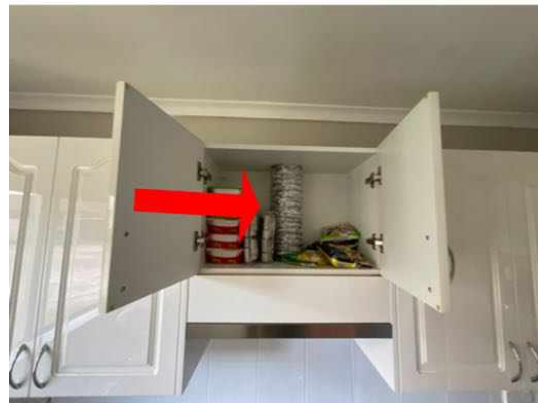
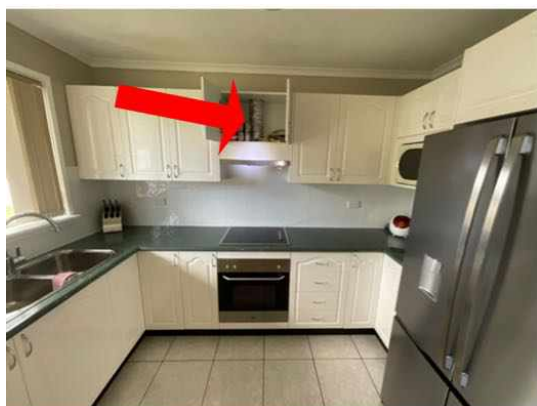
Finding 3.10

Building:	Main Building
Location:	Kitchen
Finding:	Rangehood - Flue disconnected
Information:	The range hood flue has become disconnected and is allowing the emission of steam and evaporative moisture into the ceiling space above.

While this does not create high potential for secondary defects, development of grease is likely to occur in the surrounding area, necessitating regular cleaning and maintenance.

Consultation with a licensed electrician may be required to reconnect the flue and thus allow the emission of gases into the external environment. Works should be completed at client discretion.

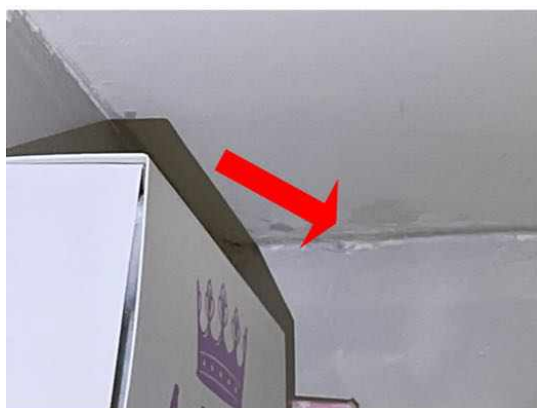
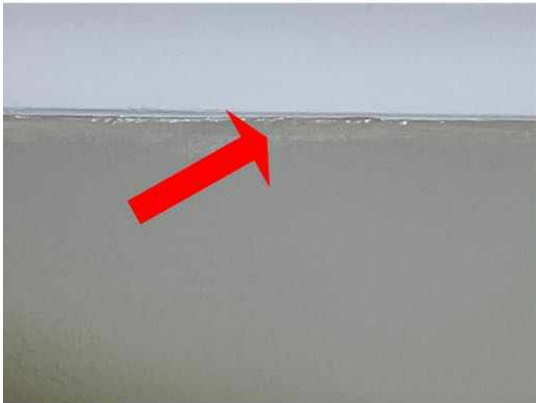
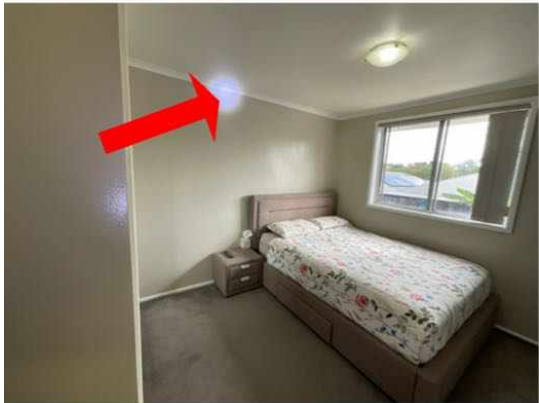
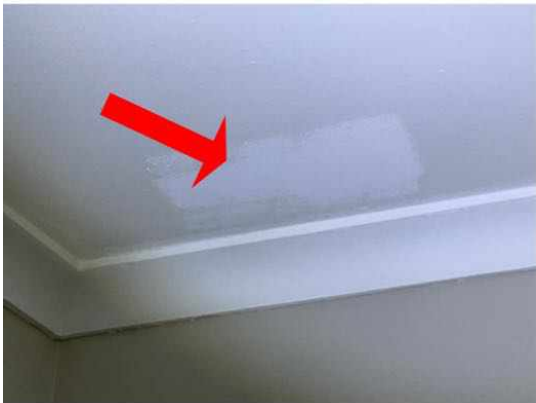
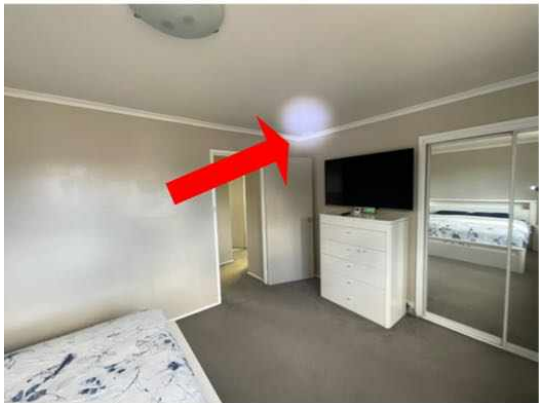
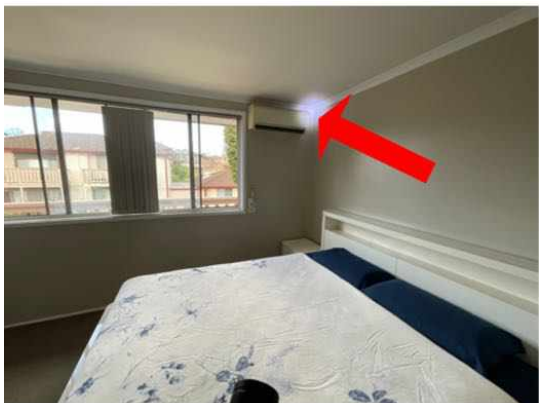
Finding 3.11

Building:	Main Building
Location:	All Internal Areas
Finding:	Paint finish - Substandard
Information:	The paint finish in this area was found to have been completed to a substandard level. Substandard painting is generally classified as an appearance defect. However, the substandard appearance may also be indicative of poor surface preparation and substandard workmanship.

If this applies, further areas of poor and incomplete finishes could develop over time. Furthermore, substandard paint finishes in areas exposed to moisture, e.g. external areas or wet areas, could lead to deterioration of underlying building materials.

Substandard paint finishes should be sanded back, filled, leveled and repainted, as applicable. Where inadequate paint protection has led to the deterioration of the associated building element, repair and/or replacement of this building element may be required.

A painting contractor should be appointed as soon as possible to perform necessary works to aid the appearance of the affected area and to ensure that the area is protected against further deterioration. Alternatively, the homeowner following manufacturer instructions may be able to provide this service.

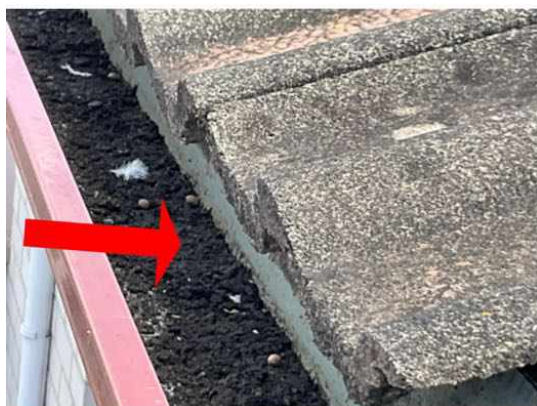
Finding 3.12

Building: Main Building
 Location: Roof Exterior
 Finding: Gutters - Blocked
 Information: Roof plumbing structures, such as guttering and downpipes, should be free of all debris to prevent blockages. Blockages of the guttering and downpipes will lead to pooling and accumulated water overflows, which is likely to subsequently flood eaves and exterior walls.

Blocked gutters are likely to lead to high levels of moisture in the affected areas. Such moisture will not only cause rust and decay of the associated building materials, but can also provide conditions that are conducive to termite and timber pest activity. Blockages in gutters should therefore be removed immediately to ensure dry conditions are maintained.

Consult a Licensed Plumber for further specific advice on remedial works that may be required. In the interim, it is highly advised that blocked gutters be removed by the homeowner or a general handyperson as a matter of urgency.

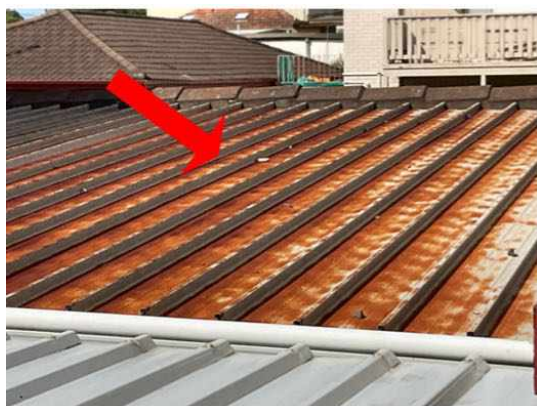
Finding 3.13

Building:	Main Building
Location:	Roof Exterior
Finding:	Roof sheets - Rusted
Information:	Metal roofs generally comprise numerous individual sheets, which join and overlap. These intersections are particularly prone to lift at the edge and consequently rust at these points.

Upon inspection of the exterior roofing structure, evidence of rust to these sections was identified. If left unmanaged, these degrading joins can allow water ingress to the internal roofing structures, potentially leading to secondary damage of building elements. Accelerated deterioration of the roofing sheets and any associated building elements is also likely to occur.

A roofing contractor should be appointed immediately to assess the damage to the roofing sheets and to perform remedial works as necessary. Works may include replacement of severely affected roofing sheets or minor works such as the application of rust-retardant surface protectors.

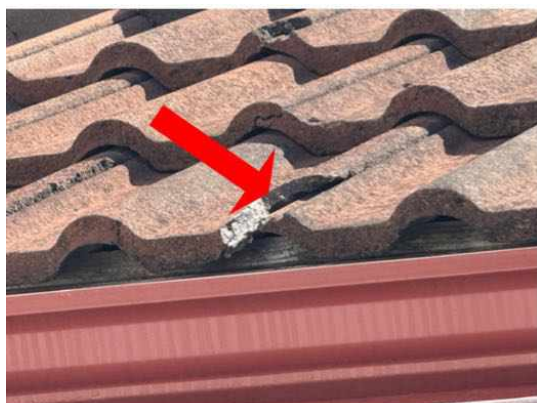
Finding 3.14

Building:	Main Building
Location:	Roof Exterior
Finding:	Roof tiles - Broken
Information:	Upon inspection of the exterior roof covering, broken roofing tiles were identified. Broken and friable roof tiles are generally the result of ageing and weathering of what is essentially a porous material.

If left to further deteriorate, broken and brittle roof tiles are likely to lead to water penetration via the roof into the ceiling space, causing secondary damage to ceiling linings, insulation and roof structures. Broken roof tiles are also likely to detract from the effectiveness of the roof drainage system, creating potential for secondary damage to the exterior roof covering and roof plumbing.

Replacement of broken tiles is required and should be performed by a roofing contractor as soon as possible.

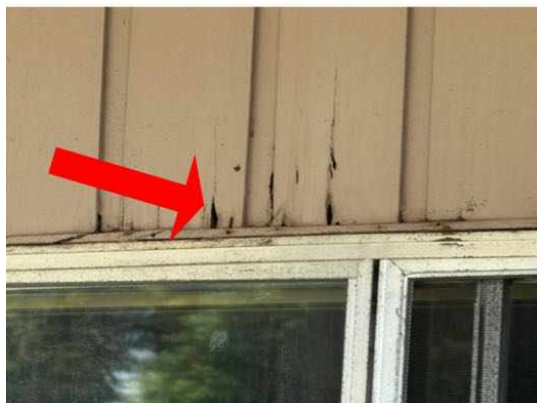
Finding 3.15

Building:	Main Building
Location:	All External Areas
Finding:	External Timber - Weather damaged

Information: Damaged external timber were found during the inspection. External timber structures are constantly exposed to weather elements and can deteriorate in an accelerated manner, ongoing assessments are required.

It is highly recommended that a Structural engineer further assess the external timber balcony/deck to inform the client of its load capacity. Regular maintenance inspections by competent practitioners is needed.

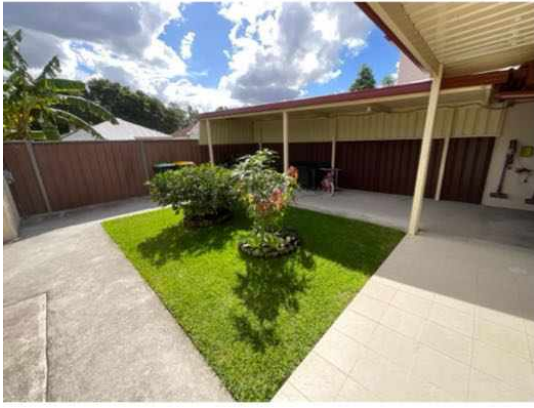
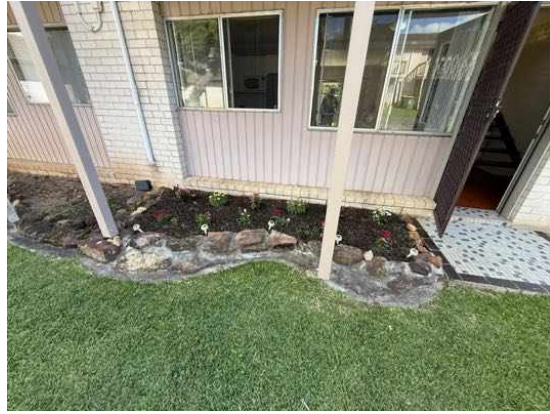
Finding 6.01

Building: Main Building
Location: All Areas
Finding: Garden Beds - Conditions Conducive to Termites
Information: Garden beds were found to be evident in the garden area. These garden beds can include untreated timber, and with a combination of moisture from watering hosing can make conditions conducive to termite activity and termite ingress.

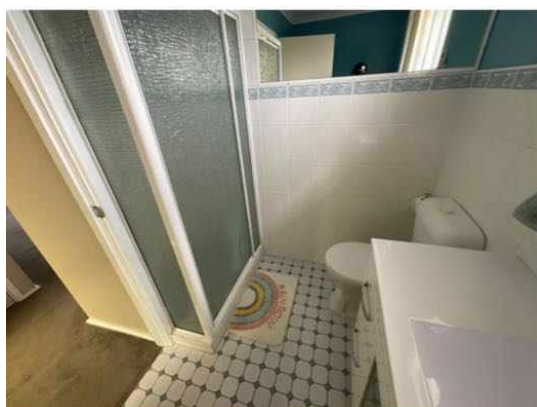
Building:	Main Building
Location:	All Areas
Finding:	Water Proofing Membranes - Information Only
Information:	Internal Water Proofing Membranes, are crucial in preventing water ingress into the property is important to know that the Membrane System used is to Australian Standards and has been installed correctly. Please refer to the original Building Documents or Maintenance Schedule for the relevant information including; - Membrane used and Manufacturers Specifications. - The Installer and Installation Certification. Especially with older property's where this information is unavailable, all wet areas should be monitored. Generally new waterproofing with a certificate may only have a guarantee of 8yrs. If any leaks, water staining, peeling or bubbling of the paint become evident to any adjacent walls or ceilings below a licensed builder or waterproofing specialist is recommended to investigate further.

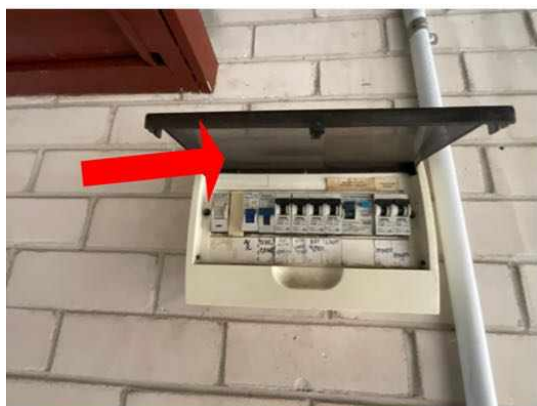
Building:	Main Building
Location:	All Areas
Finding:	Termite Management System - no evidence of a chemical installation
Information:	The application of a post-construction chemical termite barrier is highly recommended for all properties, particularly if live termite activity has been found on the site previously. Such barriers are highly effective in preventing termite attack on any timber building elements throughout the property.

A durable notice should be placed in the switchboard unit to indicate current termite barriers. At the time of inspection, it appeared as though no termite management system has been installed, with no evidence to suggest preventative works taking place.

The client may consider gaining further advice from a pest controller as to the costs and procedures involved with this application. It is recommended that obtaining such advice be a short-term priority.
