Building and Timber Pest Inspection Report

Inspection Date: Tue, 17 Mar 2026

Property Address: 112 Reservoir St, Surry Hills NSW 2010,
Australia

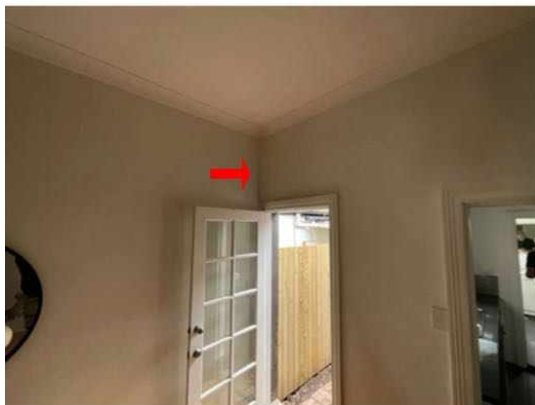
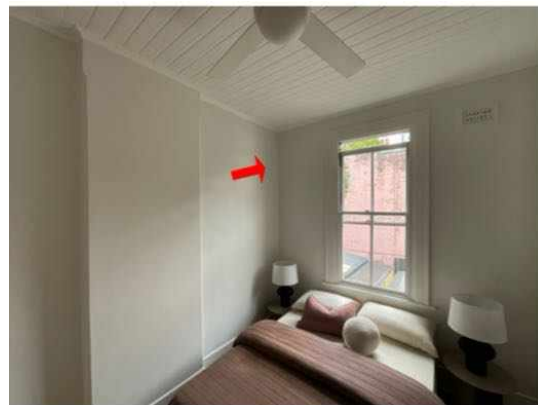
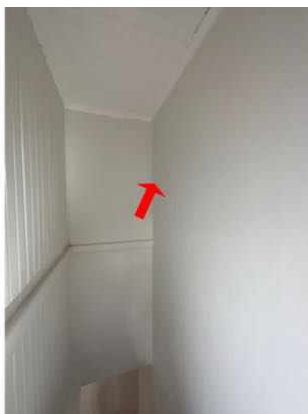
Finding 2.01

Building: Main Building
Location: Dining Room, Bedroom 2 & Stairs
Finding: Damp - Rain penetration
Information: Rain penetration (also known as penetrating damp) is a common form of dampness that can occur through walls, roofs or openings (e.g. windows).

Common causes include faulty or missing flashing, lack of sealant and lateral damp.

The cause of the water leak should be addressed to prevent further damage. It is recommended that the water leak be resolved prior to any repairs of the damaged area, which may require localised replacement of building materials and refinishing.

I recommend appointing a builder to see what necessary works are required.

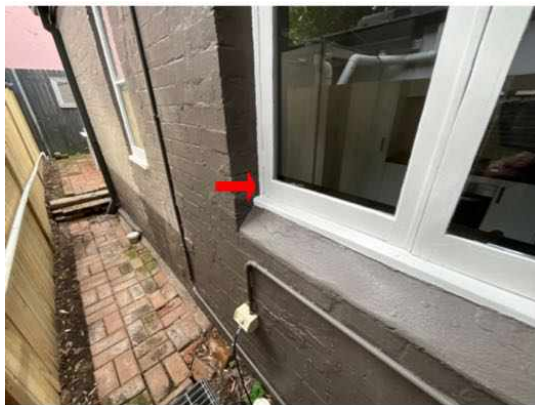
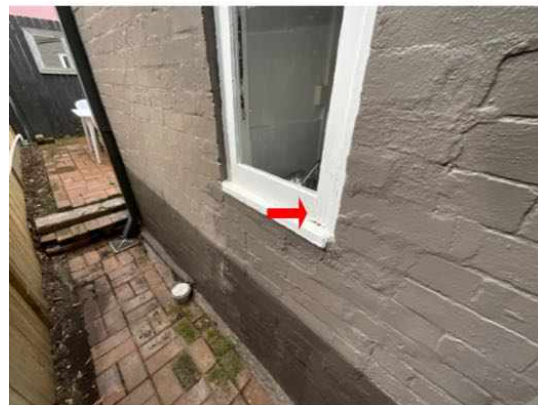
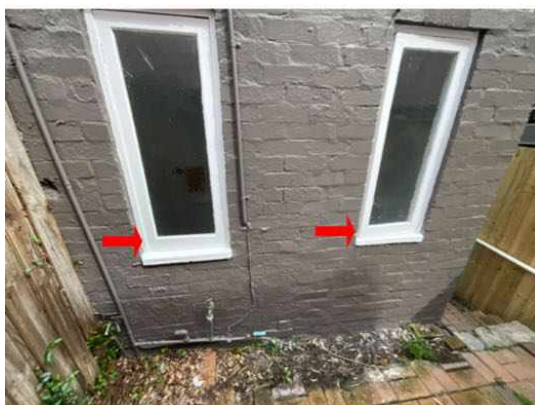
Finding 3.01

Building: Main Building

Location: External Areas

Finding: Wood rot

Information: This building element shows evidence of wood rot. Wood rot, also known as Fungal Decay, occurs when timbers and other cellulose building materials are exposed to damp conditions on an ongoing basis. This could be the result of exposure to weathering over a prolonged period of time, or the attraction of excessive moisture from other abutting building materials.

Early intervention and regular maintenance, particularly of exterior timbers, will prolong the useful life of these building elements. Prior to any works being performed, the cause of the moisture that has created the visible wood rot should be identified and addressed in a suitable manner. Replacement of affected timbers may then be a necessary step in protecting surrounding building elements from such deterioration.

A qualified carpenter or registered builder may also be required to replace affected building materials.

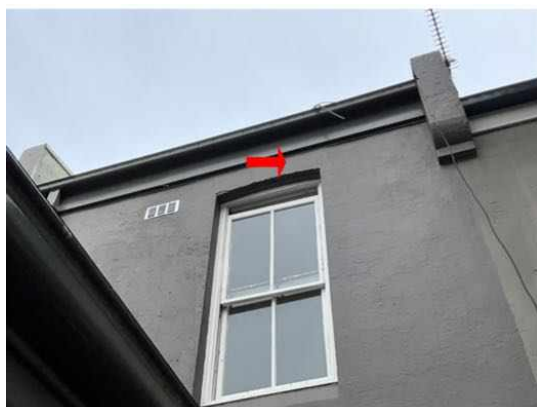
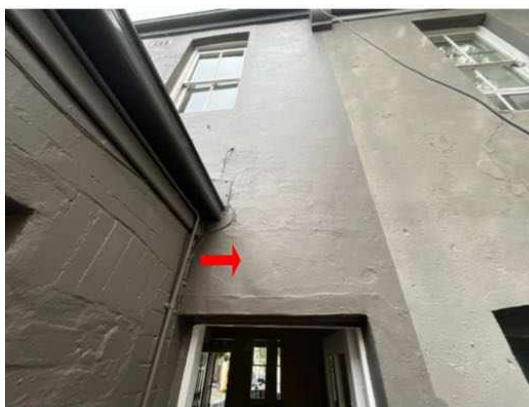
Finding 3.02

Building:	Main Building
Location:	Exterior walls
Finding:	Brickwork - Cracking noticeable
Information:	There were several cracks and or crack repairs evident to external brickwork.

Noticeable cracks are a common occurrence in external brickwork and are a likely result of age expected building movement, general expansion, and/or contraction of building materials in different weather conditions.

It is highly advised that a qualified bricklayer be appointed to provide necessary works to cracked brickwork to prevent any further damage.

Always monitor these cracks and contact a building inspector should cracks widen, lengthen, or become more numerous.

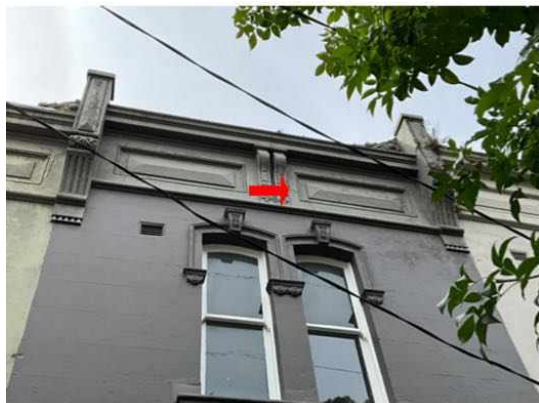
Finding 3.03

Building:	Main Building
Location:	Exterior walls
Finding:	Cracking - Damage Category 2 - Noticeable (up to 5mm) - Structural
Information:	Noticeable cracks are a common occurrence as a result of many primary defects. Such causes may include age, general wear and tear, expected building movement, general expansion/contraction of building materials in different weather conditions, and/or minor failings in the installation or application of building materials but some cracks in this degree may result in significant works.

Although the wall does appear to be stable I would recommend appointing a structural engineer to give further advice.

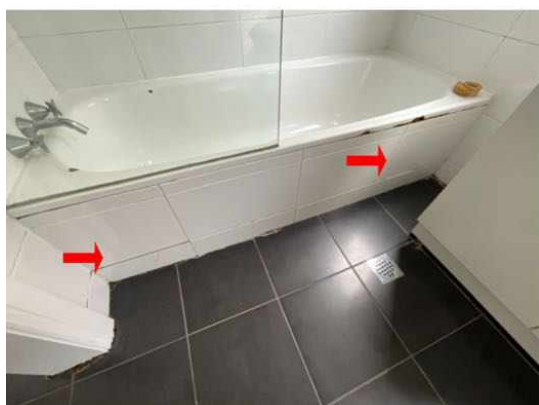
Finding 3.04

Building:	Main Building
Location:	Bathroom
Finding:	Tile - Cracked or damaged
Information:	Cracking was evident to the tiling in this area at the time of inspection.

I recommend appointing a tiling contractor to see what necessary works are required to replace any damaged tiles.

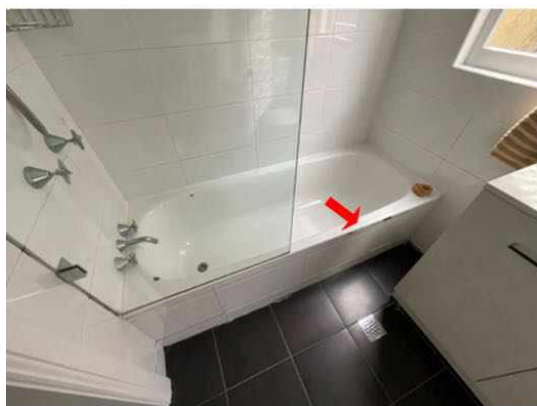
Finding 3.05

Building:	Main Building
Location:	Bathroom
Finding:	Rusted Metal Bath
Information:	The metal bath is showing signs of rust and surface deterioration.

Corrosion may worsen over time, potentially leading to leaks, reduced durability, and deterioration of surrounding finishes.

The bath should be repaired, resurfaced, or replaced as required to restore functionality and prevent further deterioration.

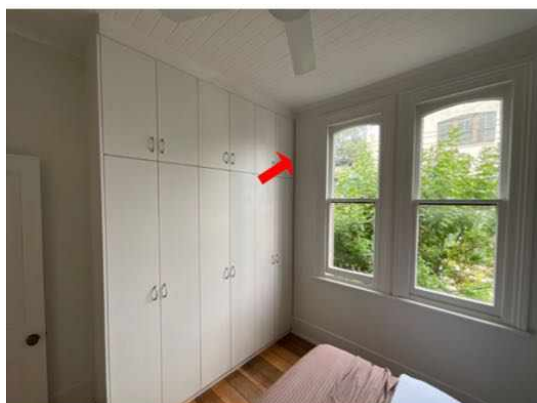
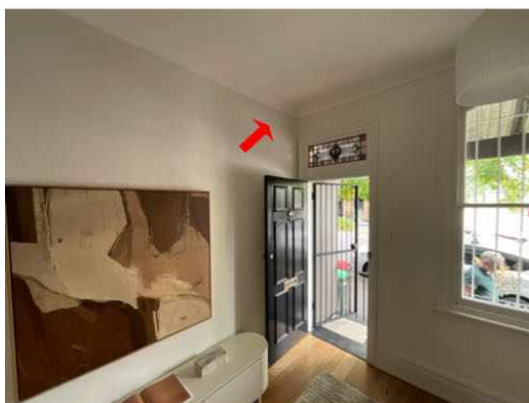
Finding 3.06

Building:	Main Building
Location:	Bedroom & Lounge Room
Finding:	Damp - Rain penetration
Information:	Rain penetration (also known as penetrating damp) is a common form of dampness that can occur through walls, roofs or openings (e.g. windows).

Common causes include faulty or missing flashing, lack of sealant and lateral damp.

The cause of the water leak should be addressed to prevent further damage. It is recommended that the water leak be resolved prior to any repairs of the damaged area, which may require localised replacement of building materials and refinishing.

I recommend appointing a builder to see what necessary works are required.

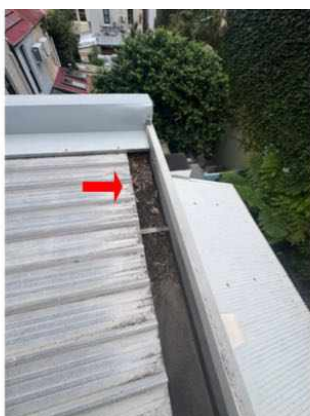
Finding 3.07

Building:	Main Building
Location:	Roof Exterior
Finding:	Gutters - Blocked
Information:	Roof plumbing structures, such as guttering and downpipes, should be free of all debris to prevent blockages. Blockages of the guttering and downpipes will lead to pooling and accumulated water overflows, which is likely to subsequently flood eaves

and exterior walls.

Blocked gutters are likely to lead to high levels of moisture in the affected areas. Such moisture will not only cause rust and decay of the associated building materials, but can also provide conditions that are conducive to termite and timber pest activity. Blockages in gutters should therefore be removed to ensure dry conditions are maintained.

Consult a Licensed Plumber for further specific advice on remedial works that may be required. In the interim, it is highly advised that blocked gutters be removed by the homeowner or a general handyperson as a matter of urgency.

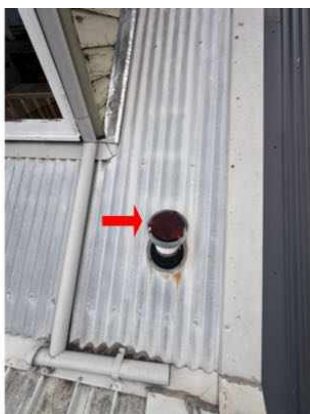
Finding 3.08

Building:	Main Building
Location:	Roof Exterior
Finding:	Building element - Rusted or corroded
Information:	This building element shows evidence of rusting and corrosion, which is likely to have developed as a result of excessive exposure to moisture and or inadequate coatings.

As surface rust provides no protection to the underlying iron, the deteriorating condition is likely to worsen if not addressed in the short-term future.

Where possible, the use of galvanized (treated) metals or aluminium coated metals aid in rust prevention, as does regular general maintenance. Rust formation can be controlled with coatings, such as paint, that isolate the iron from the environment.

Rusting and corrosion should be managed by ideally removing or limiting the affected surface from exposure to moisture.

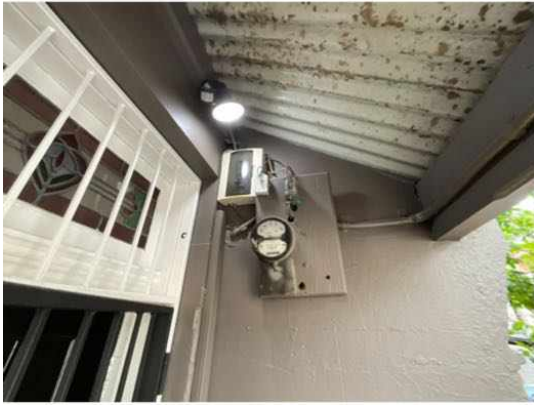
Finding 6.01

Building:	Main Building
Location:	All Areas
Finding:	Termite Management System - no evidence of a chemical installation
Information:	The application of a post-construction chemical termite barrier is highly recommended for all properties, particularly if live termite activity has been found on the site previously. Such barriers are highly effective in preventing termite attack on any timber building elements throughout the property.

A durable notice should be placed in the switchboard unit to indicate current termite barriers. At the time of inspection, it appeared as though no termite management system has been installed, with no evidence to suggest preventative works taking place.

The client may consider gaining further advice from a pest controller as to the costs and procedures involved with this application. It is recommended that obtaining such advice be a short-term priority.

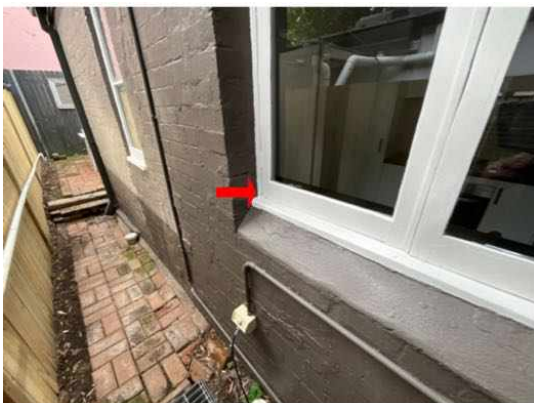
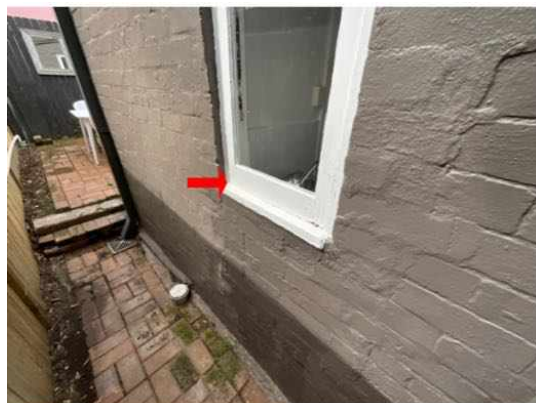
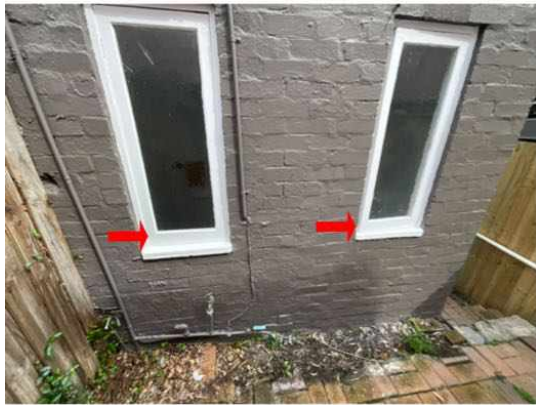
Finding 7.01

Building:	Main Building
Location:	External Areas
Finding:	Fungal decay - present (localised)
Information:	Fungal decay also known as wood decay or wood rot generally refers to the deterioration of timber elements when in contact with excessive levels of moisture for a prolonged period of time.

The development of fungal decay is accelerated by temperatures in the range of 5degreeC to 40degreeC as well as the presence of oxygen. Generally fungal decay develops on timber elements that are in use in an external environment which are exposed to rain penetration.

In this case although the affected timber element is in a decaying state the extent of any visible damage appears to be localised to a specific area and is yet to spread to other parts of the building element or affect adjoining structures. The fungal decay is therefore likely to be of a relatively superficial nature with minimal impact on the structural integrity or tensile strength of the timber element.

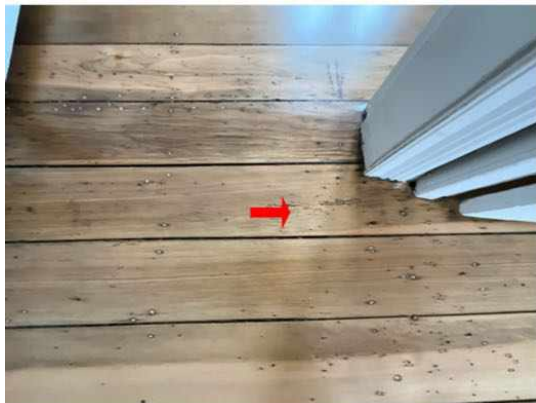
Finding 8.01

Building: Main Building
Location: Flooring
Finding: Evidence of wood borer activity identified
Information: Wood borers small beetles that colonise in exposed timber elements are a common timber pest that are regularly mistaken for termites.

The Lyctid borer which generally attacks hardwoods such as subfloor and roofing structures is generally identified by a fine dust surrounding the affected timbers.

As no live wood borer activity was identified treatment is not required at this time.

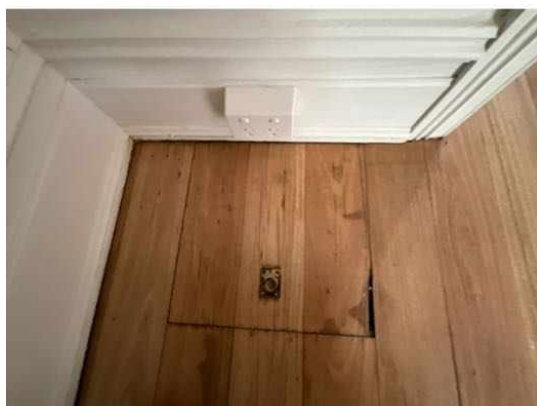
Building: Main Building
Location: Subfloor
Finding: Additional Photos - Obstructions and Limitations
Information: These photographs are an indication of the obstructions and limitations which impeded full inspection of the property at the time of inspection. These obstructions can hide an array of defects and should be removed to allow full inspection to be carried out. A re-inspection is recommended once the areas are made accessible.
