# Building and Timber Pest Inspection Report

Inspection Date: Sat, 14 Mar 2026

Property Address: 51 Galah St, Melonba NSW 2765, Australia

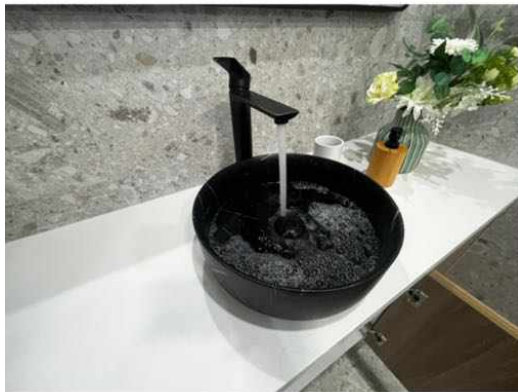
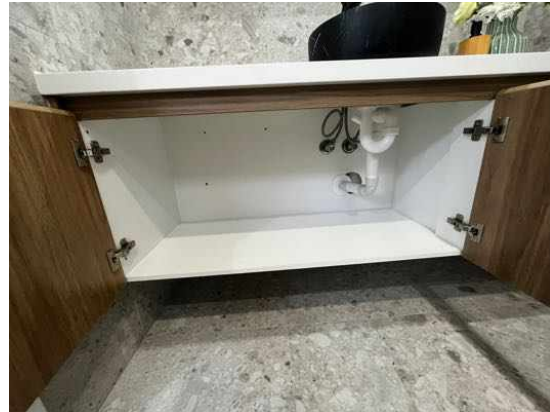
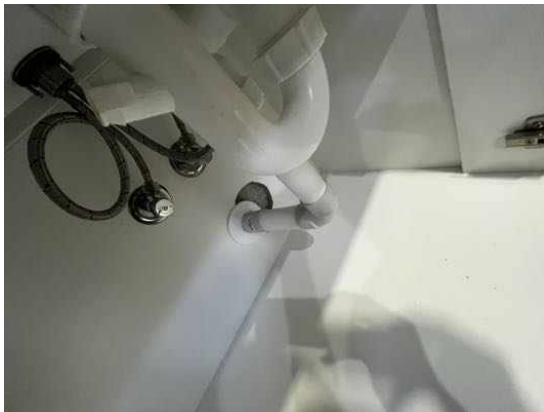
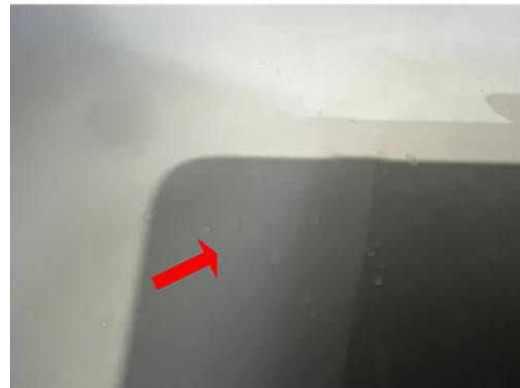
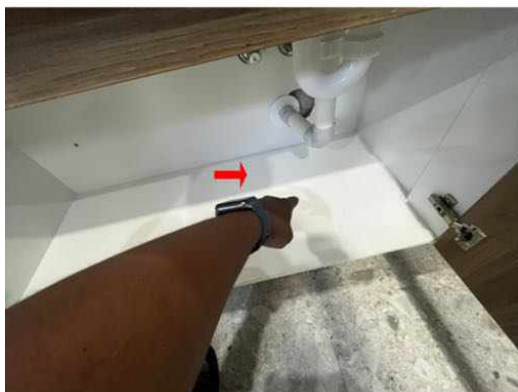
All cupboards where sinks and basins with drainage plumbing were inspected and it was noted that there was a leak in one of the cupboards were present at the time of inspection.

It is recommended that a Licensed Plumber may be appointed to inspect and remedy the situation.

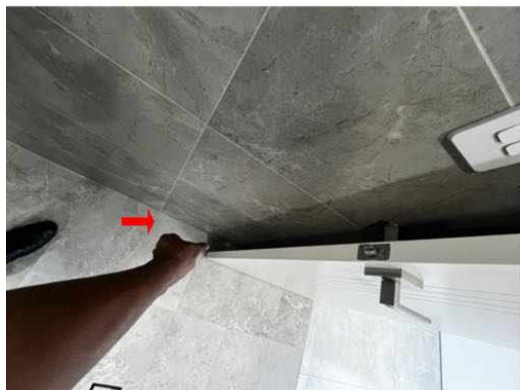
Building:	Main Building
Location:	Ground floor bathroom
Finding:	Door stop - Missing Rubber edge
Information:	At the time of inspection The door stop was missing or was inadequate to stop the door handle from damaging the wall. Although some building elements may seem irrelevant or unnecessary, all building elements play a key role in the operation and function of the overall structure and its performance.

Re-installation or replacement of the door stop is advised as soon as possible to prevent any subsequent damage to the door or associated structures. A general handyman may be appointed to perform these works at client discretion.

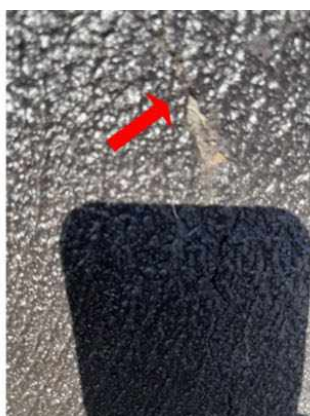
### Finding 3.05

Building:	Main Building
Location:	Driveway
Finding:	Cracking - Damage Category 1 - Fine (up to 1mm)
Information:	Although fine cracks are quite noticeable, they are often only considered to be an appearance defect, and usually do not indicate any structural damage. Generally, the cause of a fine crack is indicative of a separation between building materials and finishes (e.g. paint, plaster, etc.) along joints.

Cracking of this nature can generally be repaired with minor sanding, filling and/or repainting. Such works should be performed by a qualified painter or a general handyman.

Monitoring of all cracking should be conducted frequently. Always contact a building inspector should cracks widen, lengthen, or become more numerous.

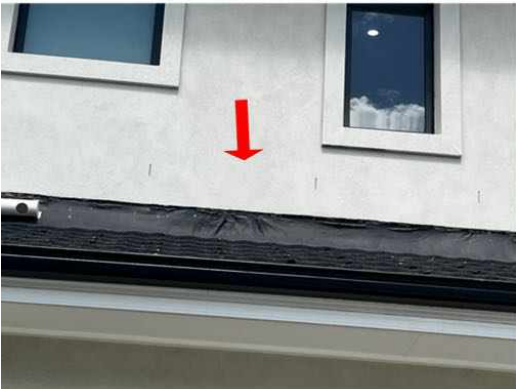
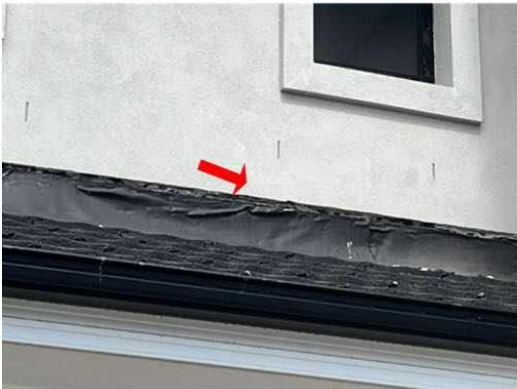
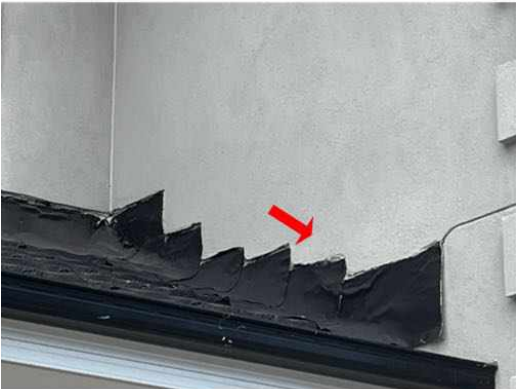
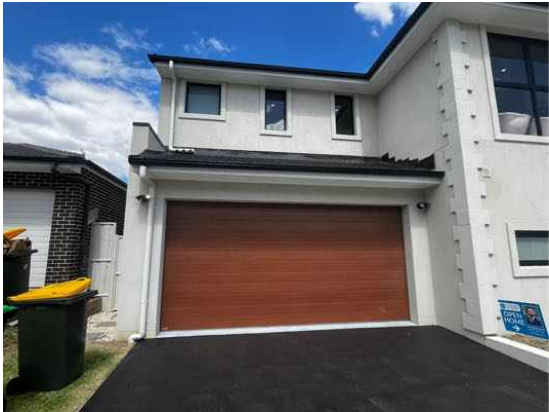
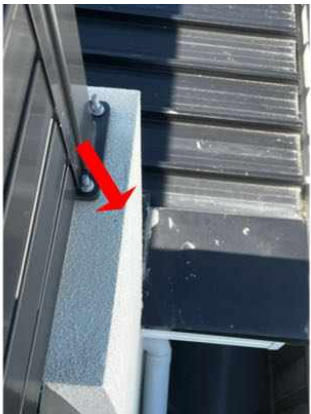
### Finding 3.06

Building:	Main Building
Location:	Roof PLumbing
Finding:	Roof plumbing - Loose flashing
Information:	Metal and other material flashings are applied to seals and intersections between roof coverings and building elements. They are designed to aid in weatherproofing of roof joins, and require regular inspection and maintenance as they are more subject to rust-related deterioration.

The flashing in this section of the exterior roofing appears to have come loose from its original fixing. It is suspected that this minor defect has occurred as a result of general deterioration over time.

Re-fixing and potential replacement of certain areas of flashing is advised to promote adequate roof drainage and protection from water penetration. Failure to perform these works may result in water damage and accelerated deterioration of associated building elements.

A roofing contractor or roofing plumber should be appointed as soon as possible to restore the flashing to a fully operational state.

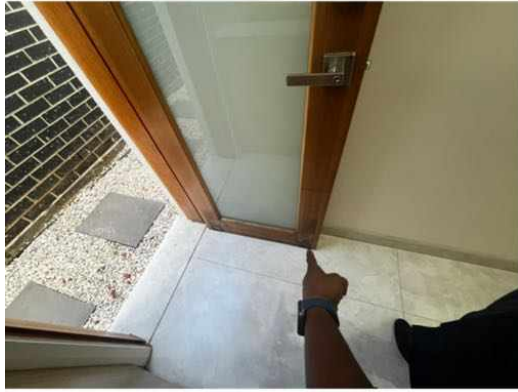
Information: External timbers that are frequently exposed to harsh weather conditions require adequate protection in order to maintain their condition. Where timbers have not been painted or treated adequately, general deterioration is likely to occur at an accelerated rate.

If left unattended, replacement of these timbers is likely to be necessary in the short-term future. Adequate treatment of these timbers is required as soon as possible by a painting contractor or general handyman.

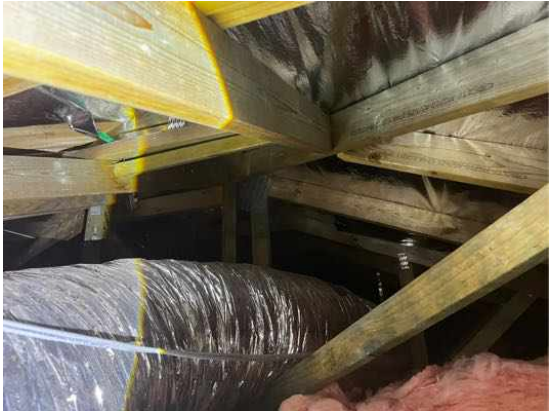
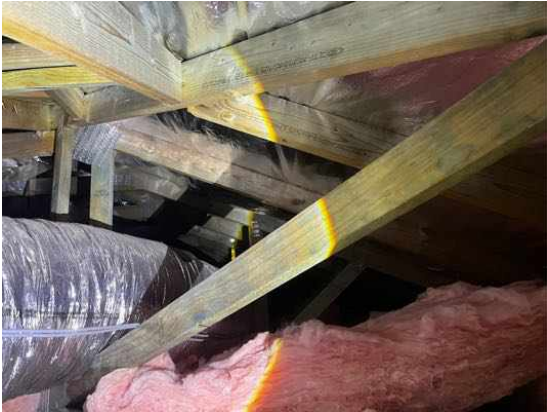
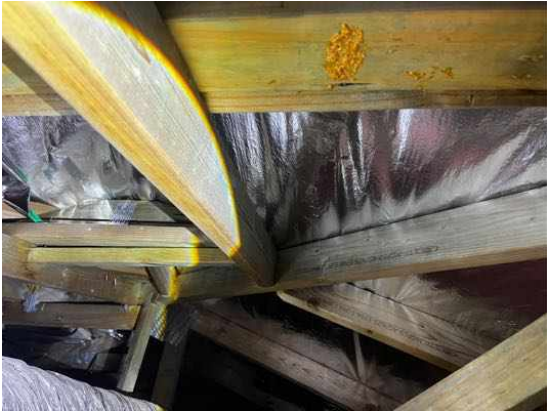
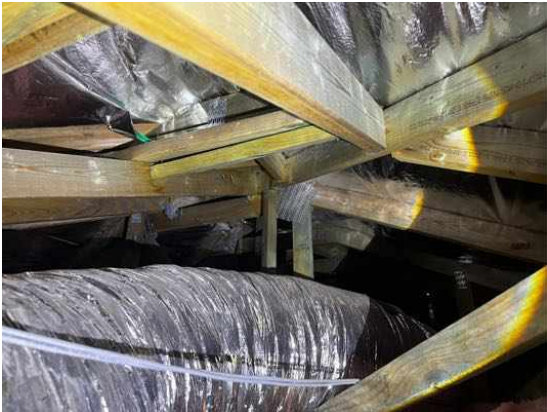
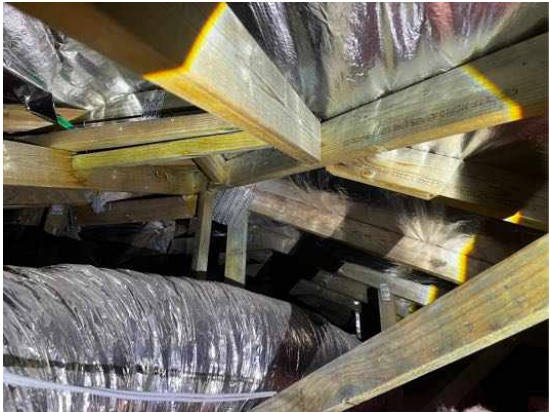
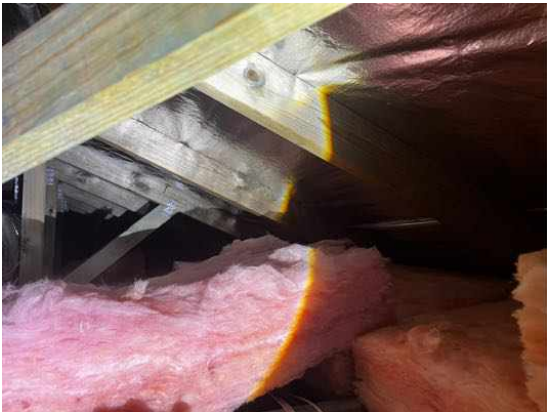
### Finding 6.02

Building: Main Building  
 Location: Roof Void  
 Finding: Obstructions and Limitations - Roof space  
 Information: Upon Inspection of the Roof void below mentioned photos have been attached as to the point been reachable to inspect the roof upon safe condition.

These photographs are an indication of the obstructions and limitations which impeded inspection of the Roof Space/Void at the time of inspection such as Stored items, Ducting, Aircon ducting, Skylight tubes, Electrical wires , insulation and cross beams, rafters, low clearance as of the pitch in the roof. These obstructions can hide an array of defects and should be removed to allow full inspection to be carried out.

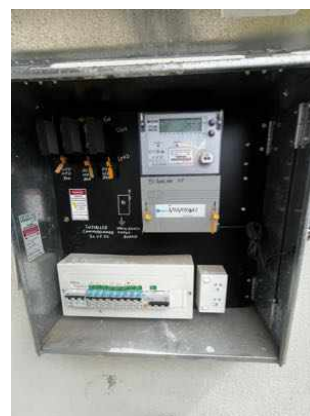
Building: Main Building  
 Location: Sink Cupboard/ Electrical Box  
 Finding: Evidence of a previous termite management system was identified  
 Information: Upon Inspection There was a Durable Notice of Termite treatment identified but the date and the information in the notice was not readable/ identifiable - So It is highly recommended to have a termite treatment organised and to follow a termite treatment proposal and keep note of the system every 12 months in duration.
