Building and Timber Pest Inspection Report

Inspection Date: Mon, 23 Mar 2026

Property Address: 16 Wattle St, Killara NSW 2071, Australia

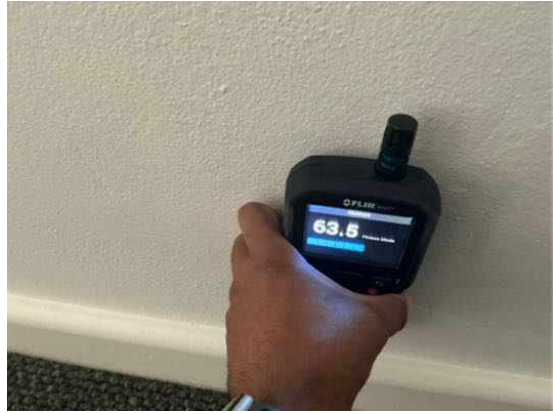
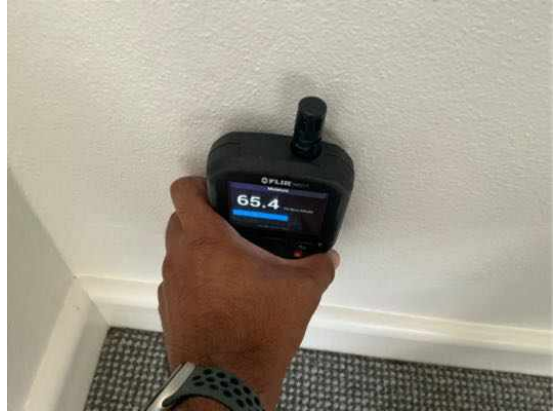
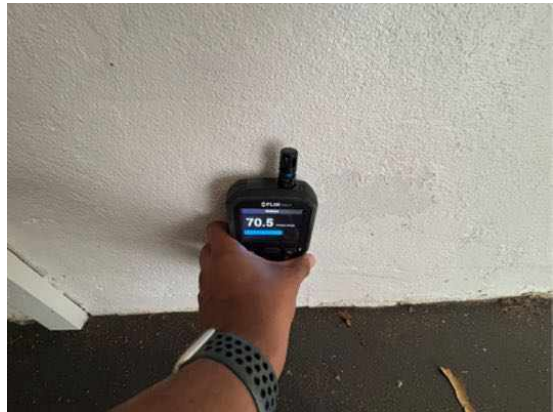
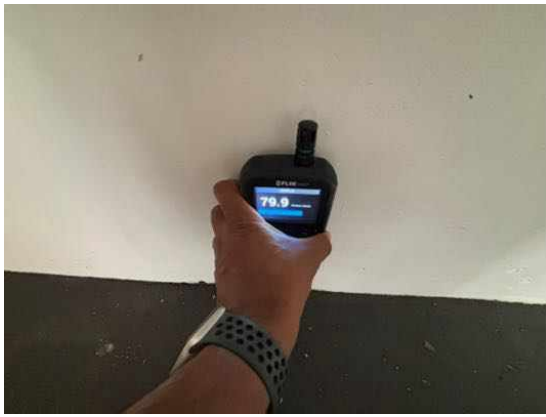
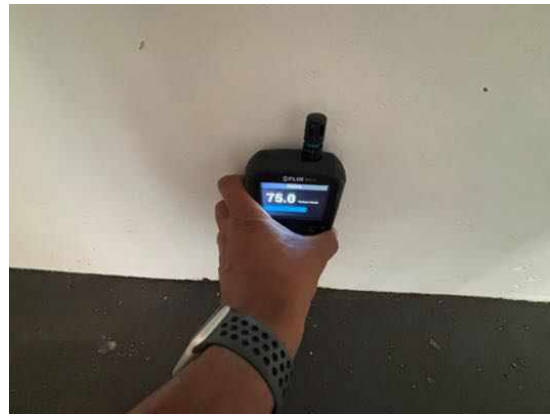
Building:	Main Building
Location:	Bedroom 1, Bedroom 2, Storage, Garage
Finding:	Damp - Rising
Information:	At the time of inspection, rising damp was identified within the property. This condition results from the upward movement of moisture through porous building materials, such as bricks, sandstone, or mortar, via capillary action. A damp-proof course (DPC), an impermeable barrier installed at the base of walls above ground level during construction, is typically used to prevent rising damp. However, the absence, deterioration, or bridging of the DPC can compromise its effectiveness, specially in older buildings, leading to moisture ingress. Inadequate site drainage, which allows water to accumulate around the foundation, is a common contributing factor to this issue.

If left unaddressed, rising damp can pose significant health risks due to mould growth and cause extensive damage to building elements, including wall finishes such as paint and plasterwork. The current condition should be monitored over a 12-month period to assess its progression.

It is strongly recommended that the client engage a qualified damp-proofing specialist for remedial actions. Additionally, consulting a qualified plumber or drainage specialist to assess and improve site drainage is advised to mitigate further risks. Monitoring the condition for 12 months is essential to evaluate its status and prevent potential recurrence or further damage.

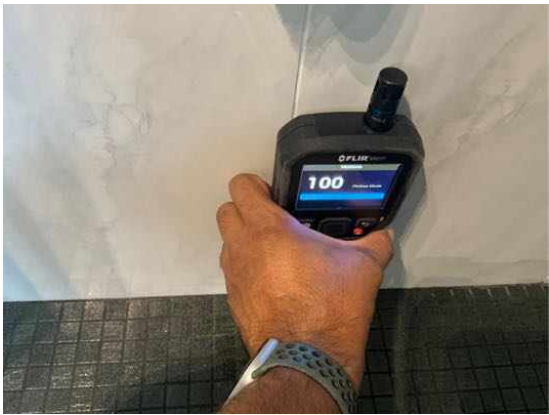
Building: Main Building
 Location: All Bathrooms
 Finding: Excessive Moisture - Shower Damp
 Information: At the time of inspection, excessive moisture was noted within the shower area, which is a common issue in wet areas due to the continual exposure to water. This condition is typically caused by moisture seeping through grout lines and settling behind tiles, resulting in localised high-moisture zones. Provided there is no evidence of water staining or elevated moisture readings on the opposite side of the wall, this is considered a minor defect.

However, persistently damp conditions may act as conducive conditions for termite activity, as termites are strongly attracted to moisture-rich environments. It is recommended that the client ensures regular use of the exhaust fan and maintains adequate ventilation after shower use to promote drying and reduce long-term moisture build-up, thereby also reducing the risk of attracting termites.

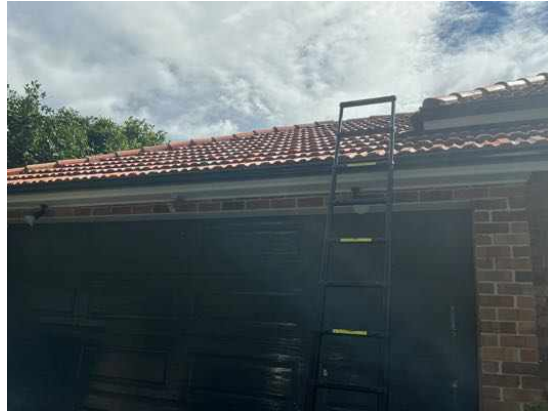
The overhanging branches can cause damage to the roof, gutters, or walls, particularly during storms or high winds. Additionally, the roots may pose a threat to the foundation by causing ground movement, leading to cracks or uneven settling over time. The accumulation of leaves and debris in gutters and drainage systems can also lead to blockages, contributing to water overflow and potential water damage.

It is recommended that a qualified arborist be engaged to prune back the overhanging branches and assess any potential risks posed by the tree roots to prevent further damage to the property. It is advised to get this fixed as soon as possible. Regular maintenance should be carried out to ensure the trees are managed effectively and the property remains safe.

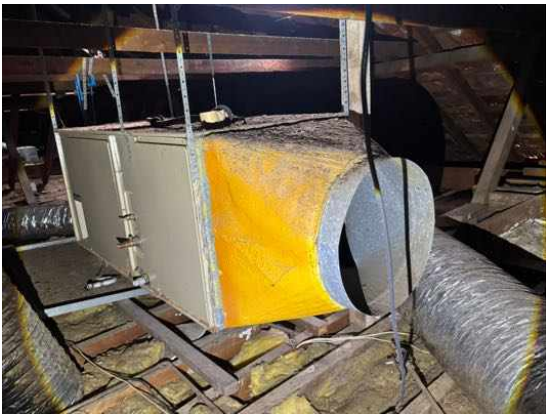
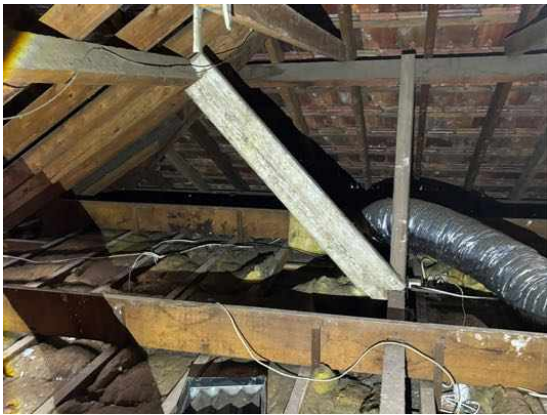
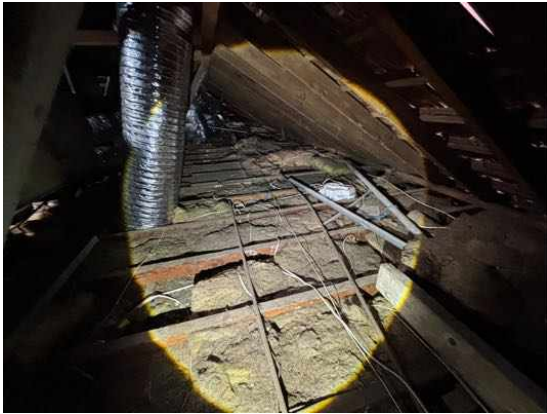
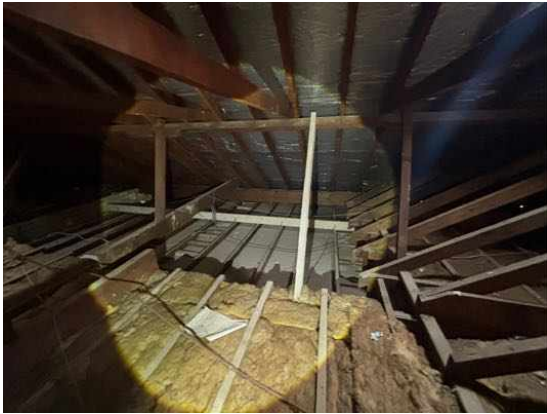
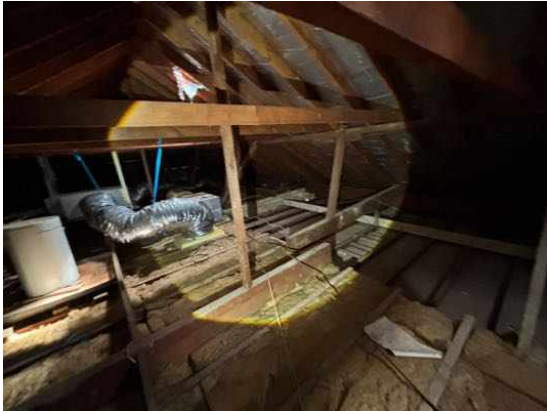
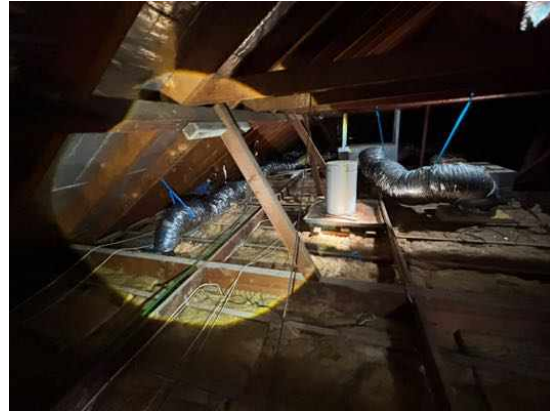
Building: Main Building
 Location: Roof Void
 Finding: Obstructions, Limitations, and General Roof Space Condition
 Information: The photographs provided document both the general condition and the obstructions and limitations that were present in the roof cavity of the main building at the time of inspection. These obstructions—such as insulation materials, stored items, structural elements, or electrical wiring—restricted safe and adequate access to key areas within the roof space. As a result, a comprehensive inspection of all components could not be completed.

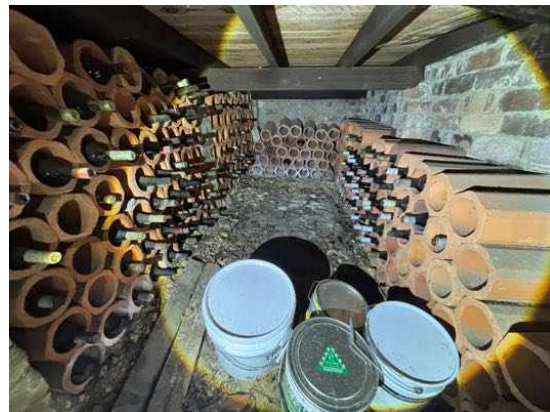
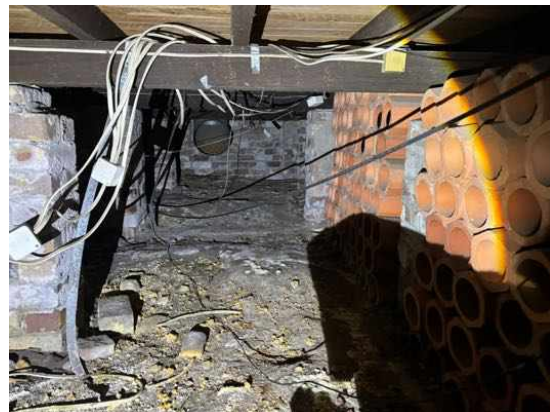
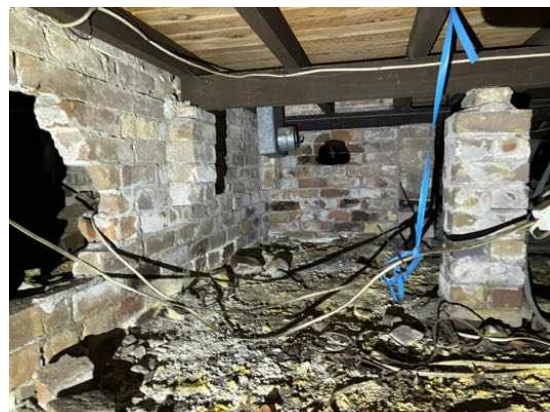
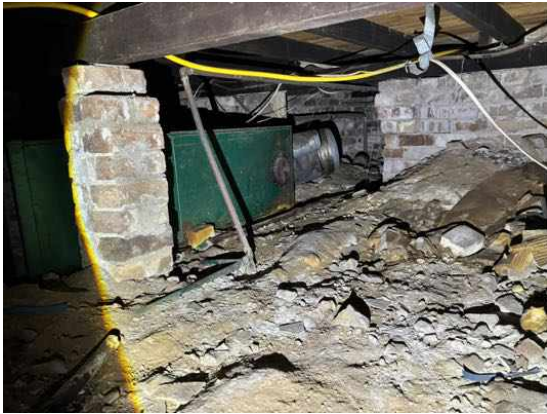
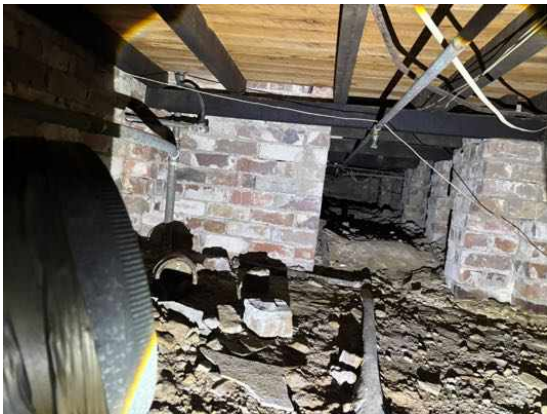
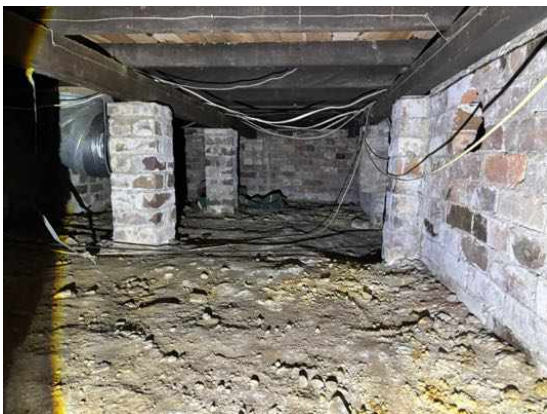
Building: Main Building
 Location: Subfloor
 Finding: Obstructions, Limitations, and General Subfloor Condition
 Information: The attached photographs illustrate the obstructions and access limitations that restricted a full inspection of the subfloor area of the main property at the time of assessment. Items such as stored materials, construction debris, low-hanging services, and insulation impeded movement and visibility within key sections of the subfloor. In addition, the limited crawl height further restricted safe access to inspect critical structural components.

important elements such as floor joists, bearers, stumps, drainage, subfloor ventilation, and signs of moisture or pest activity. These obstructions may also conceal defects such as timber decay, water ingress, termite damage, inadequate support, or ventilation issues that are not immediately visible during a limited inspection.

While no major concerns were identified in the accessible areas, a full and unobstructed inspection is necessary to properly assess the overall condition of the subfloor. It is recommended that obstructions be removed and access improved where possible. Once adequate clearance is provided, a re-inspection should be arranged to ensure that any concealed defects can be identified and addressed accordingly. This will assist in providing a more comprehensive understanding of the subfloor's condition and reduce the risk of unforeseen issues.

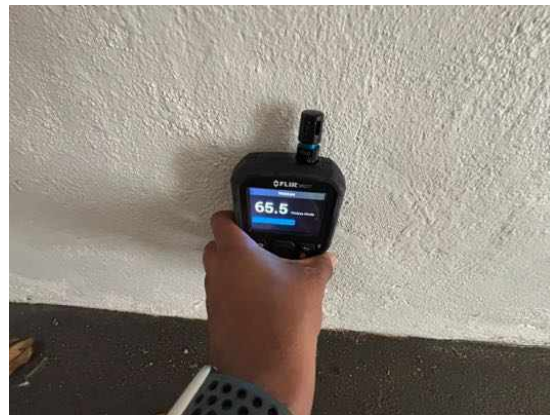
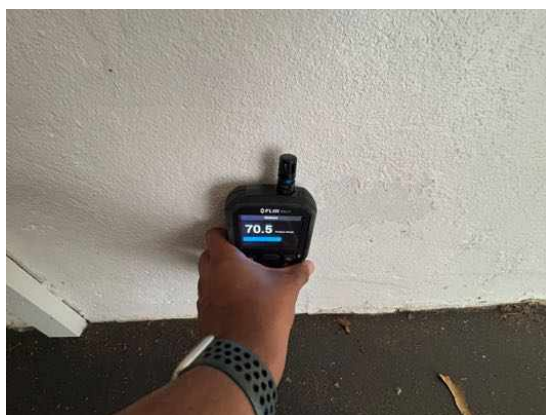
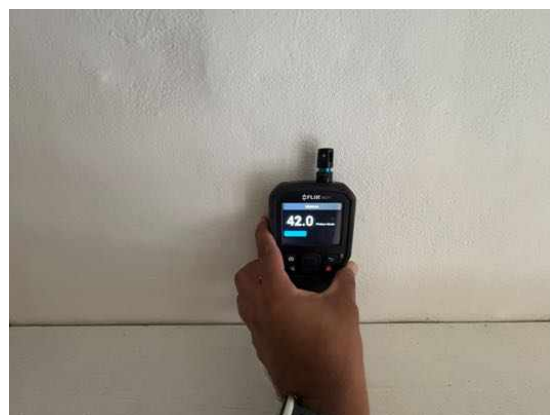
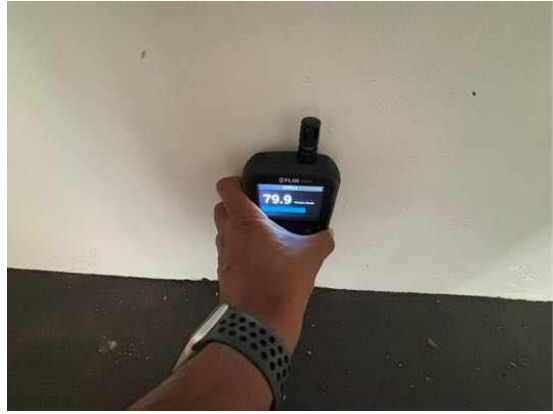
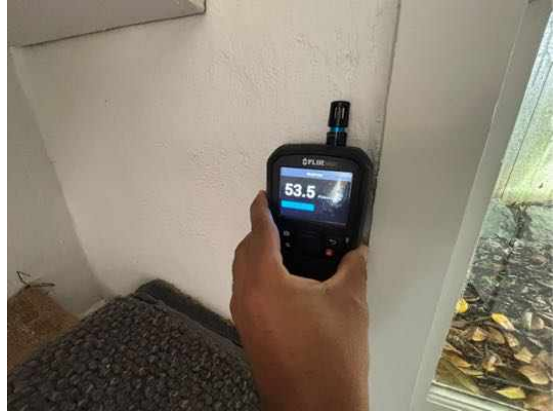
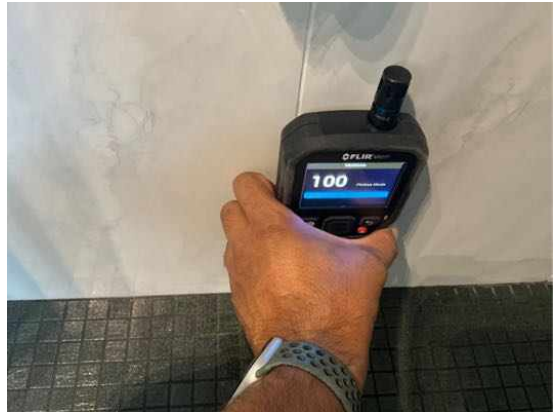
Building: Main Building
Location: All Areas
Finding: Additional Photos - Moisture Meter Readings
Information: Additional moisture meter reading photos have been provided for the property to offer further clarity on areas tested during the inspection. These photos are intended to give a visual reference for the specific locations where moisture levels were measured. These readings were taken at the time of the inspection to assess any potential moisture-related issues within the property. Any defects related to moisture that were identified during the inspection have been separately mentioned in the defect statements within the report.

It is important for the client to understand that moisture levels can fluctuate over time due to various factors, including changes in weather, humidity, and environmental conditions. While the readings reflect the property's moisture levels during the inspection, they may not represent future conditions, and increased moisture could lead to issues such as dampness, mould growth, or deterioration of building materials if left unmonitored.

For further clarification or additional information regarding the moisture readings, the client is encouraged to contact the building inspector directly. Regular monitoring of moisture-prone areas is recommended to ensure any emerging concerns are addressed promptly, particularly during wetter seasons or in high-humidity conditions.
