# Building and Timber Pest Inspection Report

Inspection Date: Thu, 19 Mar 2026

Property Address: 1/36 - 38 Eighth St, Gawler South SA 5118,  
Australia

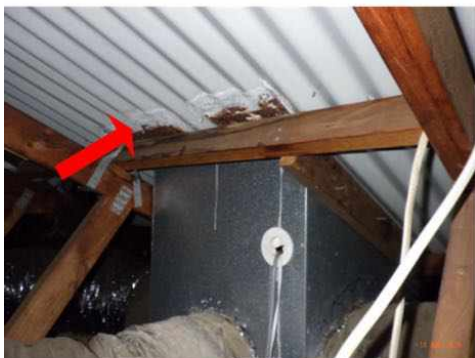
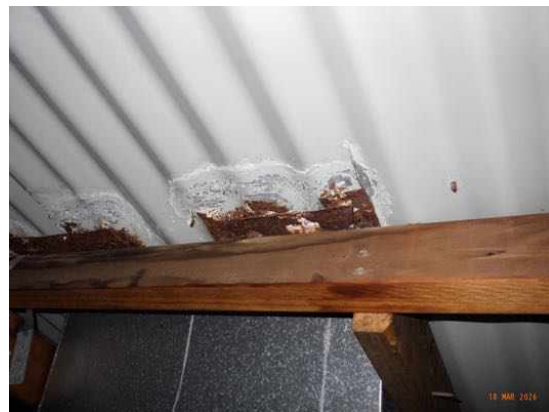
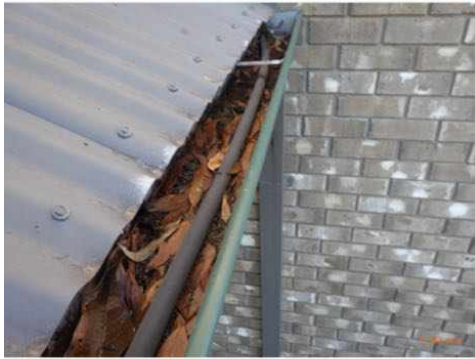
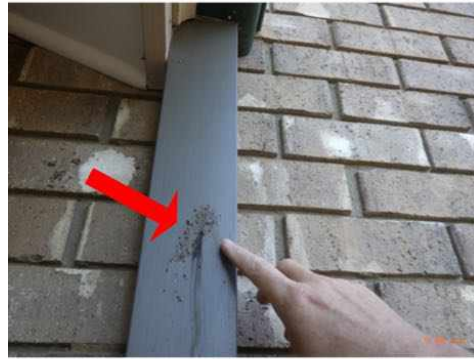
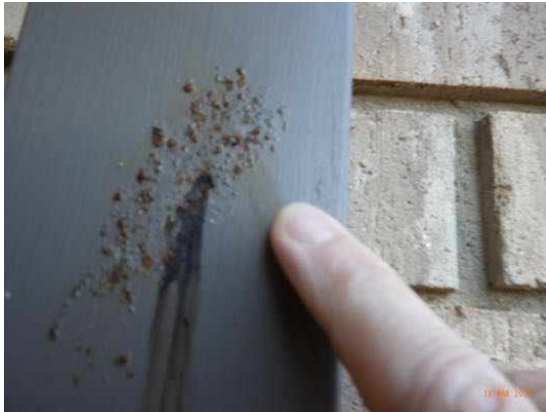
#### Finding 2.01

Building: Building 1  
Location: Roof Exterior  
Finding: Roof plumbing - Rusted or corroded  
Information: The roof plumbing has areas of rust and corrosion to the rear gutter due to the AC drain being in the area. The flashings around the AC unit on the roof were also found to be rusted through.

Rusted roof plumbing will generally develop holes and leaks that can affect other building elements with poor drainage of storm water.

Poorly drained roof areas will also lead to damp conditions surrounding the base perimeter of the building which, if left unmanaged, can lead to a range of secondary building defects.

Repair and/or replacement of rusted roof plumbing is highly required in order to reinstate the roof drainage system to a fully operational level.

To further maintain these areas, gutters should be cleaned frequently, allowing the avoidance of any partial blockages.

A licensed plumber should be appointed to undertake these works. It is advised that such works be completed as soon as possible to prevent any further damage and deterioration.

Repair AC flashing on roof.

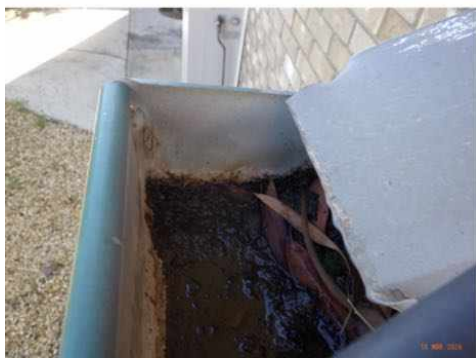
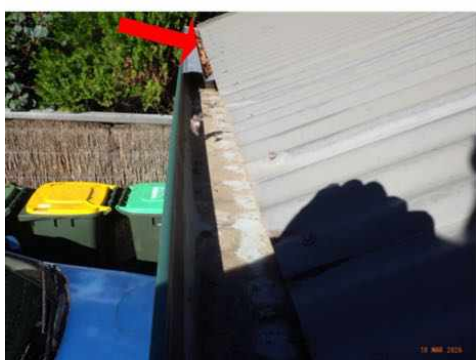
### Finding 3.01

Building:	Building 1
Location:	Roof Exterior
Finding:	Gutters - Blocked
Information:	Roof plumbing structures, such as guttering and downpipes, should be free of all debris to prevent blockages. Blockages of the guttering and downpipes will lead to pooling and accumulated water overflows, which is likely to subsequently flood eaves and exterior walls.

At the time of inspection there were varying levels of blocked gutters evident.

Blocked gutters are likely to lead to high levels of moisture in the affected areas. Such moisture will not only cause rust and decay of the associated building materials, but can also provide conditions that are conducive to termite and timber pest activity. Blockages in gutters should therefore be removed immediately to ensure dry conditions are maintained.

Consult a Licensed Plumber for further specific advice on remedial works that may be required. In the interim, it is highly advised that blocked gutters be removed by the homeowner or a general handyperson as a matter of urgency.

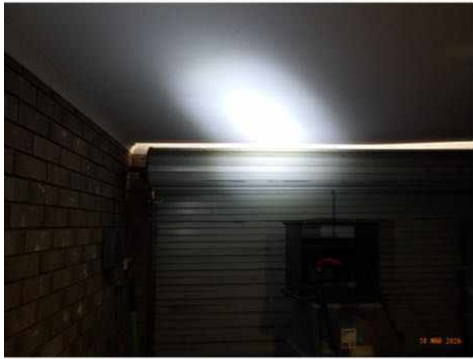
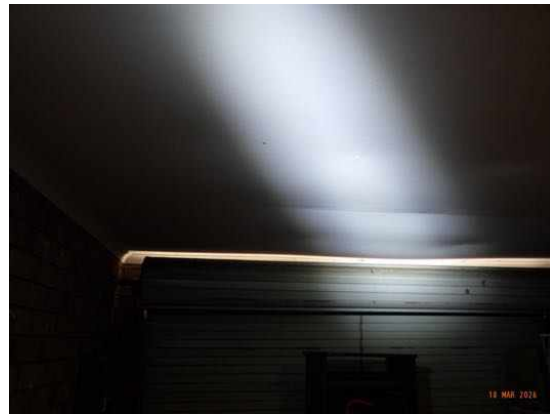
### Finding 3.02

Building:	Building 1
Location:	Garage
Finding:	Ceiling - Garage
Information:	A very common defect found in garages is that the ceiling can sag over time, due to their lack of insulation and or their susceptibility to moisture. Condensation builds up in the roof and rests on the plasterboard softening it somewhat which makes it more likely to sag and release from its fixing points. Moisture evaporating from cars can also contribute to this issue.

Therefore we recommend that you insulate your garage and also apply a good coat of washable paint to the ceiling of the garage to prevent any moisture entering the plasterboard and creating issues in the future. A licensed building insulation installer and licensed painting contractor could be appointed to carry out these works at the discretion of the client.

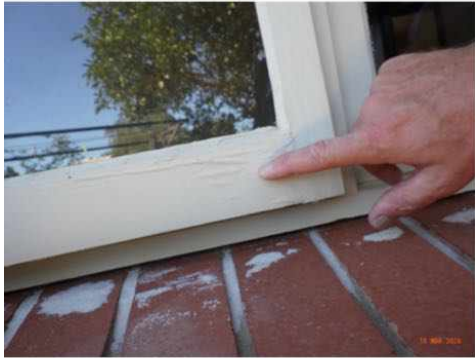
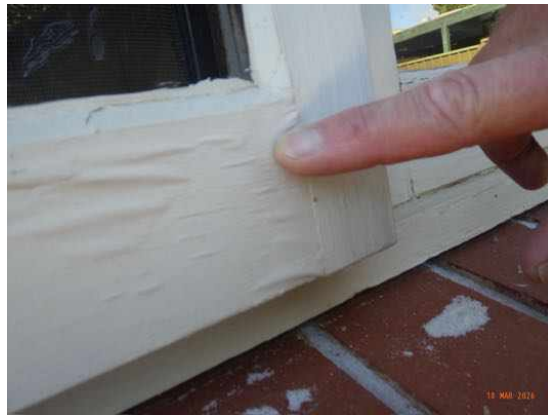
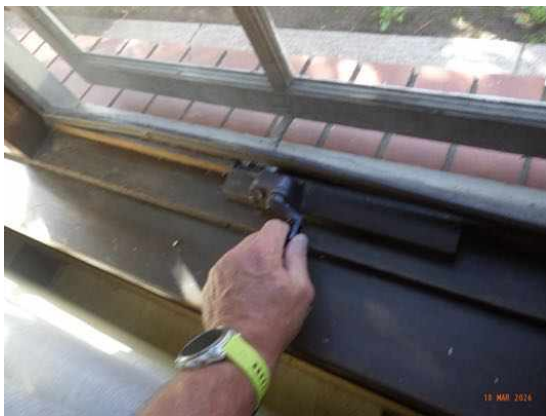
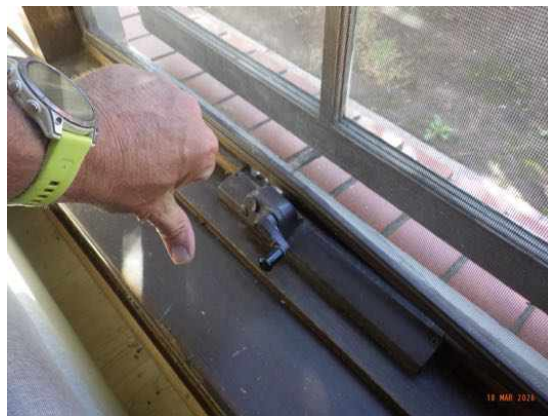
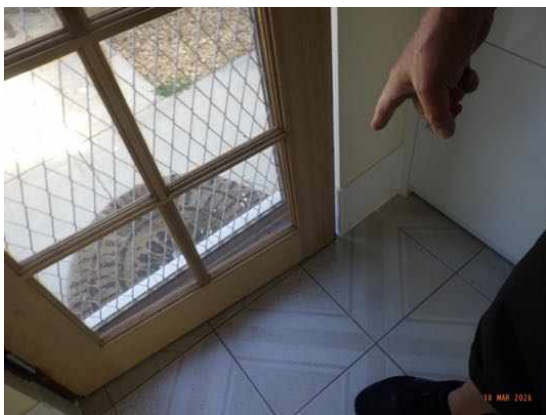
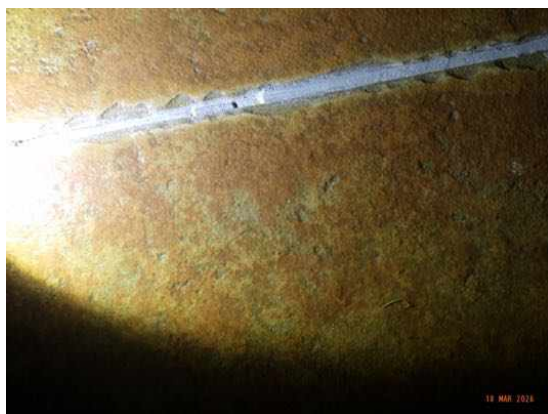
### Finding 3.03

Building:	Building 1
Location:	All Areas
Finding:	Minor defects present
Information:	Minor defects were evident throughout the dwelling at the time of inspection, which are consistent with normal wear and tear and considered appropriate for a property of this age.

These defects are typical of ongoing material ageing, settlement, and general use over time, and include, but are not limited to:

- Minor deteriorated exterior paint

- Window winder to lounge not smooth operation
- Laundry door rubbing on the frame.
- 1 drummy tile to bathroom

While these defects are not considered structurally significant at present, they should be addressed as part of routine and ongoing property maintenance to prevent further deterioration. Repairs and maintenance works should be carried out by appropriately licensed and qualified tradespeople to ensure the continued serviceability and longevity of the dwelling.

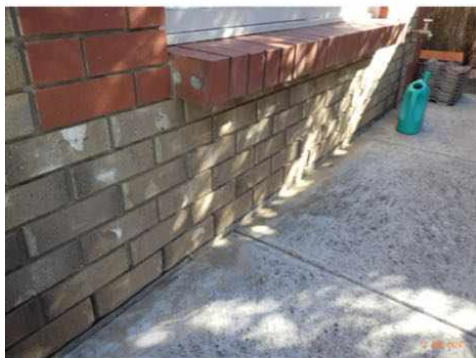
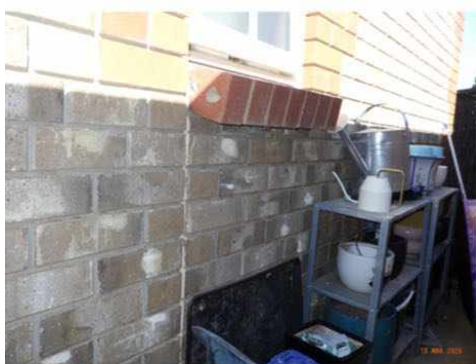
### Finding 6.01

Building:	Building 1
Location:	All External Areas
Finding:	Slab Edge - Exposure
Information:	An inspection zone of at least 75mm in relation to the exposed slab edge, between the bottom brick and the perimeter pavement, is required. This inspection zone should be maintained in order to force termites into the open where they can be detected more readily during regular inspections. The slab edge should not be concealed by anything that may prevent inspection of the area, including render, landscaping, soil, turf, paving, concrete cladding or other structures.

If the slab edge is not properly exposed there is a high risk of concealed termite attack which your inspector will likely not be able to see. Sometimes, in order to determine the type of slab, a suitably qualified person such as an architect or builder may be required to consult construction plans.

Where the slab edge cannot be properly inspected, it is highly recommended that termite or timber pest inspections be carried out every 6-12 months to aid protection of the property against infestation and termite treatment advice is followed closely.

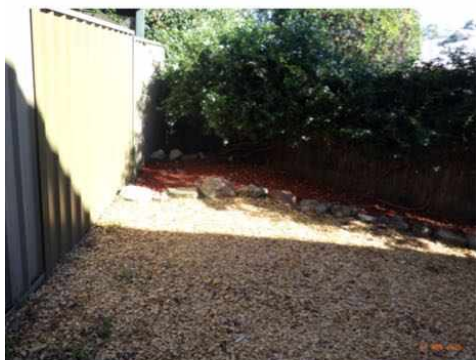
### Finding 6.02

Building:	Building 1
Location:	Yard - Back
Finding:	Untreated or non-durable timbers in a hazardous environment
Information:	To reduce the risk of timber pest attack it is essential that timber used in a hazardous environment (e.g. in direct contact with the ground or frequently exposed to damp conditions) is of sufficient durability and/or is adequately preservative treated. Additionally any timber lying around or timber stumps should be removed.

Untreated timbers in direct contact with the ground are likely to develop severe wood rot and/or fungal decay if left unattended creating attraction for subterranean termites to infest the timbers from surrounding areas.

If untreated or non-durable timbers are found to be in a hazardous environment it is highly advised that replacement of these building elements be performed as soon as possible to aid the protection of the property against termite / timber pest attack. Failing this close monitoring is recommended in an attempt to identify termite infestation at an early stage.

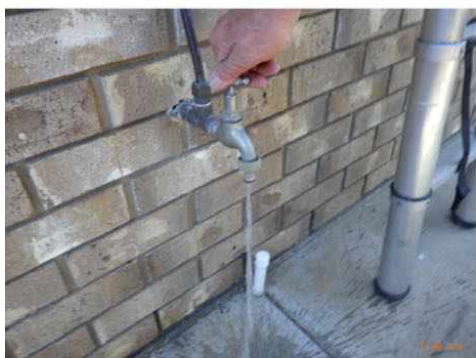
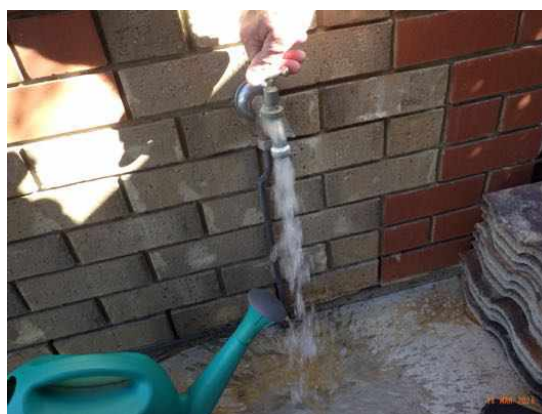
### Finding 6.03

Building: Building 1  
 Location: All External Areas  
 Finding: Air conditioner and or external tap - No drainage  
 Information: Moisture around the perimeter of the building should be minimised to ensure that the area is kept dry and stable which in turn reduces the risk of water damage and termite infestation.

There appears to be no drainage points set up to the air conditioning unit, and or the external tap. While this is not a legal requirement it is recommended to reduce the risk of moisture related issues and the creation of an environment conducive to termite activity.

It is recommended that a licensed plumber be appointed to set up drainage in order to prevent such an environment from being created.

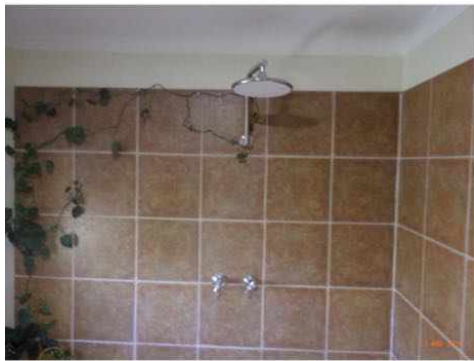
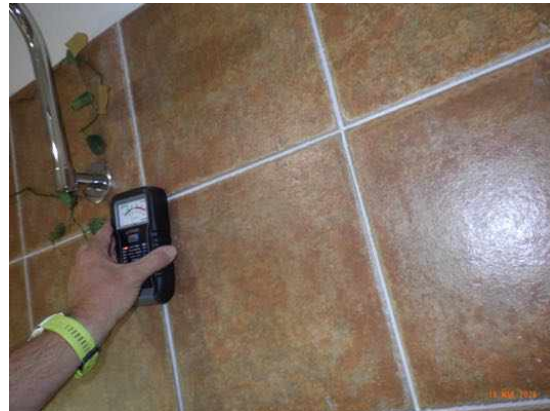
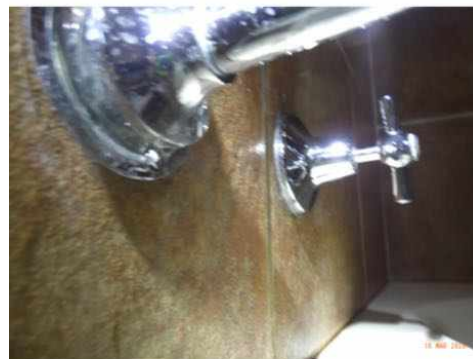
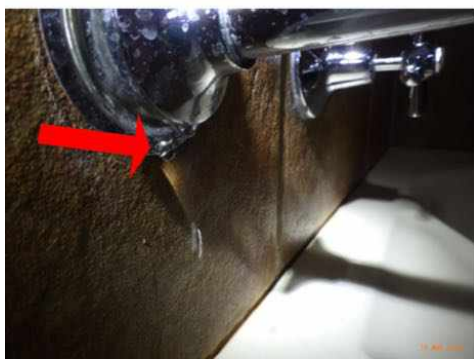
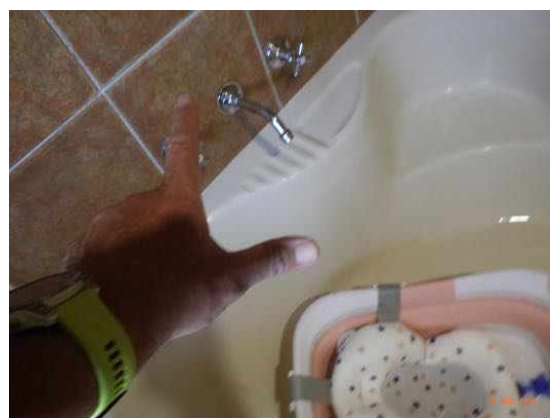
### Finding 6.04

Building: Building 1  
 Location: Bathroom  
 Finding: Bath - Leaking  
 Information: At the time of inspection, the bath tap showed evidence of leaking during operation.

Although common, water leaks can be detrimental to surrounding building elements. Rust, corrosion, decay and water damage are all potential outcomes of a water leak that is left unattended, which are then likely to develop into more serious defects and may necessitate major repair works.

Additionally, water leaks may significantly increase the termite risk to the dwelling.

It is highly advised that water leak be addressed by a licensed plumber as soon as possible to prevent any damage.

Repair leaking tap to bath

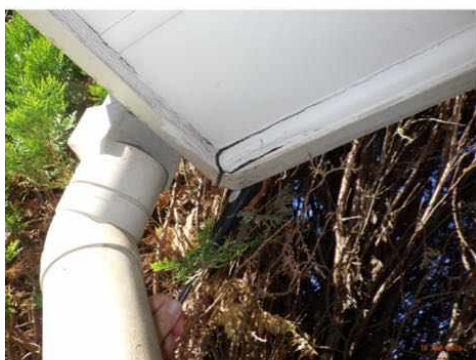
## Finding 7.01

Building:	Building 1
Location:	All External Areas
Finding:	Fascias - Wood rot
Information:	Wood rot was found to be affecting fascias and barges throughout the roof, evidenced by the presence of deterioration on the surface in some areas. Wood rot, also known as Fungal Decay, occurs when timbers and other cellulose building materials are exposed to damp conditions on an ongoing basis.

It is likely that this wood rot has developed as a result of faults in the roof plumbing, creating excessive moisture in this areas.

Frequent exposure to rain and other weather conditions also make fascias and barges susceptible to accelerated deterioration.

Early intervention and regular maintenance will prolong the useful life of these building elements. Prior to any works being performed, the cause of the moisture that has created the visible wood rot should be identified and addressed in a suitable manner.

It is advised that a roof plumber be appointed to inspect all roof plumbing and subsequently identify the cause of the wood rot. Replacement of affected fascias and barges may then be a necessary step in protecting surrounding building elements from such deterioration.

A qualified plumber may be appointed to assess the cause of excessive moisture and to provide advice on any remedial works as required. A qualified carpenter or may also be required to replace affected building materials.

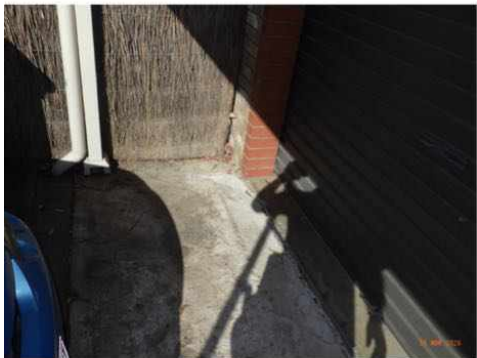
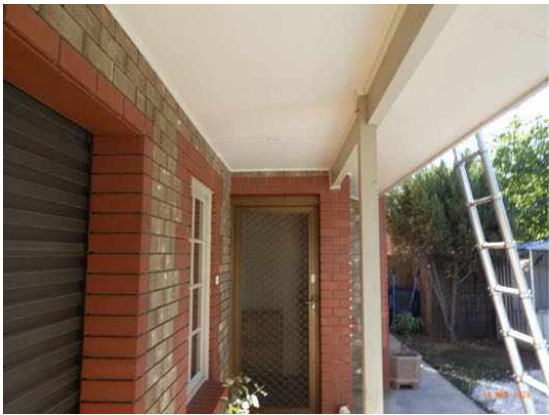
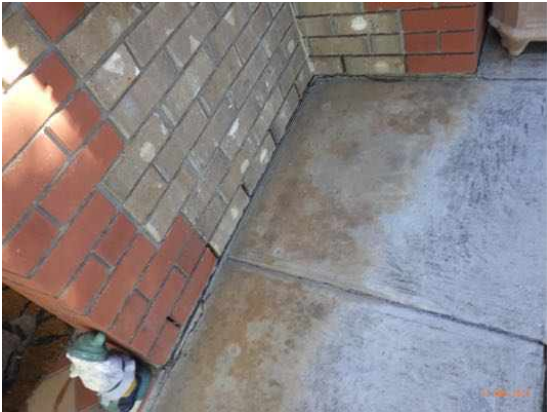
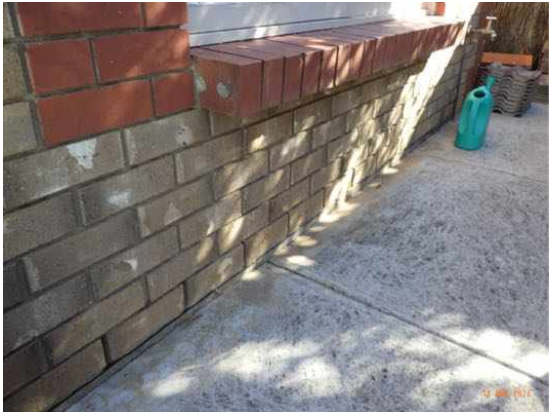
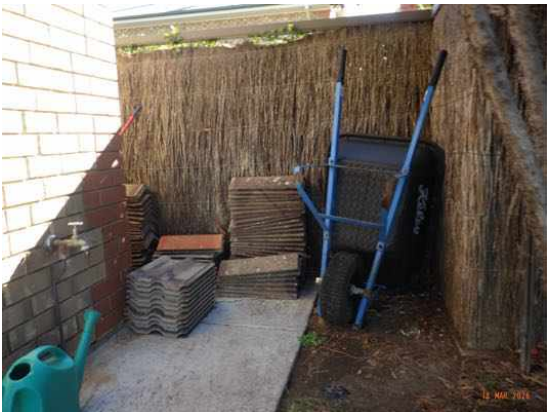
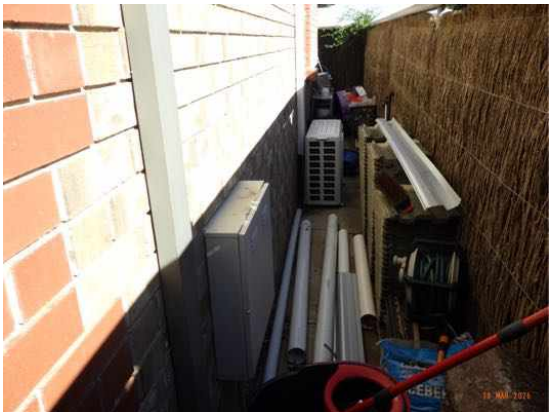
Building: Building 1  
 Location: All Areas  
 Finding: Additional Photos - Obstructions and Limitations  
 Information:

These photographs are an indication of the obstructions and limitations which impeded full inspection of the property at the time of inspection. These obstructions can hide an array of defects and should be removed to allow full inspection to be carried out.

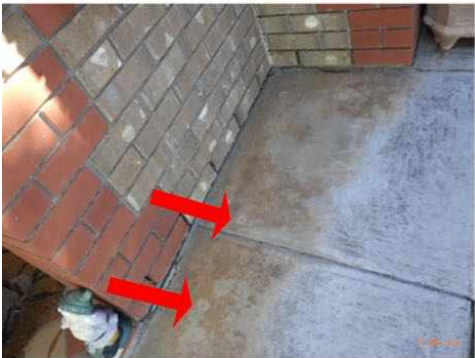
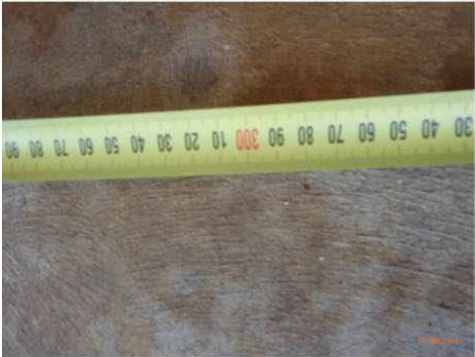
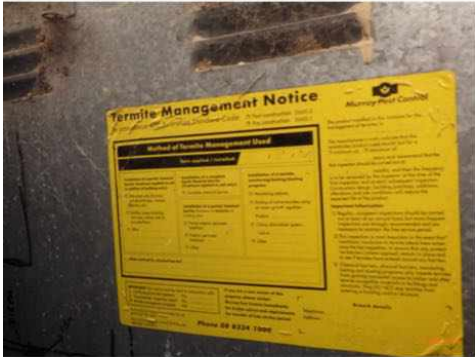
Building:	Building 1
Location:	All Areas
Finding:	Evidence of a chemical treated zone barrier was identified - drill and inject
Information:	During inspection of the property, it was noted that works to install a chemical treated zone barrier had previously been completed. A chemical treated zone barrier is likely to ensure effective protection against termites.

We strongly recommend annual inspections of the barrier and surrounding areas as there are several factors that can lead to deterioration of the barrier and decrease its effectiveness.

Where a Termite Management System has been identified, the client should identify to the type of barrier, date of installation, warranty conditions and any documentation provided by a builder or past owner. Consult the company who installed the barrier to confirm whether the system is still under warranty.
