# Building and Timber Pest Inspection Report

Inspection Date: Wed, 18 Mar 2026

Property Address: 2/20 Ewos Parade, Cronulla NSW 2230,  
Australia

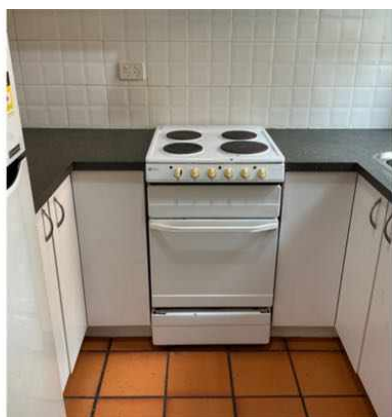
Building:	Main Building
Location:	Kitchen
Finding:	Unsecured Oven Installation
Information:	The electric oven located beneath the gas cooktop in the kitchen island was found to be unsecured.

During a light pull, the oven moved forward freely, presenting a potential safety hazard, especially if weight is applied to the open door. According to AS 4349.1–2007 Appendix C (C2.2 and C2.3), appliances should be properly installed to prevent movement or dislodgement.

This defect is considered a major safety concern due to the risk of injury or damage. Immediate rectification is recommended by a licensed kitchen installer or qualified tradesperson to properly secure the appliance in accordance with manufacturer installation instructions. Rectification should occur within 24–48 hours to eliminate the risk.

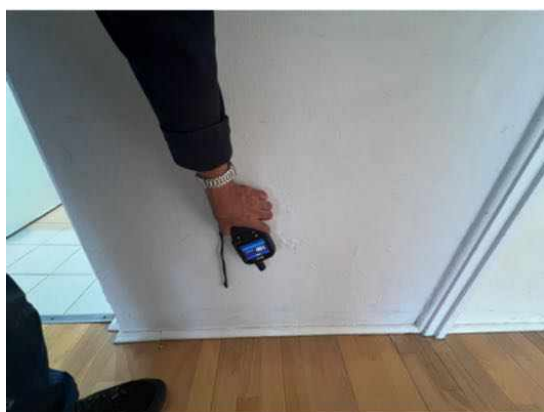
#### Finding 2.01

Building:	Main Building
Location:	Bathroom
Finding:	Elevated Moisture Bathroom & Back of shower (Possible waterproofing)
Information:	Elevated moisture levels were detected to tiled surfaces in bathroom/shower areas. This may be due to porous or missing grout, cracked tiles or recent use, however the possibility of waterproofing membrane failure or plumbing leaks cannot be excluded.

Persistent moisture ingress can lead to concealed damage, including timber rot and mould growth. Further investigation by a licensed plumber and/or waterproofing contractor is recommended as soon as possible. The back of shower area also showed elevated moisture with visible deterioration evident at the time of inspection.

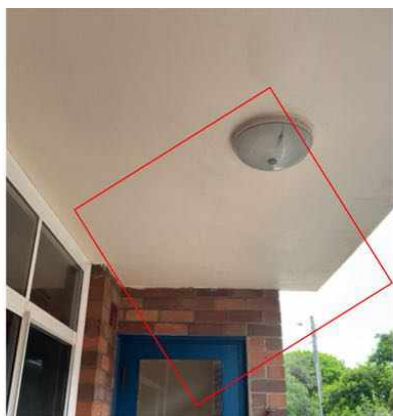
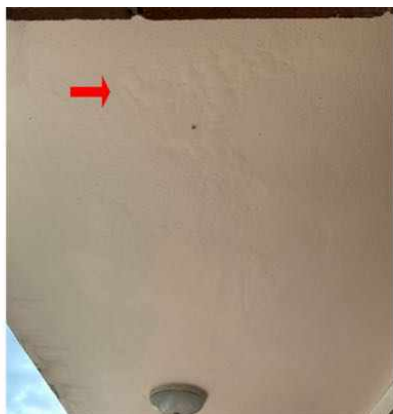
### Finding 2.02

Building:	Main Building
Location:	Balcony
Finding:	Painted surface - Bubbling - Balcony Soffit (Possible waterproofing)
Information:	Sections of paint in this area was found to have bubbled and deteriorated. Paint bubbling is generally an indication of excessive moisture in the area, that is currently hidden by the painted surface.

The presence of excessive moisture can have major implications on associated building elements if left unattended. While only seemingly minor at this stage, the damage cannot be determined due to the paint obstructing any further inspection of the damage.

It is highly advised that the affected paint be cleaned to allow a further, more invasive inspection by a licensed plumber. Failure to act on this defect may necessitate major works in the future.

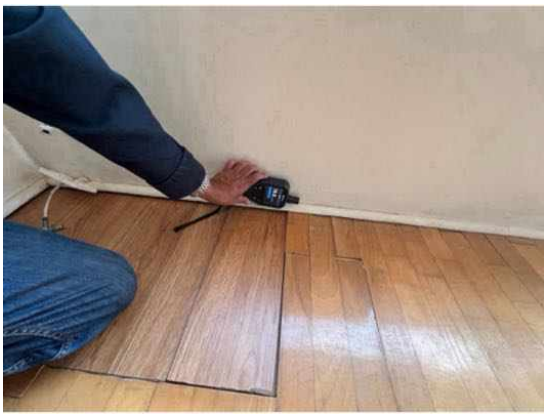
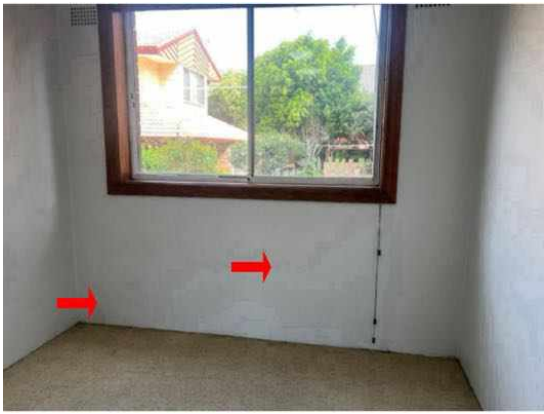
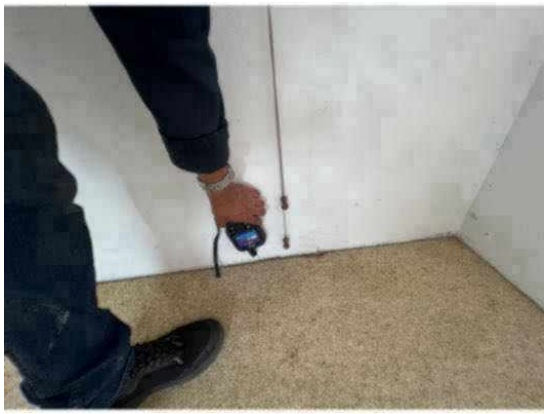
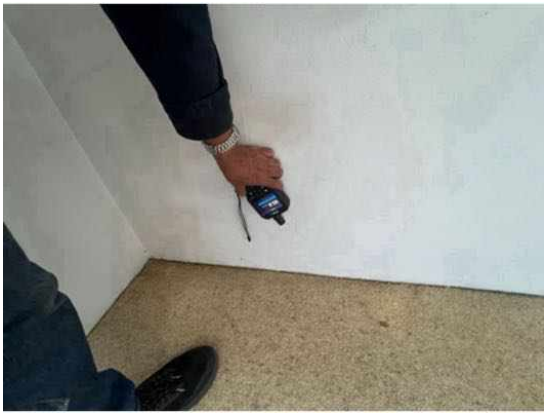
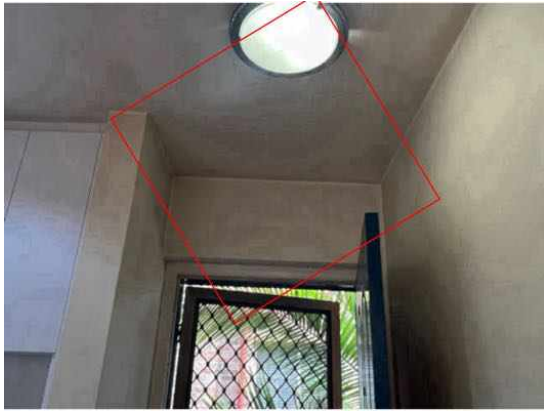
### Finding 3.01

Building:	Main Building
Location:	All Internal Areas - Rear wall lounge , bedrooms , front entrance and bedroom front ceiling
Finding:	Elevated Moisture – Further Investigation Recommended - Multiple areas (possible moisture ingress from external pathways and balcony)
Information:	Elevated moisture readings were detected in several locations, with some areas also showing signs of dampness while others did not present visible surface issues, although no significant structural damage was evident at the time of inspection, dampness can contribute to deterioration if left unaddressed. Inspector was not able to inspect the external wall due to space constraints. A further investigation by a licensed plumber or waterproofing specialist is recommended to confirm the source and ensure no concealed issues are developing.

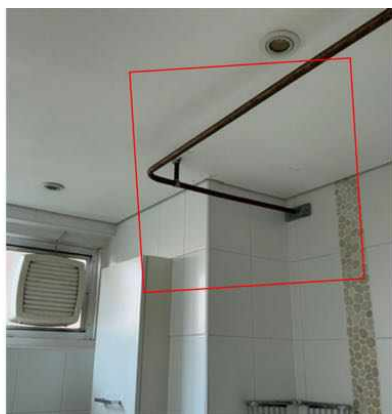
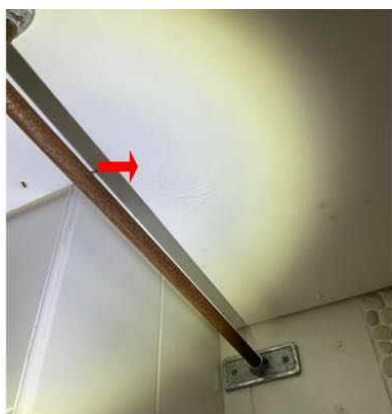
Building:	Main Building
Location:	Bathroom
Finding:	Ceiling - Water damaged
Information:	Water damage to the ceiling lining is generally an indication of excessive moisture being present in the roof void, usually via a leak to the roof covering.

Where water damage is evident to the ceiling, the primary requirement is to identify and rectify the source of the leak. A roofing plumber should be appointed as soon as possible to identify the leak and perform rectification works as necessary, ensuring the water damage is restricted.

Once the leak is repaired, consultation with relevant tradespeople, including plasterers and painters, is advised. Rectification works may include replacement of ceiling lining or minor repainting, depending on the extent of the damage.

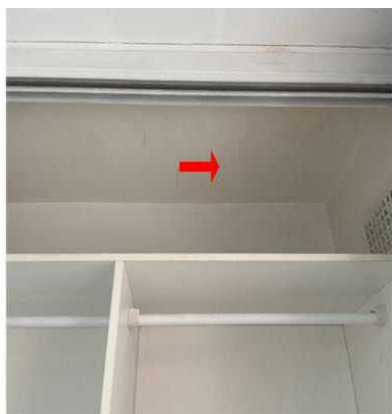
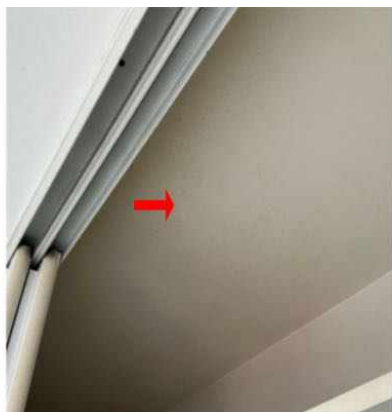
### Finding 3.04

Finding: Water staining

Information: Water staining was evident in this area at the time of inspection. Water staining indicates that surfaces have been exposed to excessive moisture over time. The minerals and other elements in the water lead to staining, which may graduate to corrosion and deterioration if left unmanaged.

While mostly an appearance defect, water staining can be indicative of more serious defects, which may be currently concealed by other building elements.

Where water staining is active, a licensed plumber must be consulted to identify the cause of the staining and to provide advice on any reparation works that may be required. Replacement of any broken or damaged structures is advised.

Conversely, where water staining is old and inactive, affected building materials may be repaired or replaced at client discretion. A qualified carpenter or registered builder may be appointed to perform these works.

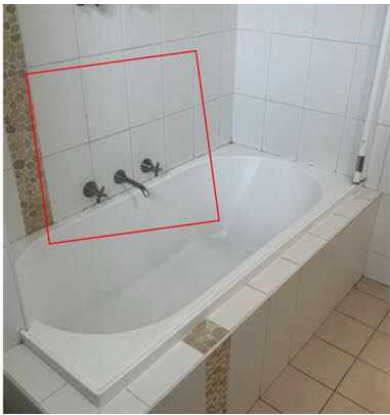
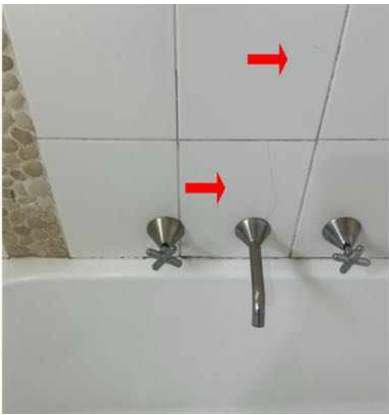
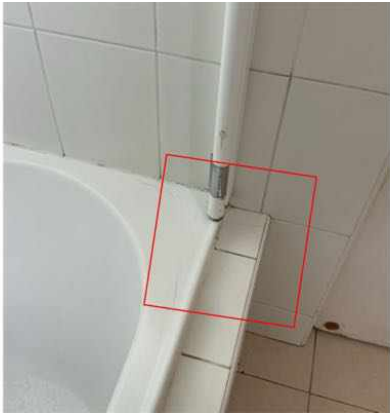
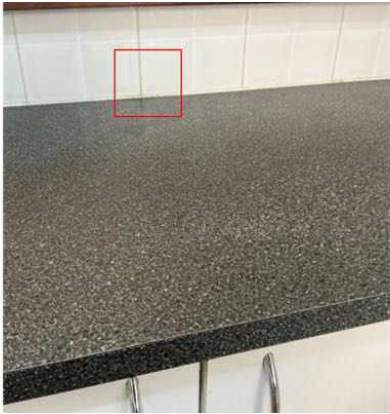
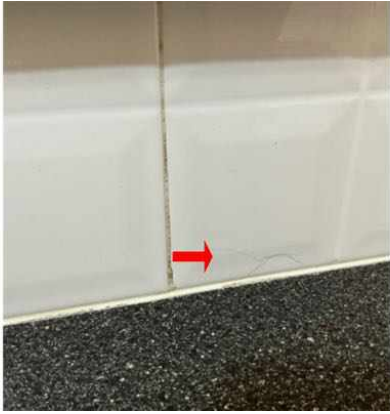
### Finding 3.05

Building:	Main Building
Location:	Bathroom, Kitchen
Finding:	Tiles - Cracked or damaged
Information:	Cracking was evident to the tiling in this area at the time of inspection. While the cracking appears to be minor, this area is frequently exposed to water, allowing potential for water penetration into adjoining sections of walls or flooring.

If left unmanaged, water penetration to these areas may lead to subsequent water damage, which is likely necessitate repair work to affected building elements.

A tiling contractor should be appointed to ensure that no further water damage occurs. The re-application of silicone and grouting throughout remaining tile work is also advised, to further protect the area against water penetration.

Where water penetration has led to water damage, appointment of a relevant tradesperson may be required to repair damaged building elements.

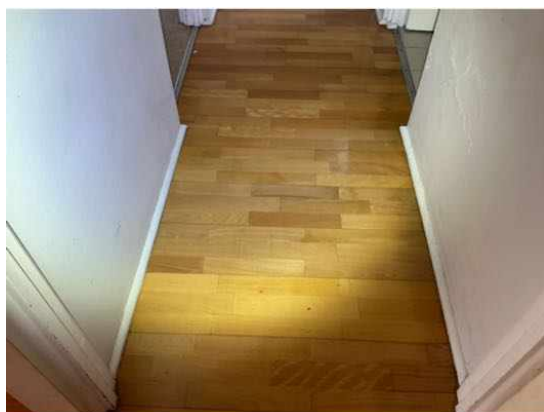
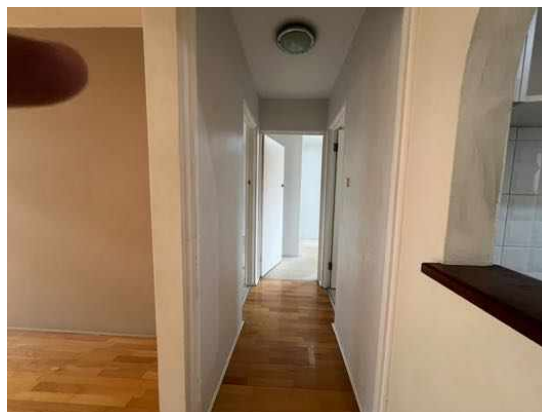
Finding 3.06

Building:	Main Building
Location:	All Internal Areas
Finding:	Laminate Flooring Movement / Creaking
Information:	Minor creaking and movement were noted when walking over sections of the laminate flooring. This condition is commonly associated with floating floor systems where slight movement occurs between boards or between the flooring and the underlying substrate, particularly if the subfloor is uneven or expansion clearances are limited. While this does not generally indicate a structural issue, ongoing movement may cause wear to the flooring over time. Monitoring is recommended, and rectification may involve lifting and reinstalling affected boards or improving subfloor preparation if the condition worsens.

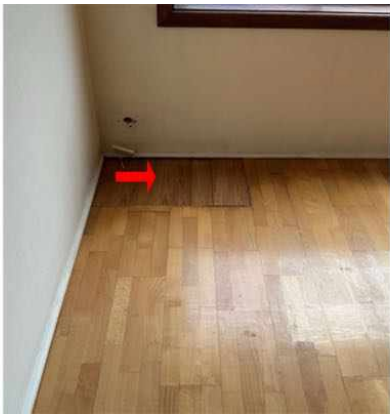
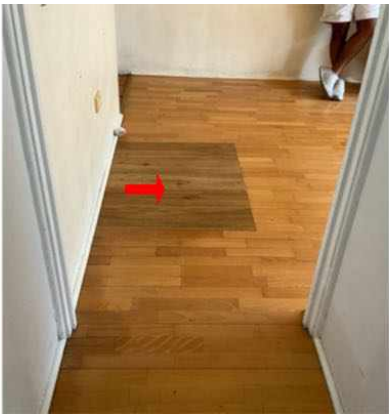
### Finding 3.07

Building:	Main Building
Location:	All Internal Areas
Finding:	Installation - substandard or incomplete - Floor
Information:	The installation of this building element appears to have been completed to a substandard level of workmanship or is incomplete. Generally substandard repairs or installation are related to poor workmanship, the use of inappropriate materials, or a failure to complete installation to a suitable standard.

Where installation is substandard and/or incomplete, the client should contact the responsible trade to undertake rectification. Unfinished and substandard building works are likely to degrade more quickly and may create potential for secondary defects to associated building elements.

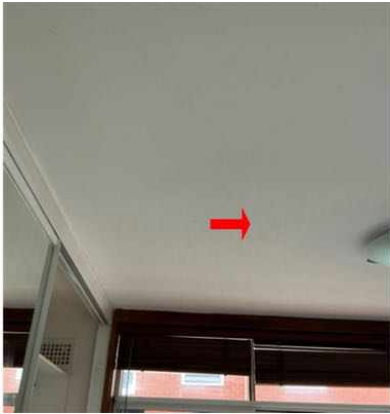
**Finding 3.08**

Building: Main Building  
Location: Bedroom  
Finding: Dark Spots - Ceiling  
Information: Very minor spotting was identified at the time of inspection, the pattern is consistent with airborne dust accumulation and/or minor environmental staining or possible insect droppings. No visible evidence of moisture ingress or structural defect was observed at the time of inspection.

Cleaning and repainting may be undertaken for cosmetic improvement. Regular cleaning and maintenance of air-conditioning filters and ventilation is recommended.

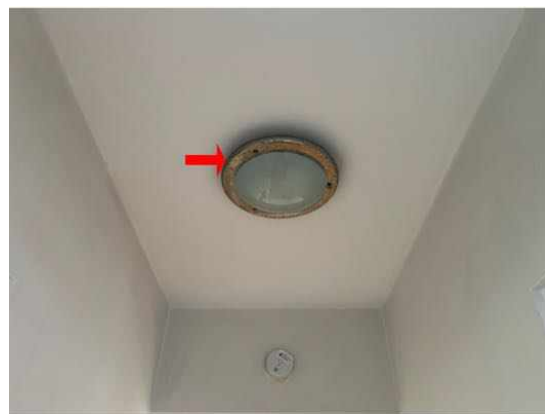
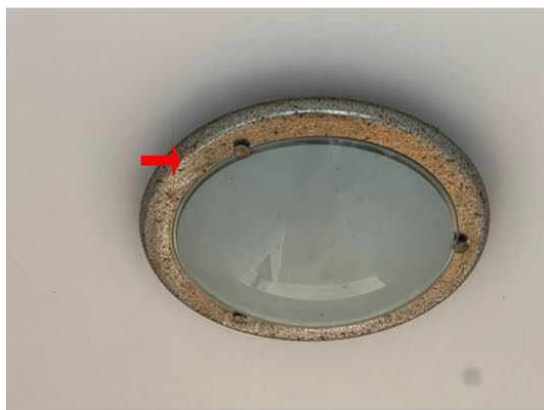
### Finding 3.09

Building: Main Building  
Location: All Internal Areas  
Finding: Building element - Damaged - Carpet deteriorated , rusted light fitting  
Information: Breakage occurs generally when the building materials have either aged and decayed, or as a result of damage (accidental or deliberate).

Repair and/or replacement of broken elements is advised to ensure that additional secondary defects do not arise as a consequence. Such works are necessary, as all building elements play a key role in the operation and function of the overall structure and its performance.

A relevant tradesperson should be appointed to repair or replace the affected building element prior to any subsequent damage being caused.

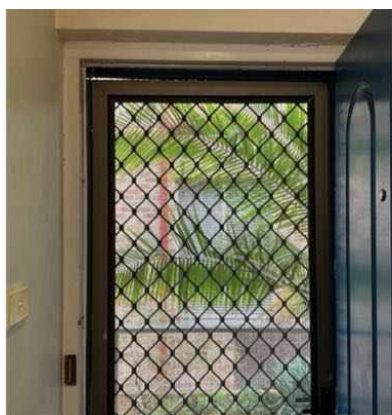
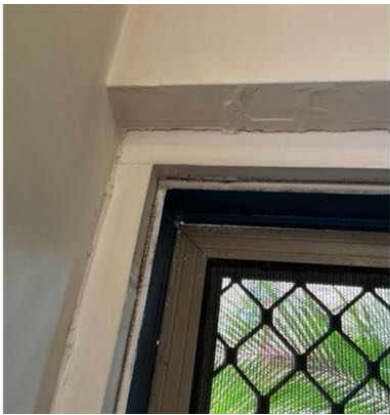
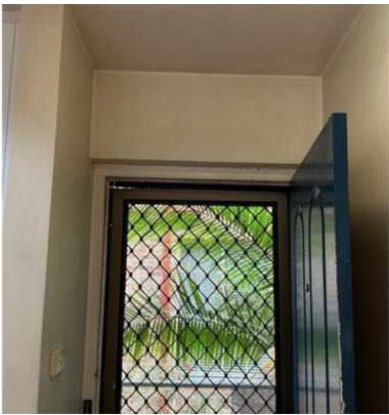
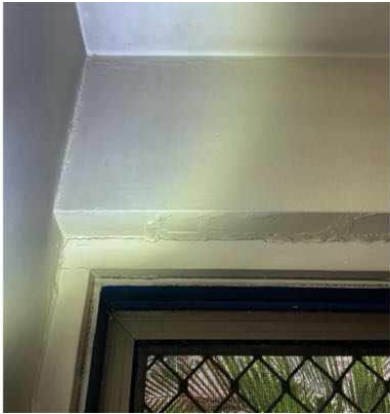
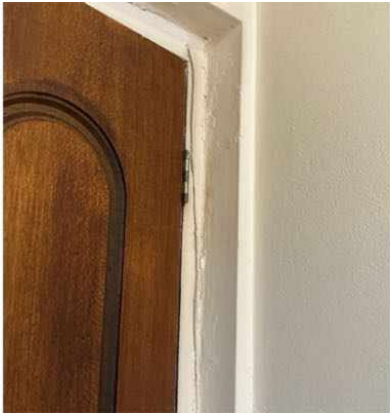
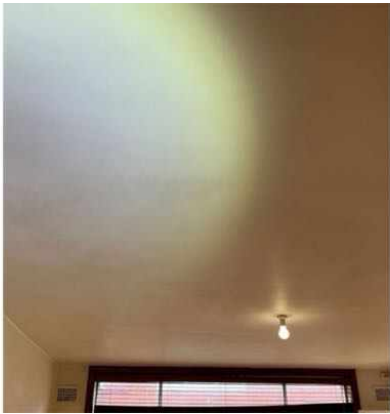
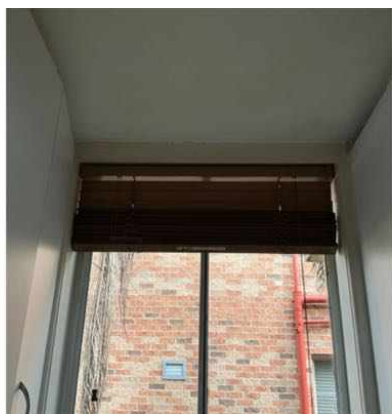
### Finding 3.10

Building:	Main Building
Location:	All Internal Areas
Finding:	Paint finish and hairline cracking
Information:	The paint finish in this area was identified as being incomplete at the time of inspection including some hairline minor cracking.

Whilst incomplete or missing paint and minor cracking and imperfections in finish is generally an appearance defect, it can also lead to the development of secondary building defects over time. Incomplete areas of paint finish expose the area to moisture, potentially accelerating the deterioration of underlying building materials.

Incomplete paint finishes should be sanded back, filled, leveled and painted, as applicable. Where inadequate or missing paint protection has led to the deterioration of the associated building element, repair and/or replacement of this building element may be required.

A painting contractor should be appointed as soon as possible to perform necessary works to aid the appearance of the affected area and to ensure the area is protected against further deterioration. Alternatively, the homeowner following manufacturer instructions may perform these works.

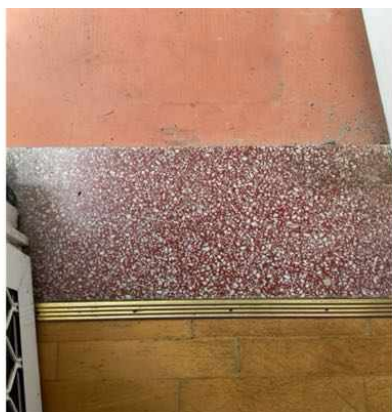
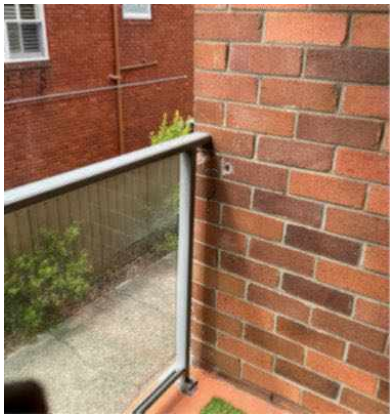
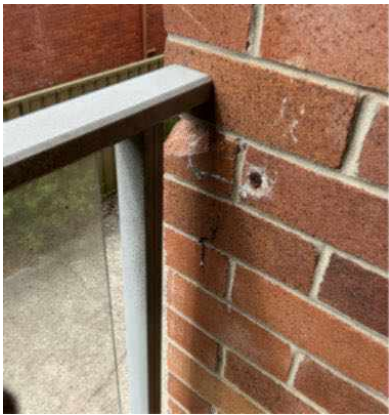
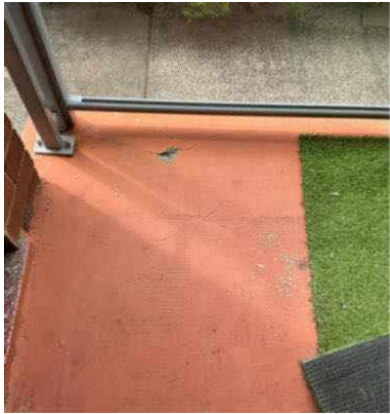
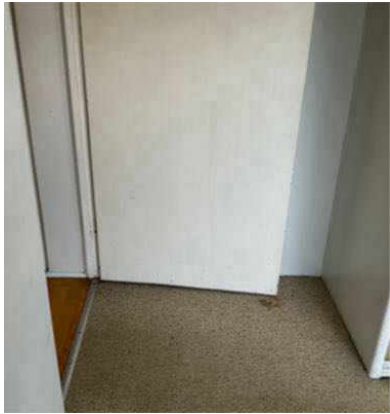
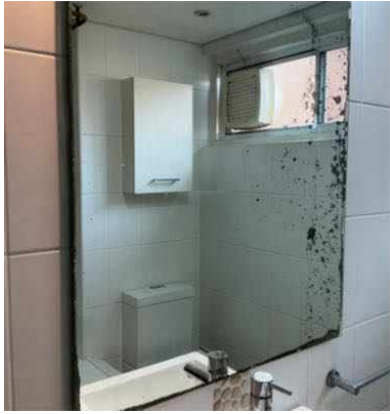
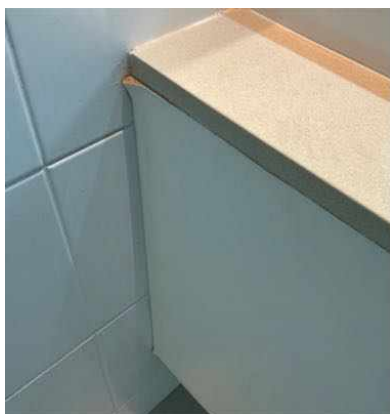
### Finding 3.11

Building:	Main Building
Location:	All Internal Areas
Finding:	Building element - Damaged - cracking in concrete paving , brickwork damaged and cracking , chipped concrete balcony , bedroom door chipped , mirror desilvering , vanity water damaged , kitchen cupboard misaligned
Information:	Breakage occurs generally when the building materials have either aged and decayed, or as a result of damage (accidental or deliberate).

Repair and/or replacement of broken elements is advised to ensure that additional secondary defects do not arise as a consequence. Such works are necessary, as all building elements play a key role in the operation and function of the overall structure and its performance.

A relevant tradesperson should be appointed to repair or replace the affected building element prior to any subsequent damage being caused.

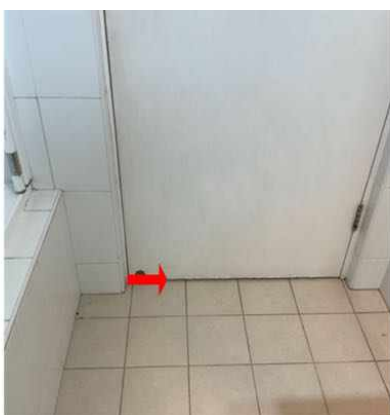
### Finding 3.12

Building:	Main Building
Location:	Bathroom
Finding:	Delamination of timbers
Information:	Localised delamination and surface deterioration were observed to sections of laminated joinery panels. This condition commonly occurs where moisture exposure or wear causes separation of laminate finishes from the underlying substrate. The defect is generally cosmetic in nature but may worsen over time if moisture exposure continues. Repair or replacement of affected joinery components may be considered as part of routine maintenance.

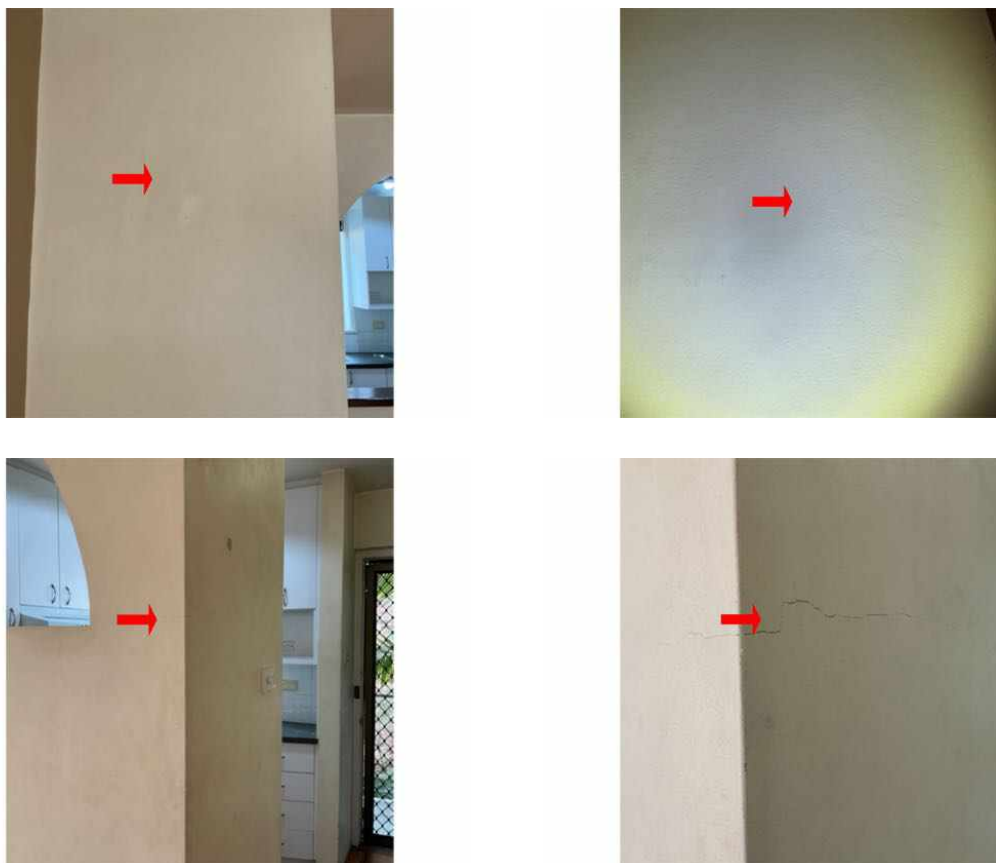
Building:	Main Building
Location:	All Internal Areas
Finding:	Cracks to internal render - Category 1 to some areas
Information:	It has been observed that cracking to internal rendered surfaces has occurred. The degree of damage falls within Category 1, described as fine cracks that do not need repair and which are less than 1.0mm in width limit.

Damage of this category is not considered a defect for rectification. Always contact your building inspector should cracks widen, lengthen, or become more numerous.

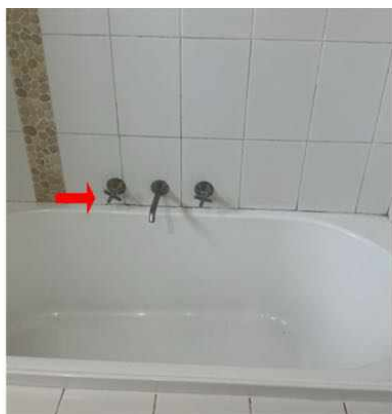
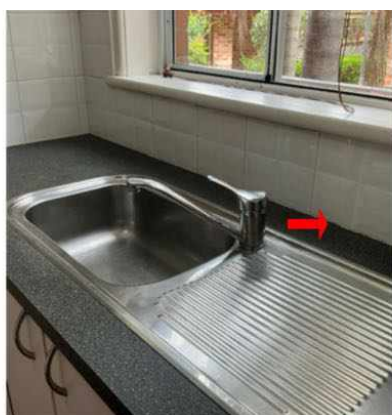
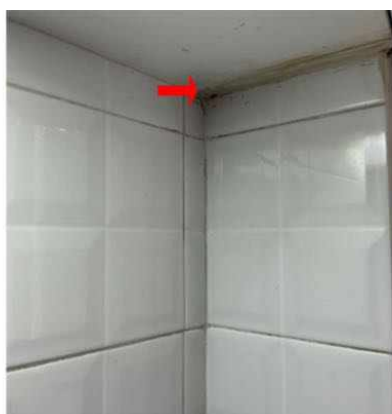
### Finding 3.15

Building:	Main Building
Location:	All Internal Areas
Finding:	Sealant and grouting - Missing or degraded to some areas
Information:	It was noted on inspection that sealant or grout is degraded. There is also evidence of poor workmanship and excessive use of sealant. Silicone should never be used as a first line of defence against waterproofing. Further inspection by a licensed waterproofing contractor is highly recommended.

Different materials and floor areas move at different rates, generally causing cracking to grout or sealant at this point. A flexible sealant is required to allow for expected expansion and contraction, while keeping the joint water tight and protective of all associated building materials.

There appears to be excessive mould to the sealant and grout which will likely require scraping out and replacement.

Flexible and mould resistant materials should be applied to affected areas to prevent any subsequent water damage that is likely to occur. Regular maintenance and replacement of damage or missing or damaged sealant and grout is highly recommended to the wet areas, as this is a regular wear and tear defect. Sealant and grouting in areas that come into regular contact with water should be maintained for the long term care of your property.

A sealant specialist or tiling contractor should be appointed to complete these works as soon as possible

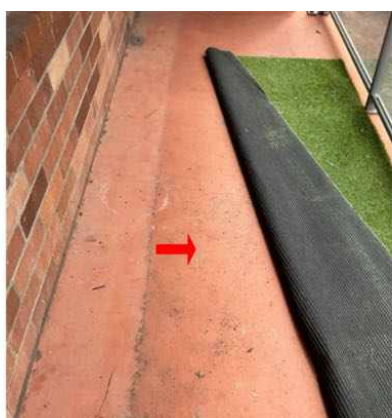
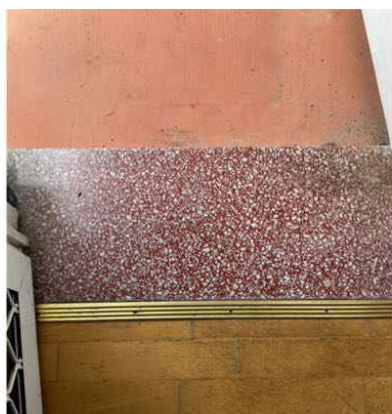
### Finding 3.16

Building:	Main Building
Location:	Balcony
Finding:	Cracking - External Concrete Paving Damage Category 0 - Hairline (less than 1mm) to some areas
Information:	Hairline cracks were identified in external concrete paving. Hairline cracks are very minor in nature and generally are only ever an appearance defect. To be classified as a Category 0 or hairline crack, the crack width would be less than 0.3mm. While such

cracking may be noticeable in some cases, it is common and does not indicate any structural damage.

Generally the cause of a hairline crack in existing concrete paving such as driveways and pathways is indicative of the expansion and contraction of the concrete. Such causes are generally due to environmental factors, such as moisture levels, weather conditions, root systems of nearby trees or the soil types on which they are laid.

Hairline cracks may also be due to poor original installation of the concrete. Factors such as poor compaction of the sub surface and/or inadequate reinforcing of the slab may create cracking and other secondary defects.

Monitoring of all cracking should be conducted frequently. Always contact a building inspector should cracks widen, lengthen, or become more numerous.

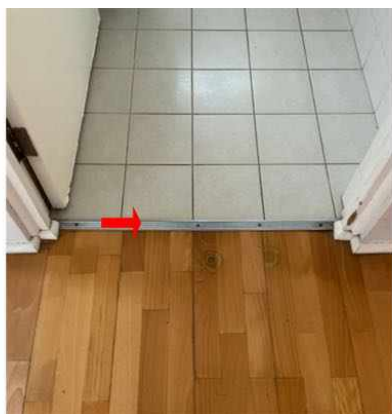
Building: Main Building  
Location: Bathroom  
Finding: Bathroom & external floor threshold  
Information: The bathroom floor is at the same level as the adjoining timber flooring. This configuration is typical in modern apartments and is permitted where compliant waterproofing and floor falls are provided. No evidence of moisture damage was observed at the time of inspection; however, waterproofing performance cannot be confirmed without invasive inspection.

Care should be taken to avoid excessive water migration beyond the bathroom during use.
