# Building and Timber Pest Inspection Report

Inspection Date: Tue, 10 Mar 2026

Property Address: 4/4 Truman St, South Kingsville VIC 3015,  
Australia

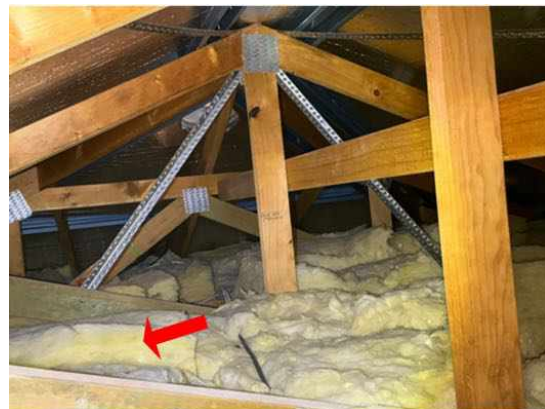
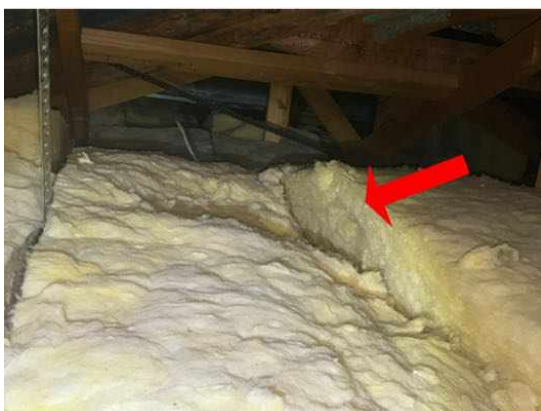
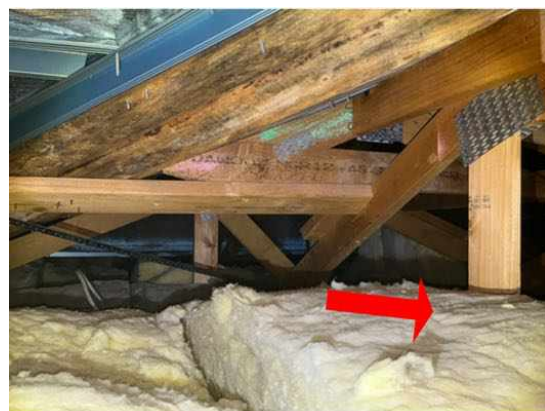
Building: Main Building  
Location: All Internal Areas  
Finding: Insulation - Covering downlights  
Information: Sections of insulation in the roof void have been poorly installed or moved from their original position and are covering down light fittings. While the down lights have been fitted with appropriate protective covers, the presence of this insulation creates a potential fire hazard.

Any insulation within the vicinity of down light fixtures should be moved and re-applied to more appropriate sections of the roof void, thus ensuring the area is fire-safe. An insulation contractor should be appointed as soon as possible to perform any necessary works as required.

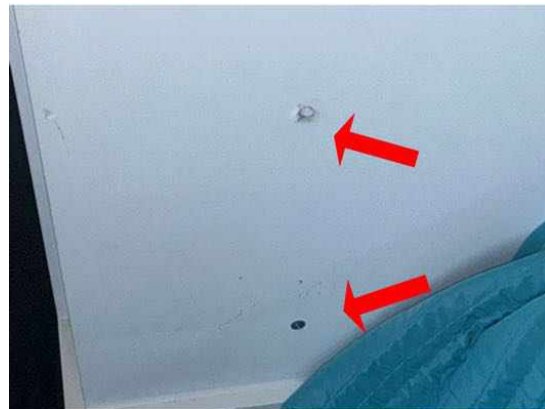
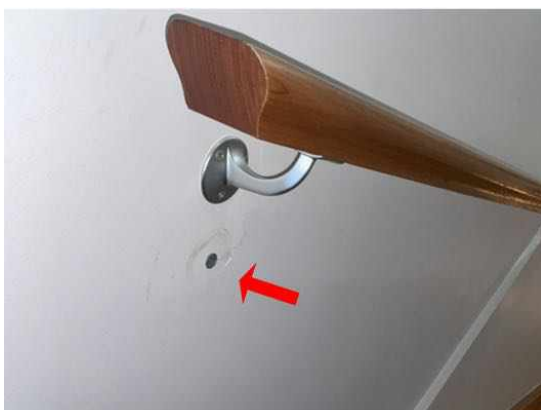
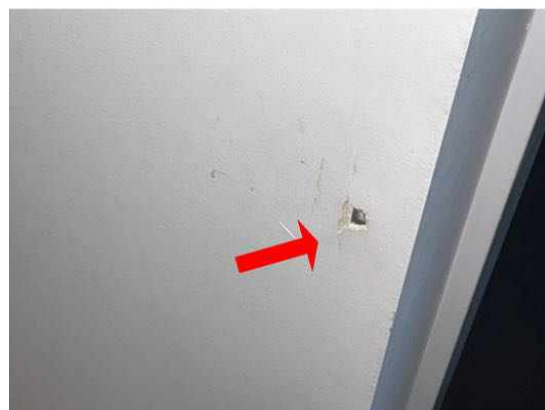
| Information: | It was observed at the time of the inspection that there were several minor holes in the plaster walls. It is suspected that the holes are present as a result of building elements being fixed to the walls and removed. |

Although this is an aesthetic defect it can detract from the overall appearance of the building.

A qualified painter should be engaged to review at owners discretion

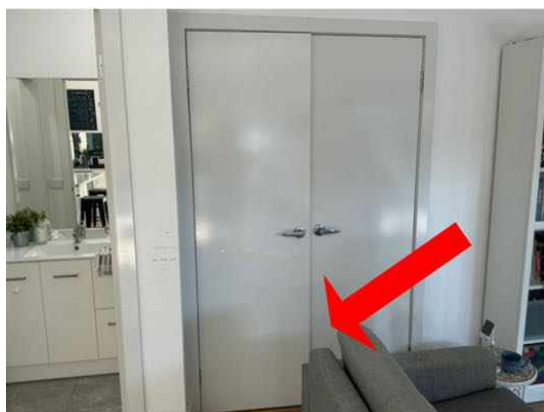
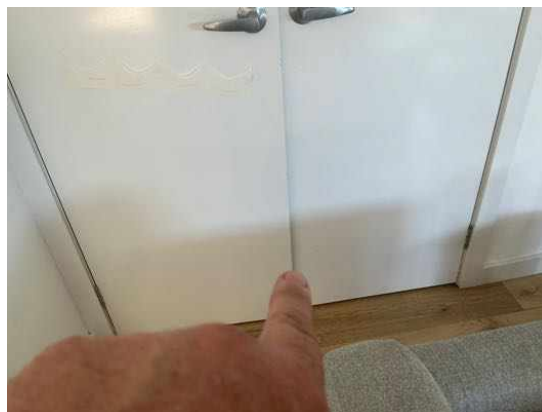
### Finding 3.02

| Information: | Binding and/or jamming of this laundry cupboard door is evident during standard operation. This defect inhibits the functionality of the affected door as well as creating |

potential for secondary defects to associated building elements, such as damage to the floor covering.

A door that binds to flooring or to the associated door frame may have several causes, ranging from minor defects, such as poor installation of the door or deteriorated hinges, through to major structural issues, such as damage to subfloor structures.

Where door binding/jamming appears to indicate major structural issues, a registered builder specialising in re-stumping should be appointed to provide an estimate on the cost of rectification.

For minor causes, a qualified carpenter or general handyperson should be appointed to perform minor rectification works at client discretion.

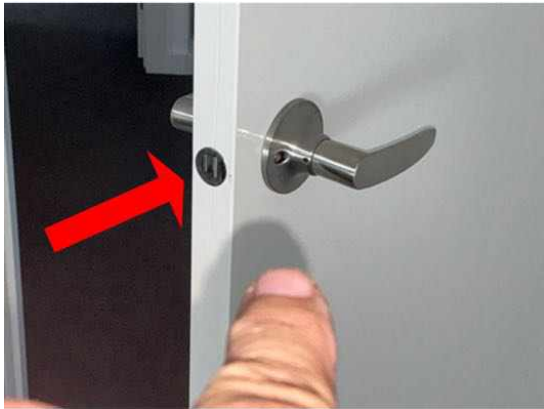
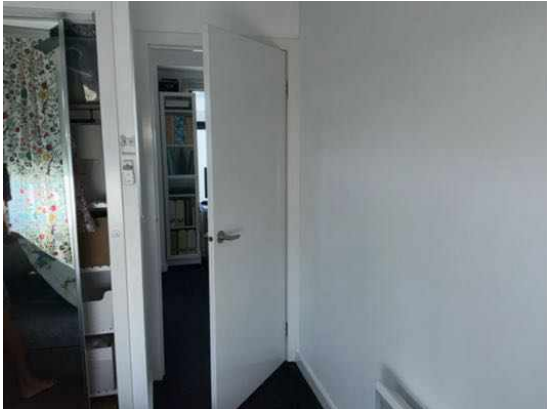
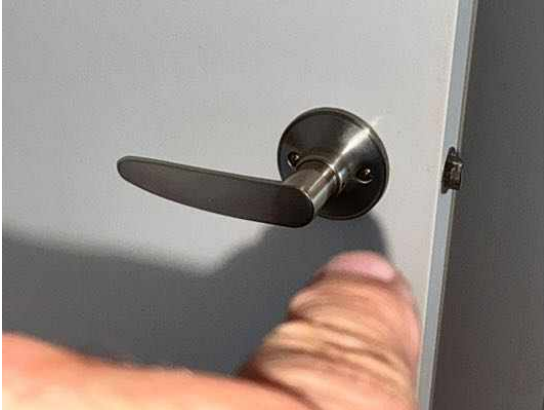
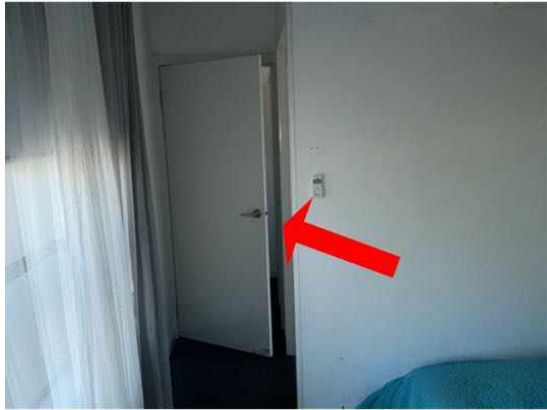
### Finding 3.03

| Information: | It was noted that the door to bed 2 was not latching during operation at the time of inspection. Whilst detracting from the functionality of this building element, this minor defect may also be a security risk, and may therefore have serious implications if left unattended. |

It is suspected that this defect has occurred due to minor issues with the associated hinges. Such damage is identified as general wear and tear, which is expected for building elements of this age.

A qualified carpenter or general handyperson may be appointed to perform rectification works as necessary, at client discretion. If left unattended, further functional impairment is likely to occur.

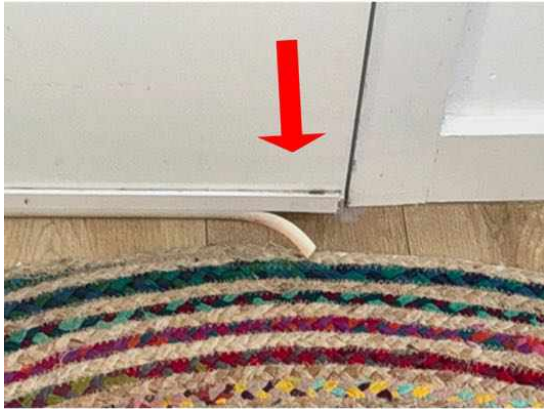
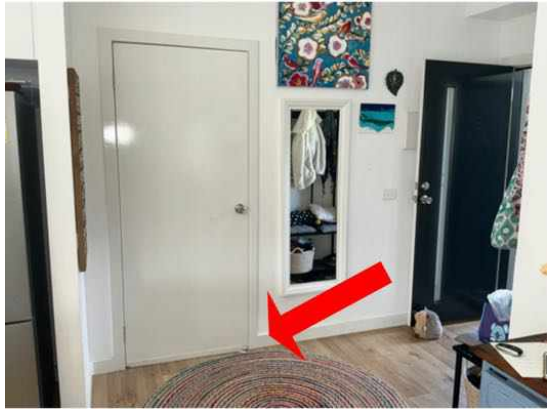
**Finding 3.04**

Building: Main Building  
Location: Garage  
Finding: Door seal damaged  
Information: Was noted at the time of the inspection that the thermal seal to the bottom of the garage/entry pedestrian door was damaged.

Unattended to the door seal could allow the ingress and egress of cold air into the building. This will reduce the thermal efficiency of the building.

A general handyman should be engaged to review of their owners discretion.

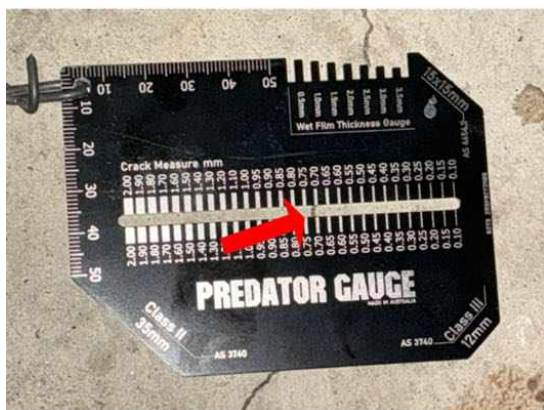
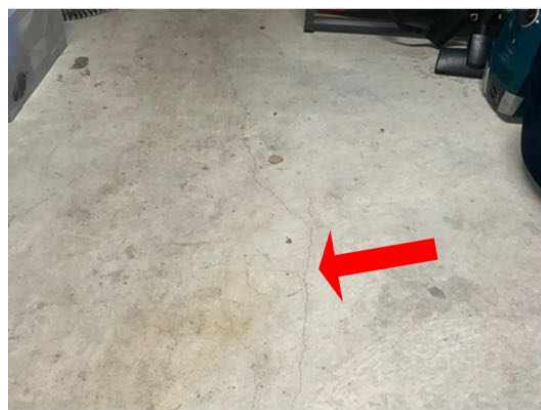
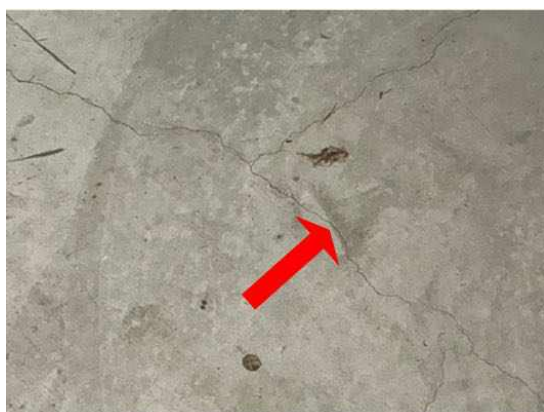
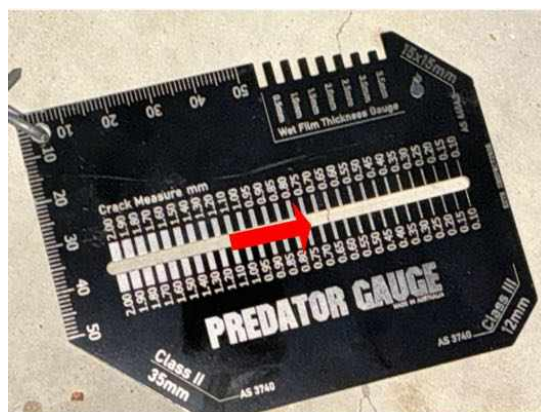
### Finding 3.05

Building: Main Building  
 Location: Garage  
 Finding: Crack in concrete slab - Category 1  
 Information: A crack coded as Category 1 was identified in the slab. A Category 1 crack is described as a fine but noticeable crack, with the slab at an otherwise reasonable level.

To be considered Category 1, the approximate width of the crack is less than 1.0mm, or a less than 10mm change in offset when a 3m straight edge is placed over the defect.

Category 1 cracks should be monitored for a period of 12 months. At the end of the monitoring period, identified cracks that are rated greater than Category 2 are considered defects, and require rectification.

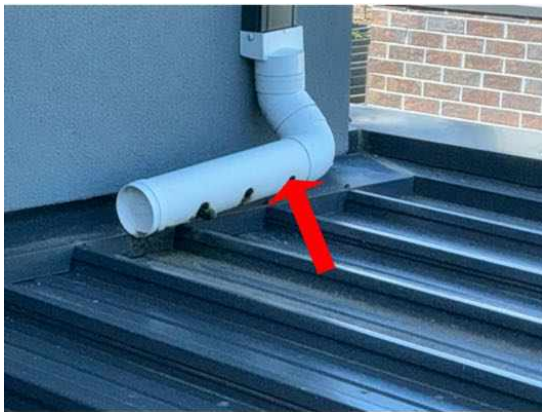
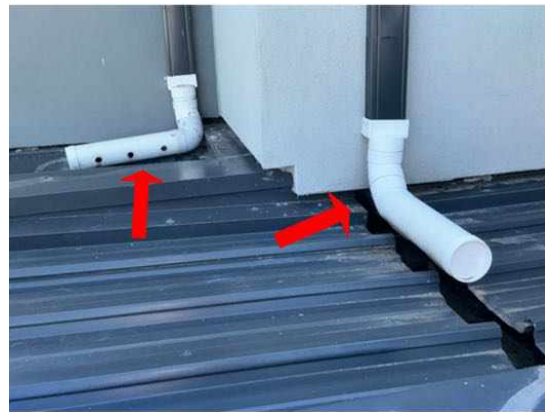
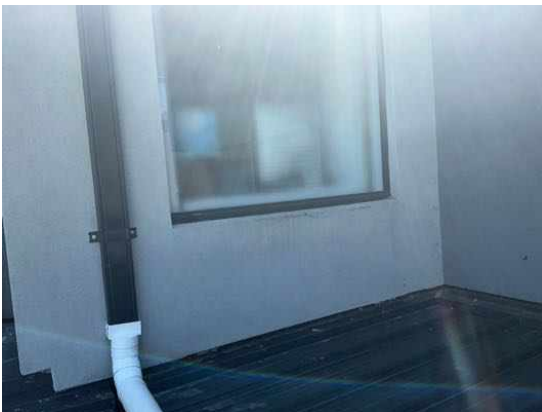
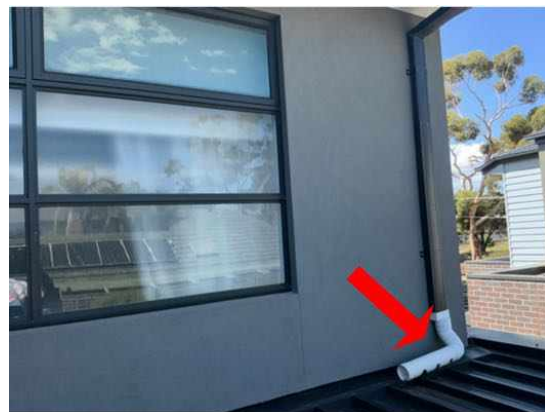
### Finding 3.06

Building: Main Building  
 Location: All External Areas  
 Finding: Downpipes PVC not painted NH  
 Information: It was observed that all PVC downpipes were not UV protected with suitable paint.

UV damage will cause the downpipes to become brittle and prematurely deteriorate the PVC.

The downpipes should be painted with a suitable paint to protect against UV damage to protect against UV damage.

The PVC downpipes should be painted by a general handyman at the owners discretion

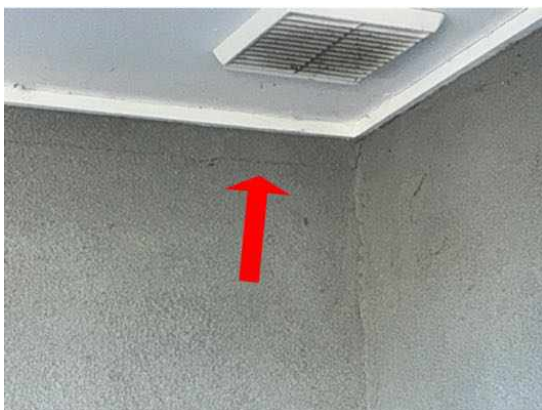
### Finding 3.07

Finding: Cracks to internal render - Category 0

Information: It has been observed that cracking to internal rendered surfaces has occurred. The degree of damage falls within Category 0, and is described as hairline cracking, which is less than 0.1mm in width. Damage of this category is not considered a defect for rectification.

No rectification is required at this time. Always contact your building inspector should cracks widen, lengthen, or become more numerous.

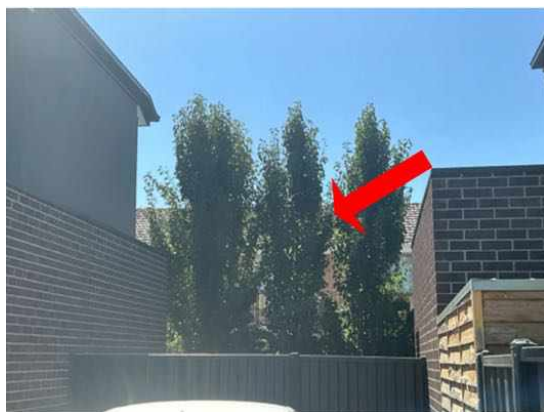
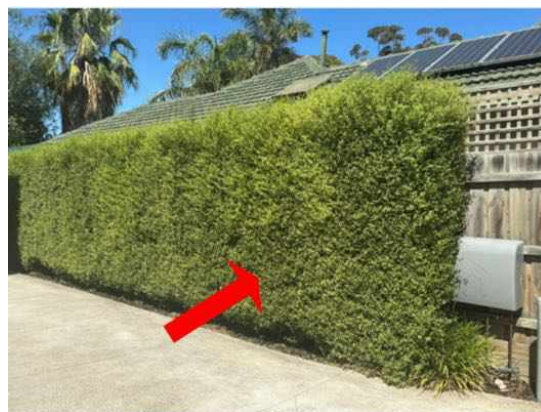
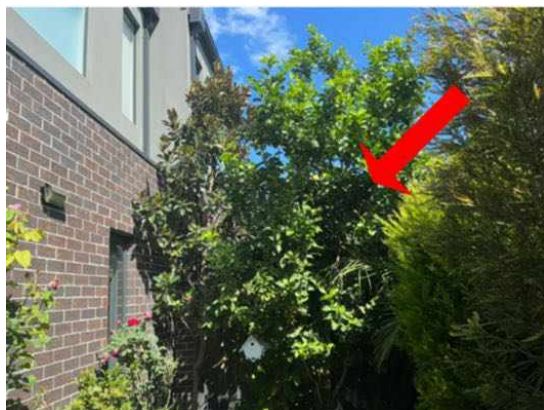
## Finding 6.02

| Information: | It was observed that there were several large trees next to or nearby the building. |

The trees have the potential to provide conducive conditions for termite infestation

It is recommended that periodic 12 monthly inspections by a registered pest control contractor be undertaken and further reinstatement of outdated termite barriers as soon as possible.

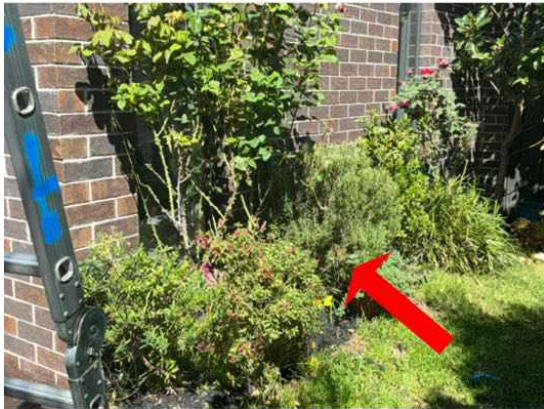
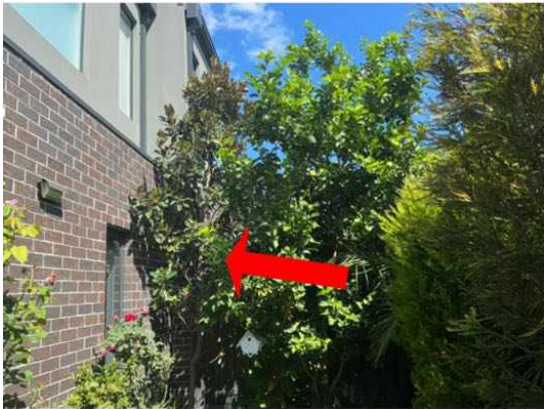
### Finding 6.03

| Information: | Where vegetation obstructs inspection of building elements, also known as bridging as it provides a bridging point for the access of termites, full inspection can not be achieved. Consequently moisture or dampness may be present and the areas becomes conducive to termite activity. Plants against or very close to buildings provide cover, shade and can provide an environment that is attractive to termite infestation. |

The removal and replanting of species that do not provide "cover" or cutting back of existing vegetation will assist greatly in preventing Bridging from occurring.

The removal of any such materials that may be conducive to termite activity should be carried out as soon as possible and arrange re inspection to minimize the risk of termite attack.

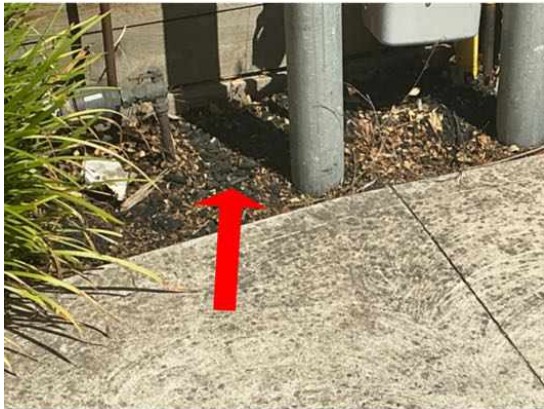
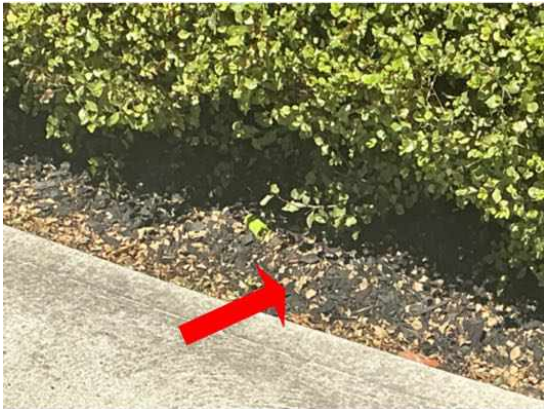
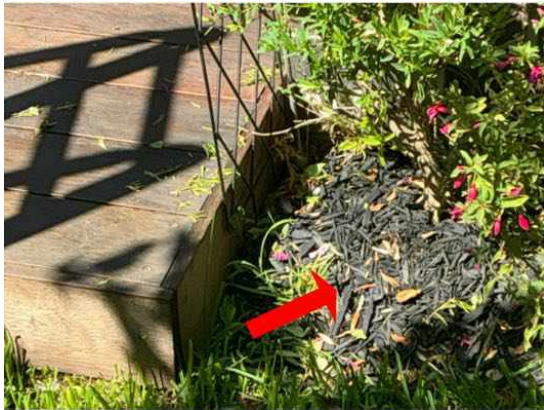
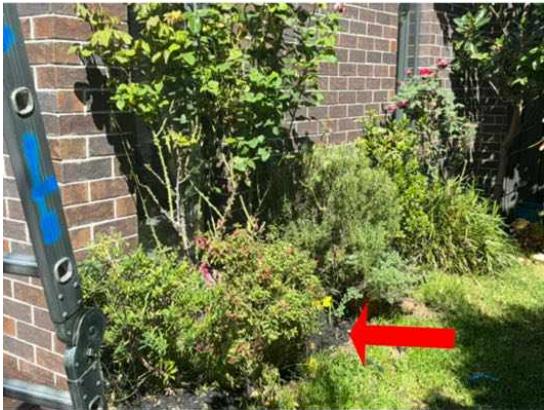
**Finding 6.04**

Building: Main Building  
 Location: All External Areas  
 Finding: Garden Beds - Conditions Conducive to Termites  
 Information: Garden beds were found to be evident in the garden area. These garden beds can include untreated timber, and with a combination of moisture from watering hosing can make conditions conducive to termite activity and termite ingress.

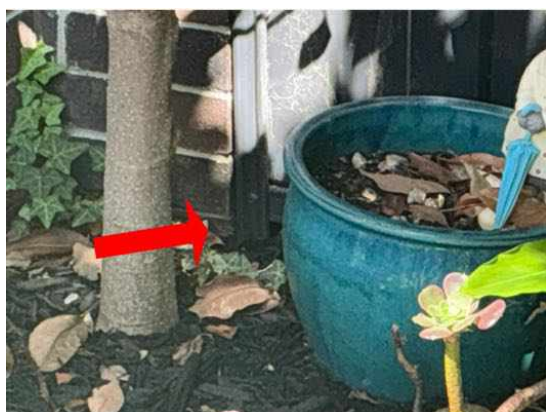
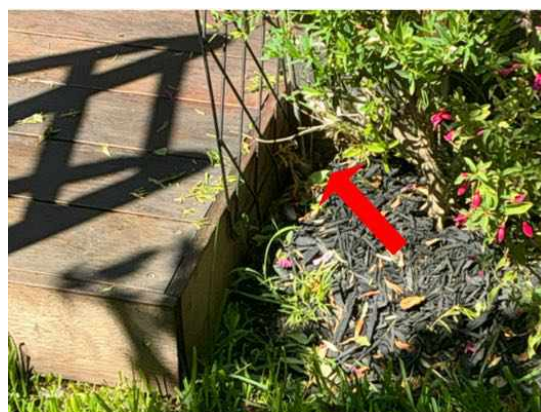
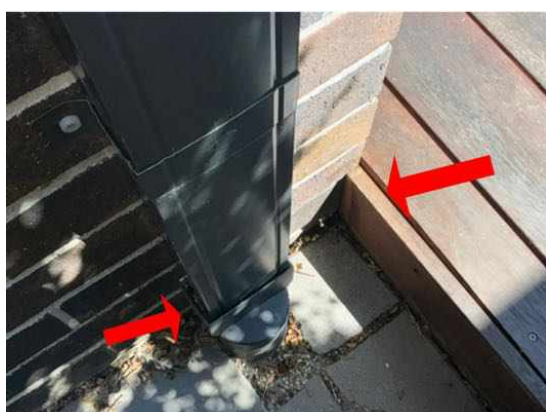
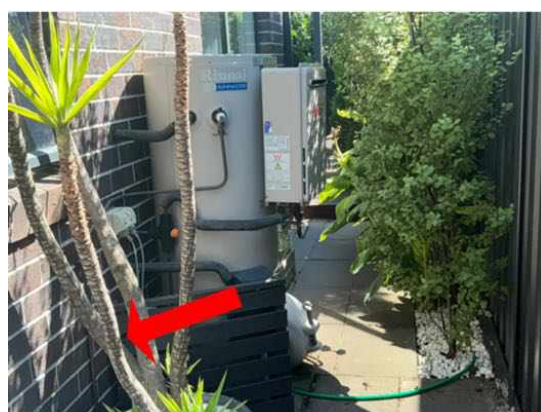
**Finding 6.05**

It is important for internal flooring to be raised above adjacent external ground levels. Where external ground levels are above internal flooring water pooling and subsequent internal flooding is likely to occur which may attract termite activity to the internal area.

It is highly advised that a landscaper or paver be appointed to lower external grounds that are raised above adjacent internal flooring. Alternatively if external grounds and internal flooring is level installation of a raised door sill may be appropriate in preventing any water pooling in the area.

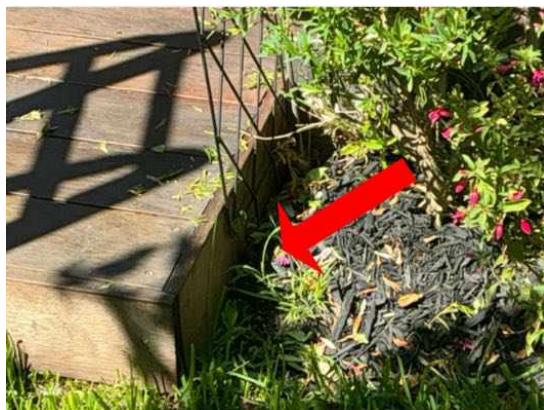
### Finding 6.06

Building: Main Building  
 Location: All External Areas  
 Finding: Untreated or non-durable timbers in a hazardous environment  
 Information: To reduce the risk of timber pest attack it is essential that timber used in a hazardous

environment (e.g. in direct contact with the ground or frequently exposed to damp conditions) is of sufficient durability and/or is adequately preservative treated.

Untreated timbers in direct contact with the ground are likely to develop severe wood rot and/or fungal decay if left unattended creating attraction for subterranean termites to infest the timbers from surrounding areas.

If untreated or non-durable timbers are found to be in a hazardous environment it is highly advised that replacement of these building elements be performed as soon as possible to aid the protection of the property against termite / timber pest attack.

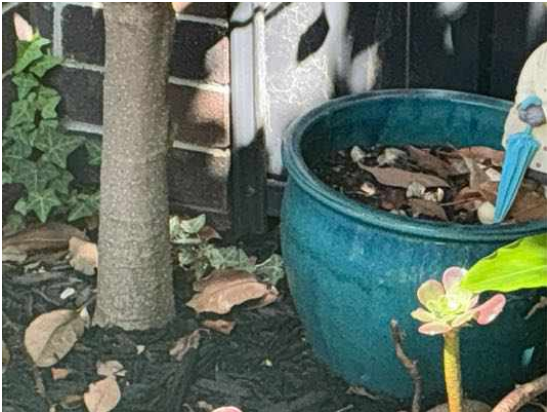
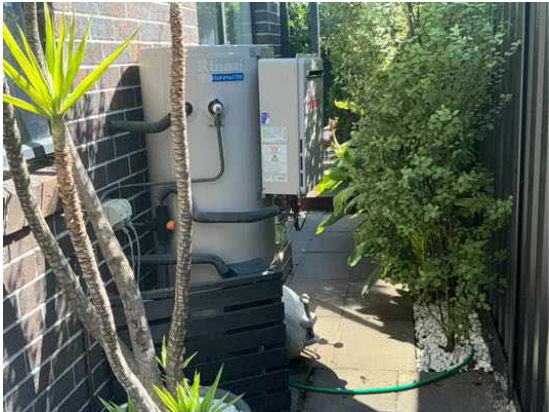
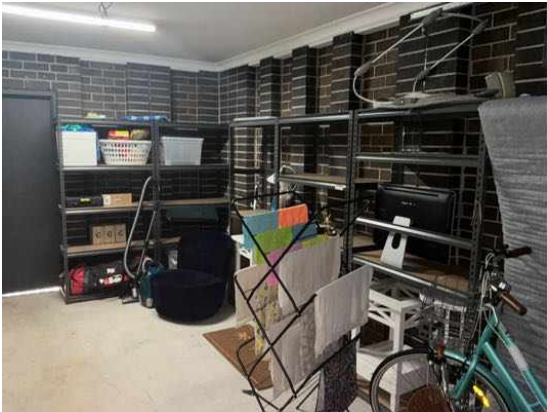
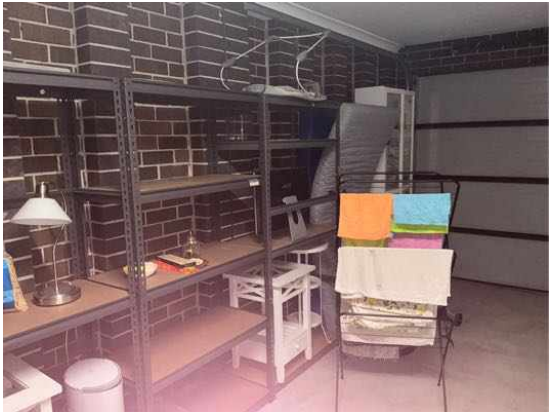
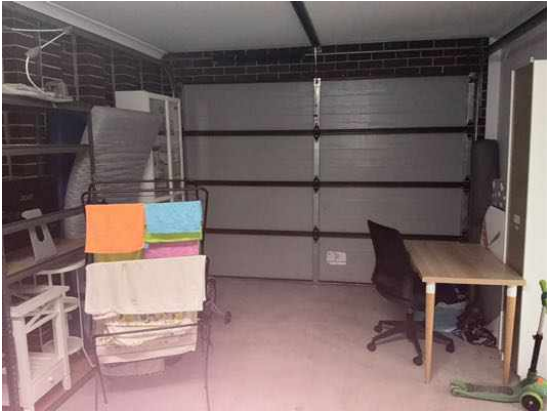
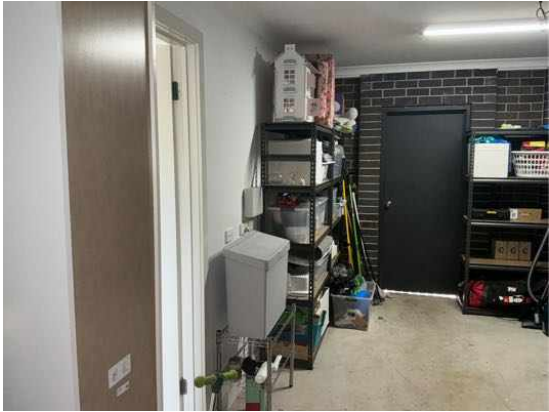
Building: Main Building  
Location: All Areas  
Finding: Additional Photos - Obstructions and Limitations  
Information: These photographs are an indication of the obstructions and limitations which impeded full inspection of the property at the time of inspection. These obstructions can hide an array of defects and should be removed to allow full inspection to be carried out. A re-inspection is recommended once the areas are made accessible.
