Building Inspection Report

Inspection Date: Fri, 27 Feb 2026

Property Address: U8 26 Peterborough Ave, Lake Illawarra
NSW 2528, Australia

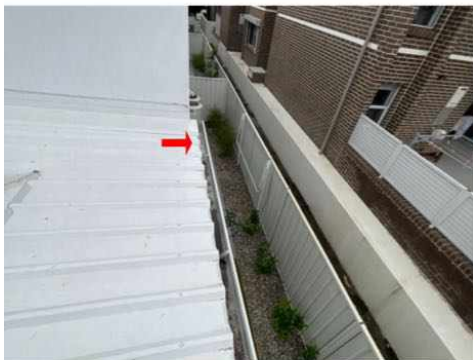
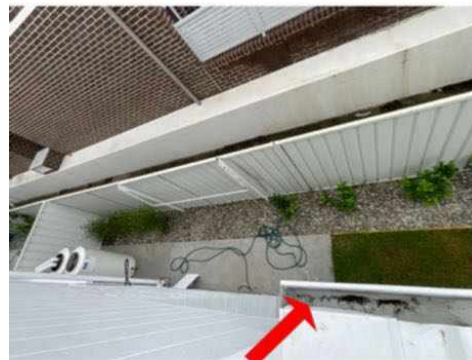
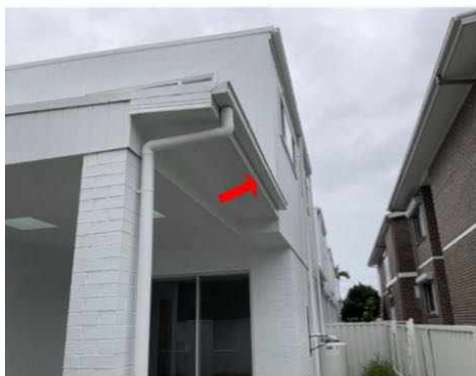
Defects 3.01

Building: Building 1
Location: Roof Exterior
Finding: Roof plumbing - Insufficient fall
Information: There is an insufficient fall in the rear roof drainage, which means that the angle is inadequate to facilitate movement of rainwater. This is resulting in pooling of water in the area, creating the potential for water damage to associated building elements.

Without adequate roof drainage, premature rust and decay of the roof plumbing structures is imminent. The development of such deterioration is likely to lead to the formation of secondary defects to adjoining wall sections and roofing elements.

Adjustment by a roofing plumber is required as soon as possible to prevent any further damage to the area.

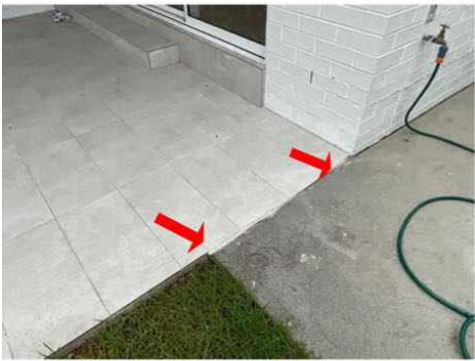
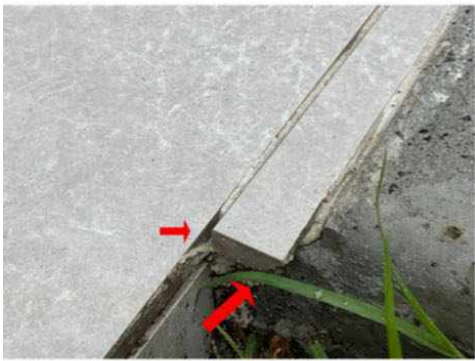
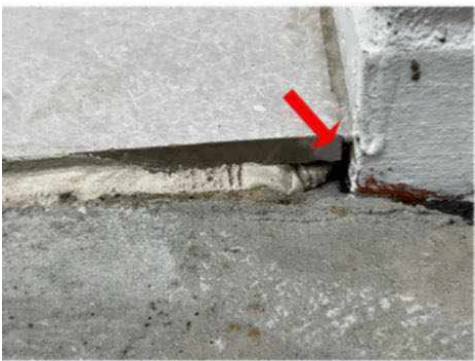
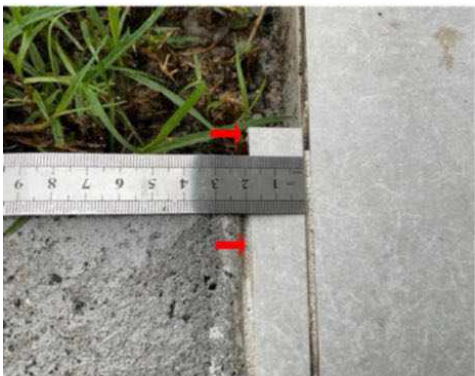
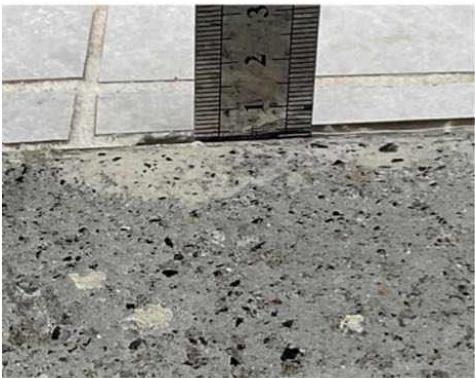
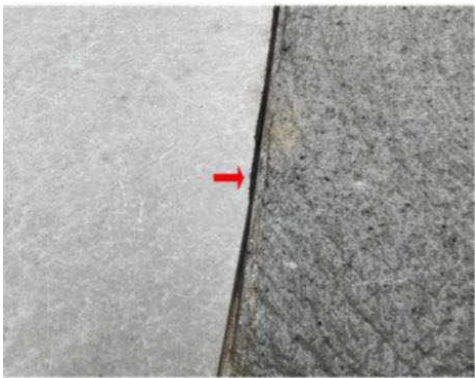
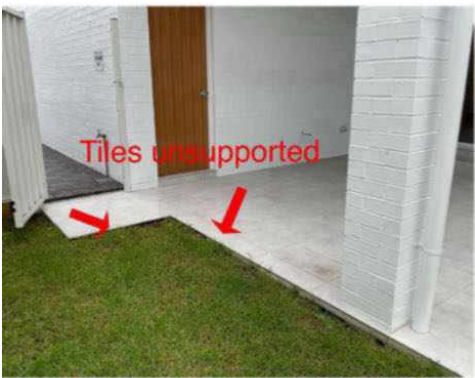
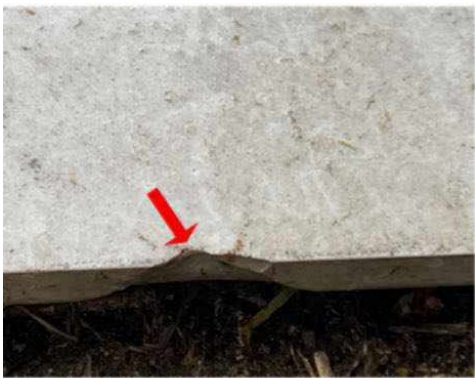
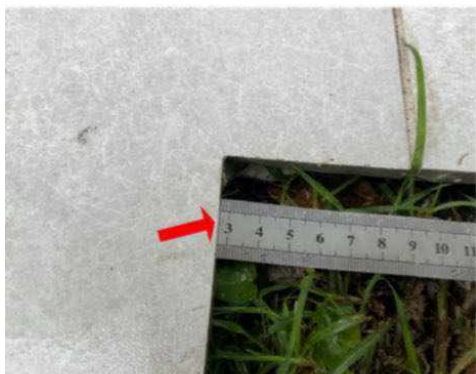
Defects 3.02

Building:	Building 1
Location:	Alfresco tiling
Finding:	Substandard construction
Information:	The alfresco tiled area is substandard. The cut tile against the path is not straight and chipped. The concrete should have filled this gap and sealant is missing.

These 2 tiles in between the alfresco and the concrete are from 2 - 20mm in width and are likely to crack in the future.

The tiled area near the gate is missing edge tiles, some edge tiles are installed and some are missing. Some tiles have over 35mm of tile overhanging the slab with no support. It is suspected these tiles may break if a heavy weight is applied (eg bbq). One tile is chipped.

Sub standard and incomplete work are determined by identifying a failure to achieve the minimum requirement set out in the mandated Australian Standard as outlined in the Building Code of Australia and referenced by the Manufacturers Guideline.

Where these tiles are installed in such as way that it fails to achieve the required minimum standard or level of finish at the time of the inspection, the builder needs to rectify the defect as soon as possible and and complete works to a high standard.

This needs to be brought to the attention of the builder.

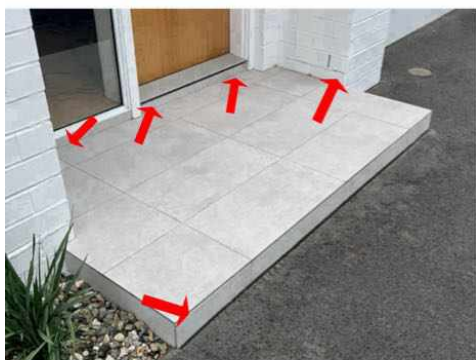
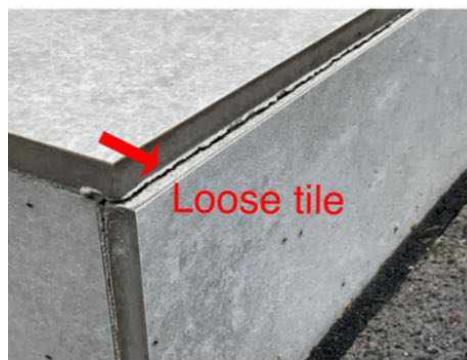
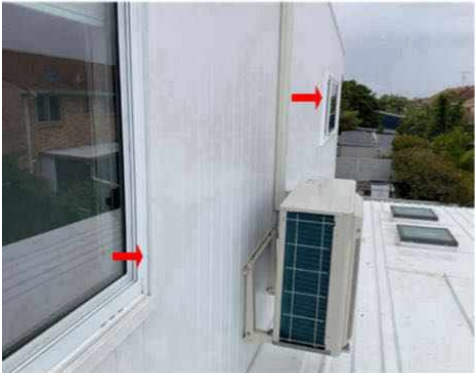
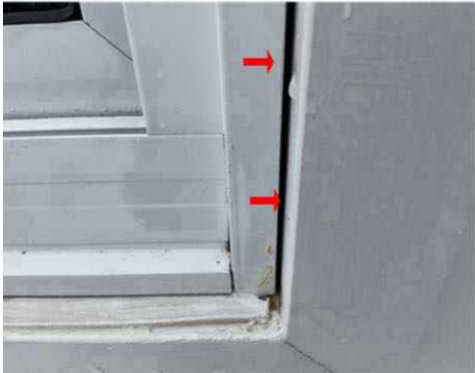
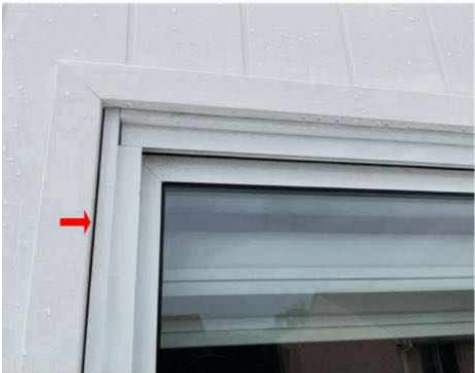
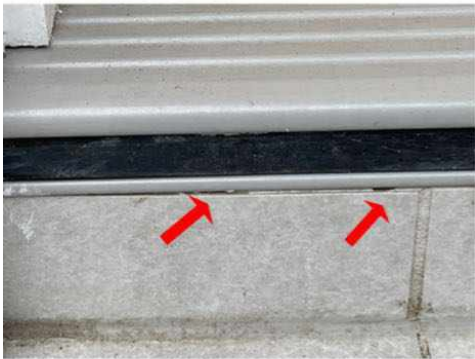
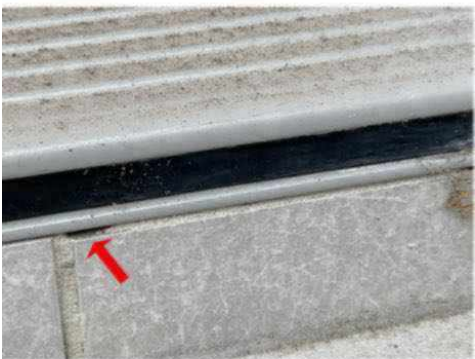
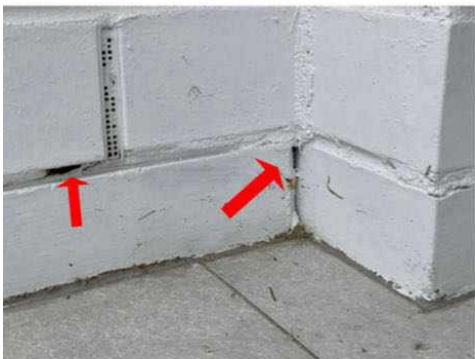
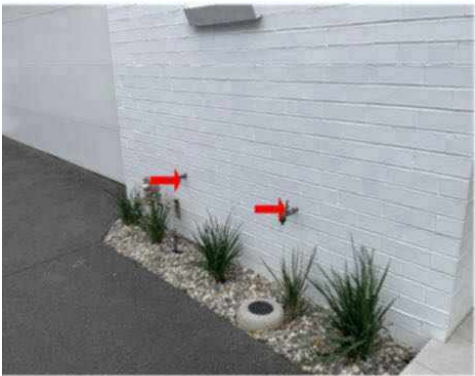
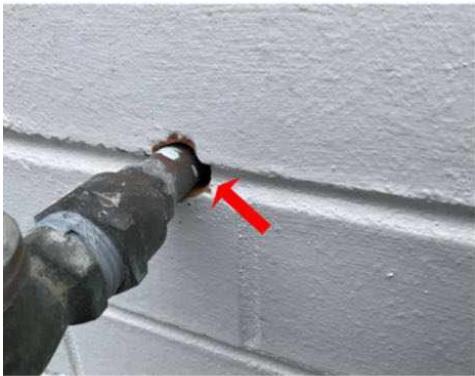
Defects 3.03

Building:	Building 1
Location:	Porch, front wall, right upper wall
Finding:	Sealant in External areas - The NSW Standards and Tolerances 2017 - 12.7
Information:	It was noted on inspection that sealant is missing or damaged to the entry, garage, front balcony, and other areas on the external walls. The right side of the main entry door and the area between the front driveway and porch are of substandard construction and require rectification works to fill gaps. The left side wall has gaps in architraves and cladding.

The NSW Standard states - 12.7 Flexible sealants to junctions states -

Flexible or waterproof sealants to junctions are defective if they are not installed

when required by the BCA and AS 3958.1.

All holes, gaps or cracks should be adequately filled by a suitable sealant or trimmings as soon as possible to prevent any water damage that may occur.

A sealant specialist or tiling contractor should be appointed to complete these works as soon as possible

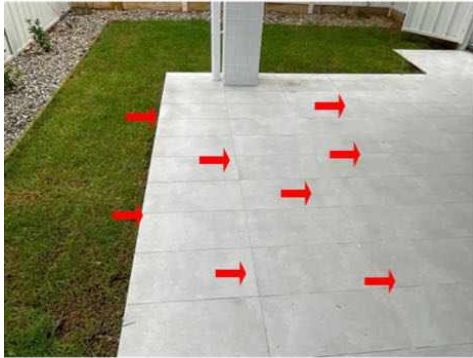
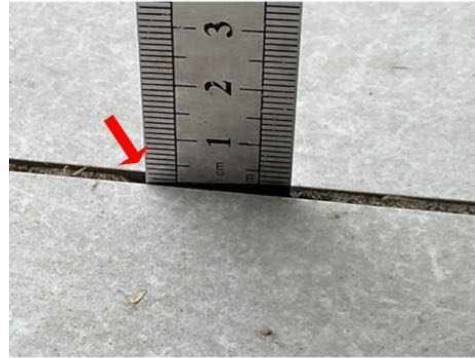
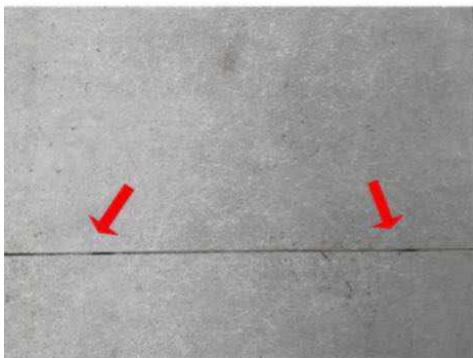
Defects 3.04

Building: Building 1
 Location: Alfresco
 Finding: Sealant in External areas - The NSW Standards and Tolerances 2017 - 12.7
 (continued)
 Information:

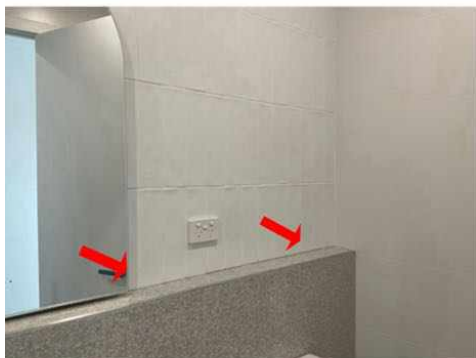
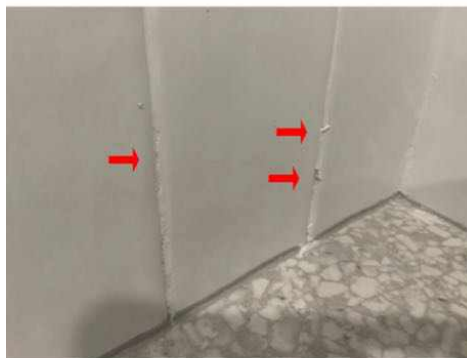
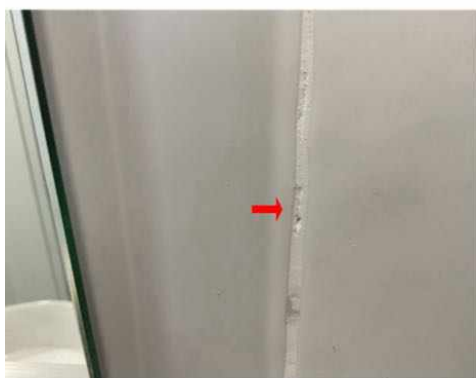
Defects 3.05

Building: Building 1
 Location: Ensuite - Master
 Finding: Sealant and grouting - roughly applied
 Information: It was noted on inspection that small areas of sealant or grout is missing and substandardly applied.

A flexible sealant is required to allow for expected expansion and contraction, while keeping the joint water tight and protective of all associated building materials.

This area needs to be brought to the attention of the builder.

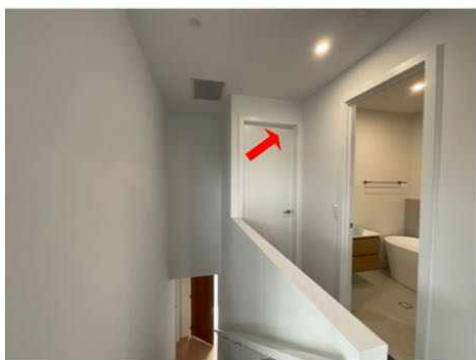
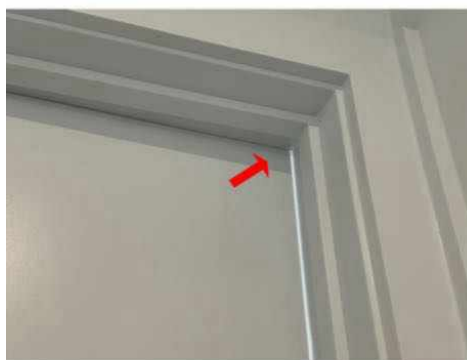
Defects 3.06

Building:	Building 1
Location:	Bedroom 2
Finding:	Door - Binding/jamming
Information:	Binding and/or jamming of this door is evident during standard operation. This defect inhibits the functionality of the affected door as well as creating potential for secondary defects to associated building elements, such as damage to the floor covering.

A door that binds to flooring or to the associated door frame may have several causes, ranging from minor defects, such as poor installation of the door or deteriorated hinges, through to major structural issues, such as damage to subfloor structures.

For this minor cause, a qualified carpenter or general handyperson should be appointed to perform minor rectification works at client discretion.

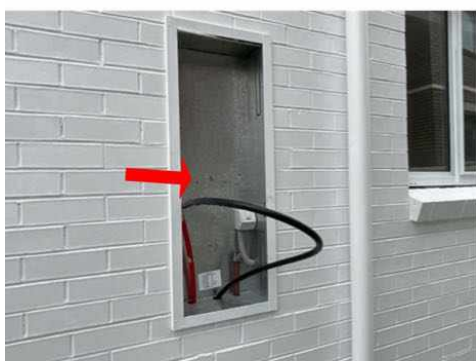
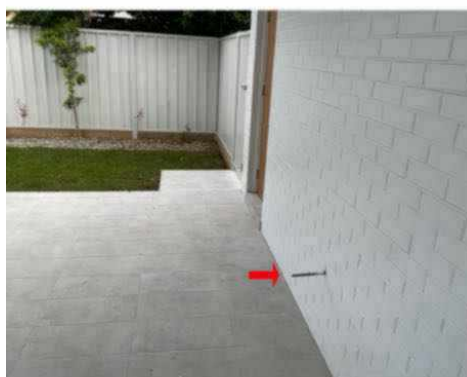
Defects 3.07

Building: Building 1
 Location: Exterior walls - rear
 Finding: Unfinished construction
 Information: The construction of this structure appears to be incomplete. These rear areas need to be completed before purchase.

The Builder should complete this construction process.

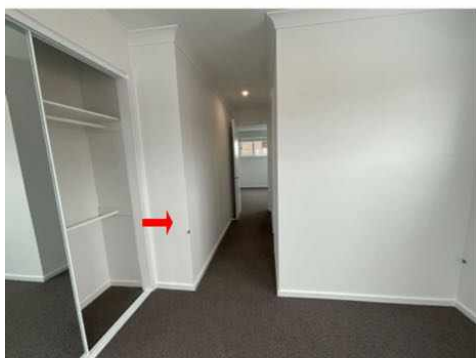
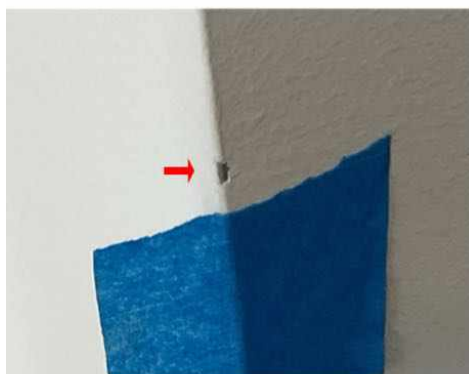
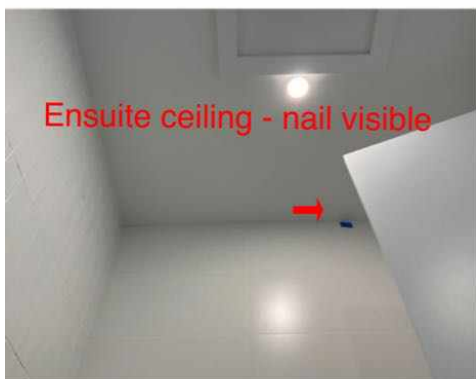
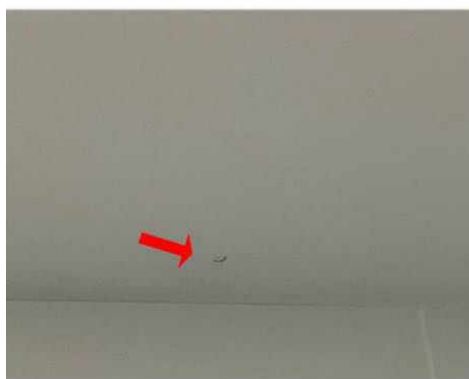
Defects 3.08

Building: Building 1
 Location: Bedroom - Master and ensuite
 Finding: Paintwork defective - NSW Guide to standards and tolerances part 13.2
 Information: A few areas of substandard paint finishes were identified on the building at the time of the inspection.

Paintwork is defective if the application has blemishes such as paint runs, paint sags, wrinkling, dust, bare or starved painted areas, colour variations, surface cracks, irregular and coarse brush marks, sanding marks, blistering, non-uniformity of gloss level and other irregularities in the surface that are visible from a normal viewing position. Paintwork is defective if the application results in excessive over-painting of

fittings, trims, skirtings, architraves, glazing and other finished edges.

These areas need to be brought to the attention of the builder.

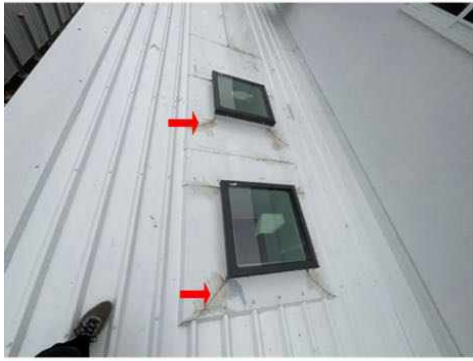
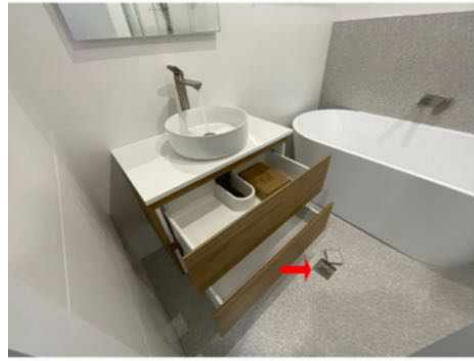
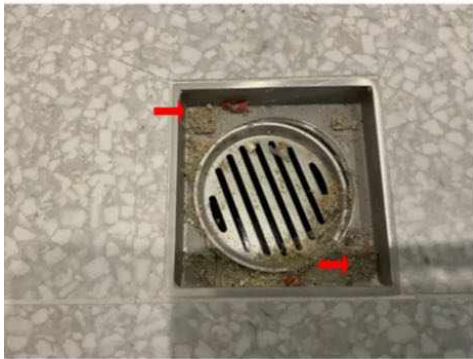
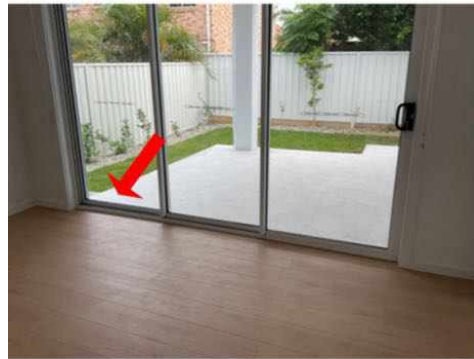
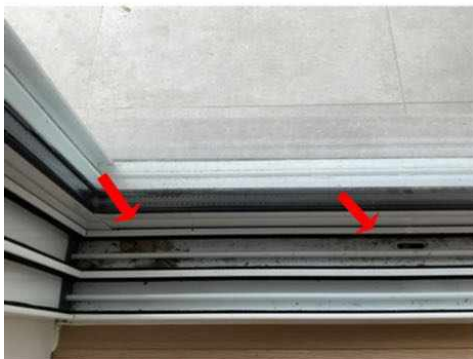
Defects 3.09

Building:	Building 1
Location:	Right roof and pictured internal areas
Finding:	Cleaning of building elements - NSW Standards and Tolerance 2017 - 3.11
Information:	It was observed that the pictured building elements are not cleaned and ready for use.

The NSW Standards and Tolerances 2017 - 3.11 state - Cleaning, mortar smears and stains

“Stains, mortar smears and damage caused by cleaning are defective if they are visible from a normal viewing position.”

These areas need to be cleaned and ready for use.

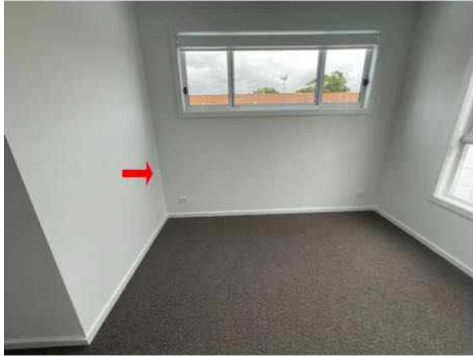
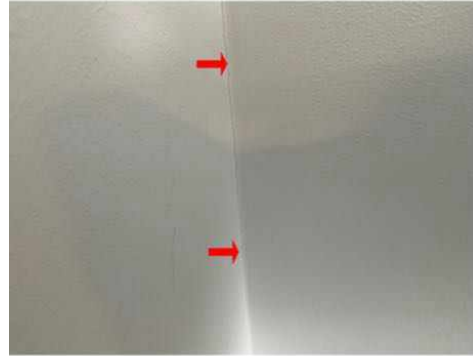
Defects 3.10

Building: Building 1
Location: Bedroom - Master
Finding: Cracks in mouldings
Information: Cracks were found in the mouldings in the master bedroom.

The NSW Standards and Tolerances 2017 - 11.1 state -

Unless documented otherwise, gaps between mouldings or between mouldings and other fixtures, at mitre or butt joints, or at junctions with a wall or other surfaces,

are defective if they exist at handover, or exceed 1 mm in width within the first 12 months of completion and are visible from a normal viewing position. This should be brought to the attention of the builder.

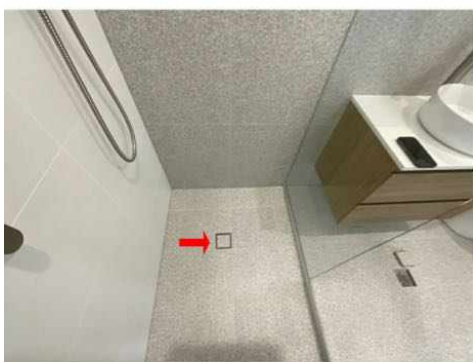
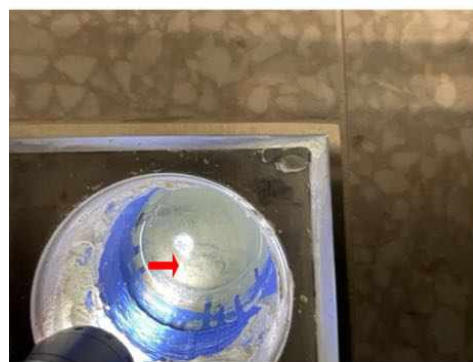
Defects 3.11

Building: Building 1
 Location: Ensuite - Master
 Finding: Building waste in drains
 Information: Builders waste was found inside this bathroom floor waste at the time of the inspection. Builders waste left in this drain has the potential to interrupt the normal function and may lead to blockages and flooding of surrounding areas.

A handy person or plumber is required to remove this waste from this drain as soon as possible .

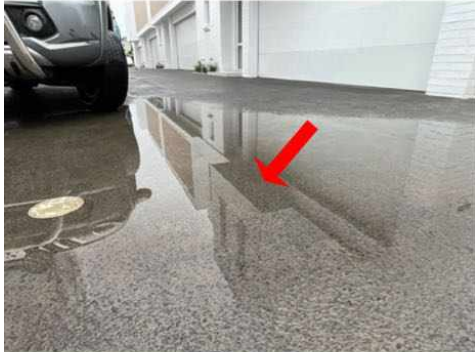
Defects 3.12

Building: Building 1
 Location: Internal Areas
 Finding: Water pooling on property

Information: Water appears to be pooling on the driveway. It is suspected that this is a result of poor site drainage. Where water is pooling, water damage may occur.

This area need to be brought to the attention of the builder.

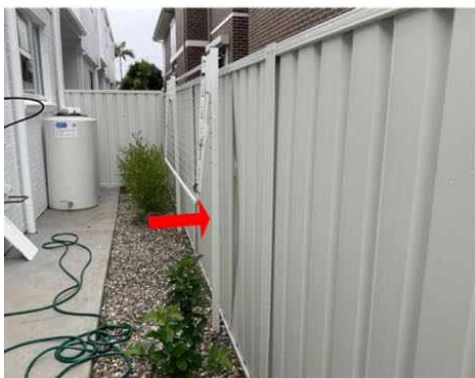
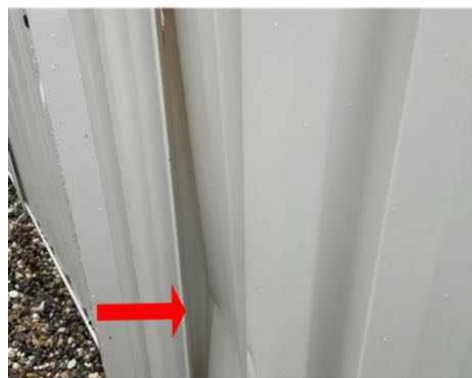
Defects 3.13

Location: Fence

Finding: Damaged fence

Information: Evidence of damage was identified to the rear fence. It appears to have suffered impact damage from this side. A fencing contractor or carpenter would be responsible for replacement of these fence panels when convenient.

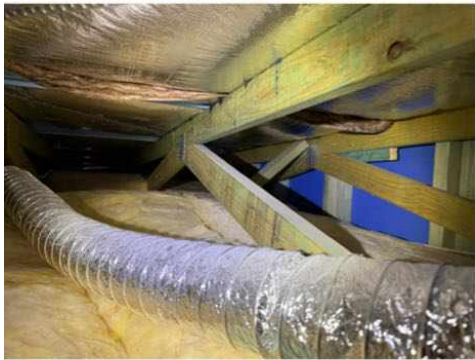
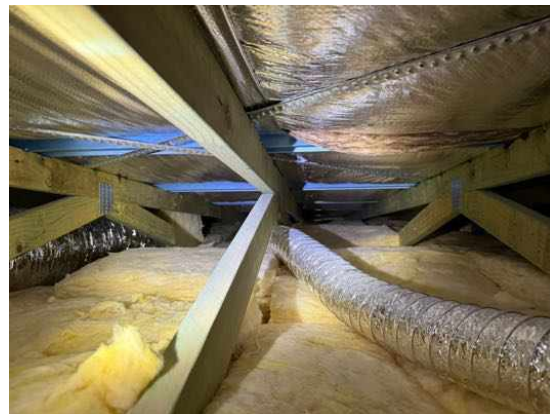
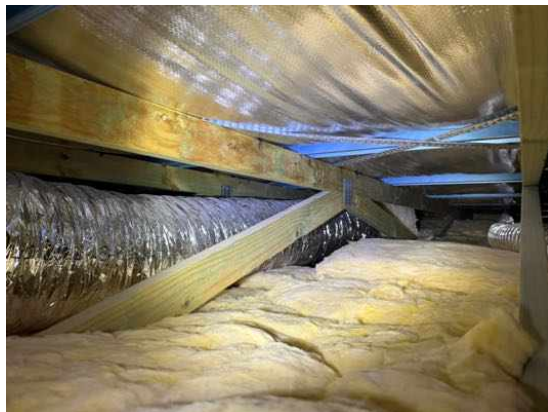
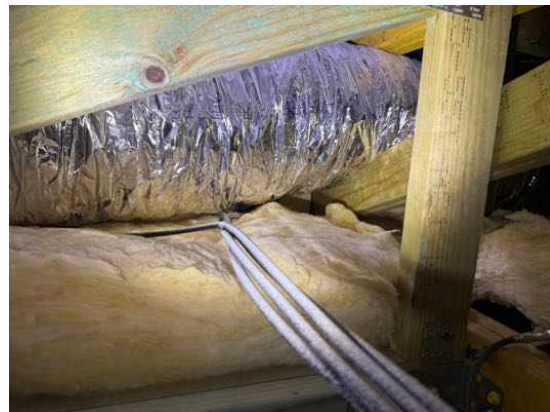
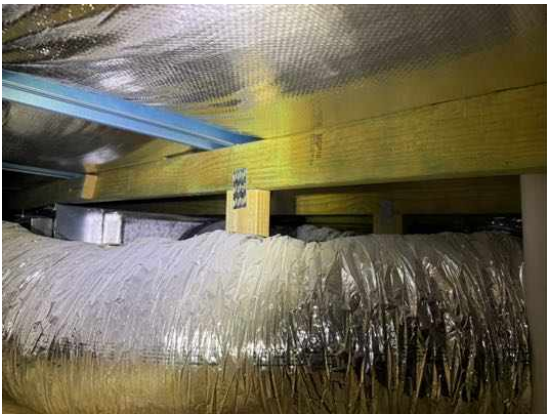
Noted Item

Building: Building 1
Location: Internal Areas
Finding: Additional Photos - Obstructions and Limitations of the ROOF CAVITY
Information: These photographs are an indication of the obstructions and limitations which impeded full inspection of roof cavity areas at the time of inspection. These obstructions can hide an array of defects and should be removed to allow full inspection to be carried out if applicable. A re-inspection is recommended once the areas are made accessible.
