# Building and Timber Pest Inspection Report

Inspection Date: Fri, 23 Jan 2026

Property Address: 1219 Mulgoa Road, Mulgoa NSW 2745

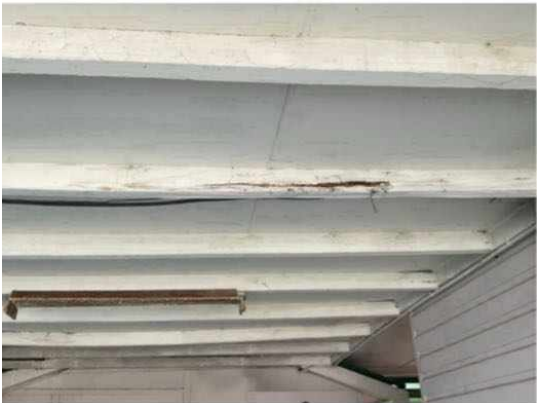
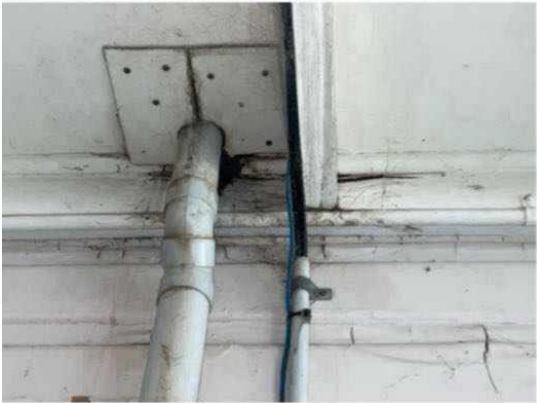
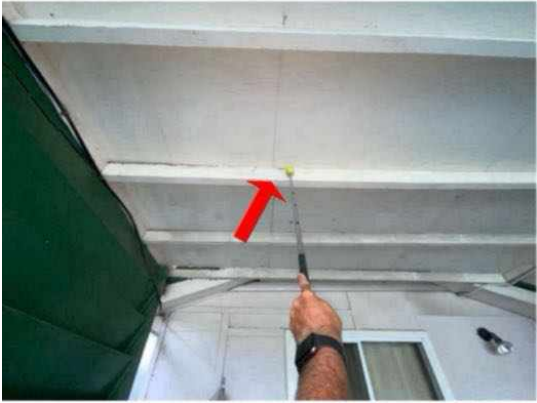
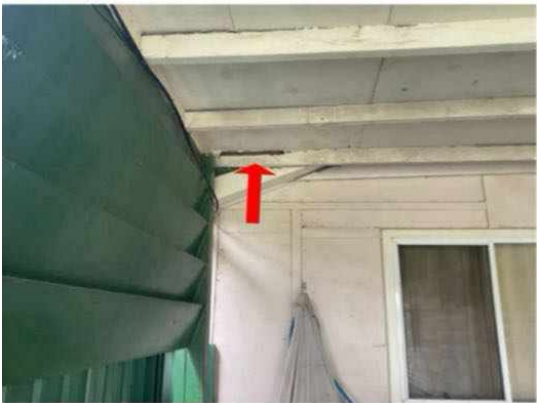
Building:	Carport
Location:	Carport
Finding:	Major Defect – Roof Rafters (Fungal Decay / Wood Rot) – Carport
Information:	Observation:

During the inspection, evidence of wood rot (fungal decay) was identified in several roof rafters within the carport structure. This type of decay typically develops when timber or other cellulose-based materials are exposed to persistent moisture, creating an environment conducive to fungal growth and progressive structural deterioration. In this instance, the timber decay is likely associated with leaks in the roof covering and defective or damaged flashings.

Temporary repairs were noted, including blocking attached to the lower ends of several affected rafters adjacent to the fascia. Sagging of some rafters was also observed, indicating that the structural integrity of these members has been compromised.

- Compromising the structural capacity of affected roof rafters, potentially leading to failure.
- Spreading of decay to adjoining or previously unaffected timber elements.
- Escalation of repair costs and more extensive remedial works if deterioration continues.

It is strongly recommended that all decayed or damaged timber elements be promptly repaired or replaced to prevent further structural compromise. A full assessment of the roof covering and associated flashings should be carried out, and any necessary repairs undertaken to prevent ongoing moisture ingress. Engagement of a qualified carpenter and a licensed roofing contractor is advised to determine the full extent of the damage and perform all remedial works in accordance with current building

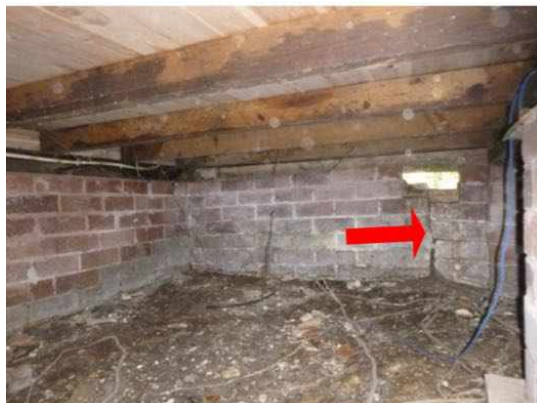
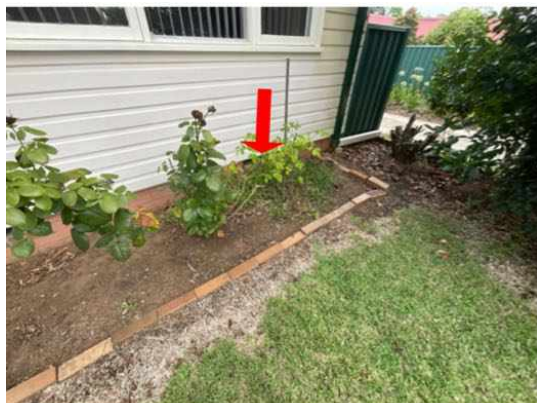
**Finding 2.02**

Building: Main Building  
 Location: Subfloor  
 Finding: Major Defect – Brickwork Cracking (Subsidence).  
 Information: Defect Type: Brickwork cracking

Location/Condition: Front right corner of the building – subsidence related

During the inspection, cracking was observed to the brickwork from within the subfloor area. This cracking was not visible externally at the time of inspection. The nature and pattern of the cracking are consistent with movement to the structure, indicating that subsidence or footing movement has occurred. This type of condition is not uncommon in properties of this age and construction type and is often associated with long-term moisture exposure and poor site or subfloor drainage.

Based on observations elsewhere in the report, inadequate drainage and elevated subfloor moisture are considered contributing factors. Additional contributing influences may include soil reactivity, water leaks, or erosion of founding material around the footings.

While the cracking currently appears minor in extent and is not assessed as structurally critical at the time of inspection, evidence of subsidence represents a major defect due to the potential for progressive movement. If underlying causes are not addressed, further movement may occur, resulting in increased cracking, misalignment of building elements, and more costly rectification works.

- Ongoing monitoring of the affected area is recommended to identify any progression in movement or cracking.
- Consultation with a suitably qualified Structural Engineer is advised to undertake a detailed assessment, determine whether movement is ongoing, and provide recommendations for any required remedial works.
- Improvements to site and subfloor drainage should be undertaken to reduce excessive moisture around the footings and minimise the risk of further subsidence.

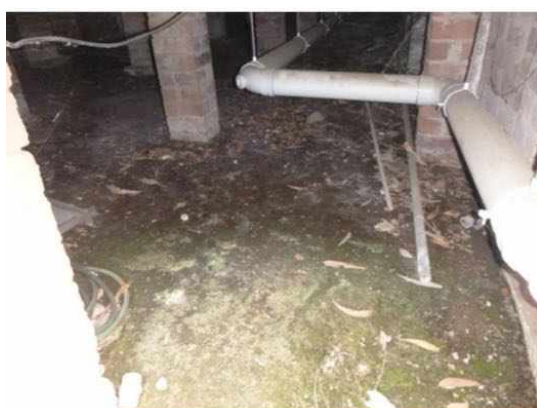
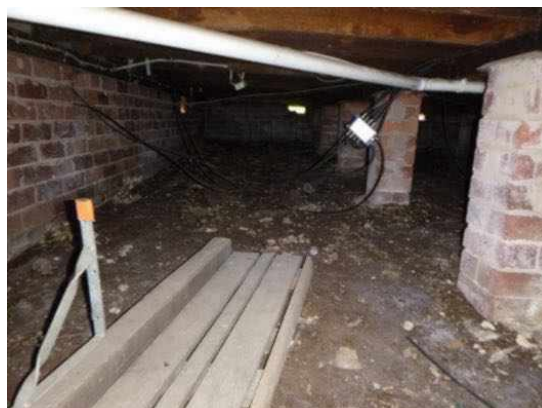
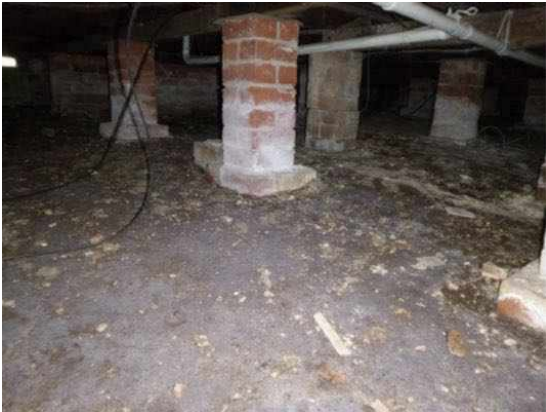
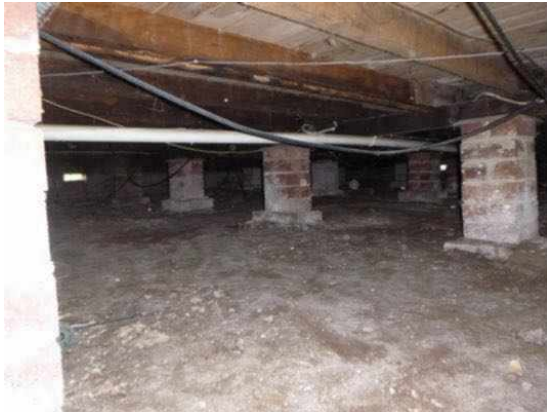
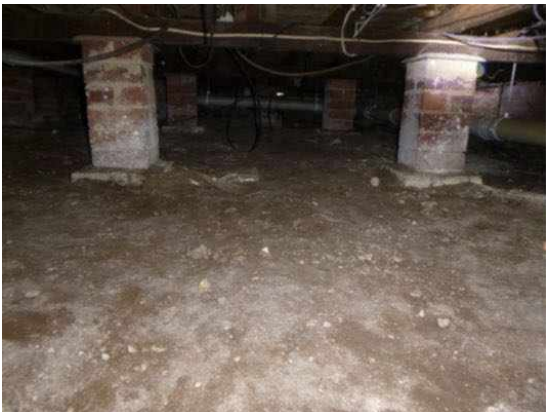
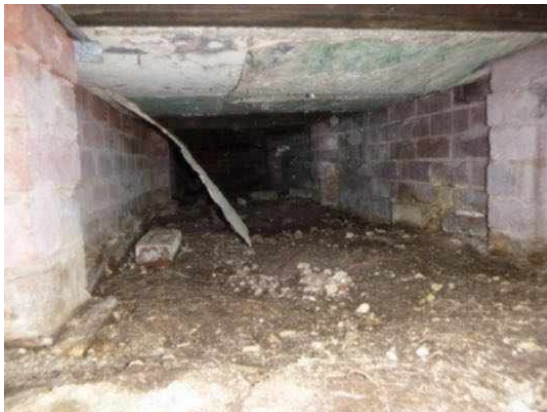
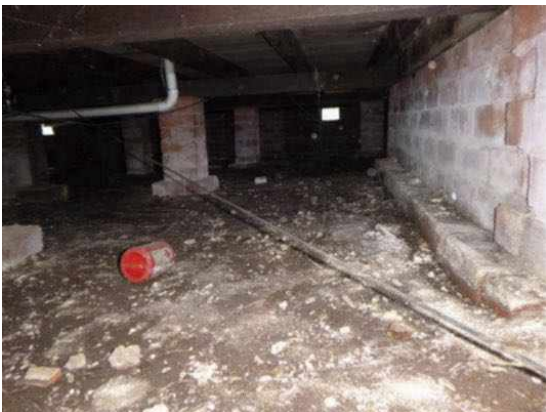
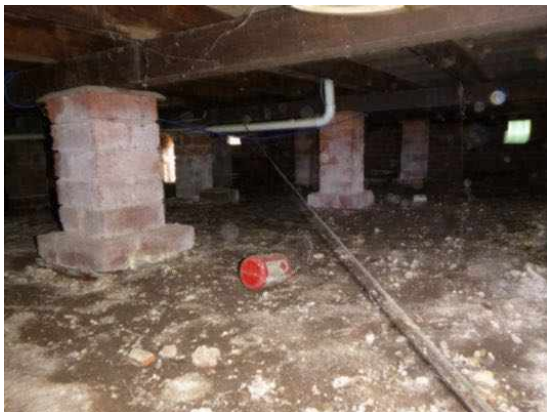
### Finding 2.03

Building:	Main Building
Location:	Subfloor
Finding:	Subfloor - Excessive Moisture identified.
Information:	Observations:

Evidence of excessive moisture was noted throughout the subfloor area, with visible mould growth in the soil. These findings indicate that moisture problems are ongoing and likely associated with substandard subfloor ventilation.

- Fungal and mould growth.
- Timber decay and deterioration of structural members.
- Mortar and brick deterioration.
- Subsidence, cracking, and movement in walls or piers.
- Increased risk of termite activity.

- Redirect all roof and surface water runoff away from the building to prevent further moisture ingress.
- Where subfloor drainage is inadequate, install an agricultural (Aggie) drain or equivalent drainage system.
- Consider the installation of fan-forced subfloor ventilation to improve airflow and assist in drying out excess moisture.
- Engage a qualified roof and drainage plumber experienced in site drainage to assess and rectify contributing issues.
- Consult a subfloor ventilation specialist to design and install an effective ventilation system suited to site conditions.

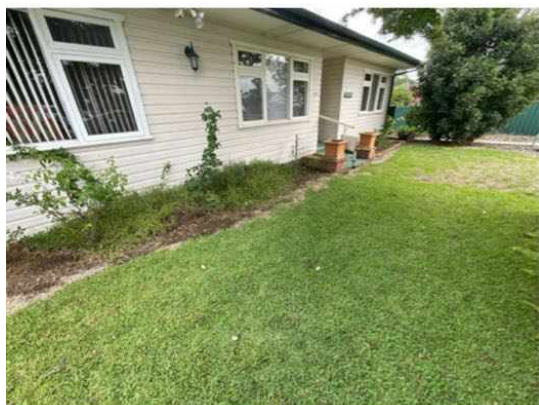
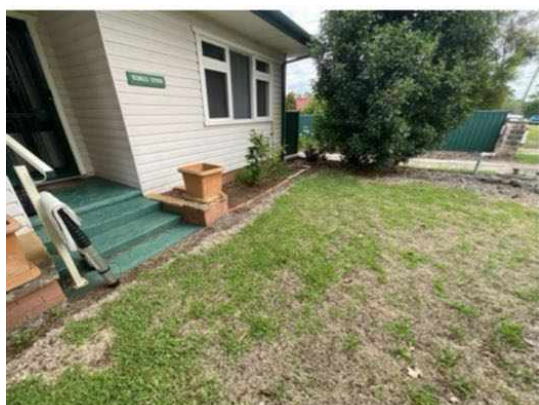
### Finding 3.01

Building:	Yard
Location:	Exterior adjacent walls - front
Finding:	Site/Yard drainage - Inadequate.
Information:	Defect / Observation – Inadequate Site Drainage

At the time of inspection, site drainage in this area was found to be inadequate, allowing water to pool against the base of the external walls.

Poor surface drainage can lead to moisture ingress and deterioration of materials at the base of walls, slab edge dampness, or foundation movement. Prolonged exposure to standing water may cause rising damp, efflorescence, or corrosion of embedded steel components. These conditions can lead to secondary structural or moisture-related defects if not rectified.

To prevent moisture-related damage, ground levels around the dwelling should:

These provisions help direct surface water away from the structure, maintaining the

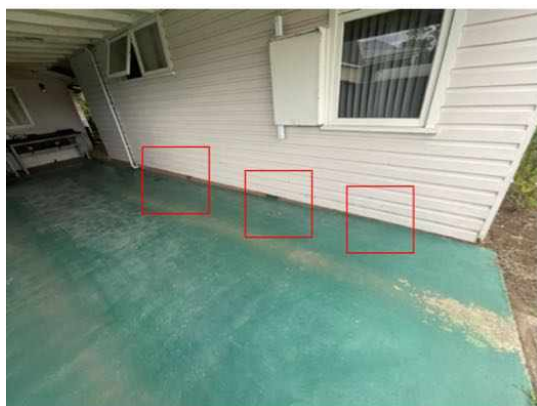
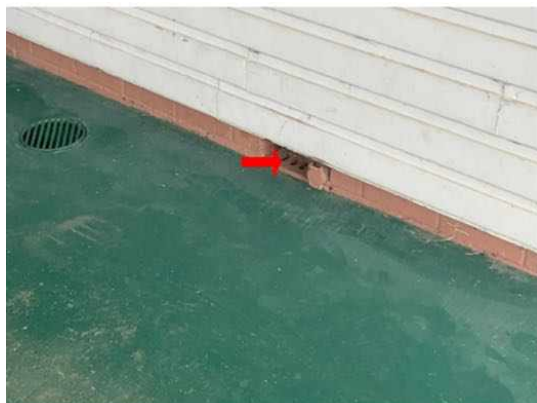
### Finding 3.02

Building:	Yard
Location:	Exterior walls - front
Finding:	Subfloor ventilation - particularly blocked and low
Information:	Subfloor Ventilation and Ground Levels – Moisture Risk

Subfloor wall vents in the inspected locations were found to be positioned too low due to substandard external landscaping and ground levels. The external ground falls toward the building perimeter, increasing the likelihood that rainwater can enter the subfloor via the vents during wet conditions.

Ongoing moisture ingress into the subfloor can result in persistently elevated moisture levels. If left unrectified, these conditions may promote fungal growth, timber decay, deterioration of mortar and brickwork, and cracking or subsidence of supporting piers. Elevated moisture levels also increase the susceptibility of the property to termite and other timber pest activity. Secondary water damage is likely to occur over time if the issue remains unmanaged.

Perimeter landscaping and ground levels should be rectified to ensure adequate fall away from the building. As a general guide, paved surfaces should fall away from the structure by a minimum of 25 mm over the first metre, and bare ground should fall away by approximately 50 mm over the first metre. This will assist in preventing moisture from pooling against the building and entering the subfloor.

Where site drainage is inadequate or rectification is complex, a qualified plumber and landscaping contractor should be engaged to further assess the site and undertake appropriate remedial works to achieve and maintain a dry subfloor environment.

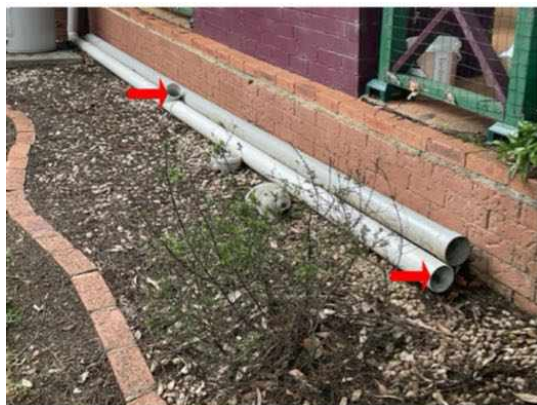
### Finding 3.03

Building:	Yard
Location:	All External Areas
Finding:	Downpipe - Unconnected.
Information:	Observation:

A section of roof plumbing was found where the downpipe is not connected to the stormwater drainage system.

Excessive moisture from uncontrolled roof runoff can create conditions that promote termite activity and timber decay.

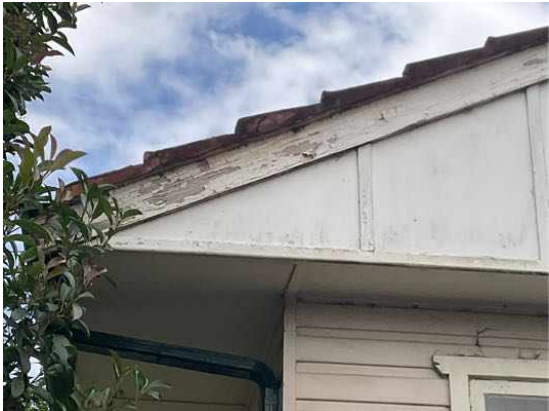
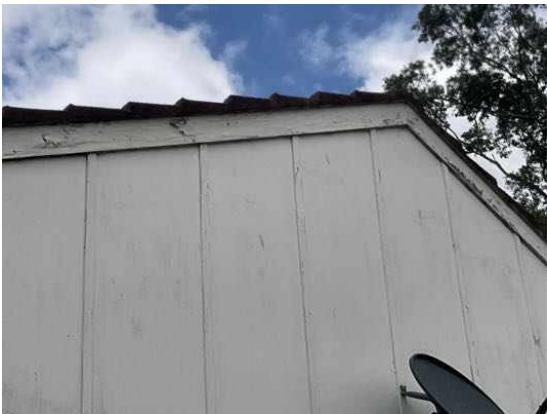
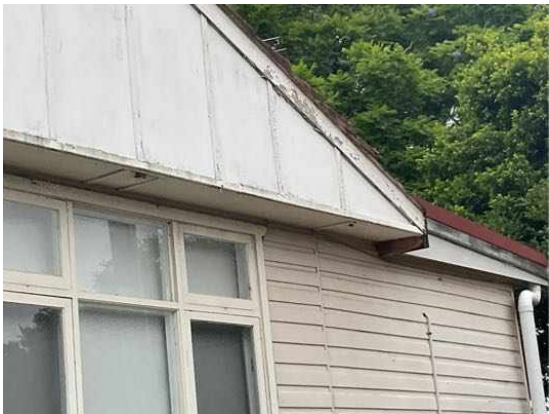
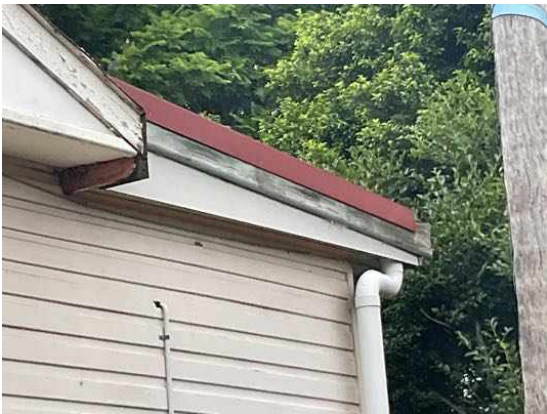
### Finding 3.04

Building:	Yard
Location:	Exterior walls - right side
Finding:	External Timber Elements – Weather Exposure and Maintenance.
Information:	Findings:

- External timber components of the building, which are frequently exposed to harsh weather conditions, show signs of wear and lack adequate protective treatment.
- In areas where timbers have not been properly painted or sealed, deterioration is likely to progress at an accelerated rate due to constant exposure to moisture, UV radiation, and temperature changes.
- Without timely intervention, the condition of these timbers may continue to degrade, potentially requiring replacement in the short-term future.

- Where timber elements have already deteriorated beyond restoration, repairs or replacement will be necessary.
- A qualified carpenter should be appointed to assess and carry out any required structural or cosmetic timber repairs.

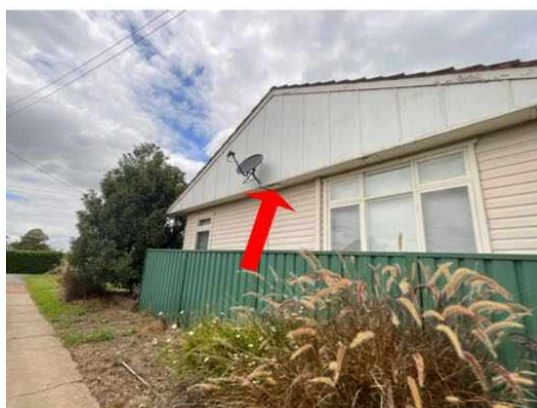
**Finding 3.05**

- Eaves play a vital role in diverting water away from the building and shielding external walls and structural elements from excessive moisture exposure.
- Sagging may indicate moisture damage, structural fatigue, or failure of fixings, and if left unaddressed, can lead to water ingress, timber deterioration, or further deformation of the roofline.

- Minor rectification works are recommended. A qualified carpenter or general handyman should be appointed to reinstate and secure the eaves to ensure proper function and alignment.
- Early maintenance will help prevent more costly repairs from developing over time.

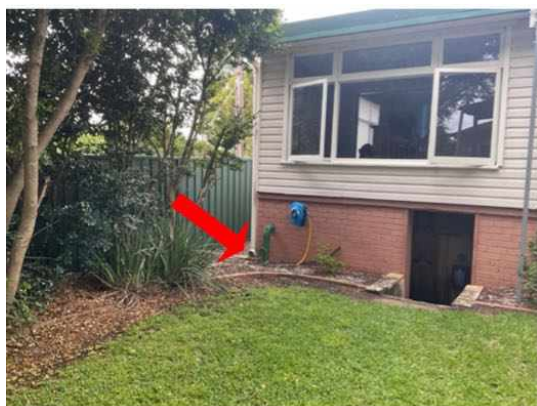
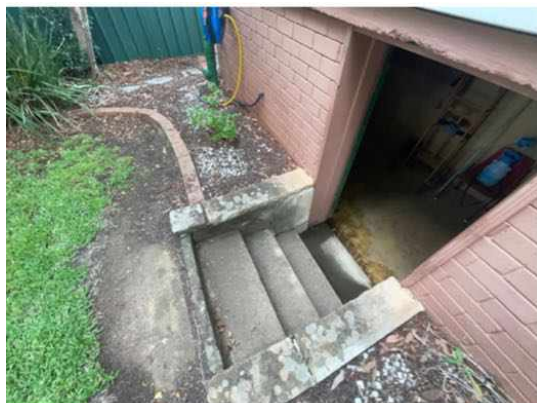
### Finding 3.06

Building: Yard  
 Location: Rear Elevation  
 Finding: Downpipe – Unconnected.  
 Information: Findings:

Inadequate roof drainage can result in prolonged damp conditions around the foundations, potentially contributing to structural movement, subfloor moisture ingress, and long-term building degradation.

Persistently damp conditions near or under the structure can create an environment highly conducive to termite activity and other timber pests.

It is strongly recommended that a licensed plumber be engaged to:

- Inspect all roof plumbing and stormwater discharge points
- Repair, replace, or install appropriate downpipes and drainage infrastructure to ensure all roof runoff is directed into a compliant stormwater system
- Assess for any secondary effects of prolonged moisture exposure near the building

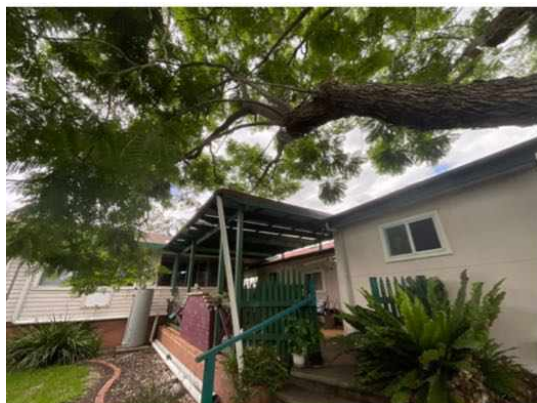
### Finding 3.07

Building:	Main Building
Location:	All External Areas
Finding:	Overhanging Trees and Gutter Maintenance – Observations & Recommendations.
Information:	Overhanging tree branches were observed above the roofline, contributing to the accumulation of leaf litter and debris within the gutters. This condition can adversely affect the performance of the roof plumbing system, particularly during periods of heavy rainfall.

Blocked or restricted gutters impede the effective discharge of stormwater, increasing the likelihood of water pooling or overflow. This may result in accelerated rusting and corrosion of gutters and downpipes, as well as the creation of damp conditions that are conducive to termite activity and other pest issues.

General gutter cleaning may be undertaken by the homeowner; however, pruning of larger branches should be carried out by a suitably qualified arborist or landscape contractor. A licensed roof plumber should be engaged to assess the condition of the guttering system and undertake any necessary remedial works. Regular maintenance will assist in preserving roof plumbing components, protecting the building envelope, and reducing the risk of moisture-related damage or pest activity.

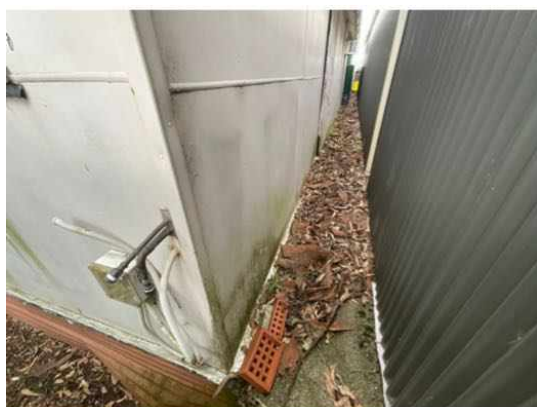
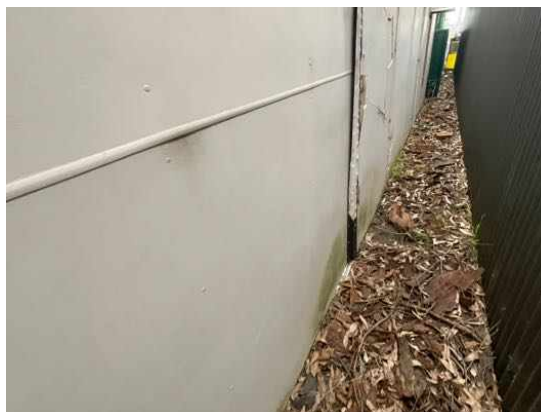
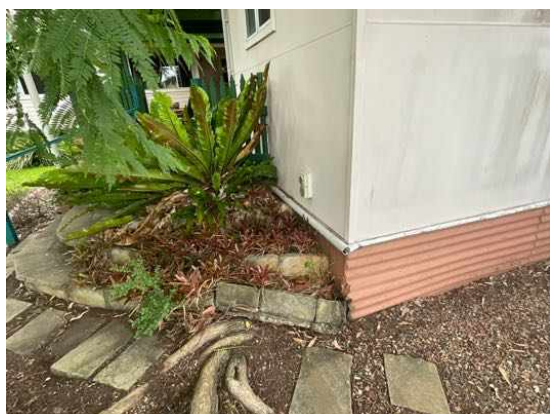
### Finding 3.08

Building:	Main Building
Location:	Exterior walls - left side
Finding:	Slab Edge Inspection Zone – Not Maintained..
Information:	Observation:

- Ensure that the slab edge is kept fully exposed around the perimeter of the building.
- Remove any obstructions such as soil, mulch, paving, or cladding that may hinder visibility.
- Where the slab edge cannot be fully exposed, it is strongly recommended that timber pest inspections be carried out every 6 to 12 months to monitor for termite activity and minimise risk to the structure.

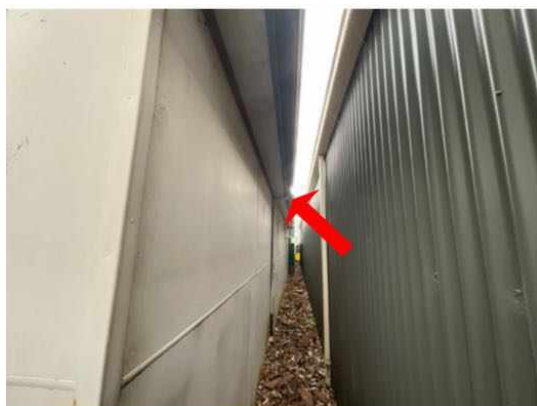
### Finding 3.09

Building: Main Building  
 Location: Exterior walls - left side  
 Finding: Roof Plumbing – Missing Gutter and Stormwater Drainage.  
 Information: Findings:

The absence of guttering and proper stormwater drainage in this area presents both functional and compliance issues. Prompt installation by a qualified roofing plumber is strongly recommended to mitigate moisture-related risks and ensure compliance with building standards.

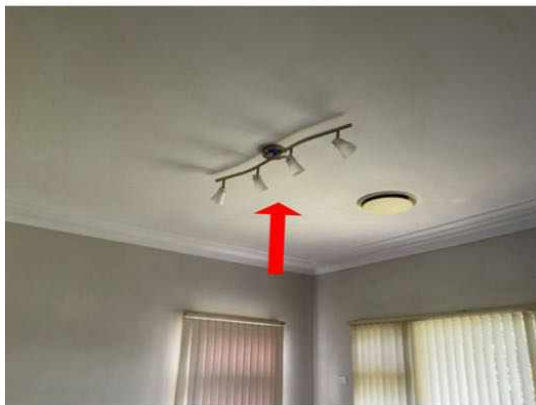
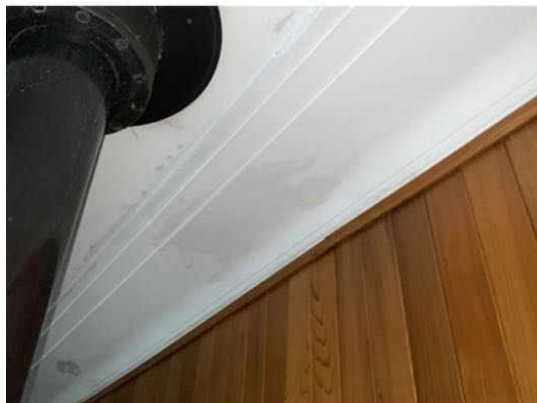
### Finding 3.10

Building:	Main Building
Location:	Bedroom and Living Room
Finding:	Ceiling - Water stained.
Information:	Observation:

Due to the visual-only nature of this pre-purchase inspection, it is not possible to conclusively determine whether water staining is active or inactive at the time of inspection. Further assessment under a special-purpose inspection is recommended if a more detailed diagnosis is required.

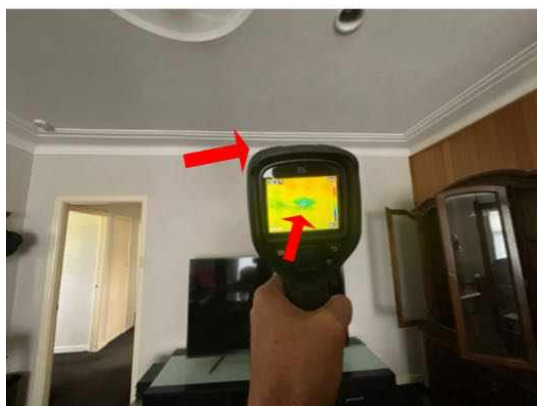
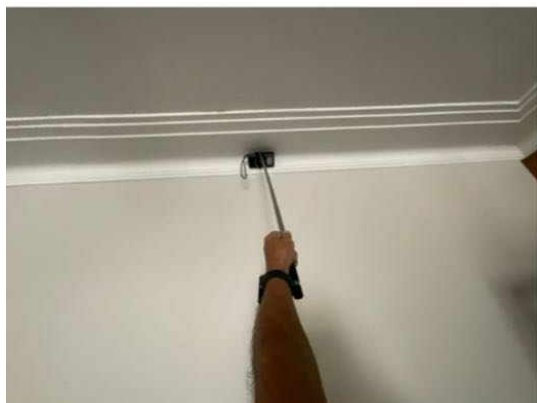
### Finding 3.11

Building: Main Building  
Location: Living Room  
Finding: Moisture – Localised Detection (Thermal Imaging)  
Information:

It is recommended that the source of moisture be further investigated as a priority by a suitably qualified tradesperson. Any identified defects should be promptly rectified to reduce moisture levels, minimise the risk of timber pest activity, and prevent potential long-term building deterioration.

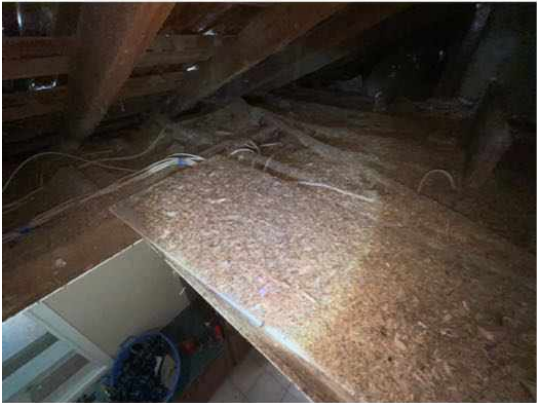
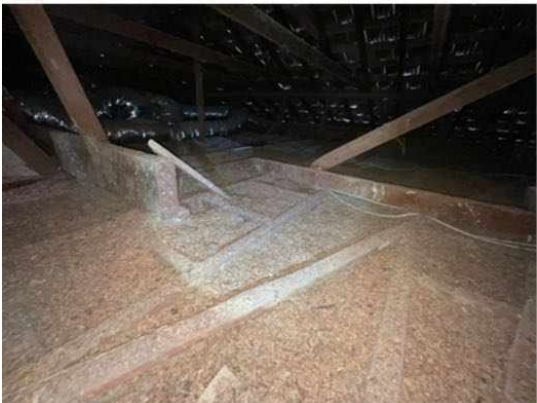
The roof space inspection was limited by restricted access, insulation coverage, and accumulated debris. While no major structural defects were identified in accessible areas, cleaning of debris and further assessment of electrical services are recommended to reduce potential risks and to maintain the overall condition of the roof space.

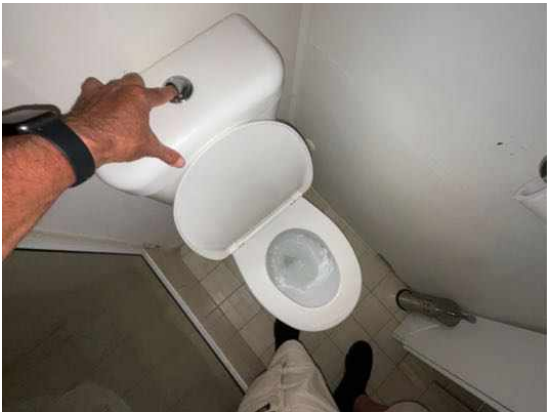
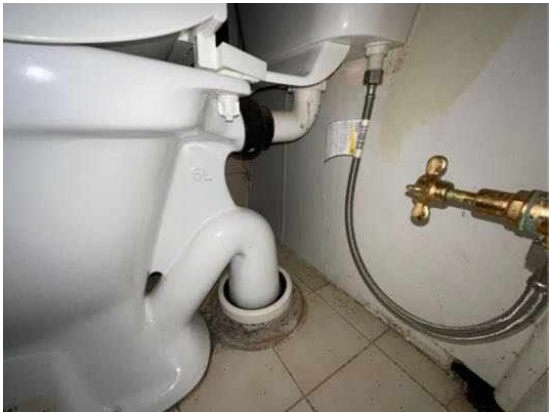
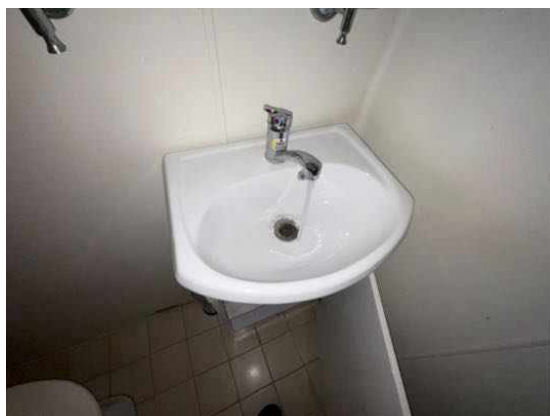
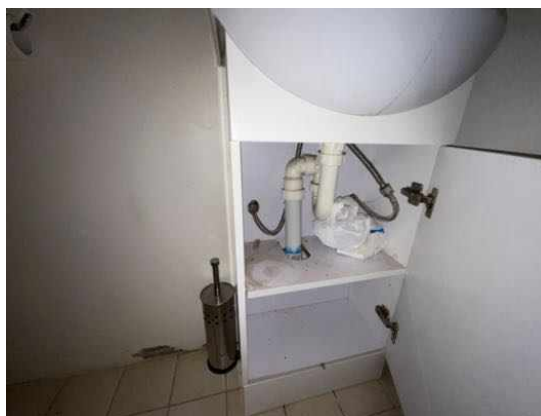
Building: Main Building  
Location: Bathroom - Retreat  
Finding: Wet Areas - Bathroom(s) - Overall Condition & Recommendations.  
Information: Overall Condition & Recommendations

It is not possible under the visual inspection criteria of a standard pre-purchase report to categorically determine if leaks are present. If a more detailed or accurate assessment is required, a special-purpose inspection should be undertaken.

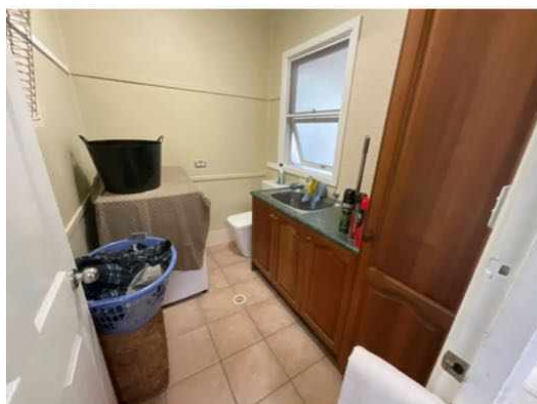
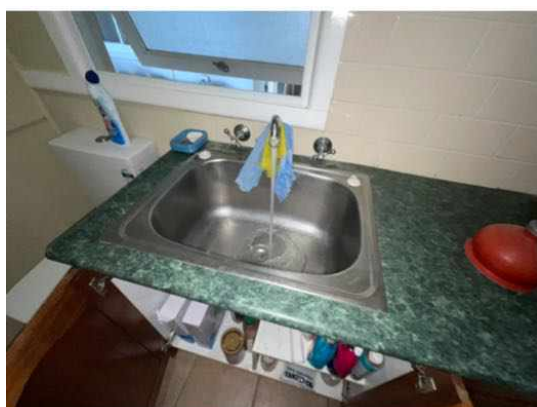
Building: Main Building  
 Location: Laundry  
 Finding: Laundry - Taps/Plumbing/Drainage.  
 Information: Observation: Laundry Tub – Taps, Plumbing, and Cabinetry

- Where required, a sealant specialist or qualified tiling contractor should be appointed to carry out remedial sealing works.

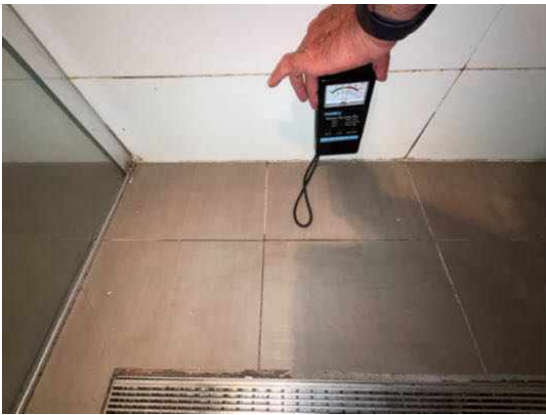
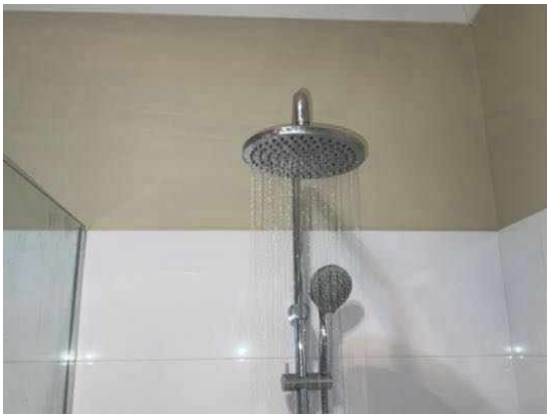
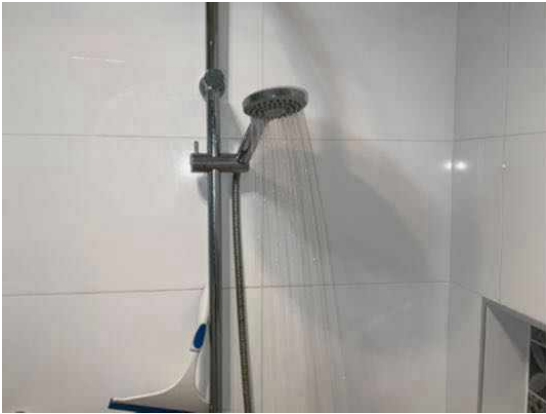
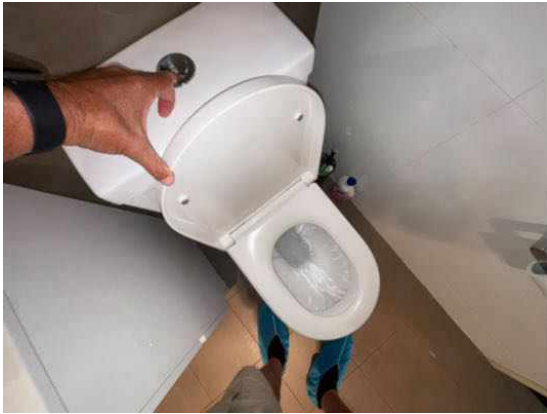
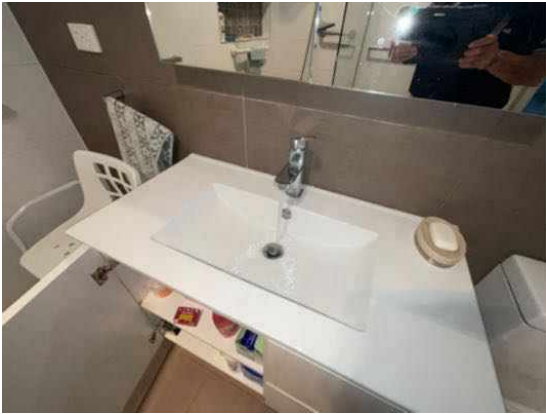
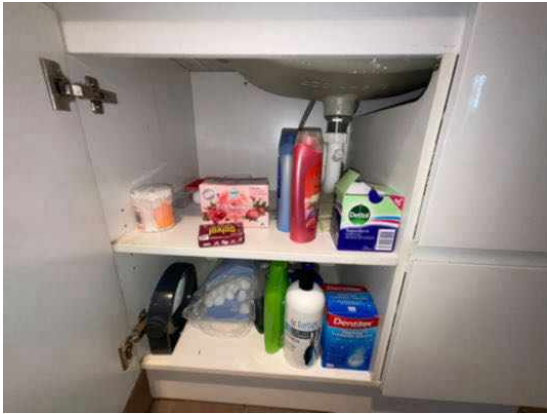
Building: Main Building  
 Location: Bathroom  
 Finding: Wet Areas - Bathroom(s) - Overall Condition & Recommendations.  
 Information: Overall Condition & Recommendations
