## Building Inspection Report VR

Inspection Date: Mon, 2 Feb 2026

Property Address: 14 Dalton St, Turvey Park NSW 2650,  
Australia

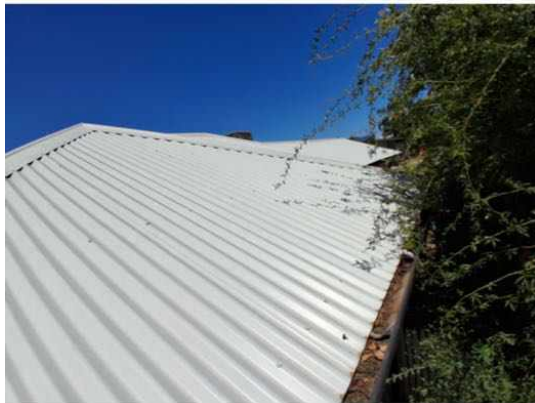
#### Defects 3.01

Building: Main Building  
Location: Exterior  
Finding: Gutters - Debris  
Information: Debris appears to be present in the gutters, including but not limited to the northern side elevation of the house most likely due to the tree down that side.

It is recommended to contact a general handyman for further evaluation and cleaning as soon as possible.

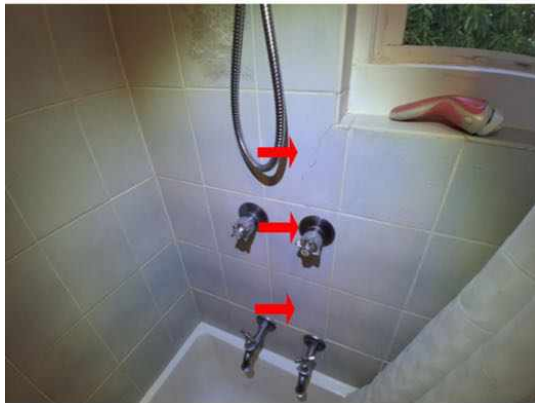
#### Defects 3.02

Building: Main Building  
Location: Bathroom  
Finding: Tiles Cracked or damaged  
Information: There appears to be cracked tiles to, but not limited to, the bathroom shower wall down through the tap area.

If left unaddressed, cracks can allow water ingress, leading to further deterioration and potential mold growth.

Recommend client contact a licensed builder or tiler for further evaluation as soon as possible.

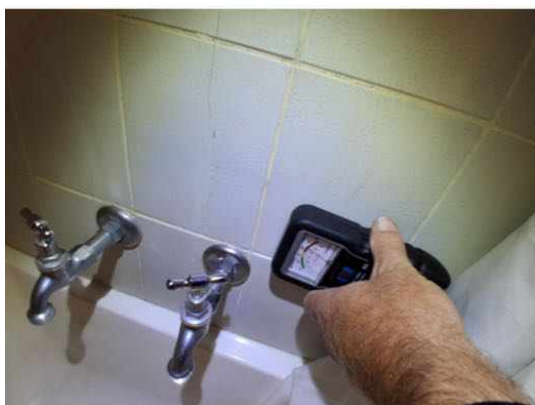
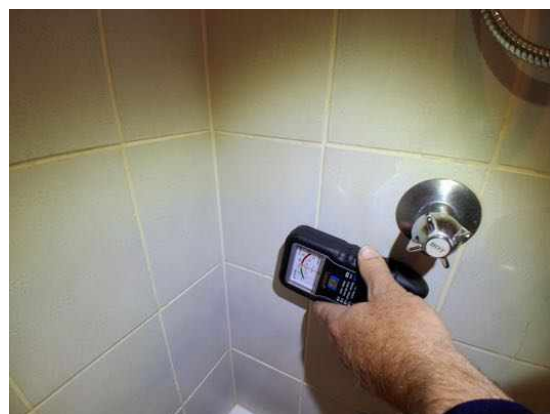
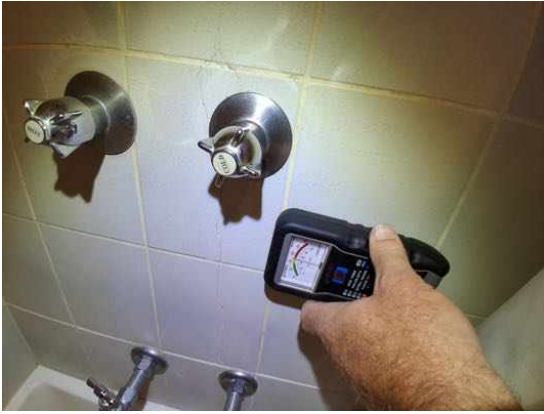
### Defects 3.03

Finding: Elevated Moisture

Information: Slightly elevated moisture readings were detected in the wall area around the shower taps during inspection, particularly near some cracked tiles which may have allowed moisture penetration. This could be caused by normal wear of grout and tiles, minor leaks, or past water exposure behind the wall lining. It is recommended that the cracked tiles and grout be repaired or replaced

Recommend contacting licenced builder for further evaluation as soon as possible.

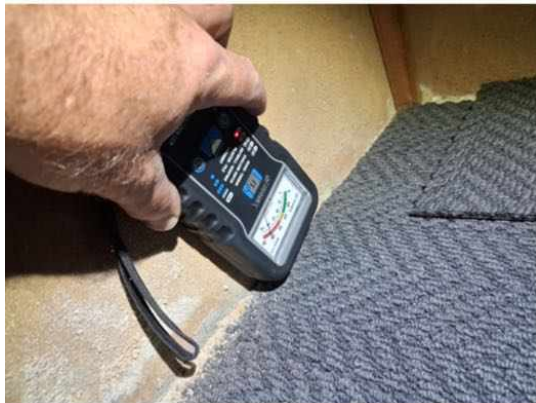
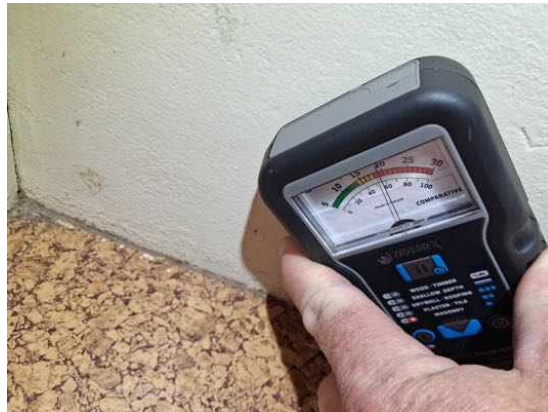
### Defects 3.04

Finding: Rising Damp basic

Information: There appears to be evidence of rising damp to, but not limited to, the laundry area and linen cupboard in this area.

Recommend client contact a builder for further evaluation as soon as possible

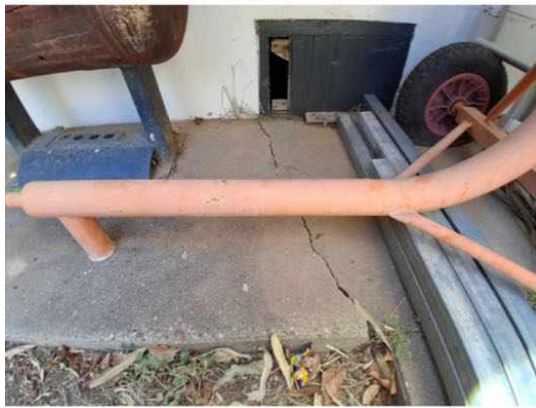
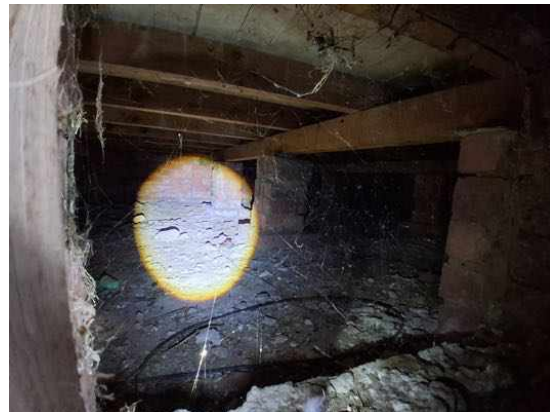
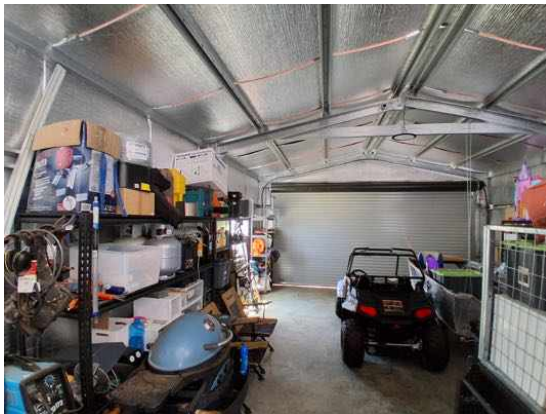
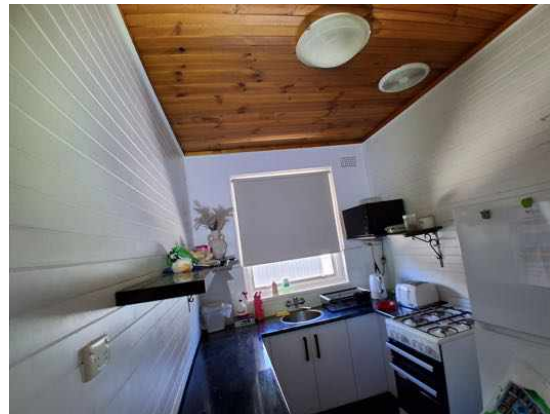
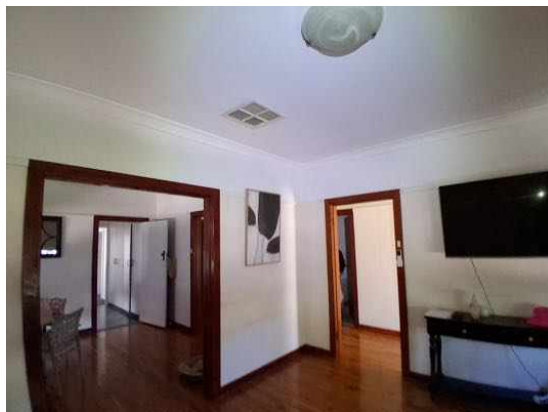
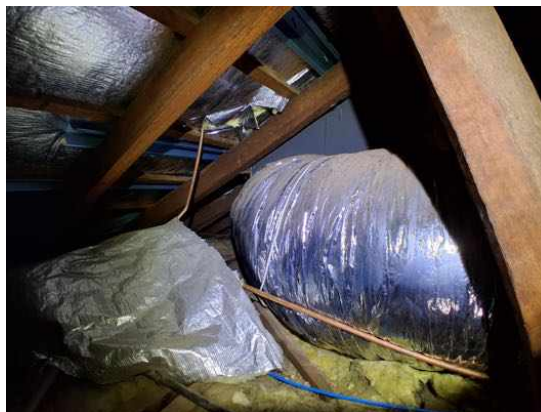
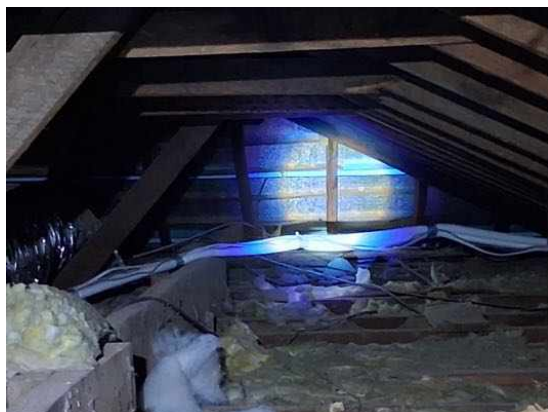
Building: Main Building  
Location: All Areas  
Finding: Additional Photos - Obstructions and Limitations  
Information: These photographs are an indication of the obstructions and limitations which impeded full inspection of the property at the time of inspection. These obstructions can hide an array of defects and should be removed to allow full inspection to be carried out. A re-inspection is recommended once the areas are made accessible.

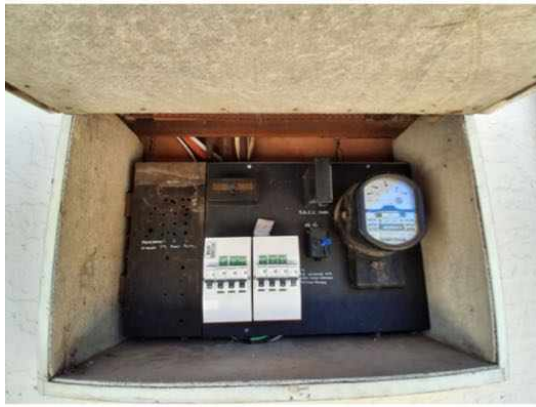
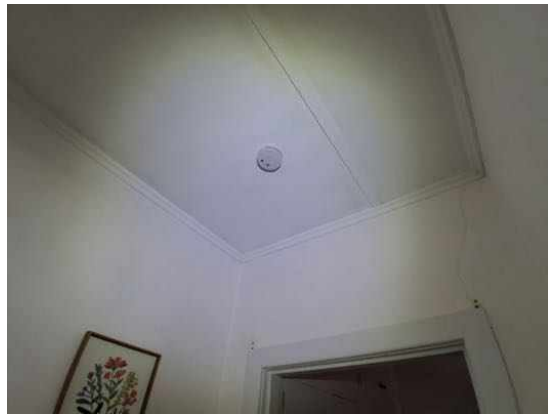
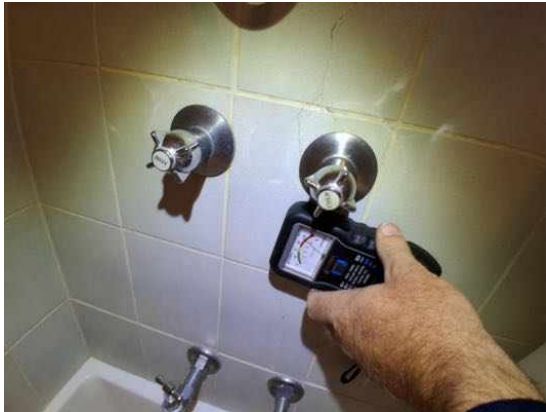
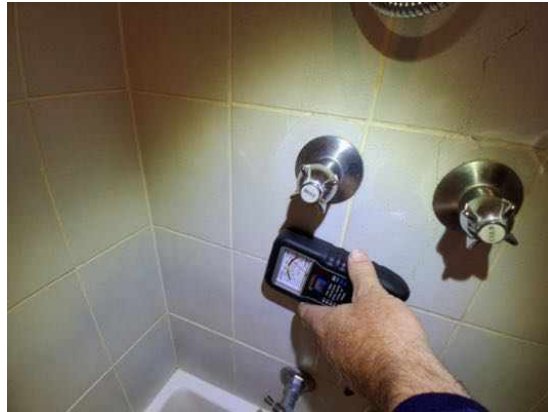
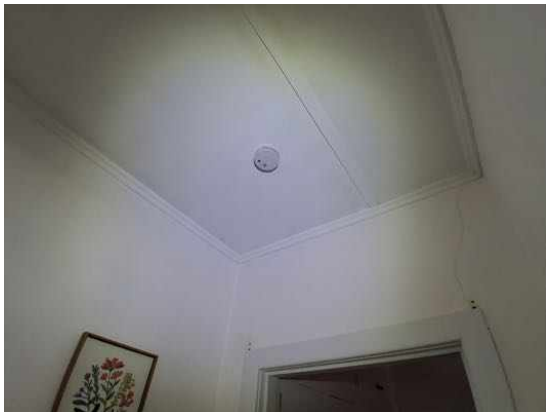
A photo of the switchboard and RCDs has been included for reference. This inspection does not assess electrical compliance and we are not licensed electricians. We recommend engaging a qualified electrician to confirm that the installation meets current safety standards, whether the property is to be rented out or occupied by the purchaser.

A photo of the smoke alarms has been included for reference. We have not assessed their location, condition, or operation. We recommend engaging a qualified person to confirm that the smoke alarms meet current safety standards, whether the property is to be rented out or occupied by the purchaser.

Moisture readings below taps where possible and walls adjacent to showers where possible. Where there appeared to be high moisture readings below the taps at the time of the inspection. Please refer to the defect

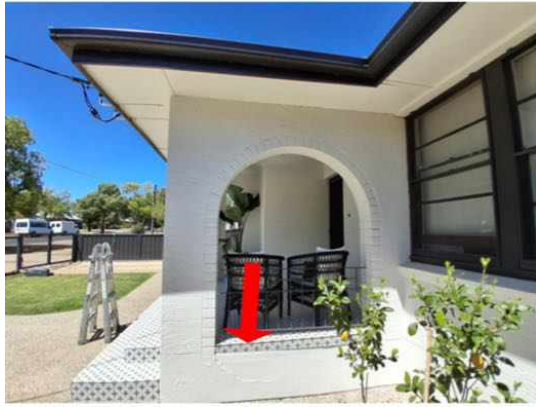
Building: Main Building  
Location: Exterior  
Finding: Porch slab Cracking  
Information: There is cracking to the side of the front porch concrete slab.

This is not uncommon in these older homes

Suggest homeowners keep an eye on this crack for further movement, should the crack widen, we suggest the homeowner contacts a structural engineer or licensed builder for further evaluation.

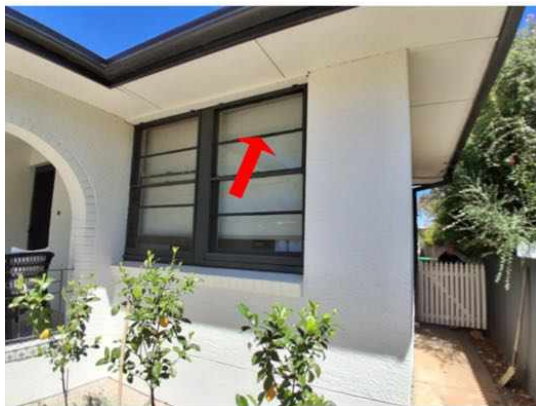
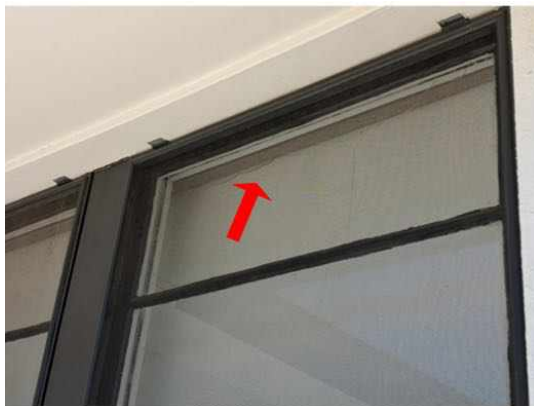
Building: Main Building  
Location: Exterior  
Finding: Window Pane Cracked  
Information: The window in the front bedroom area appears to have a cracked window pane.

A cracked window poses a potential safety hazard and could allow water to enter the building.

Clients may wish to contact a glazier for further evaluation at clients discretion.

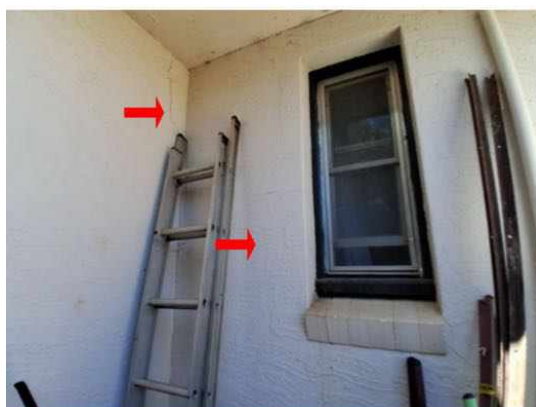
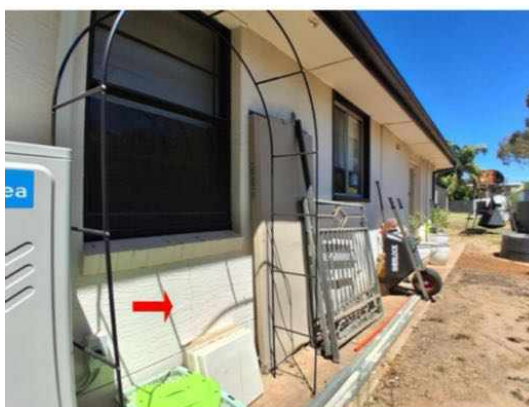
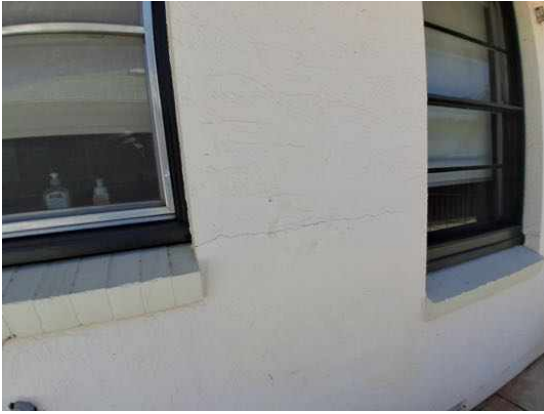
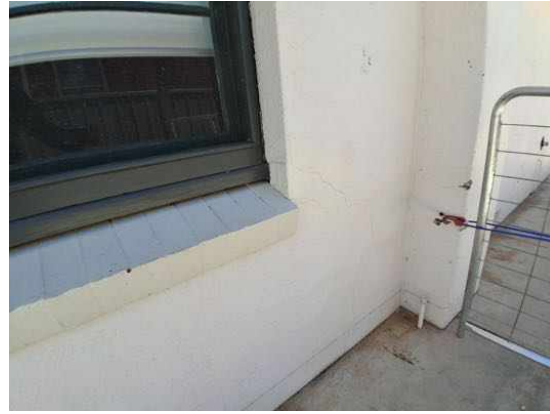
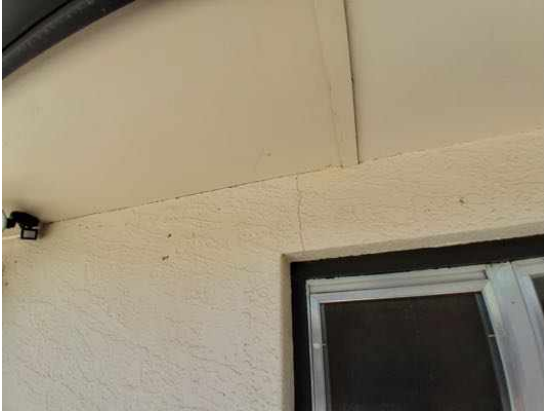
Building: Main Building  
Location: Exterior  
Finding: Cracking (small) to External brickwork  
Information: There appears to be small cracking to the external brickwork in various locations around the house. These cracks are classed as number 2 below which is typically not structural but should be monitored

#### 2. Small Cracks (1mm – 5mm) – Minor

- Slight cracks that may require cosmetic repairs (e.g., repointing). Typically not structural but should be monitored.

Client may wish to contact a licensed builder for further assessment if desired.

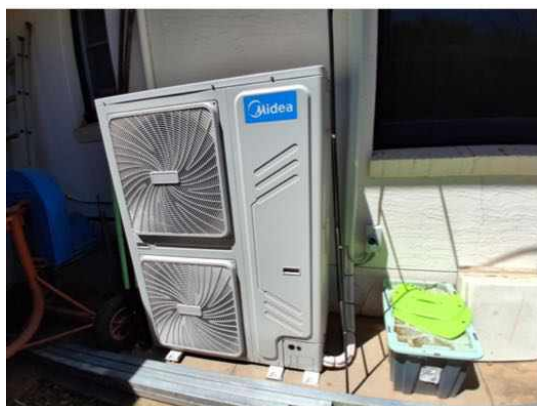
Building: Main Building  
Location: Exterior  
Finding: Air conditioner condensation drains  
Information: The air conditioner condensate drains are not connected to the stormwater system and currently discharge to the ground, which can lead to damp soil conditions that may attract termites or cause minor surface pooling. While there is no specific requirement for these drains to be connected, it is recommended they be directed to suitable drainage or the stormwater system where practical to reduce ongoing moisture near the structure.

Client may wish to contact a plumber for further evaluation at clients discretion

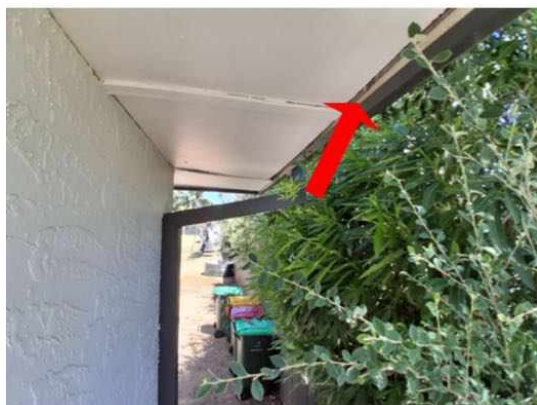
Building: Main Building  
 Location: Exterior  
 Finding: Eave out of fascia  
 Information: A small section of the eave lining to, but not limited to, the northern elevation has come away from the fascia. This may be due to age-related fixings loosening or minor timber shrinkage. While it does not appear to pose an immediate safety' risk, it may allow pests or moisture into the roof space if left unaddressed. This is a low to moderate priority maintenance item that can be addressed as part of routine exterior upkeep.

Client may wish to contact a carpenter or licenced builder for further evaluation at clients discretion.

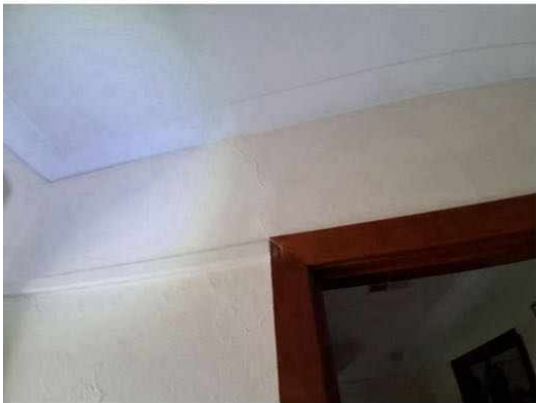
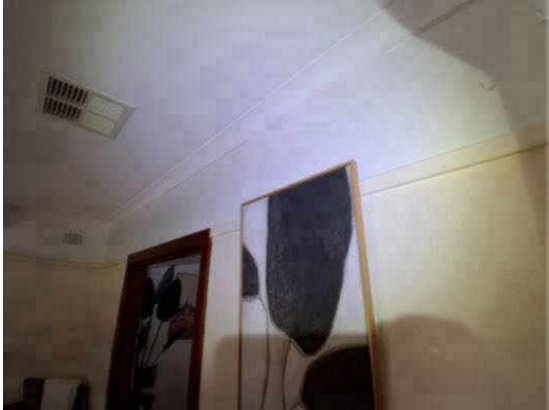
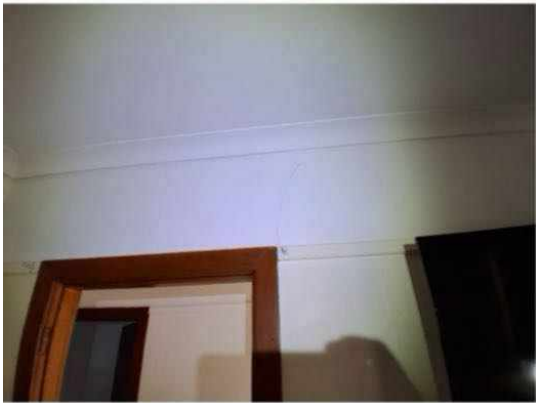
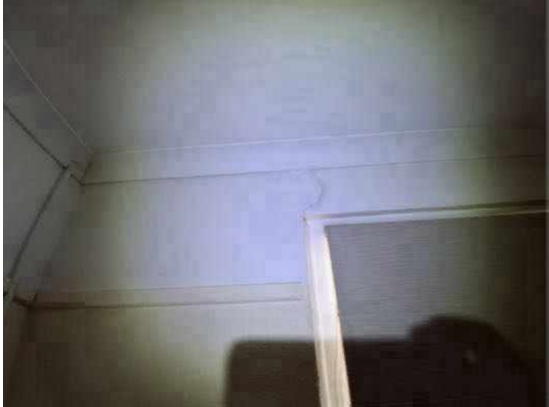
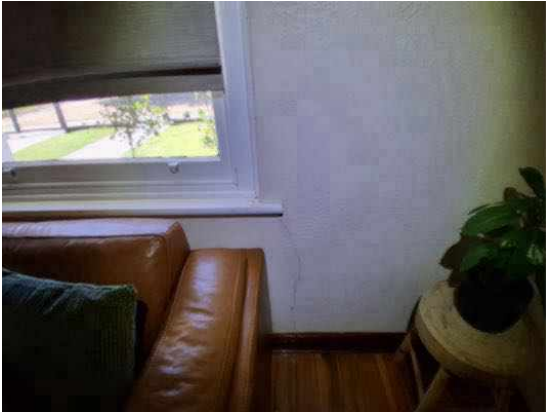
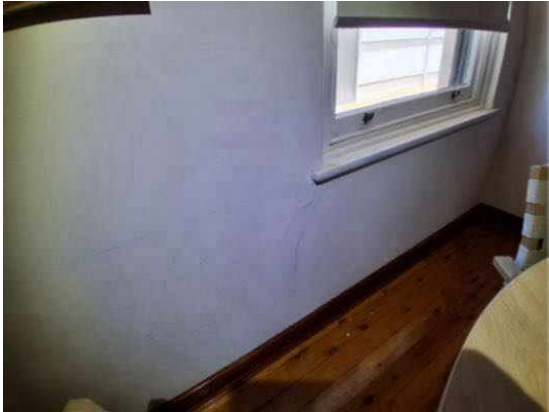
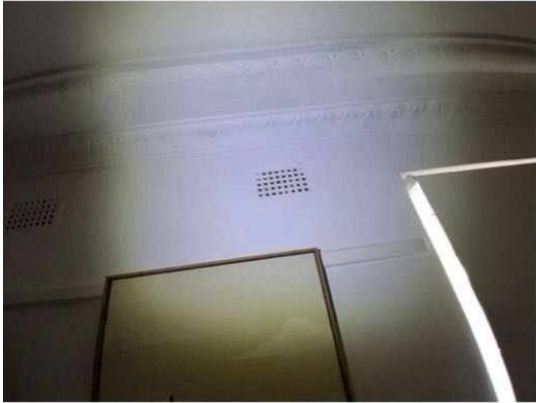
Building: Main Building  
 Location: Interior  
 Finding: Patching to Walls  
 Information: Some internal walls show evidence of past patching and repainting, likely from previous cracking or minor surface imperfections that have been repaired. No significant current cracking or movement was noted at the time of inspection.

Monitoring is recommended as part of normal maintenance.

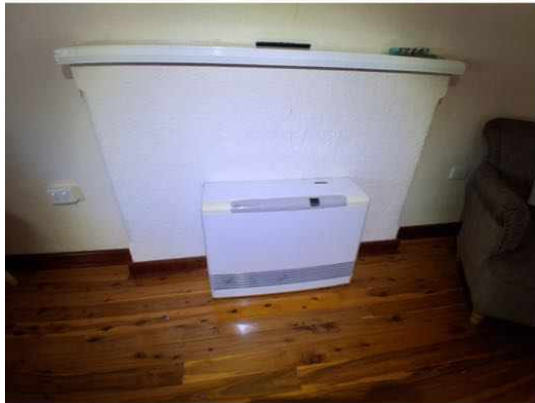
Building: Main Building  
Location: Interior  
Finding: Gas Heater  
Information: There appears to be a gas heater in the lounge room. It is recommended to ensure that the operation, installation and ventilation of the room meet NSW regulations.

Contacting a plumber for further evaluation at clients discretion.

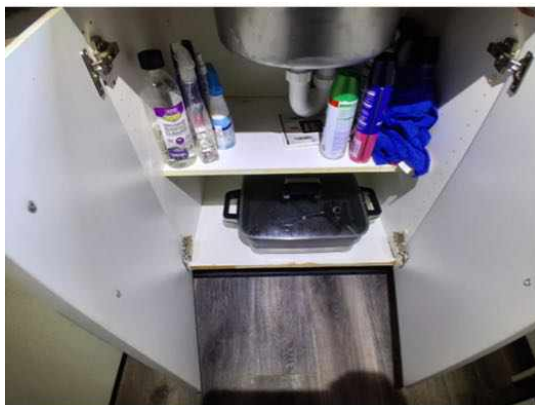
Building: Main Building  
Location: Interior  
Finding: Wear and Tear to cabinets  
Information: There is wear and tear consistent with their age to, but not limited to, the kitchen cabinets

Client may wish to contact a handy person or carpenter for further evaluation at clients discretion

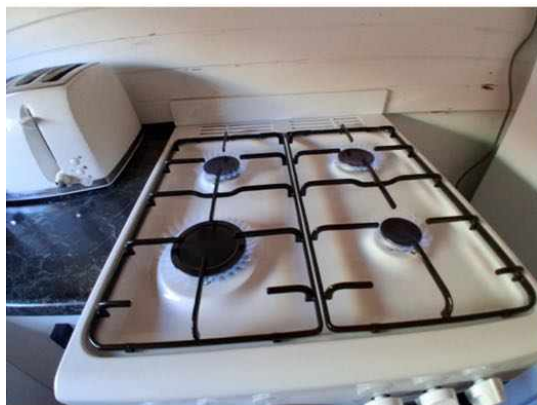
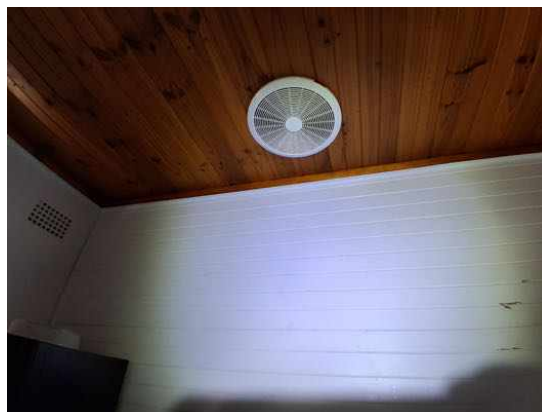
Building: Main Building  
 Location: Interior  
 Finding: Cooktop & Rangehood  
 Information: Cooktops appeared to be working

Rangehood which appears to be a ceiling exhaust fan appeared to be working

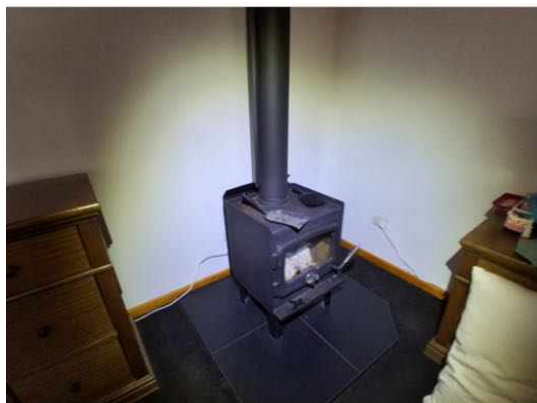
Building: Main Building  
 Location: Interior  
 Finding: Wood Fires  
 Information: We recommend contacting a professional chimney sweep or a certified chimney technician to ensure your fireplace, hearth, and flue are safe and functioning correctly

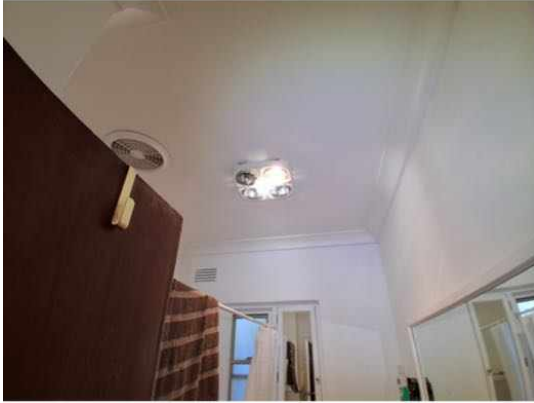
Building: Main Building  
 Location: Bathroom  
 Finding: Heat lamp  
 Information: The heat light in the bathroom appears to have three heat lights not working.

Client may wish to contact a handy person for further evaluation

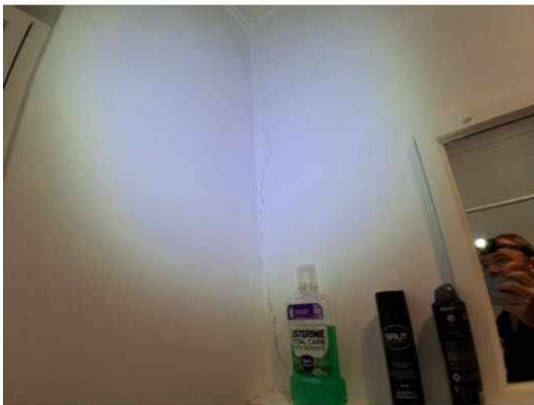
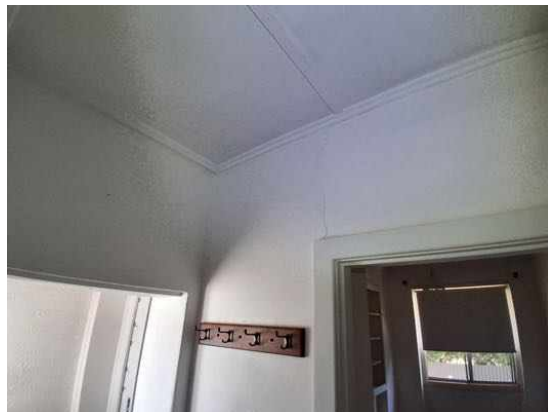
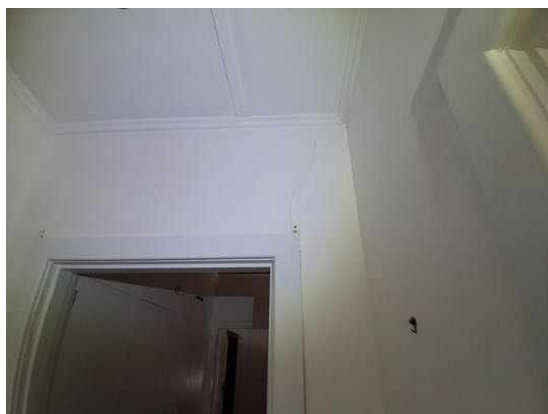
Building: Main Building  
 Location: Interior  
 Finding: Cracking to interior wall  
 Information: There appears to be cracking to, but not limited to the bathroom wall and rear section of the house . Although fine cracks are noticeable, they are often only considered to be an appearance defect.

If desired, a painter or home maintenance professional could be contacted to repair the cracks when desired.

Monitoring of all cracking should be conducted frequently. Always contact a building inspector or licensed builder should cracks widen, lengthen, or become more numerous.

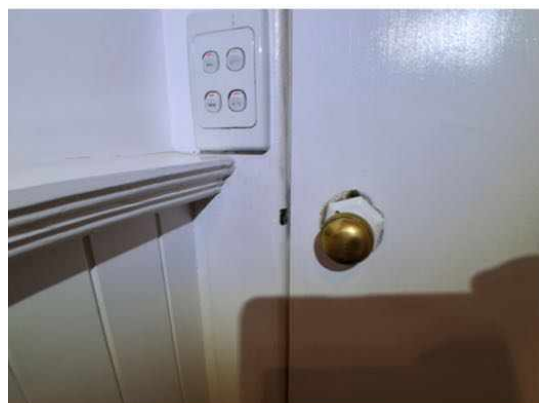
Building: Main Building  
 Location: Interior  
 Finding: Door handle Adjustment  
 Information: It appears the door handle to, but not limited to, the bathroom door requires adjustment to operate freely. This is only considered n appearance defect

Clients may wish to contact a carpenter or handy person for further evaluation at clients discretion.

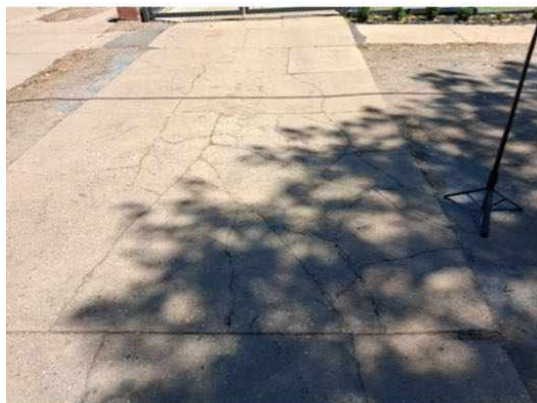
Building: Main Building  
 Location: Exterior  
 Finding: Driveway Cracking  
 Information: There is minor cracking to the driveway.

This is not uncommon in buildings of similar age and can be caused by a number of different factors including tree roots, water pooling and vehicle traffic

Suggest homeowners keep an eye on this crack for further movement, should the crack widen, we suggest the homeowner contacts a structural engineer or licensed builder for further evaluation.

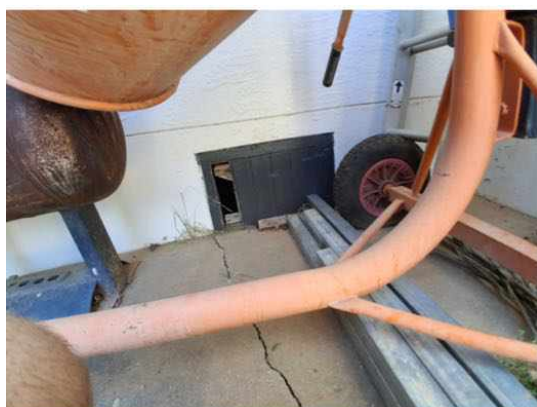
Building: Main Building  
 Location: Exterior  
 Finding: Footpath Cracking  
 Information: There is minor cracking to footpaths in various locations.

This is not uncommon in buildings of similar age and can be caused by a number of different factors including ground movement in clay soils

Suggest homeowners keep an eye on this crack for further movement, should the crack widen, we suggest the homeowner contacts a builder for further evaluation.
