Building and Timber Pest Inspection Report

Inspection Date: Thu, 8 Jan 2026

Property Address: 31 George St, Berry NSW 2535, Australia

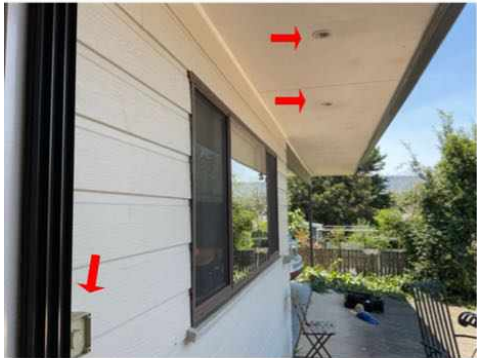
Building: Building 2
Location: Roof Cavity and described flat downlights
Finding: Electrical cables missing a junction box and lights faulty.
Information: The electrical fitting in the flat kitchen roof area was found to be missing a junction box at the time of inspection.

This missing fitting and loose cables does expose electrical works, and may create a safety hazard if there is potential contact with persons in the area.

Both the flat external lights and internal loungeroom lights are intermittent and do not appear to work consistently.

A Licensed electrician should be appointed to rectify these areas immediately.

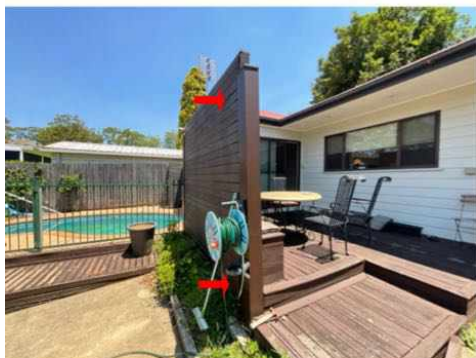
Building: Building 1
 Location: Granny Flat
 Finding: Wall - Loose
 Information: The wall in this area is loose and requires additional urgent support. The base of this post has severe wood rot and now provides no support.

If left unmanaged, the wall will fail, causing potential for injury.

A carpenter should be appointed to perform these rectification works immediately.

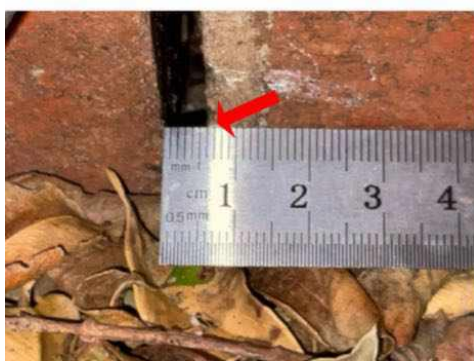
Building: Building 1
 Location: Exterior house wall & flat rear wall
 Finding: Step cracking to brickwork - major at base - 6mm
 Information: Step cracking was identified to the brickwork in the external rear flat wall area at the time of inspection. The crack at the bottom of this rear flat wall is 6mm (photos 1-3).

Most other cracks are 2-3mm.

The NSW Standards and Tolerances 2017 states cracks over 5mm in width are a major defect requiring rectification. This applies to the flat middle lower wall.

The other wall cracks are minor and should be monitored annually.

Step cracking, which is similar to other forms of cracking, has a variety of possible causes. However, the most common is the subsidence of adjacent footings.

Where step cracking is extensive or severe in this case, the client is advised to consult a structural engineer. Minor step cracking can be used as a warning sign to address factors causing stress to the wall, which can include the effect of surrounding trees, water leaks, soil erosion, or even the presence of reactive soils in the surrounding area.

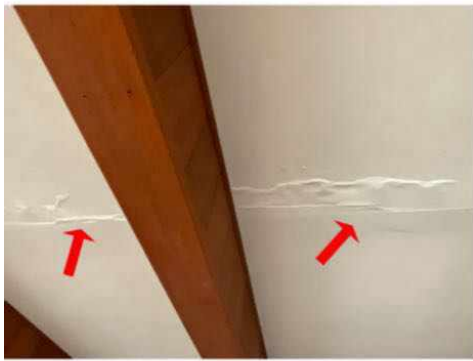
Building: Building 1
Location: Both Lounge Rooms
Finding: Ceilings - Water stained, minor mould and sagging and moisture in rear
Information: Water staining to ceiling linings in both lounge room ceilings was evident at the time of inspection. Water staining indicates that surfaces have been exposed to excessive moisture over time. The minerals and other elements in the water lead to staining, which may graduate to corrosion and deterioration if left unmanaged.

Where water staining is active in the case of the rear loungeroom (a low reading of 19.4 was recorded), a licensed roof plumber must be consulted to identify the cause of the staining and to provide advice on any reparation works that may be required. Replacement of any damaged structures is required.

Conversely, where water staining is old and inactive, as appears to be on the front loungeroom, the affected building materials may be repaired or replaced at client discretion.

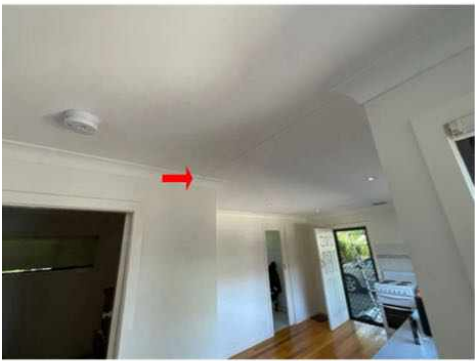
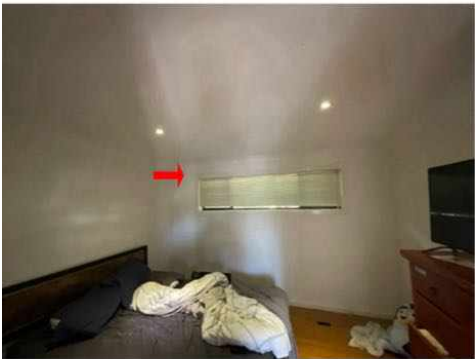
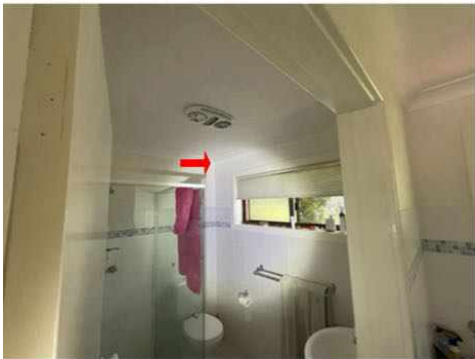
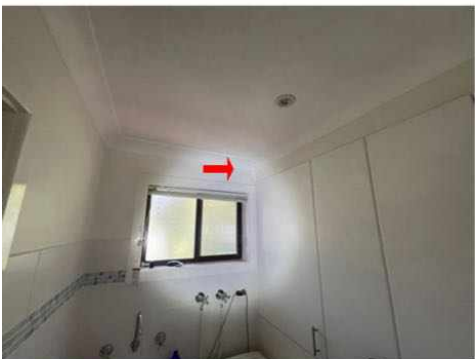
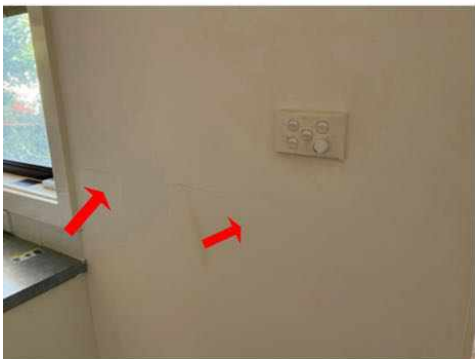
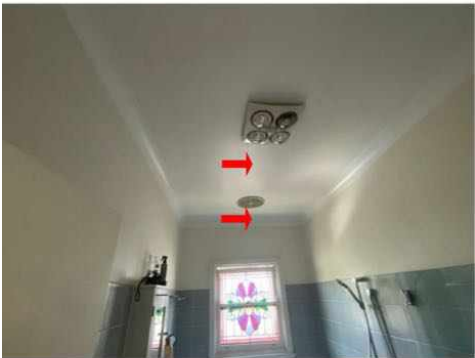
Finding 3.05

Building:	Building 2
Location:	Most flat rooms & some house areas
Finding:	Cracking - Damage Category 1 - Fine (up to 1mm)
Information:	Although fine cracks are quite noticeable, they are often only considered to be an appearance defect, and usually do not indicate any structural damage. Generally, the cause of a fine crack is indicative of a separation between building materials and finishes (e.g. paint, plaster, etc.) along joints. In this granny flat, it is suspected due to the amount of internal and rear brickwork cracking, that movement in the foundations has occurred. As the rear wall cracking is up to 6mm, a structural engineer should be consulted for further advice and a scope of works (see major defects).

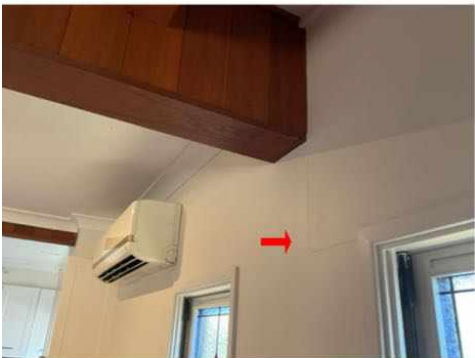
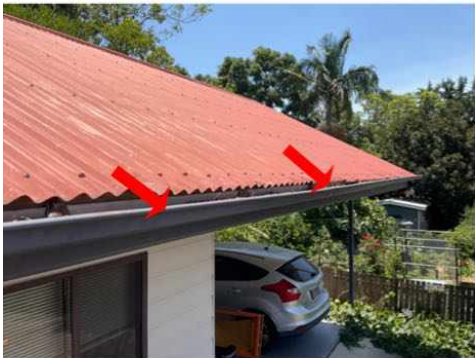
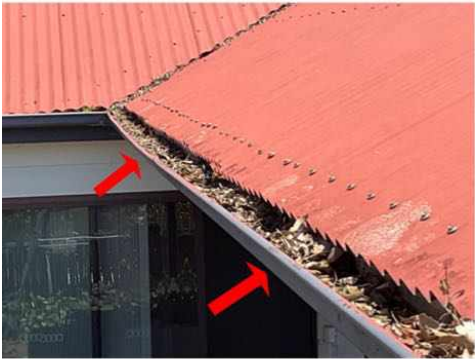
Finding 3.06

Building: Building 2
Location: Pictured areas
Finding: Gutter - Insufficient fall
Information: There is an insufficient fall in some flat gutters, which means that the angle of this gutter is inadequate for rainwater to drain away. This has resulted in pooling of water in these areas, creating water damage to nearby timber areas. This will lead to further defects if not repaired. Adjustment by a roofing contractor is required as soon as possible to prevent further damage to these areas.

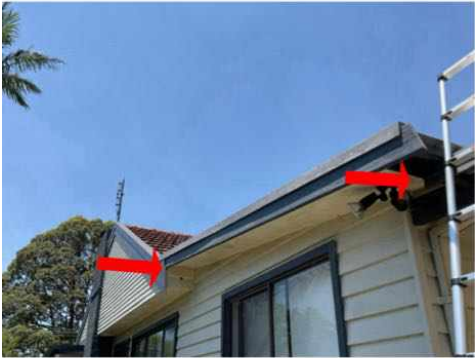
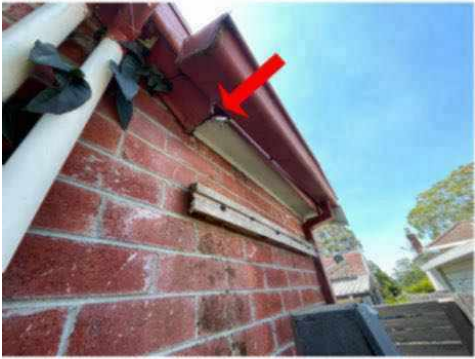
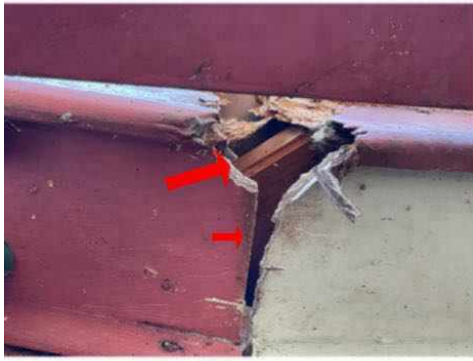
Finding 3.07

Building: Building 1
Location: Pictured Areas of both buildings
Finding: Sealant (external) - Missing.
Information: It was noted on inspection that areas of external sealant was missing to the external walls and roof areas of both buildings.

Flexible sealants should be applied to these affected areas to prevent any subsequent water damage that is likely to occur.

A sealant specialist or skilled handy person should be appointed to complete these works as soon as possible

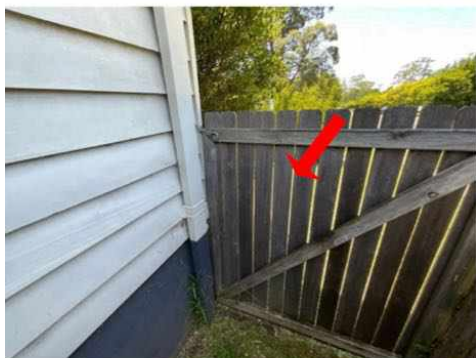
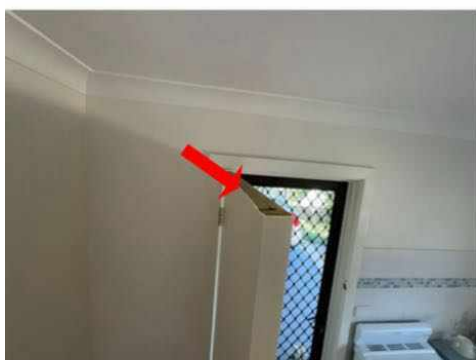
Finding 3.08

Building: Building 1
 Location: Pictured areas of both buildings .
 Finding: Building elements - Damaged
 Information: Evidence of minor missing or damaged areas was identified at the time of the inspection. These include -

1. The left front gate is bowed but working.
2. Many doors have not been painted top and bottom, crucial in wet areas to prevent swelling.
3. The bathroom window does not close at the top.

A carpenter would be the trade responsible for rectification of these areas when convenient.

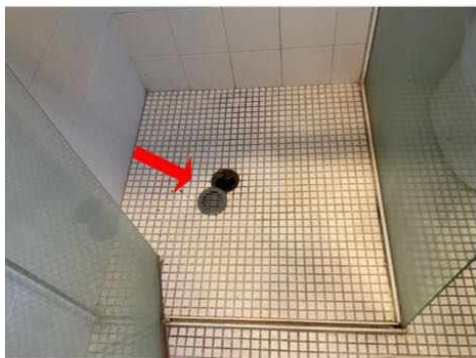
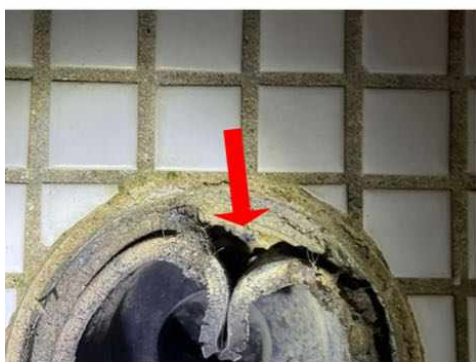
Finding 3.09

Building:	Building 2
Location:	Pictured areas
Finding:	Incomplete or substandard works
Information:	The works to this flat bathroom area appear to have been completed to a substandard level. It appears water may escape under the flat from this substandard plumbing connection. When remove it the drain cover the while drain was found to be loose.

Works that have not been completed to a satisfactory level create potential for the development of building defects and may impede on the safety and integrity of the overall structure.

It is highly recommended that a licensed plumber be appointed to complete these works and ensure the safety of the area and the longevity of all associated building elements.

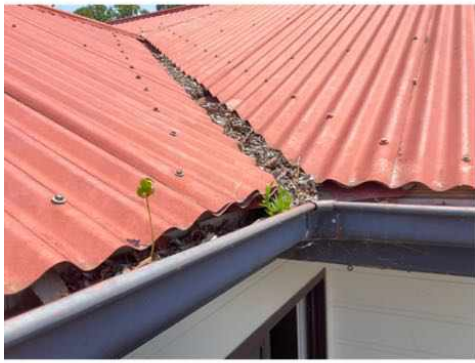
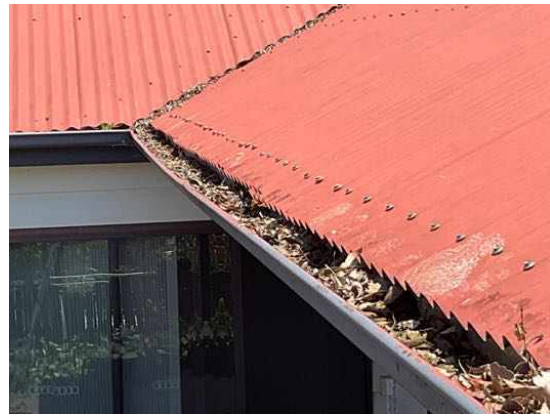
Finding 3.10

Building:	Building 1
Location:	Roof exterior
Finding:	Gutters - Full and blocked
Information:	The guttering on around the roof was found to be blocked at the time of the inspection. Roof plumbing structures, such as guttering and downpipes, should be free of all debris to prevent blockages. Blockages of the guttering and downpipes will lead to pooling and accumulated water overflows, which is likely to subsequently flood eaves and exterior walls.

Blocked gutters are likely to lead to high levels of moisture in the affected areas which can cause rust and decay of the gutters and downpipes and wood rot to adjoining timber areas. Blockages in gutters should therefore be removed immediately to ensure dry conditions are maintained.

It is highly advised that gutters be cleaned by the homeowner or a general handyman as a matter of urgency.

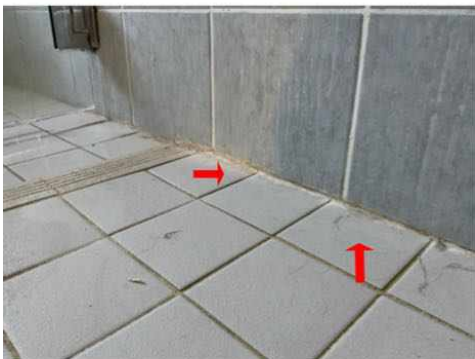
Finding 3.13

Building:	Building 1
Location:	Main bathroom
Finding:	Sealant and grouting - Missing or damaged
Information:	It was noted on inspection that sealant or grout is degraded to this bathroom.

Flexible and mould resistant materials should be applied to affected areas to prevent any subsequent water damage that is likely to occur. Regular maintenance and replacement of damage or missing or damaged sealant and grout is highly recommended to the wet areas, as this is a regular wear and tear defect. Sealant and grouting in areas that come into regular contact with water should be maintained for the long term care of your property.

A sealant specialist or tiling contractor should be appointed to complete these works as soon as possible

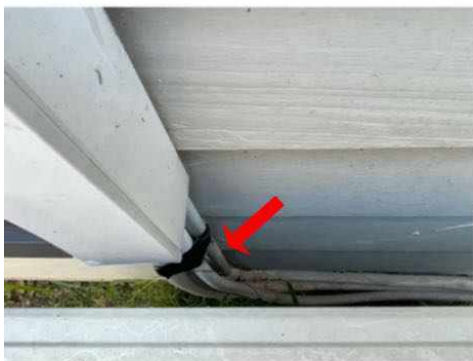
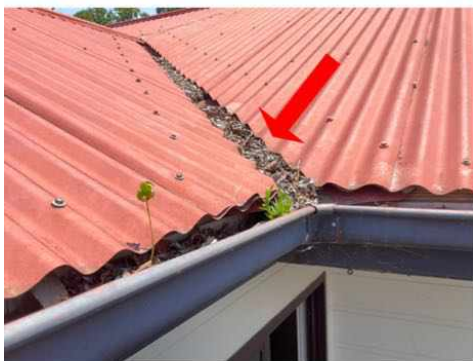
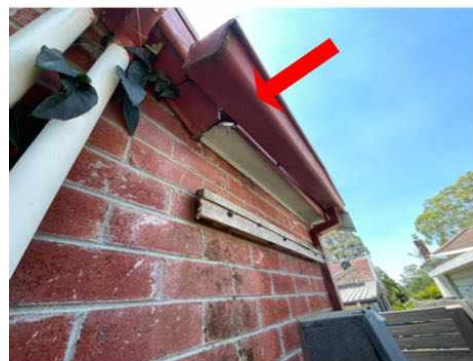
Finding 3.14

Building: Building 1
 Location: Walls
 Finding: Site drainage - Inadequate

It is important that water does not lie against the base of walls; surrounding paths and ground levels should be sloped to drain water away from walls. Downpipes should not discharge stormwater onto lower walls or plinths. Stormwater should be carried away by large, regularly cleaned drains. Ground levels may need to be lowered to expose a buried DPC.

Where site drainage is inadequate, installation of an Agricultural (Aggie) Drain may be required. A qualified plumber should be appointed to further inspect the property and perform any remedial works as necessary. Secondary defects are likely to occur if left unmanaged.

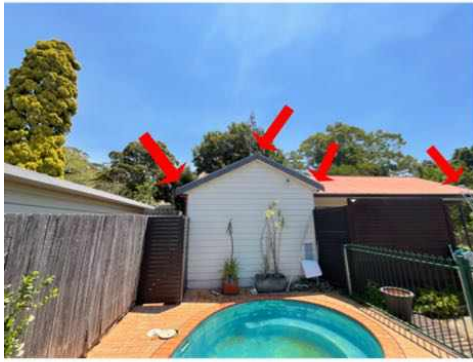
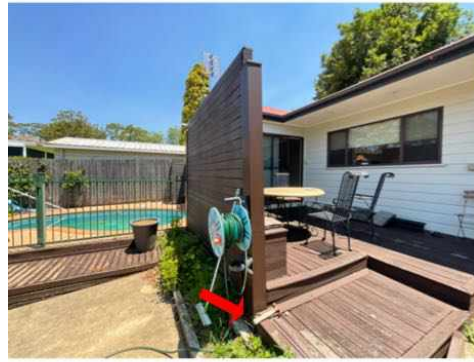
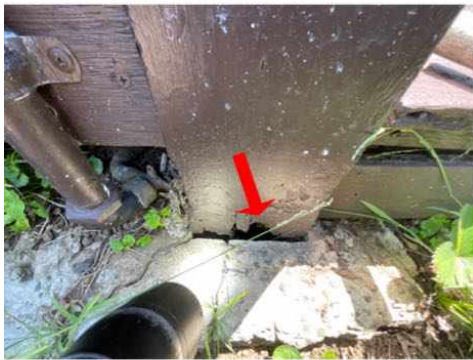
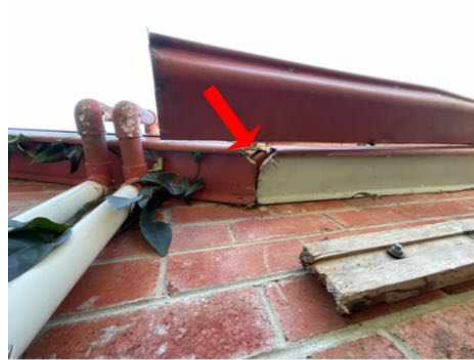
Finding 7.01

In this case, the affected timber facias and wall areas are in a decaying state and will need replacement by a carpenter or licensed builder.

Note - See ALL wood rot photos, all these show fungal decay.

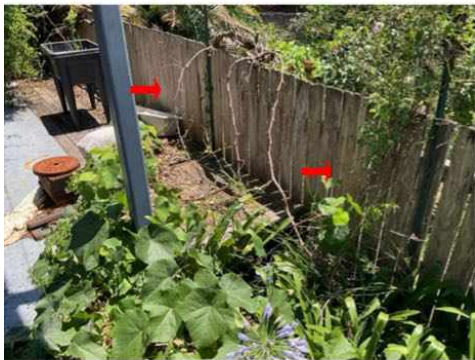
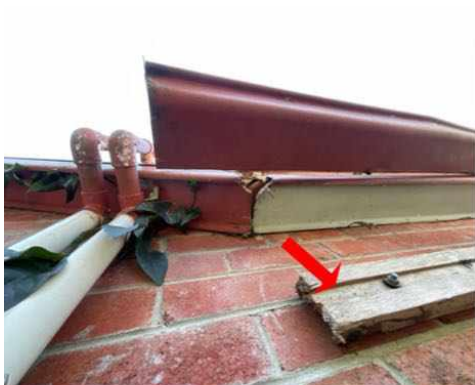
Finding 8.01

As no live wood borer activity was identified treatment is not required at this time. Replacement of affected timbers may be considered by the client for superficial reasons.
