Building Inspection Report

Inspection Date: Mon, 23 Mar 2026

Property Address: 180/38 Shoreline Dr, Rhodes NSW 2138,
Australia

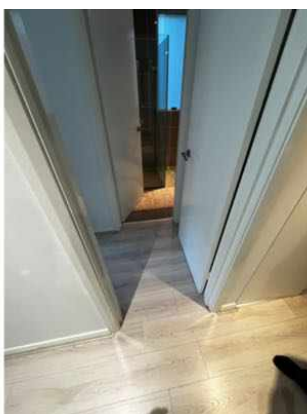
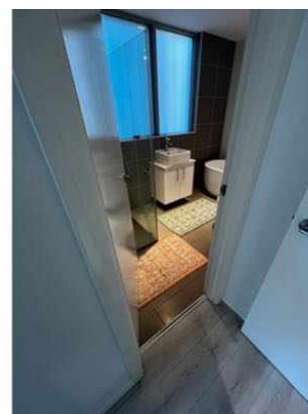
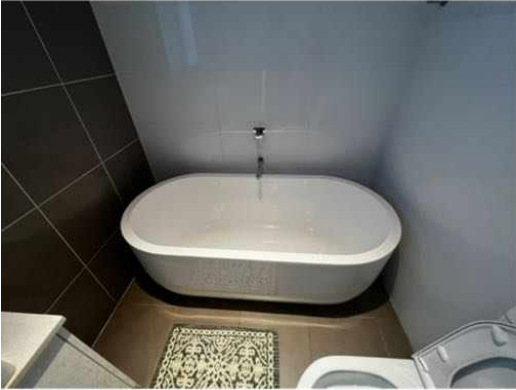
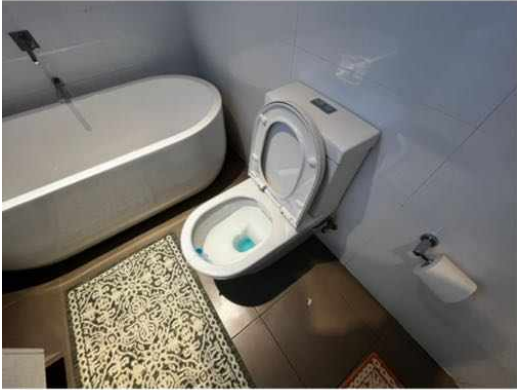
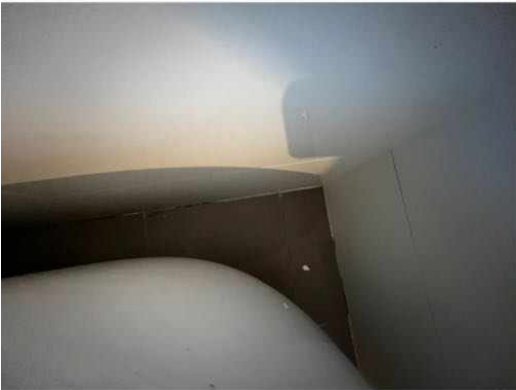
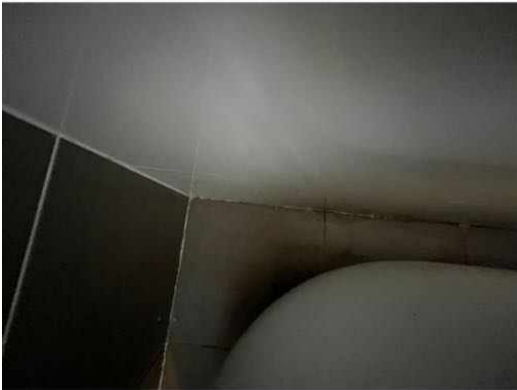
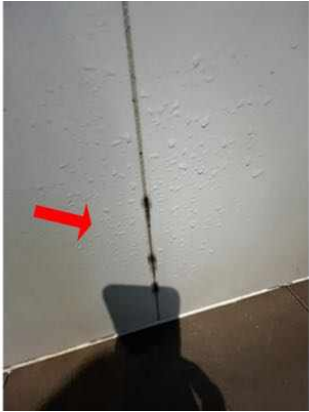
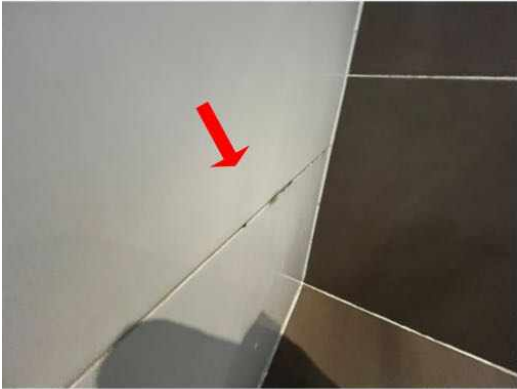
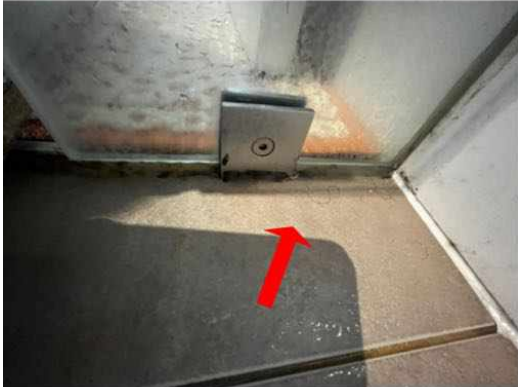
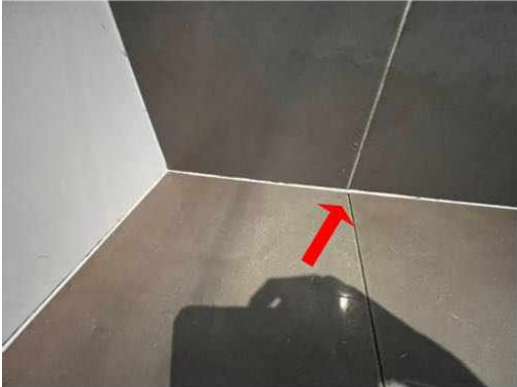
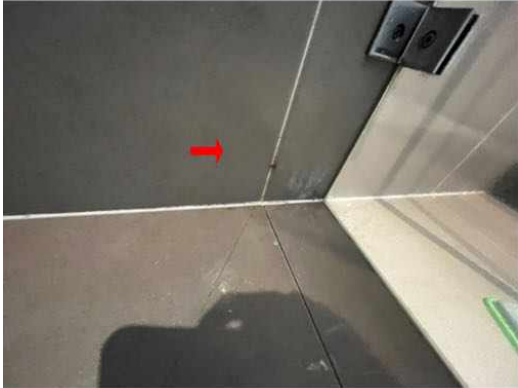
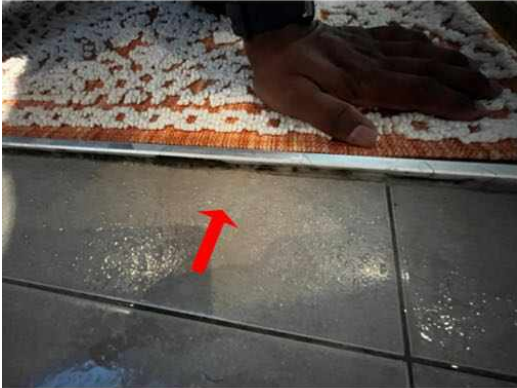
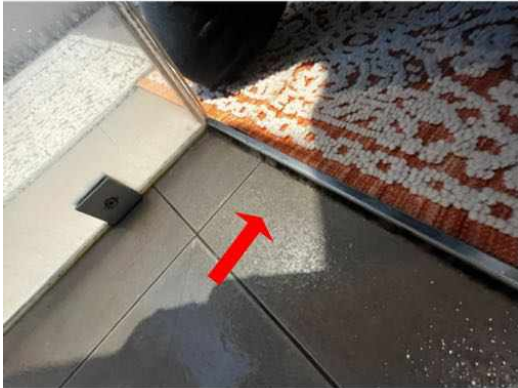
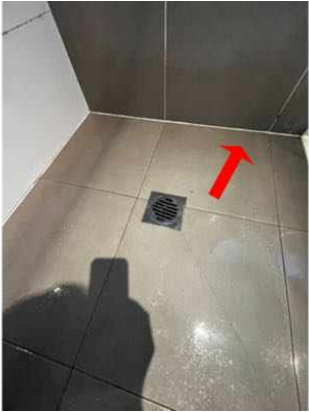
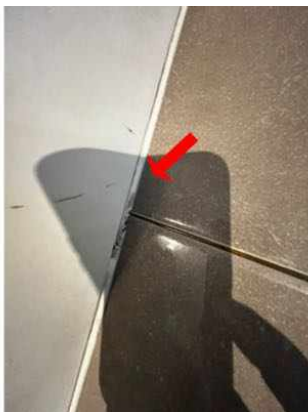
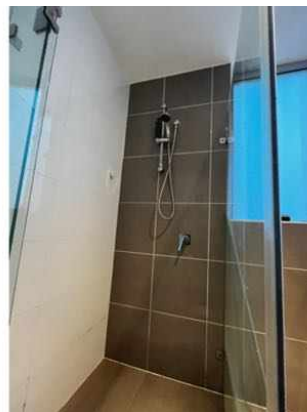
Defects 2.01

Building: Main Building
Location: Bathroom/Ensuite >
Finding: Sealant and grouting - Missing or damaged
Information: It was noted on inspection that sealant or grout is degraded to the tiled shower alcove in the Ensuite. I have also attached Visual photos taken during inspection FYI.

Different materials and floor areas move at different rates, generally causing cracking to grout or sealant at this point. A flexible sealant is required to allow for expected expansion and contraction, while keeping the joint water tight and protective of all associated building materials.

Flexible and mould resistant materials should be applied to affected areas to prevent any subsequent water damage that is likely to occur. Regular maintenance and replacement of damage or missing or damaged sealant and grout is highly recommended to the wet areas, as this is a regular wear and tear defect. Sealant and grouting in areas that come into regular contact with water should be maintained for the long term care of your property.

A sealant specialist or tiling contractor should be appointed to complete the job.

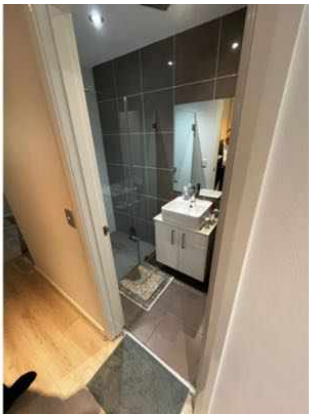
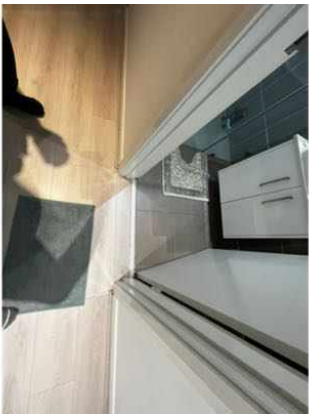
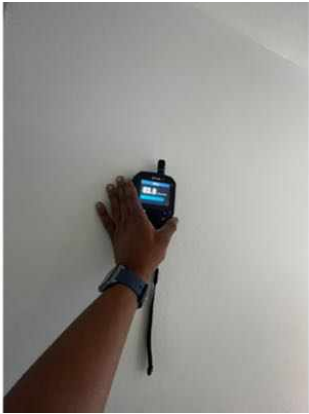
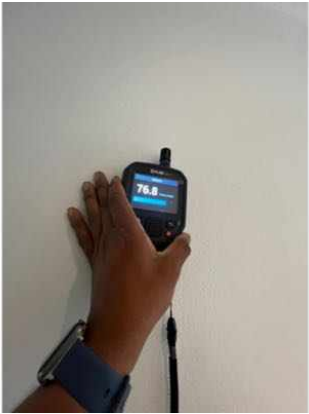
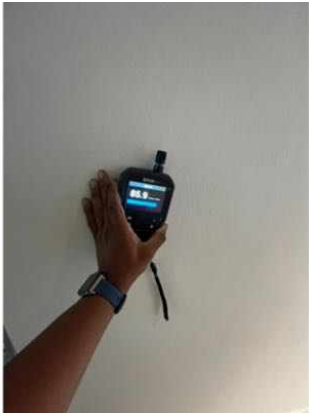
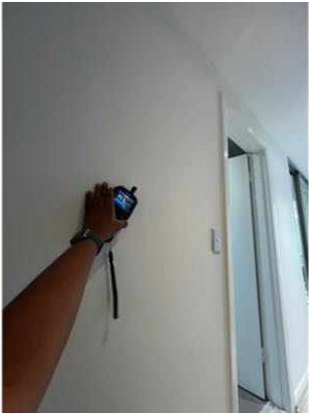
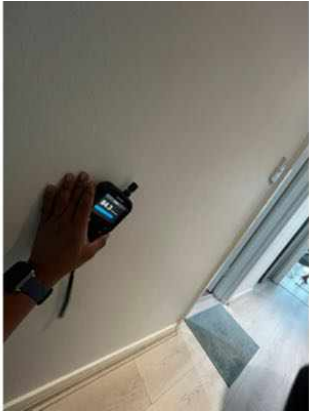
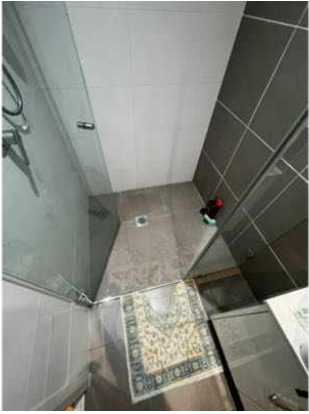
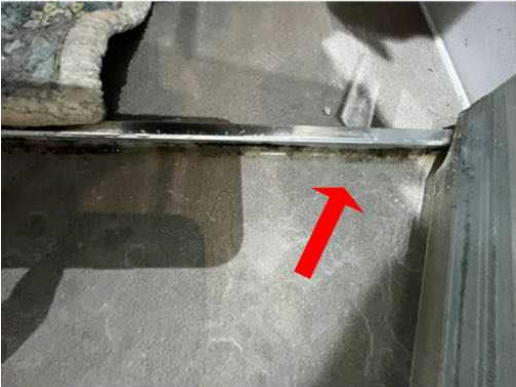
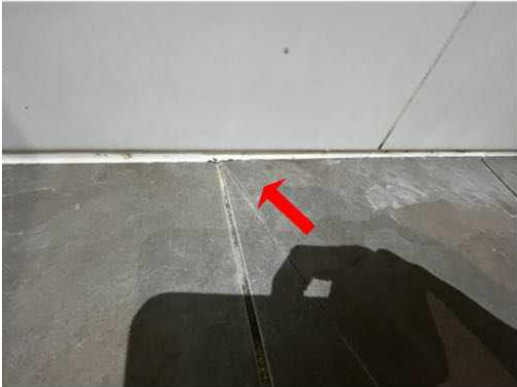
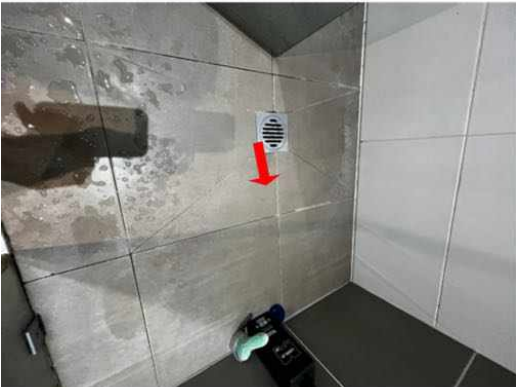
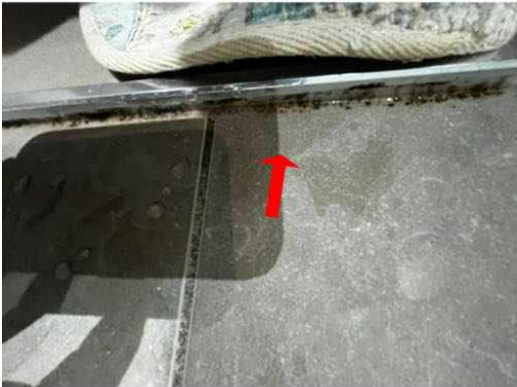
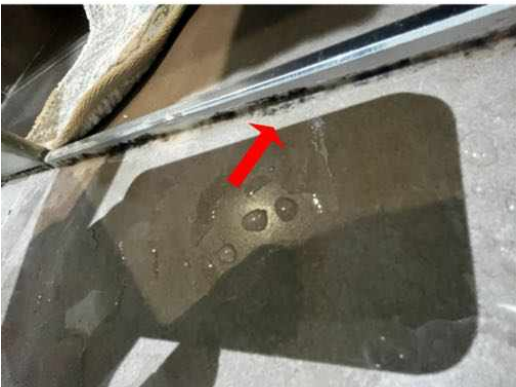
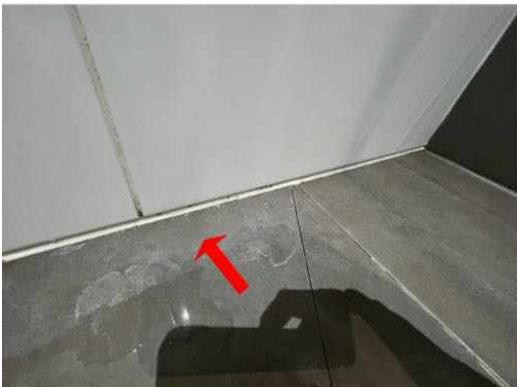
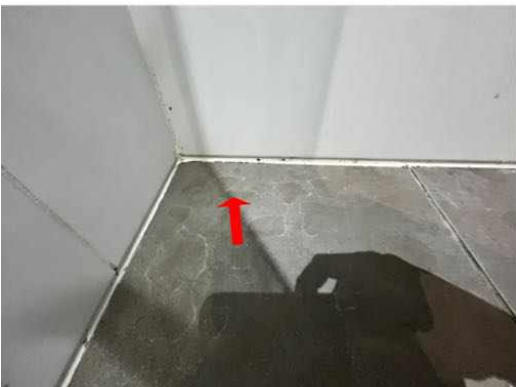
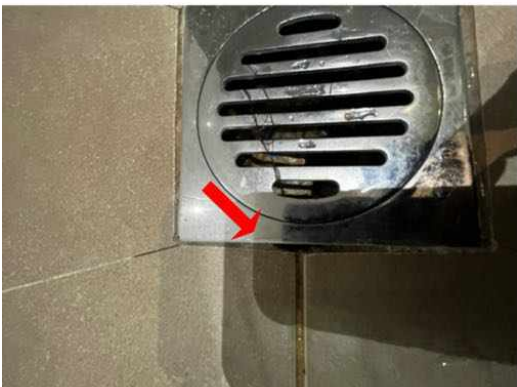
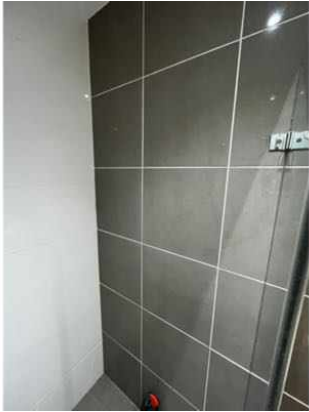
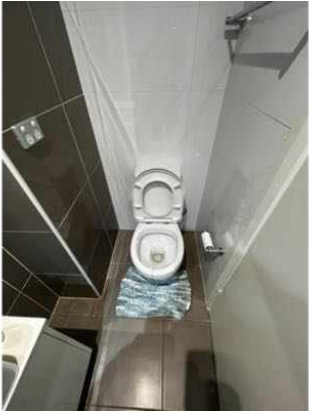
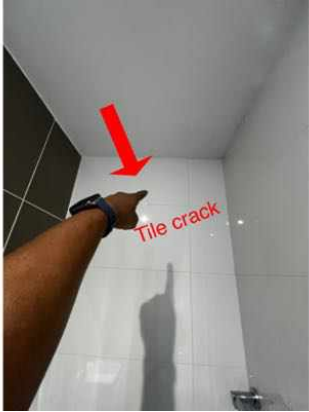
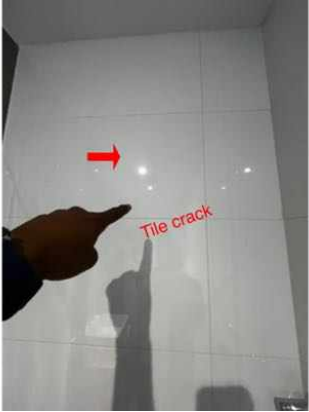
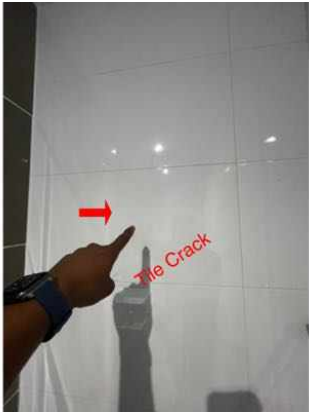
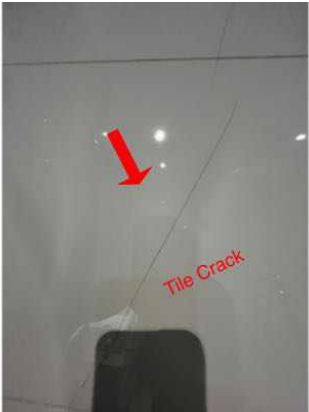
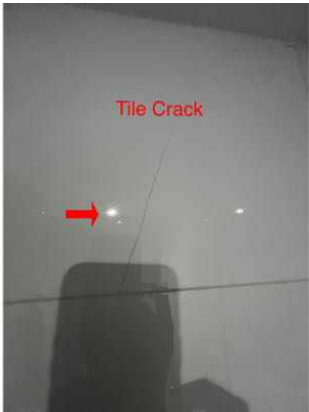
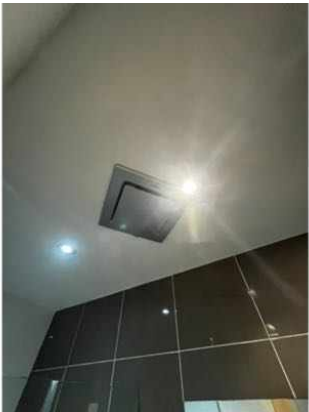
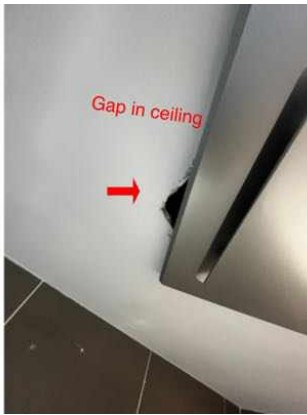
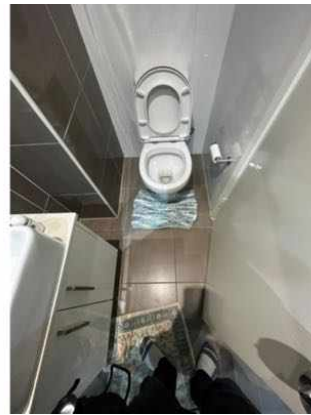
Defects 2.02

Building:	Main Building
Location:	Main Bathroom
Finding:	Sealant and grouting - Missing or damaged - crack in Tile.
Information:	It was noted on inspection that sealant or grout is degraded to the tiled shower alcove and or other areas of the bathroom.

Several points of the bathroom floor tiles have been identified for silicon crack.

Several Tiles on the wall shown on the photos have cracks identified in inspection.

A Gap in the ceiling near the exhaust fan was identified in the ceiling at the time of inspection.

Different materials and floor areas move at different rates, generally causing cracking to grout or sealant at this point. A flexible sealant is required to allow for expected expansion and contraction, while keeping the joint water tight and protective of all associated building materials.

There appears to be excessive mould to the sealant and grout which will likely require scraping out and replacement.

Flexible and mould resistant materials should be applied to affected areas to prevent any subsequent water damage that is likely to occur. Regular maintenance and replacement of damage or missing or damaged sealant and grout is highly recommended to the wet areas, as this is a regular wear and tear defect. Sealant and grouting in areas that come into regular contact with water should be maintained for the long term care of your property.

A sealant specialist or tiling contractor should be appointed to complete these works as soon as possible.

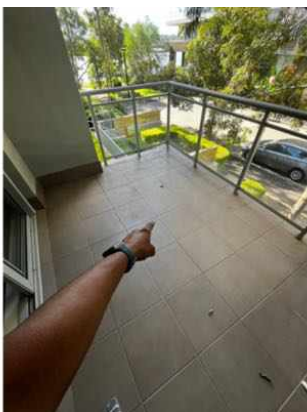
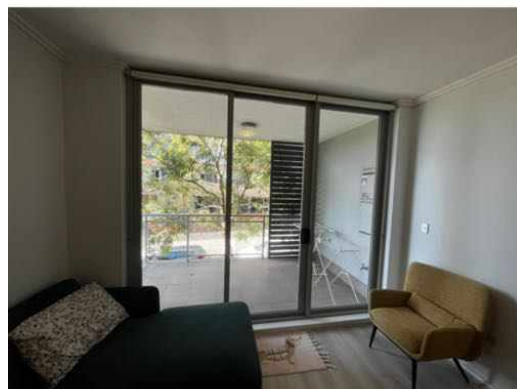
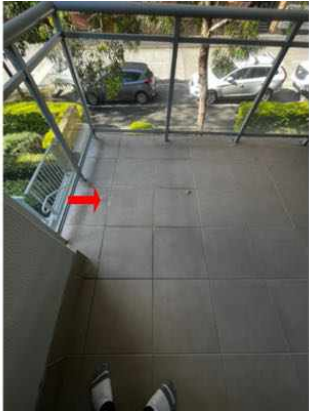
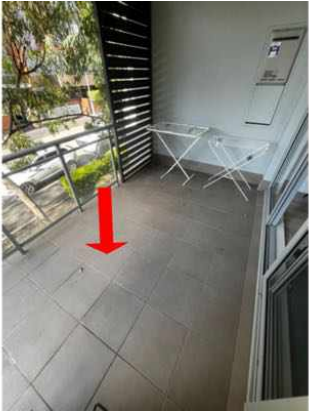
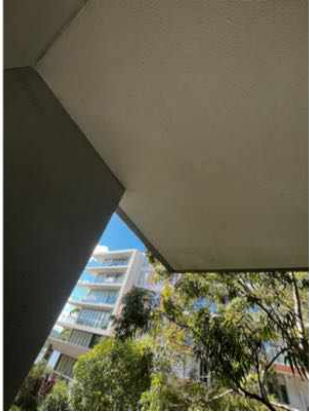
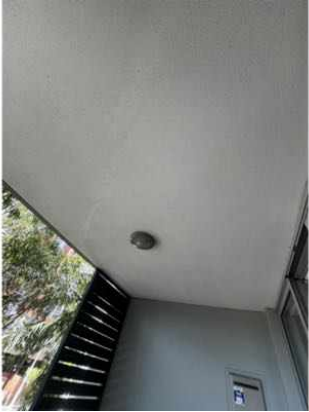
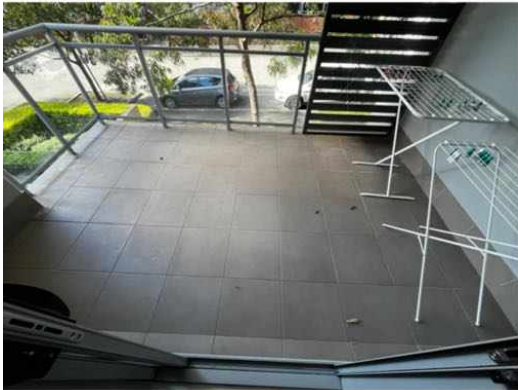
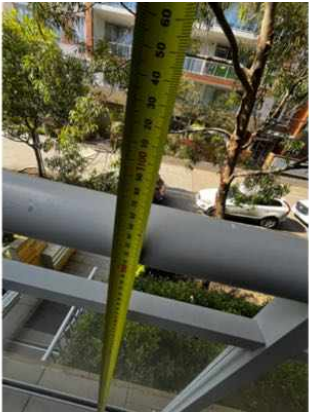
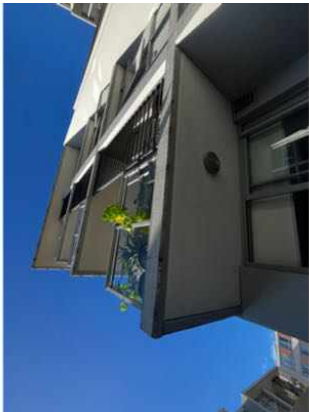
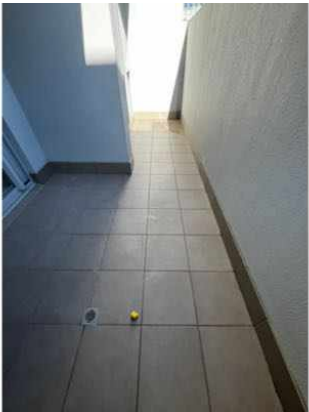
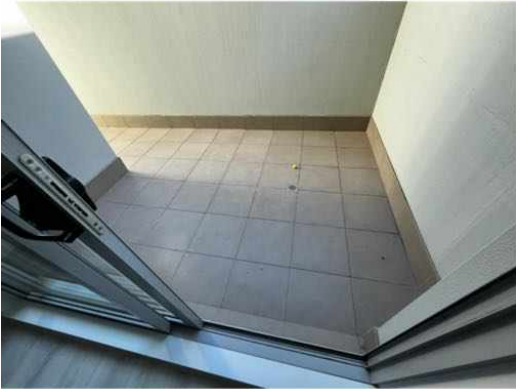
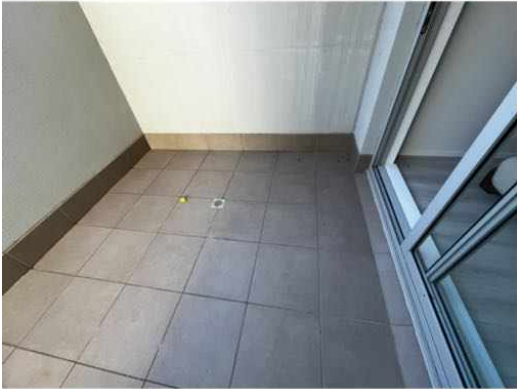
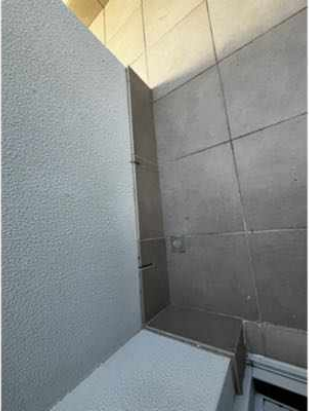
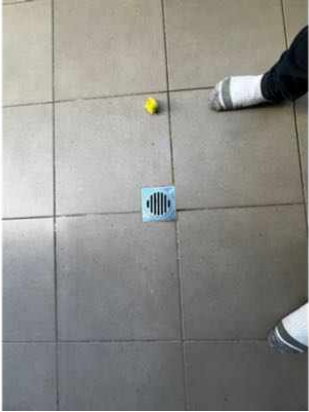
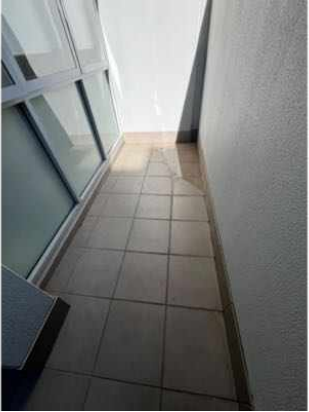
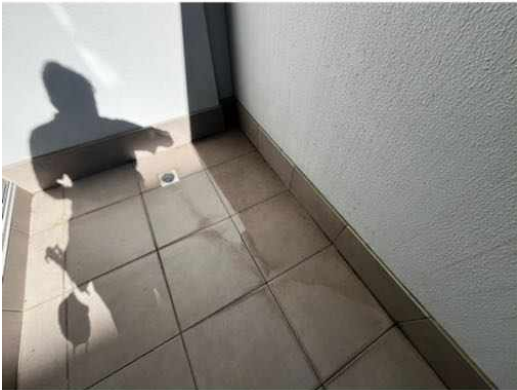
Defects 3.01

Building:	Main Building
Location:	Front Balcony
Finding:	Balcony - Floor
Information:	Upon Inspection The gradients of the Balcony floor levels are checked and found to be ok with a fall towards the floor trap.

The area being exposed to different weather is also a Cause for the grout/ silicone to dry up. Regular maintenance and replacement of damage or missing or damaged sealant and grout is highly recommended to the wet areas, as this is a regular wear and tear defect. Sealant and grouting in areas that come into regular contact with water should be maintained for the long term care of your property.

Suggest to always keep the area clear of rubbish and leaves, for the free flow of water/ rainwater to go through the downpipes.

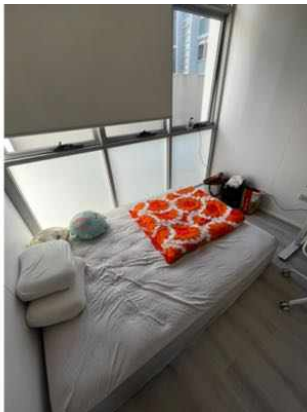
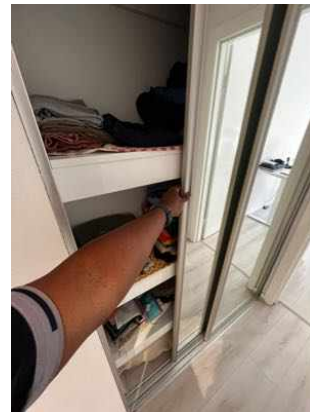
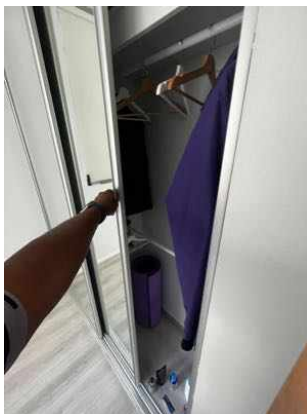
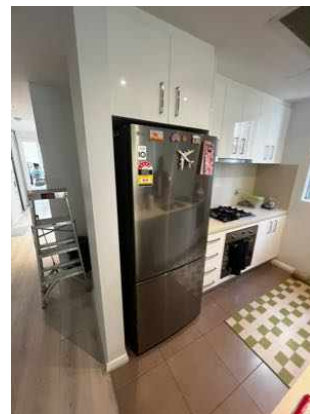
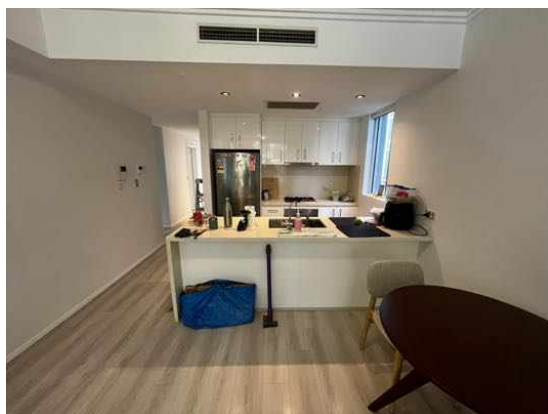
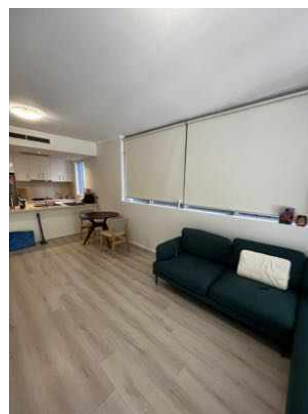
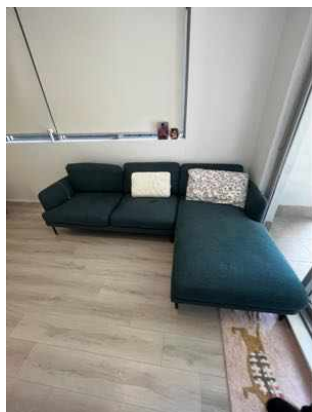
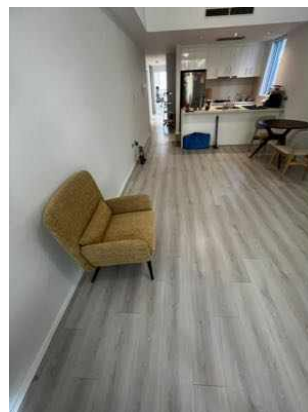
Finding: Additional Photos - Obstructions and Limitations

Information: These photographs are an indication of the obstructions and limitations which impeded full inspection of the property at the time of inspection. These obstructions can hide an array of defects and should be removed to allow full inspection to be carried out. A re-inspection is recommended once the areas are made accessible.

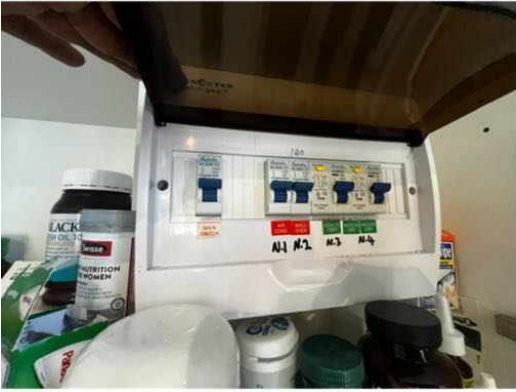
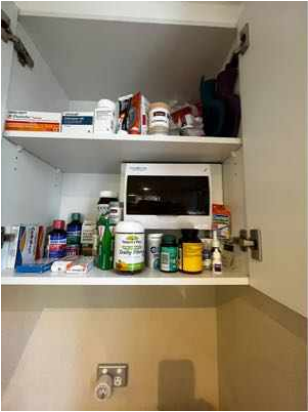
Building: Main Building
 Location: Electrical Switchboard
 Finding: Termite Management System - no evidence of a chemical installation no Durable Notice
 Information: The application of a post-construction chemical termite barrier is highly recommended for all properties, particularly if live termite activity has been found on the site previously. Such barriers are highly effective in preventing termite attack on any timber building elements throughout the property.

A durable notice should be placed in the switchboard unit to indicate current termite barriers. At the time of inspection, it appeared as though no termite management system has been installed, with no evidence to suggest preventative works taking place.

The client may consider gaining further advice from a pest controller as to the costs and procedures involved with this application. It is recommended that obtaining such advice be a short-term priority.
