# Building and Timber Pest Inspection Report

Inspection Date: Fri, 27 Mar 2026

Property Address: 77 Macpherson St, Mosman NSW 2088,  
Australia

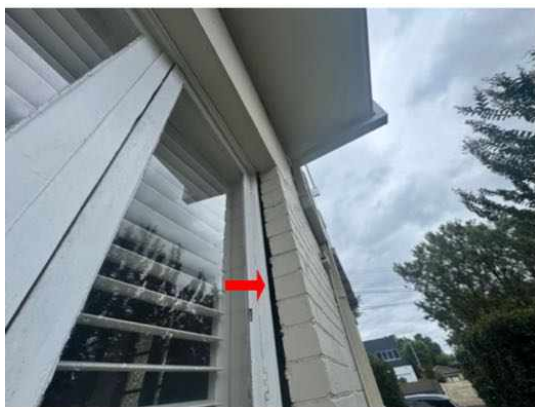
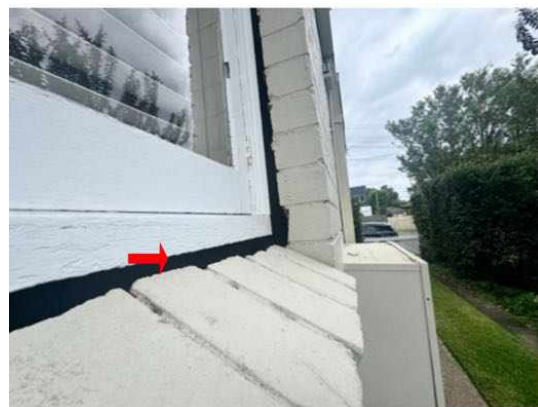
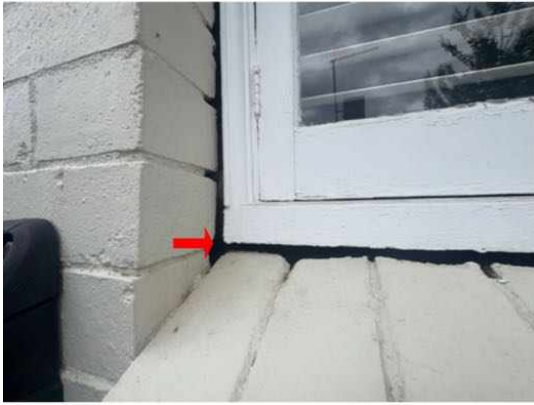
Building: Main Building  
Location: Exterior walls - left side  
Finding: Window seals - deteriorated  
Information: The window seals have deteriorated and are in a generally poor condition. Due to frequent exposure to weather conditions and subsequent moisture, deterioration of window seals is expected in a property of this condition and age.

Where window seals have deteriorated, the window is no longer weather-tight; rain penetration and subsequent water damage is therefore likely to ensue. Insulation of the area against external weather conditions will also be compromised.

It is recommended that all deteriorated window seals be replaced by a general handyman or sealant expert to prevent any further damage and to restore the window to a fully functional level.

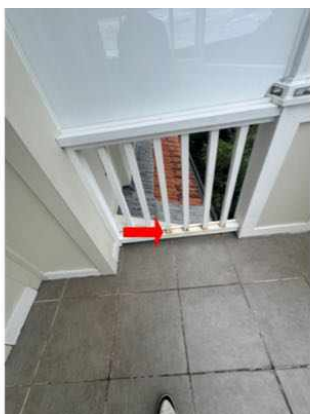
Finding: Building element - Rusted or corroded  
 Information: This building element shows evidence of rusting and corrosion, which is likely to have developed as a result of excessive exposure to moisture and or inadequate coatings.

As surface rust provides no protection to the underlying iron, the deteriorating condition is likely to worsen if not addressed in the short-term future.

Where possible, the use of galvanized (treated) metals or aluminium coated metals aid in rust prevention, as does regular general maintenance. Rust formation can be controlled with coatings, such as paint, that isolate the iron from the environment.

Rusting and corrosion should be managed by ideally removing or limiting the affected surface from exposure to moisture. A registered builder may be appointed to replace any building elements that have been severely affected by rust or water damage.

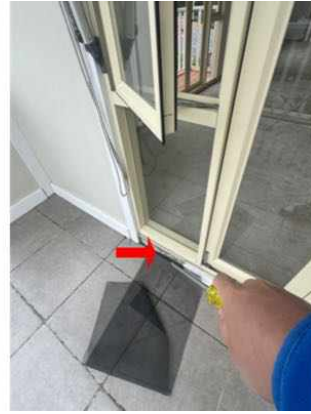
### Finding 3.04

Building: Main Building  
 Location: Balcony  
 Finding: Skirting tiles - Missing  
 Information: Skirting tiles were missing in this area at the time of inspection. Complete tiled skirting is important in preventing water ingress into the adjoining walls and flooring, protecting the areas against potential water damage. The incomplete skirting also detracts from the overall appearance of the area.

If left unmanaged, water ingress into adjoining areas may have major implications, and may potentially necessitate works to other building elements in the long-term future.

It is highly recommended that a tiling contractor be appointed to complete these minor works as soon as possible to prevent such damage from occurring.

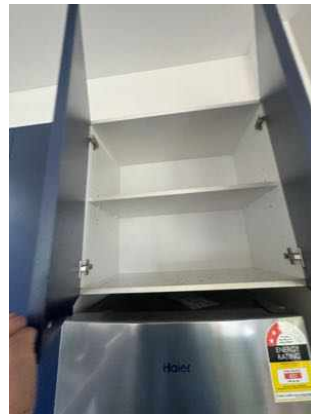
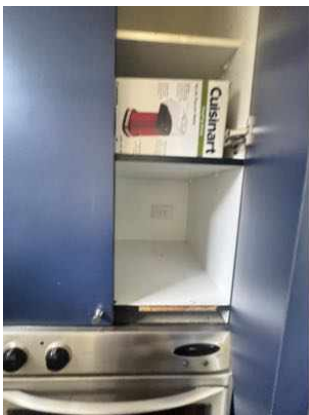
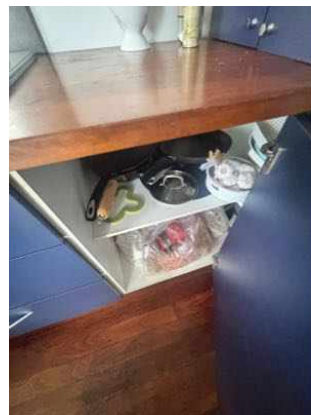
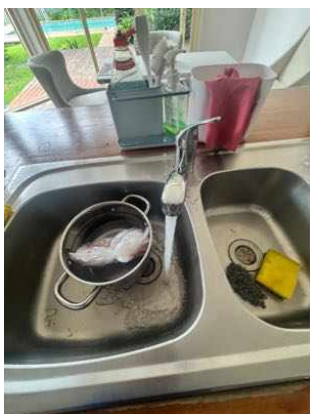
### Finding 3.05

Finding: Additional Photos - Obstructions and Limitations

Information: These photographs are an indication of the obstructions and limitations which impeded full inspection of the property at the time of inspection. These obstructions can hide an array of defects and should be removed to allow full inspection to be carried out. A re-inspection is recommended once the areas are made accessible.

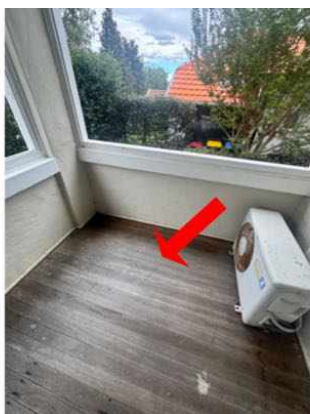
### Finding 3.06

Information: The internal flooring in this area is out of level and uneven. Uneven flooring is likely to indicate minor defects such as expected movement of the foundations of the property, but may also indicate subsidence of the associated subfloor stumps.

It is advised that the flooring be closely monitored to identify any further movement. Where flooring remains relatively unchanged for an extended period of time (i.e. several months), it is likely that this defect has been caused by expected movement of the foundations of the property.

However, where flooring is uneven further, potentially invasive inspection of the subfloor structures and stumps in this area is required. In this case, works to repair are likely to be required, and would be carried out by a registered builder specialising in re-stumping.

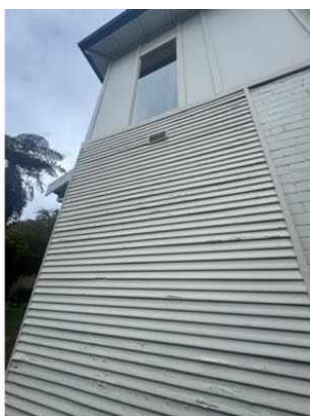
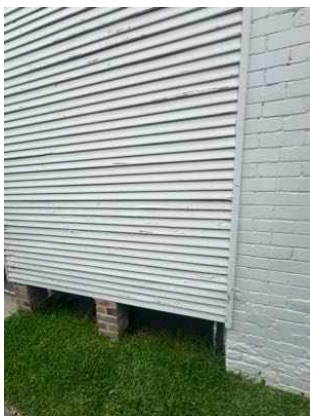
### Finding 3.07

Building:	Main Building
Location:	Exterior walls - left side
Finding:	External painting deteriorated
Information:	Much of the external paintwork including but not limited to windows, fascias, guttering, veranda and other external fitments have been neglected and require attention to prepare and re-paint.

Whilst incomplete or missing paint finish is generally an appearance defect, it can also lead to the development of secondary building defects over time. Incomplete areas of paint finish expose the area to moisture, potentially accelerating the deterioration of underlying building materials.

Degraded paint finishes should be sanded back, filled, leveled and painted, as applicable. Where inadequate or missing paint protection has led to the deterioration of the associated building element, repair and/or replacement of this building element may be required.

A painting contractor should be appointed as soon as possible to perform necessary works to aid the appearance of the affected area and to ensure the area is protected against further deterioration. Alternatively, the homeowner following manufacturer instructions may perform these works.

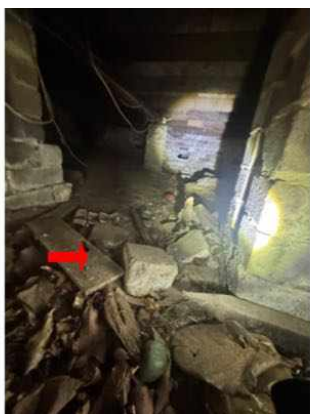
Building:	Main Building
Location:	Subfloor
Finding:	Subfloor - Debris
Information:	An array of debris was found in the subfloor area at the time of inspection. Debris in this area restricts subfloor ventilation and creates potential for concealed pest entry. Stored timbers and other materials may also make the area susceptible to termite activity and wood rot.

A clear and empty subfloor will be better ventilated and easier to maintain in a dry condition. The removal of any timber debris is vital in minimising the risk of termite or wood borer activity.

Debris in the subfloor should be removed as soon as possible. Depending on the location and amount of debris and stored items, the homeowner may elect to undertake this task. Alternatively there are a large number of rubbish removal subcontractors that could undertake these works.

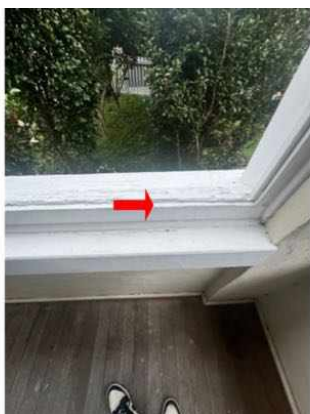
Finding: Wood rot

Information: This building element shows evidence of wood rot. Wood rot, also known as Fungal Decay, occurs when timbers and other cellulose building materials are exposed to damp conditions on an ongoing basis. This could be the result of exposure to weathering over a prolonged period of time, or the attraction of excessive moisture from other abutting building materials. Contributing factors also include poor air ventilation in the area.

Wood rot is often associated with general damp problems and is evidenced by a 'musty' smell or mould and mildew occurring on surfaces. If left unmanaged, damp conditions can lead to further health problems and the decay of timbers will continue.

Early intervention and regular maintenance, particularly of exterior timbers, will prolong the useful life of these building elements. Prior to any works being performed, the cause of the moisture that has created the visible wood rot should be identified and addressed in a suitable manner. Replacement of affected timbers may then be a necessary step in protecting surrounding building elements from such deterioration.

A qualified plumber may be appointed to assess the cause of excessive moisture and to provide advice on any remedial works as required. A qualified carpenter or registered builder may also be required to replace affected building materials.

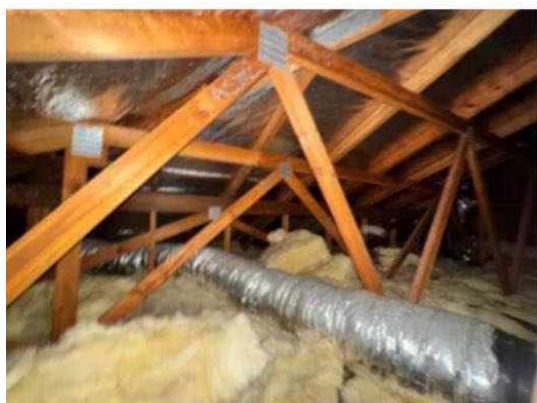
Building: Main Building  
Location: Roof Void  
Finding: Additional Photos - Obstructions and Limitations  
Information: These photographs are an indication of the obstructions and limitations which impeded full inspection of the property at the time of inspection. These obstructions can hide an array of defects and should be removed to allow full inspection to be carried out. A re-inspection is recommended once the areas are made accessible.

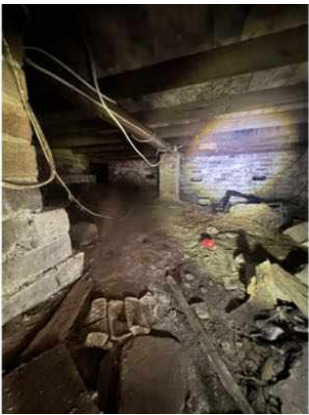
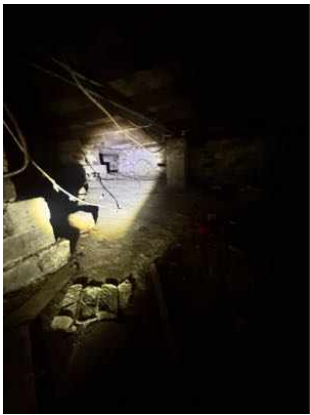
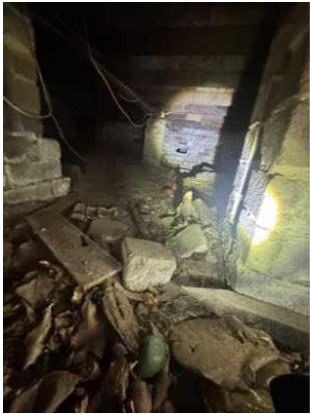
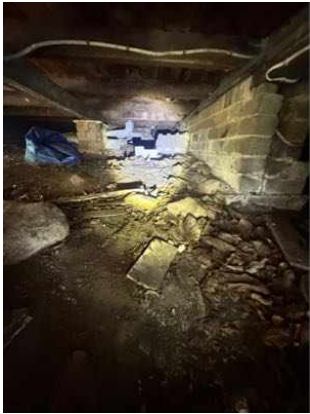
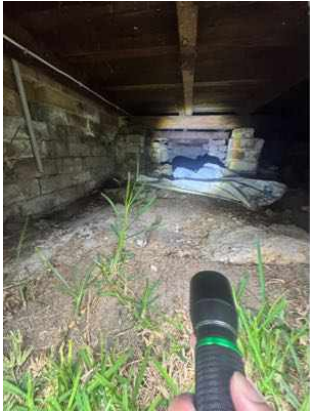
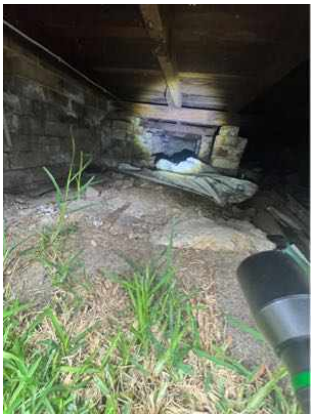
Building: Main Building  
Location: Subfloor  
Finding: Additional Photos - Obstructions and Limitations  
Information: These photographs are an indication of the obstructions and limitations which impeded full inspection of the property at the time of inspection. These obstructions can hide an array of defects and should be removed to allow full inspection to be carried out. A re-inspection is recommended once the areas are made accessible.

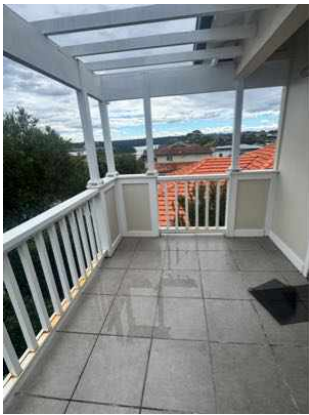
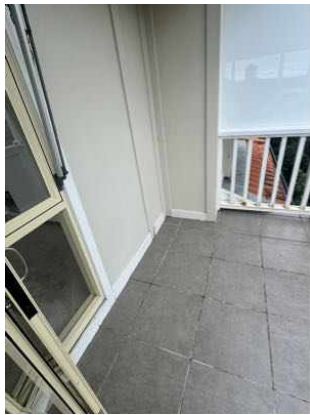
Information: These photographs are an indication of the obstructions and limitations which impeded full inspection of the property at the time of inspection. These obstructions can hide an array of defects and should be removed to allow full inspection to be carried out. A re-inspection is recommended once the areas are made accessible.

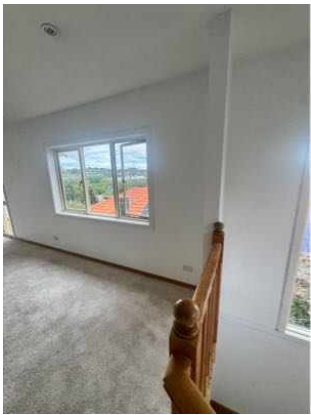
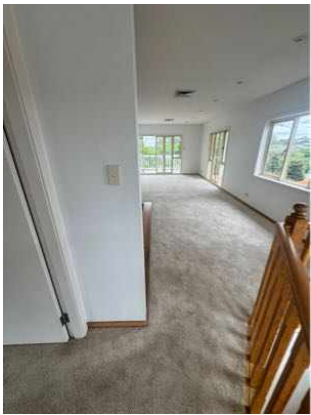
Building: Main Building  
Location: Living Room  
Finding: Additional Photos - Obstructions and Limitations  
Information: These photographs are an indication of the obstructions and limitations which impeded full inspection of the property at the time of inspection. These obstructions can hide an array of defects and should be removed to allow full inspection to be carried out. A re-inspection is recommended once the areas are made accessible.

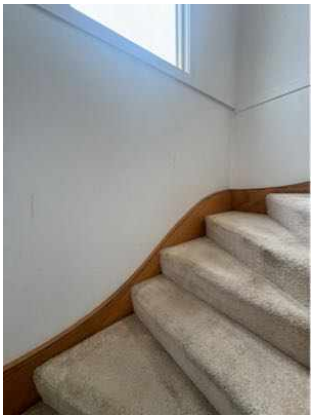
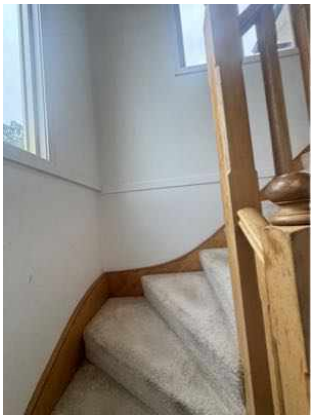
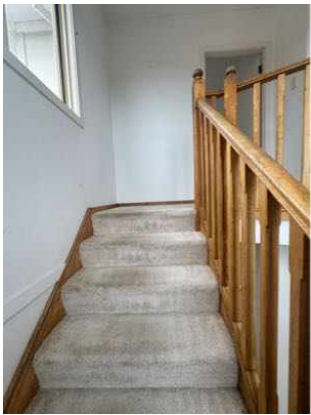
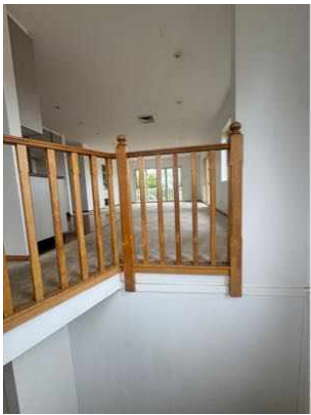
Building: Main Building  
Location: Stairs - Internal  
Finding: Additional Photos - Obstructions and Limitations  
Information: These photographs are an indication of the obstructions and limitations which impeded full inspection of the property at the time of inspection. These obstructions can hide an array of defects and should be removed to allow full inspection to be carried out. A re-inspection is recommended once the areas are made accessible.

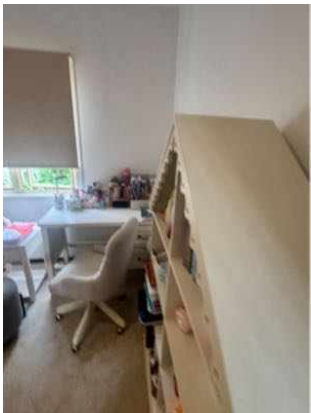
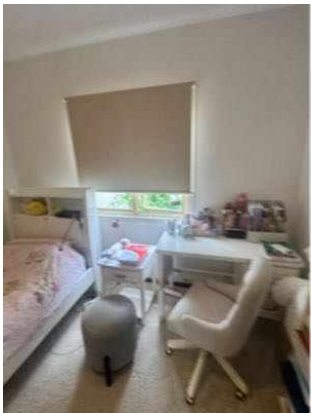
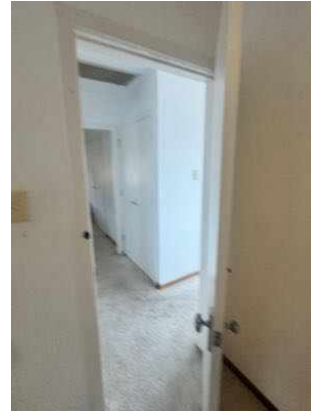
Building: Main Building  
Location: Bedroom 4  
Finding: Additional Photos - Obstructions and Limitations  
Information: These photographs are an indication of the obstructions and limitations which impeded full inspection of the property at the time of inspection. These obstructions can hide an array of defects and should be removed to allow full inspection to be carried out. A re-inspection is recommended once the areas are made accessible.

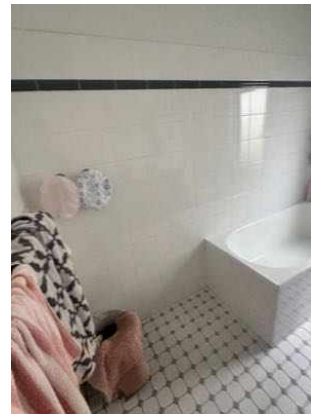
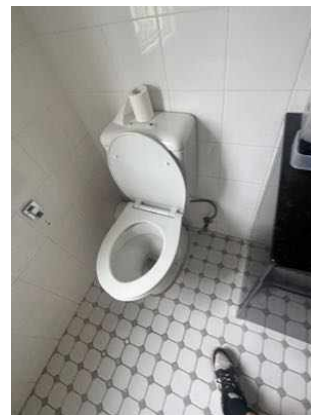
Information: These photographs are an indication of the obstructions and limitations which impeded full inspection of the property at the time of inspection. These obstructions can hide an array of defects and should be removed to allow full inspection to be carried out. A re-inspection is recommended once the areas are made accessible.

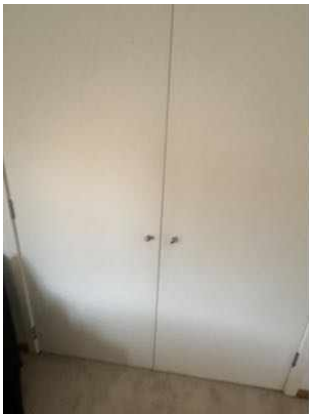
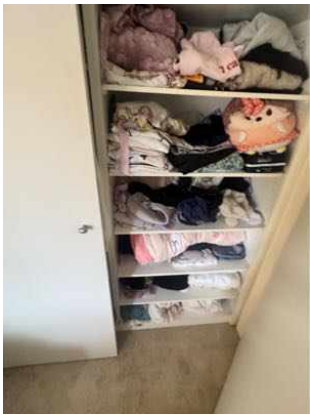
Building: Main Building  
Location: Bedroom 5  
Finding: Additional Photos - Obstructions and Limitations  
Information: These photographs are an indication of the obstructions and limitations which impeded full inspection of the property at the time of inspection. These obstructions can hide an array of defects and should be removed to allow full inspection to be carried out. A re-inspection is recommended once the areas are made accessible.

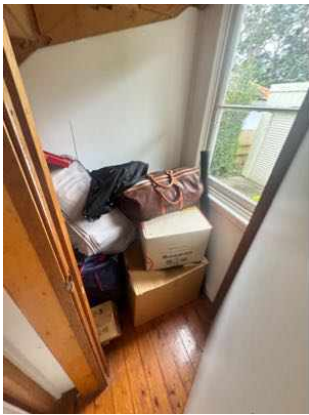
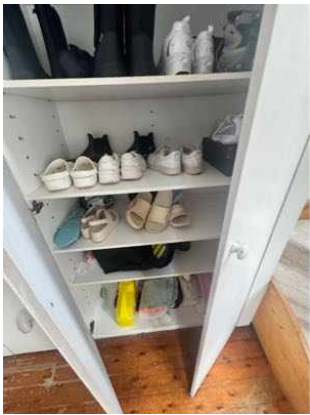
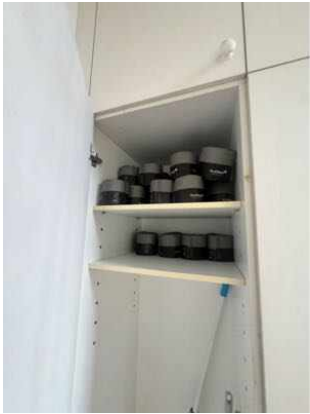
Building: Main Building  
Location: Entry  
Finding: Additional Photos - Obstructions and Limitations  
Information: These photographs are an indication of the obstructions and limitations which impeded full inspection of the property at the time of inspection. These obstructions can hide an array of defects and should be removed to allow full inspection to be carried out. A re-inspection is recommended once the areas are made accessible.

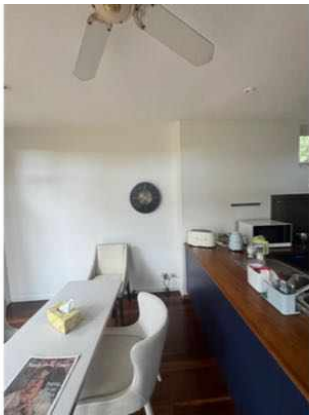
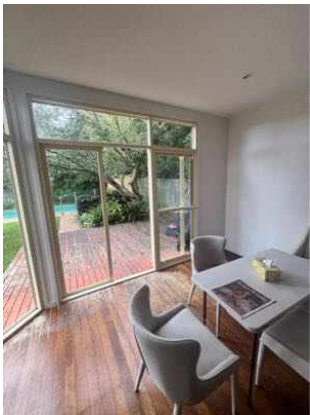
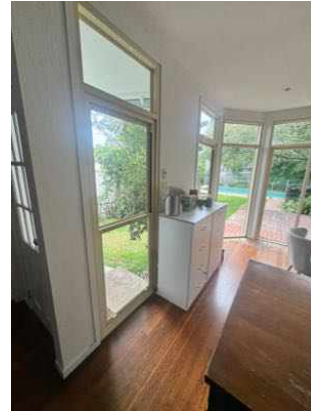
Building: Main Building  
Location: Dining Room  
Finding: Additional Photos - Obstructions and Limitations  
Information: These photographs are an indication of the obstructions and limitations which impeded full inspection of the property at the time of inspection. These obstructions can hide an array of defects and should be removed to allow full inspection to be carried out. A re-inspection is recommended once the areas are made accessible.

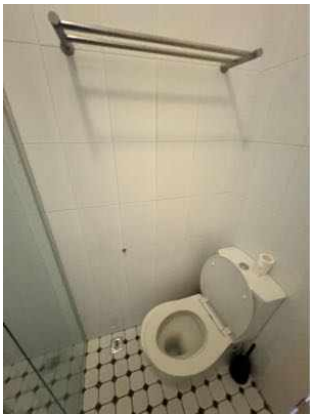
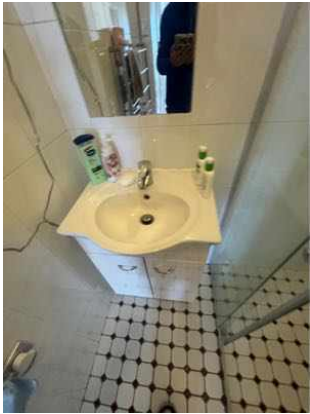
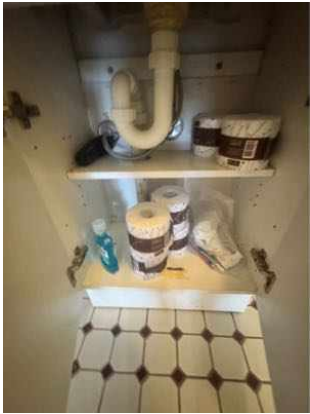
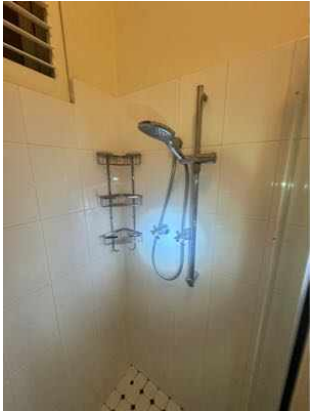
Building: Main Building  
 Location: Bathroom  
 Finding: Additional Photos - Obstructions and Limitations  
 Information: These photographs are an indication of the obstructions and limitations which impeded full inspection of the property at the time of inspection. These obstructions can hide an array of defects and should be removed to allow full inspection to be carried out. A re-inspection is recommended once the areas are made accessible.

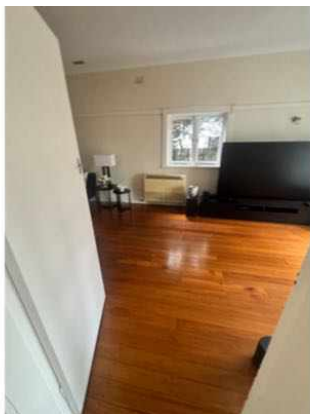
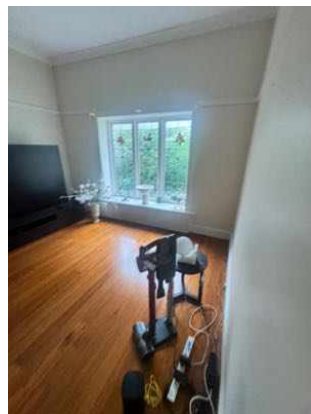
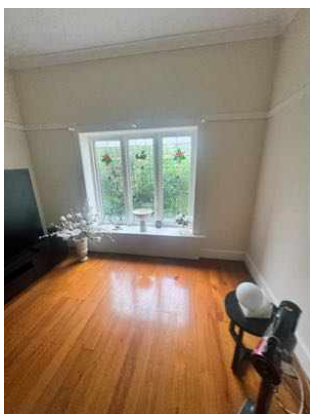
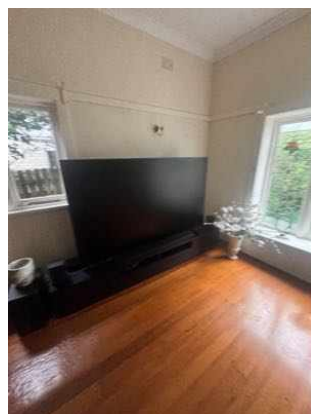
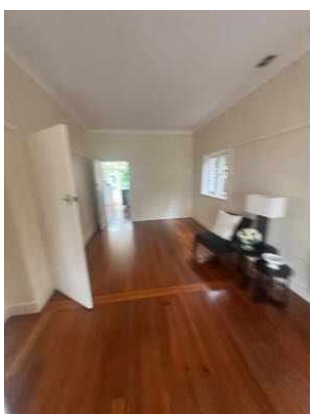
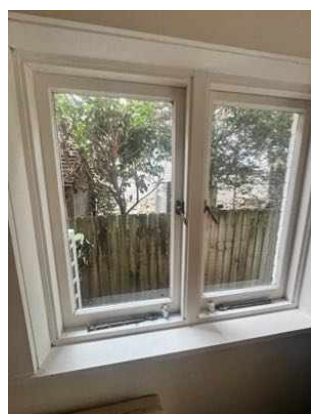
Finding: Additional Photos - Obstructions and Limitations

Information: These photographs are an indication of the obstructions and limitations which impeded full inspection of the property at the time of inspection. These obstructions can hide an array of defects and should be removed to allow full inspection to be carried out. A re-inspection is recommended once the areas are made accessible.

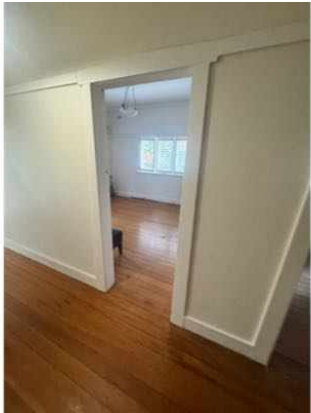
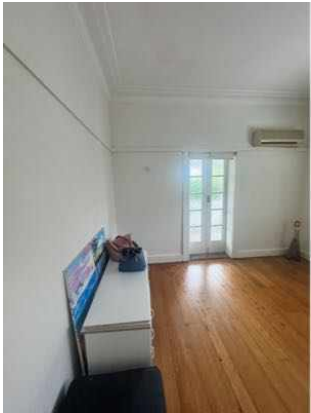
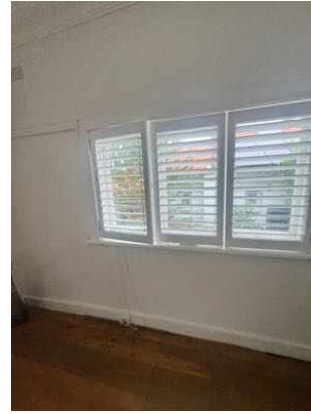
Building: Main Building  
Location: Bedroom 3  
Finding: Additional Photos - Obstructions and Limitations  
Information: These photographs are an indication of the obstructions and limitations which impeded full inspection of the property at the time of inspection. These obstructions can hide an array of defects and should be removed to allow full inspection to be carried out. A re-inspection is recommended once the areas are made accessible.

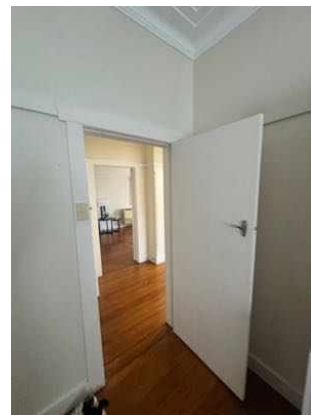
Finding: Additional Photos - Obstructions and Limitations

Information: These photographs are an indication of the obstructions and limitations which impeded full inspection of the property at the time of inspection. These obstructions can hide an array of defects and should be removed to allow full inspection to be carried out. A re-inspection is recommended once the areas are made accessible.

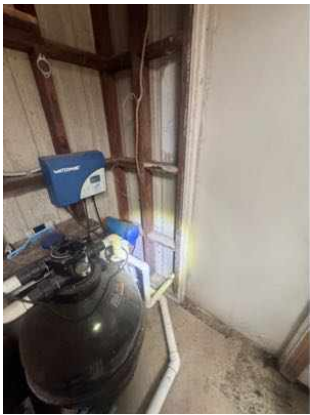
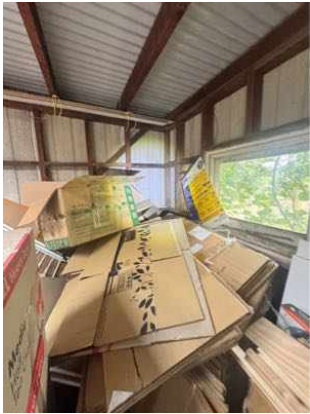
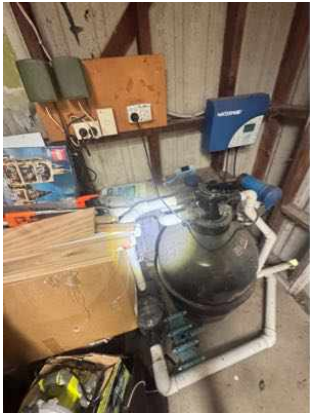
Building: Main Building  
Location: Garage  
Finding: Additional Photos - Obstructions and Limitations  
Information: These photographs are an indication of the obstructions and limitations which impeded full inspection of the property at the time of inspection. These obstructions can hide an array of defects and should be removed to allow full inspection to be carried out. A re-inspection is recommended once the areas are made accessible.

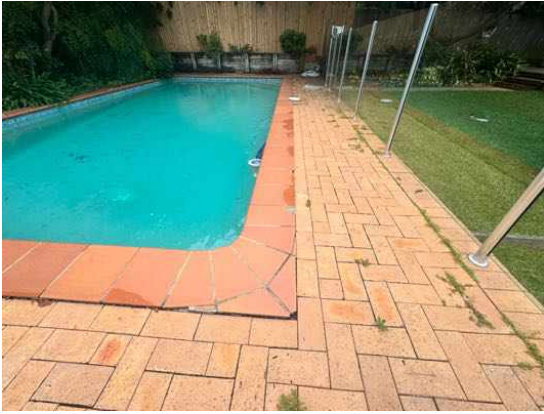
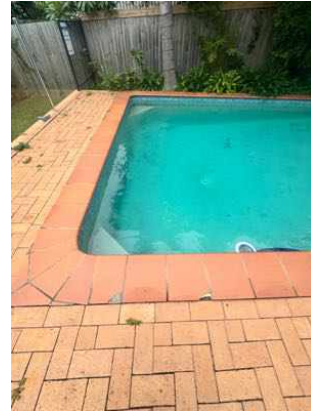
Building: Main Building  
Location: Swimming Pool - Below Ground  
Finding: Additional Photos - Obstructions and Limitations  
Information: These photographs are an indication of the obstructions and limitations which impeded full inspection of the property at the time of inspection. These obstructions can hide an array of defects and should be removed to allow full inspection to be carried out. A re-inspection is recommended once the areas are made accessible.

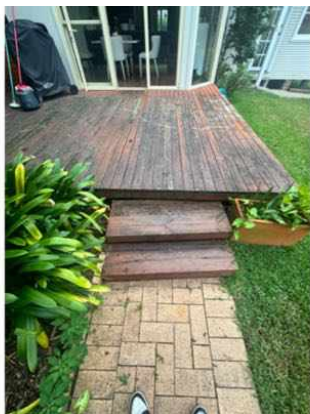
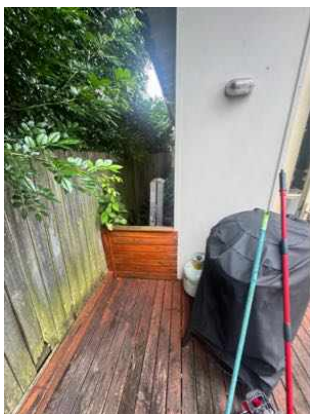
Building:	Main Building
Location:	Deck
Finding:	External Timber Balcony or Deck - Structural Stability
Information:	The load capacity of the external balcony or deck could not be verified during the inspection.

External timber structures are also constantly exposed to weather elements and can deteriorate in an accelerated manner, ongoing assessments are required.

It is highly recommended that a Structural Engineer further assess the external timber balcony or deck to inform the client of its load capacity. Regular maintenance inspections by competent practitioners is needed.

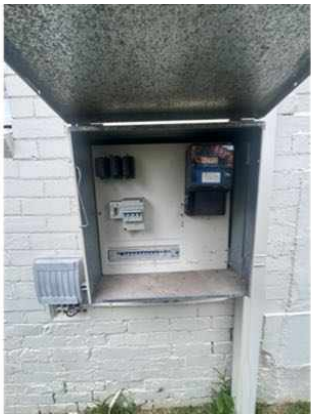
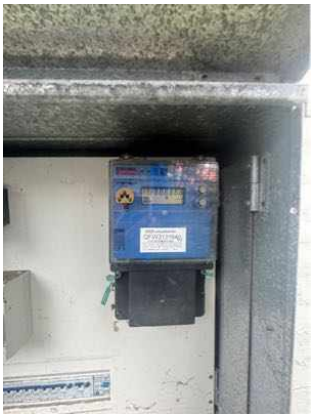
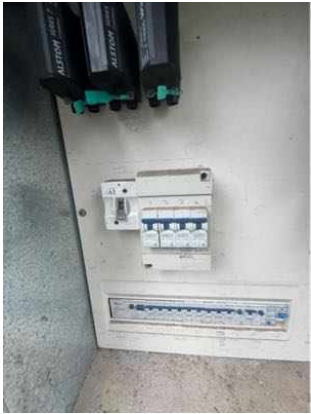
Building:	Main Building
Location:	Meter Box
Finding:	Termite Management System - no evidence of a chemical installation
Information:	The application of a post-construction chemical termite barrier is highly recommended for all properties, particularly if live termite activity has been found on the site previously. Such barriers are highly effective in preventing termite attack on any timber building elements throughout the property.

A durable notice should be placed in the switchboard unit to indicate current termite barriers. At the time of inspection, it appeared as though no termite management system has been installed, with no evidence to suggest preventative works taking place.

The client may consider gaining further advice from a pest controller as to the costs and procedures involved with this application. It is recommended that obtaining such advice be a short-term priority.
