# Building and Timber Pest Inspection Report

Inspection Date: Thu, 5 Feb 2026

Property Address: 321/18 Tocumwal Rd, Mulwala NSW 2647,  
Australia

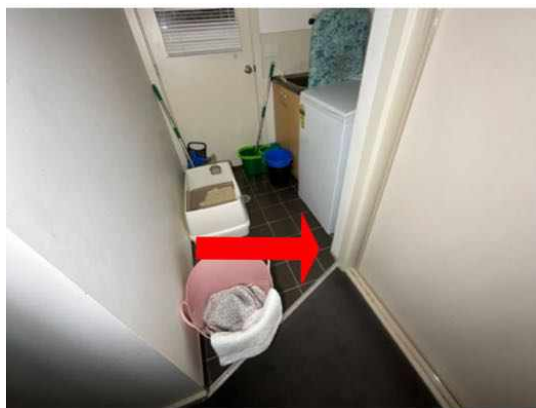
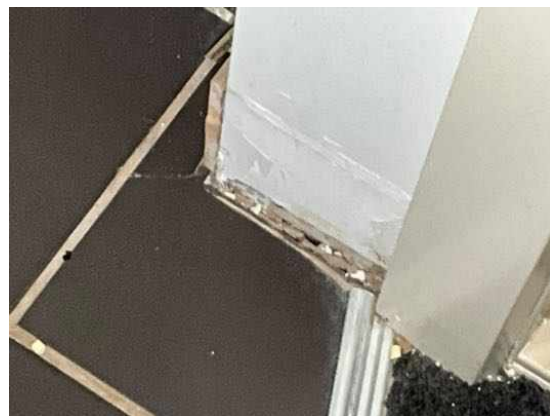
#### Finding 3.01

Building: Building 1  
 Location: Laundry  
 Finding: Inadequate sealant or Grout  
 Information: This area has a lack of effective Sealant or Grout. This is allowing the ingress of water to the structure inside the wall.

The presence of water encourages Termite attack, Mould and Fungal Decay.

A Tiler or General Handy person must be contacted as soon as possible to effect repairs and prevent further deterioration.

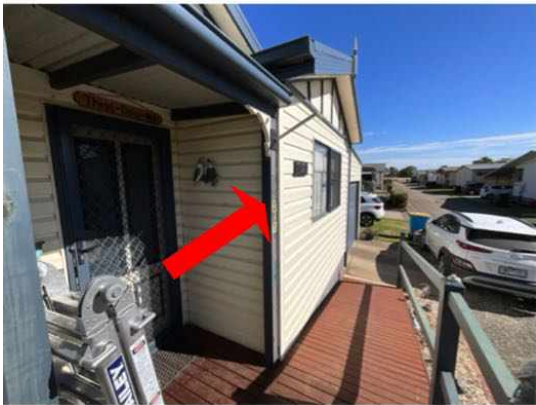
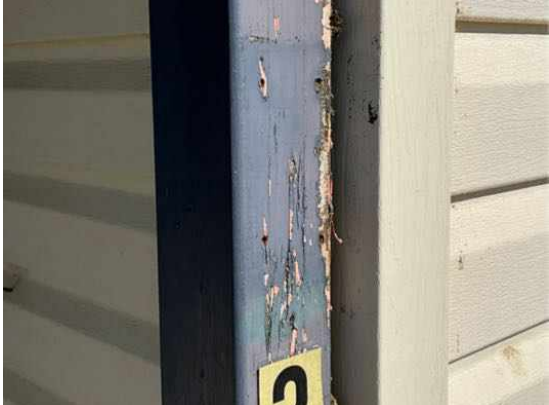
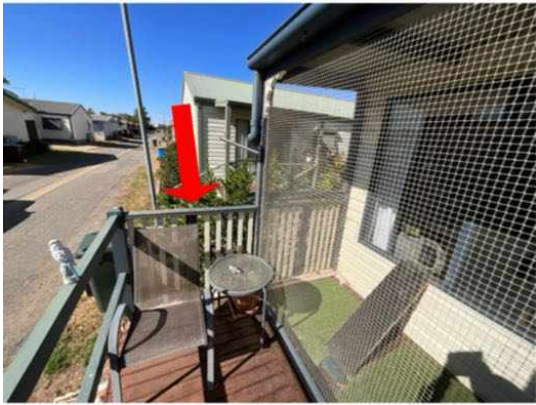
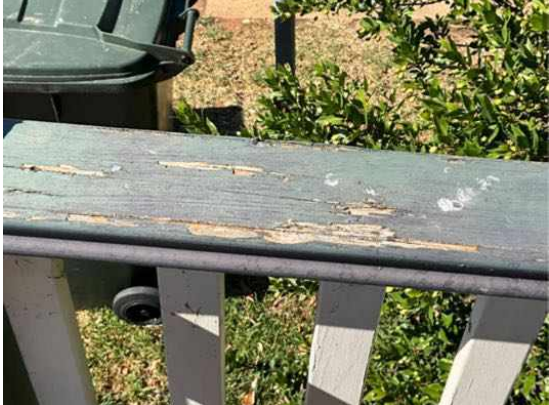
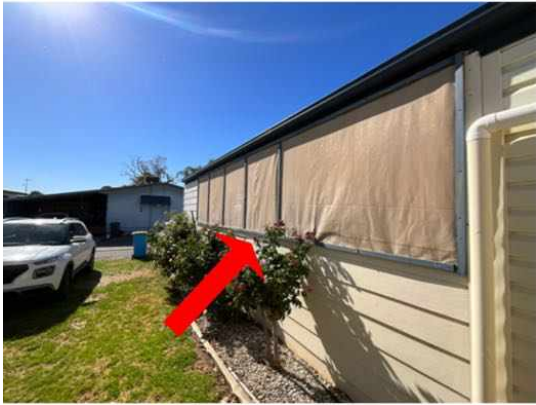
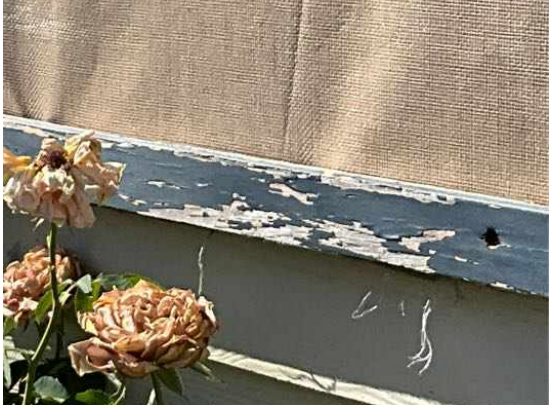
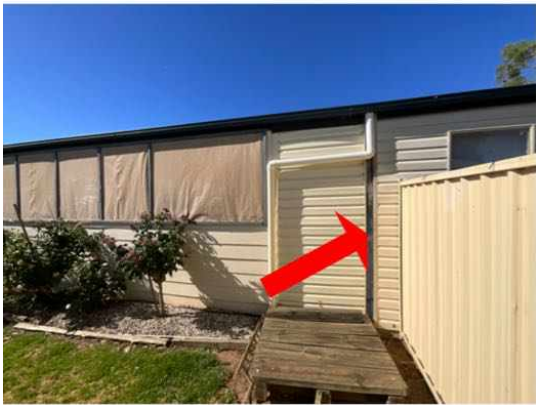
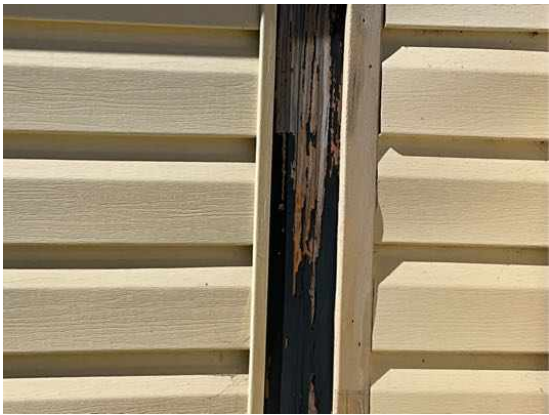
#### Finding 3.02

Building: Building 1  
 Location: Timber elements  
 Finding: Timber - exposed to weather  
 Information: External timbers that are frequently exposed to harsh weather conditions require adequate protection in order to maintain their condition. Where timbers have not been painted or treated adequately, general deterioration is likely to occur at an accelerated rate.

If left unattended, replacement of these timbers is likely to be necessary in the short-term future. Adequate treatment of these timbers is required as soon as possible by a painting contractor or general handyman.

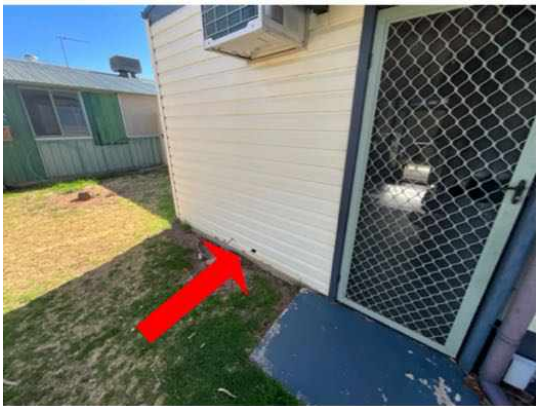
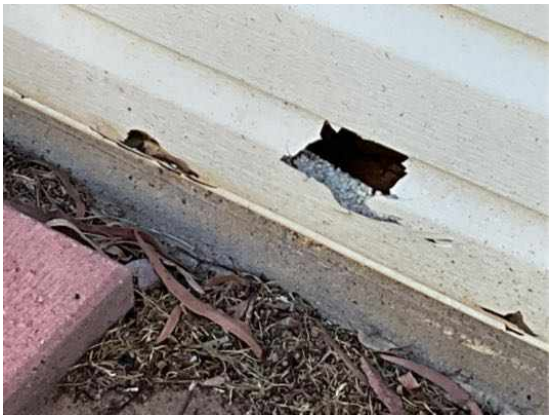
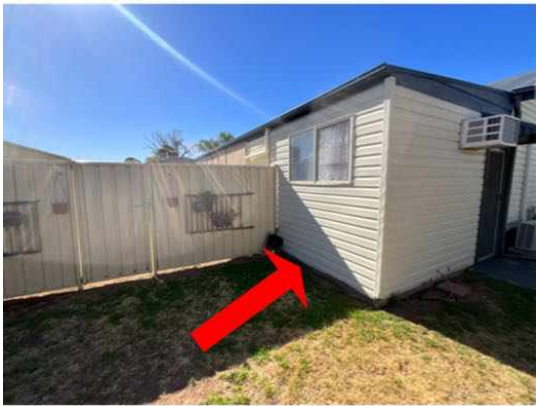
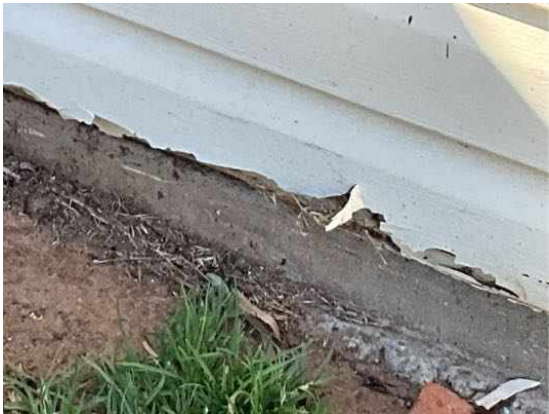
**Finding 3.03**

Building: Building 1  
Location: Back wall  
Finding: Cladding- deteriorated  
Information: The external cladding shows signs of damage in several areas. Although not serious at this point, monitoring should be undertaken at intervals to ensure no further damage occurs.

A cladding specialist or handyman could be contacted as needed to patch any damage to prevent further deterioration.

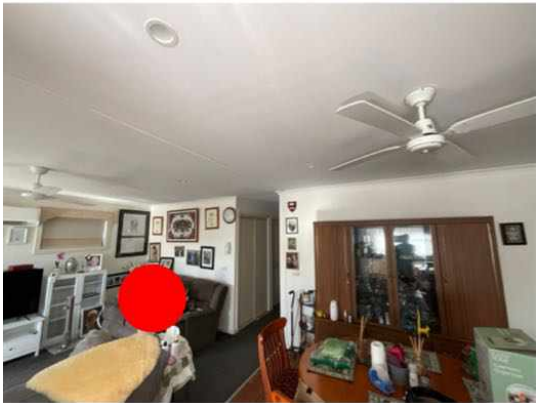
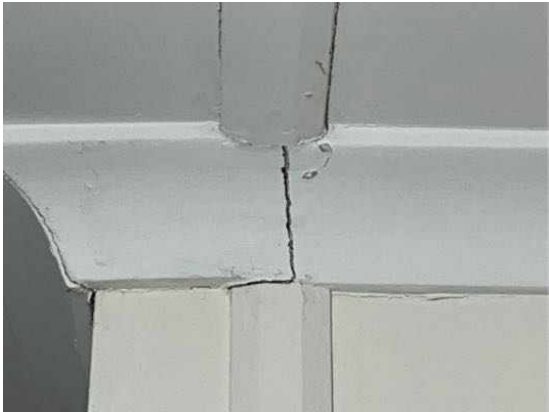
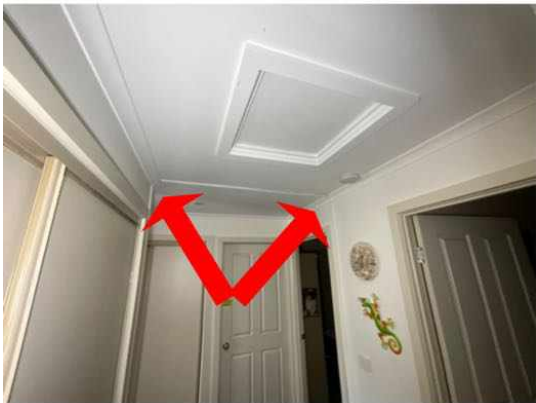
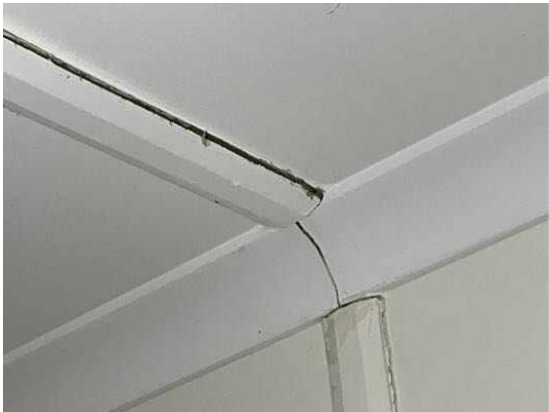
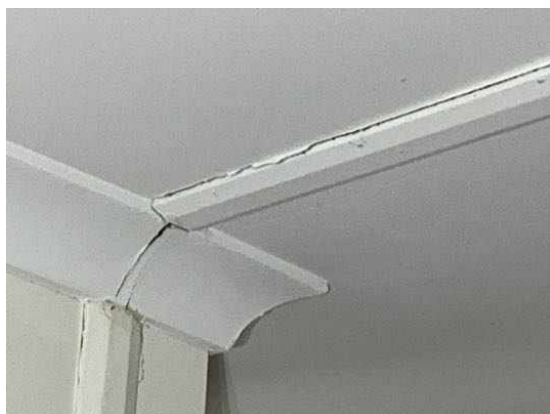
**Finding 3.04**

Building: Building 1  
Location: Living Room, hall  
Finding: Cracking - Damage Category 1 - Fine (up to 1mm)  
Information: Although fine cracks are quite noticeable, they are often only considered to be an appearance defect, and usually do not indicate any structural damage. Generally, the cause of a fine crack is indicative of a separation between building materials and finishes (e.g. paint, plaster, etc.) along joins.

Cracking of this nature can generally be repaired with minor sanding, filling and/or repainting. Such works should be performed by a qualified painter or a general handyman.

Monitoring of all cracking should be conducted frequently. Always contact a building inspector should cracks widen, lengthen, or become more numerous.

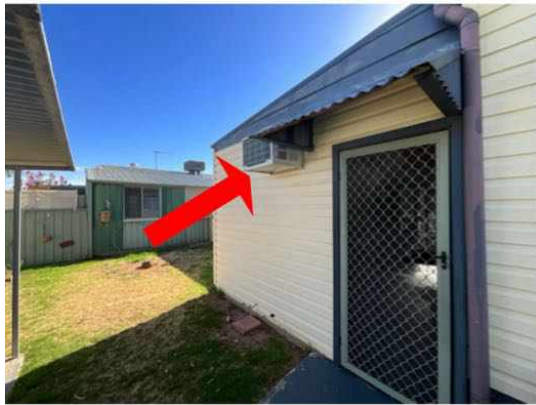
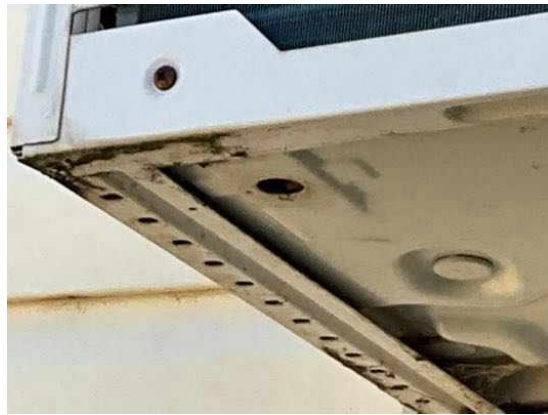
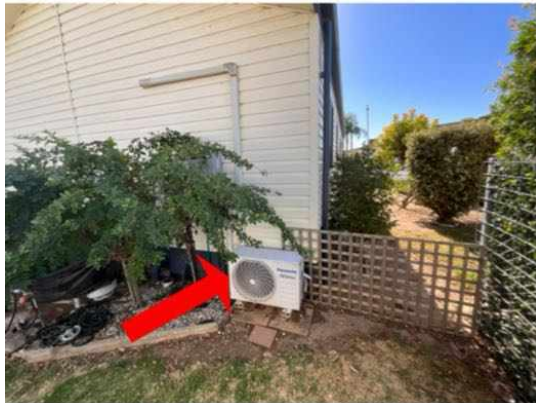
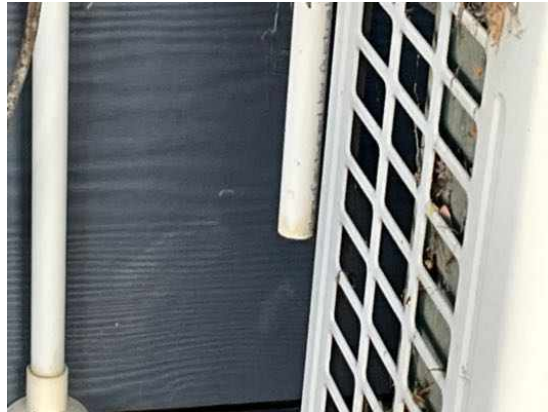
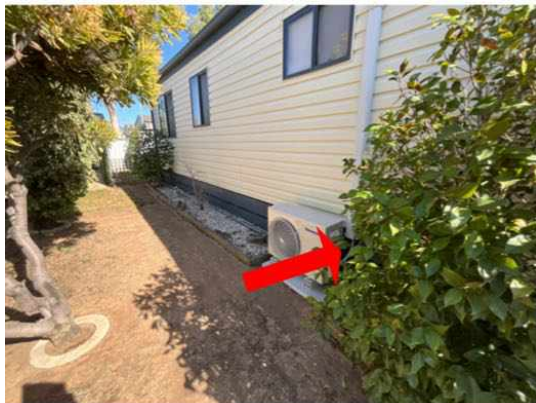
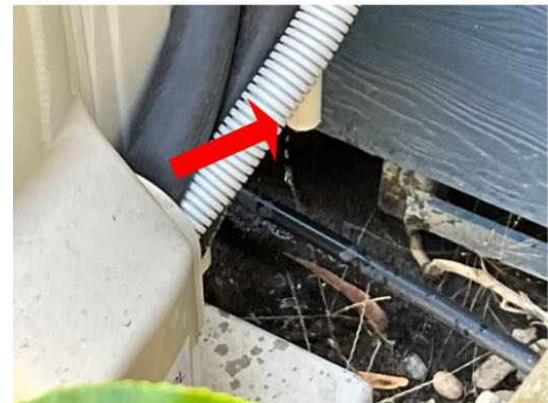
### Finding 6.01

Building:	Building 1
Location:	Yard - Back, side
Finding:	Air conditioner - Disconnected overflow
Information:	The Air Conditioner (A/C) overflow was found to be disconnected from storm water drainage and is creating excessive moisture in the surrounding area.

Such leaking creates an environment which is conducive to an array of defects, including water damage to associated building elements and the attraction of termite or timber pest infestation.

It is highly recommended that a licensed plumber be appointed to connect the A/C overflow in order to prevent such an environment from being created. These minor works should be carried out as soon as possible.

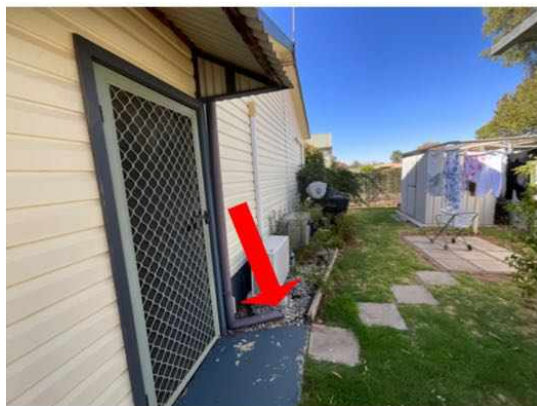
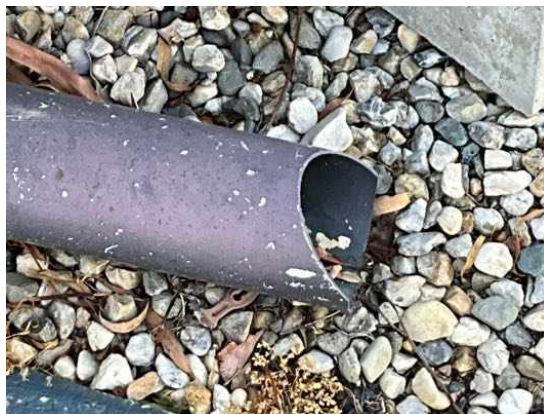
### Finding 6.02

Building: Building 1  
 Location: Yard - Back  
 Finding: Stormwater drain - Not connected  
 Information: The roof plumbing is not adequately connected to stormwater drainage on the site. This disconnection negatively impacts the functional capacity of the roof plumbing.

Where roof plumbing doesn't drain adequately, the area at the base perimeter can become excessively damp, potentially creating an environment that is susceptible to rust and corrosion of surrounding building elements, as well as attracting termites and other pests.

It is highly recommended that a plumber be appointed to further inspect the area and to install adequate drainage equipment where necessary.

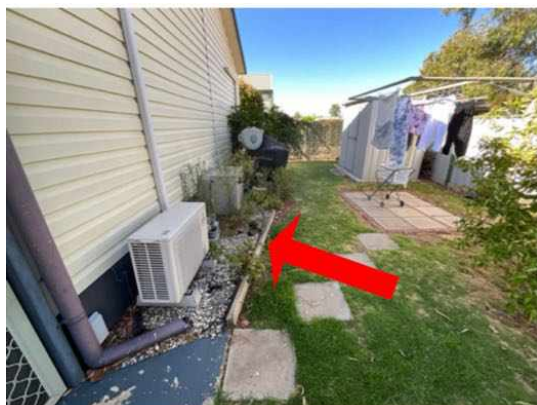
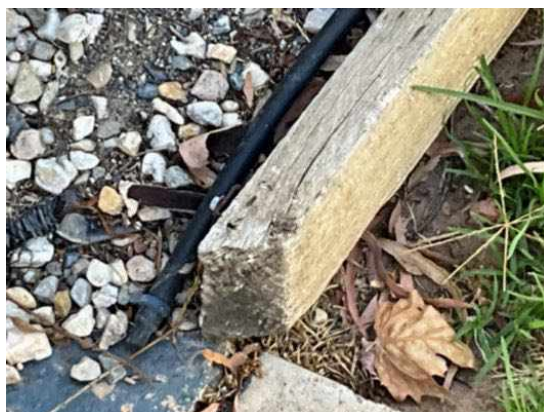
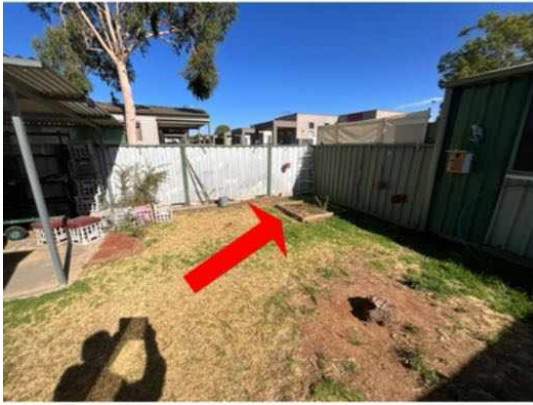
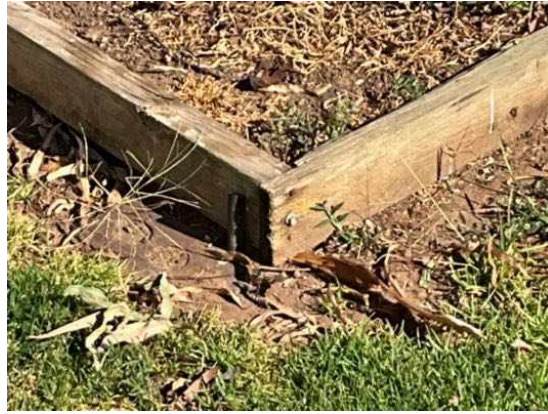
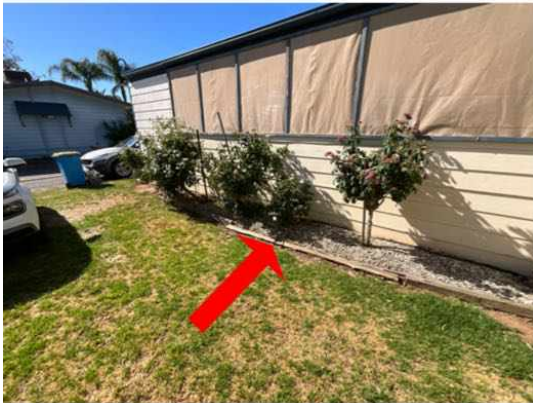
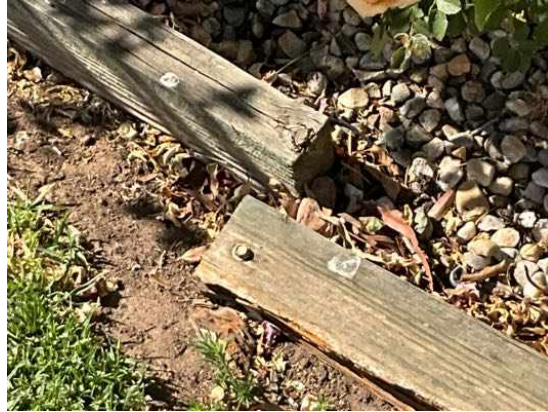
### Finding 6.03

Building:	Building 1
Location:	Yard - Back, front
Finding:	Untreated or non-durable timbers in a hazardous environment
Information:	To reduce the risk of timber pest attack it is essential that timber used in a hazardous environment (e.g. in direct contact with the ground or frequently exposed to damp conditions) is of sufficient durability and/or is adequately preservative treated.

Untreated timbers in direct contact with the ground are likely to develop severe wood rot and/or fungal decay if left unattended creating attraction for subterranean termites to infest the timbers from surrounding areas.

If untreated or non-durable timbers are found to be in a hazardous environment it is highly advised that replacement of these building elements be performed as soon as possible to aid the protection of the property against termite / timber pest attack.

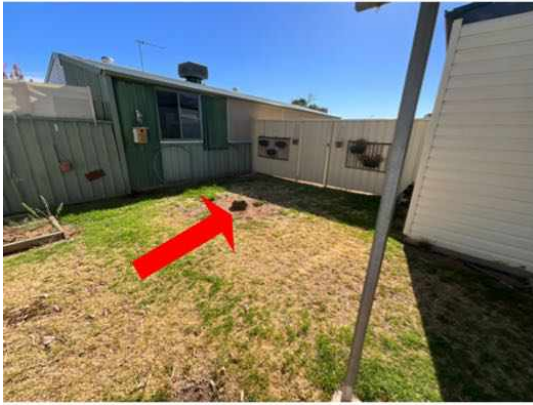
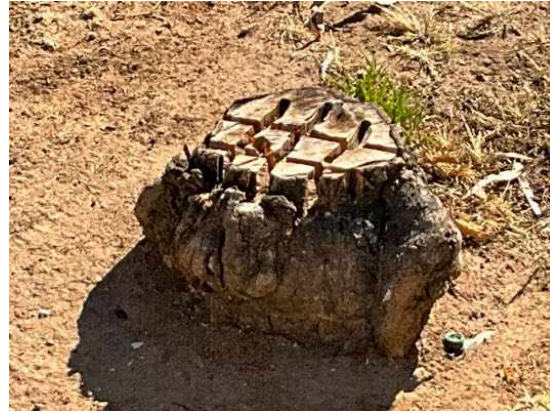
### Finding 6.04

Building:	Building 1
Location:	Yard - Back
Finding:	Tree Stump in Ground
Information:	Any tree stumps in the yard not removed during the tree removal process provides the opportunity for Termite infestation and is likely to be subject to decay from damp conditions against the stump.

All tree stumps should be removed by professional tree removal services where possible. Meanwhile regular inspections are advised to identify any termite activity in the areas identified.

Services for tree stump removal should be contacted as soon as possible to reduce the risk of timber pest attack.

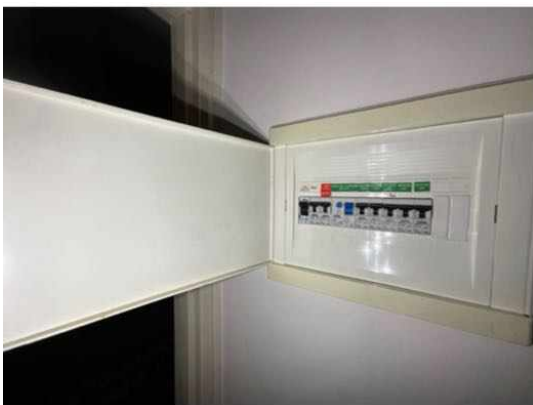
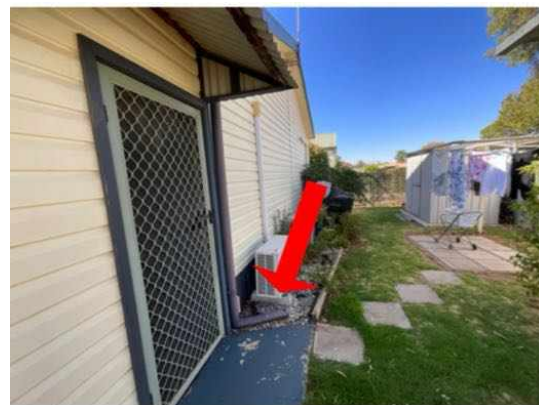
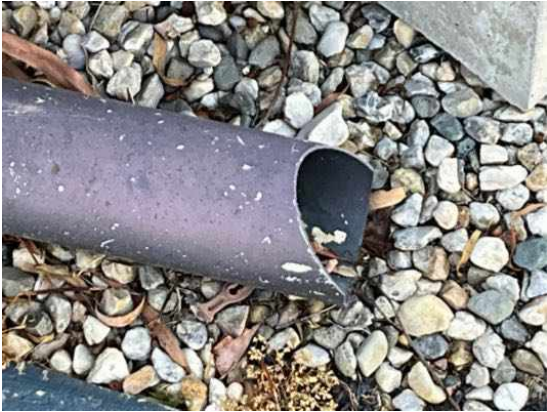
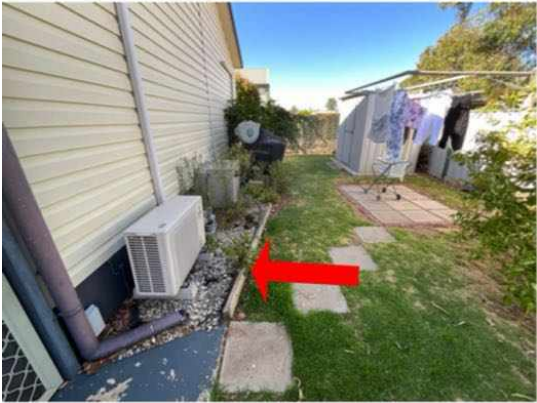
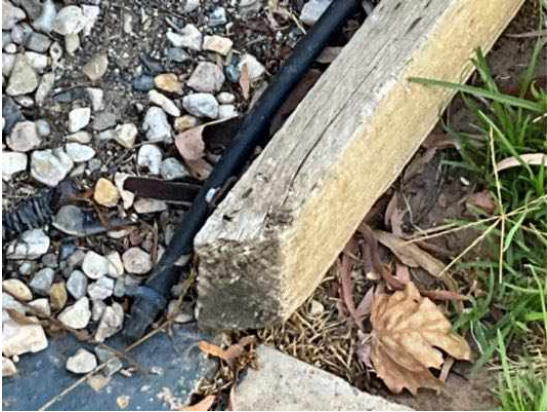
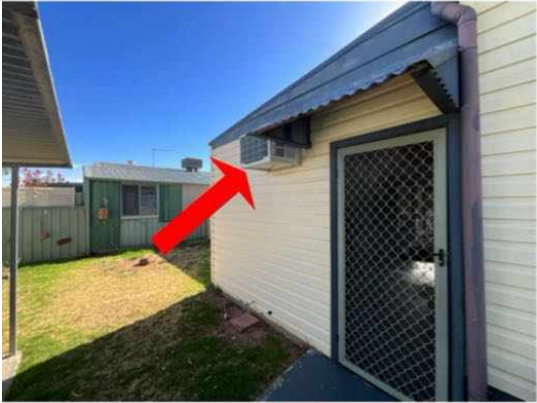
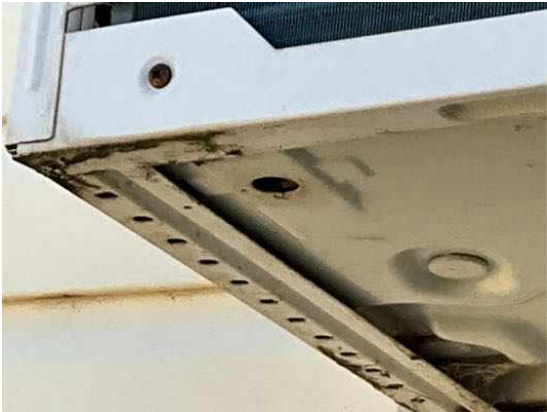
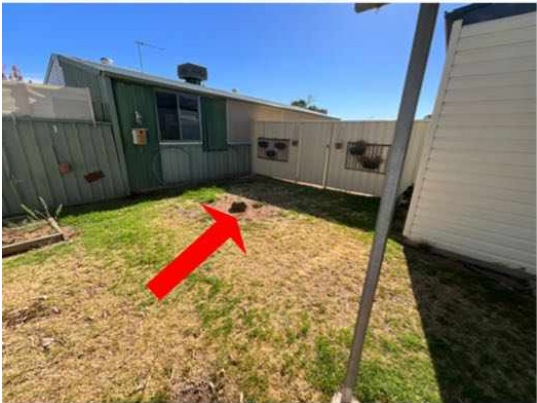
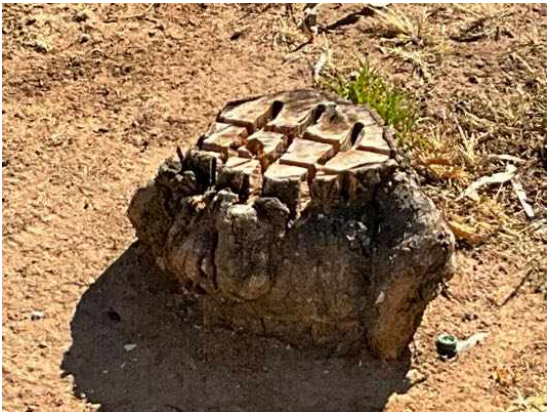
### Finding 6.05

Building:	Building 1
Location:	All External Areas
Finding:	Termite Management System - no evidence of a chemical installation
Information:	The application of a post-construction chemical termite barrier is highly recommended for all properties, particularly if live termite activity has been found on the site previously. Such barriers are highly effective in preventing termite attack on any timber building elements throughout the property.

A durable notice should be placed in the switchboard unit to indicate current termite barriers. At the time of inspection, it appeared as though no termite management system has been installed, with no evidence to suggest preventative works taking place.

The client may consider gaining further advice from a pest controller as to the costs and procedures involved with this application. It is recommended that obtaining such advice be a short-term priority.

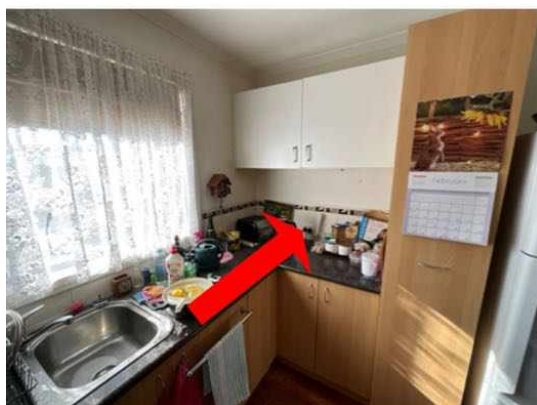
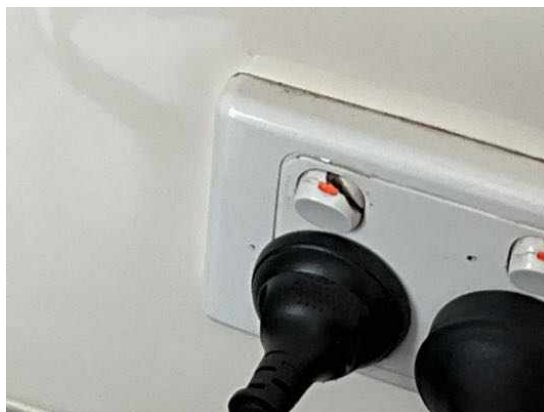
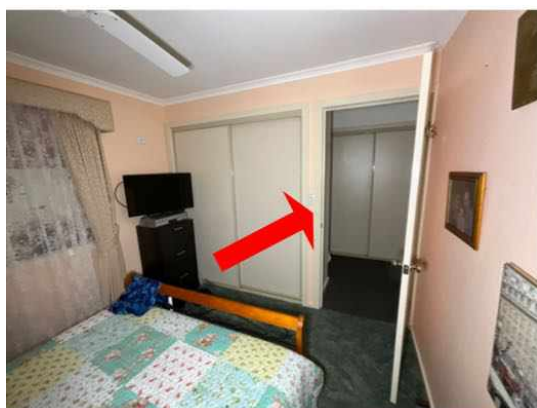
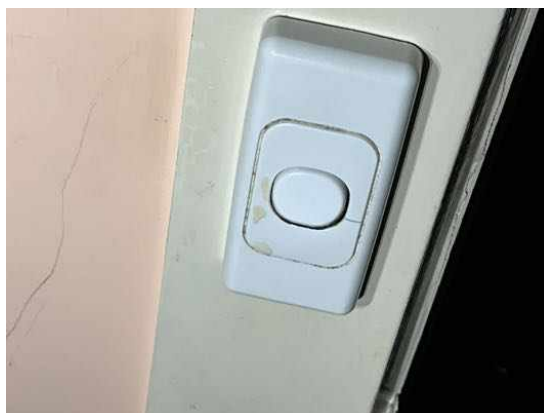
Building: Building 1  
 Location: Kitchen, bed 2  
 Finding: Electrical fitting - Broken  
 Information: The electrical fitting in this area was found to be broken at the time of inspection. Breakage occurs generally when the building materials have aged and decayed, but may also be indicative of impact damage to the building element (accidental or deliberate).

Left unmanaged, the fitting is unlikely to cause further damage to surrounding building elements. However, the broken fitting does expose electrical works, and may create a safety hazard if there is potential contact with persons in the area.

Repair and/or replacement of the broken fitting is advised. A Licensed electrician should be appointed to repair/replace the fitting immediately.

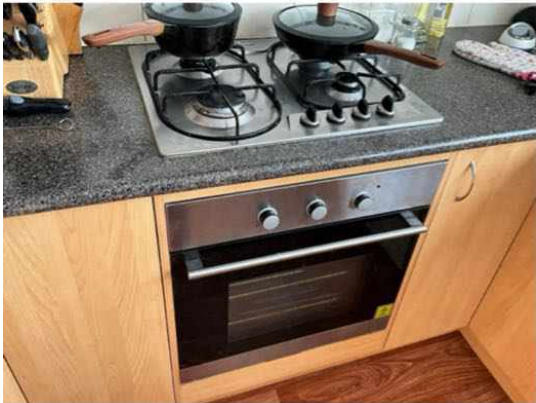
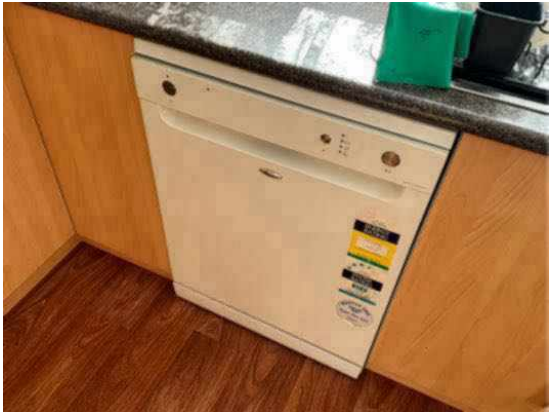
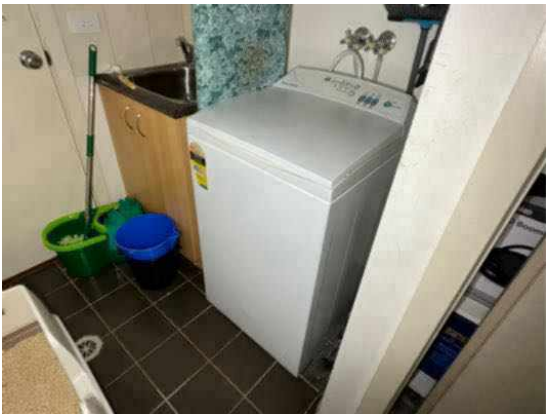
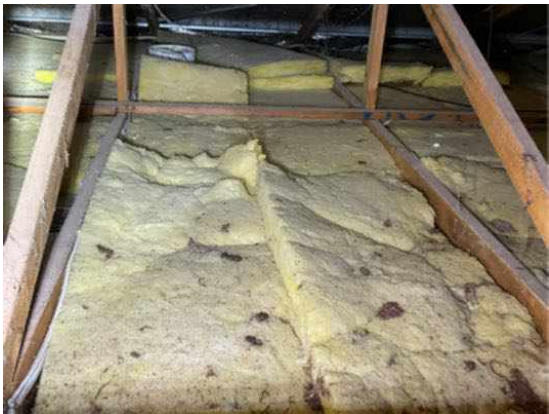
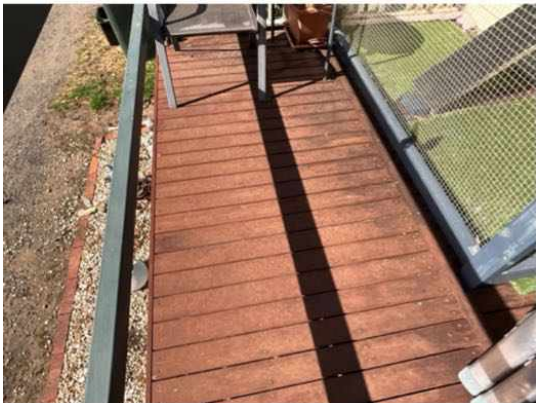
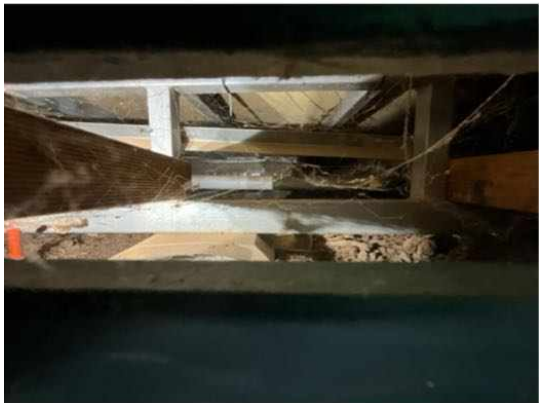
Building: Building 1  
Location: All Areas  
Finding: Additional Photos - Obstructions and Limitations  
Information: These photographs are an indication of the obstructions and limitations which impeded full inspection of the property at the time of inspection. These obstructions can hide an array of defects and should be removed to allow full inspection to be carried out. A re-inspection is recommended once the areas are made accessible.
