Building and Timber Pest Inspection Report

Inspection Date: Wed, 25 Mar 2026

Property Address: 10/10 Carlisle St, St Kilda VIC 3182,
Australia

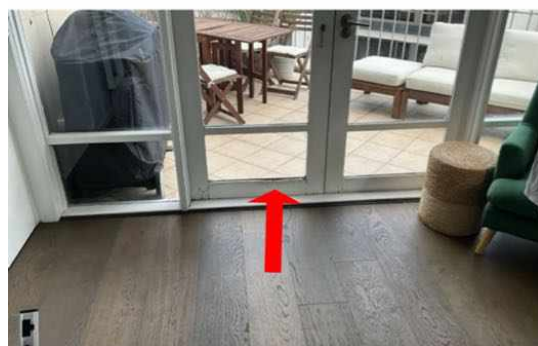
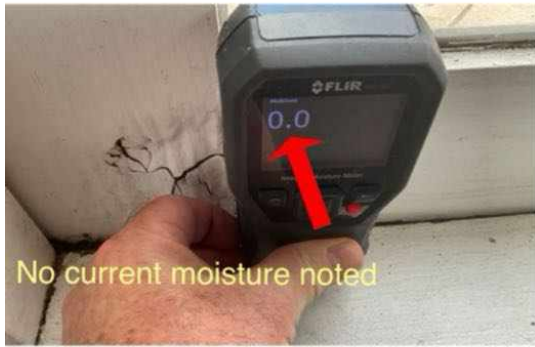
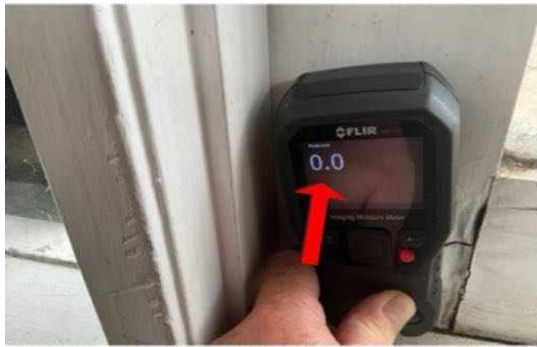
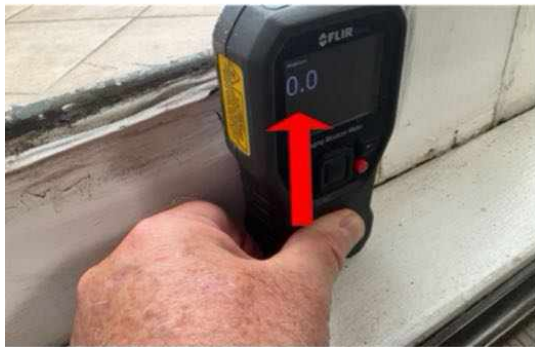
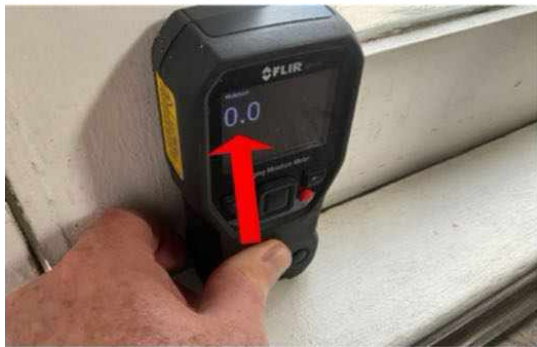
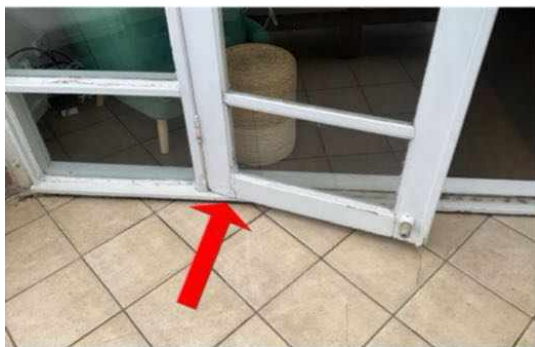
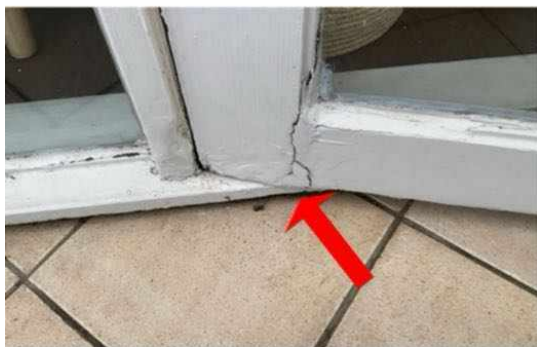
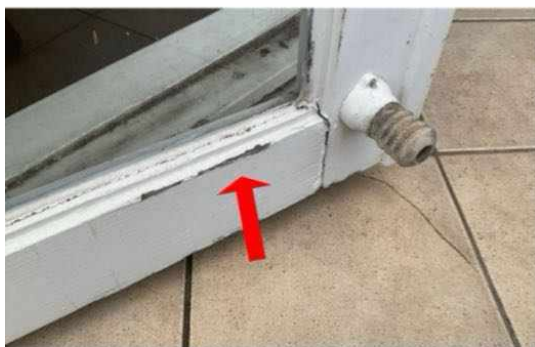
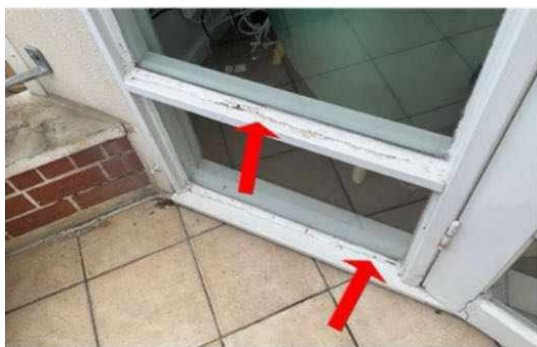
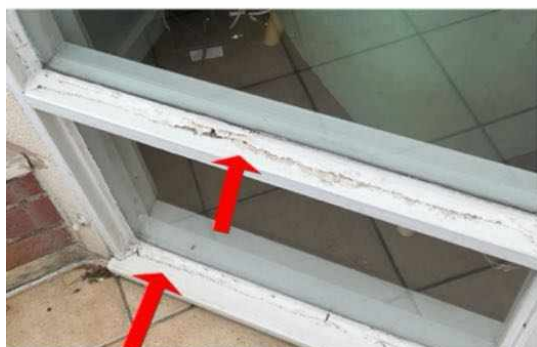
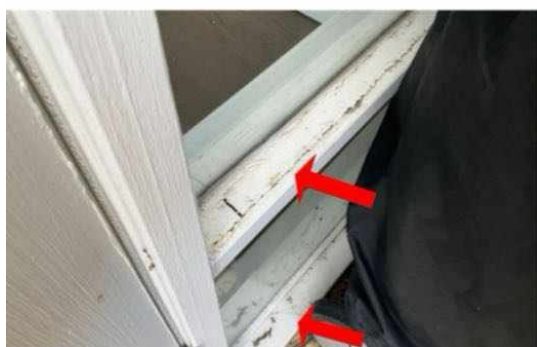
Finding: Door and window frames - extensive wood rot

Information: Extensive Wood rot was noted to the door and window frames leading onto the balcony. Due to the extent of the damage, this defect is classified as a major defect (* see definition below). It is suspected that this wood rot has occurred due to a lack of maintenance and painting to the timber surfaces.

Any External timbers that are frequently exposed to harsh weather conditions require adequate protection in order to maintain their condition. Where these areas have not been painted or treated adequately, general deterioration is likely to occur at an accelerated rate.

Repairs will need to be carried out to the doors and window frames. An invasive inspection will be required to determine the extent of the rotting within the timber. It is highly likely replacement of some items will be necessary.

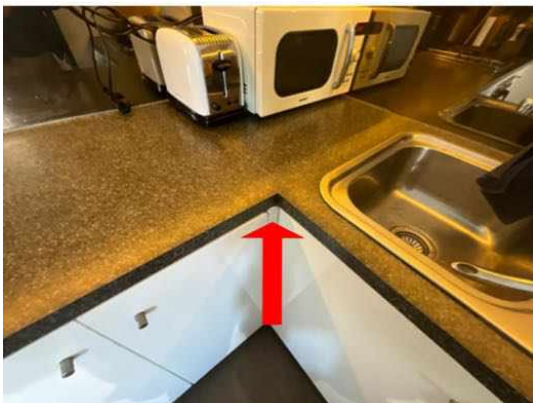
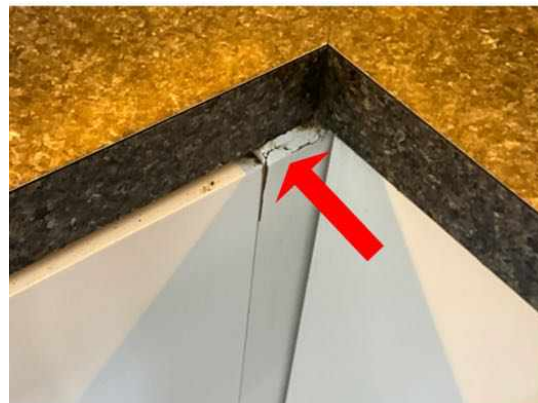
Finding: Moisture damage to the kitchen cabinetry

Information: Evidence of moisture damage was identified to the kitchen cabinetry at the time of inspection .

It is suspected that this has occurred as a result of internal spills and possible damage to the cabinets allowing moisture to get inside.

A licenced carpenter or competent handyman may be engaged to inspect the moisture damaged areas and repair or replace any items where necessary.

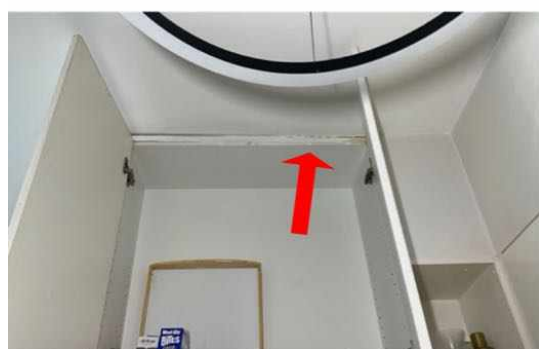
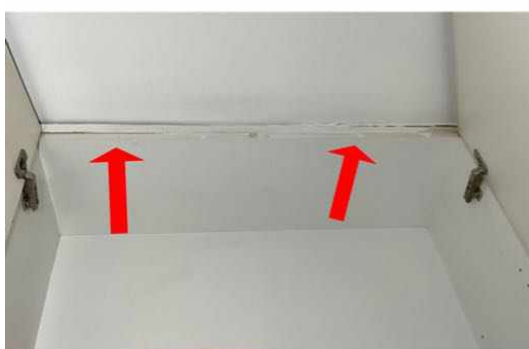
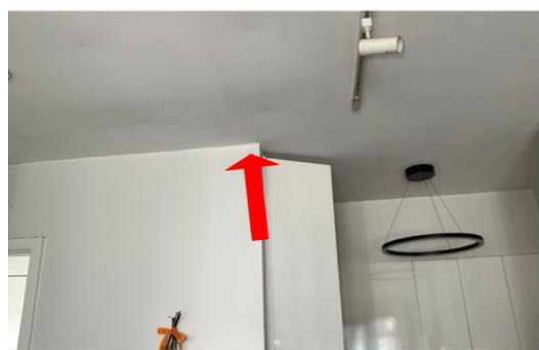
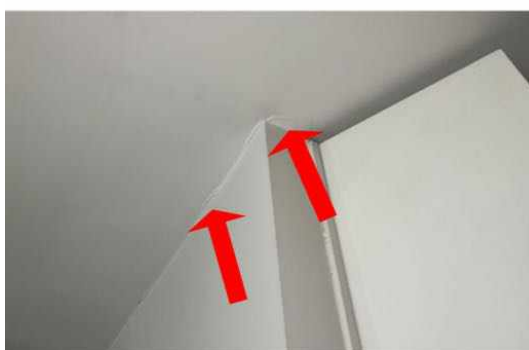
Finding 3.04

Finding: Ceiling - Suspected previous moisture damage

Information: At the time of inspection some moisture damage was noted to the ceiling within the kitchen. No current moisture was noted within the ceiling area when tested with a moisture meter.

Where moisture is evident to the ceiling, the primary requirement is to identify and rectify the source of the damage. Where there is current moisture noted (not observed here) a licensed plumber should be appointed as a matter of urgency to identify the leak and perform rectification works as necessary, ensuring any moisture damage is restricted.

As no current moisture was noted in the area , consultation with relevant tradespeople, including plasterers and painters, should be carried out.

Rectification works may include replacement of ceiling linings / cornices and/or minor repainting, depending on the extent of the damage.

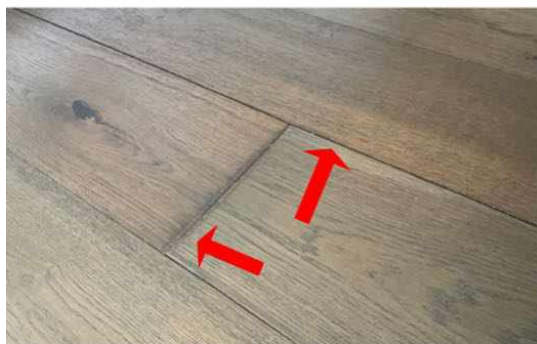
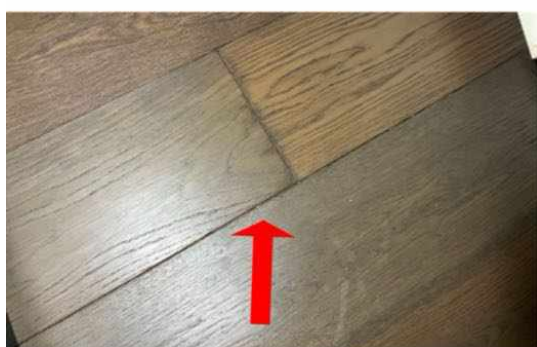
Finding 3.05

Building:
 Location: All Areas
 Finding: Damage to flooring due to previous water leak
 Information: Damage from a previous water leak was found in the flooring of the kitchen area at the time of inspection. There was no signs of any current leaking or moisture in the area when tested with a moisture meter.

It is suspected that the flooring will need to be replaced in the area. An invasive

inspection will be required to determine the extent of the damage. This would involve lifting and removing the damaged floor boards and inspecting the base underneath. Depending on the extent of the damage, repairs may range from replacing the floorboards through to replacing any damaged subfloor structures.

These works should be carried out as a priority.

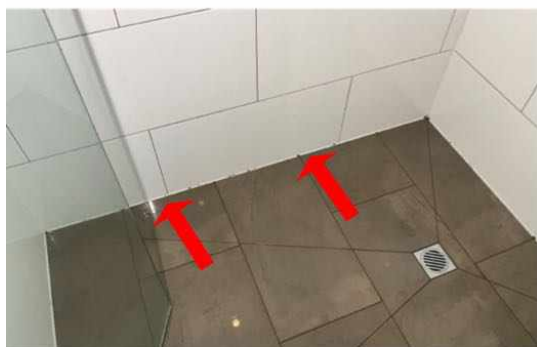
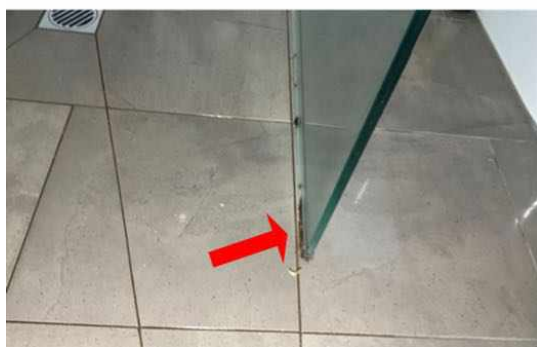
Finding 3.06

Grout / sealant - degraded within the bathroom area

It was noted on inspection that grout / sealant is degraded to the shower and other areas within the bathroom.

Different materials move at different rates, generally causing cracking to grout at this point. Build up of moisture in the bathroom can also cause grout and sealants to degrade and become mouldy.

Any damaged or degraded materials should be scraped out and flexible and mould resistant materials should be applied to affected areas to prevent any subsequent

water damage that may occur. Regular maintenance and replacement of damaged or missing grout/ sealant is highly recommended to the wet areas, as this is a regular wear and tear defect. Both grout and sealant in areas that come into regular contact with water should be maintained for the long term care of your property.

A bathroom specialist or tiling contractor should be appointed to complete these works as a priority.

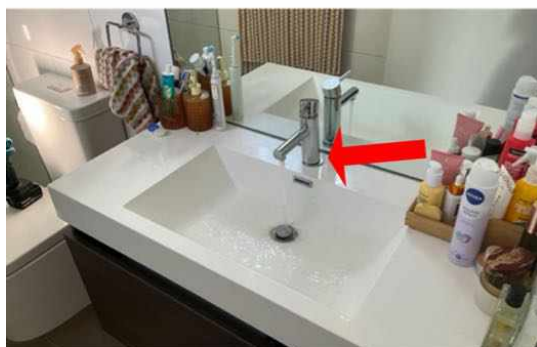
Finding 3.07

Finding: Tap - Loose

Information: The tap in this area has not been installed correctly, or has deteriorated with age, and is consequently loose. This tap being loose creates potential for water leaks and subsequent water damage to the surrounding area.

Where taps or spouts are loose, a qualified plumber should be appointed to re-fix the plumbing fitting as a matter of urgency.

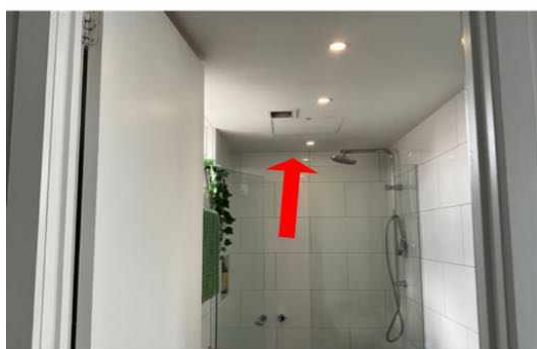
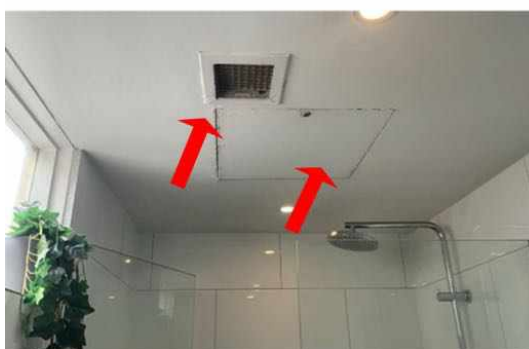
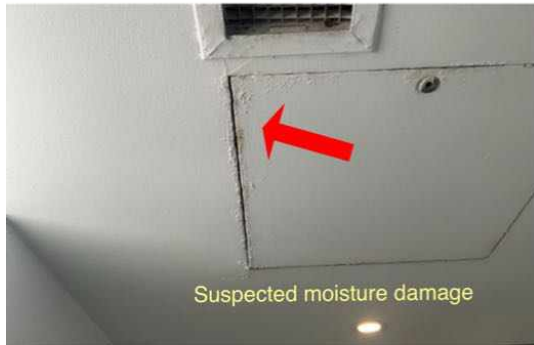
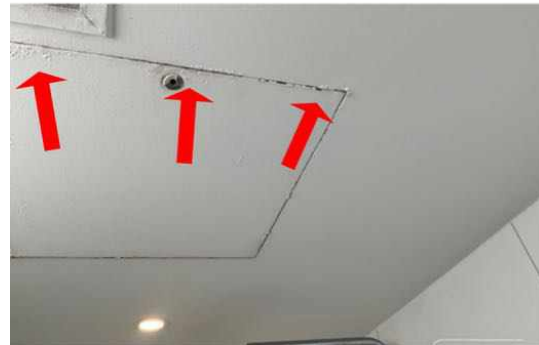
Finding 3.08

Information: The exhaust fan in the bathroom was not positioned above the shower - it was in the middle of the bathroom. This may lead to a build up of condensation above the shower which in turn can result in the development of mould. Some rusting and deterioration was noted around the services access hatch in the ceiling - suspected to be caused by a build up of condensation.

It is recommended that the ceiling above the shower be monitored for any signs of condensation build up or mould. Should this occur, consultation with a licensed electrician should be carried out to inspect the area and look at ways to improve the exhausting in the area.

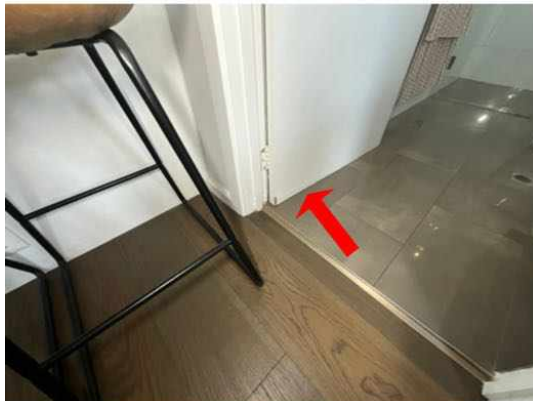
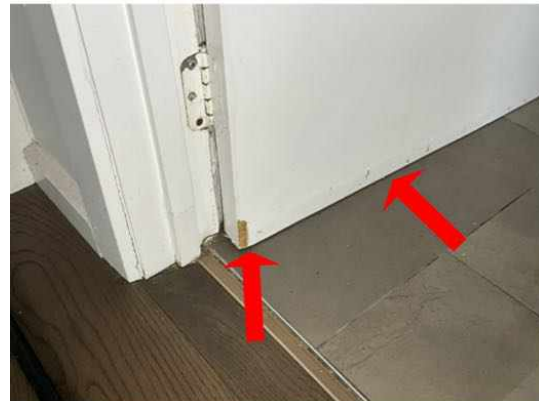
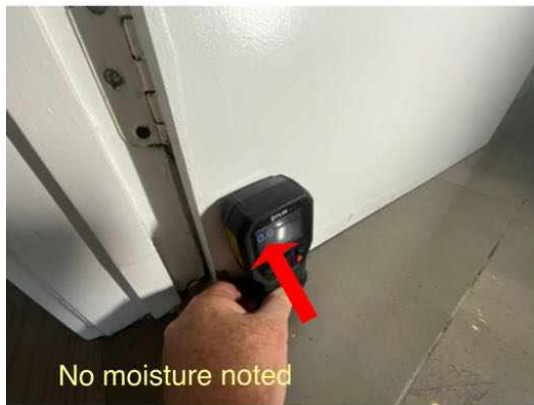
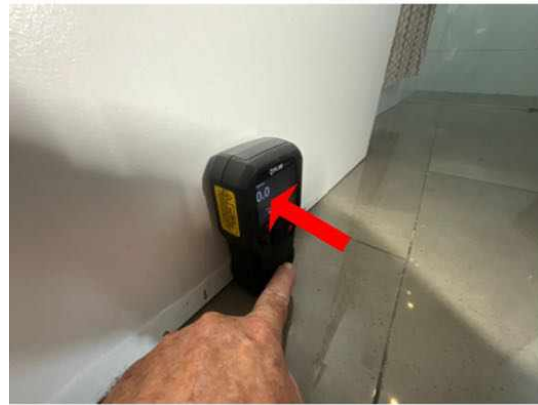
Finding 3.09

Finding: Door showing signs of moisture damage

Information: At the time of inspection there appeared to be some moisture damage to the door to the bathroom. No current moisture was noted in the door at the time of inspection.

A suitably qualified handyman may be engaged to remove door, repair any damage, paint the door including top and bottom and rehang them.

If the door cannot be repaired, a new door may be required.

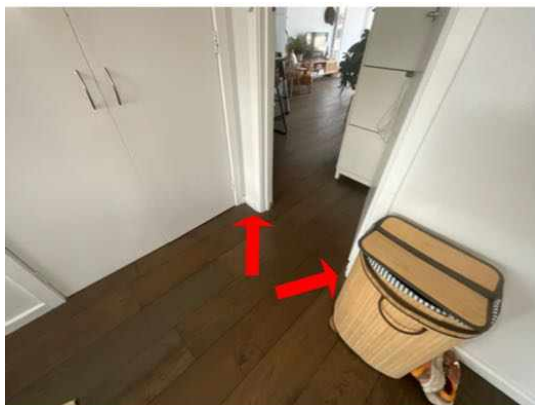
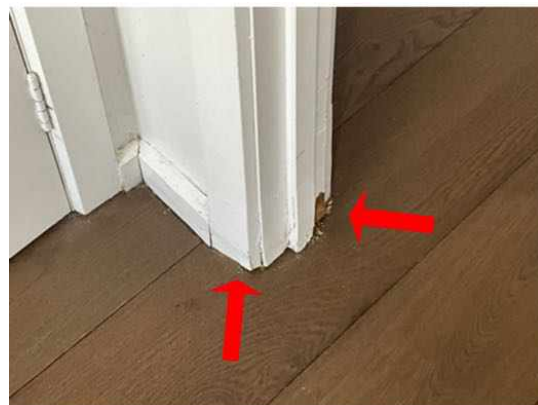
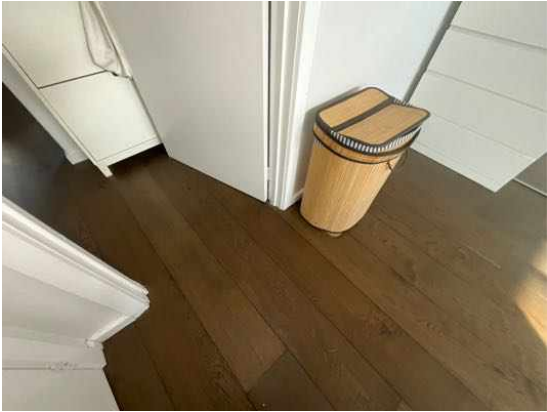
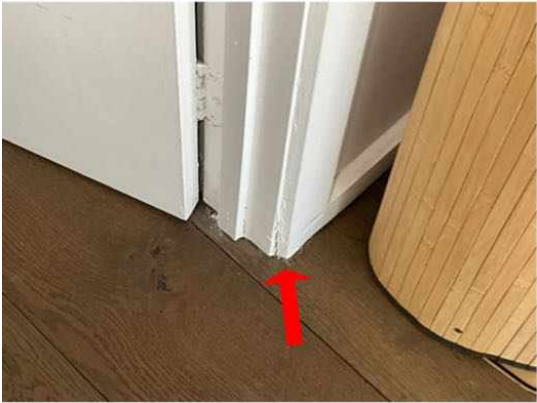
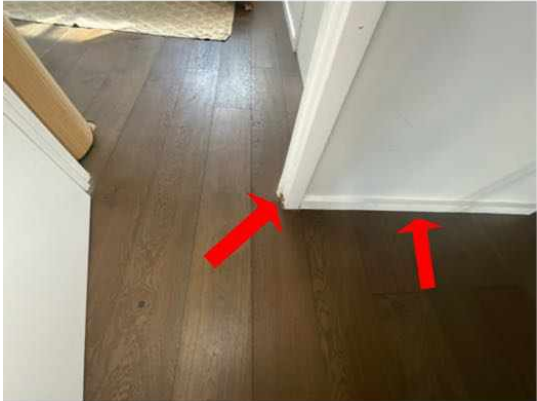
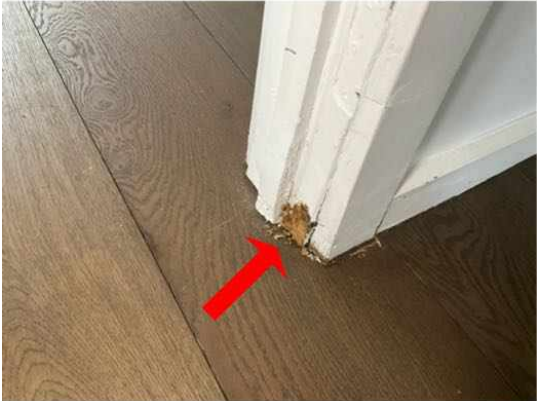
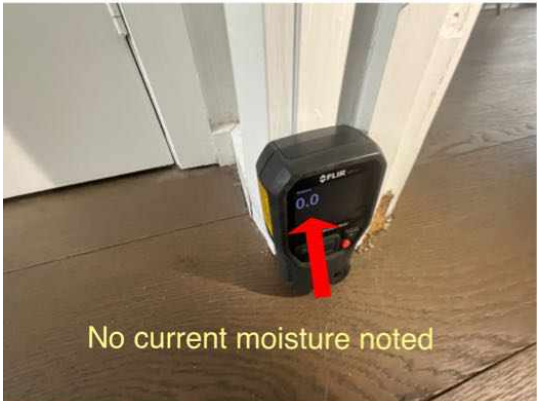
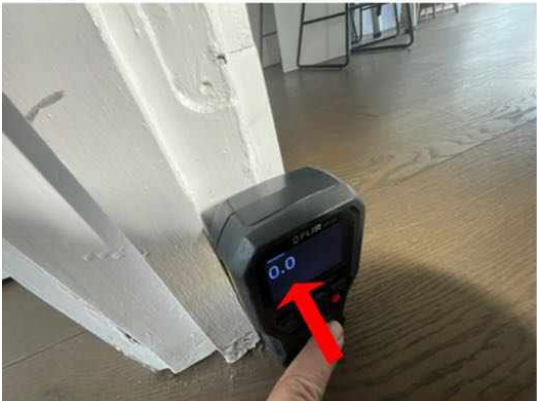
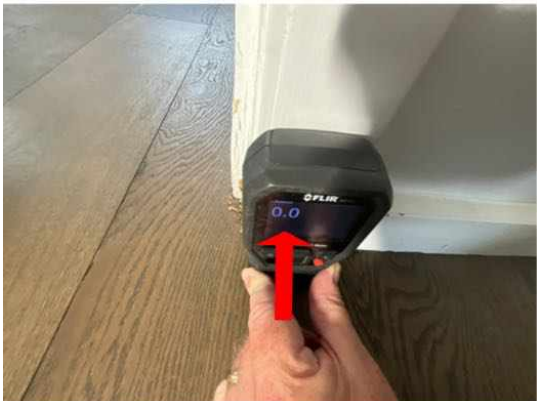
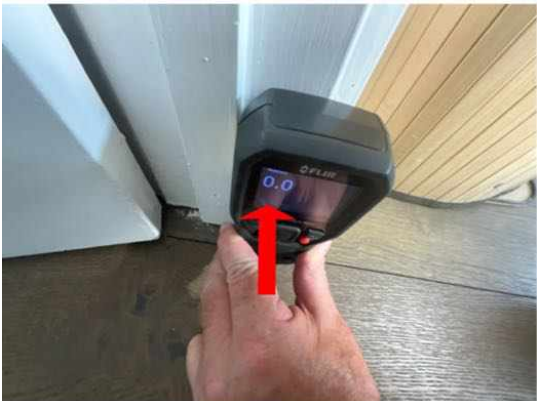
Finding 3.10

Finding: Moisture damage to skirting board and architrave in various areas

Information: Evidence of moisture damage was identified to the skirting boards and door frames in these areas.

It is suspected that this has occurred as a result of excess moisture from the leak as noted in the report earlier. No current moisture was noted to the areas when tested with a moisture meter.

A licenced carpenter or competent handyman should be engaged to inspect the moisture damaged areas and repair or replace any items as necessary.

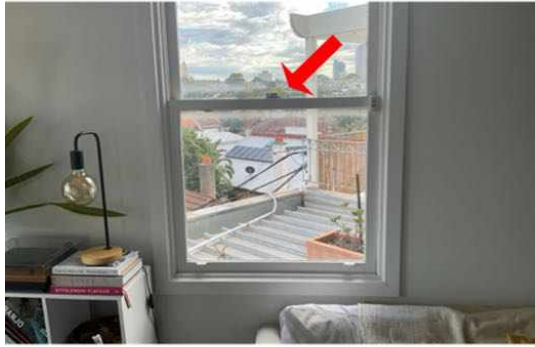
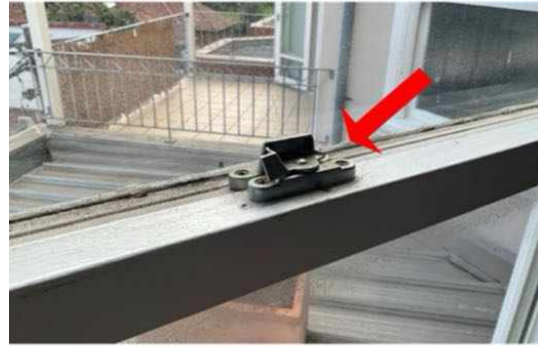
Finding 3.11

Windows provide ventilation to the area and should be at a fully operational level to ensure user comfort. If windows can not be opened, this can also provide a potential safety hazard and must be addressed as a matter of urgency.

A suitably qualified window installer or carpenter may be engaged to rectify this.

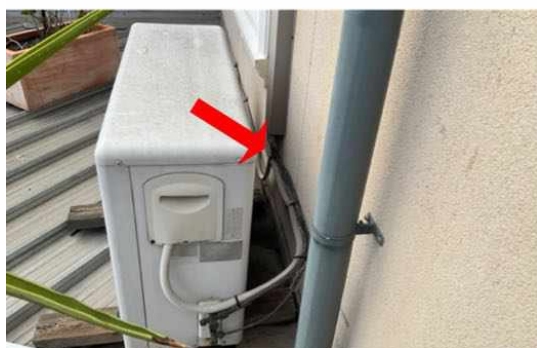
Finding: Pipework - Insulation deteriorated

Information: Sections of the pipe insulation show evidence of damage and deterioration. It is

suspected that this deterioration has developed as a result of excessive exposure to weather, including UV exposure in daylight. Deteriorated insulation reduces the effectiveness of the material in helping to maintain the desired temperature and work most efficiently.

If left in an exposed position, it is likely that the deterioration will continue and worsen over time, potentially resulting in secondary building defects as well as a further loss in insulating properties.

Some areas of replacement of pipe insulation is likely to be required. Further preventative measures to remove or protect the material from future exposure are also advisable. Consultation with a licensed plumber is advised to gain quotes for the repair and/or replacement of deteriorated insulation.

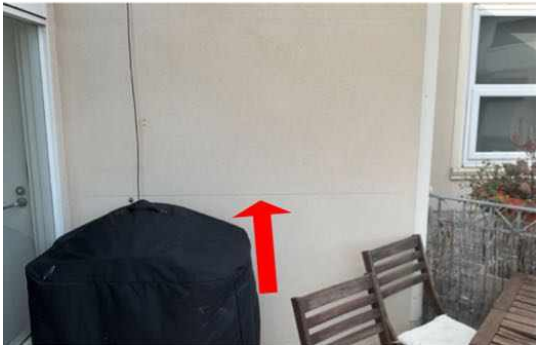
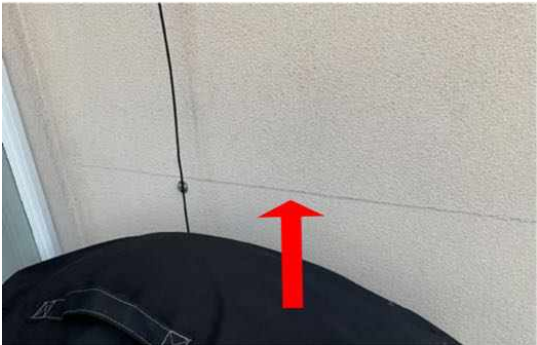
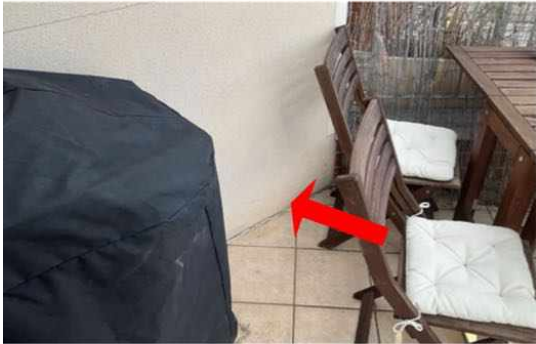
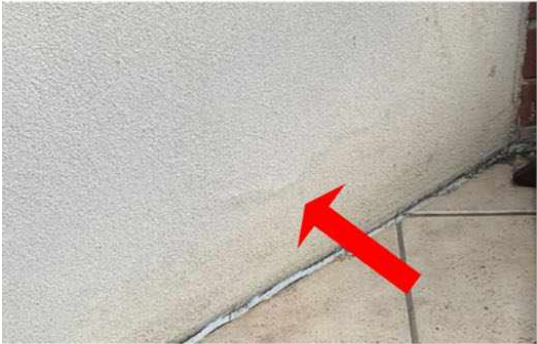
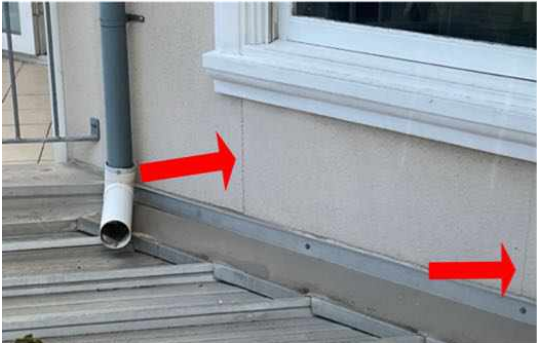
Finding 3.14

| Finding: | Rendered wall - minor cracking |
| Information: | Minor cracking to the rendered wall was identified at the time of inspection. It is suspected the cracking has occurred in the joints between various cement sheets on the wall. |

This type of cracking is often consistent with general movement of the foundations of the property and is not considered a major structural defect.

Whilst it is more of an appearance issue, repairs may be required as failure to act may allow moisture to enter the crack and cause secondary damage to other building elements.

Consultation with a suitably qualified renderer should be sought to determine costs involved with any repairs necessary.

Should cracks increase in size or number, speak with your building inspector for further advice.

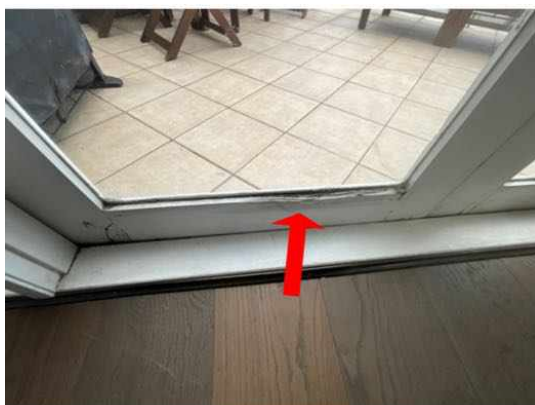
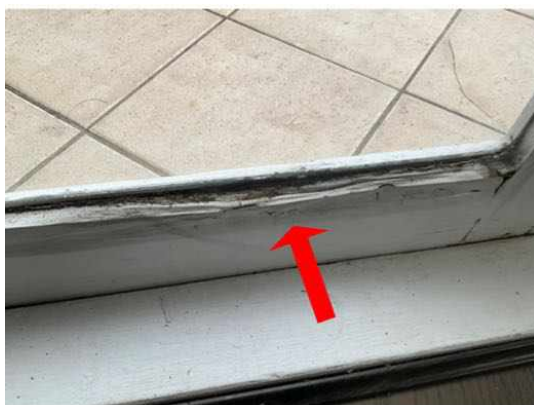
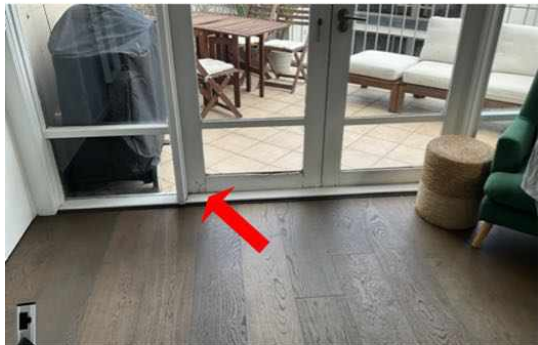
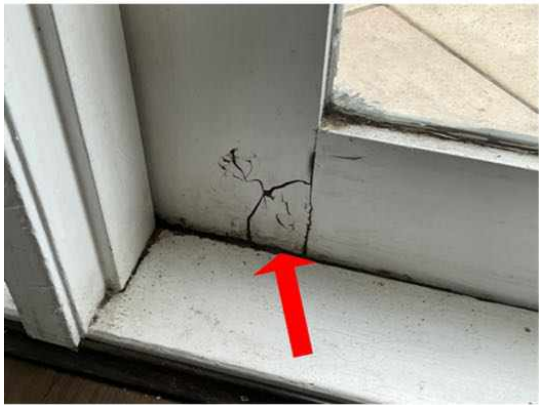
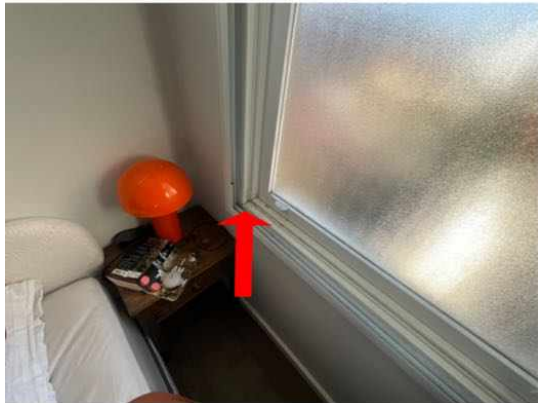
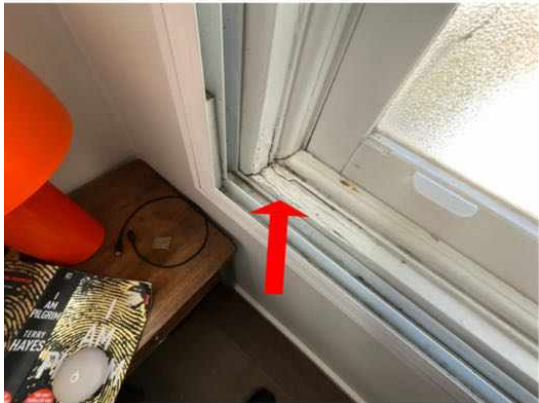
Finding: Fungal decay - conditions conducive to timber pest attack

Information: Fungal decay also known as wood decay or wood rot generally refers to the deterioration of timber elements when in contact with excessive levels of moisture for a prolonged period of time.

Generally fungal decay develops on timber elements that are in use in an external environment which are exposed to rain penetration.

Decaying timbers can create an environment conducive to timber pest attack. It is recommended that the decaying timbers be repaired / replaced to lessen the risk of timber pests.
