Building and Timber Pest Inspection Report

Inspection Date: Mon, 9 Mar 2026

Property Address: 71/3 Taylor St, Lidcombe NSW 2141,
Australia

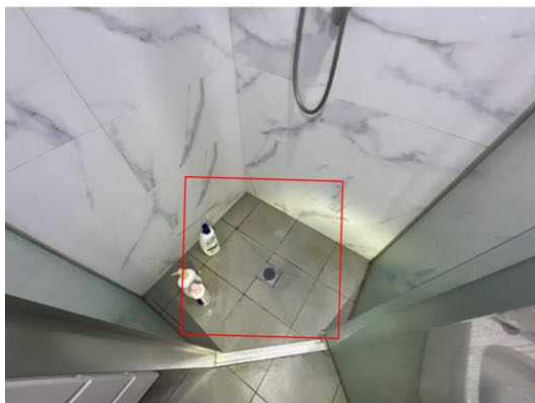
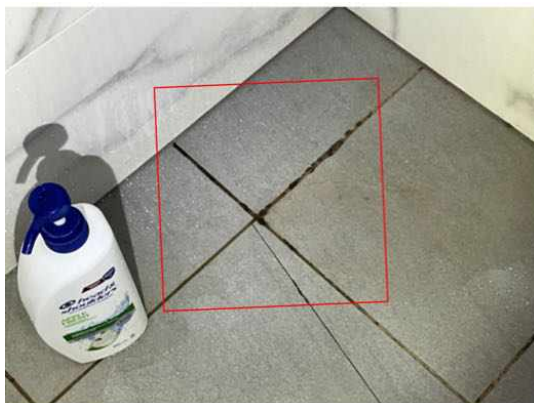
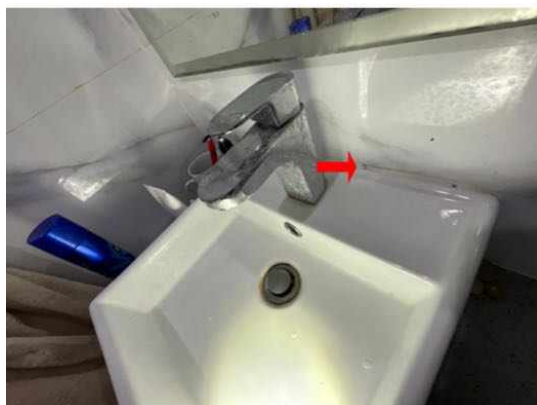
Finding 3.01

Building: Main Building
Location: All Wet Areas
Finding: Sealant and grouting - Missing or damaged
Information:

It was noted on inspection that sealant or grout is degraded to this area.

Different materials and floor areas move at different rates, generally causing cracking to grout or sealant at this point. A flexible sealant is required to allow for expected expansion and contraction, while keeping the joint water tight and protective of all associated building materials.

Flexible and mould resistant materials should be applied to affected areas to prevent any subsequent water damage that is likely to occur. Regular maintenance and replacement of damage or missing or damaged sealant and grout is highly recommended to the wet areas, as this is a regular wear and tear defect. Sealant and grouting in areas that come into regular contact with water should be maintained for the long term care of your property.

A sealant specialist should be appointed to complete these works as soon as possible.

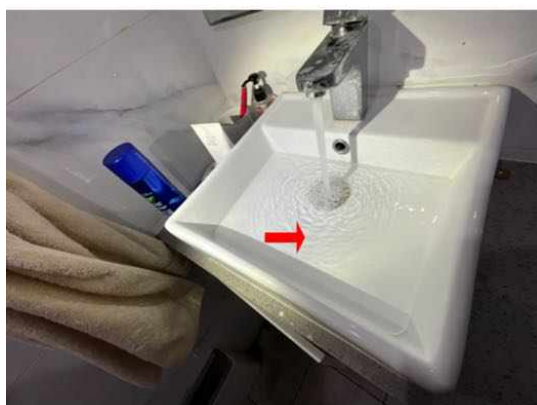
Finding 3.02

Building: Main Building
 Location: Bathroom
 Finding: Sink/basin - slow draining
 Information:

The sink/basin drain appeared to be partially blocked at the time of inspection. Blockages here are usually caused by hair and other debris. If left unmanaged, a lack of general maintenance may lead to the development of more significant defects, such as water damage to surrounding building materials.

A licensed plumber should be appointed to remove the blockage at the client discretion.

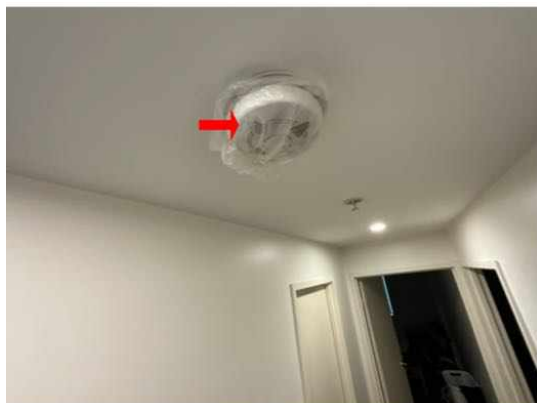
Finding 3.03

Building: Main Building
 Location: Hallway
 Finding: Incomplete or substandard works
 Information: The works to this area appear to be incomplete or have been completed to a substandard level. The smoke alarm cover must be removed.

Works that have not been completed to a satisfactory level create potential for the

development of building defects and may impede on the safety and integrity of the overall structure.

It is highly recommended that a general handyman be appointed to complete these works and ensure the safety of the area and the longevity of all associated building elements.
