# Building and Timber Pest Inspection Report

Inspection Date: Tue, 24 Feb 2026

Property Address: 33/9 Miller St, Fitzroy North VIC 3068,  
Australia

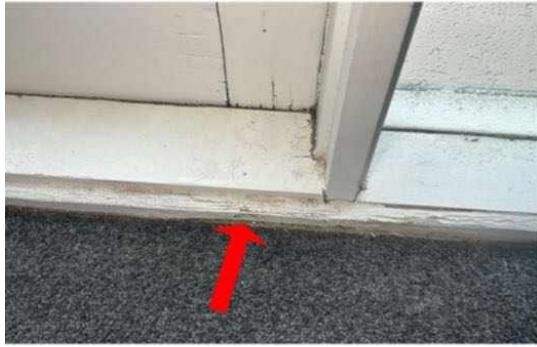
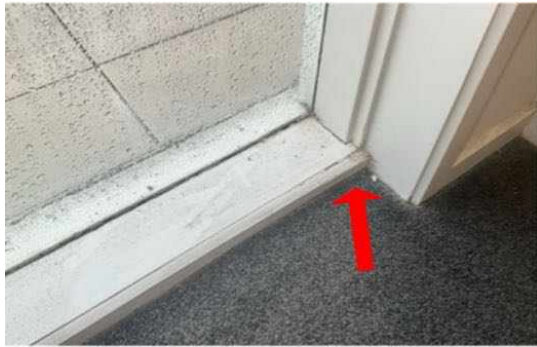
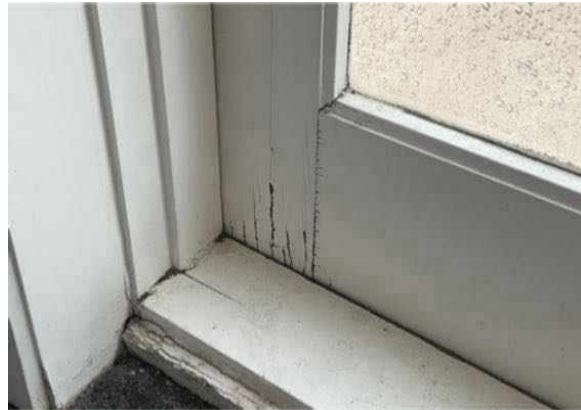
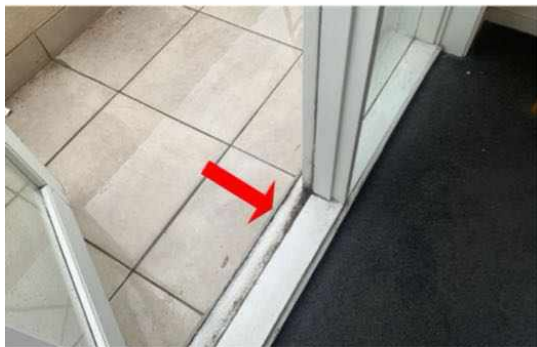
Finding: Moisture damage to skirting board and architrave at balcony door ( major defect)

Information: Evidence of moisture damage was identified to the skirting boards and door frames next to the balcony doors. Wood rot was noted within some areas of the framing. It was noted that the doors did not close properly which appears to have contributed to the moisture getting in a causing secondary damage. Water was actually sitting on the base of the frame inside the door. This defect is listed as a major defect\*

It is suspected that the damage has occurred as a result of excess moisture from external sources. Moisture was noted in some areas when tested with a moisture meter.

It is suspected that this may be an ongoing problem as there is no cover to prevent rain from directly hitting this area. If possible, an awning above these doors may provide some protection.

A licenced carpenter or competent handyman should be engaged as a matter of urgency to inspect the moisture damaged areas and repair or replace any items where necessary.

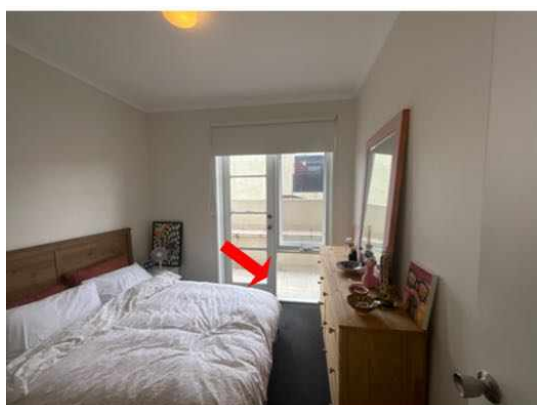
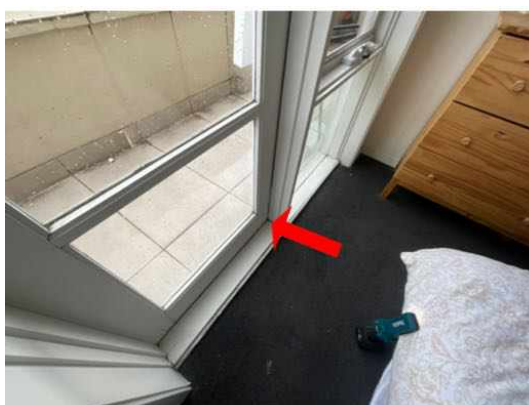
Information: At the time of inspection, both door in the bedrooms did close and lock effectively. The left hand bedroom door closed but not completely flush with the framing. It is suspected that the door may be slightly warped due to moisture. The right hand bedroom door didn't close fully - suspected striker plate misalignment.

The doors should be inspected and repairs made as a matter of urgency. Failure to rectify these defects may result in further moisture ingress within the property.

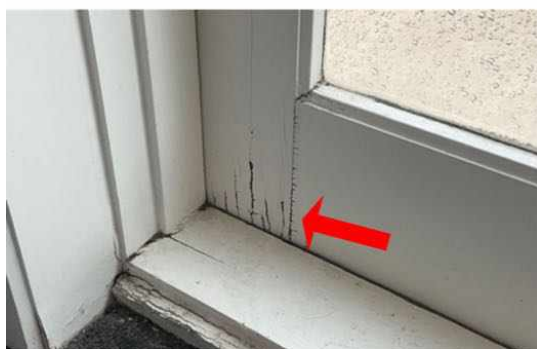
### Finding 2.03

Finding: Doors - Moisture damage and Wood rot noted

Information: Moisture damage and Wood rot was found to be affecting the external doors in this area. Wood rot, also known as Fungal Decay, occurs when timbers and other cellulose building materials are exposed to damp conditions on an ongoing basis.

It is likely that this wood rot has developed as a result of frequent exposure to rain and other weather conditions. It is suspected that failure to maintain the door over a prolonged period has resulted in it deteriorating at an accelerated rate, increasing its susceptibility to the development of wood rot. Constant exposure to the weather may have also contributed to the formation of the wood rot in this area.

Replacement of the affected door will be necessary.

A qualified carpenter or competent handyman should be engaged as a matter of urgency to perform this task..

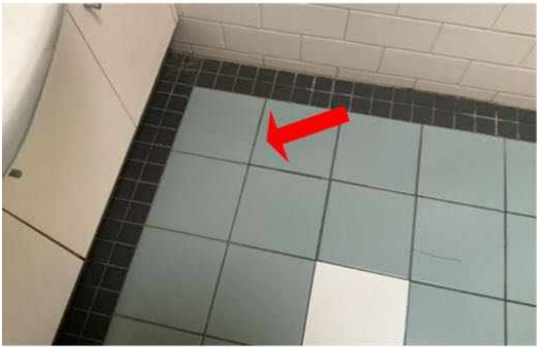
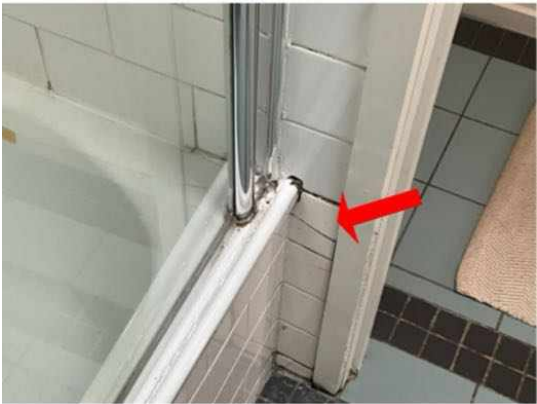
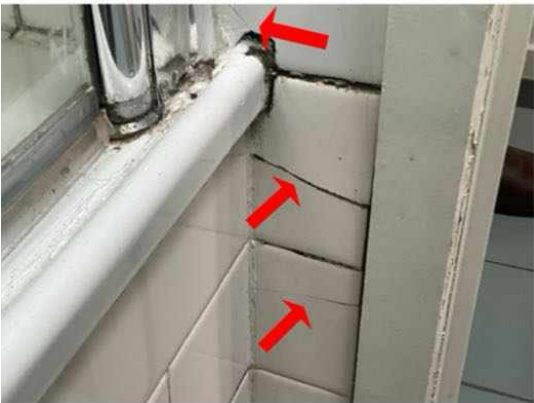
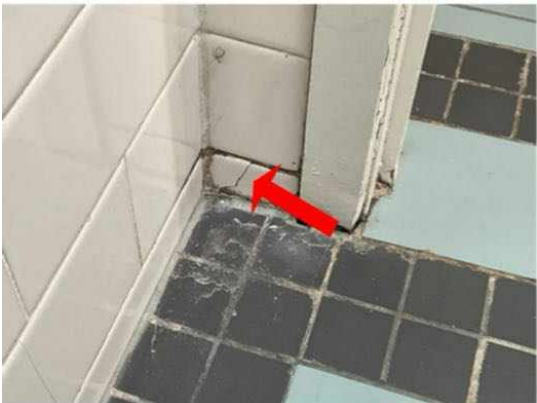
### Finding 2.04

Finding: Wet area tiles - Cracked or damaged

Information: Cracking was evident to the tiling in this area at the time of inspection. While the cracking appears to be minor, this area is frequently exposed to water, allowing potential for water penetration into adjoining sections of walls or flooring ( as was noted here)

It is suspected that the base underneath the floor tiles is also damaged or has not been installed correctly as the tiles appeared not to be stable in this area. The base may have been damaged by moisture via the leaks from the shower. It is suspected that the tiles will need to be lifted, a new base installed and new tiles laid.

If left unmanaged, water penetration in these areas will lead to further water damage, which is likely necessitate repair work to affected building elements.

Where water penetration has led to water damage, appointment of a relevant tradesperson will be required to repair damaged building elements.

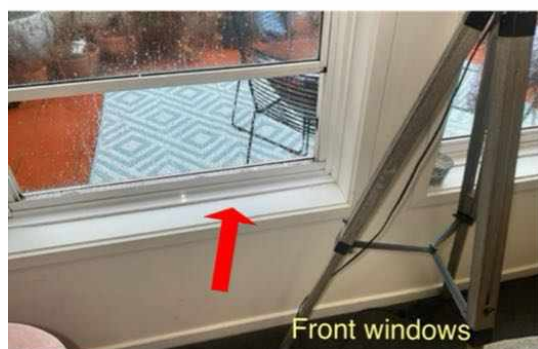
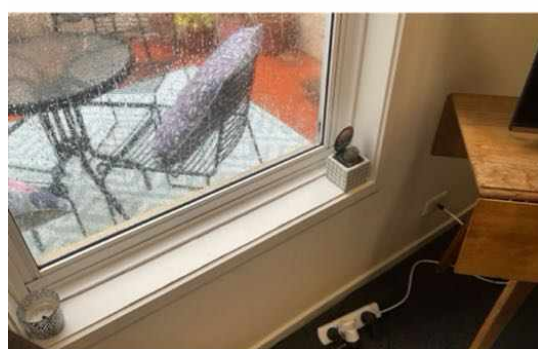
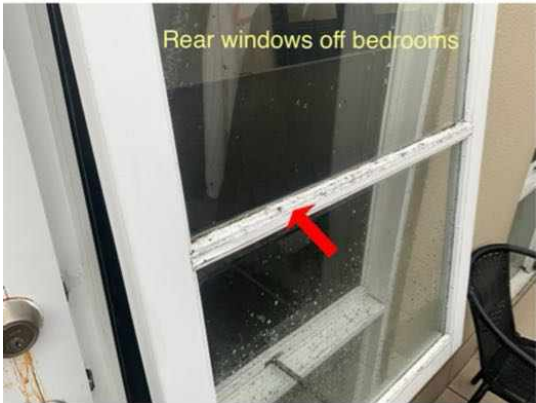
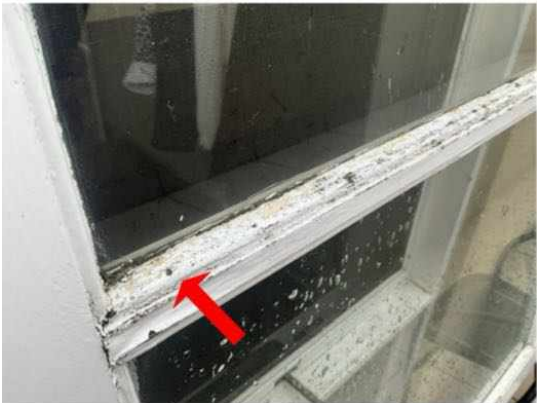
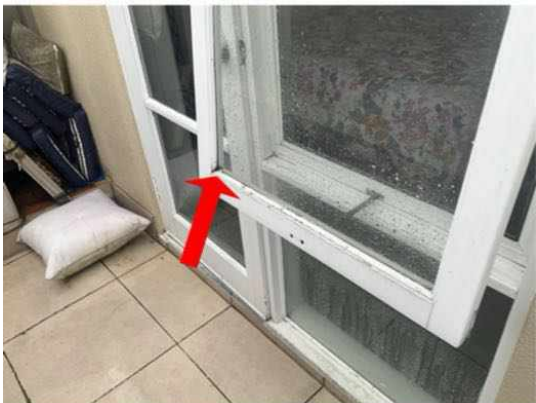
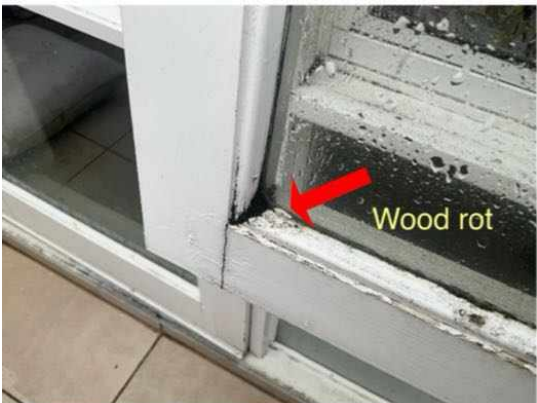
## Finding 2.05

Finding: Moisture damage to the windows

Information: At the time of inspection, moisture damage was noted to the insides of the windows of the living room and also to the outside of the windows off the rear bedrooms . Wood rot was noted to the rear windows.

It is suspected that a breakdown in the sealant around the glass in the front windows may be allowing moisture to get inside the windows. Lack of maintenance of the external windows ie painting has probably contributed to the damage at the rear.

The sealant around all window should be replaced so as to ensure no further the moisture gets into the property. Repairs to damaged window frames should be carried out and all windows repainted.

A window specialist or a competent handyman maybe engaged to perform this task as a matter of urgency.

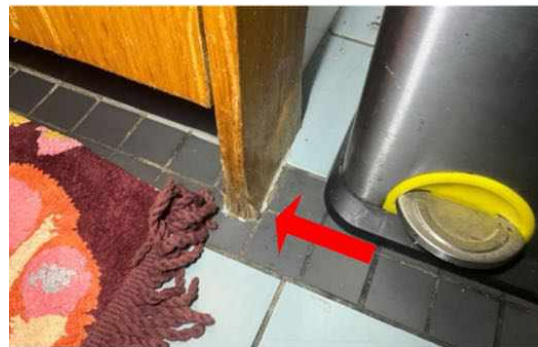
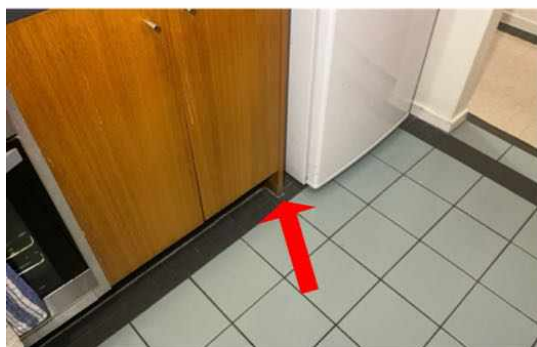
### Finding 3.01

Finding: Moisture damage to the kitchen cupboards

Information: Evidence of moisture damage was identified to the kitchen cupboards at the time of inspection .

It is suspected that this has occurred as a result of excess moisture from internal spills. No current moisture was noted in the area when tested with a moisture meter.

A licenced carpenter or competent handyman should be engaged to inspect the moisture damaged areas and repair or replace any items where necessary.

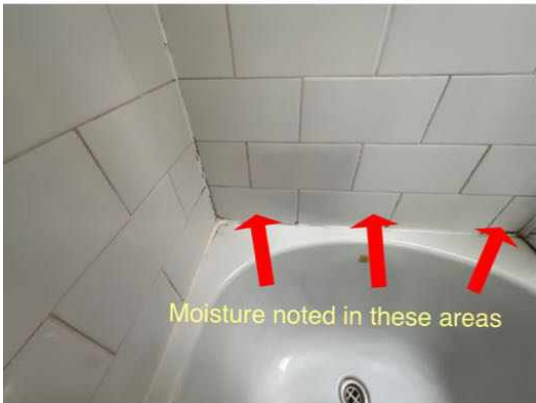
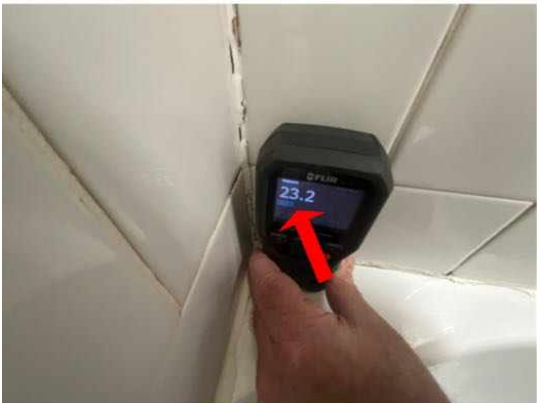
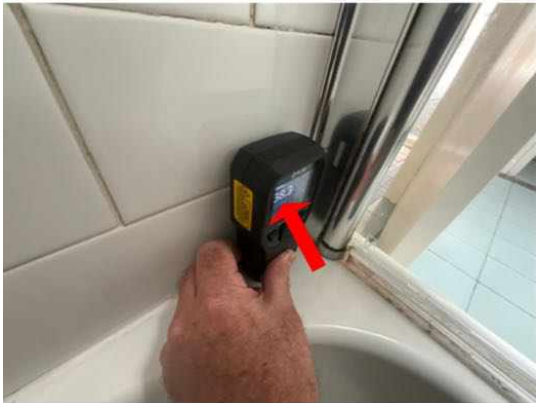
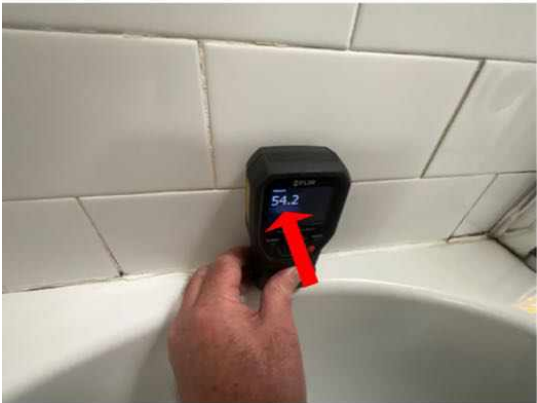
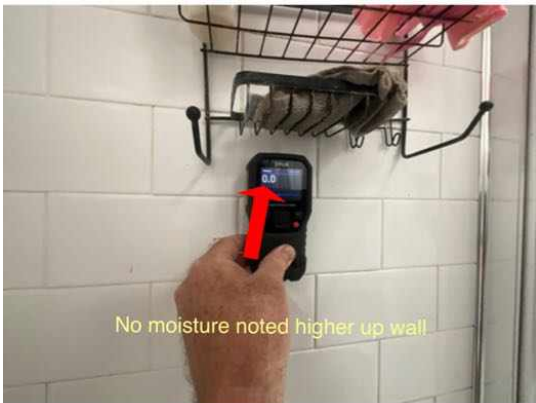
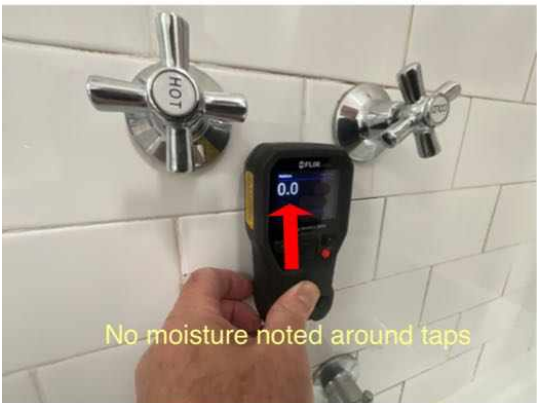
### Finding 3.02

Finding: Shower - Damp noted within wall of shower

Information: Damp was evident to the lower part of the tiled walls within the shower alcove when tested with a moisture meter. This defect is quite common, and is suspected to have been caused by moisture permeating through the grouting in this area, which shows evidence of deterioration. Leaking pipes within the adjoining wall is also a possible cause although there was no moisture noted higher up the wall nor to the wall in the bedroom or living area behind the shower.)

Should the damp continue and/or staining to the walls behind the bathroom occurs, consultation with a qualified plumber or bathroom specialist would be advised immediately to identify the cause of damp and to perform remedial works as required.

Always ensure that sealant and grout is in good condition to prevent any moisture issues occurring in the future.

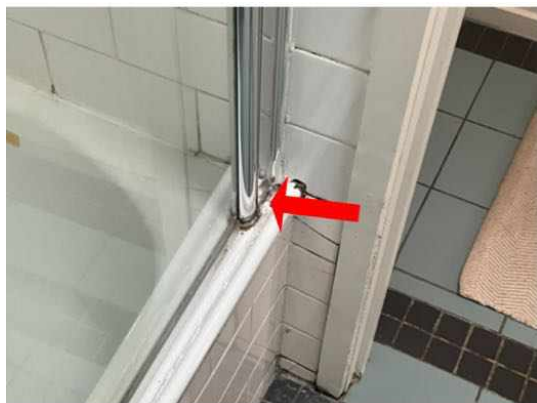
Building:  
 Location: Bathroom  
 Finding: Shower screen seal - Leaking  
 Information: Leaking was evident to the shower screen close to where it meets the wall at the time of inspection. It is suspected that the leaking has occurred as a result of the screen not being sealed correctly in this area.

Leaking from the shower , where left unattended, can lead to water damage and necessitate extensive remedial works being required. Active water leaks may also create an environment that is susceptible to the formation and development of mould.

Appointment of a tiling contractor or competent handyman is required to repair / replace the sealant. Such works should be performed immediately to ensure that no further damage occurs.

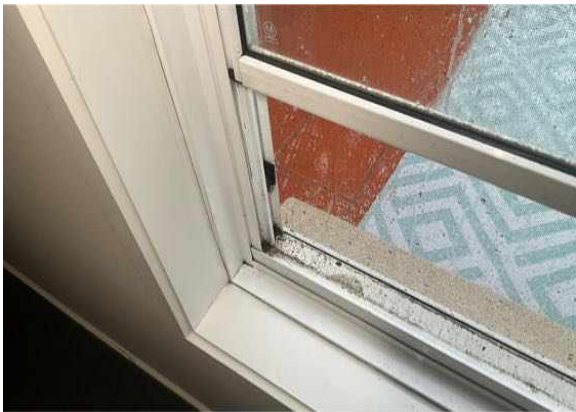
Information: At the time of the inspection, the windows in this area were sticking slightly when opened. Windows provide ventilation to the adjoining area and should be at a fully operational level to ensure user comfort. Restricted function of the window may also create potential for secondary defects to the associated building elements, such as damage to the window frames as well as a potential safety hazard if required for emergency egress from the building.

The most usual causes of sticking with aluminium windows is slight misalignment of window within frame, buckling of the frame, or stiffness from lack of use. Easement may be required, which may involve slight adjustment to the window frames. It will almost always include ensuring the areas are cleaned and free of any debris that may be detrimental to their operational state.

A competent handyman can be engaged where necessary to address this issue.

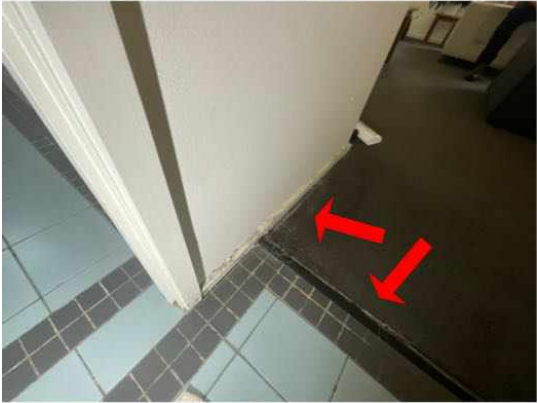
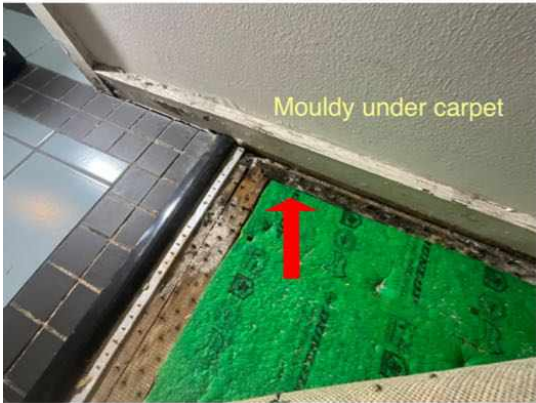
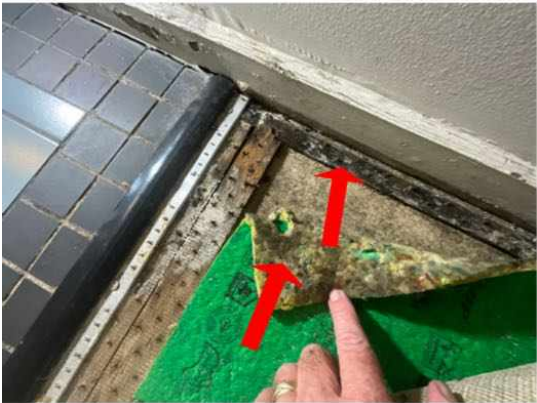
**Finding 3.07**

Building:  
 Location: All Areas  
 Finding: Carpet deteriorated in some areas  
 Information: At the time of inspection, some areas of the carpet throughout the property showed signs of wear . This is consistent with properties of this age.

The carpet may be replaced at the discretion of the homeowner.

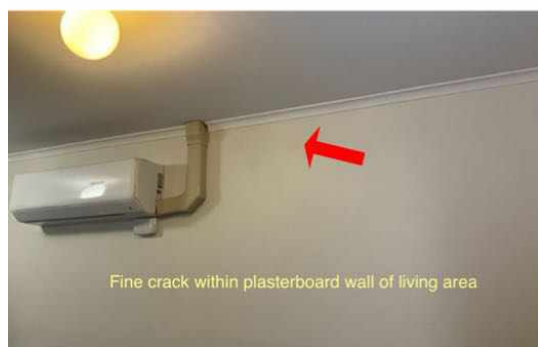
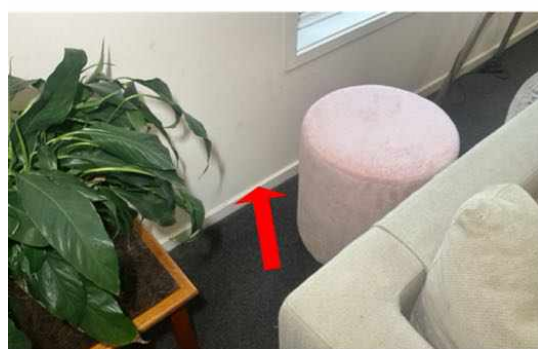
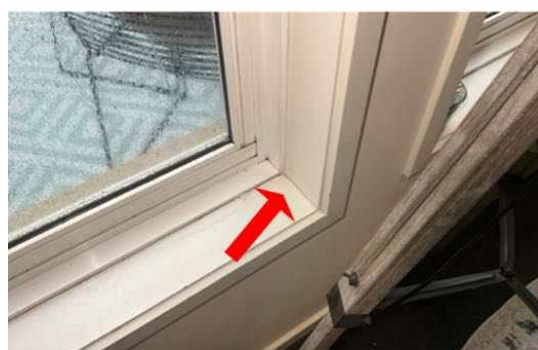
Building:	
Location:	All Areas
Finding:	Cracking - fine
Information:	Some fine cracking was noted throughout the property.

Although fine cracks are quite noticeable, they are often only considered to be an appearance defect, and usually do not indicate any structural damage. Generally, the cause of a fine crack is indicative of a separation between building materials and finishes (e.g. paint, plaster, etc.) along joints.

Cracking of this nature can generally be repaired with minor sanding, filling and/or repainting. Such works should be performed by a qualified painter or a general handyman.

Monitoring of all cracking should be conducted frequently. Always contact a building inspector should cracks widen, lengthen, or become more numerous.

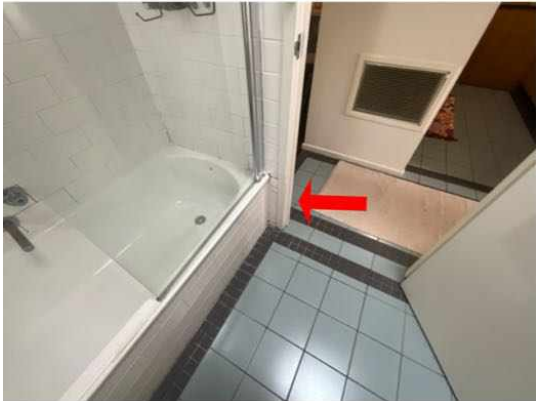
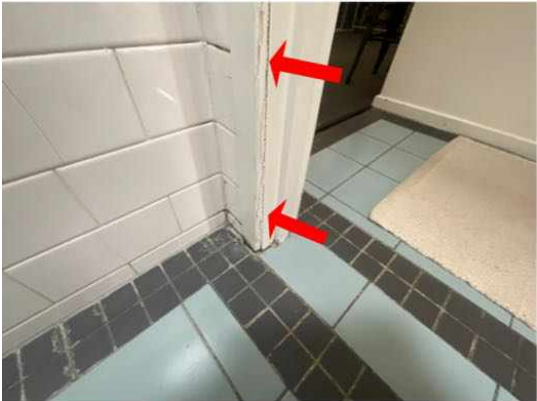
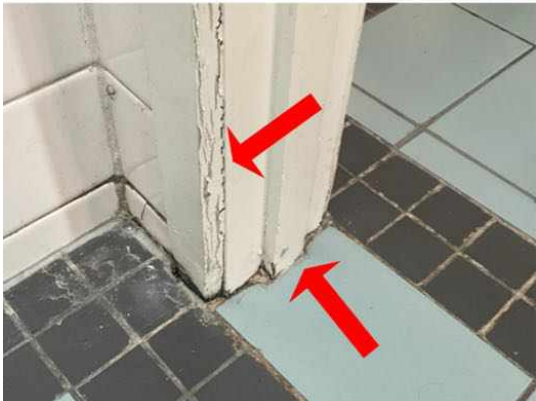
### Finding 3.10

Finding: Moisture damage to door frame and possible lack of a water stop.

Information: Evidence of moisture damage was identified to the door frame in the bathroom. It is suspected that this has occurred as a result of excess moisture from internal spills and possible moisture getting into the frame from under the tiles.

waterproofing system in the bathroom. Having gaps at either end means the water stop is not complying with current standards. Standards have changed however over the years and bathrooms only needed to meet the standards that were applicable at the time of installation.

It is highly recommended a Tiler be engaged to inspect the area to improve the water tightness of the bathroom and prevent moisture exiting. This could involve sealing the ends of the water stop, through to installing new stops.

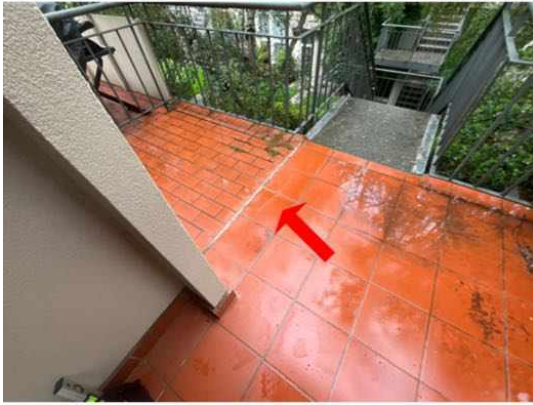
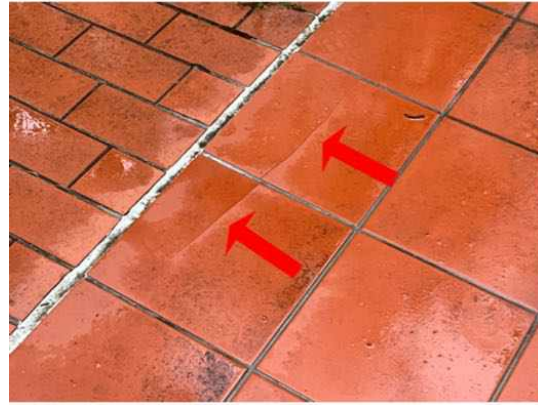
Building:  
 Location: Balcony  
 Finding: Fine Cracking - External Paving ( probable owners corporation issue)  
 Information: Fine cracks were identified in external paving. Although fine cracks are quite noticeable, they are often only considered to be an appearance defect, and usually do not indicate any structural damage.

Generally the cause of a fine crack in existing paving such is indicative of expansion and contraction. Such causes are generally due to environmental factors, such as moisture levels, weather conditions, root systems of nearby trees or the soil types on which they are laid.

Fine cracks may also be due to poor original installation of the pavers. Factors such as poor compaction of the sub surface and/or inadequate reinforcing of the base may create cracking and other secondary defects.

Monitoring of all cracking should be conducted frequently. Always contact a building inspector should cracks widen, lengthen, or become more numerous.

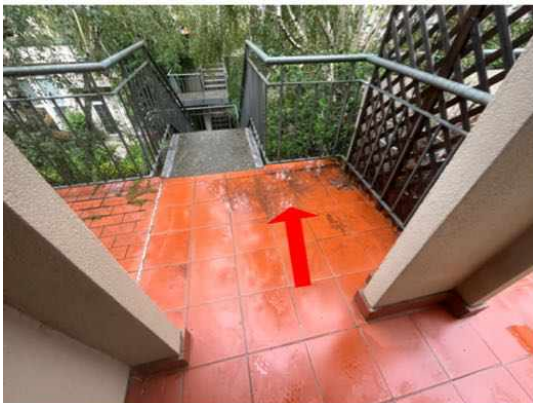
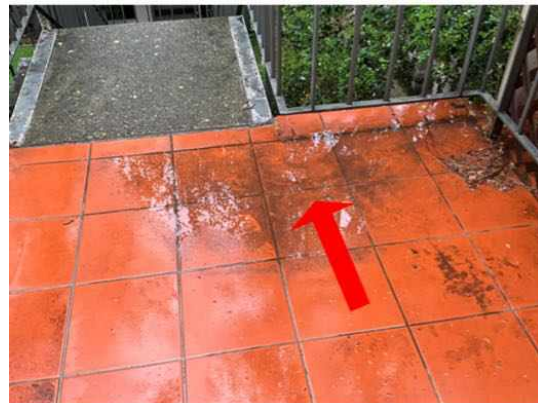
### Finding 3.13

This pooling of water can cause a slipping hazard, along with allowing mould to build up in the area.

It is suspected this defect would be covered by the owners corporation. A tiler may be engaged to inspect the area and make any necessary repairs/ improvements.

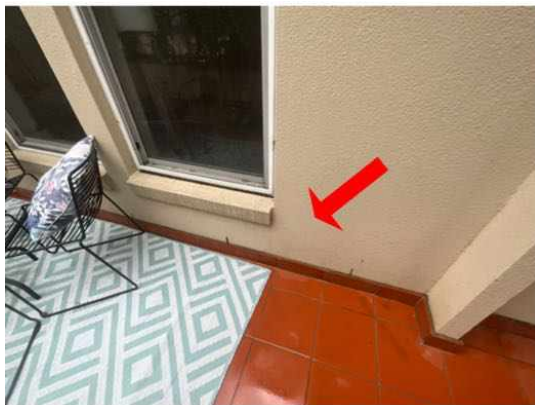
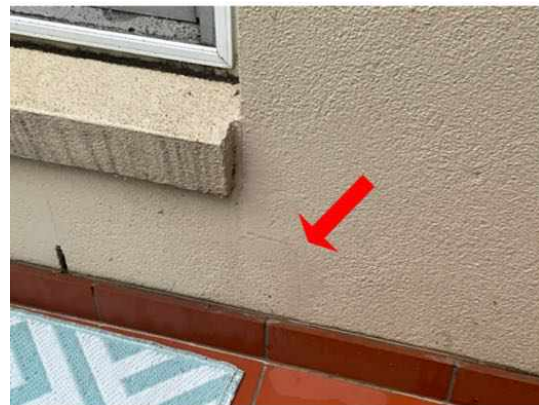
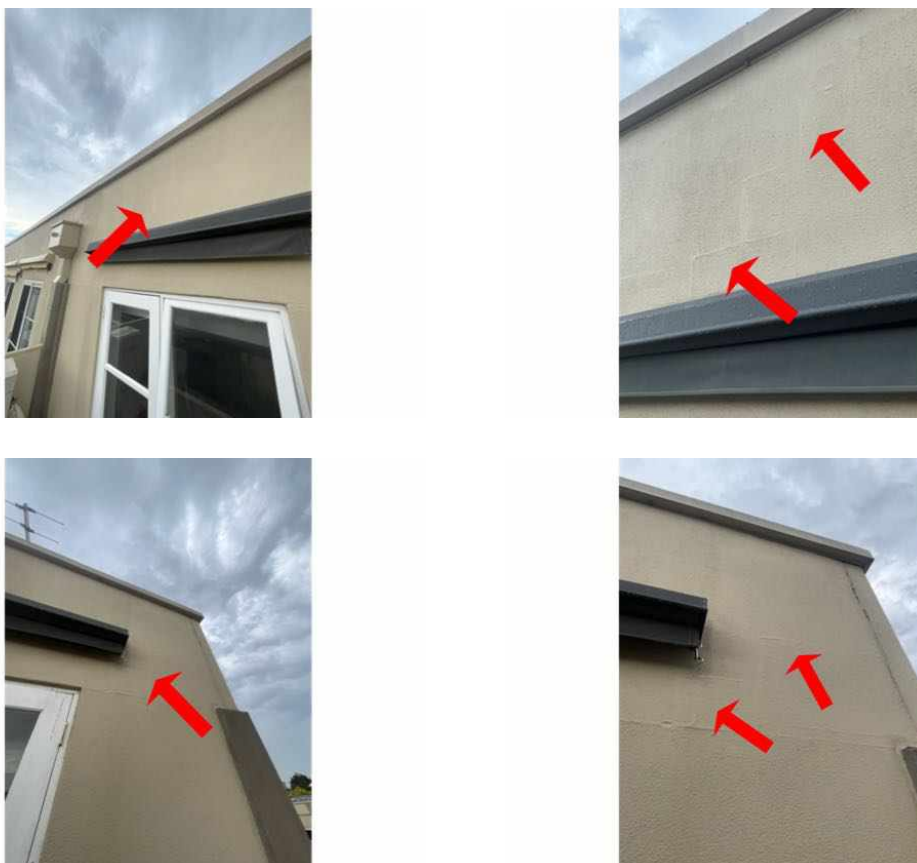
### Finding 3.14

Finding: Brickwork - Step cracking ( possible owners corporation issue)

Information: Step cracking was identified to the external walls in these areas at the time of inspection. Step cracking, which is similar to other forms of cracking, has a variety of

possible causes. However, the most common is movement in the wall or the subsidence of adjacent footings.

Step cracking is a relatively common defect, and is most likely to occur adjacent to windows, doors and other openings. Mortar failure in the gaps between affected block work indicates the stresses and tensions affecting the wall.

It is highly recommended that the cracking be monitored for a period of time e.g. six months, to determine if there is any further cracking or active movement within the bricks. Should no further cracking or movement occur, the bricks may be patched by qualified bricklayer.

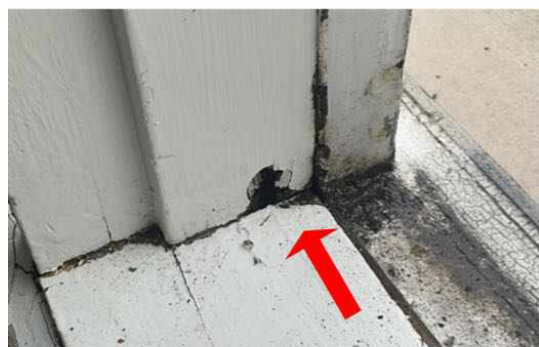
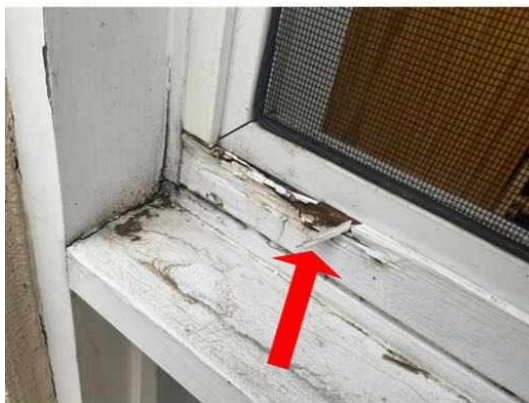
Building:	
Location:	All External Areas
Finding:	Fungal decay - present (localised)
Information:	Fungal decay also known as wood decay or wood rot generally refers to the deterioration of timber elements when in contact with excessive levels of moisture for a prolonged period of time.

In this case although the affected timber element is in a decaying state the extent of any visible damage appears to be localised to a specific area and is yet to spread to other parts of the building element or affect adjoining structures. The fungal decay is therefore likely to be of a relatively superficial nature with minimal impact on the structural integrity or tensile strength of the timber element.

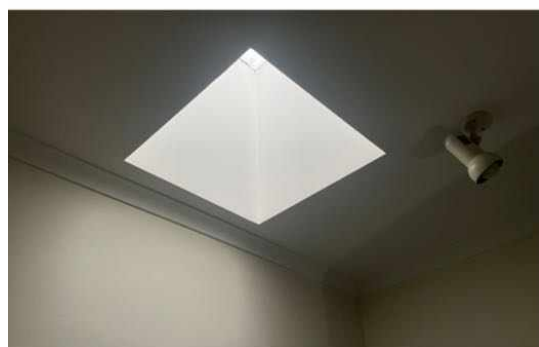
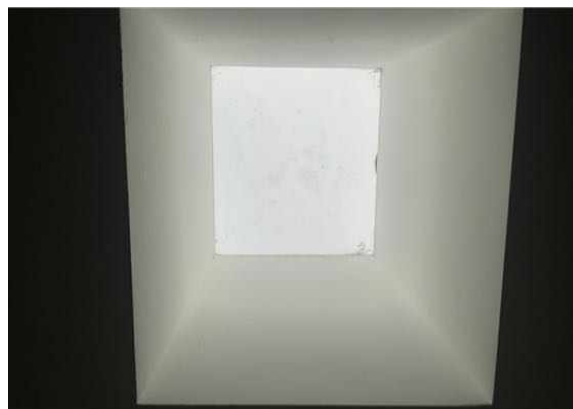
The ceilings around the skylights should be regularly monitored for any evidence of moisture leaking eg staining or bubbling of paint.

Where moisture damage is evident, a plumber should be appointed as soon as possible to identify the leak and perform rectification works as necessary, ensuring the moisture damage is restricted.
